Expertise

Protocol number: 46265926
Order No. / Reference: 26423893
Inspection date: 1 Jul 2026

Model: Ateca 1.5 TSI ACT DSG OPF Style

VIN: VSSZZZ5F9P6540922

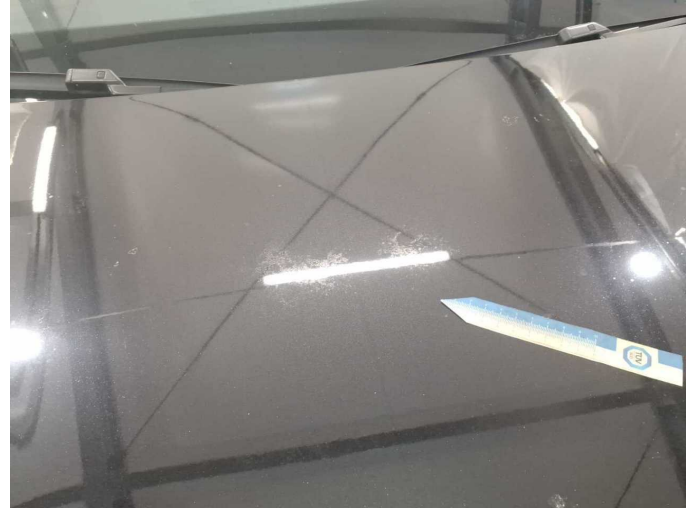
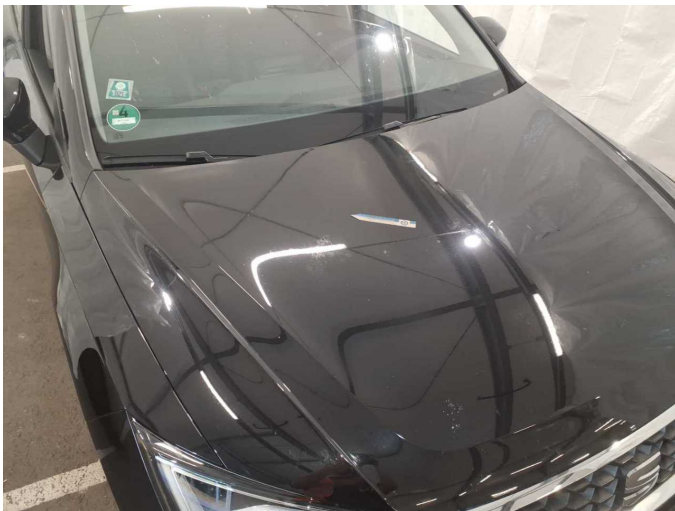
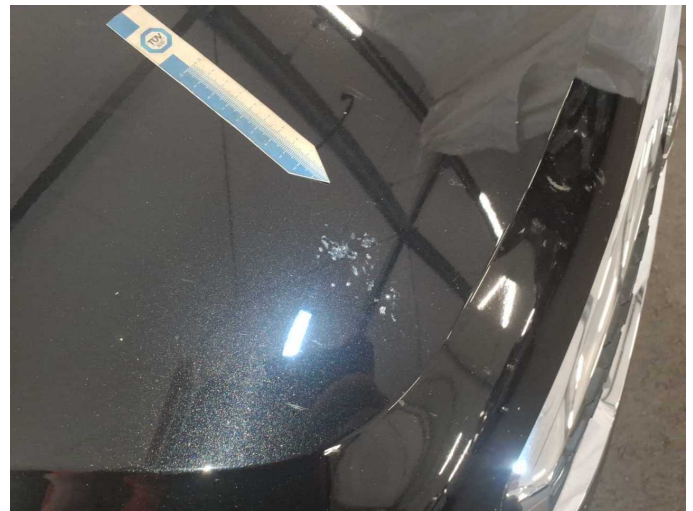
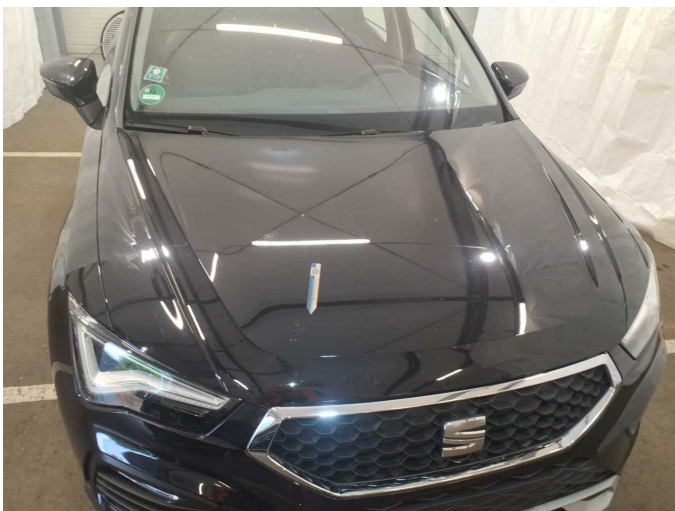
Damage 2: Bonnet: Bonnet (Mehrkosten möglich) - Soiled - Conditioning

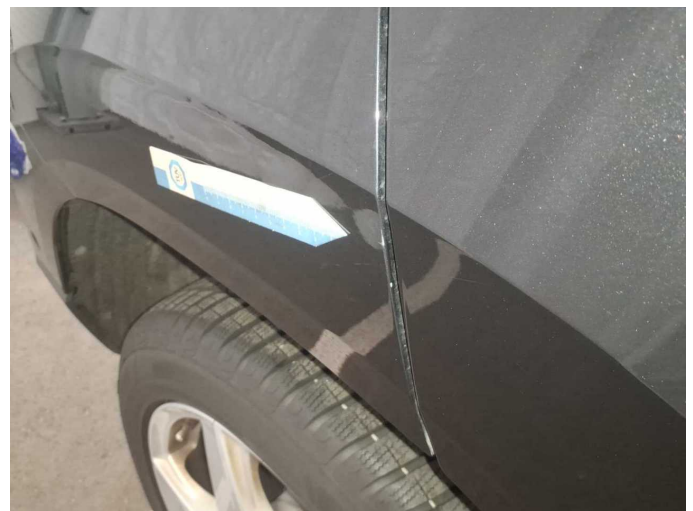
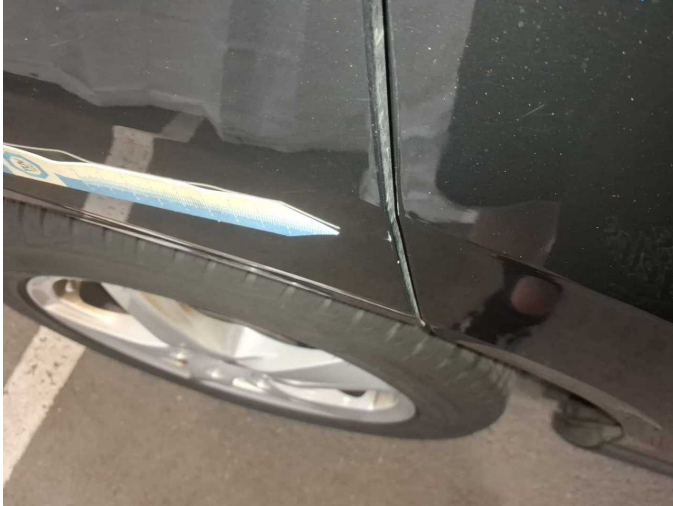
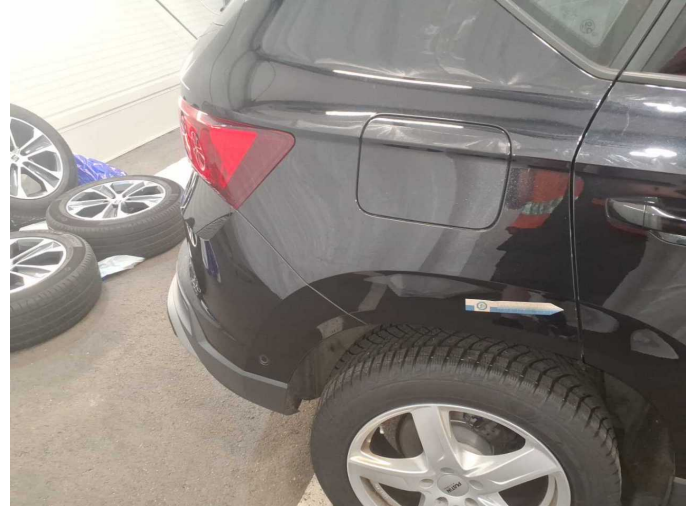
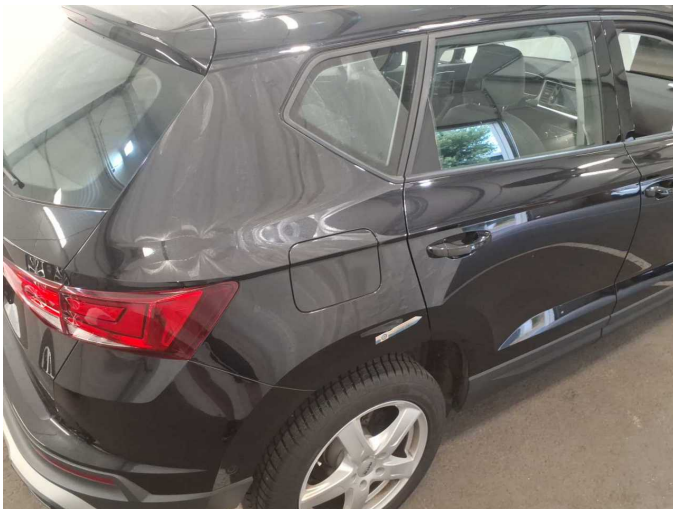
Damage 3: Side panel - rear right side: Side panel - Scratch(es) - Smart repair

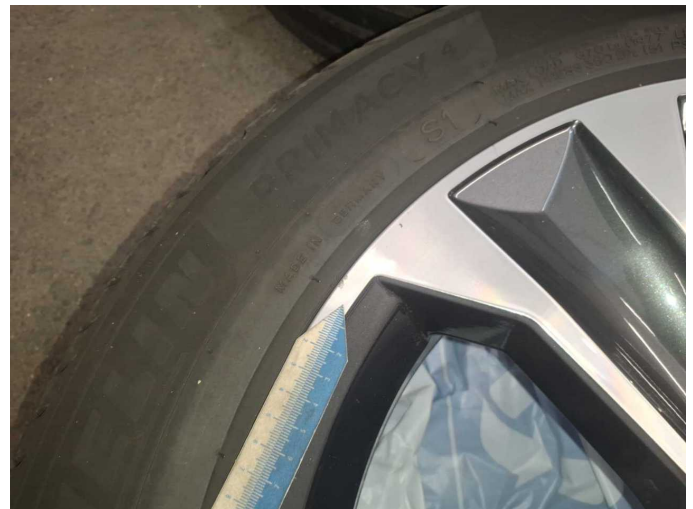
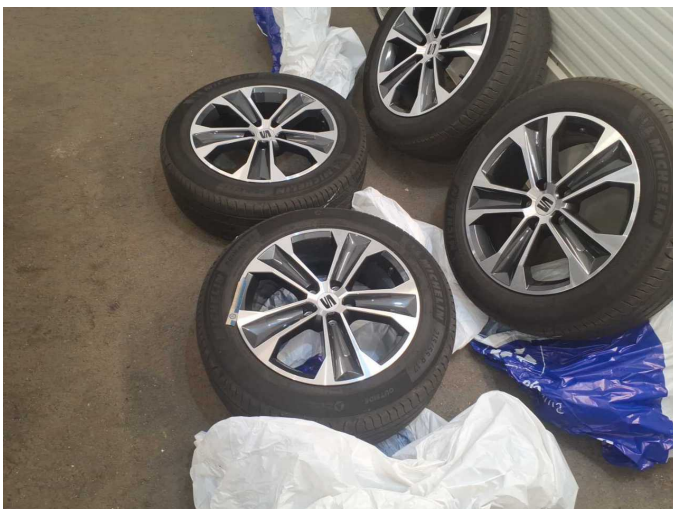
Damage 4: 2nd wheel set: 1 alloy rim - Scratch(es) - Loss in value

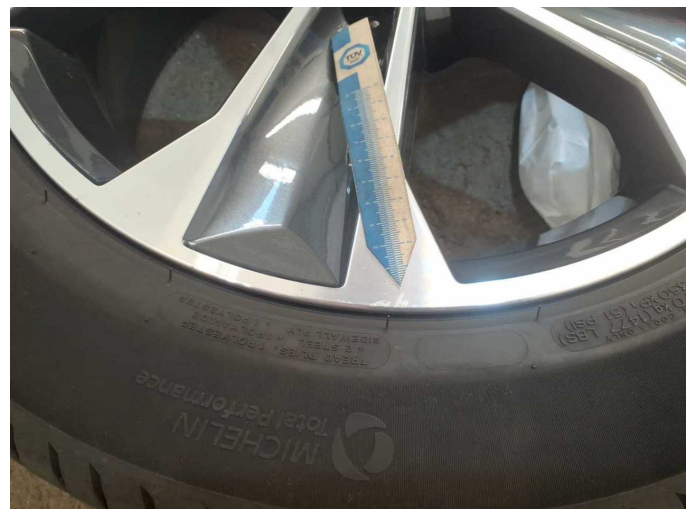
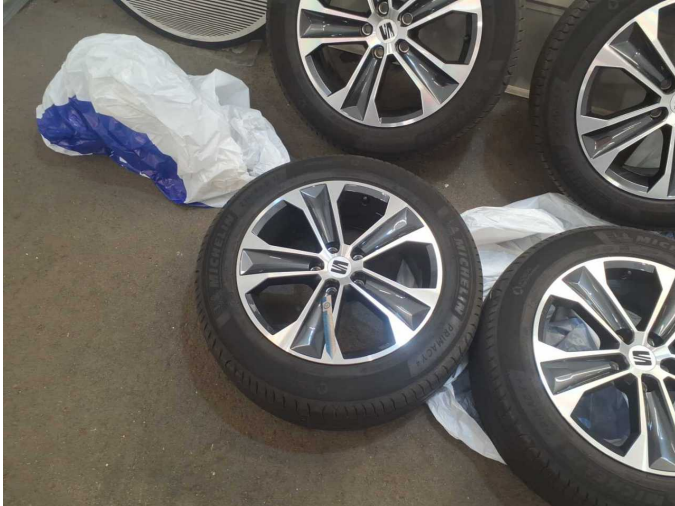
Damage 5: 2nd wheel set: 1 alloy rim - Scratch(es) - Loss in value

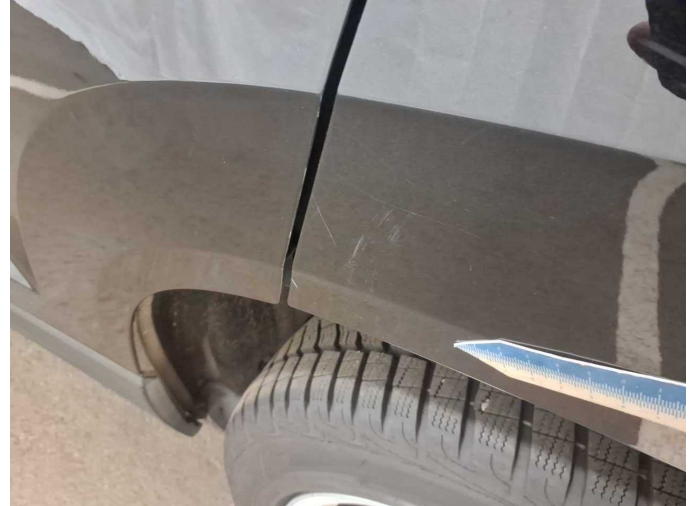
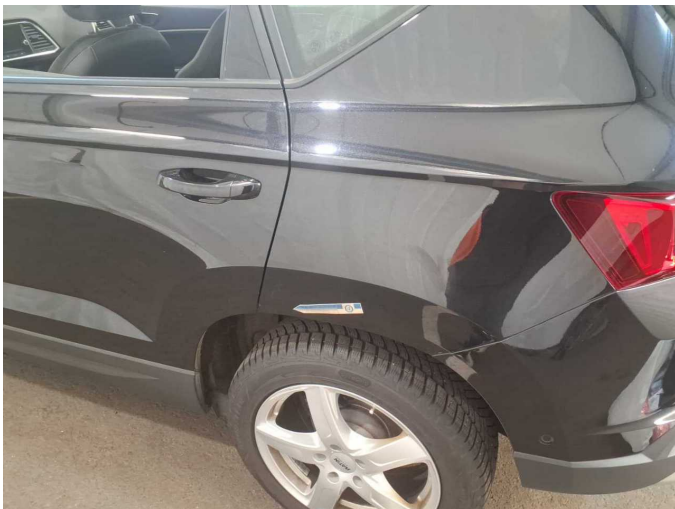
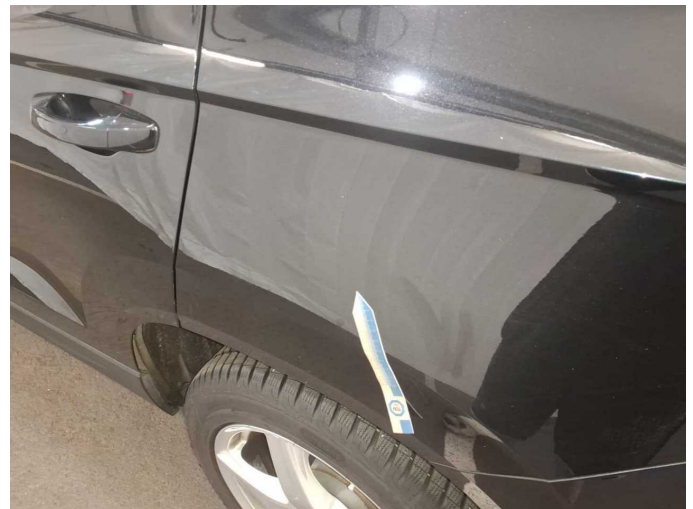
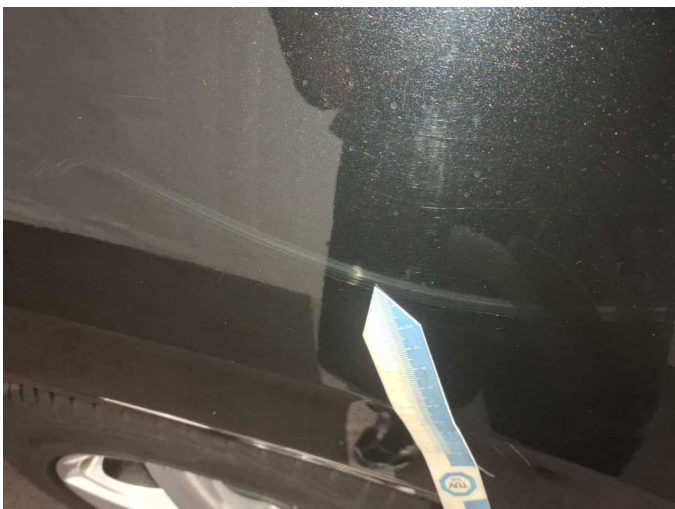
Damage 6: Side panel - rear left side: Side panel - Scratch(es) - Paint

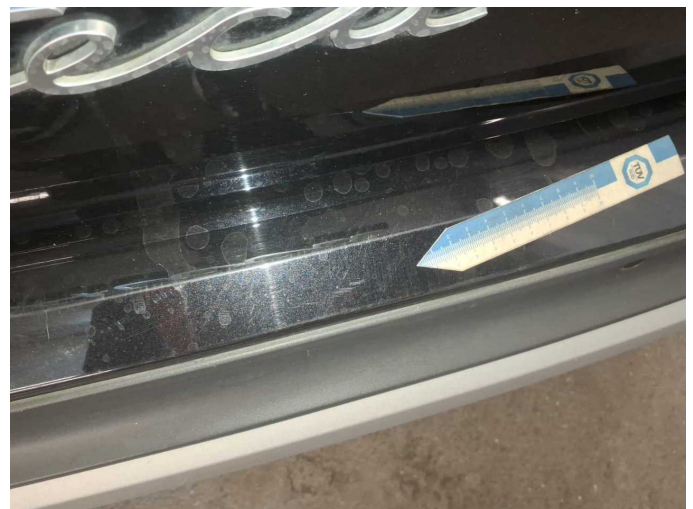
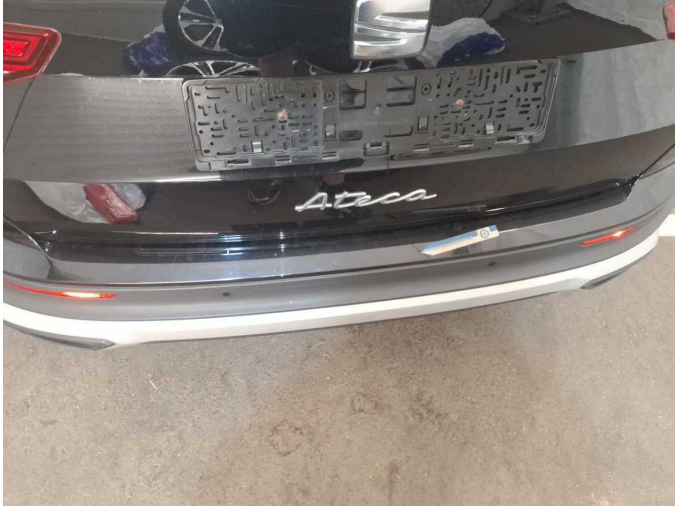
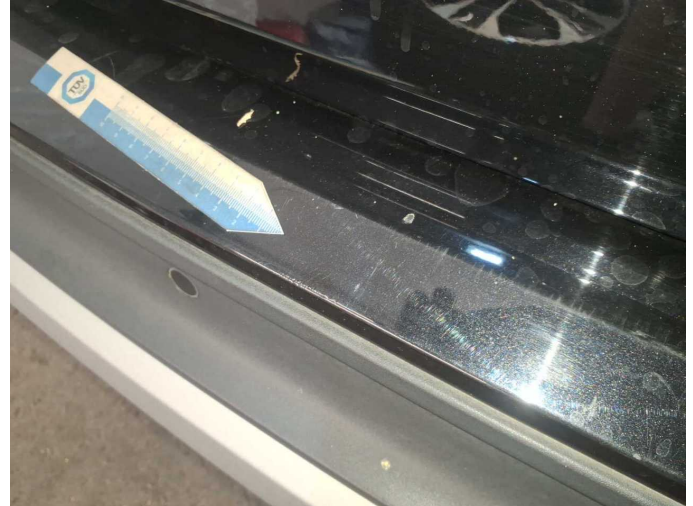
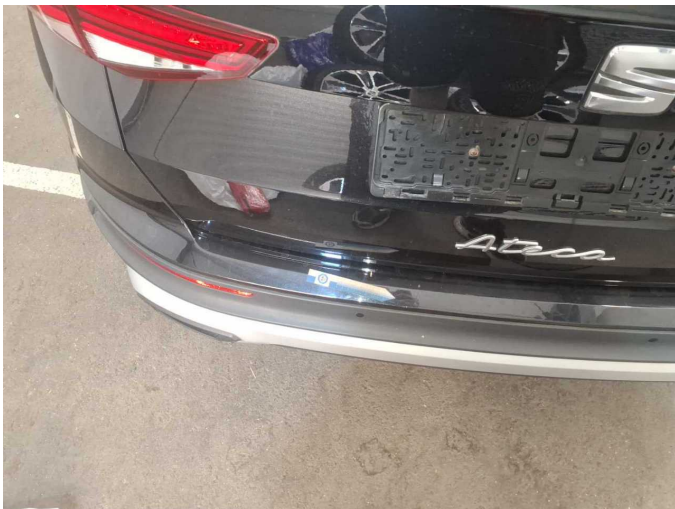
Damage 7: Rear bumper: Rear bumper - Scratch(es) - Paint

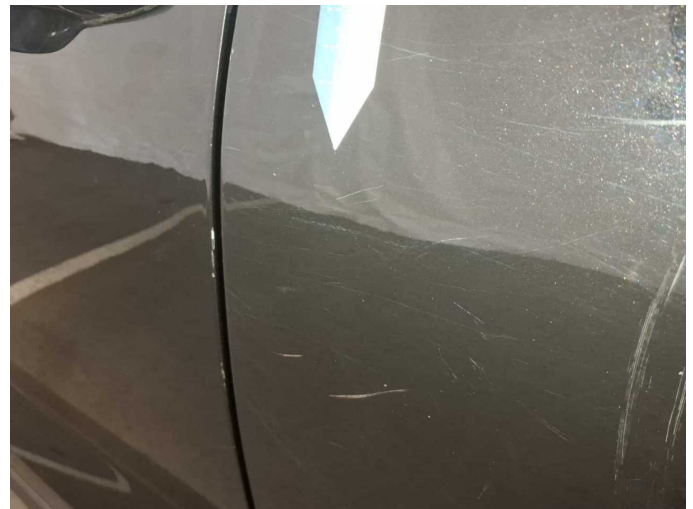
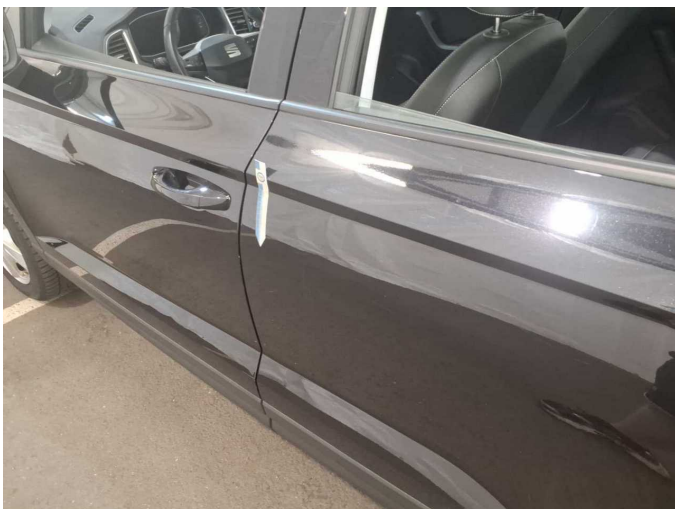
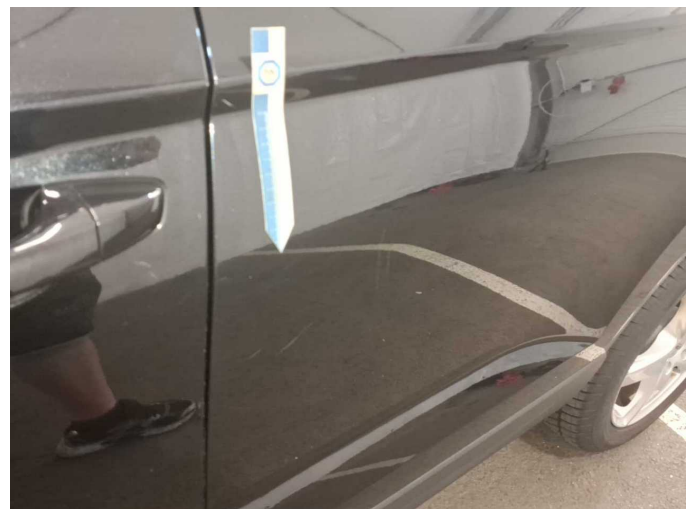
Damage 8: Door - rear left side: Door - Scratch(es) - Paint

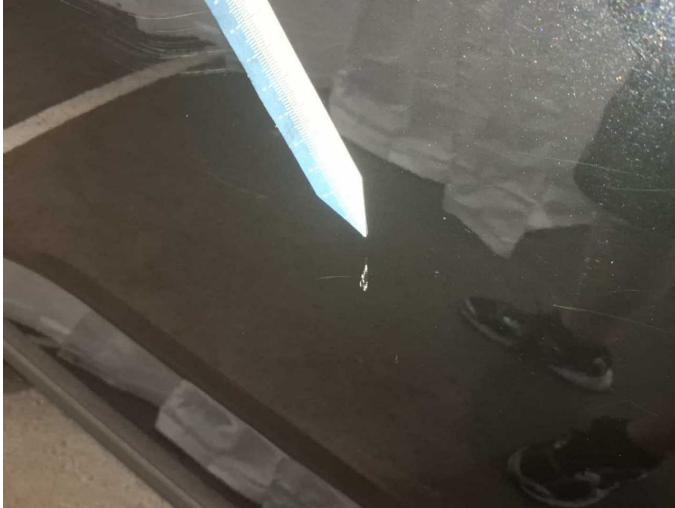
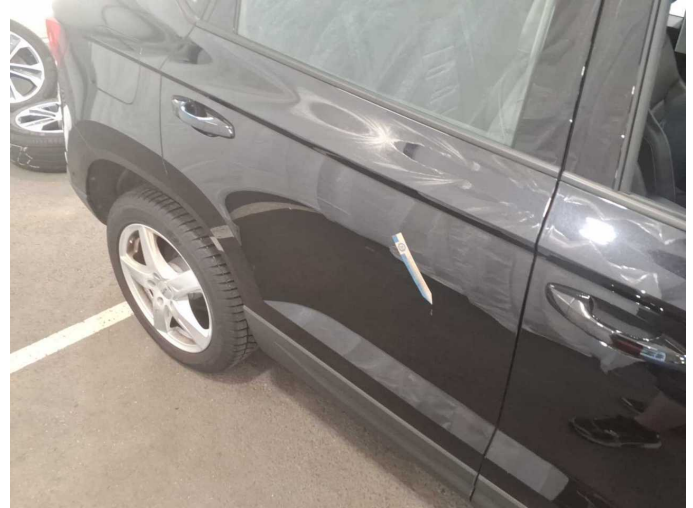
Damage 9: Door - rear right side: Door - Scratch(es) - Paint

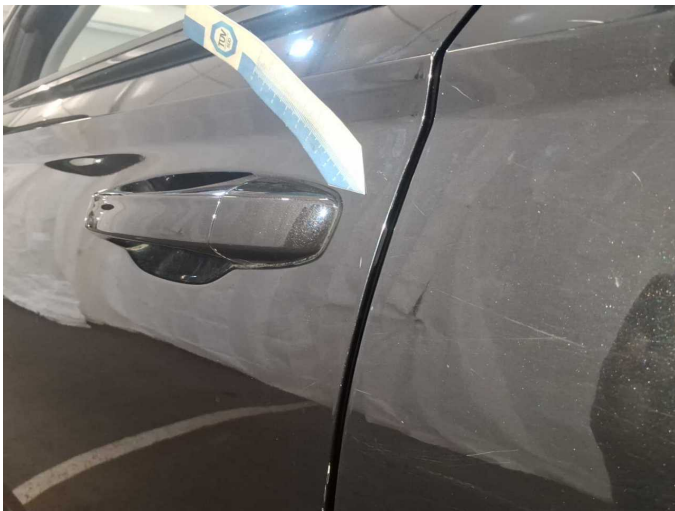
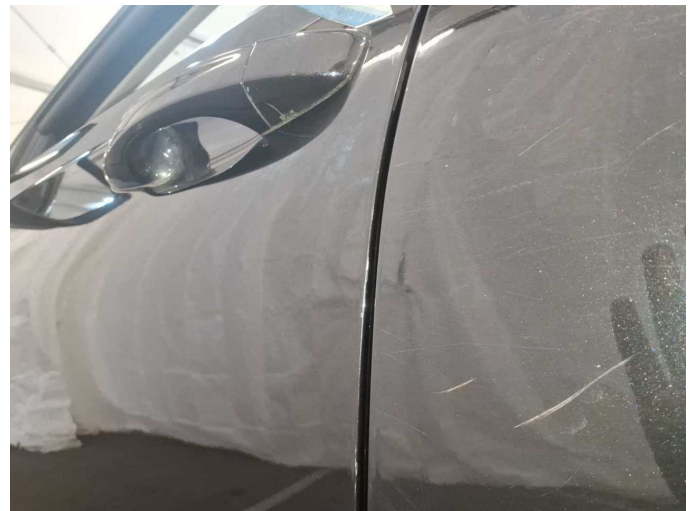
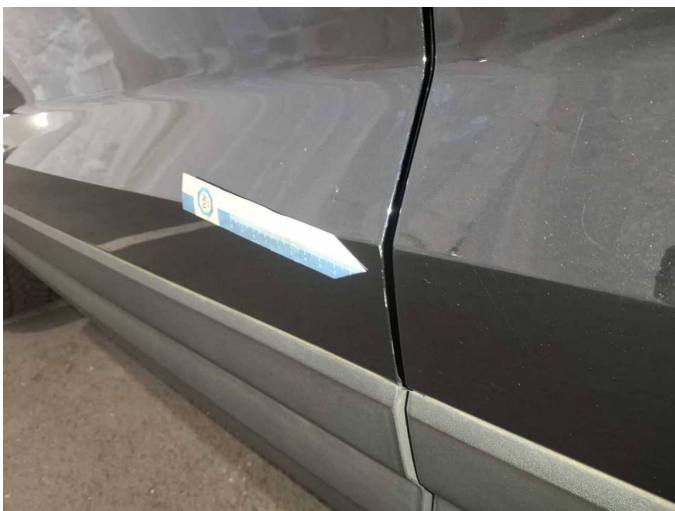
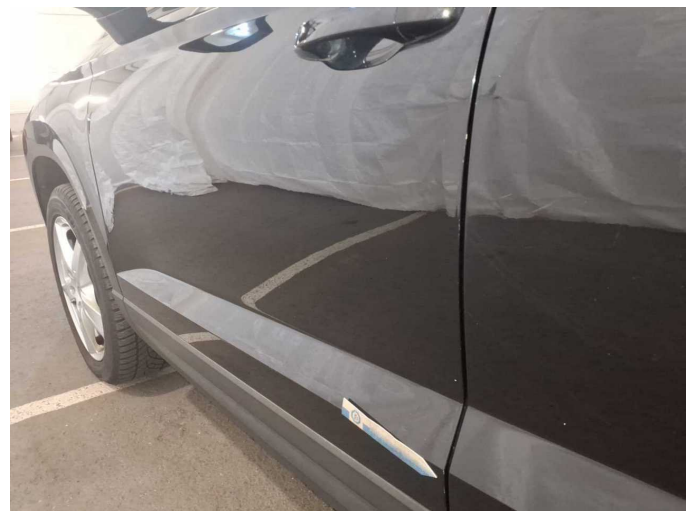
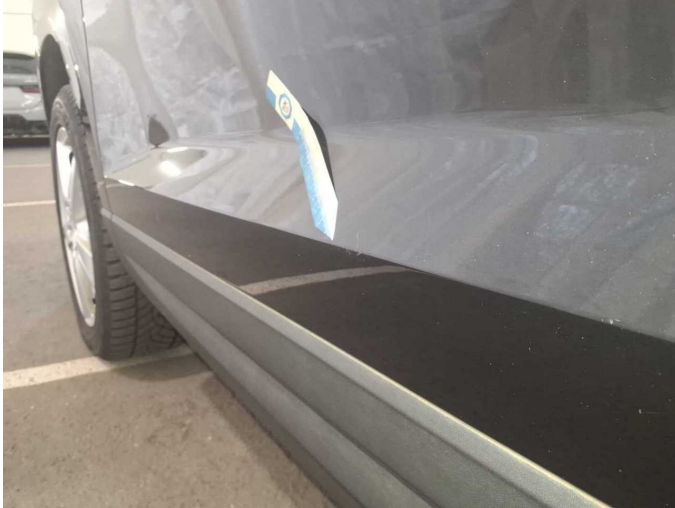
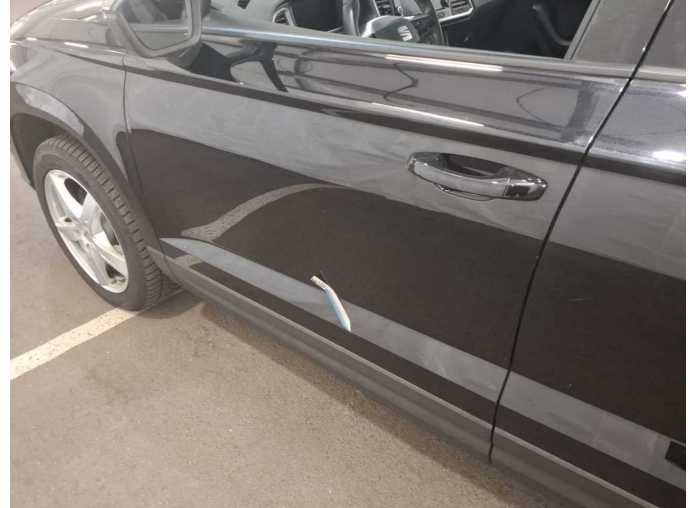
Damage 10: Door - front left side: Door - Scratch(es) - Paint

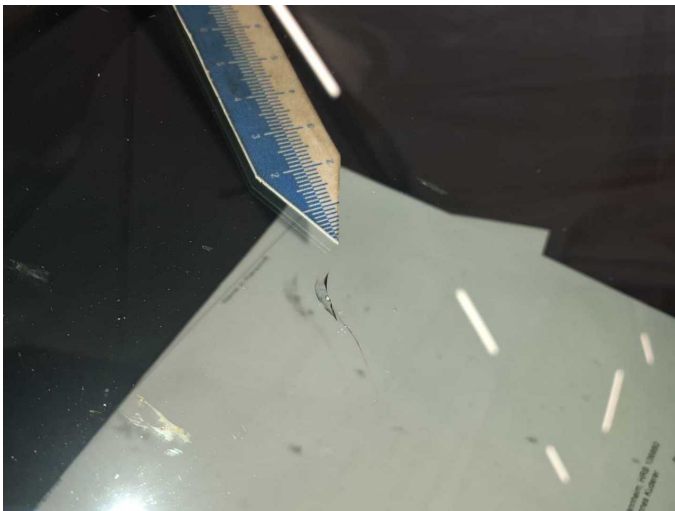
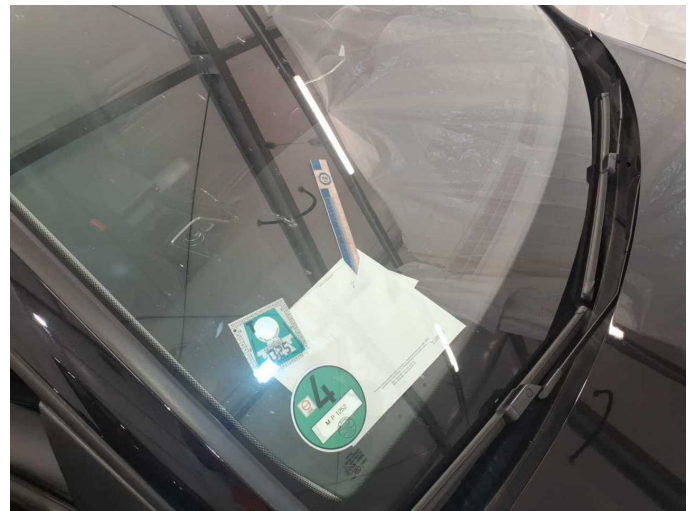
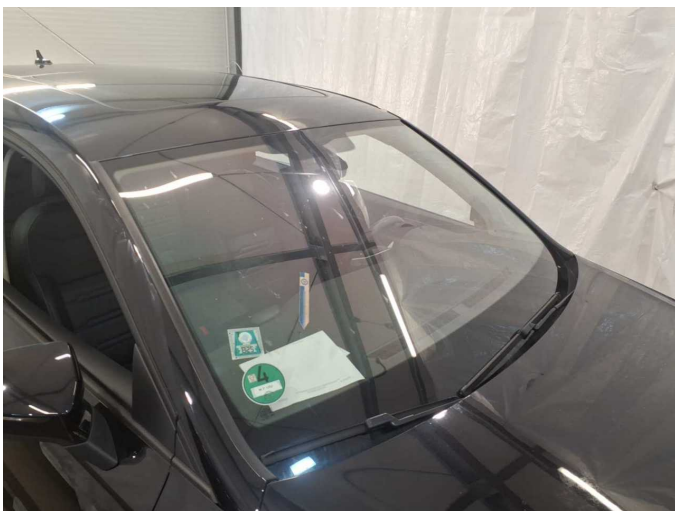
Damage 11: Vehicle glazing: Windscreen - Broken / torn - repair according to calculation

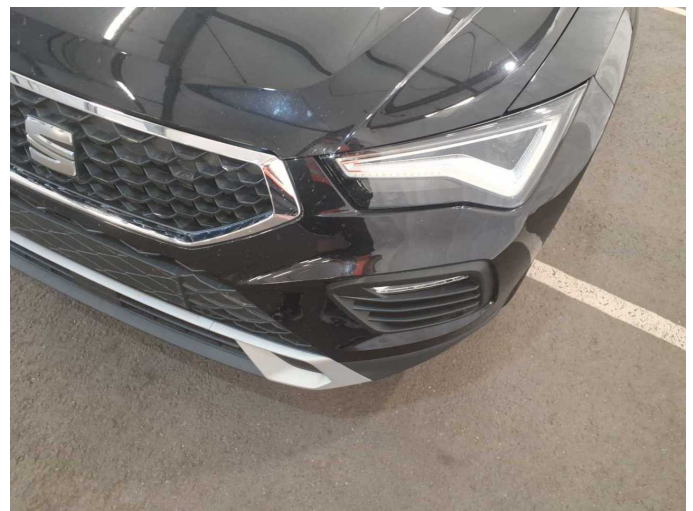
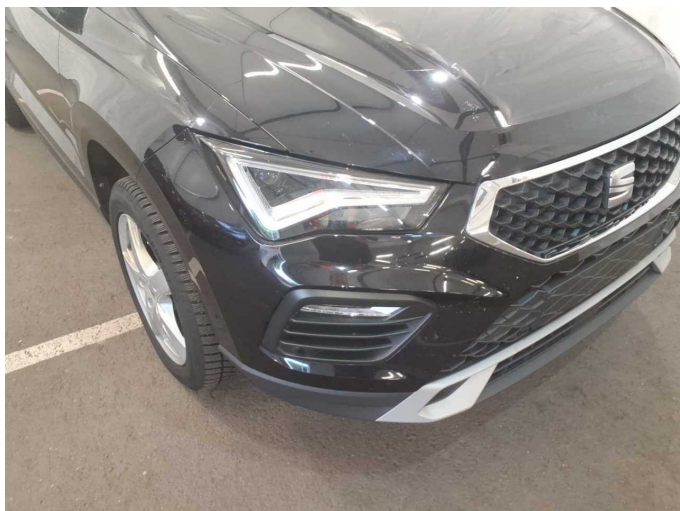
Wear and tear 1: Front bumper: Front bumper - Stone chips - No deduction

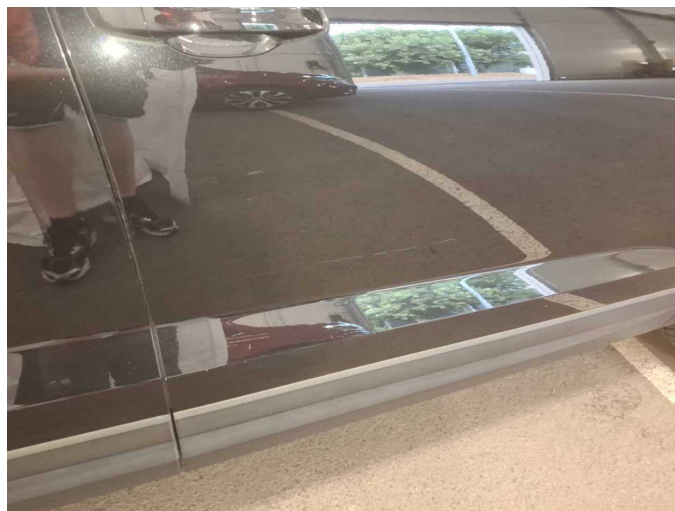
Wear and tear 2: Door - front right side: Door - Scratch(es) - No deduction
