Expertise

Protocol number: 46279531
Order No. / Reference: 26511540
Inspection date: 1 Jul 2026

Manufacturer: Skoda

Model: Enyaq iV 60

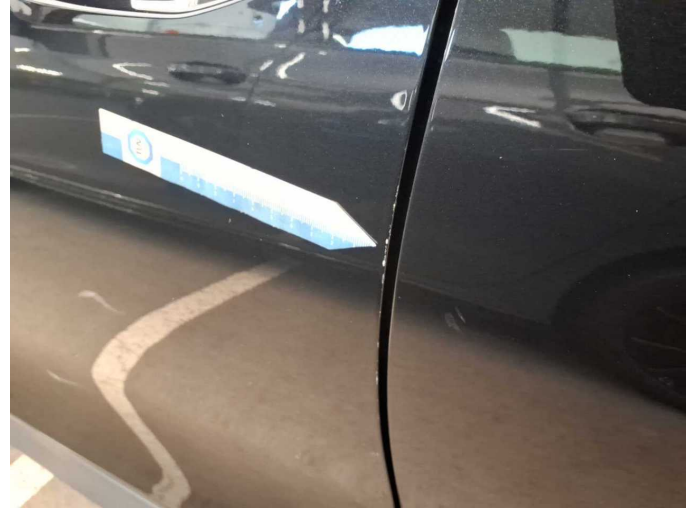
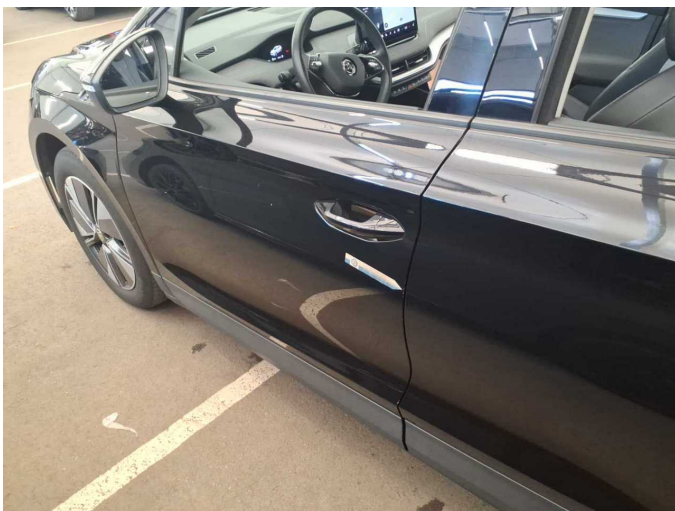
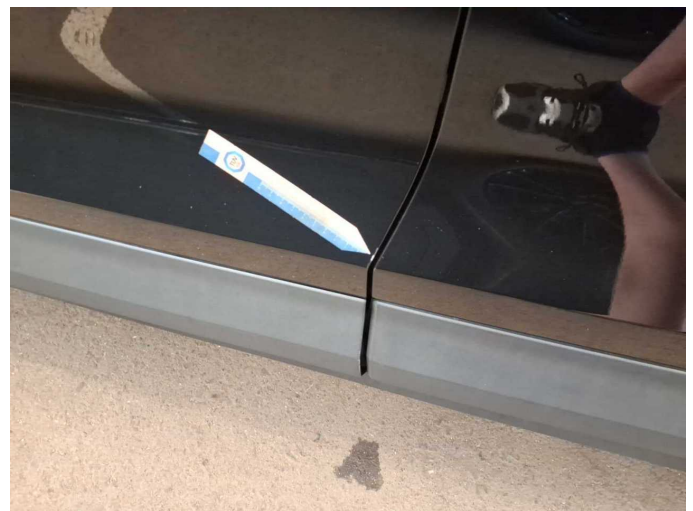
| No. | Component group | Description |
|---|---|---|
| 1 | Door - front left side | Door edge - Scratch(es) - Smart repair |

Damage 1: Door - front left side: Door edge - Scratch(es) - Smart repair

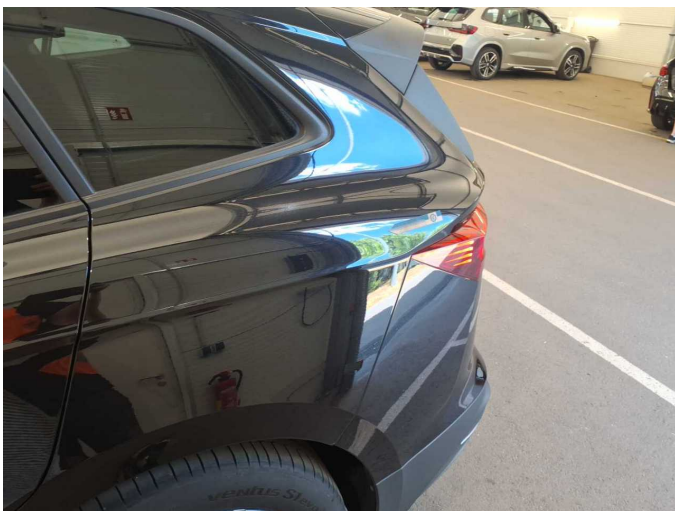
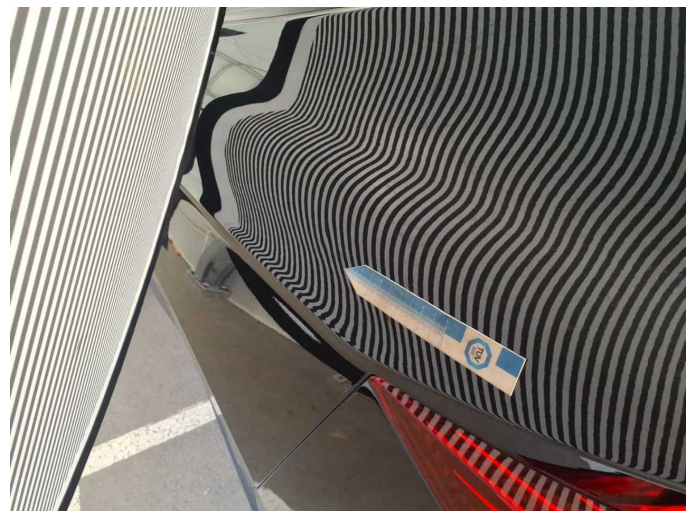
| No. | Component group | Description |
|---|---|---|
| 2 | Side panel - rear left side | Side panel - dent(s) - Smooth repair work |

Damage 2: Side panel - rear left side: Side panel - dent(s) - Smooth repair work

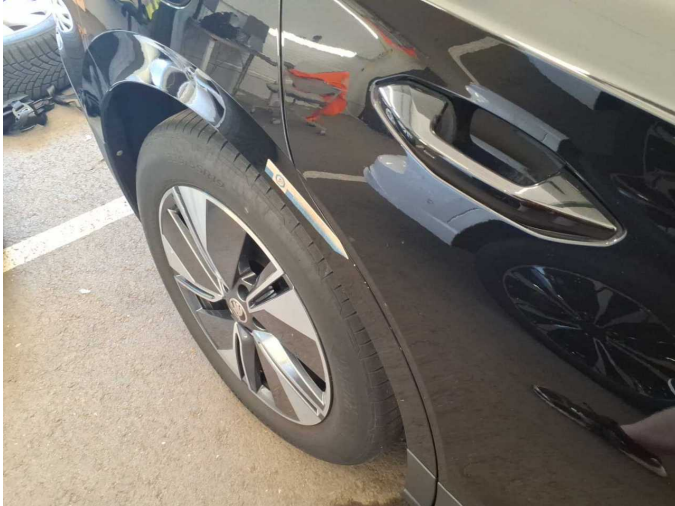
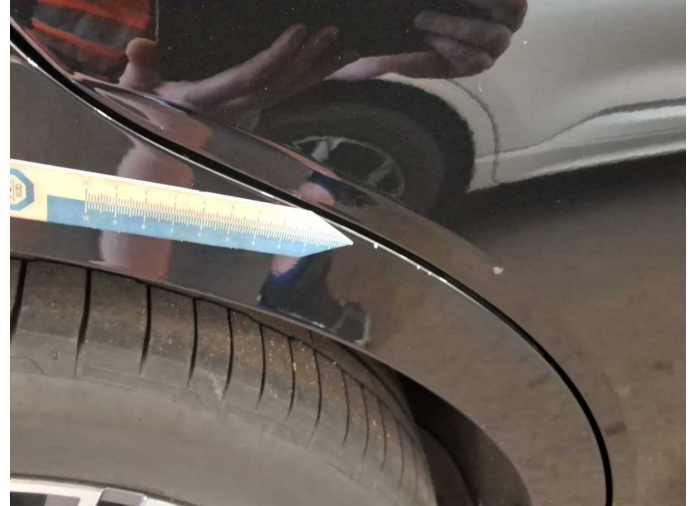
| No. | Component group | Description |
|---|---|---|
| 3 | Side panel - rear right side | Side panel - Scratch(es) - Smart repair |

Damage 3: Side panel - rear right side: Side panel - Scratch(es) - Smart repair

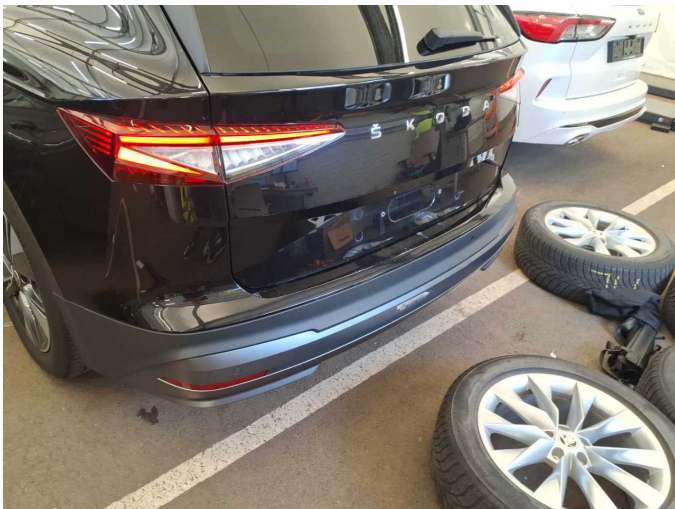
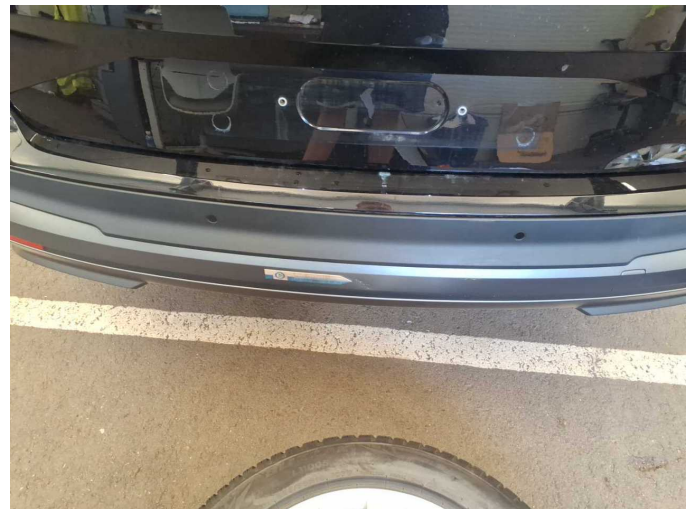
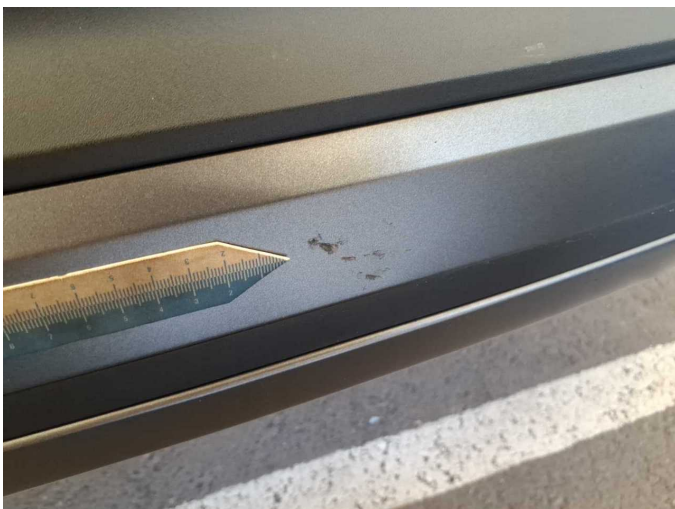
| No. | Component group | Description |
|---|---|---|
| 4 | Rear bumper | Spoiler (Diffusor Stossfänger Hinten) - Scratch(es) - Replace |

Damage 4: Rear bumper: Spoiler (Diffusor Stossfänger Hinten) - Scratch(es) - Replace
