Expertise

Protocol number: 44042954
Order number / reference: 26060496
Inspection date: 23 Feb 2026

Model: Vito 116 CDI Extralang HA Aut. PRO

VIN: W1VVLCEZ5T4564030

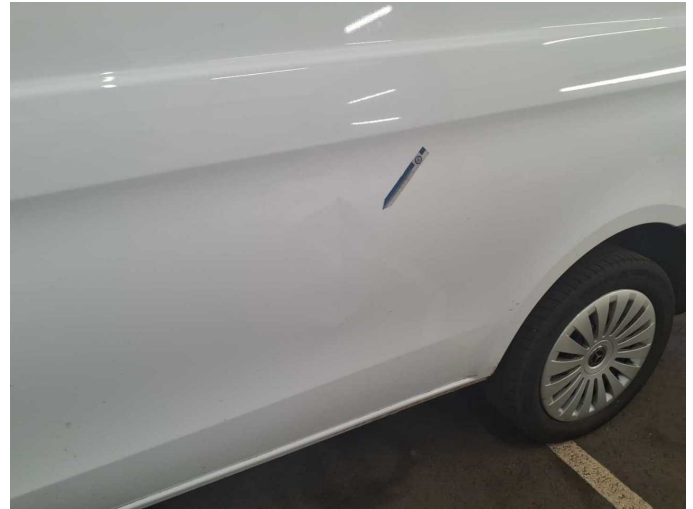
No.	Component group	Description
1	Side panel - rear left side	Side panel - Deformed - Repair and paint

Damage 1: Side panel - rear left side: Side panel - Deformed - Repair and paint

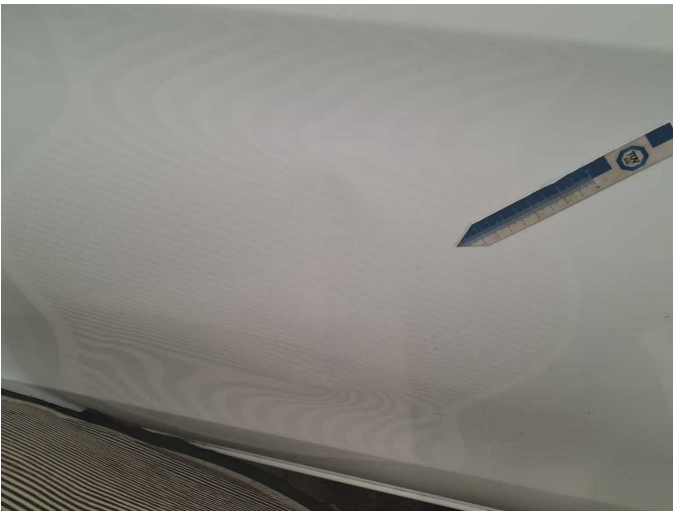
Damage 1: Side panel - rear left side: Side panel - Deformed - Repair and paint
