Expertise

Protocol number: 45463053
Order No. / Reference: 26276483
Inspection date: 13 May 2026

Manufacturer: Opel

Model: Vivaro 2.0 BlueHDi 145 Lang S&S EAT8

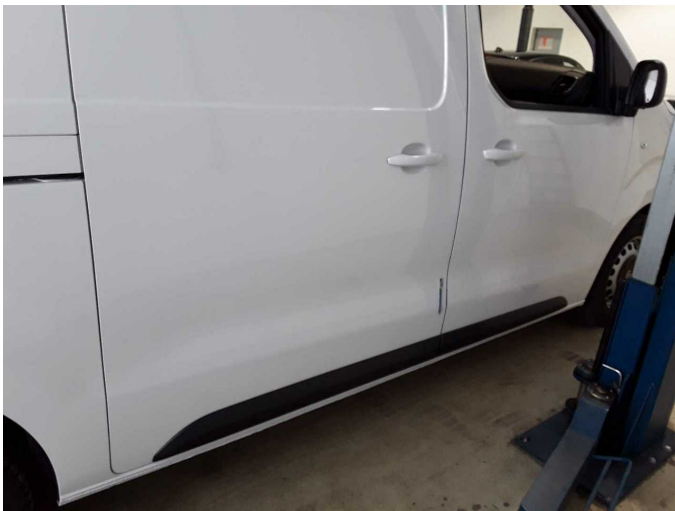
No.	Component group	Description
1	Wheel / tyres	Wheel cover - rear left side - Missing - Replace
2	Sliding door, right	Sliding door - Scratch(es) - Paint

Damage 2: Sliding door, right: Sliding door - Scratch(es) - Paint

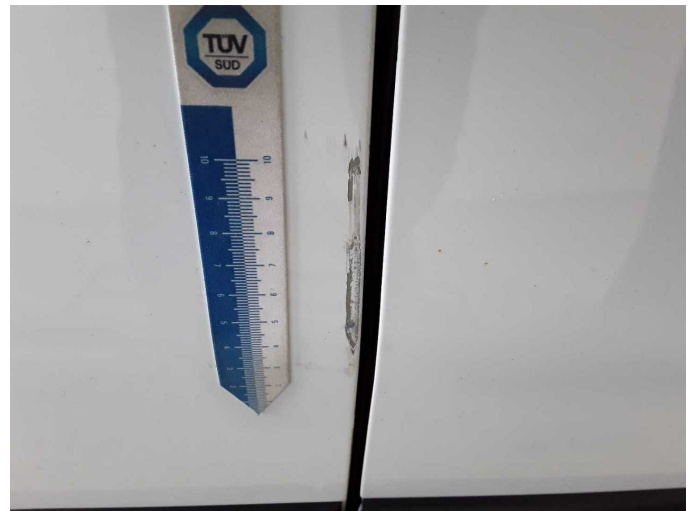
Damage 2: Sliding door, right: Sliding door - Scratch(es) - Paint
