# INSPECTION REPORT

End of contract

| License plate | 2DEH185 |
| Make | Iveco Daily 40C18HA8Z H2 4100 |

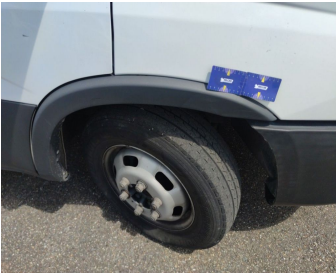
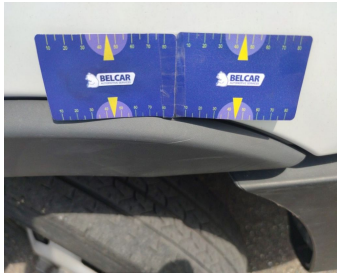
| Damages | Type | Acceptable |
|---|---|---|
| 237 | Wing Front right / Trim / Replace | Y |

Wing Front right / Trim / Replace-scratch

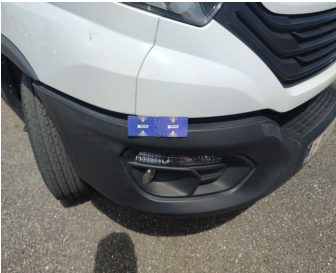
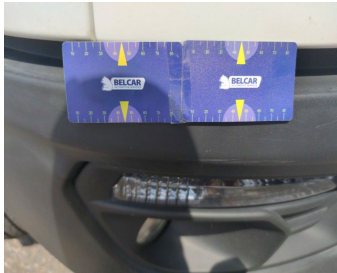
| Damages | Type | Acceptable |
|---|---|---|
| 19 | Bumper Front / Lower Cover Not Painted / Replace | Y |

Bumper Front / Lower Cover Not Painted / Replace-scratch

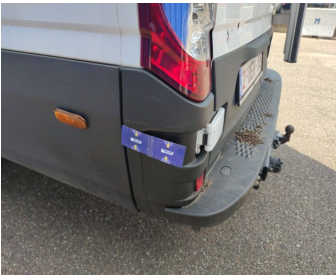
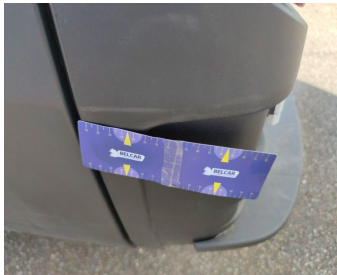
| Damages | Type | Acceptable |
|---|---|---|
| 138 | Bumper Rear / Lower Cover Not Painted / Replace | Y |

Bumper Rear / Lower Cover Not Painted / Replace-scratch

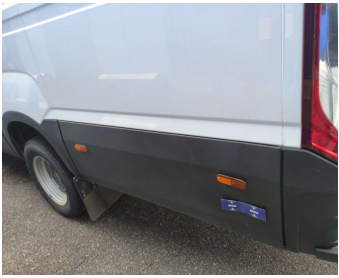
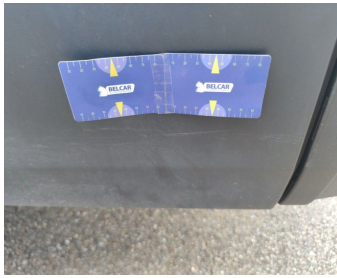
| Damages | Type | Acceptable |
|---|---|---|
| 117 | Wing Rear Left / Trim / Replace | Y |

Wing Rear Left / Trim / Replace-scratch

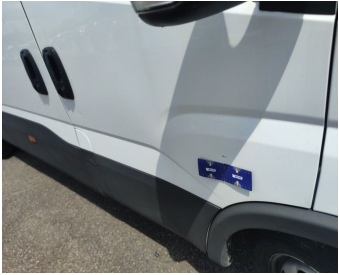
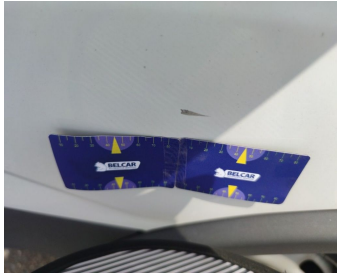
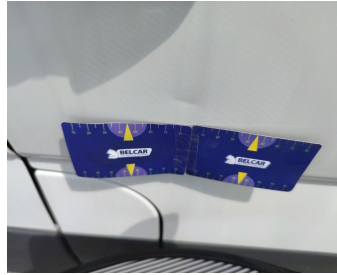
| Damages | Type | Acceptable |
|---|---|---|
| 214 | Door Front Right // Repair & Painting | Y |

Door Front Right // Repair & Painting-scratch + dent

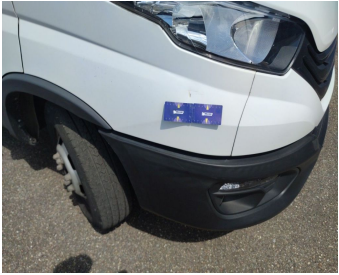
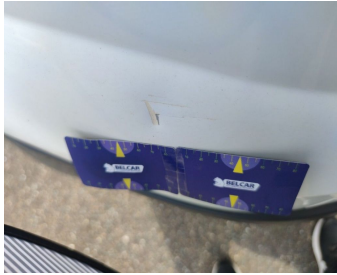
| Damages | Type | Acceptable |
|---|---|---|
| 14 | Bumper Front // Repair & Painting | Y |

Bumper Front // Repair & Painting-scratch + dent

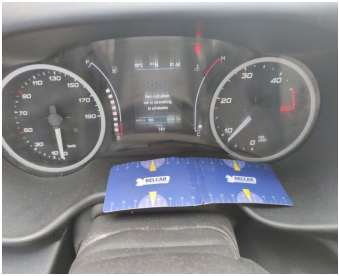
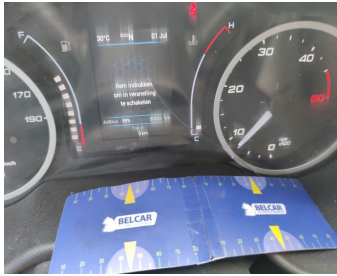
| Damages | Type | Acceptable |
|---|---|---|
| 562 | Dashboard / Instruments Panel / Replace | N |

Dashboard / Instruments Panel / Replace-cracked
