Expertise

Protocol number: 44871503
Order No. / Reference: 26009919
Inspection date: 9 Apr 2026

Manufacturer: Mercedes-Benz

Model: Vito 116 CDI Extralang HA Aut. PRO

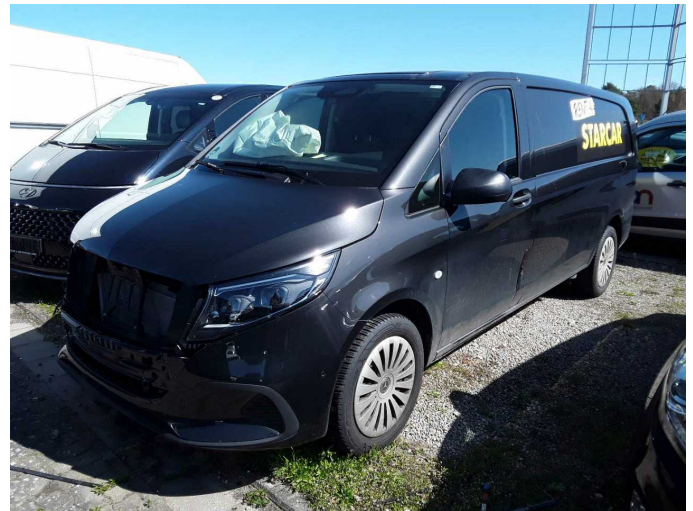
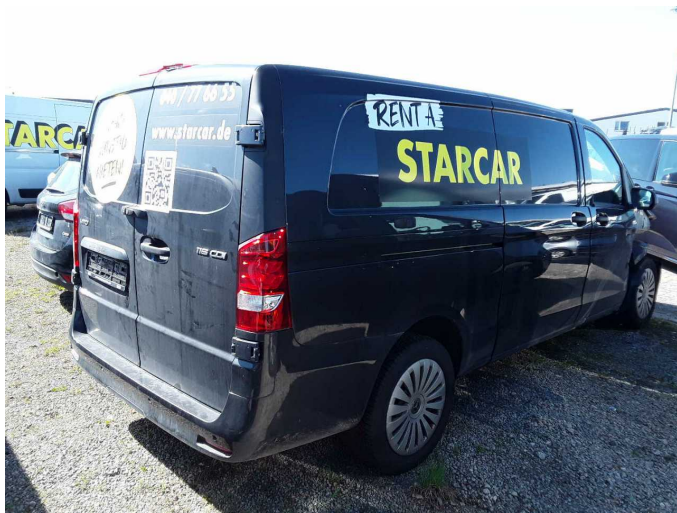
Damage 2: Body: Body - Glued / labelled - De-glue / neutralise

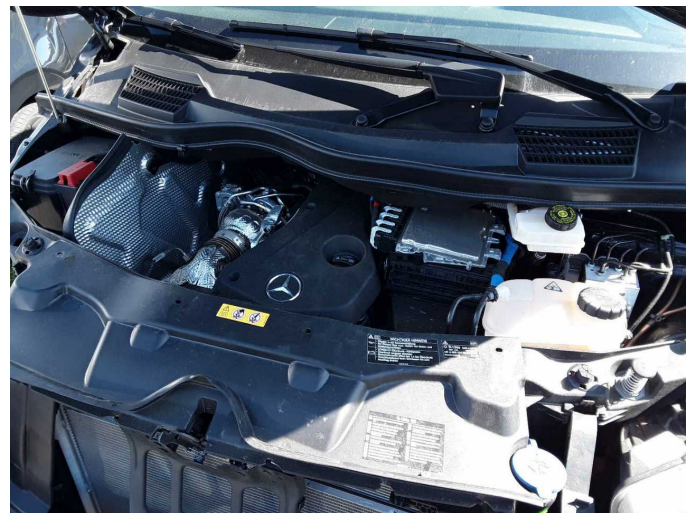
Documents submitted	At the time of the inspection, the vehicle registration certificate Part 2 (title) was available, but the vehicle registration certificate Part 1 (document) was not. (Copy)
VIN comparison	The vehicle identification number (VIN) was read from the vehicle and its conformity with the submitted documents was confirmed by the undersigned during the inspection.
Inspection	A proper visual inspection of the paintwork and bodywork was only possible to a limited extent due to insufficient lighting conditions/dampness or dirt. No lifting equipment or pit was available for inspecting the vehicle. Therefore, inspection of the vehicle's underside was only possible to a limited extent.
Test drive	It was not possible to drive the vehicle at the time of the inspection.
Engine function test	An engine test run could not be performed. This is due to the following reason: Zündung geht, kein Motorstart

Damage 3: Engine: Engine - Functional / admissibility - Perform diagnosis

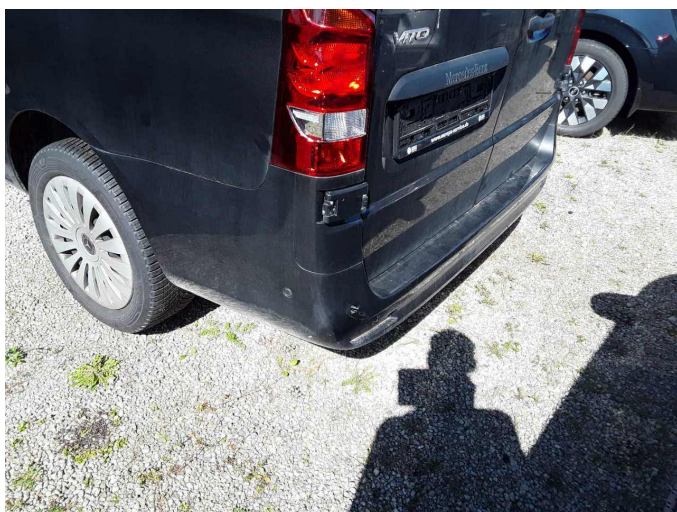
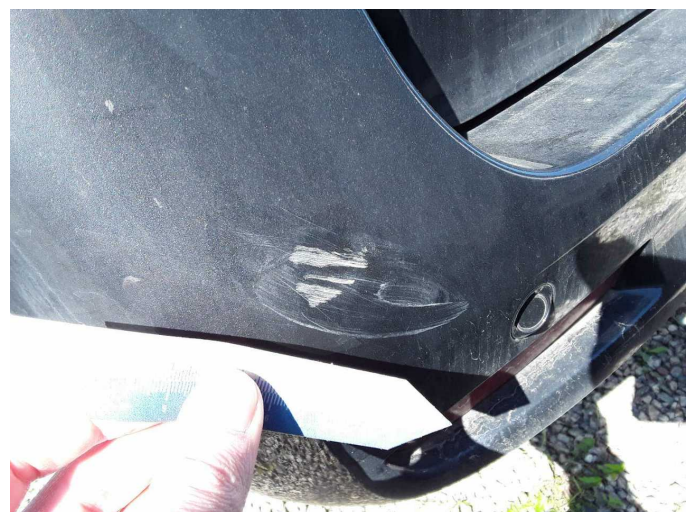
Damage 4: Rear bumper: Rear bumper - Scratch(es) - Paint

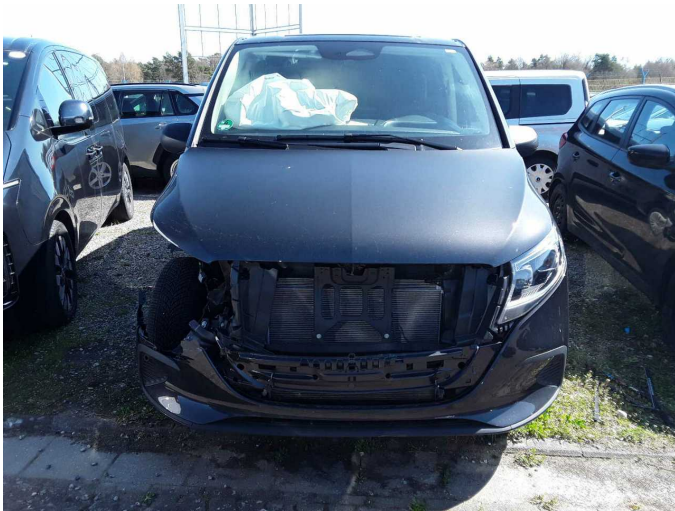
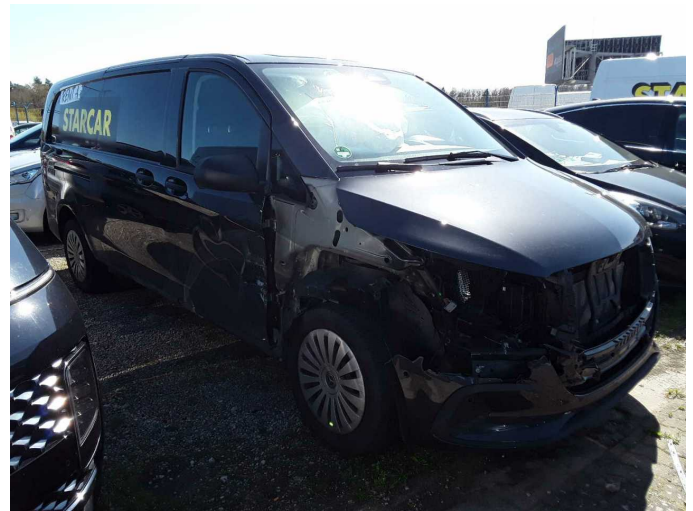
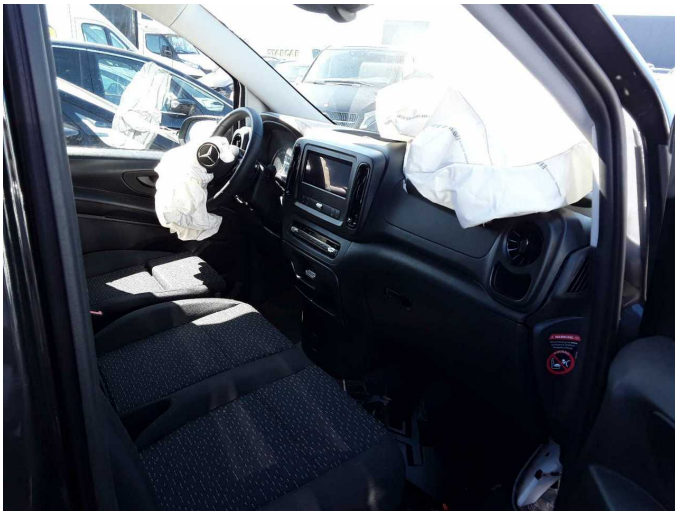
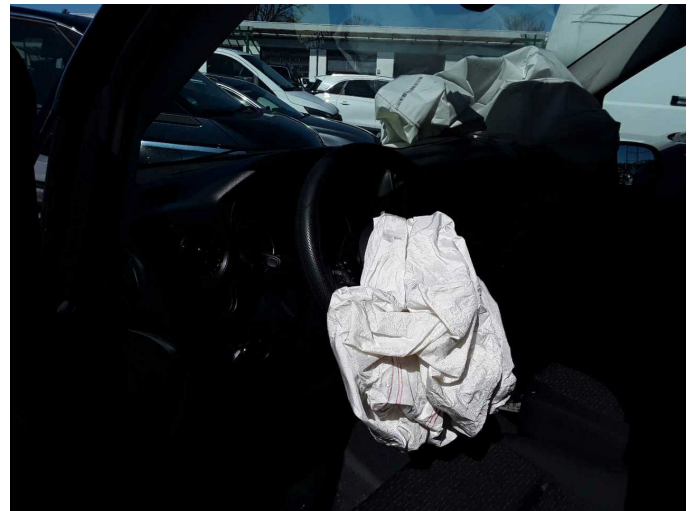
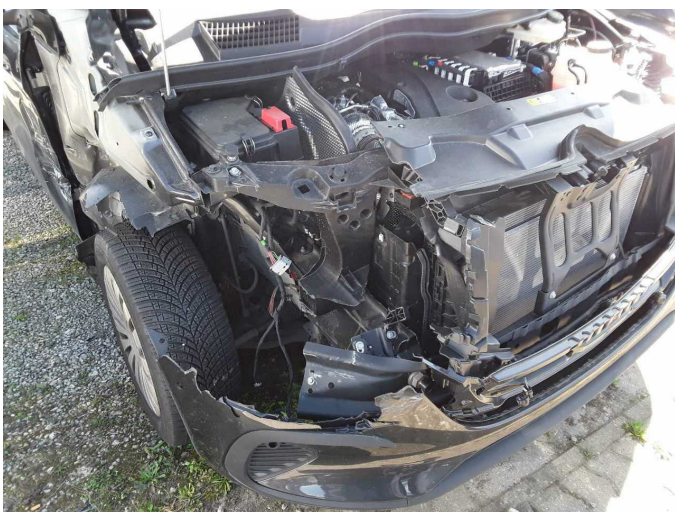
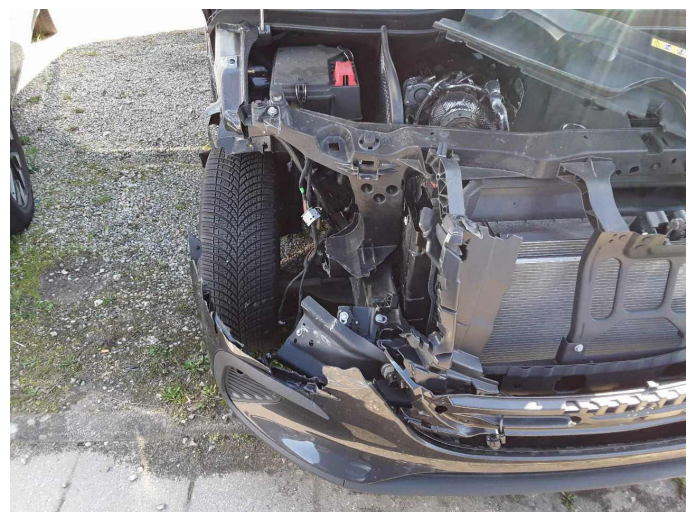
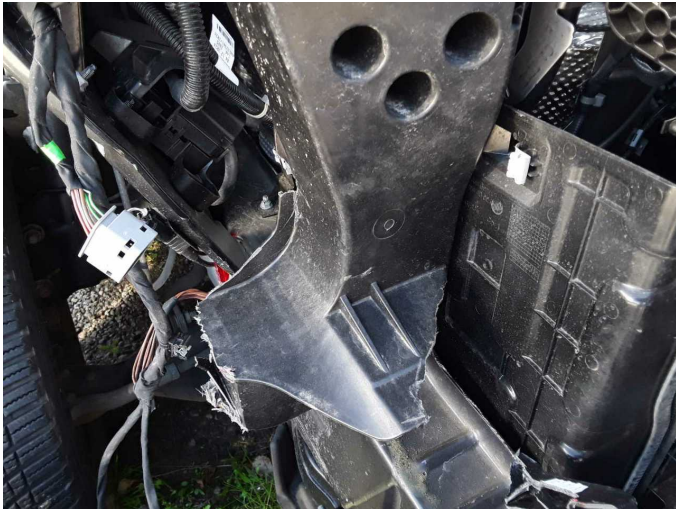
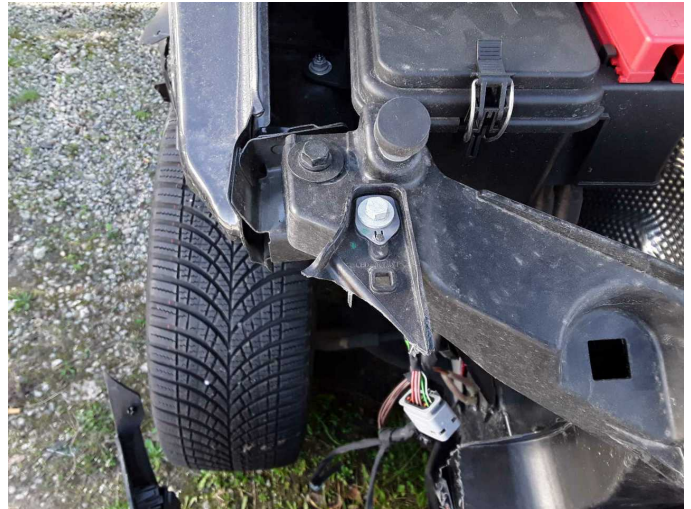
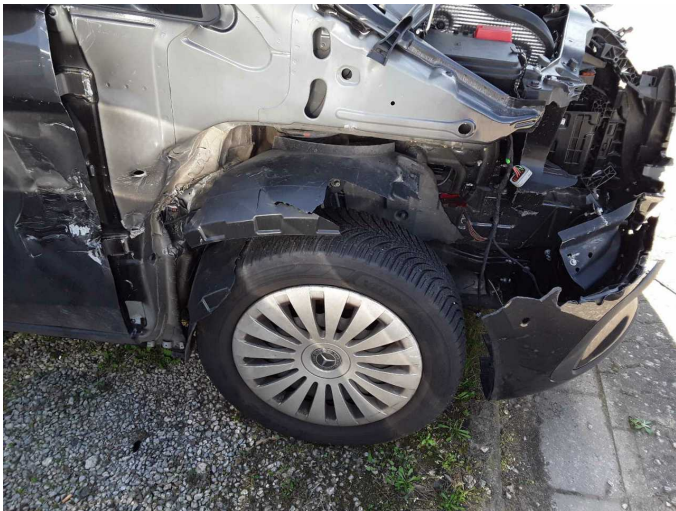
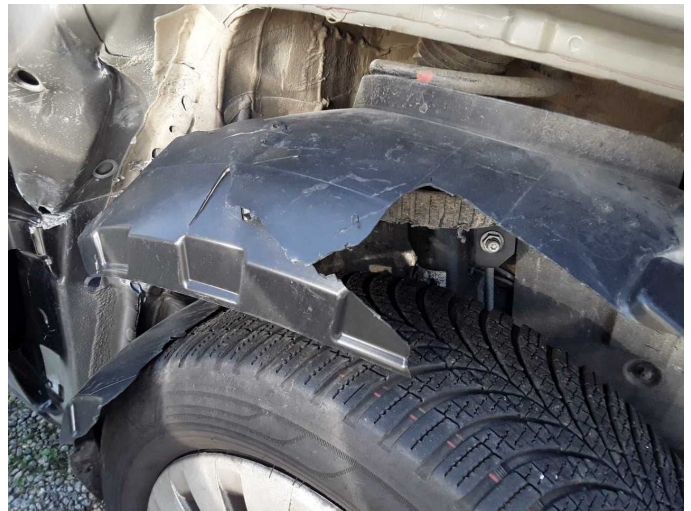
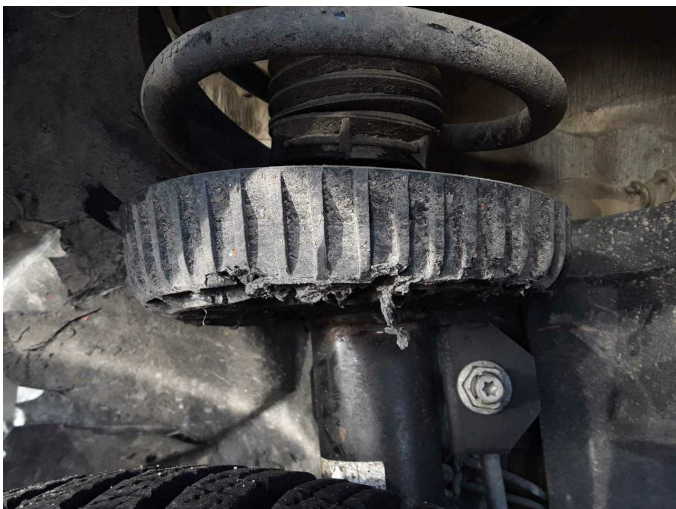
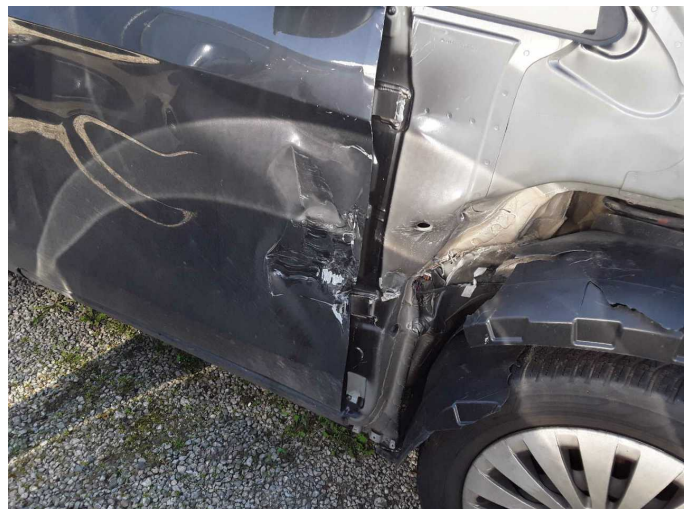
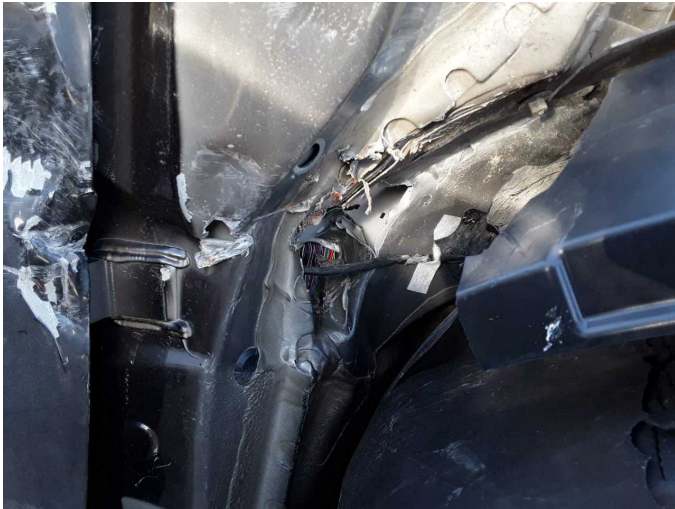
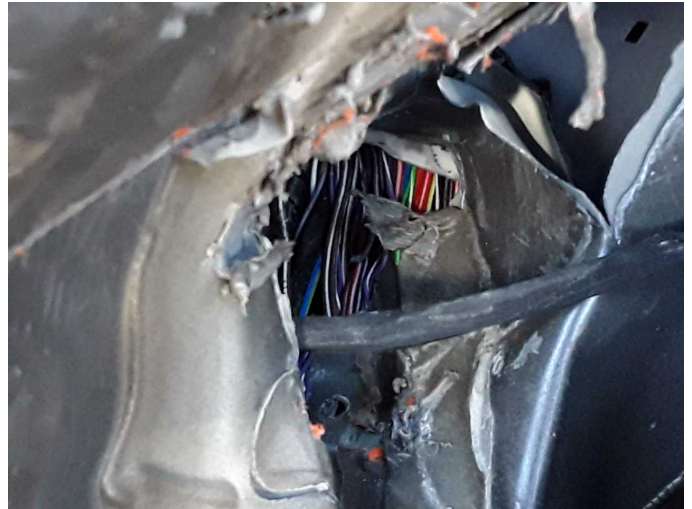
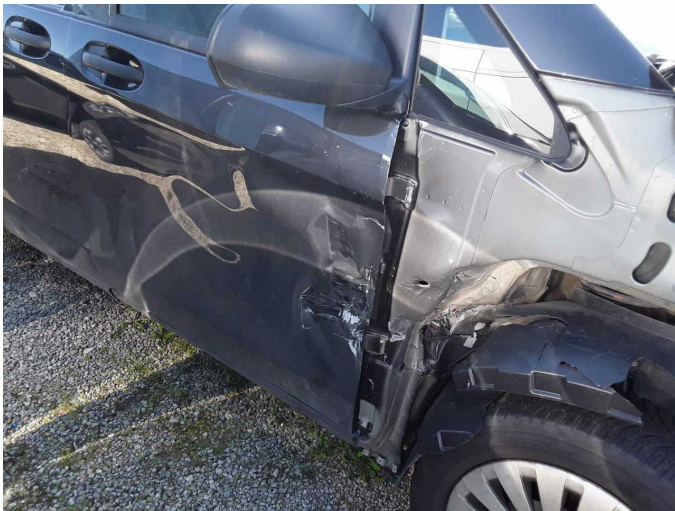
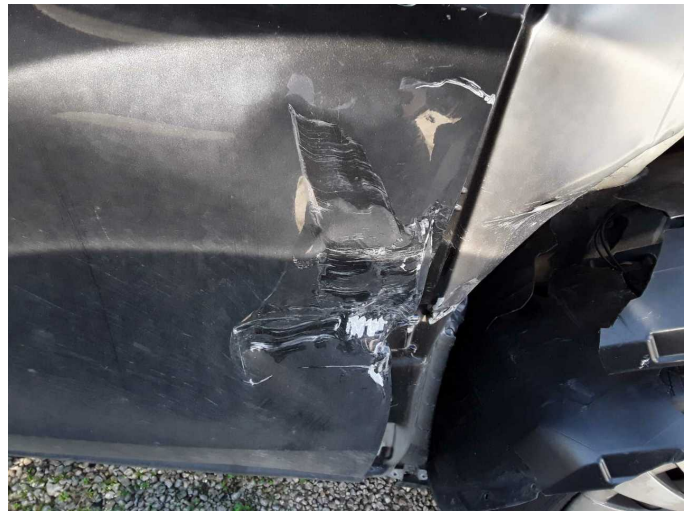
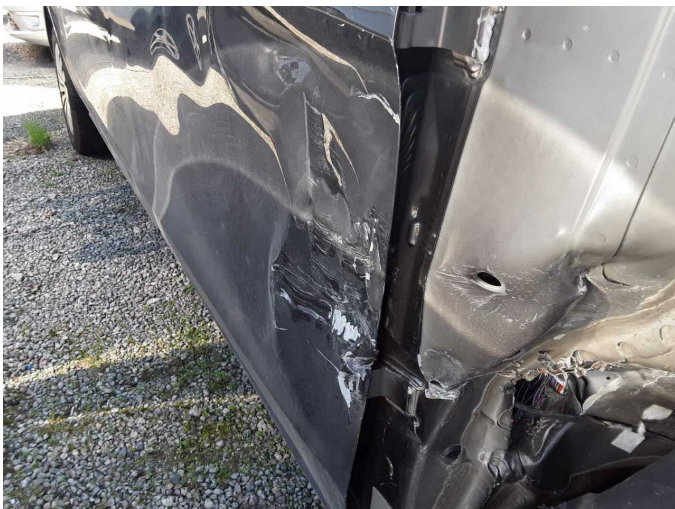
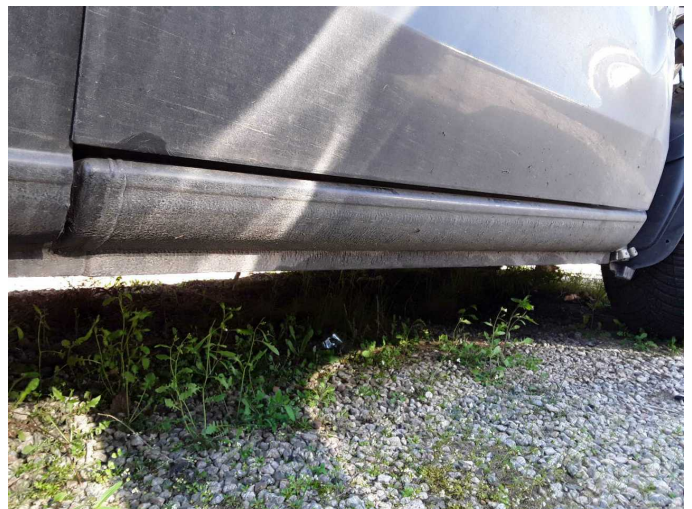
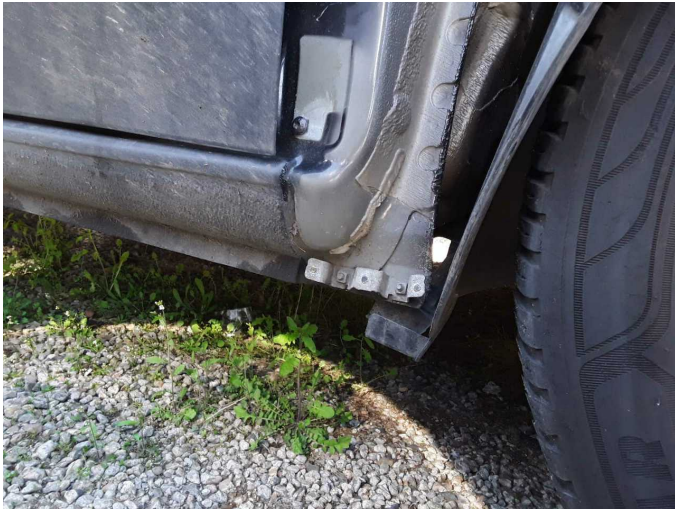
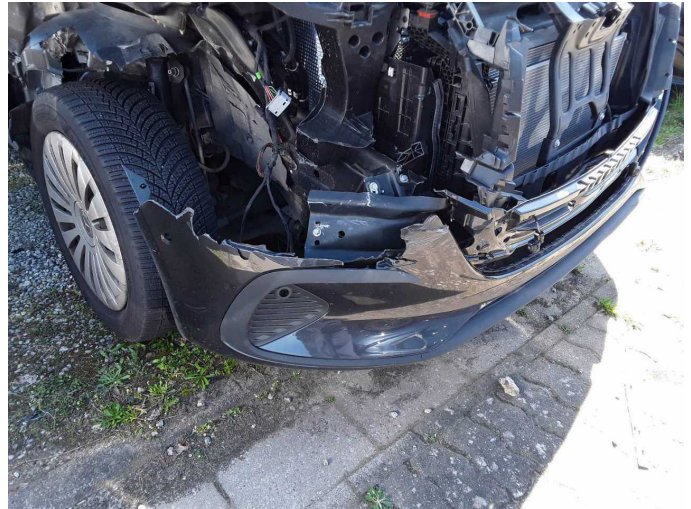
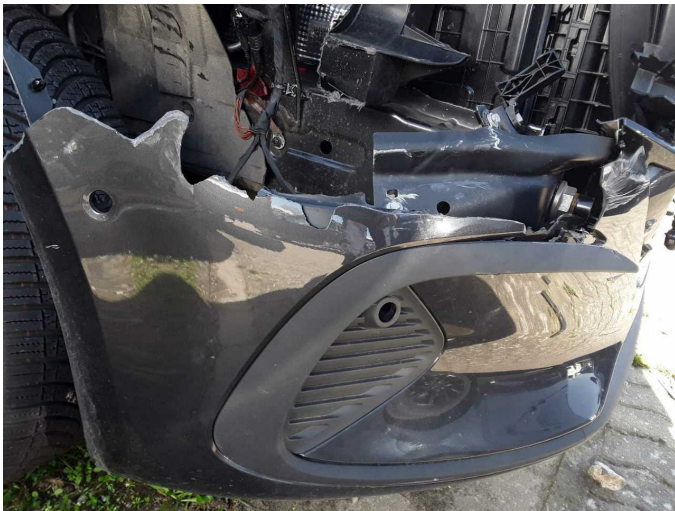
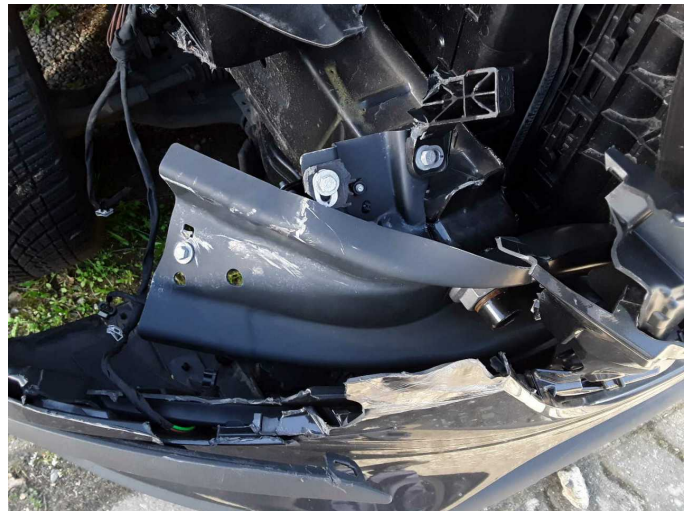
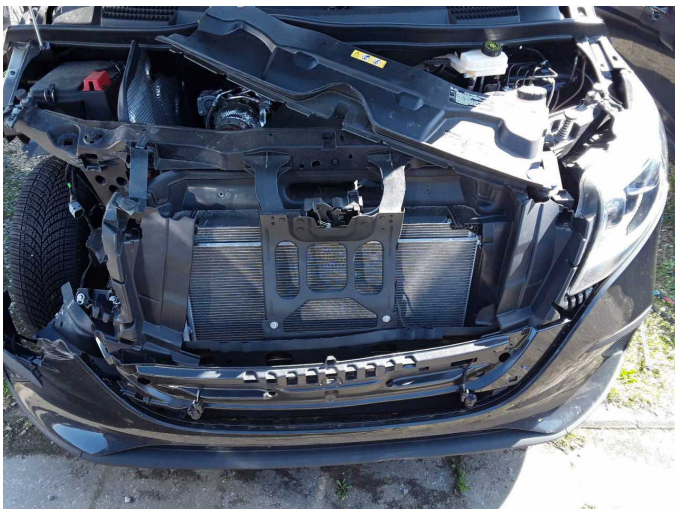
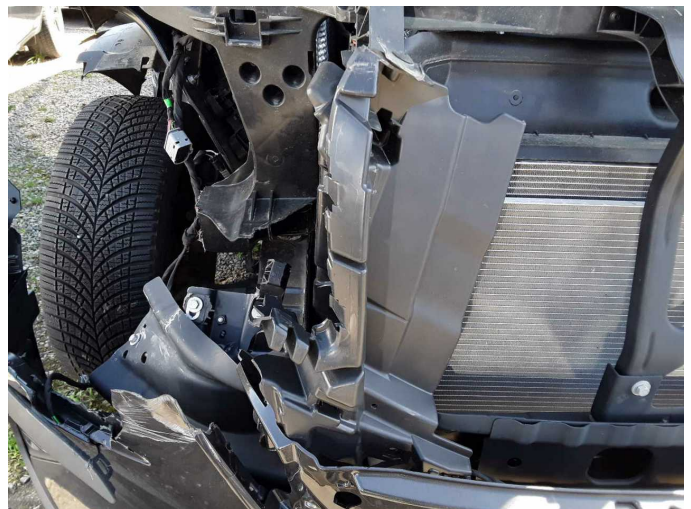
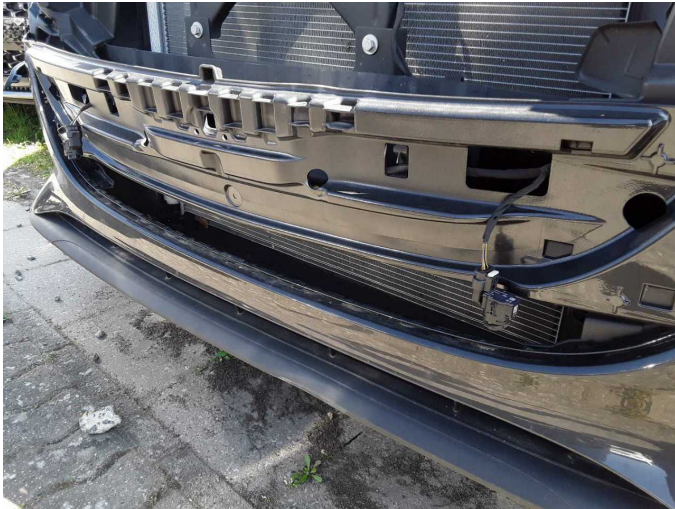
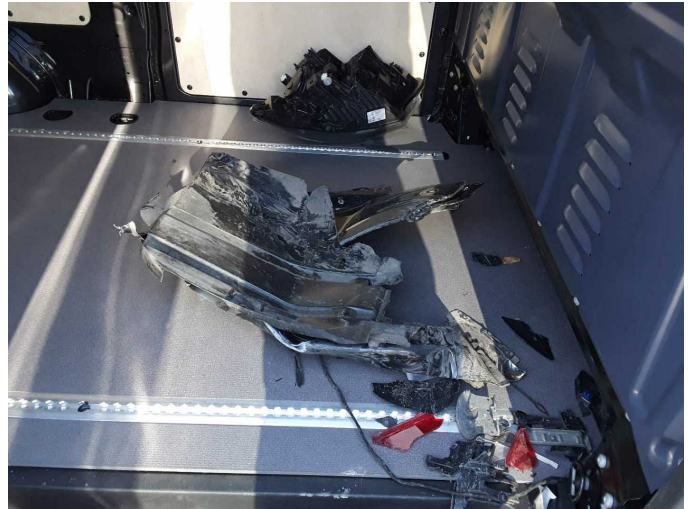
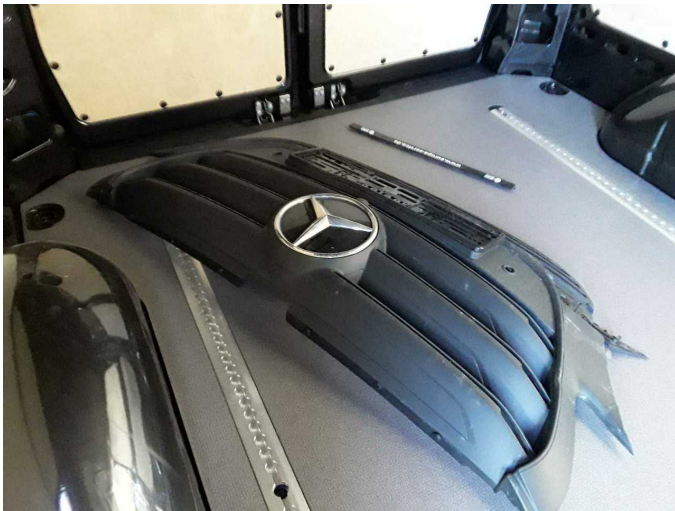
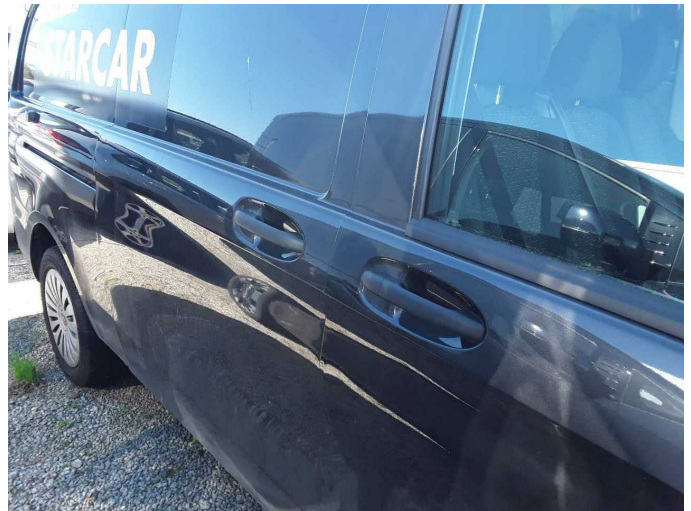
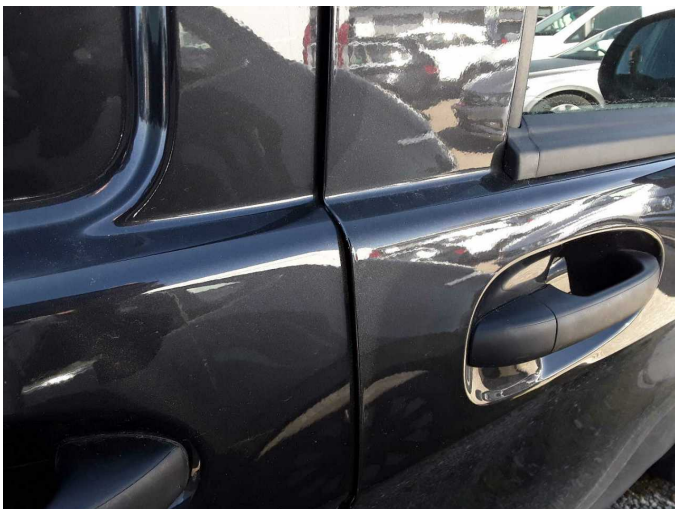
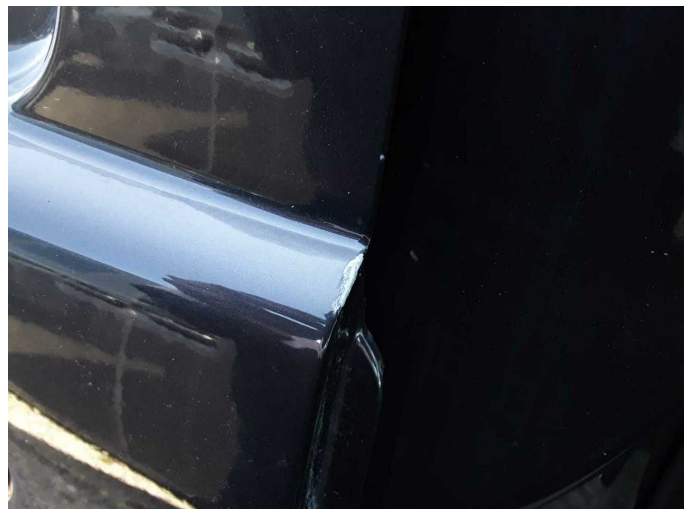
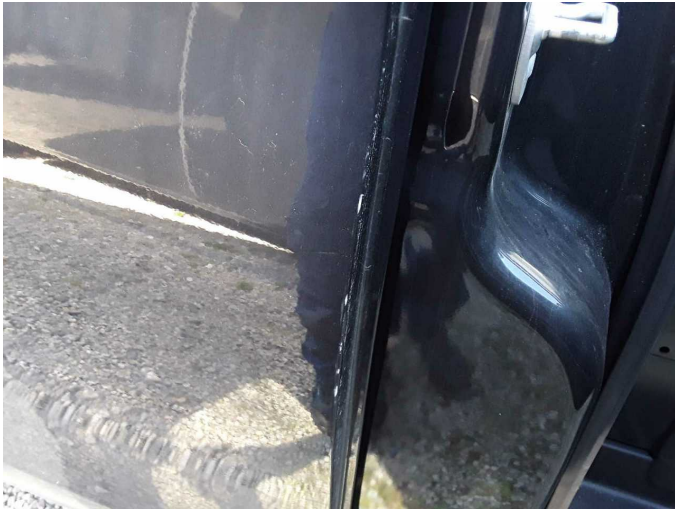
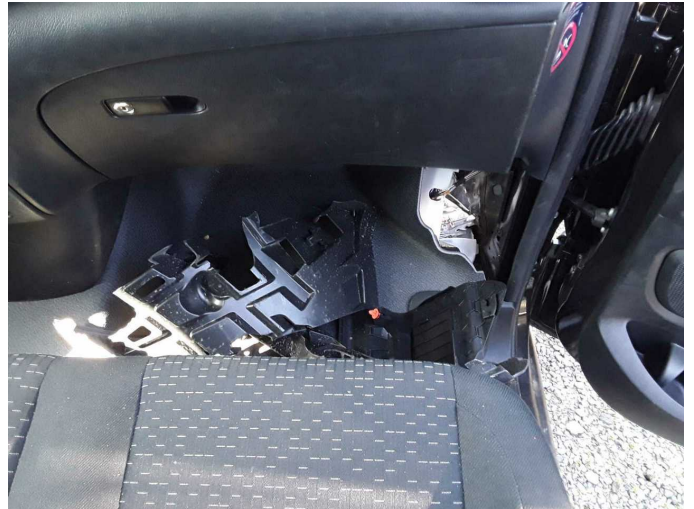
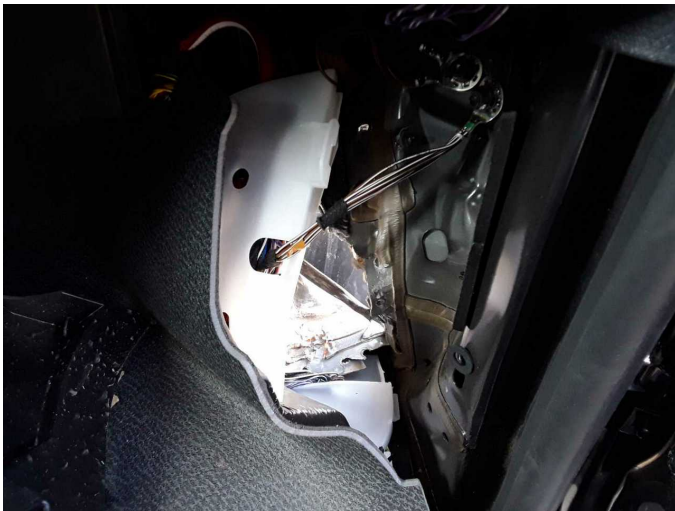
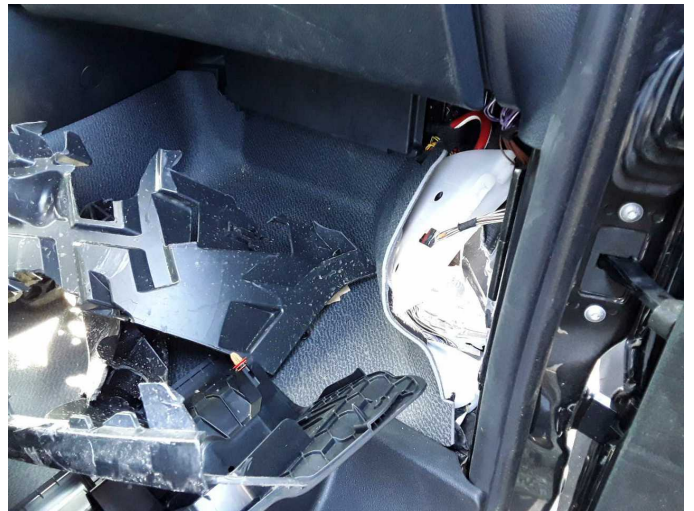
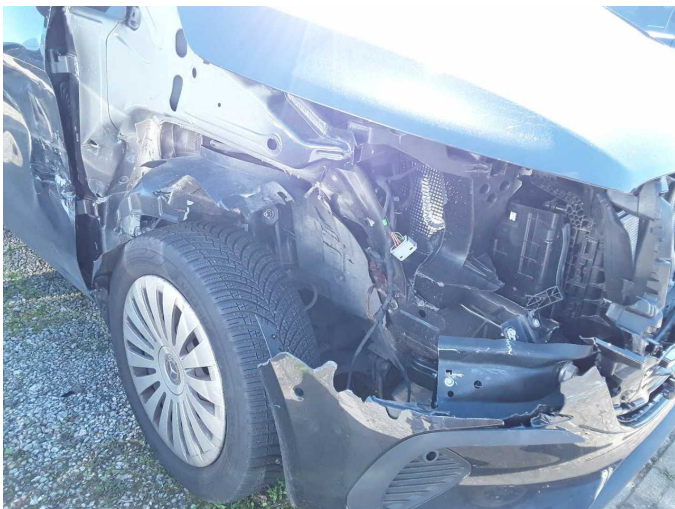
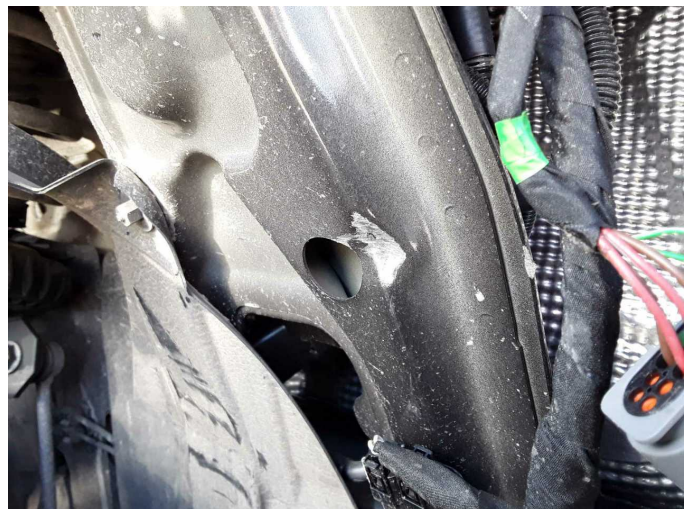
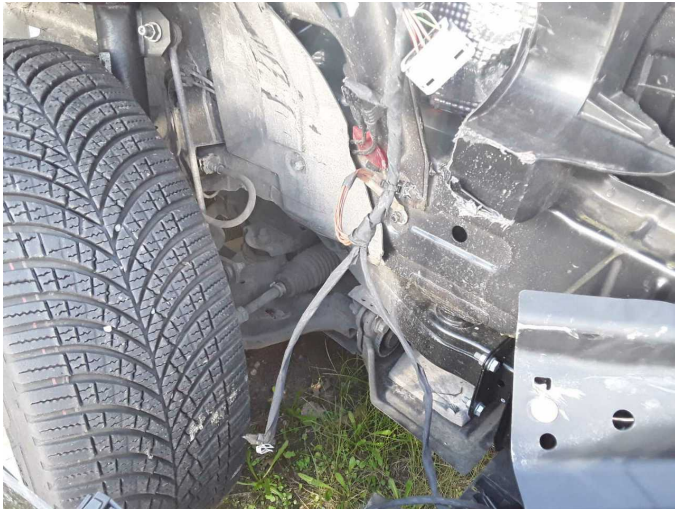
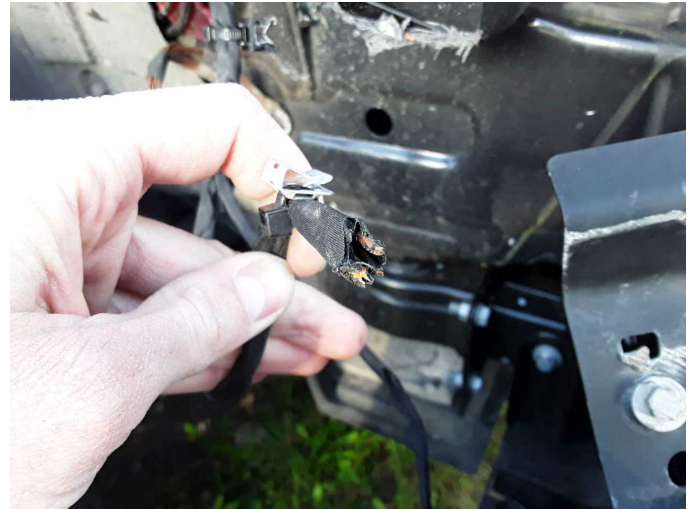
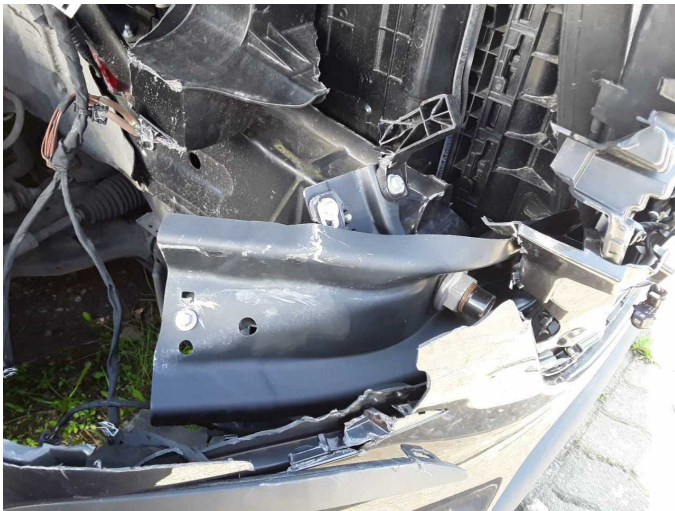
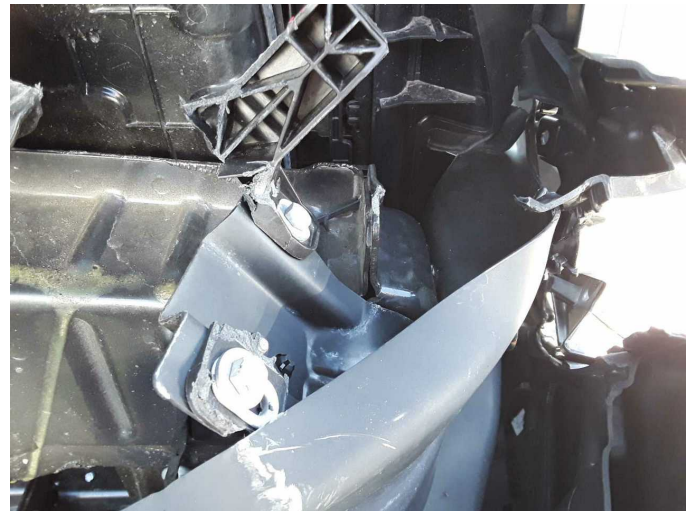
1 Front, Side right

Non-repaired previous damages were found at the vehicle. The necessary repair costs are listed in the expert report or if necessary, are listed in detail in a separately enclosed repair cost calculation.

Accident 1: Front, Side right
