Expertise

Protocol number: 46134356  
Order No. / Reference: 26539184  
Inspection date: 24 Jun 2026

Manufacturer: CUPRA

Model: Born 150kW/58kWh

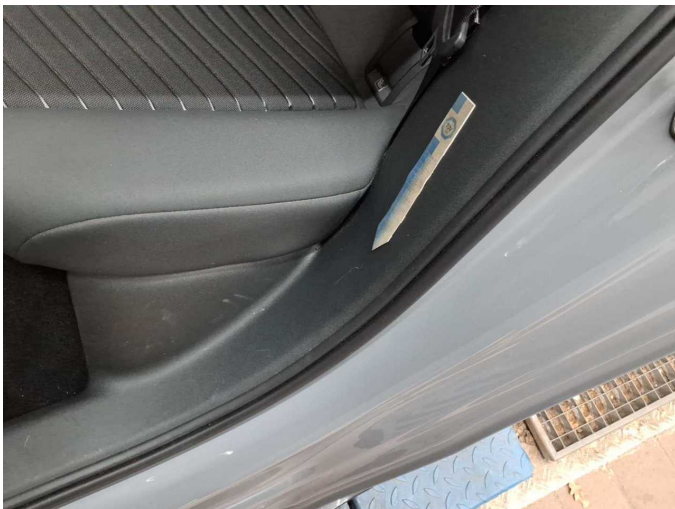
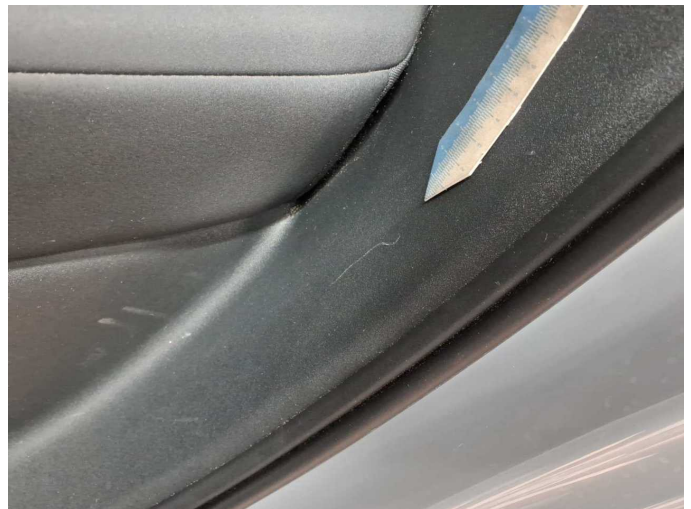
| No. | Component group | Description |
|---|---|---|
| 1 | Side panel - rear left side | Interior trim - Scratch(es) - Loss in value |

**Damage 1:** Side panel - rear left side: Interior trim - Scratch(es) - Loss in value

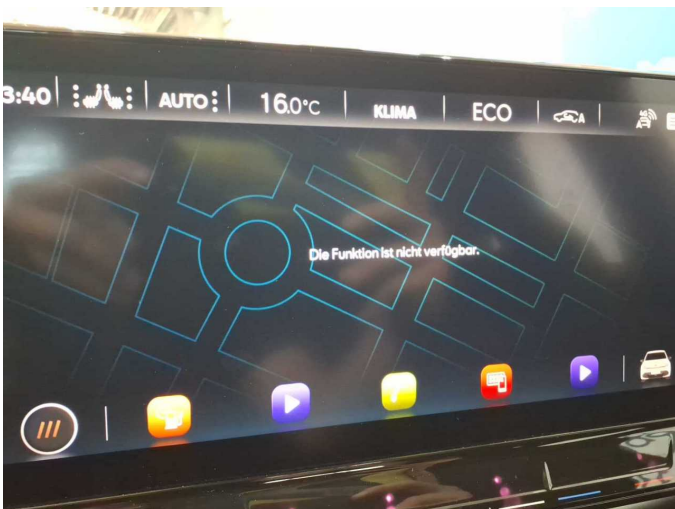
| No. | Component group | Description |
|---|---|---|
| 2 | Multimedia system | Navigation system - Non-operational - Perform diagnosis |

**Damage 2:** Multimedia system: Navigation system - Non-operational - Perform diagnosis

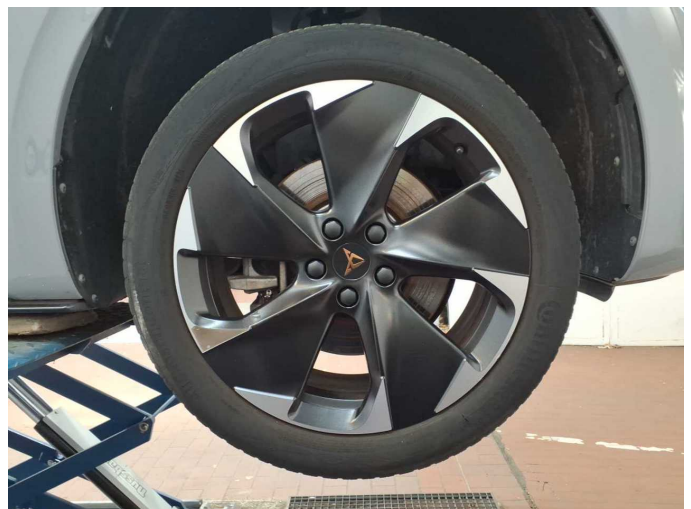
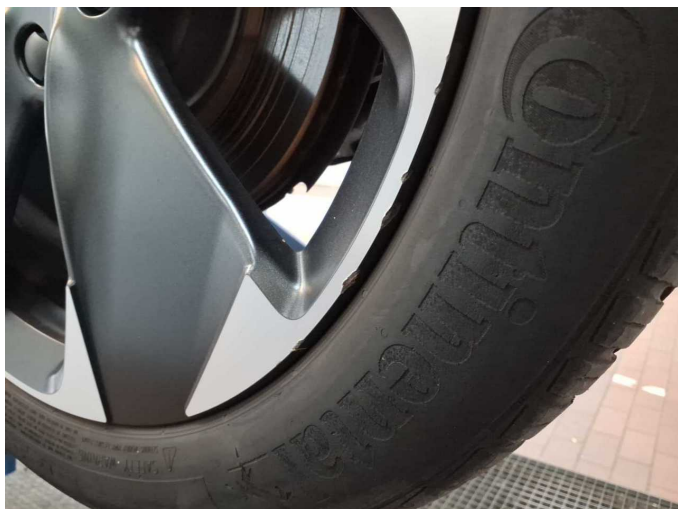
| No. | Component group | Description |
|---|---|---|
| 3 | Wheel / tyres | Alloy rim - front right side - Scratch(es) - Loss in value |

**Damage 3:** Wheel / tyres: Alloy rim - front right side - Scratch(es) - Loss in value

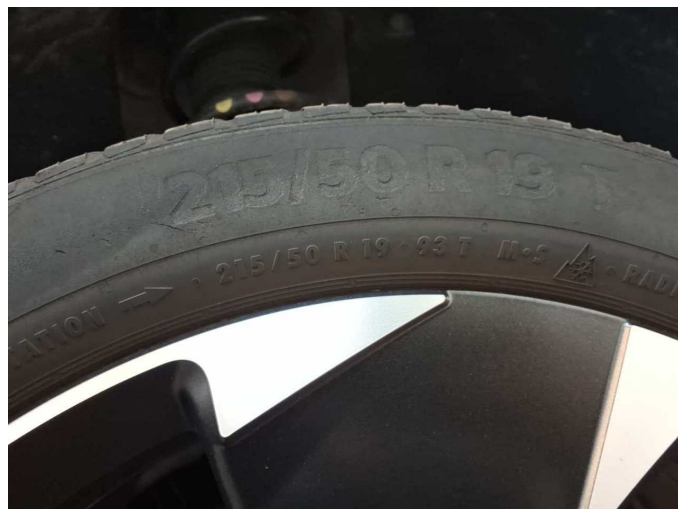
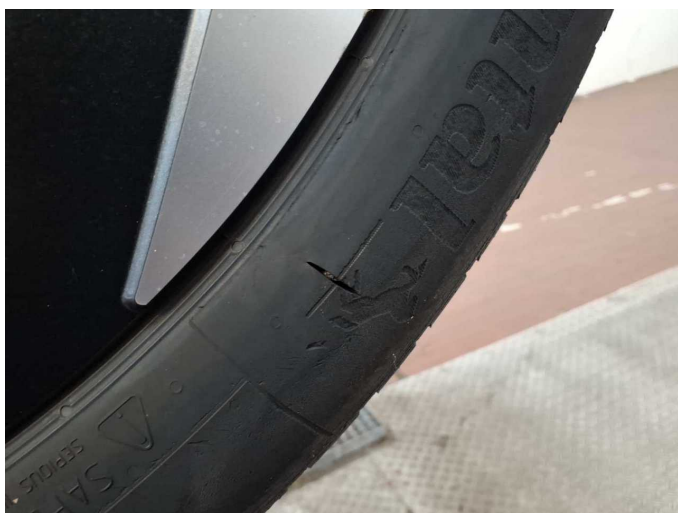
| No. | Component group | Description |
|---|---|---|
| 4 | Wheel / tyres | Tyre - front right side - Damaged - Replace |

**Damage 4:** Wheel / tyres: Tyre - front right side - Damaged - Replace

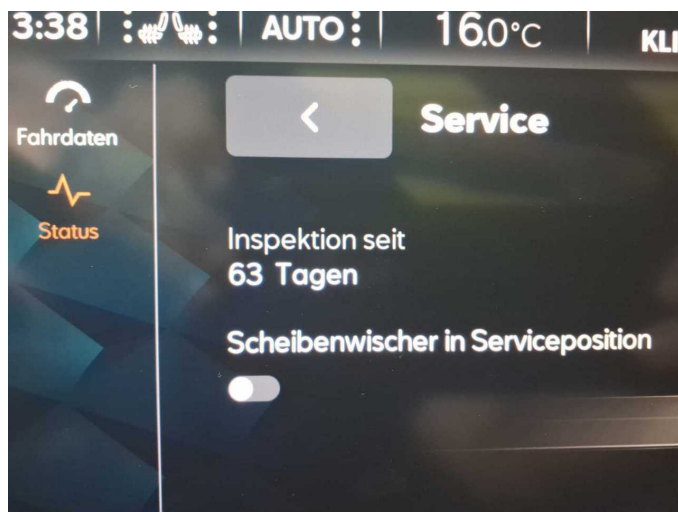
| No. | Component group | Description |
|---|---|---|
| 5 | Misc. | Inspection / maintenance (Kein Nachweis) - Due - Perform diagnosis |

**Damage 5:** Misc.: Inspection / maintenance (Kein Nachweis) - Due - Perform diagnosis
