## Expertise

Protocol number: 45980868  
Order No. / Reference: 26500353  
Inspection date: 16 Jun 2026

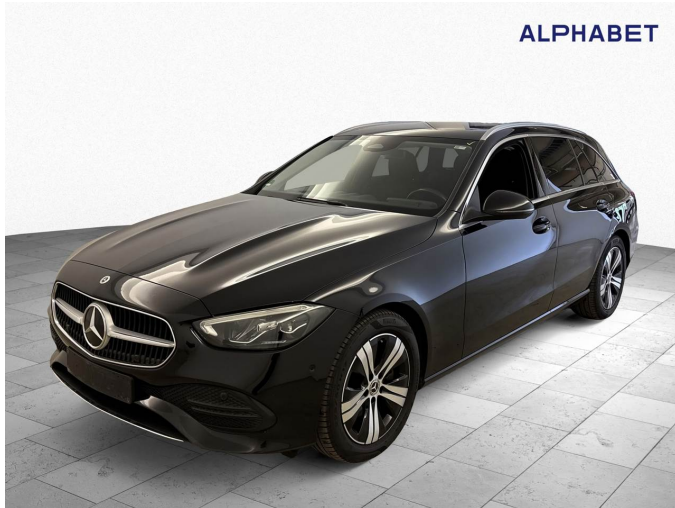
Figure 1: Diagonal front (left)

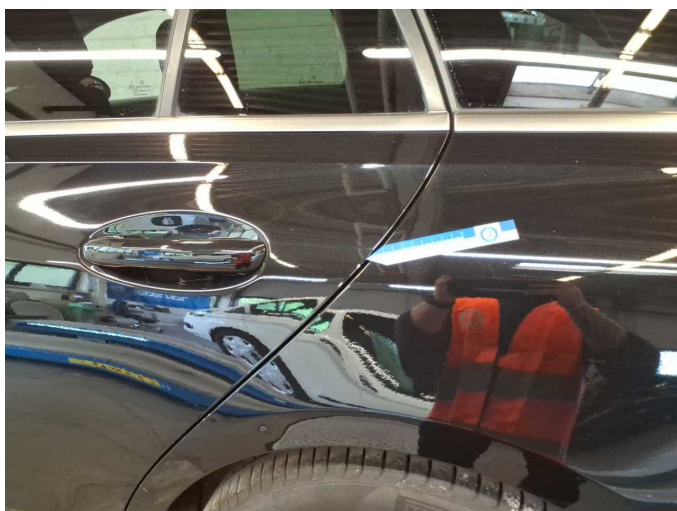
Damage 3: Door - rear left side: Door - Scratch(es) - Smart repair

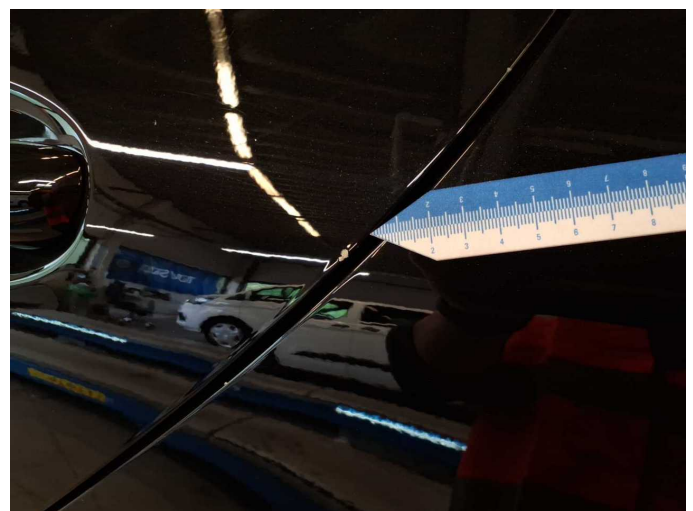
Damage 3: Door - rear left side: Door - Scratch(es) - Smart repair

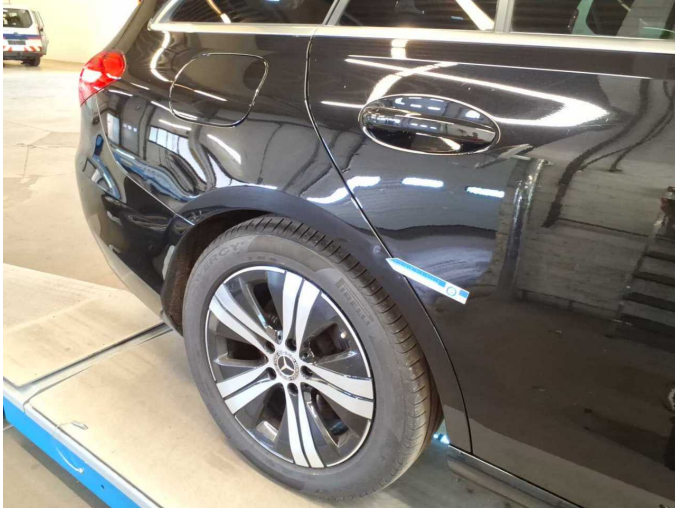
**Damage 4:** Side panel - rear right side: Side panel - dent(s) - Smooth repair work

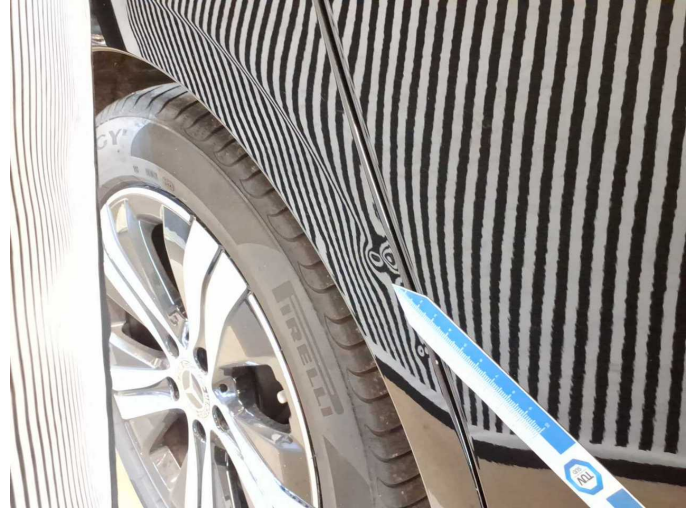
**Damage 4:** Side panel - rear right side: Side panel - dent(s) - Smooth repair work

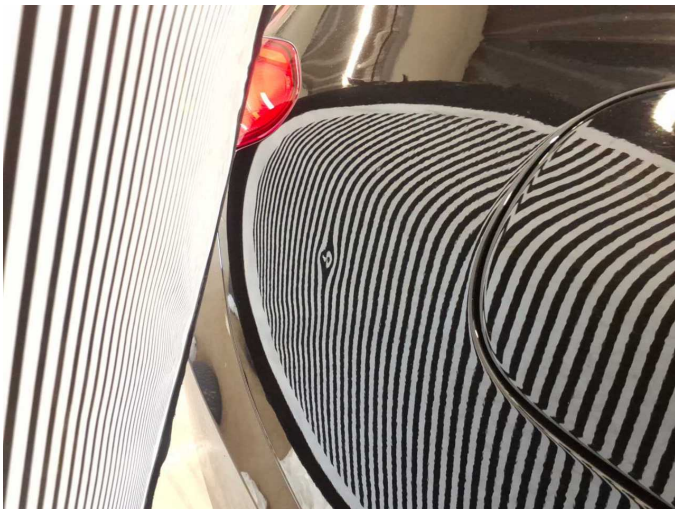
**Damage 4:** Side panel - rear right side: Side panel - dent(s) - Smooth repair work

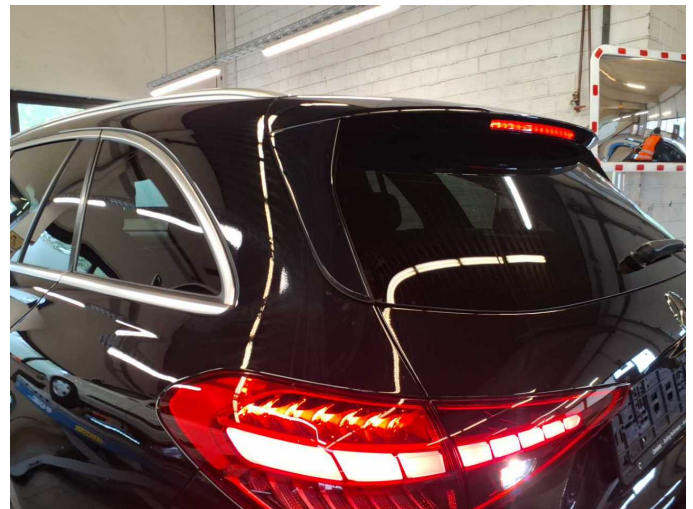
**Damage 5:** Boot lid / rear door: Boot lid (Zierleiste) - Malposition - Replace

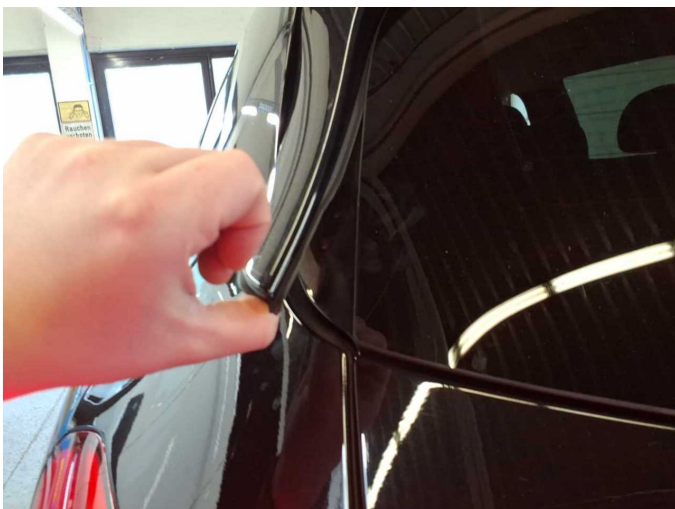
**Damage 5:** Boot lid / rear door: Boot lid (Zierleiste) - Malposition - Replace

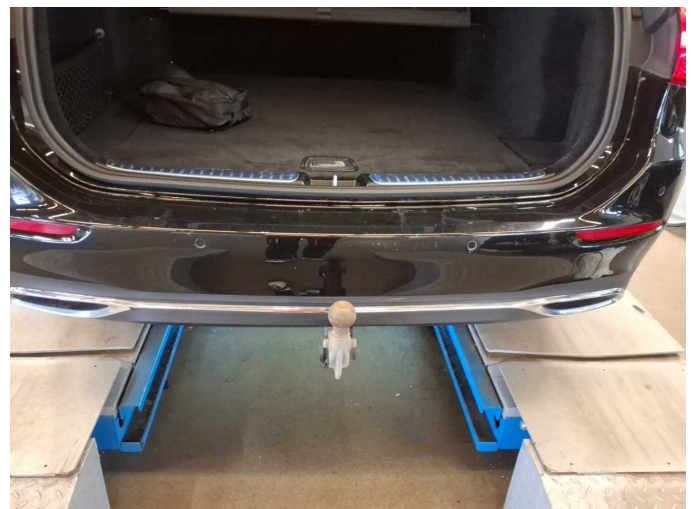
**Damage 6:** Rear bumper: Rear bumper - Scratch(es) - Paint

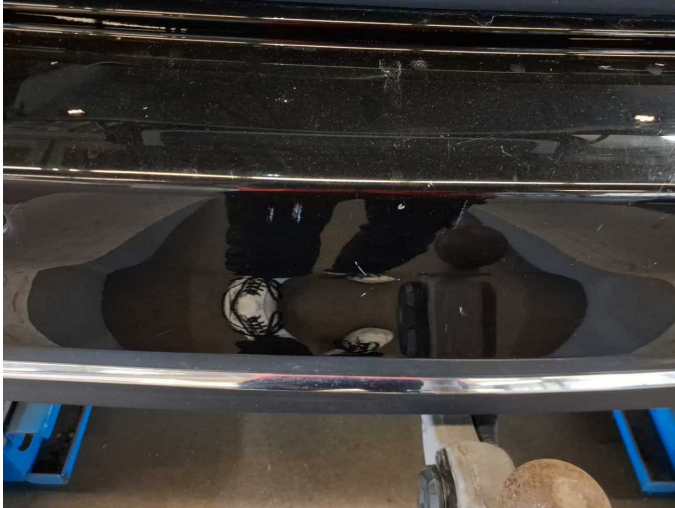
**Damage 6:** Rear bumper: Rear bumper - Scratch(es) - Paint

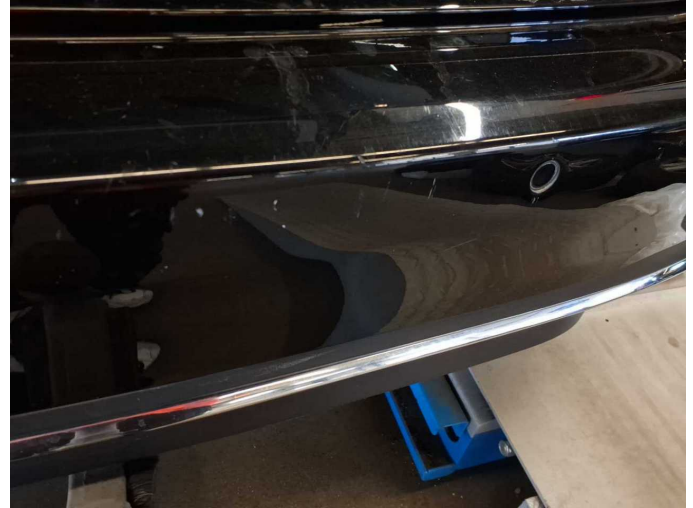
**Damage 6:** Rear bumper: Rear bumper - Scratch(es) - Paint

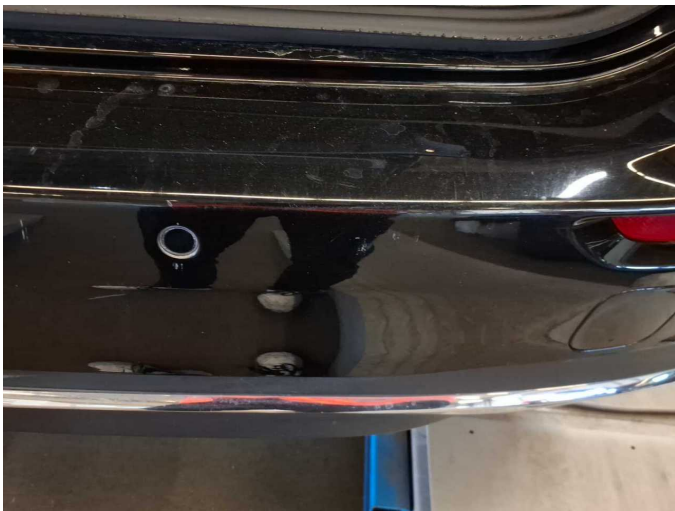
**Damage 6:** Rear bumper: Rear bumper - Scratch(es) - Paint

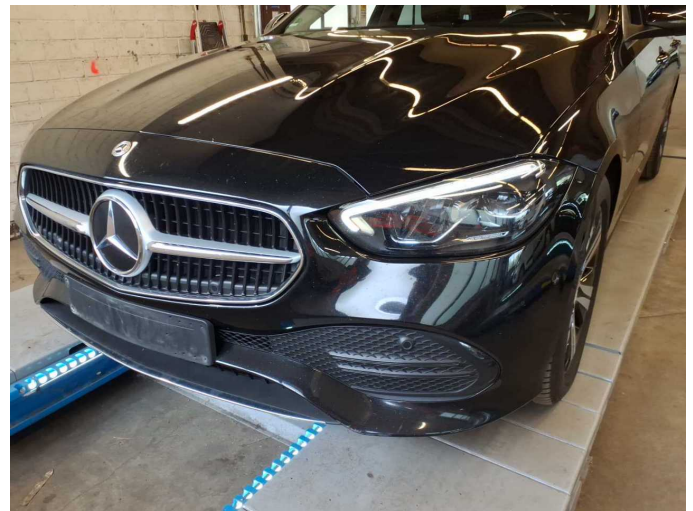
**Damage 7:** Front bumper: Front bumper (Sandstrahleffekt) - Stone chips - Paint

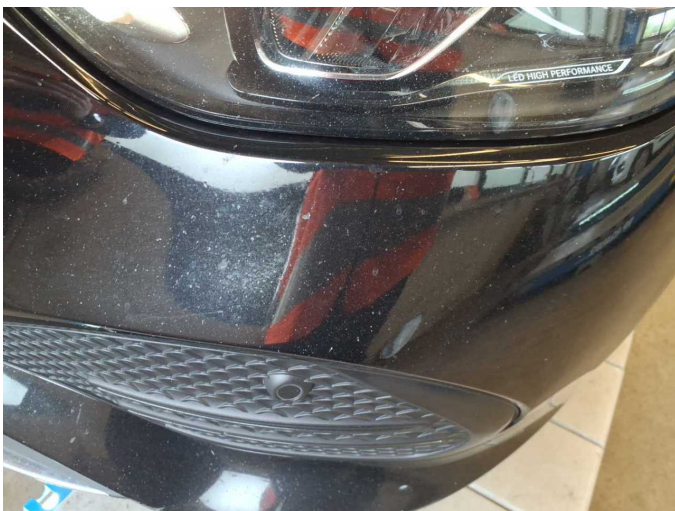
**Damage 7:** Front bumper: Front bumper (Sandstrahleffekt) - Stone chips - Paint

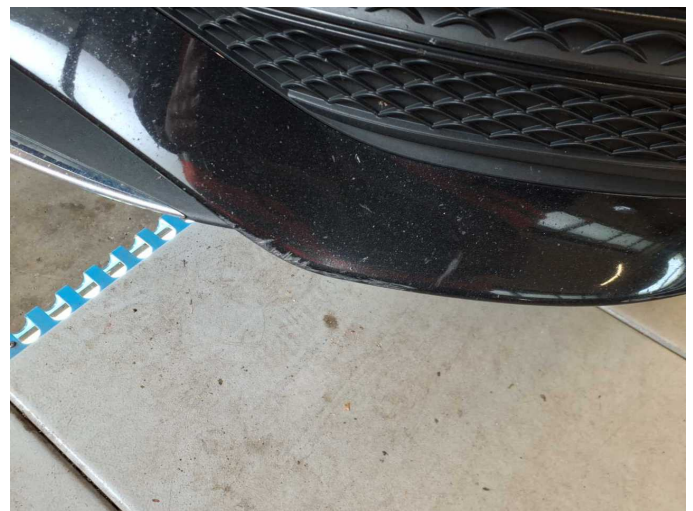
**Damage 7:** Front bumper: Front bumper (Sandstrahleffekt) - Stone chips - Paint

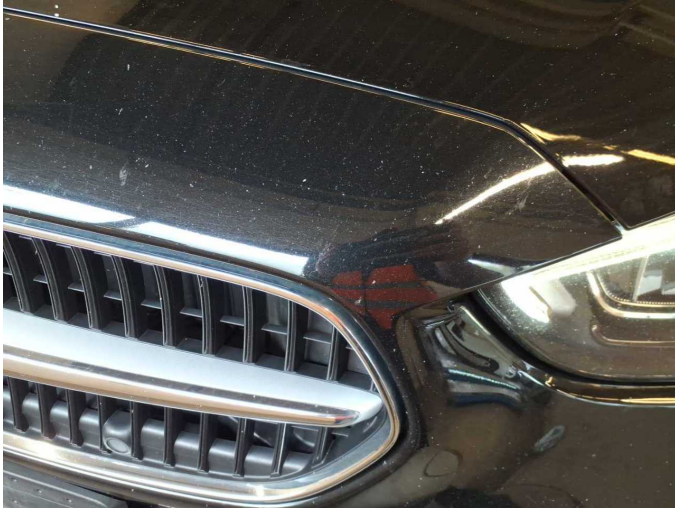
**Damage 7:** Front bumper: Front bumper (Sandstrahleffekt) - Stone chips - Paint

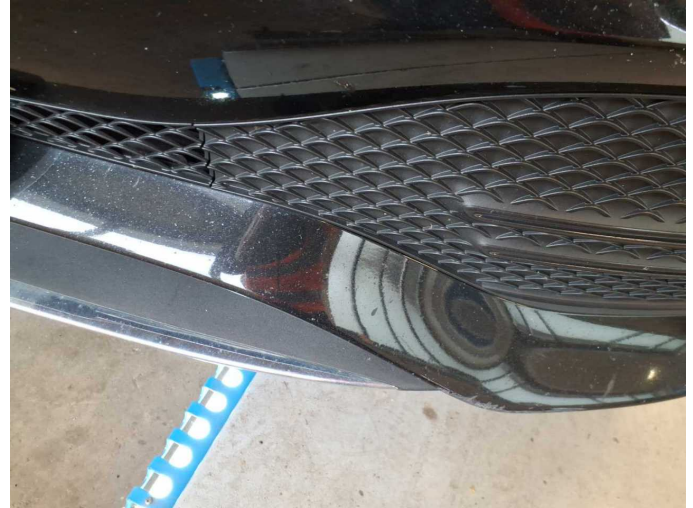
**Damage 7:** Front bumper: Front bumper (Sandstrahleffekt) - Stone chips - Paint

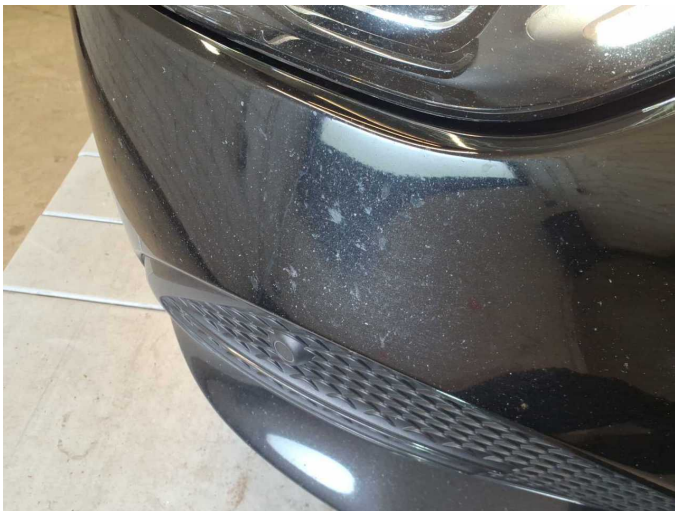
**Damage 7:** Front bumper: Front bumper (Sandstrahleffekt) - Stone chips - Paint

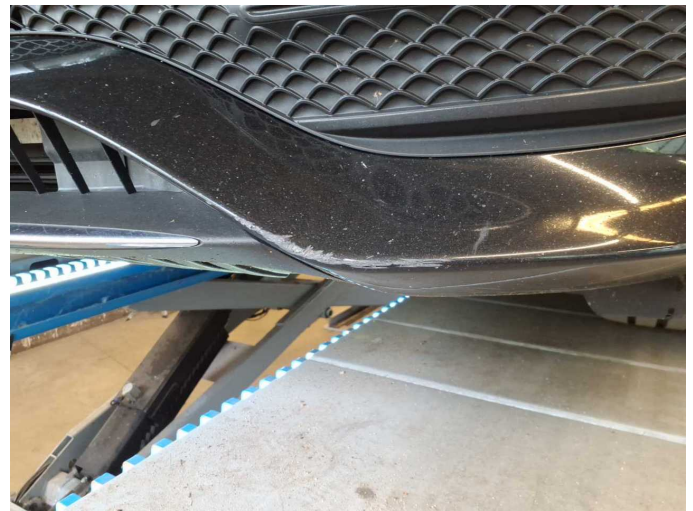
**Damage 7:** Front bumper: Front bumper (Sandstrahleffekt) - Stone chips - Paint

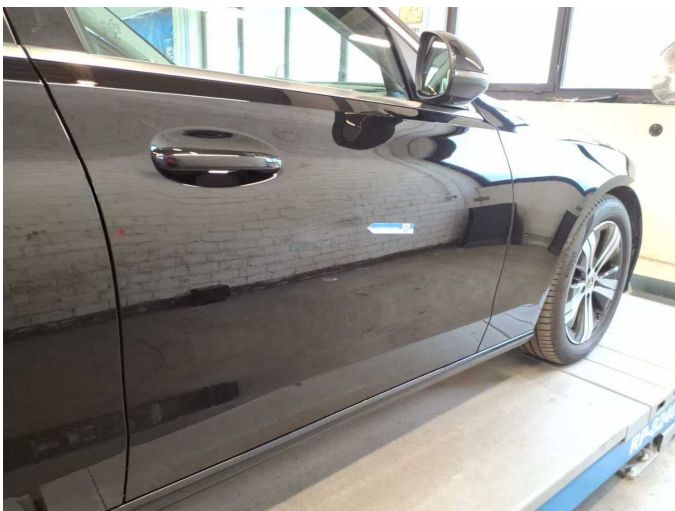
**Damage 8:** Door - front right side: Door - Dent / paintcoat damage - Repair and paint

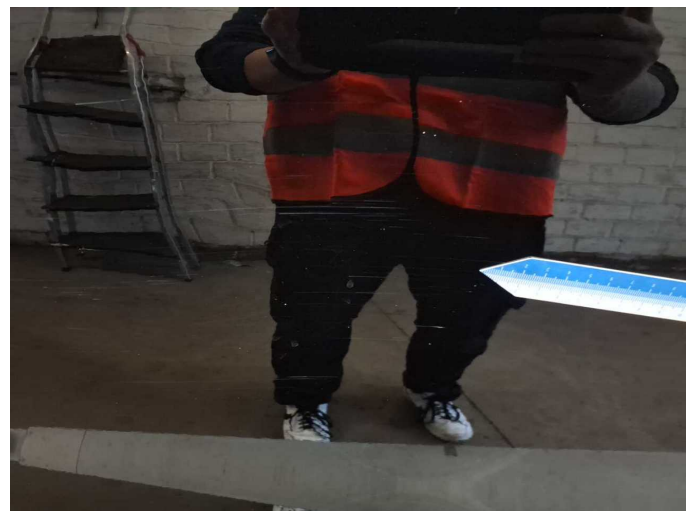
**Damage 8:** Door - front right side: Door - Dent / paintcoat damage - Repair and paint

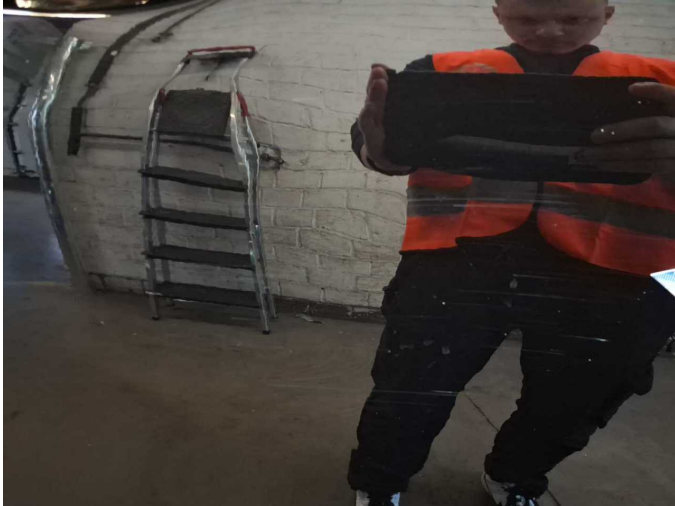
**Damage 8:** Door - front right side: Door - Dent / paintcoat damage - Repair and paint

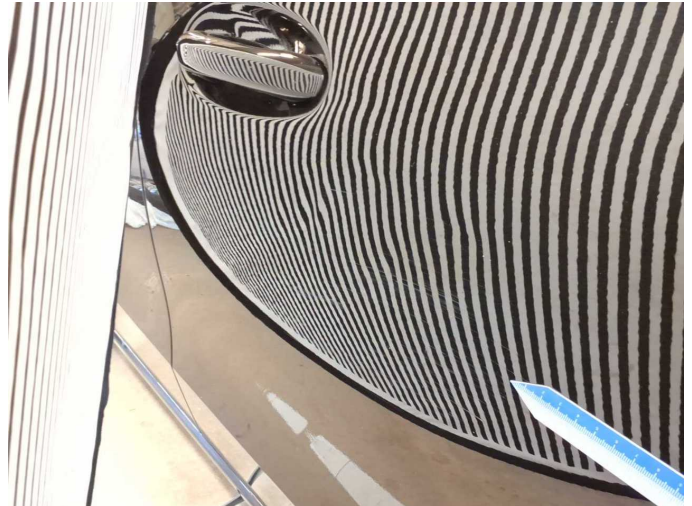
**Damage 8:** Door - front right side: Door - Dent / paintcoat damage - Repair and paint

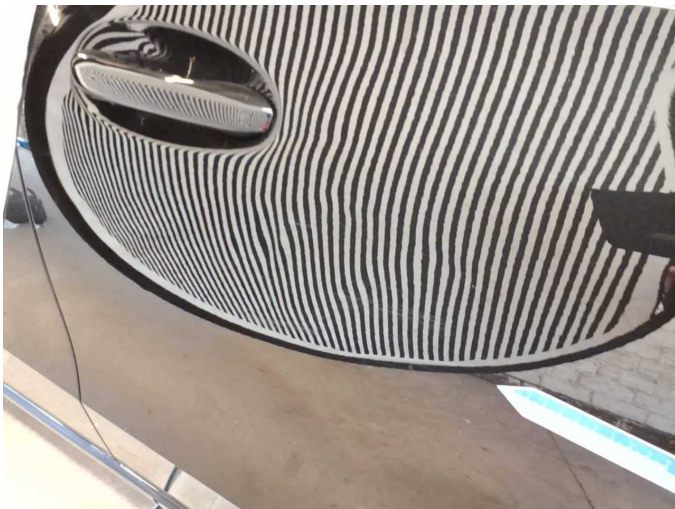
**Damage 8:** Door - front right side: Door - Dent / paintcoat damage - Repair and paint

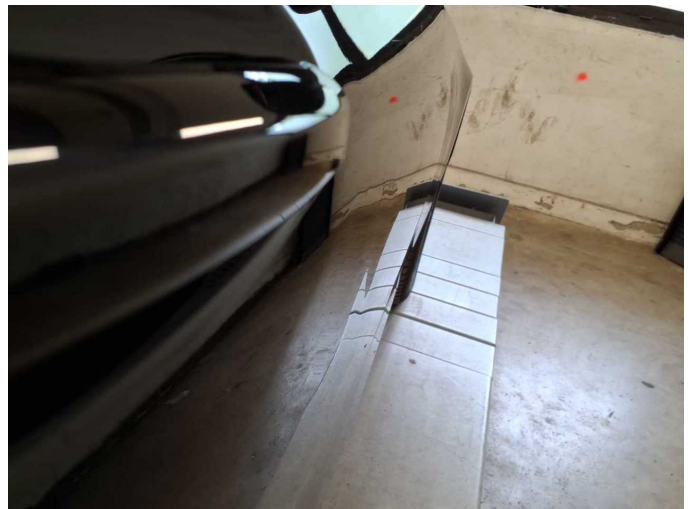
**Damage 8:** Door - front right side: Door - Dent / paintcoat damage - Repair and paint

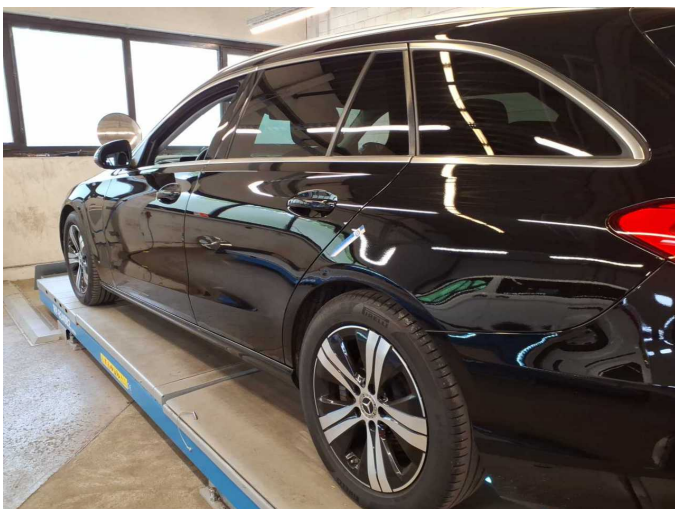
**Damage 9:** Side panel - rear left side: Side panel - Dent / paintcoat damage - Repair and paint

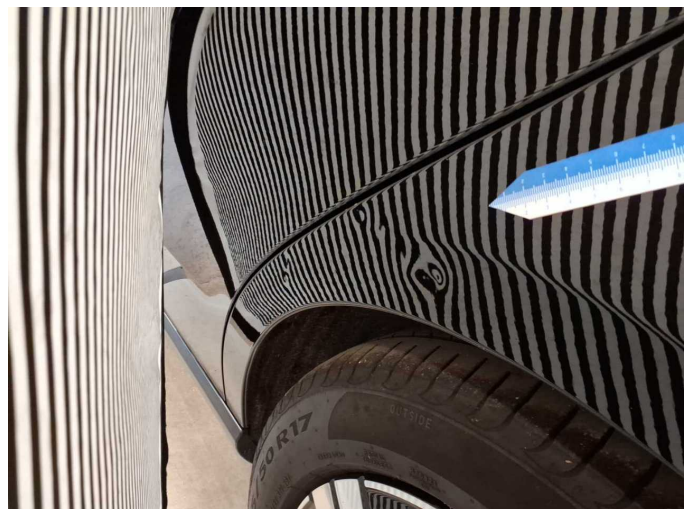
**Damage 9:** Side panel - rear left side: Side panel - Dent / paintcoat damage - Repair and paint

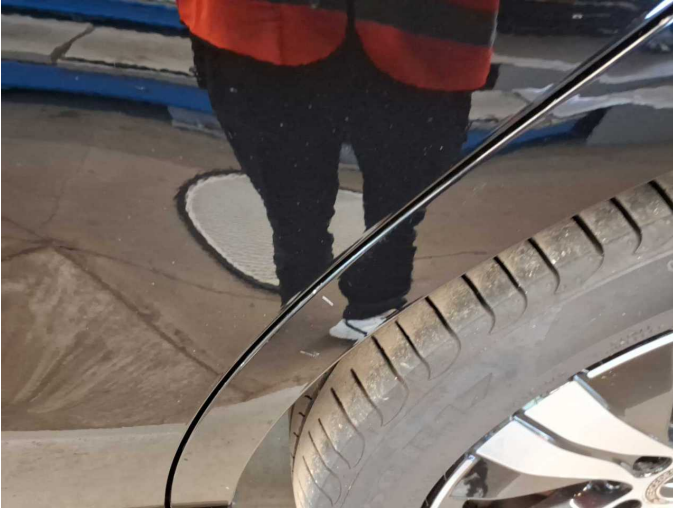
**Damage 9:** Side panel - rear left side: Side panel - Dent / paintcoat damage - Repair and paint

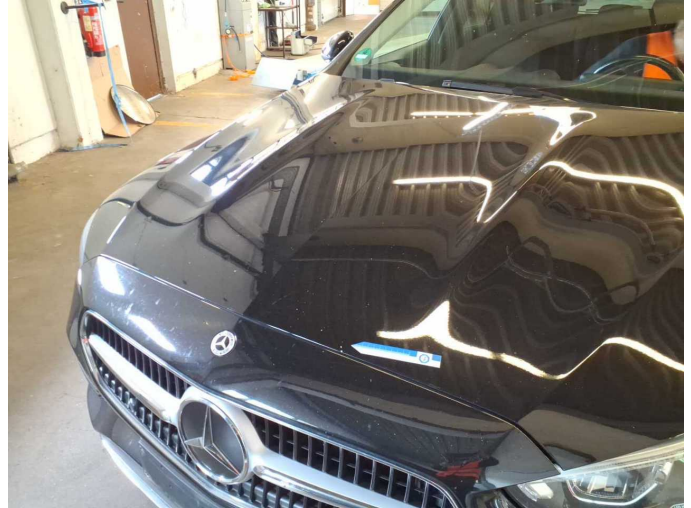
**Damage 10:** Bonnet: Bonnet - Stone chips - Paint

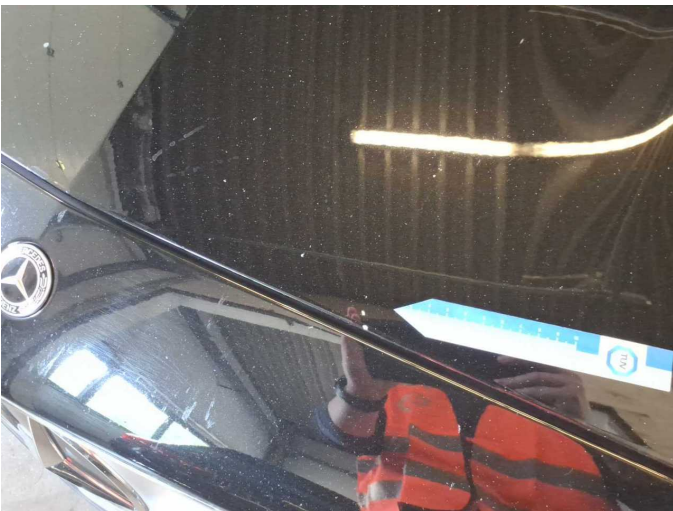
**Damage 10:** Bonnet: Bonnet - Stone chips - Paint

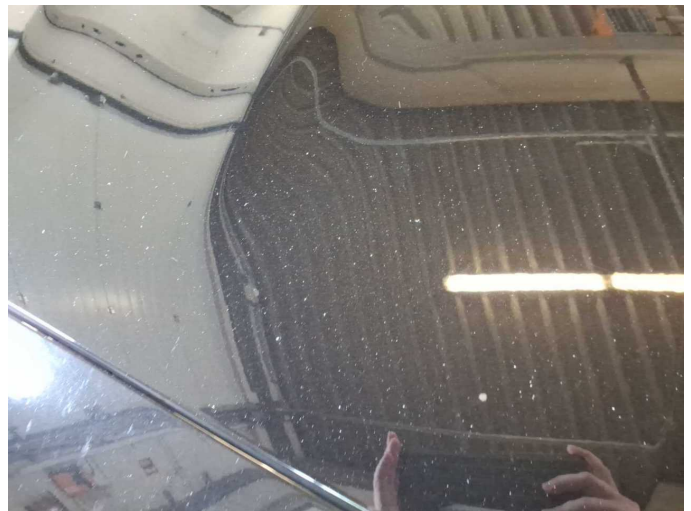
**Damage 10:** Bonnet: Bonnet - Stone chips - Paint
