Expertise

Protocol number: 45514439  
Order No. / Reference: 26106128-1  
Inspection date: 10 Mar 2026

Manufacturer: Ford

Model: Transit Custom 340 L1H1 LKW VA Trend

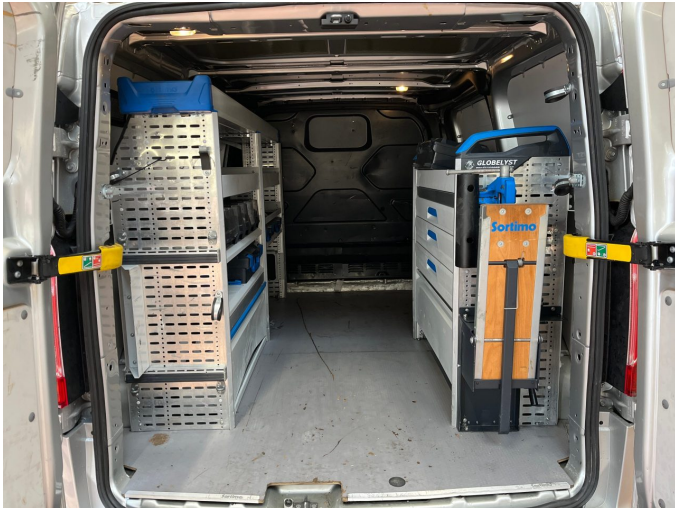
| No. | Component group | Description |
|---|---|---|
| 1 | Misc. | Main inspection (laut Wartungshis. 07.2024 durchgeführt) - No evidence - No deduction |

**Damage 1:** Misc.: Main inspection (laut Wartungshis. 07.2024 durchgeführt) - No evidence - No deduction

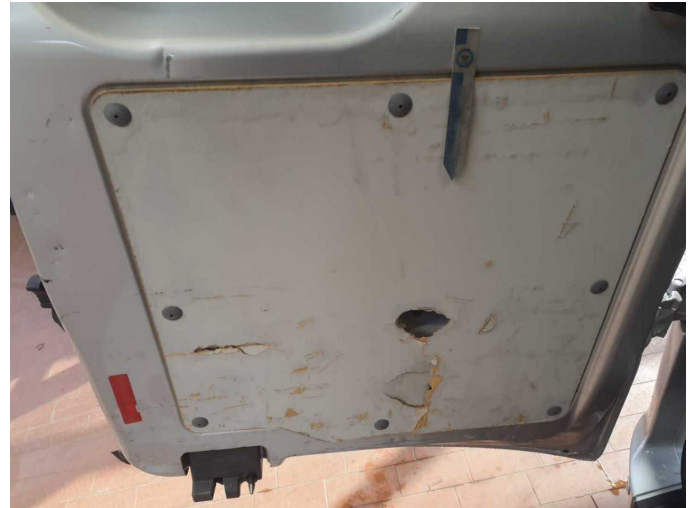
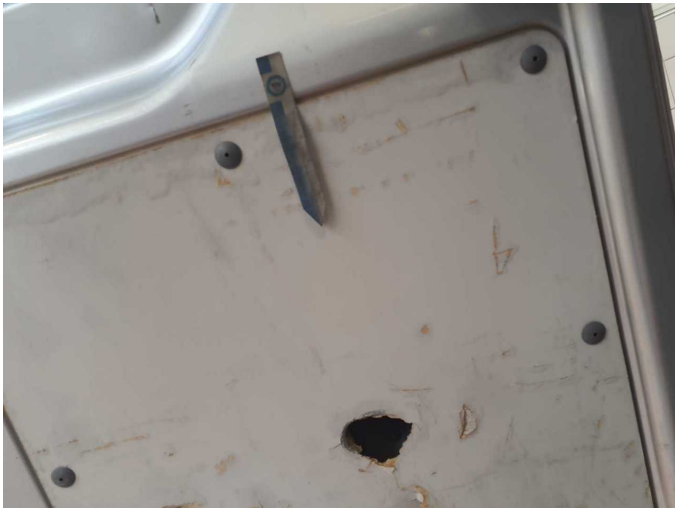
| No. | Component group | Description |
|---|---|---|
| 3 | Boot lid / rear door | Trim rear door - plywood - lower - Broken / torn - Replace |

**Damage 3:** Boot lid / rear door: Trim rear door - plywood - lower - Broken / torn - Replace

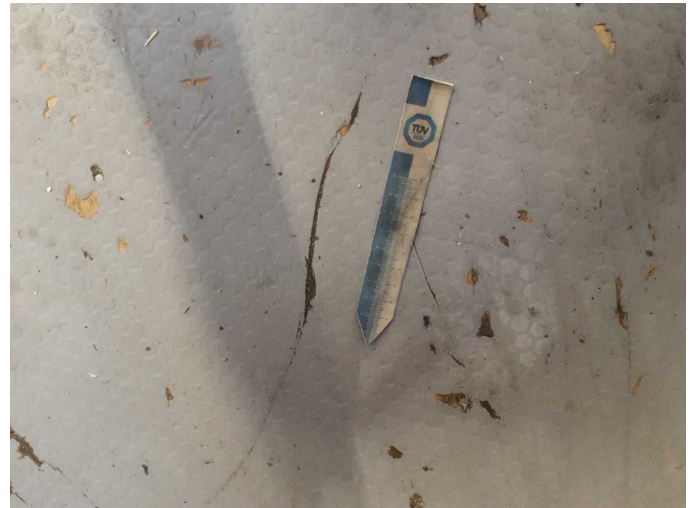
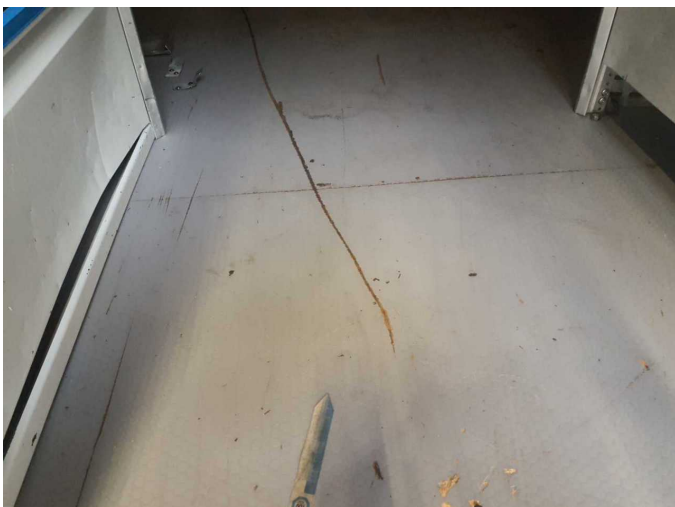
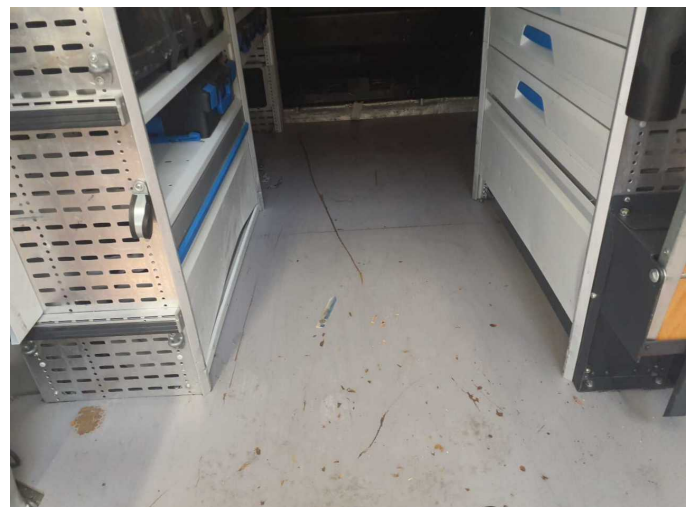
| No. | Component group | Description |
|---|---|---|
| 4 | Interior | Cargo area floor - Scratched - Loss in value |

**Damage 4:** Interior: Cargo area floor - Scratched - Loss in value

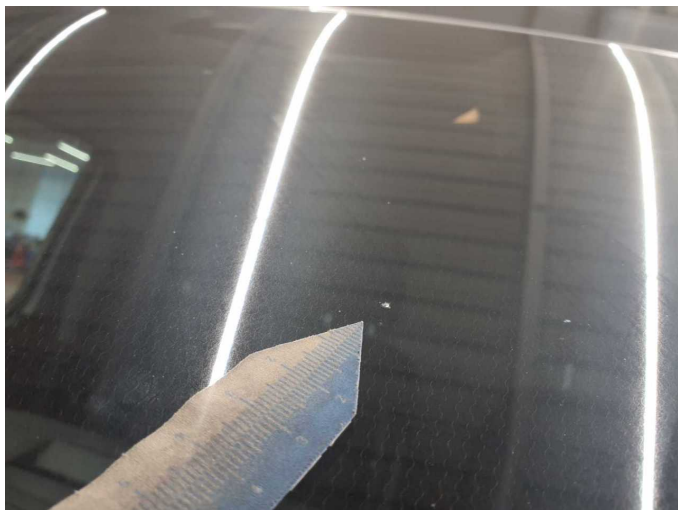
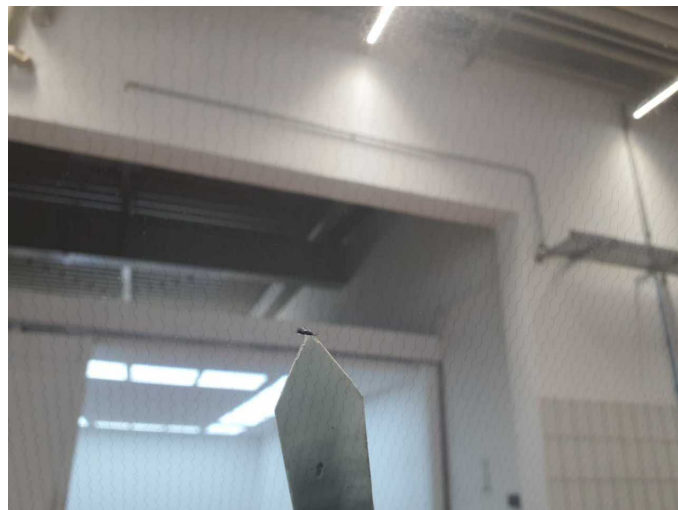
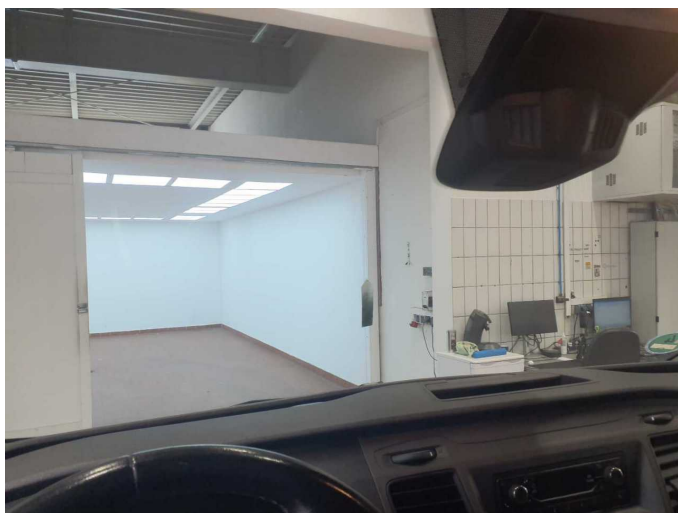
| No. | Component group | Description |
|---|---|---|
| 5 | Vehicle glazing | Windscreen - Stone chips - Smart repair |

**Damage 5:** Vehicle glazing: Windscreen - Stone chips - Smart repair

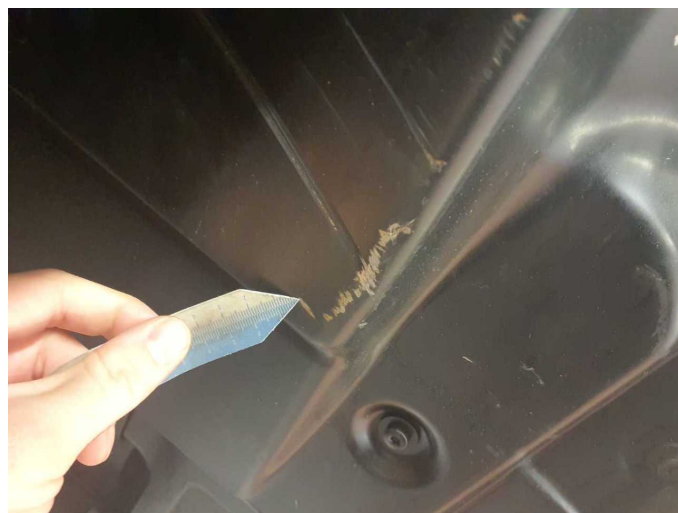
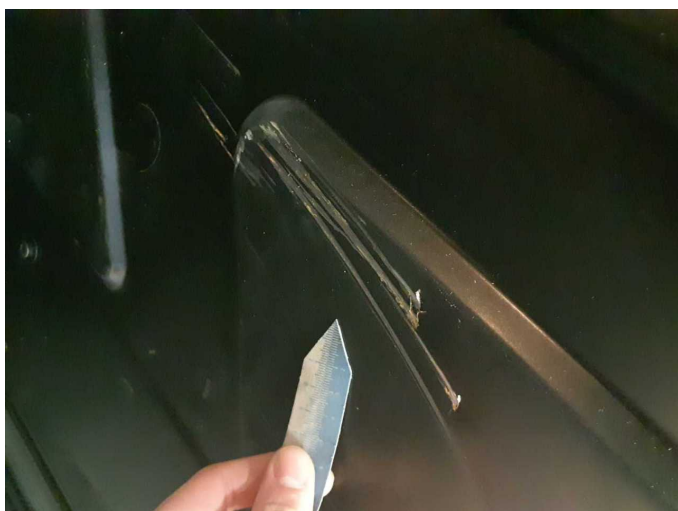
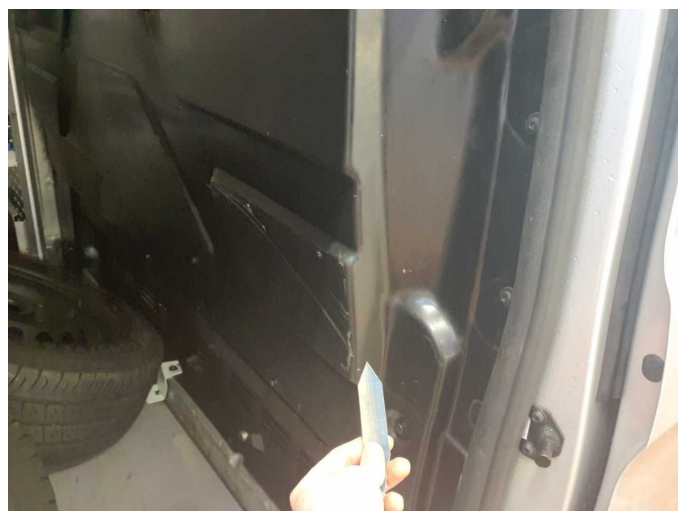
| No. | Component group | Description |
|---|---|---|
| 6 | Body | Partition wall - Dent / paintcoat damage - Loss in value |

**Damage 6:** Body: Partition wall - Dent / paintcoat damage - Loss in value

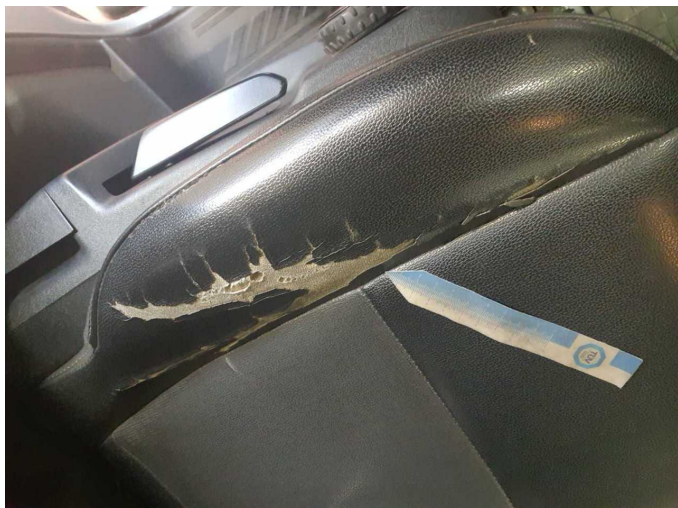
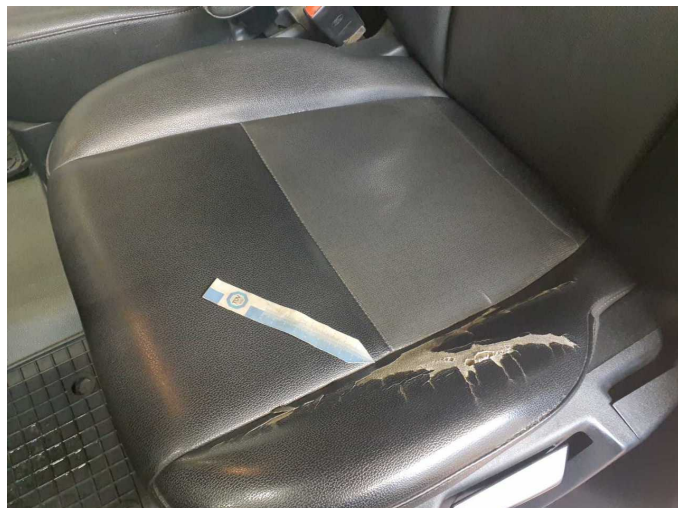
| No. | Component group | Description |
|---|---|---|
| 7 | Seat - front | Seat cover - left side - Broken / torn - Replace |

**Damage 7:** Seat - front: Seat cover - left side - Broken / torn - Replace

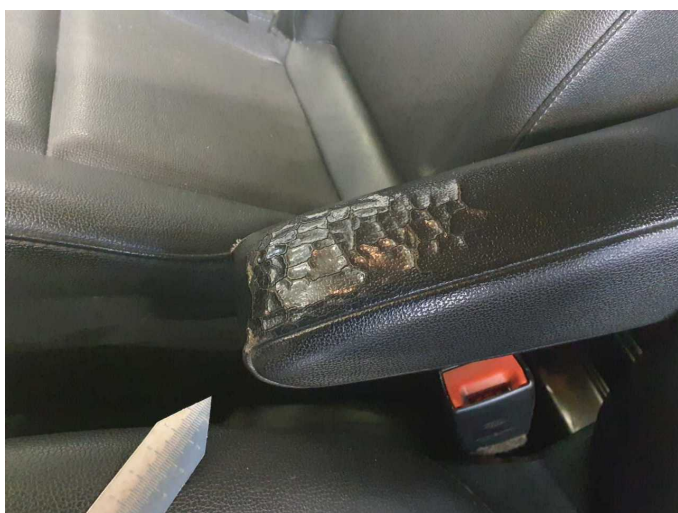
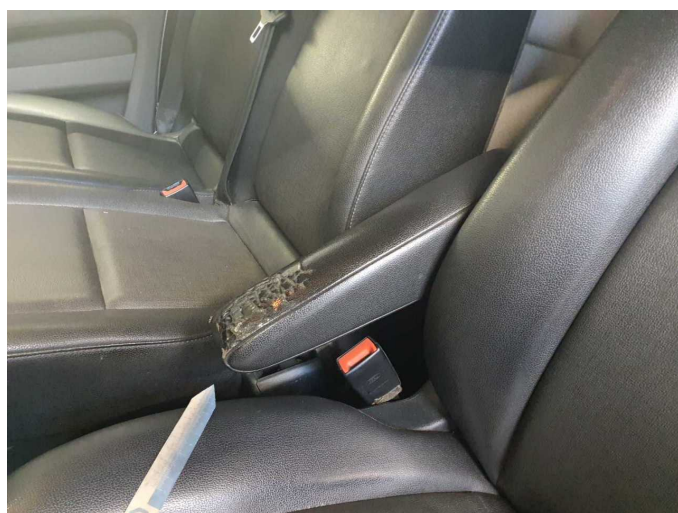
| No. | Component group | Description |
|---|---|---|
| 8 | Seat - front | armrests - Broken / torn - Replace |

**Damage 8:** Seat - front: armrests - Broken / torn - Replace

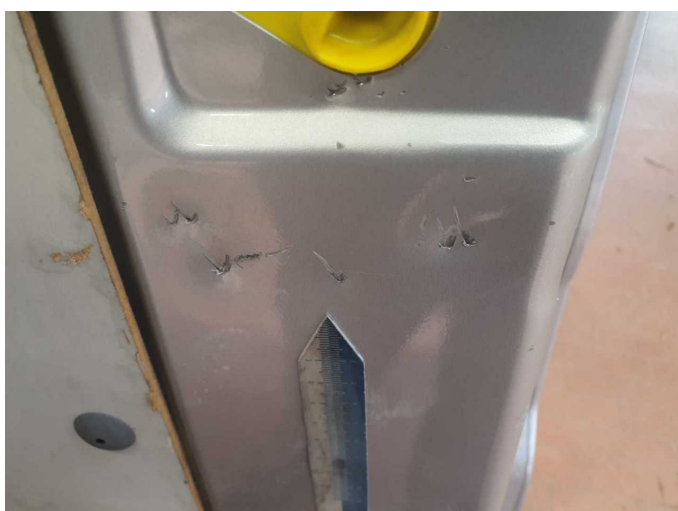
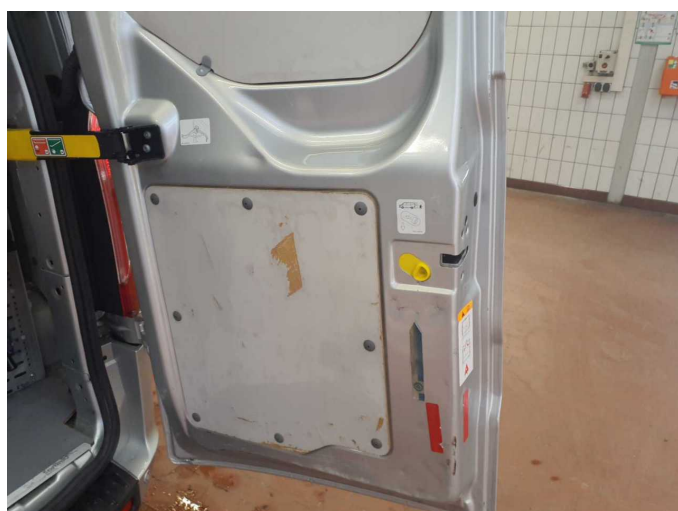
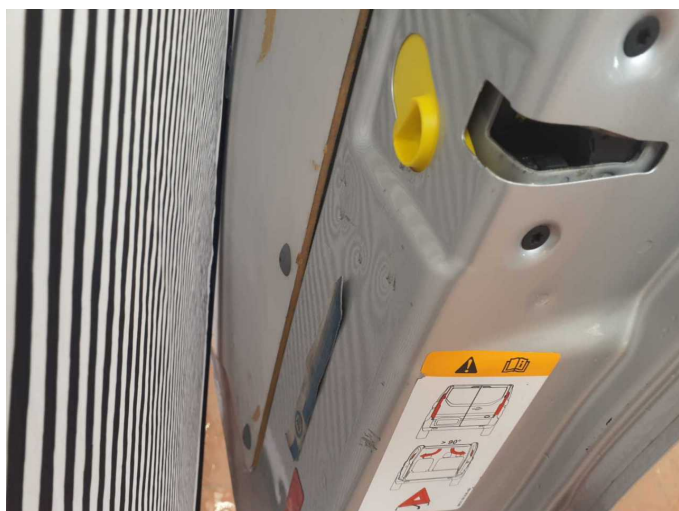
| No. | Component group | Description |
|---|---|---|
| 9 | Boot lid / rear door | Rear door - right side - Dent / paintcoat damage - Repair and paint |

**Damage 9:** Boot lid / rear door: Rear door - right side - Dent / paintcoat damage - Repair and paint

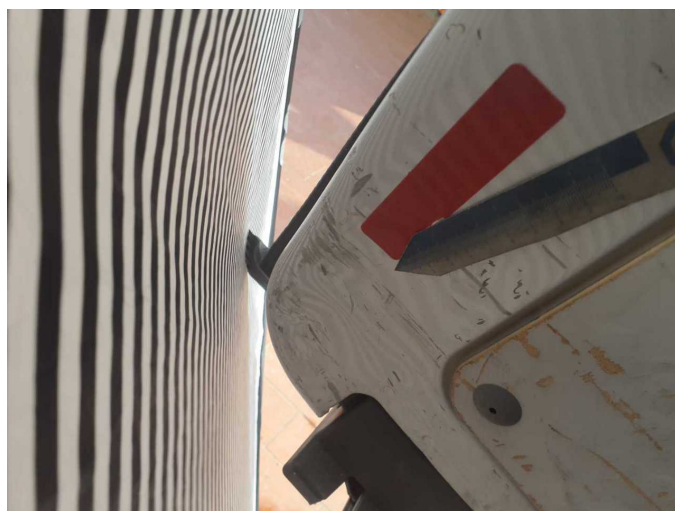
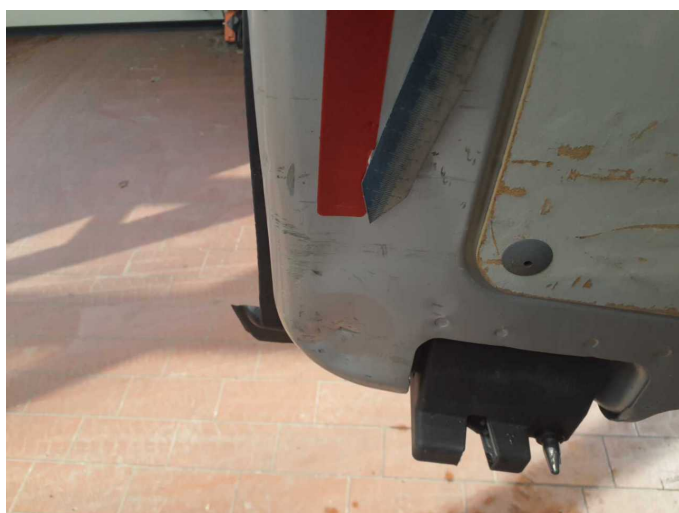
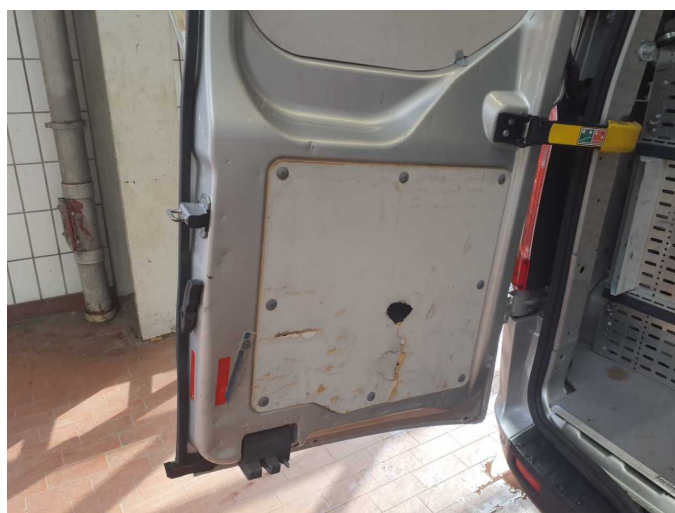
| No. | Component group | Description |
|---|---|---|
| 10 | Boot lid / rear door | Rear door - left side - Dent / paintcoat damage - Repair and paint |

**Damage 10:** Boot lid / rear door: Rear door - left side - Dent / paintcoat damage - Repair and paint

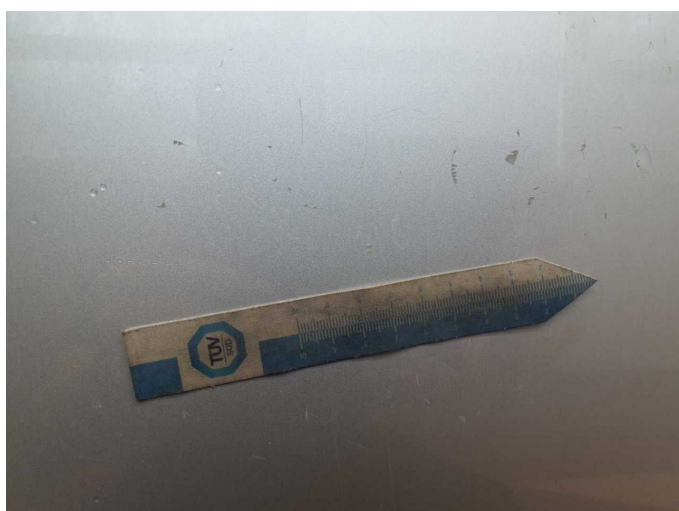
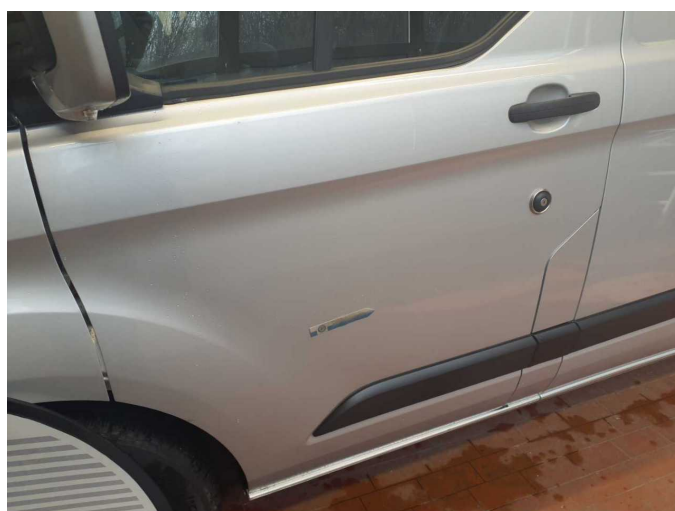
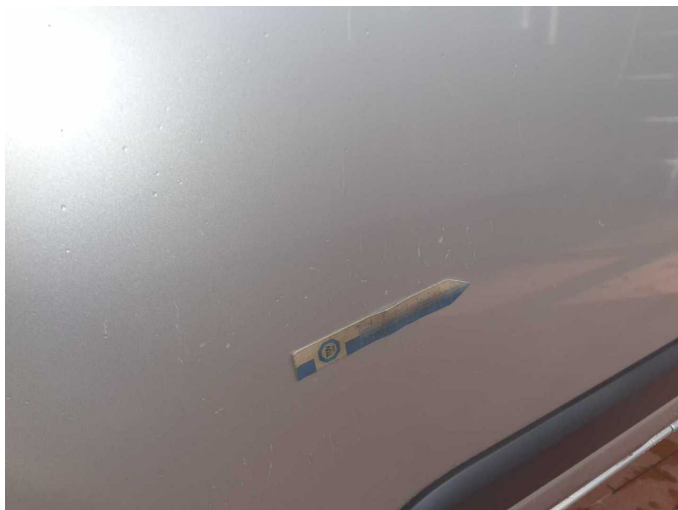
| No. | Component group | Description |
|---|---|---|
| 11 | Door - front left side | Door - Scratched - Paint |

**Damage 11:** Door - front left side: Door - Scratched - Paint

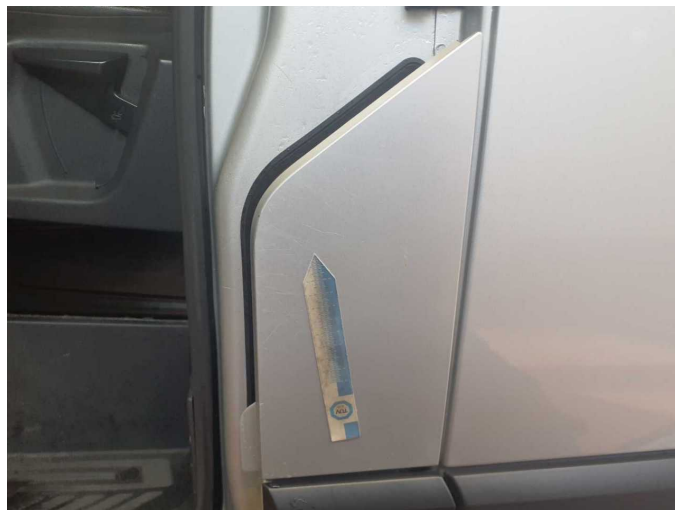
| No. | Component group | Description |
|---|---|---|
| 1 | Fuel system | Tank cap - Scratch(es) - No deduction |

**Wear and tear 1:** Fuel system: Tank cap - Scratch(es) - No deduction

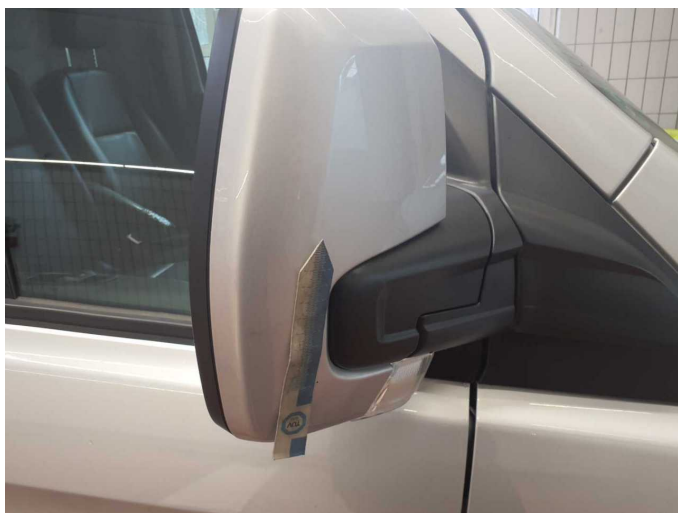
| No. | Component group | Description |
|---|---|---|
| 2 | Wing mirror - right side | Cap - Scratch(es) - No deduction |

**Wear and tear 2:** Wing mirror - right side: Cap - Scratch(es) - No deduction

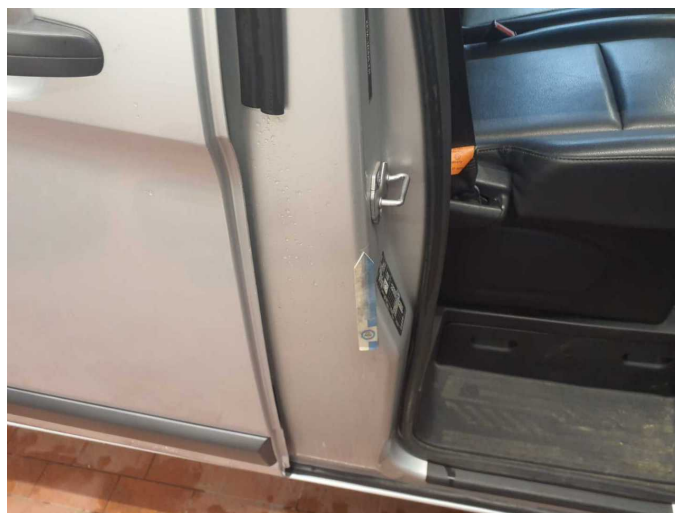
| No. | Component group | Description |
|---|---|---|
| 3 | Sill - right side | Sill - Scratch(es) - No deduction |

**Wear and tear 3:** Sill - right side: Sill - Scratch(es) - No deduction

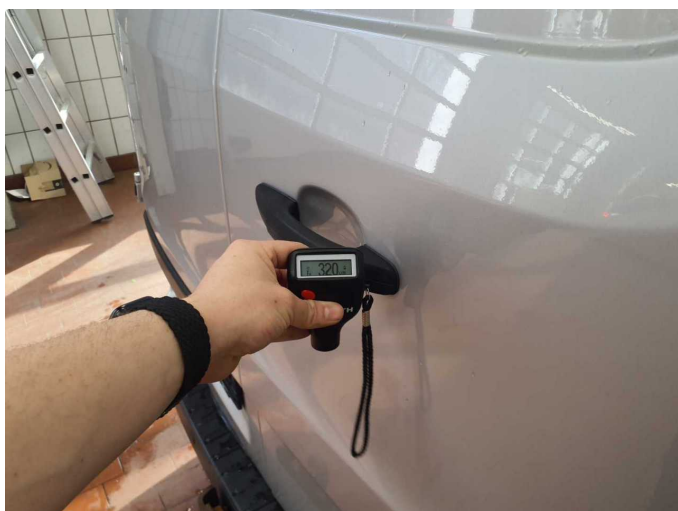
| No. | Repainting |
|---|---|
| 1 | Boot lid / rear door, Professionally carried out, Invoice of repair done Non-existent |

| Boot lid / rear door | 320 µm | Mudguard - right side | 223 µm |

**Repainting 1:** Boot lid / rear door

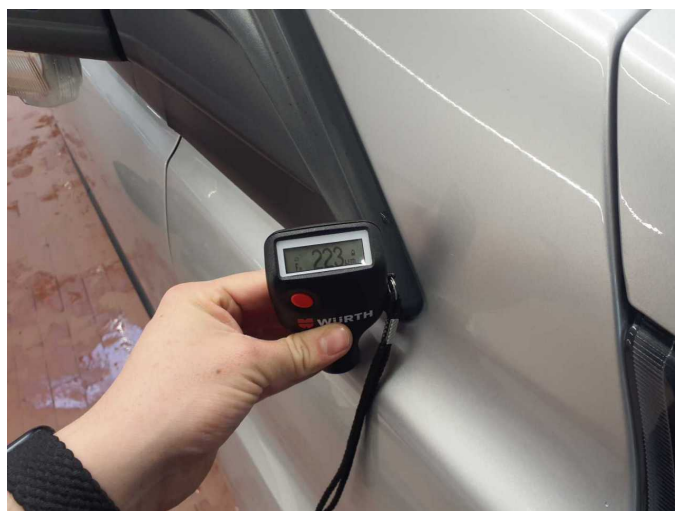
| No. | Repainting |
|---|---|
| 2 | Mudguard - right side, Professionally carried out, Invoice of repair done Non-existent |

**Repainting 2:** Mudguard - right side

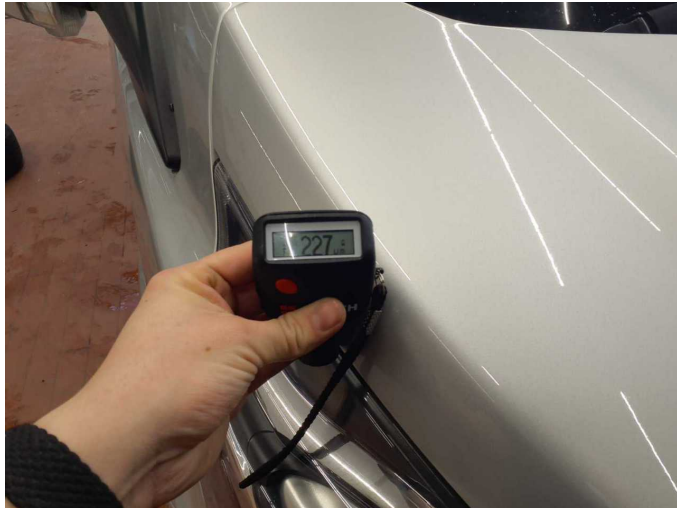
| No. | Repainting |
|---|---|
| 3 | Bonnet, Professionally carried out, Invoice of repair done Non-existent |

| Bonnet | 227 µm | Side panel - rear left side | 219 µm |

**Repainting 3:** Bonnet

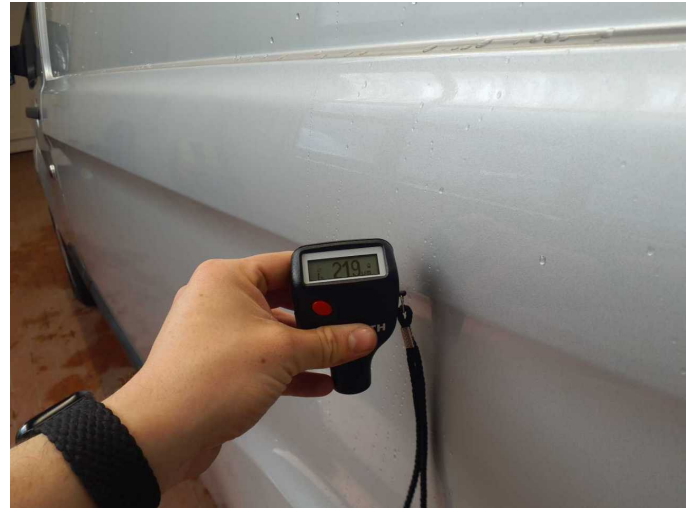
| No. | Repainting |
|---|---|
| 4 | Side panel - rear left side, Professionally carried out, Invoice of repair done Non-existent |

**Repainting 4:** Side panel - rear left side

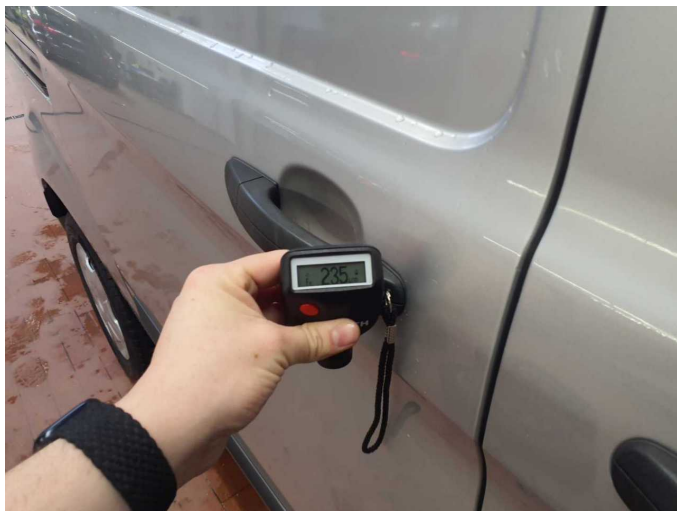
| No. | Repainting |
|---|---|
| 5 | Door - rear right side, Professionally carried out, Invoice of repair done Non-existent |

| Door - rear right side | 235 µm | Door - front right side | 191 µm |

**Repainting 5:** Door - rear right side

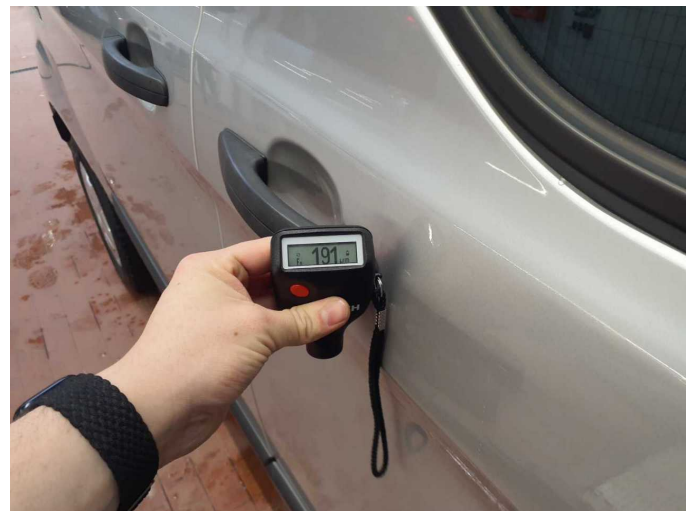
| No. | Repainting |
|---|---|
| 6 | Door - front right side, Professionally carried out, Invoice of repair done Non-existent |

**Repainting 6:** Door - front right side
