Expertise

Protocol number: 46509728  
Order No. / Reference: 26427260  
Inspection date: 10 Jul 2026

Manufacturer: Volkswagen

Model: Touran 2.0 TDI SCR Comfortline

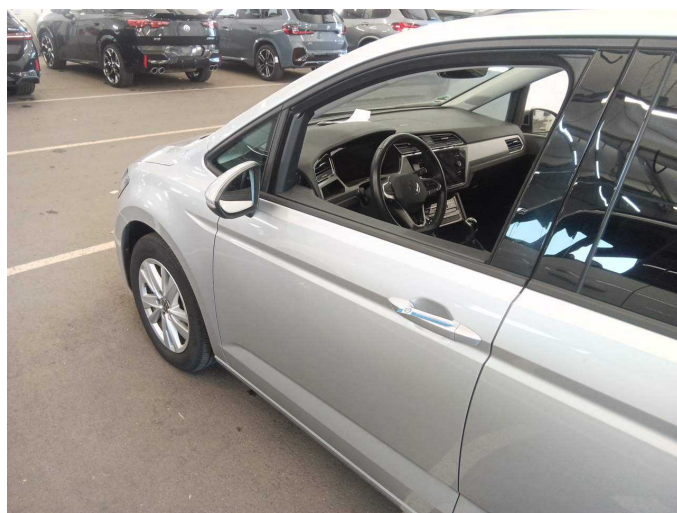
| No. | Component group | Description |
|---|---|---|
| 2 | Door - front left side | Door handle - outside (Abdeckkappe Türschloss) - Deformed - Replace |

**Damage 2:** Door - front left side: Door handle - outside (Abdeckkappe Türschloss) - Deformed - Replace

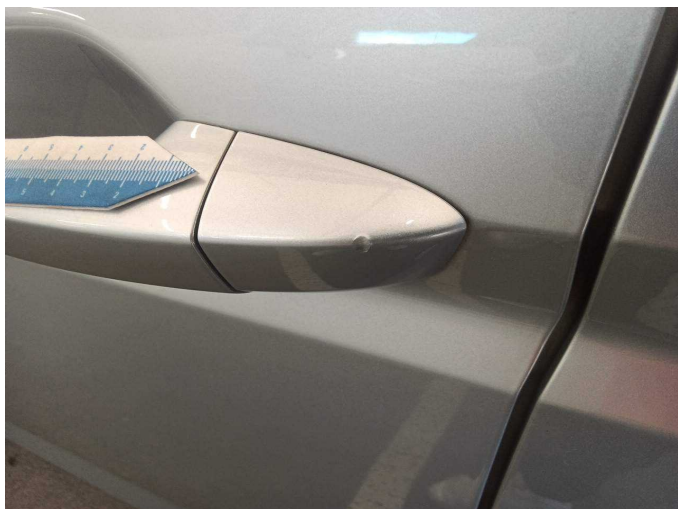
**Damage 2:** Door - front left side: Door handle - outside (Abdeckkappe Türschloss) - Deformed - Replace

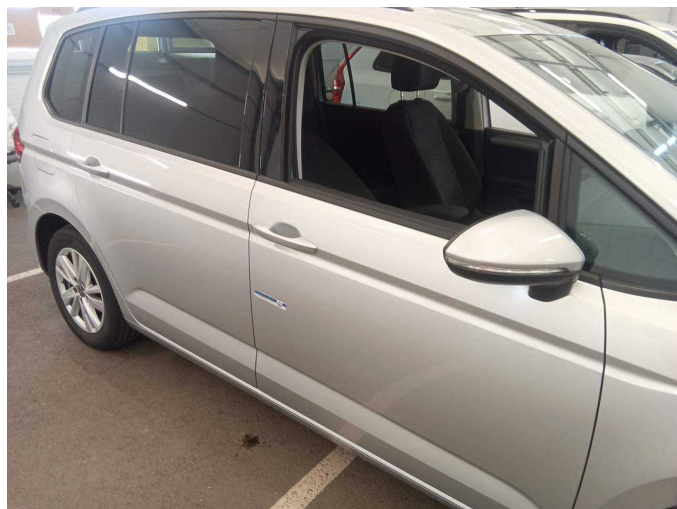
| No. | Component group | Description |
|---|---|---|
| 3 | Door - front right side | Door edge - Scratch(es) - Smart repair |

**Damage 3:** Door - front right side: Door edge - Scratch(es) - Smart repair

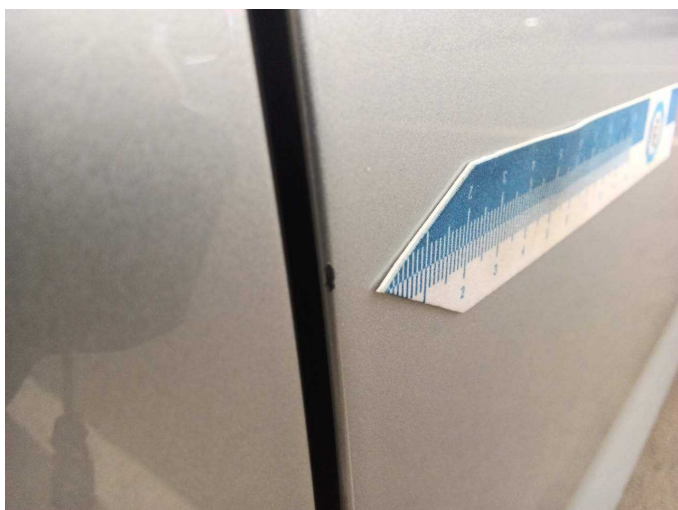
**Damage 3:** Door - front right side: Door edge - Scratch(es) - Smart repair

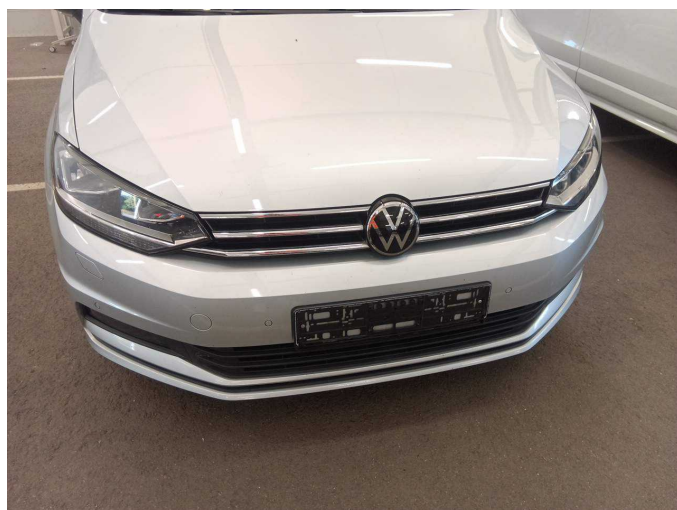
| No. | Component group | Description |
|---|---|---|
| 4 | Front bumper | Front bumper (Sandstrahleffekt) - Stone chips - Paint |

**Damage 4:** Front bumper: Front bumper (Sandstrahleffekt) - Stone chips - Paint

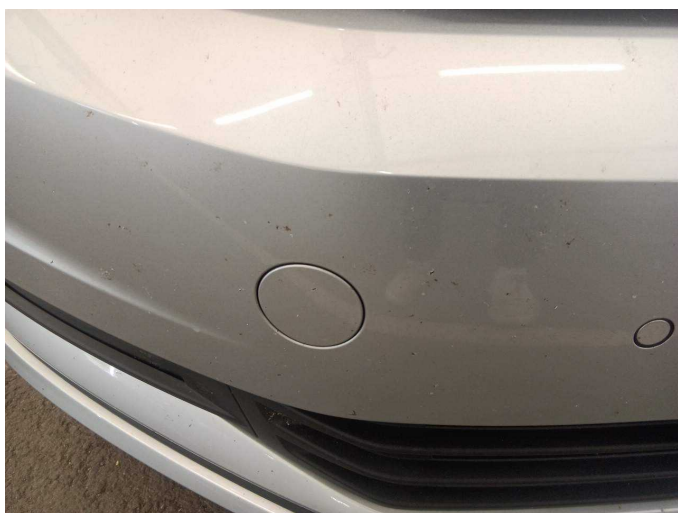
**Damage 4:** Front bumper: Front bumper (Sandstrahleffekt) - Stone chips - Paint

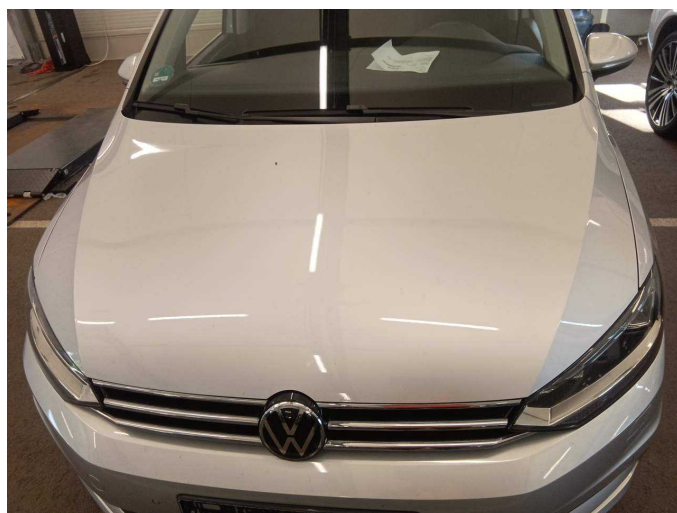
| No. | Component group | Description |
|---|---|---|
| 5 | Bonnet | Bonnet (Übermäßige Steinschläge) - Stone chips - Paint |

**Damage 5:** Bonnet: Bonnet (Übermäßige Steinschläge) - Stone chips - Paint

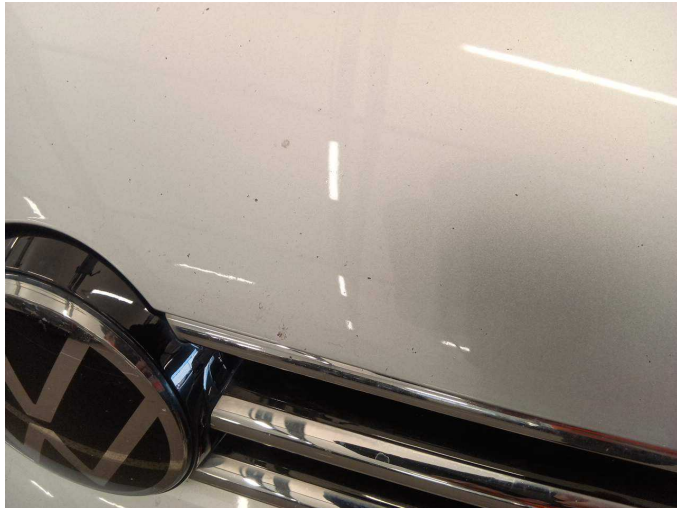
**Damage 5:** Bonnet: Bonnet (Übermäßige Steinschläge) - Stone chips - Paint

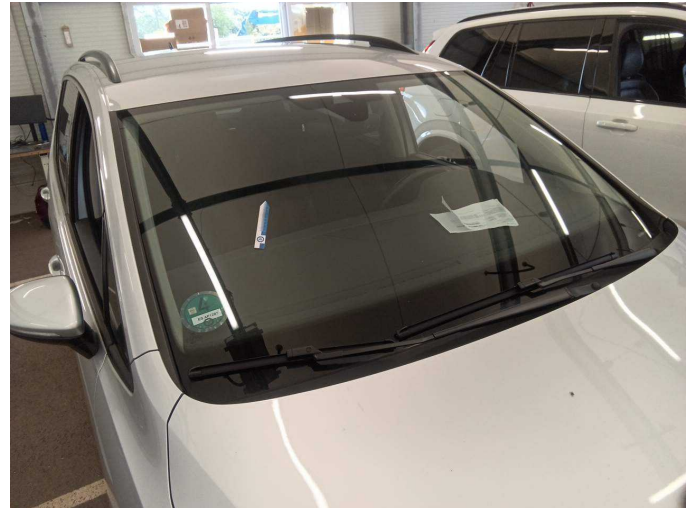
| No. | Component group | Description |
|---|---|---|
| 6 | Vehicle glazing | Windscreen (Mit Rissbildung) - Stone chips - Replace |

**Damage 6:** Vehicle glazing: Windscreen (Mit Rissbildung) - Stone chips - Replace

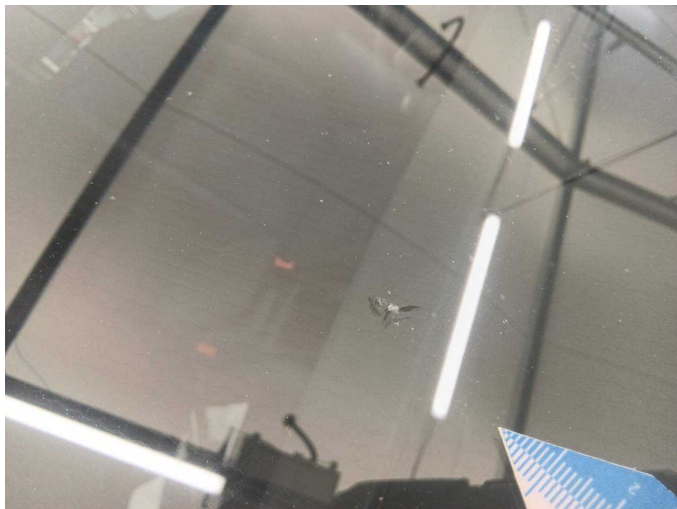
**Damage 6:** Vehicle glazing: Windscreen (Mit Rissbildung) - Stone chips - Replace
