Expertise

Protocol number: 45920093
Order No. / Reference: 26421983
Inspection date: 10 Jun 2026

Manufacturer: Volkswagen

Model: Passat Variant 2.0 TDI SCR DSG Business

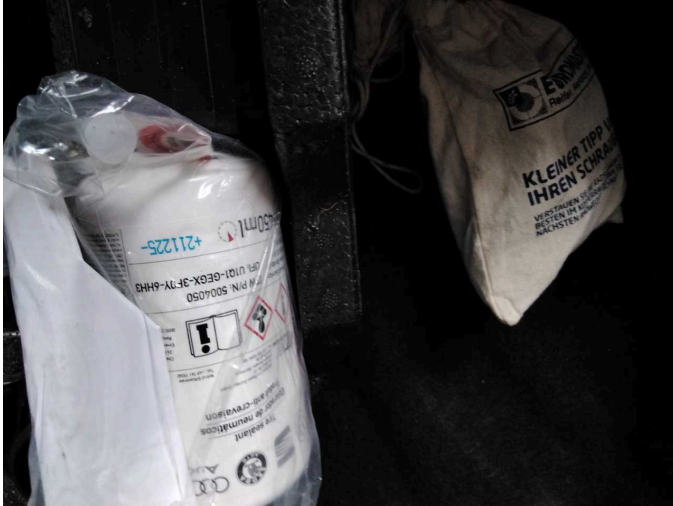
Damage 1: Equipment: Tirefit filler - Expired - Replace

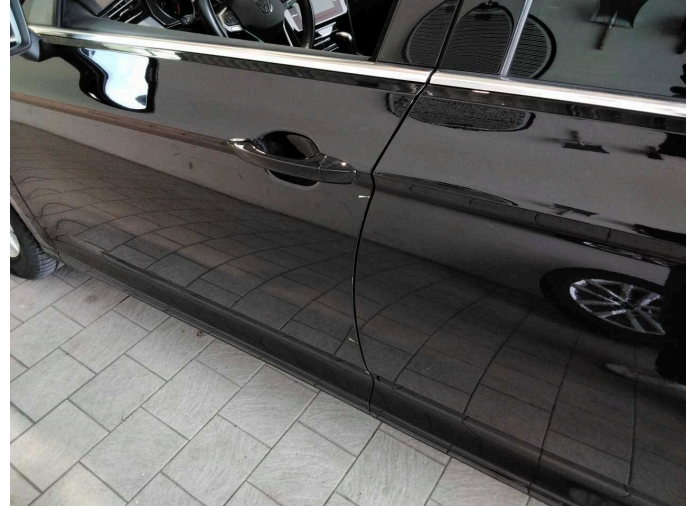
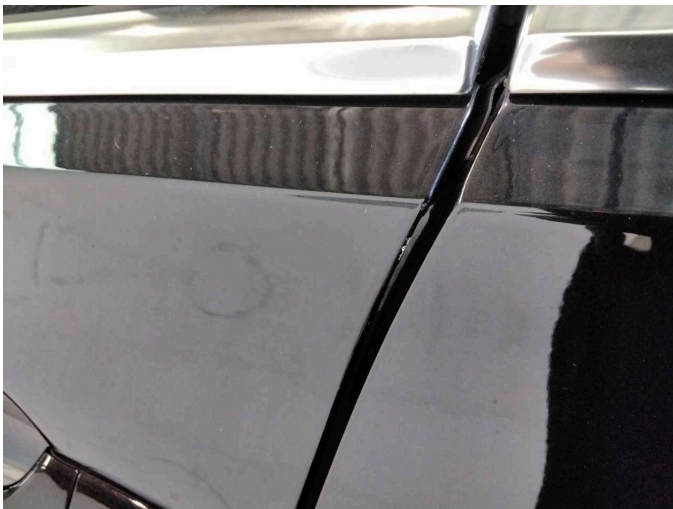
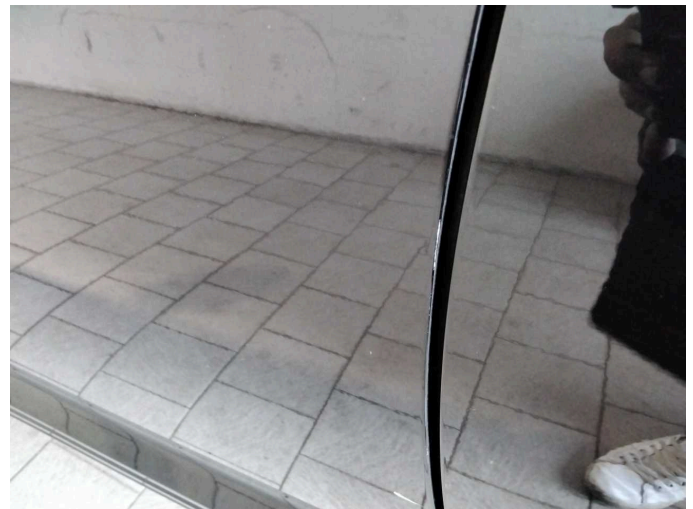
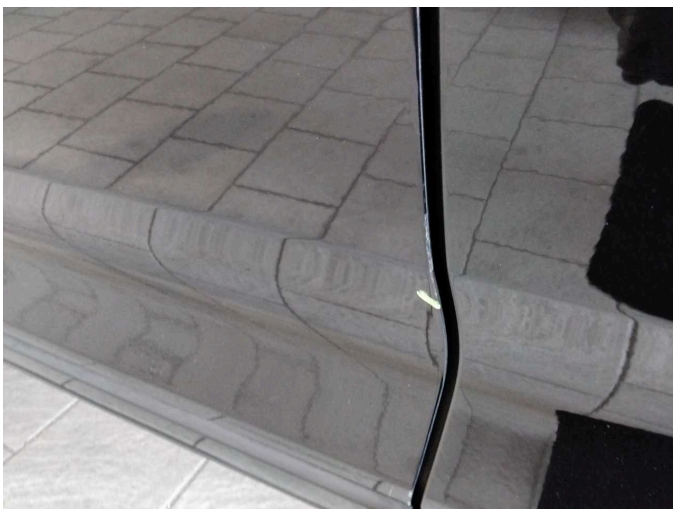
Damage 2: Door - front left side: Door edge - Scratch(es) - Smart repair

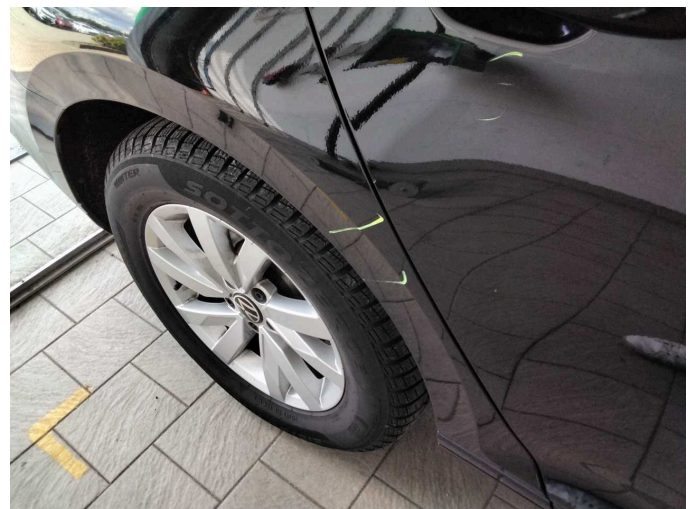
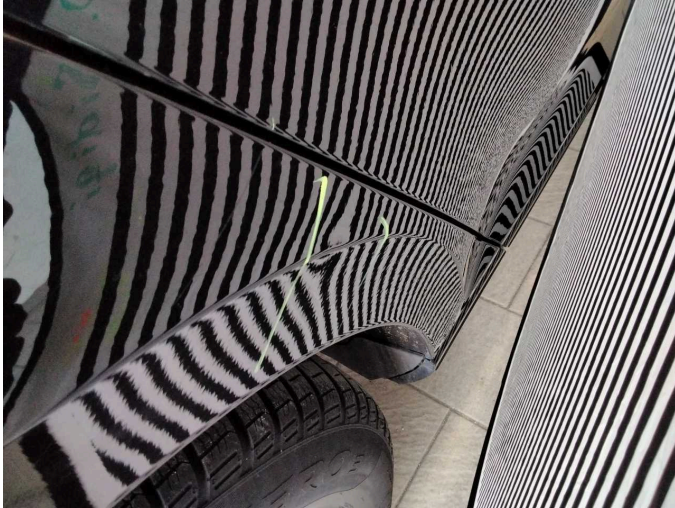
Damage 3: Side panel - rear right side: Side panel - dent(s) - Smooth repair work

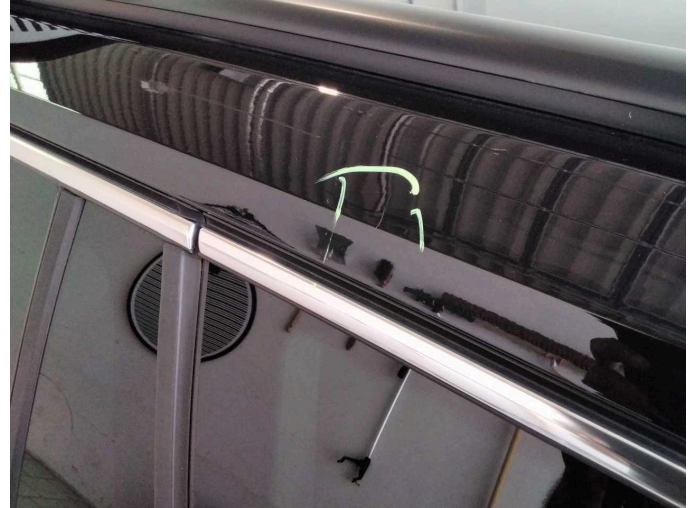
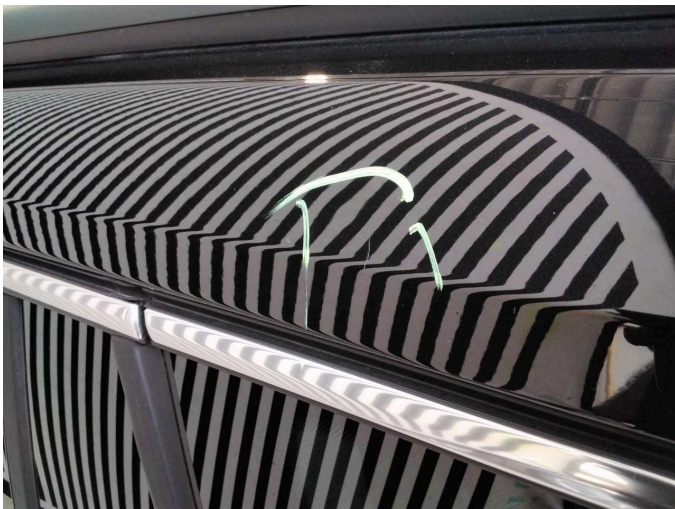
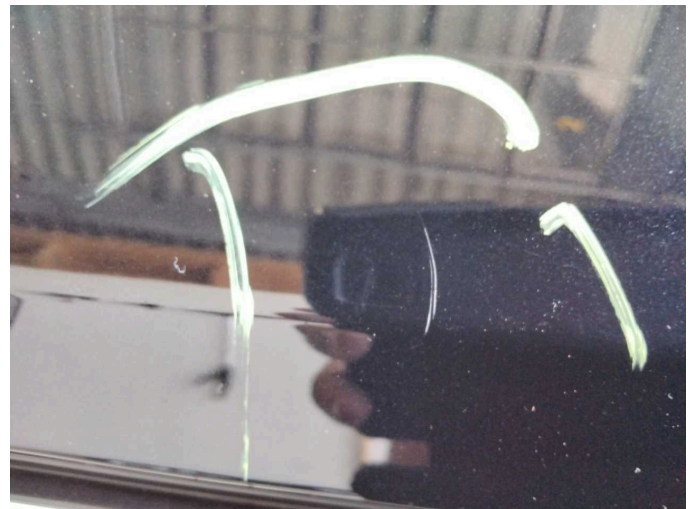
Damage 4: Roof: Roof rail - left side - Dent / paintcoat damage - Smart repair

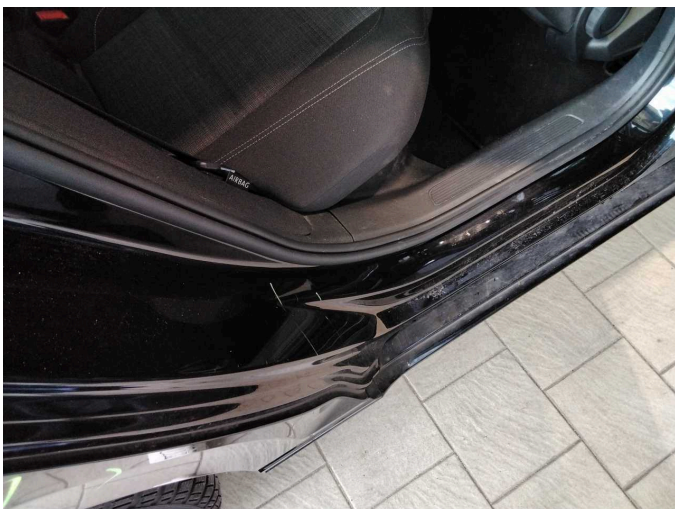
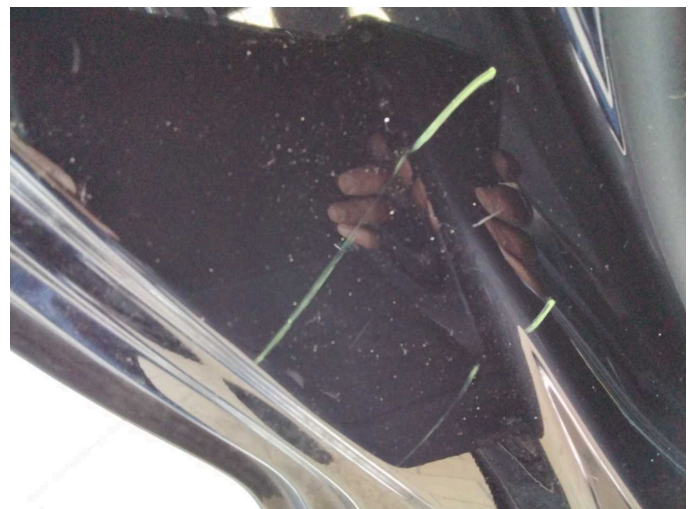
Damage 5: Body: C-pillar - right side - Scratch(es) - Smart repair

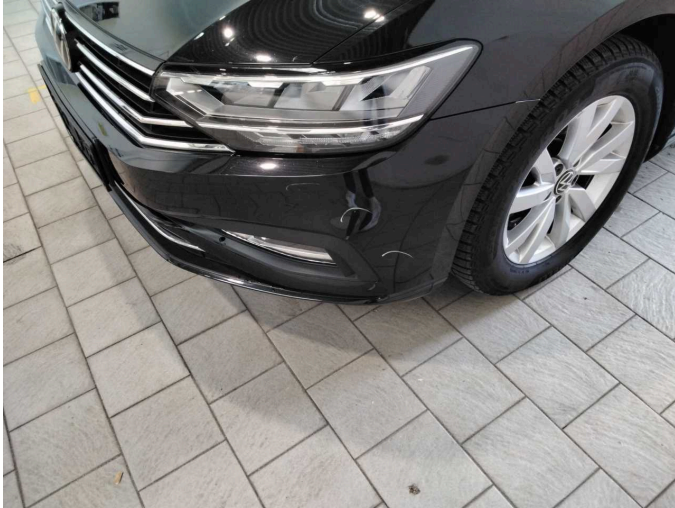
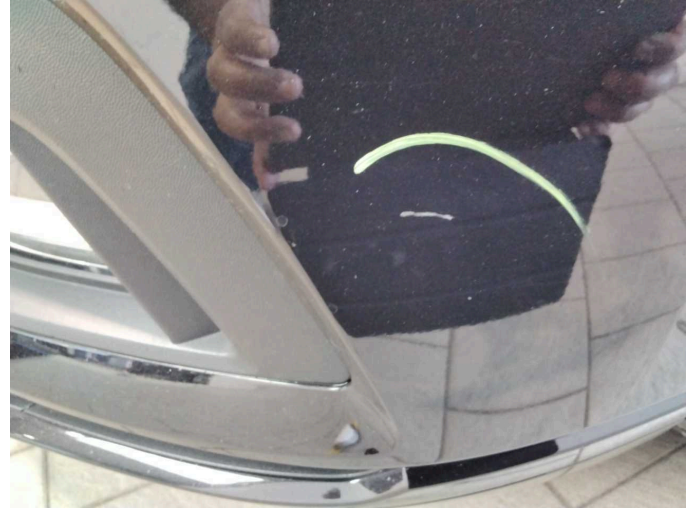
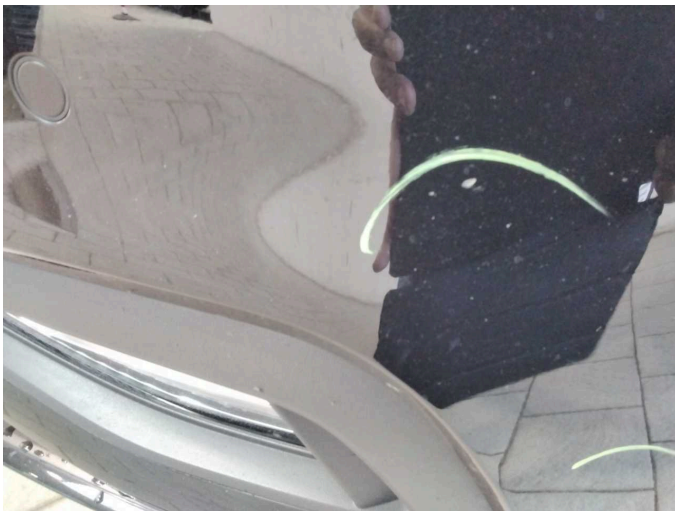
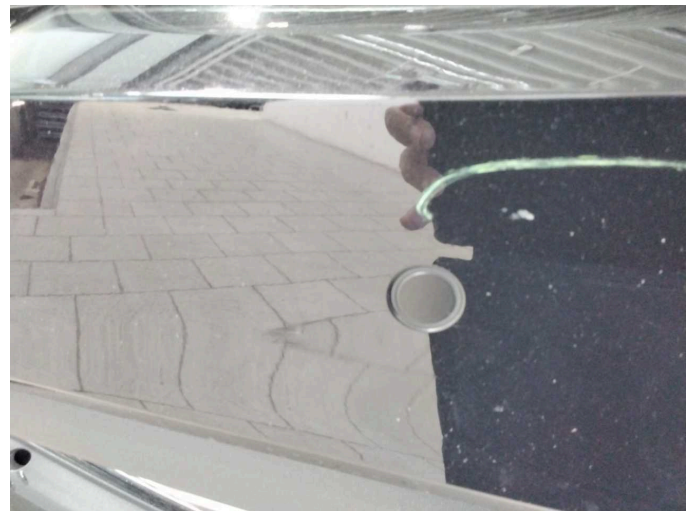
Damage 6: Front bumper: Front bumper - Stone chips - Smart repair

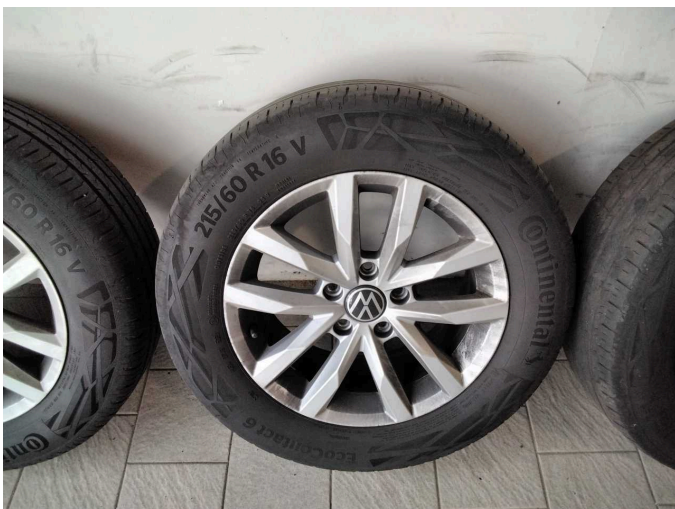
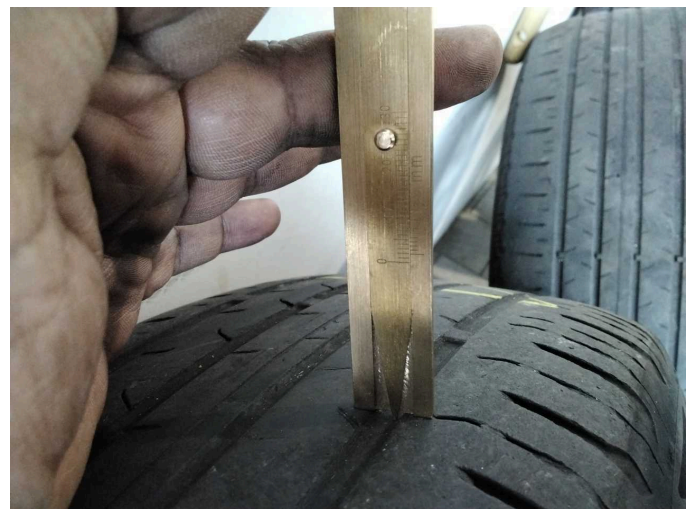
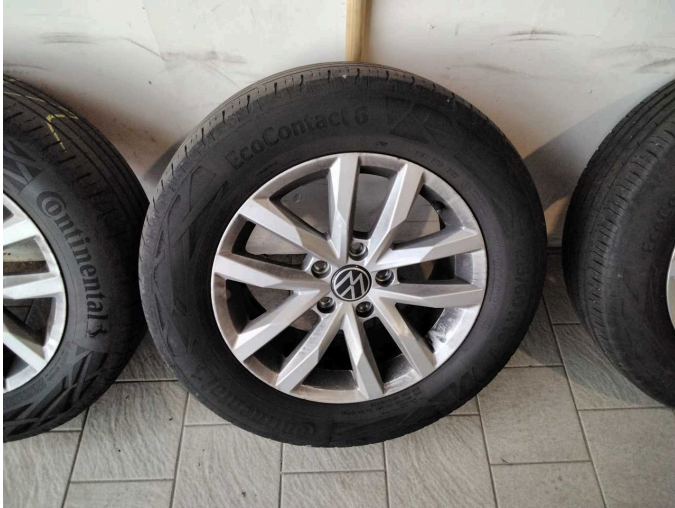
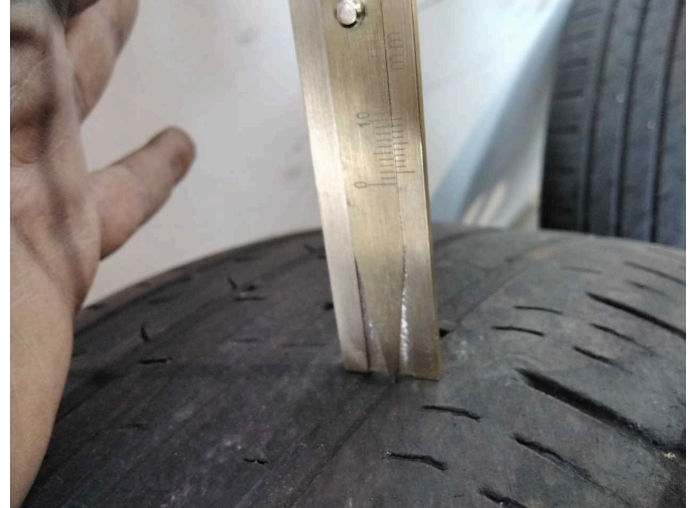
Damage 7: 2nd wheel set: 2 tyres (2mm) - Expired - Replace

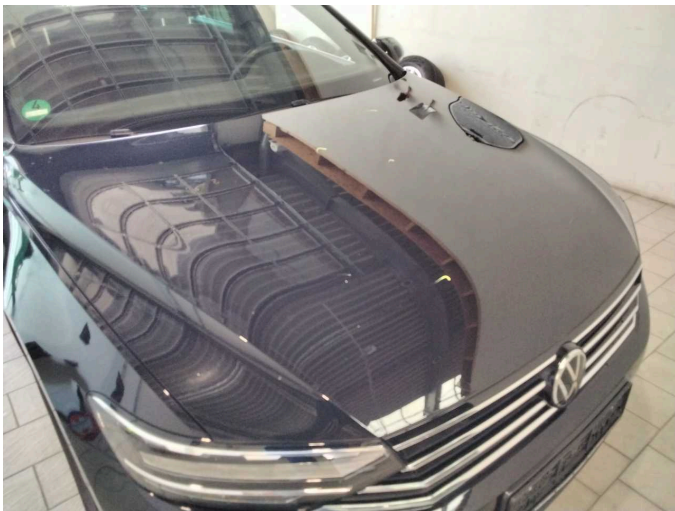
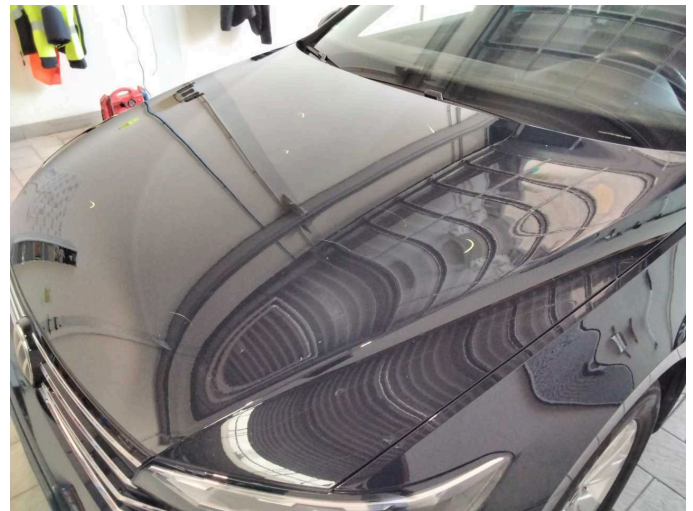
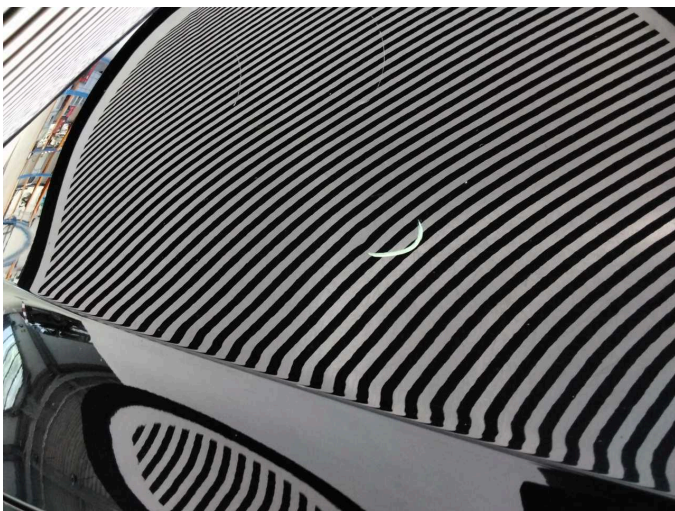
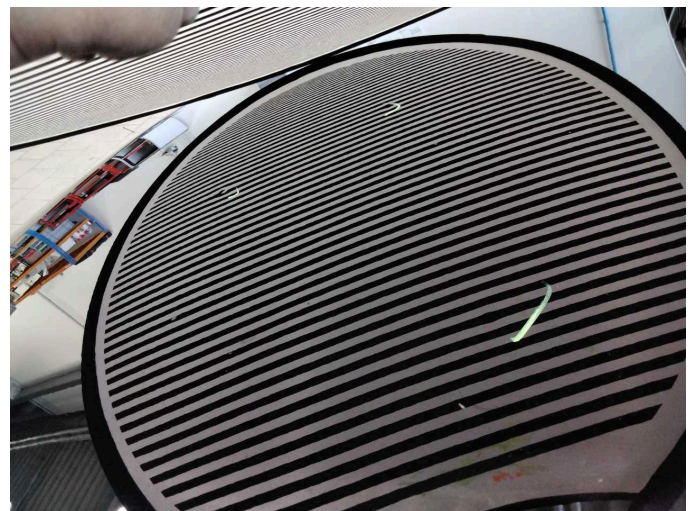
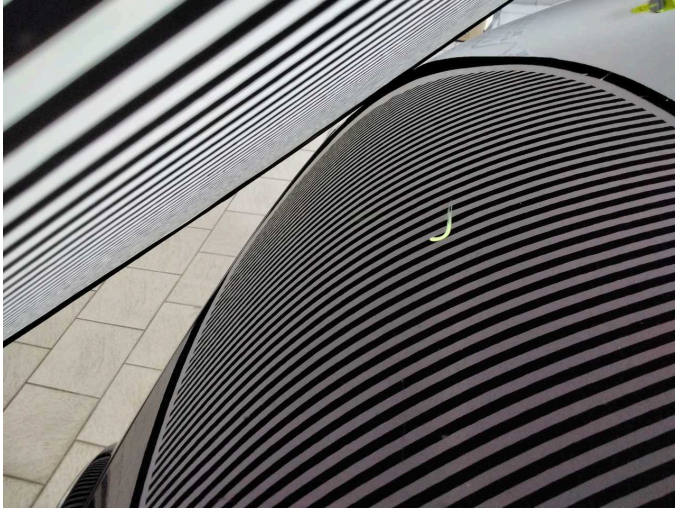
Damage 8: Bonnet: Bonnet - Damage by hail - Smooth repair work

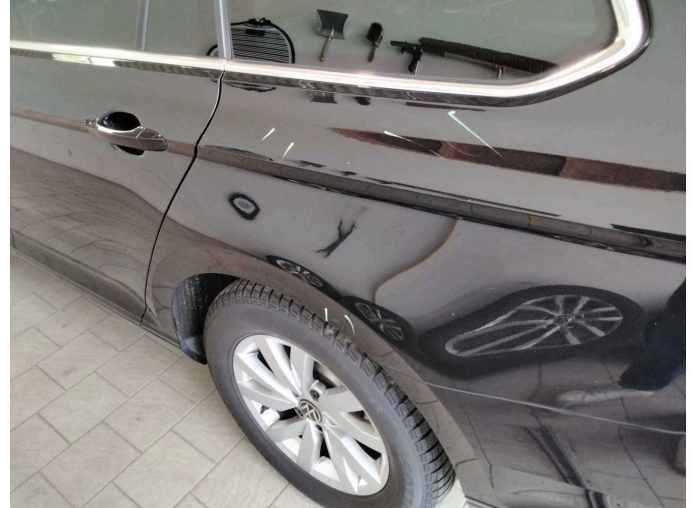
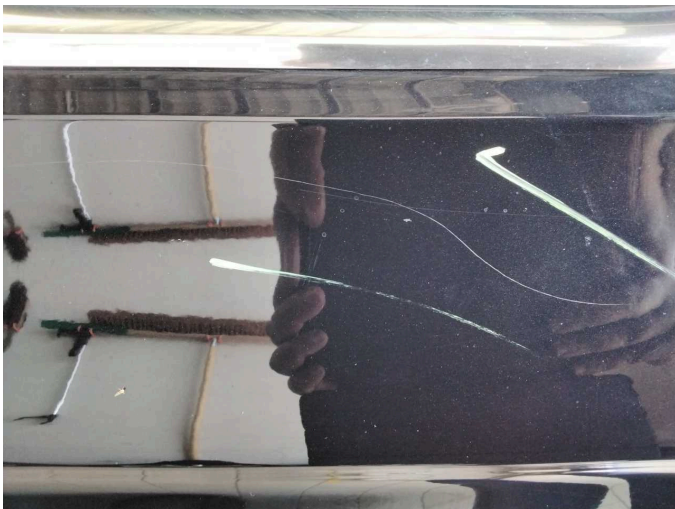
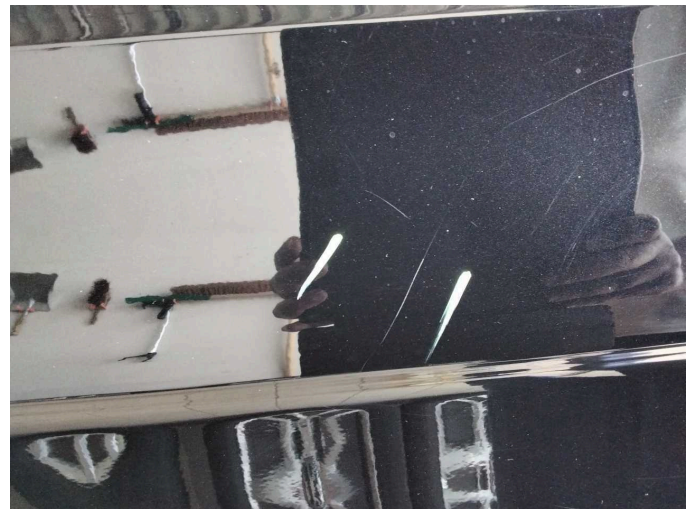
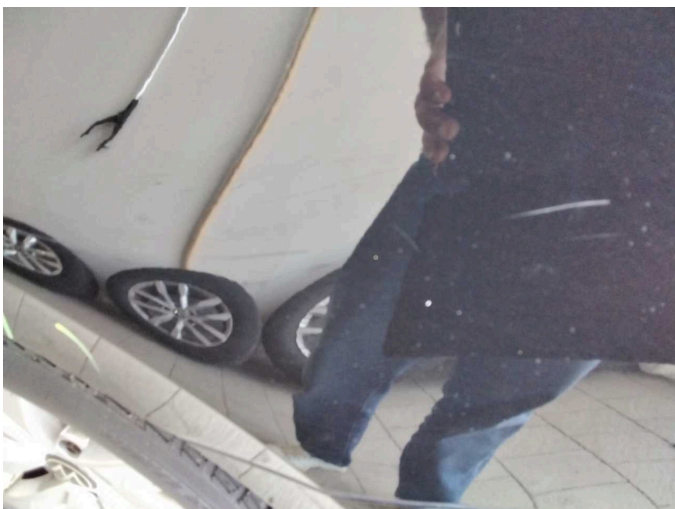
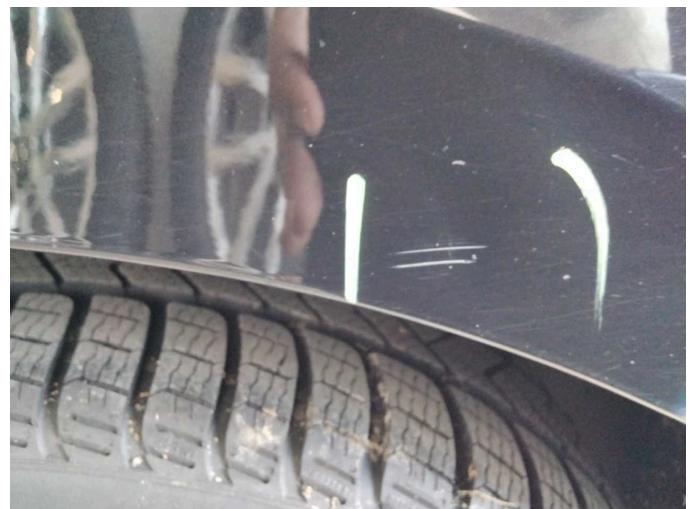
Damage 9: Side panel - rear left side: Side panel - Scratch(es) - Paint

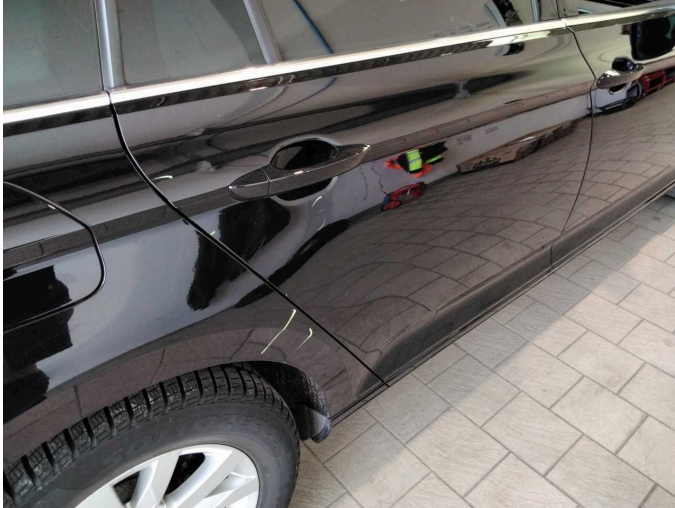
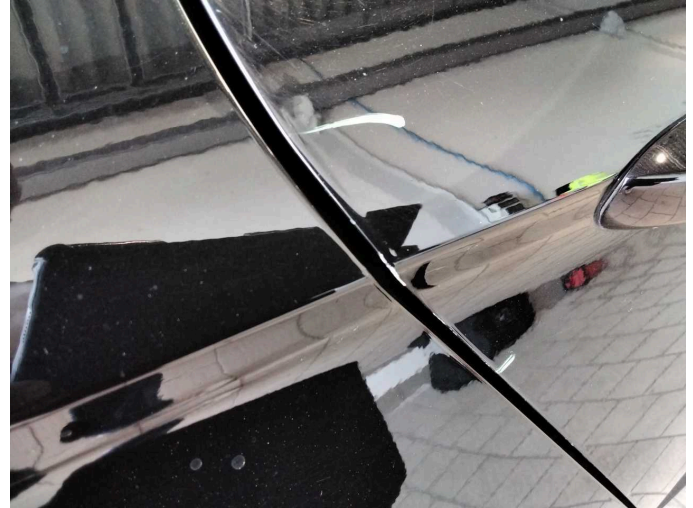
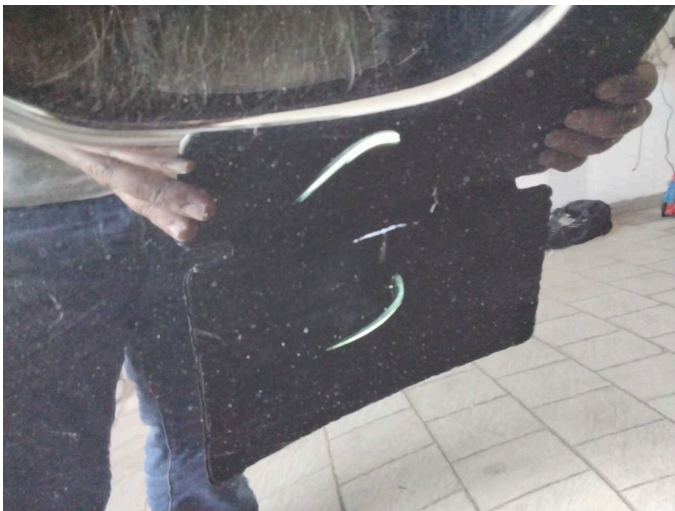
Damage 10: Door - rear right side: Door - Scratch(es) - Paint

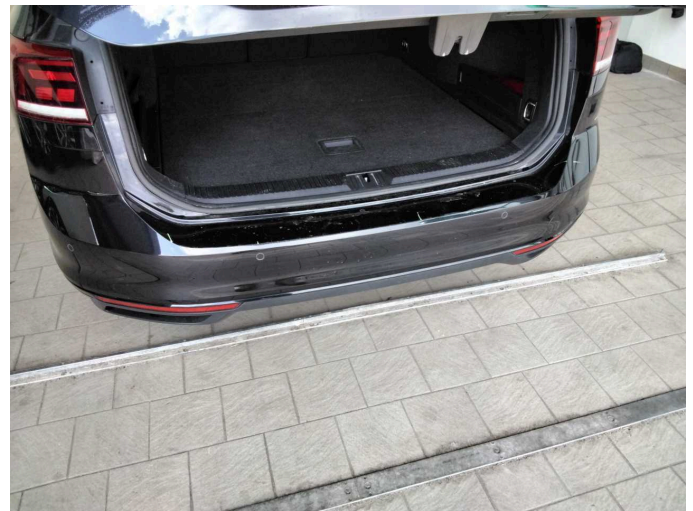
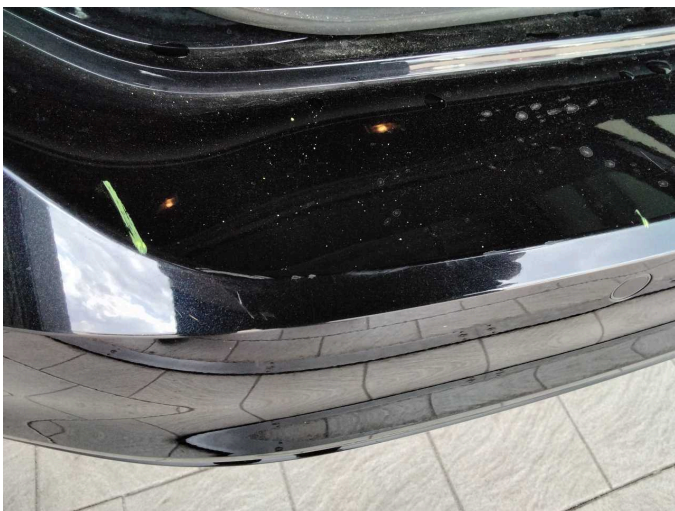
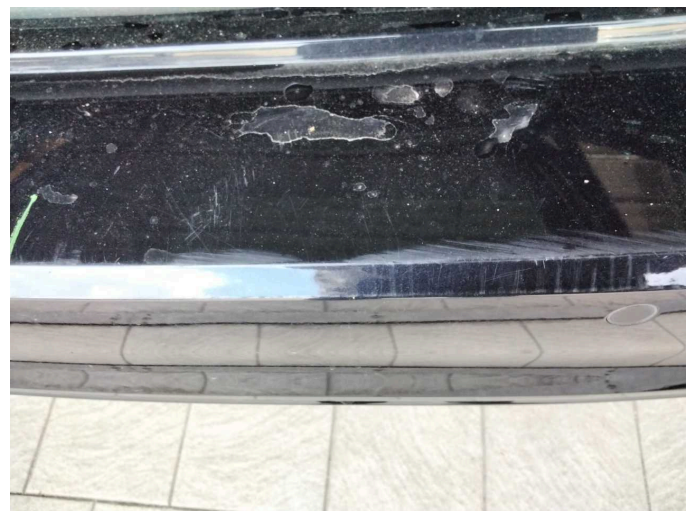
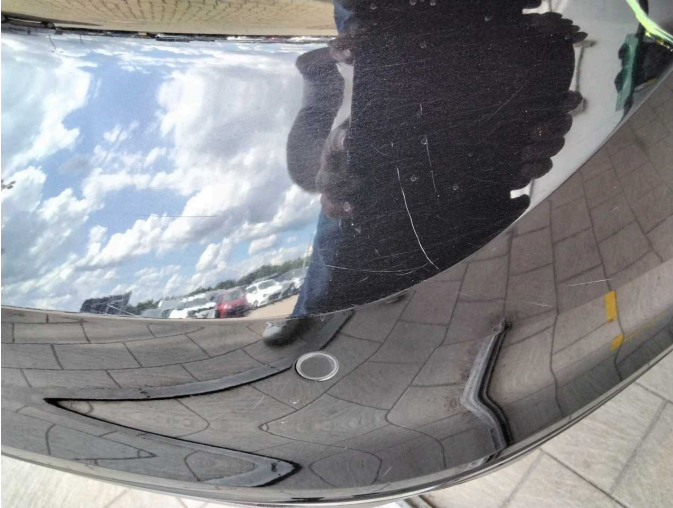
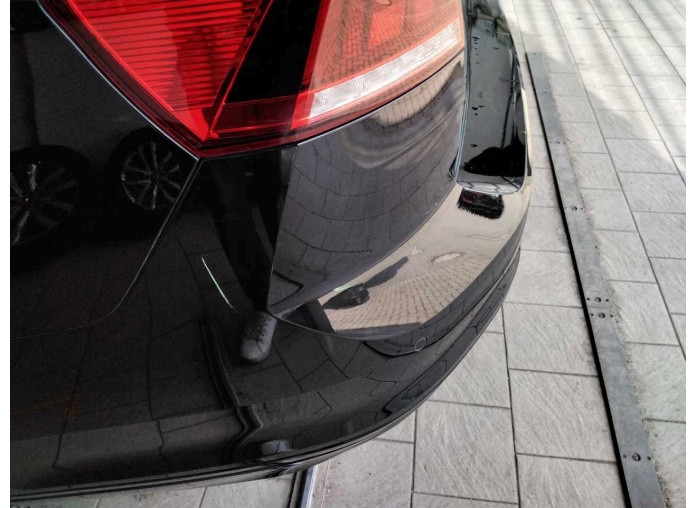
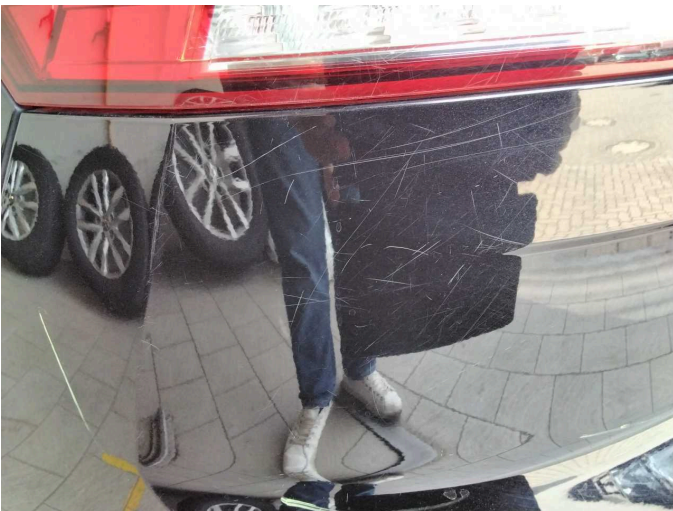
Damage 11: Rear bumper: Rear bumper - Scratch(es) - Paint

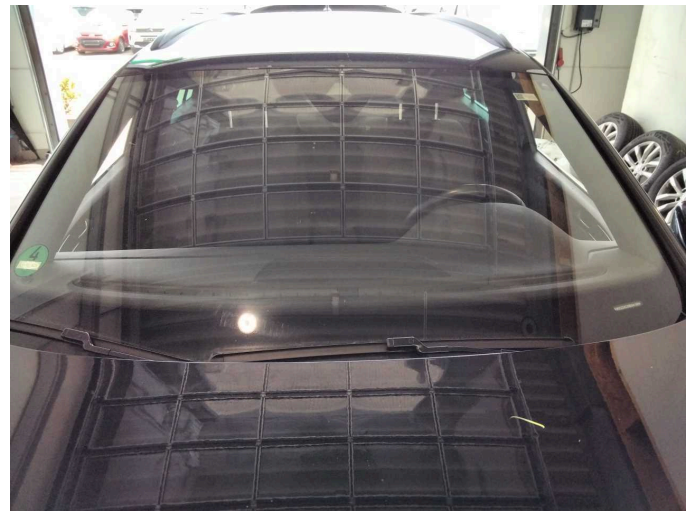
Wear and tear 1: Vehicle glazing: Windscreen - Stone chips - No deduction
