Expertise

Protocol number: 46926164  
Order No. / Reference: 26461345  
Inspection date: 6 Aug 2026

| Manufacturer: Ford | Model: Focus Turnier 1.5 EcoBlue Start-Stopp-System Aut. ACTIVE X |
| VIN: WF0PXXGCHPPD60112 | |

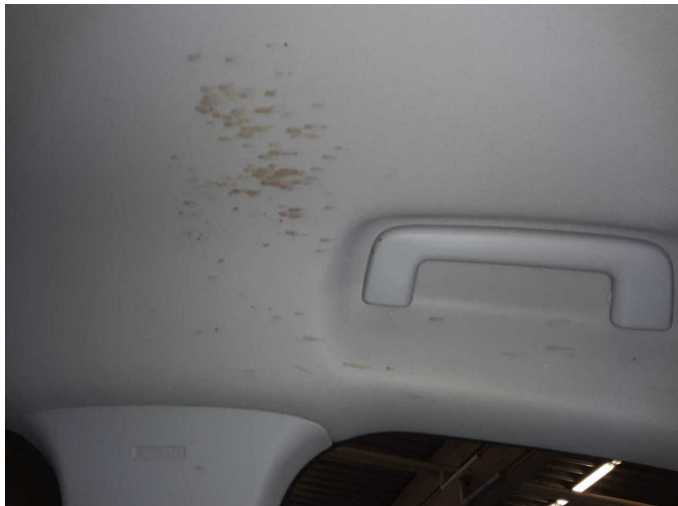
| No. | Component group | Description |
|---|---|---|
| 1 | Trim / covers | Roof lining - Soiled - Clean |

**Damage 1:** Trim / covers: Roof lining - Soiled - Clean

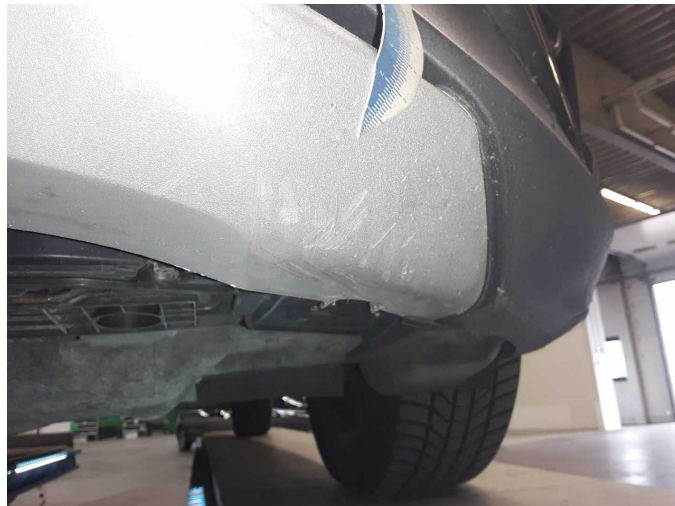
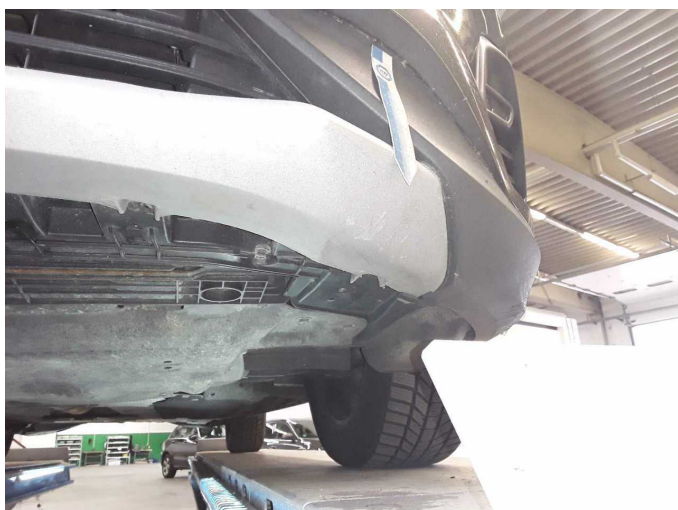
| No. | Component group | Description |
|---|---|---|
| 2 | Front bumper | Spoiler - Scratched - Loss in value |

**Damage 2:** Front bumper: Spoiler - Scratched - Loss in value

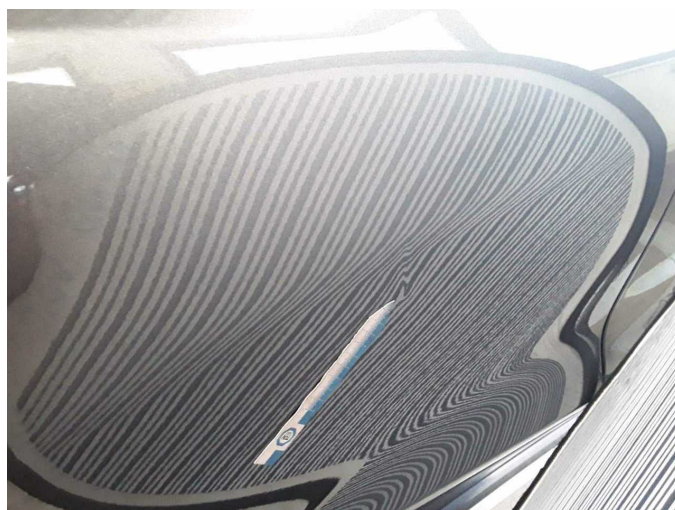
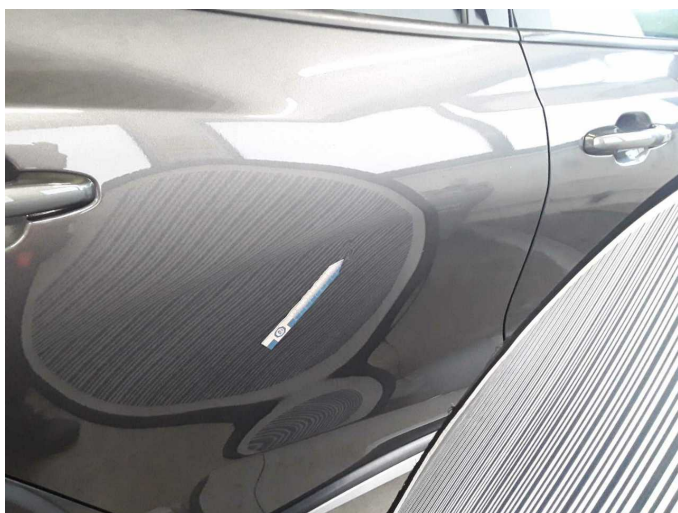
| No. | Component group | Description |
|---|---|---|
| 3 | Door - rear right side | Door - dent(s) - Smooth repair work |

**Damage 3:** Door - rear right side: Door - dent(s) - Smooth repair work

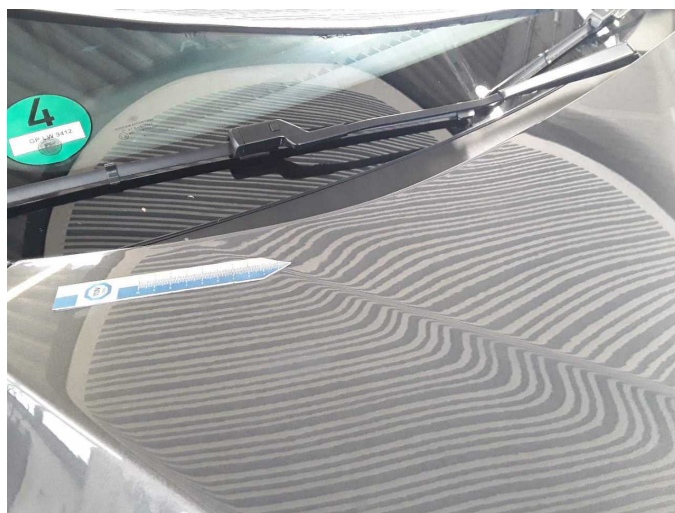
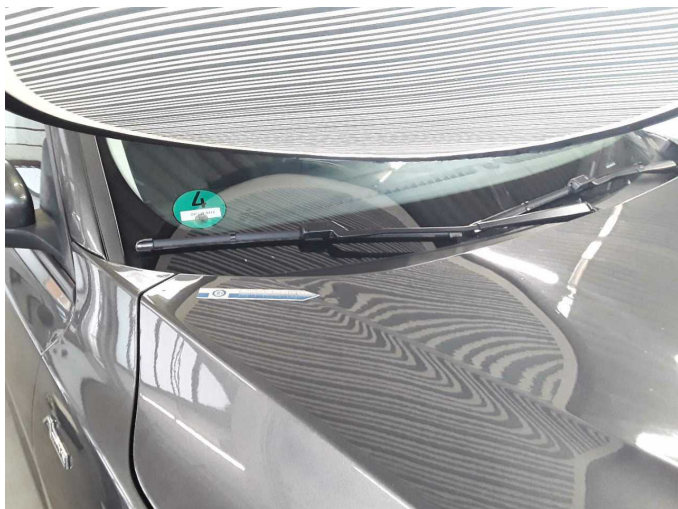
| No. | Component group | Description |
|---|---|---|
| 4 | Bonnet | Bonnet - dent(s) - Smooth repair work |

**Damage 4:** Bonnet: Bonnet - dent(s) - Smooth repair work

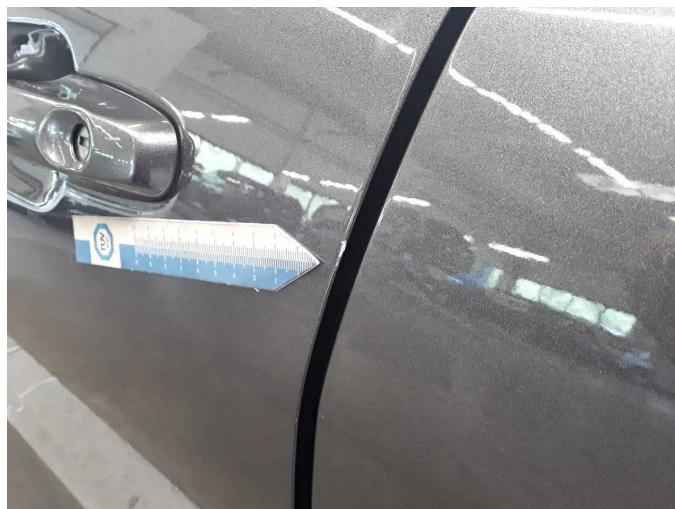
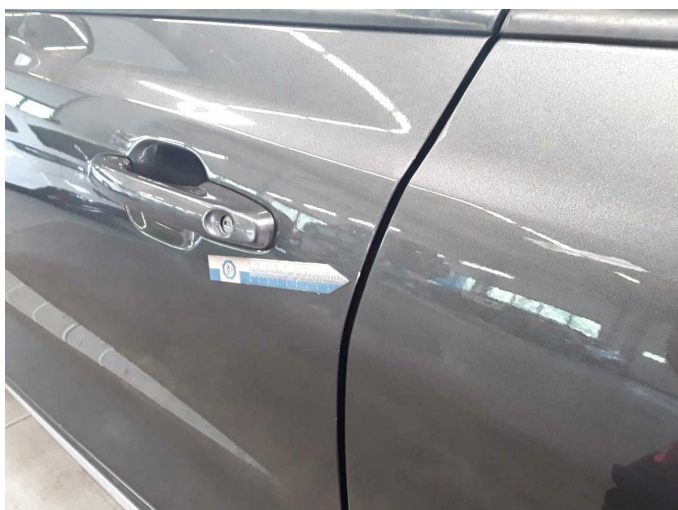
| No. | Component group | Description |
|---|---|---|
| 5 | Door - front left side | Door edge - Scratch(es) - Smart repair |

**Damage 5:** Door - front left side: Door edge - Scratch(es) - Smart repair

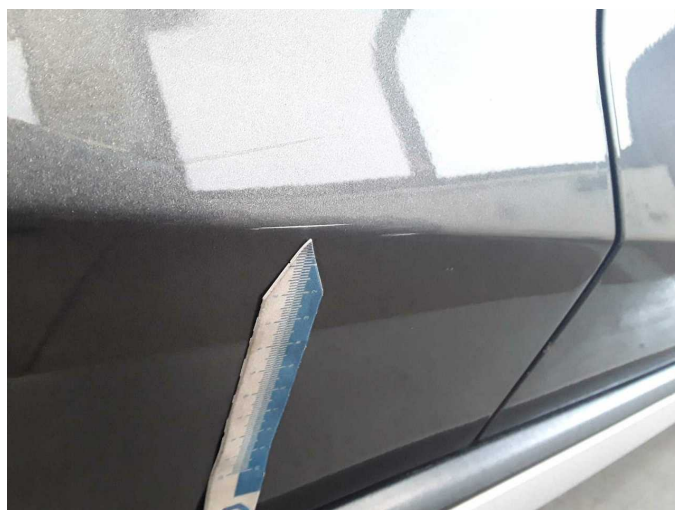
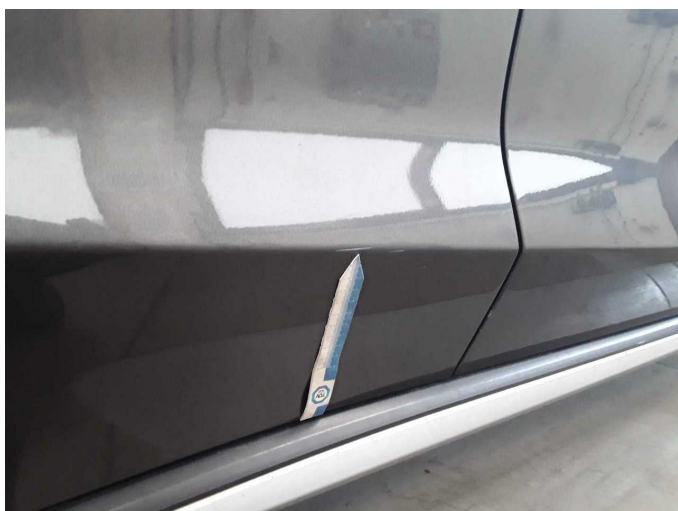
| No. | Component group | Description |
|---|---|---|
| 6 | Door - rear right side | Door - Scratch(es) - Smart repair |

**Damage 6:** Door - rear right side: Door - Scratch(es) - Smart repair

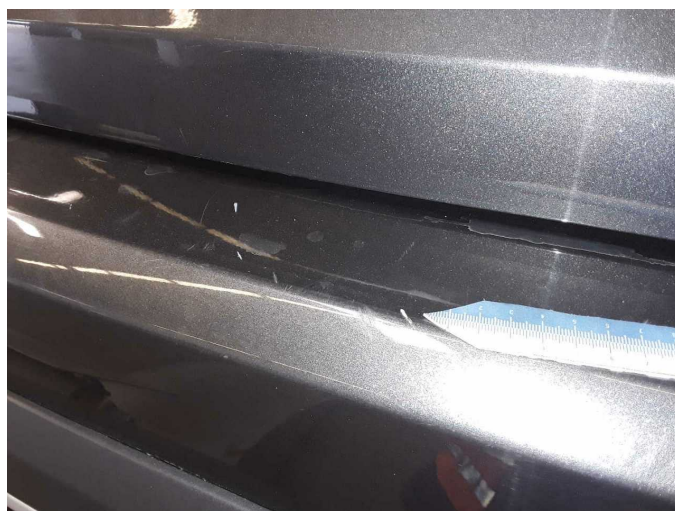
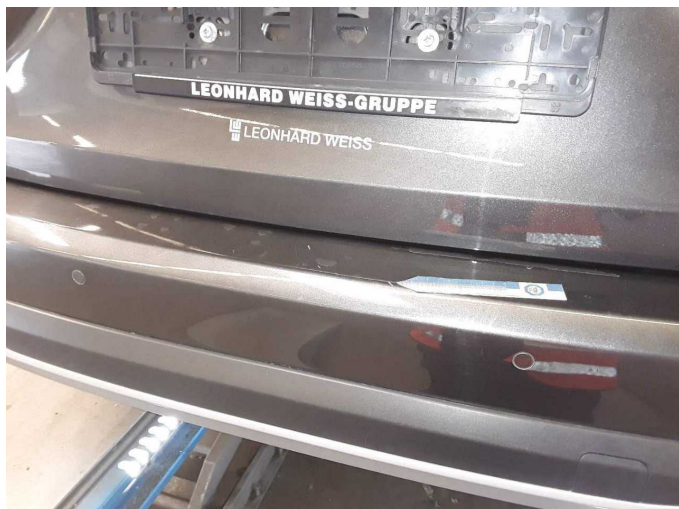
| No. | Component group | Description |
|---|---|---|
| 7 | Rear bumper | Rear bumper - Scratch(es) - Paint |

**Damage 7:** Rear bumper: Rear bumper - Scratch(es) - Paint

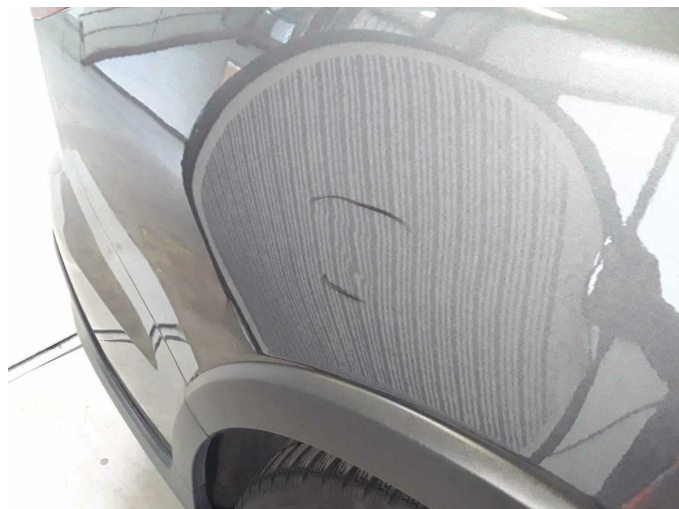
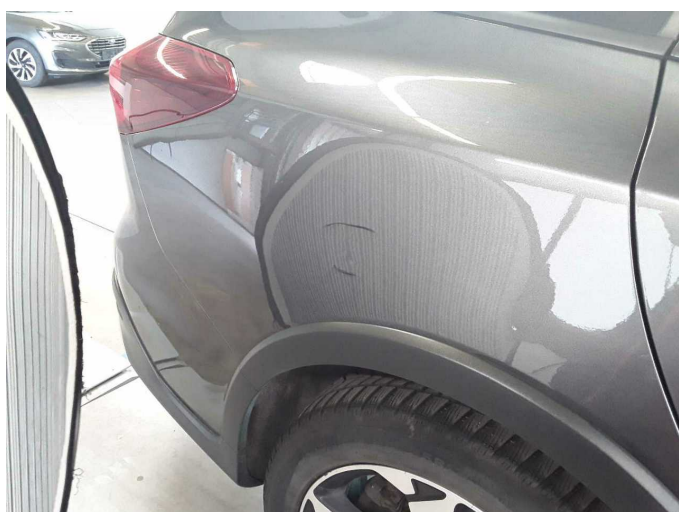
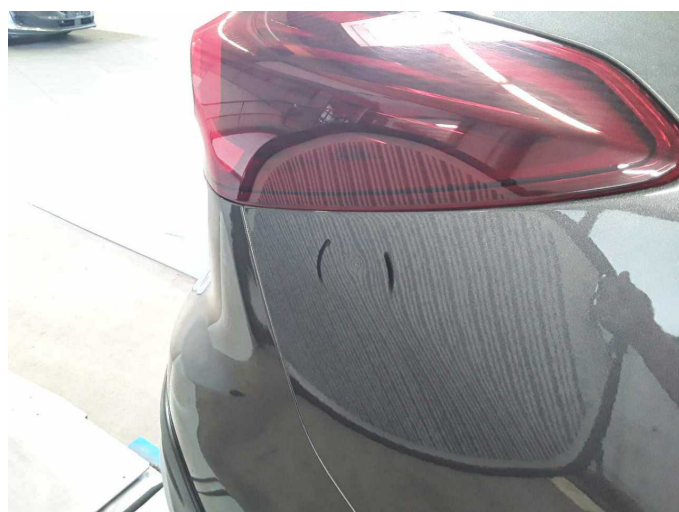
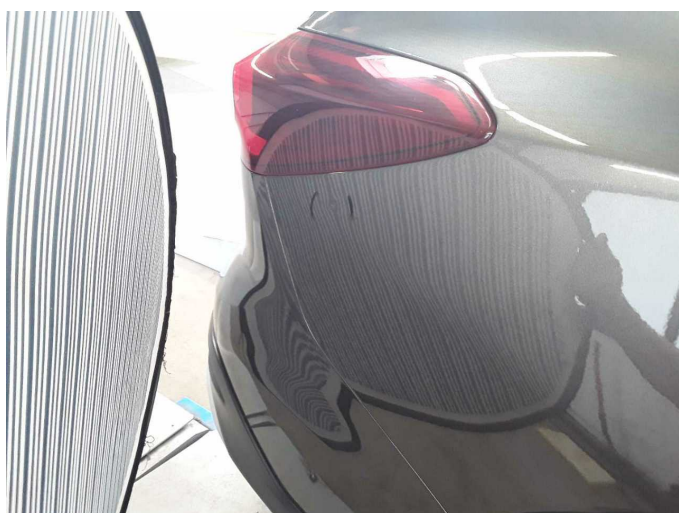
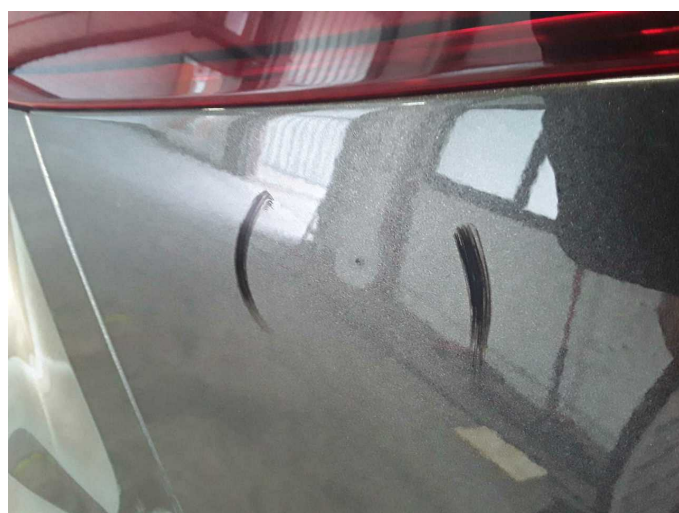
| No. | Component group | Description |
|---|---|---|
| 8 | Side panel - rear right side | Side panel - Dent / paintcoat damage - Repair and paint |

**Damage 8:** Side panel - rear right side: Side panel - Dent / paintcoat damage - Repair and paint

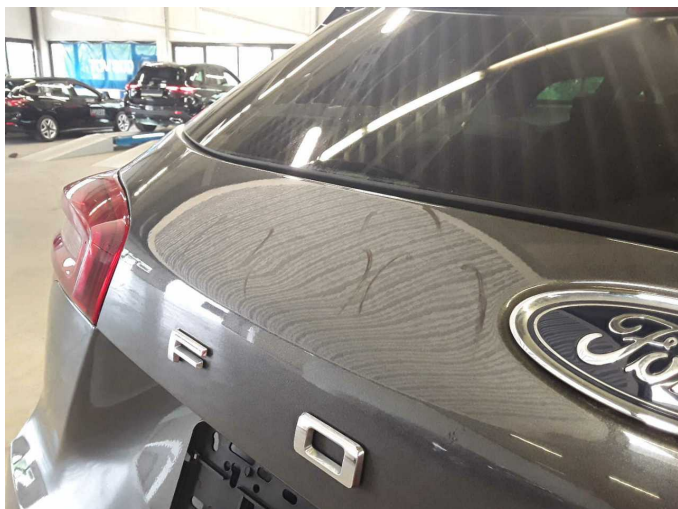
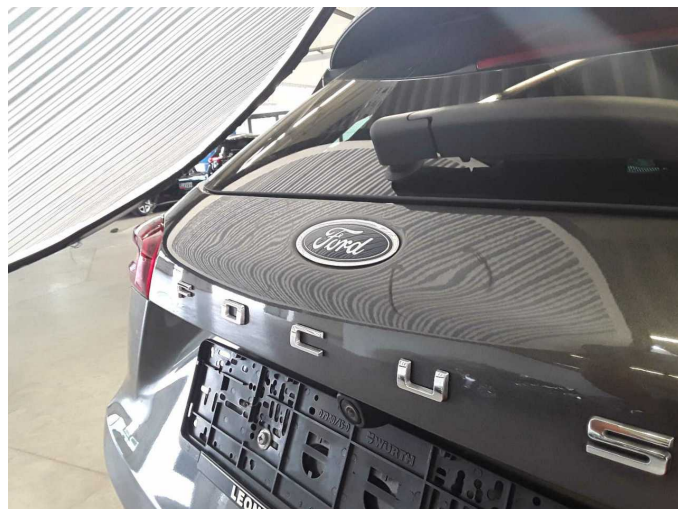
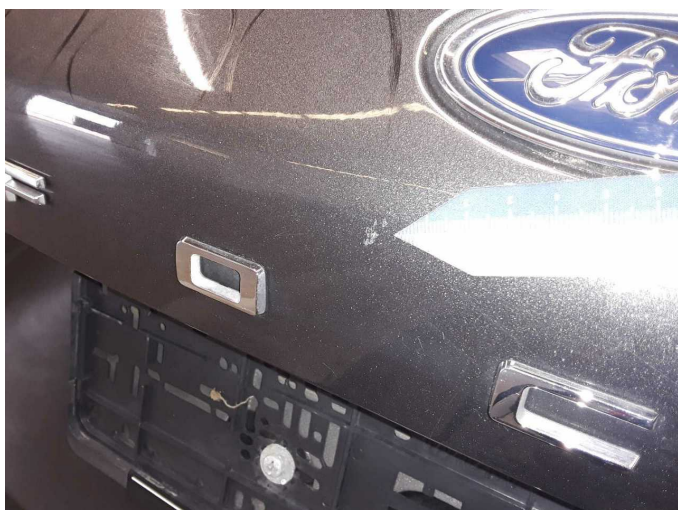
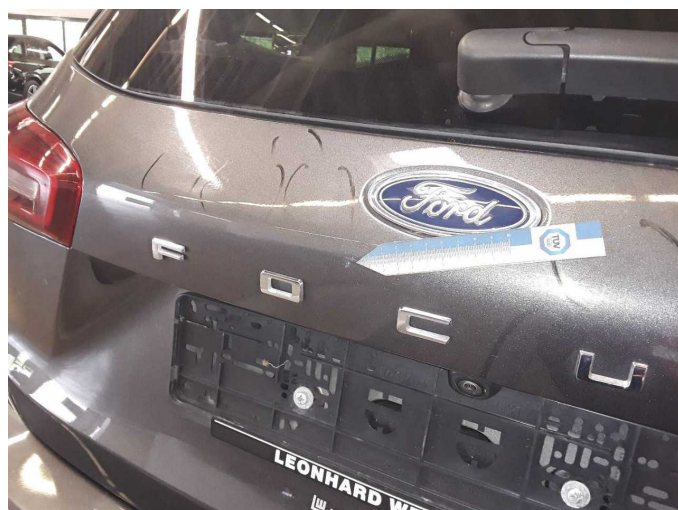
| No. | Component group | Description |
|---|---|---|
| 9 | Boot lid / rear door | Boot lid (5 Dellen) - dent(s) - Repair and paint |

**Damage 9:** Boot lid / rear door: Boot lid (5 Dellen) - dent(s) - Repair and paint

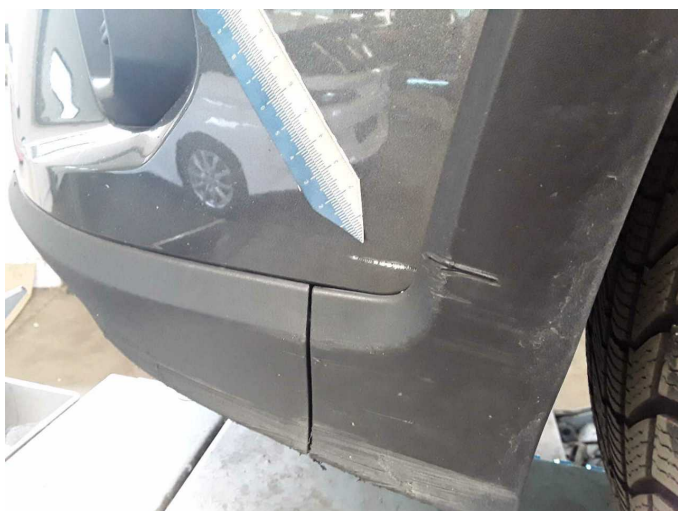
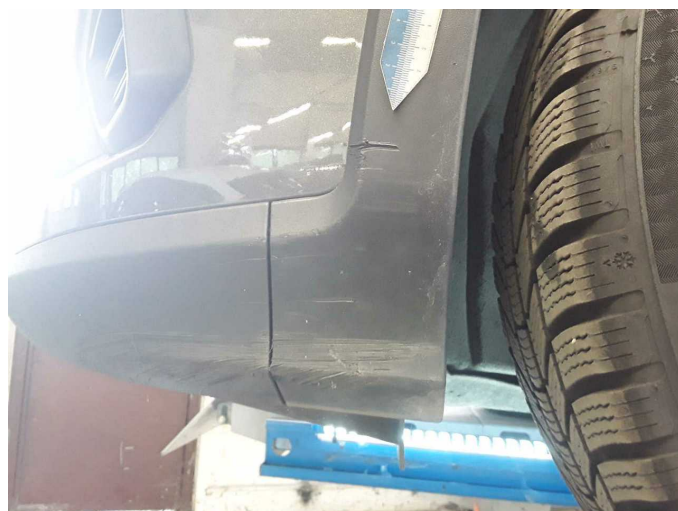
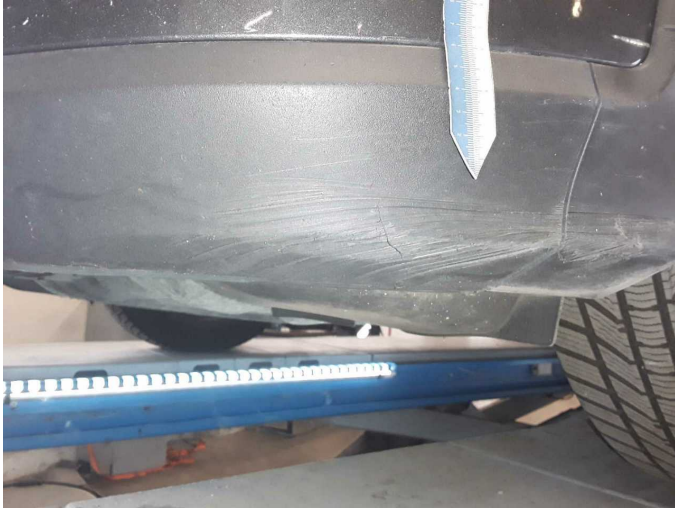
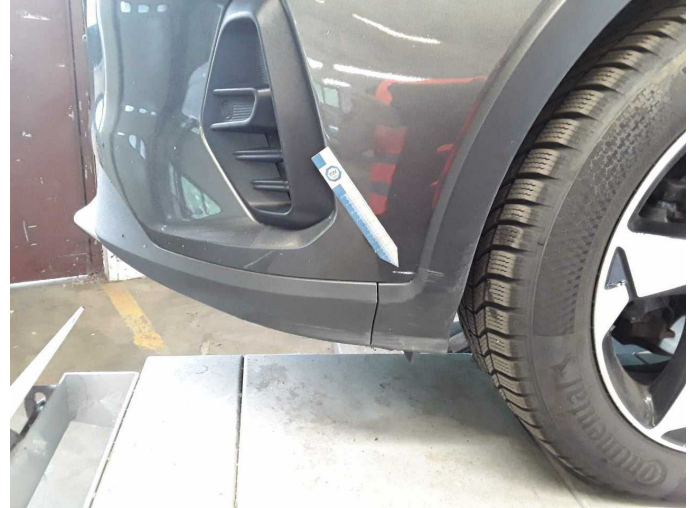
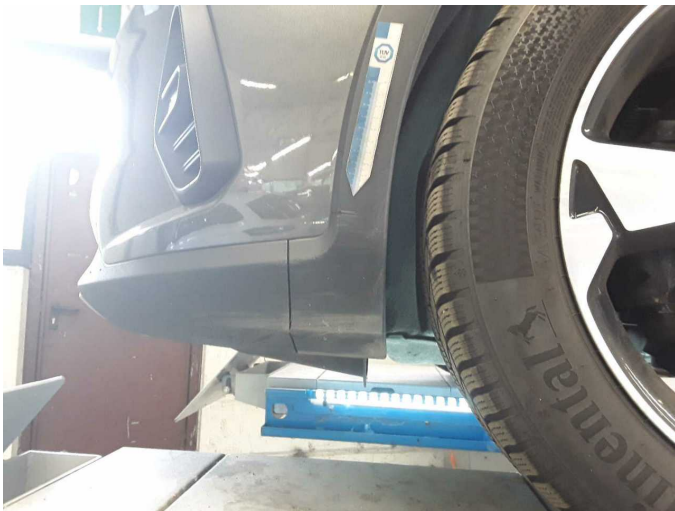
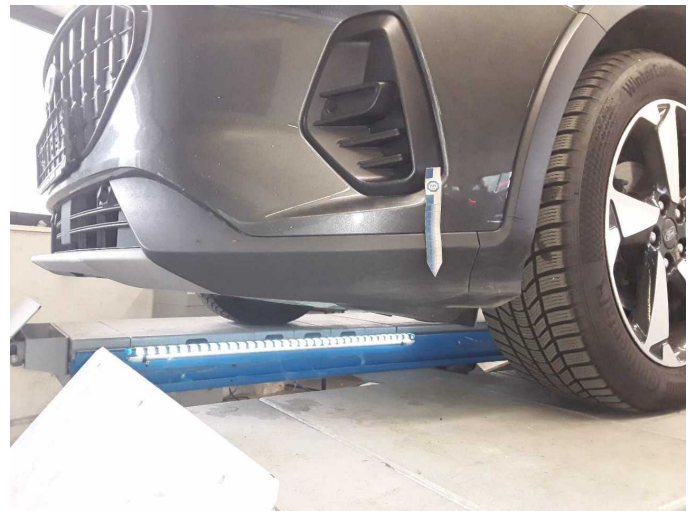
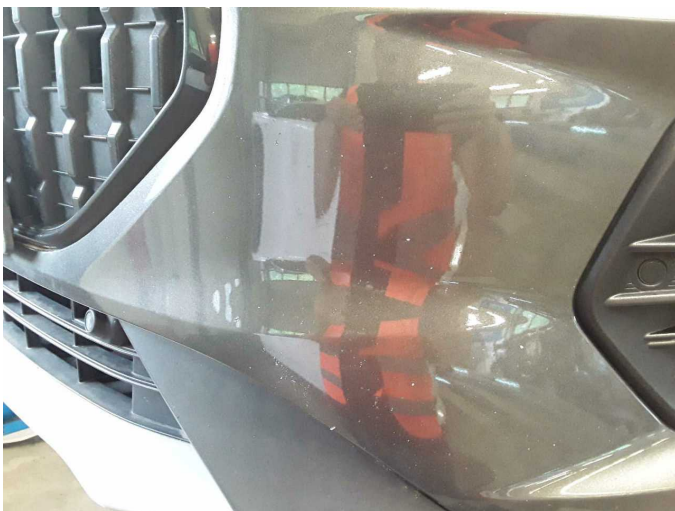
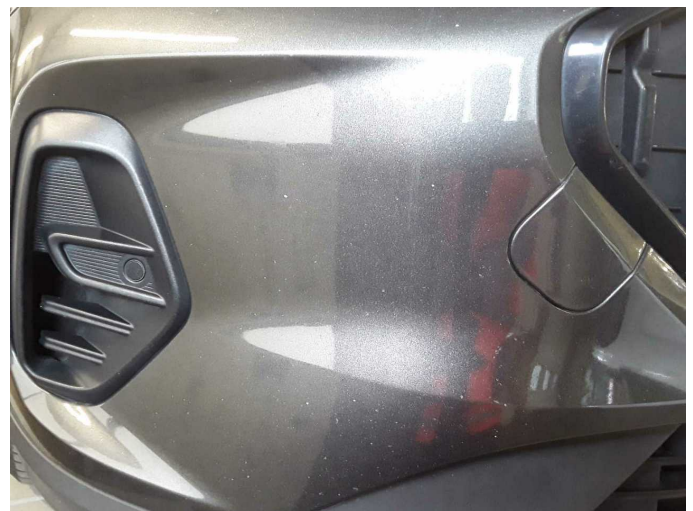
| No. | Component group | Description |
|---|---|---|
| 10 | Front bumper | Front bumper (Inklusive Steinschläge, + Blenden ersetzen) - Scratch(es) - Paint |

**Damage 10:** Front bumper: Front bumper (Inklusive Steinschläge, + Blenden ersetzen) - Scratch(es) - Paint

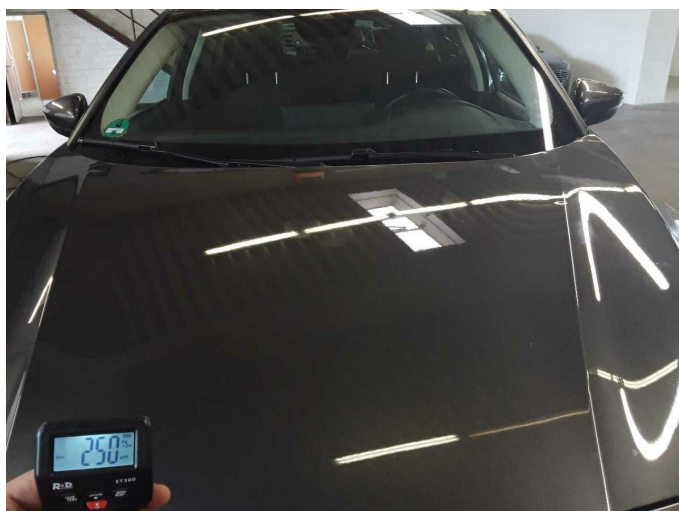
1 Bonnet, Door - front right side, Professionally carried out

**Bonnet:** 250 µm

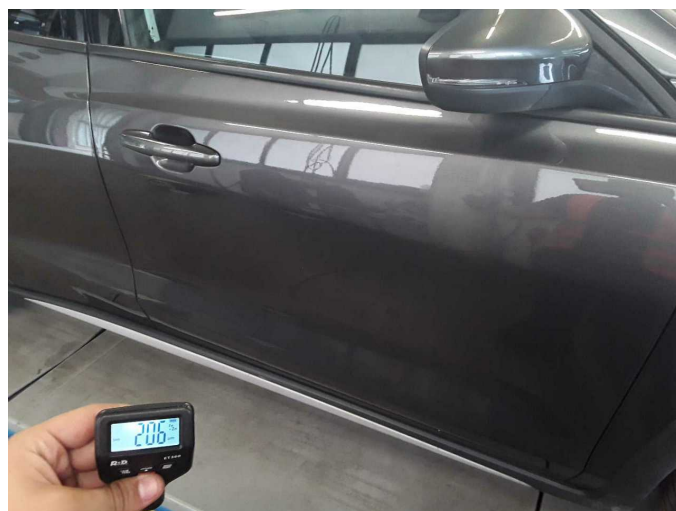
**Door - front right side:** 206 µm
