Expertise

Protocol number: 46488599  
Order No. / Reference: 26609309  
Inspection date: 14 Jul 2026

Manufacturer: Ford

Model: Transit Custom 320 L2H1 VA MH Trend

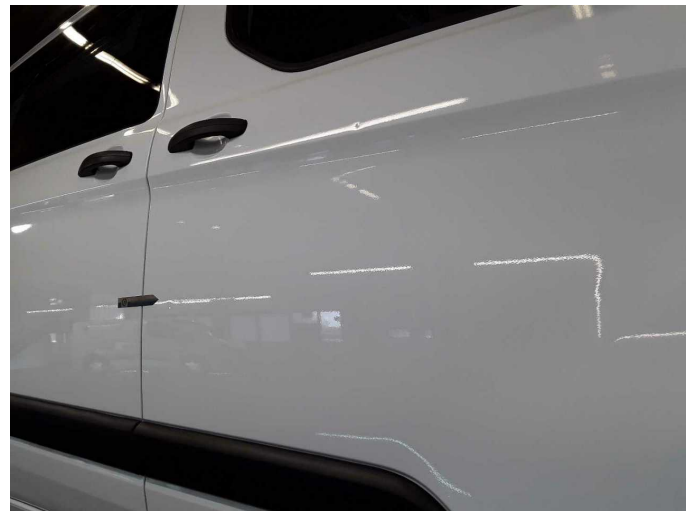
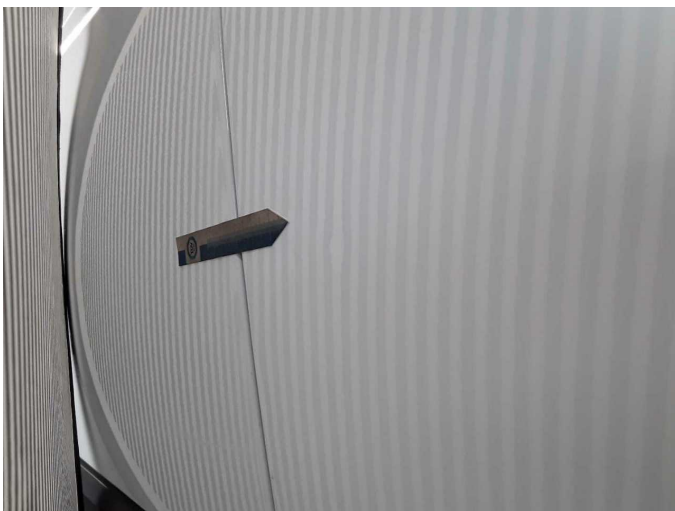
| No. | Component group | Description |
|---|---|---|
| 1 | Door - front right side | Door - dent(s) - Smooth repair work |

**Damage 1:** Door - front right side: Door - dent(s) - Smooth repair work

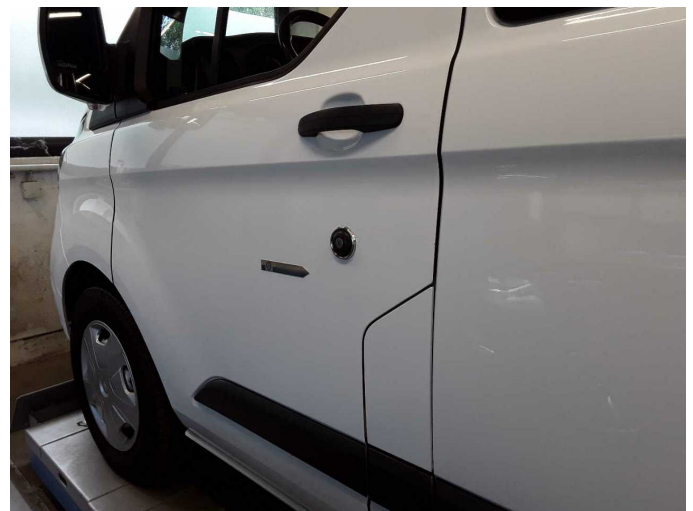
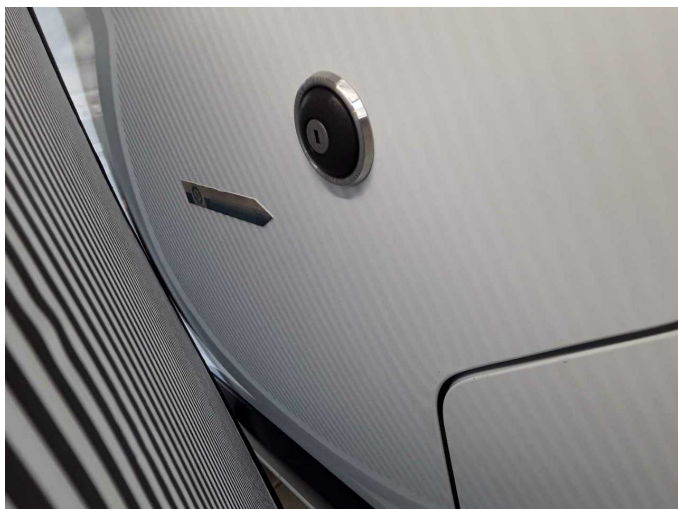
| No. | Component group | Description |
|---|---|---|
| 2 | Door - front left side | Door - dent(s) - Smooth repair work |

**Damage 2:** Door - front left side: Door - dent(s) - Smooth repair work

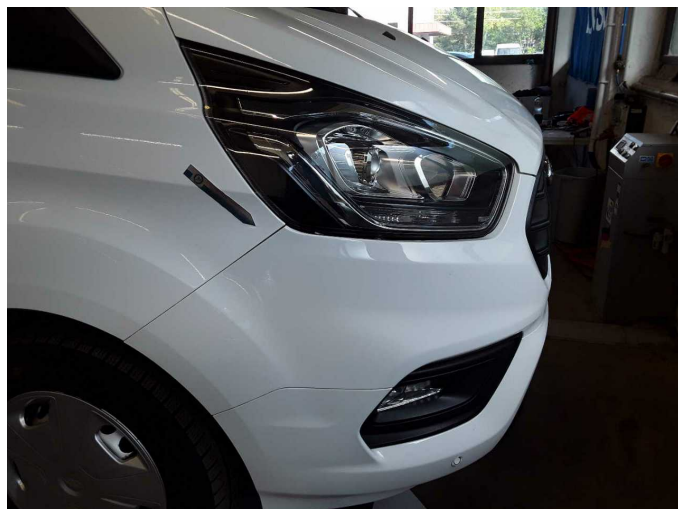
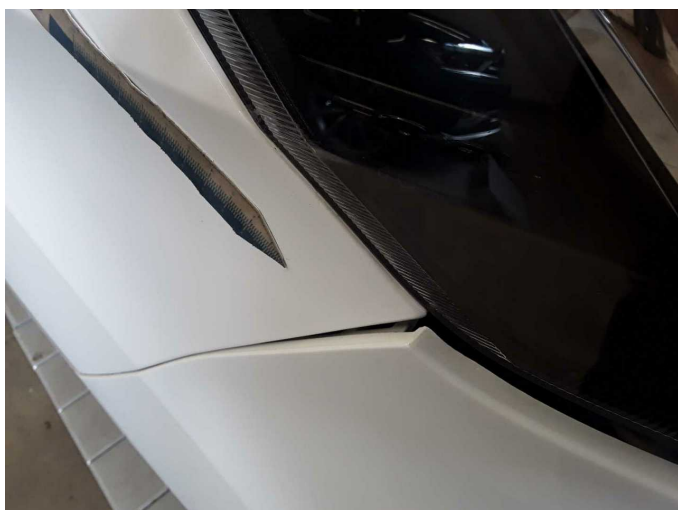
| No. | Component group | Description |
|---|---|---|
| 3 | Front bumper | Front bumper - Malposition - Set / adjust |

**Damage 3:** Front bumper: Front bumper - Malposition - Set / adjust

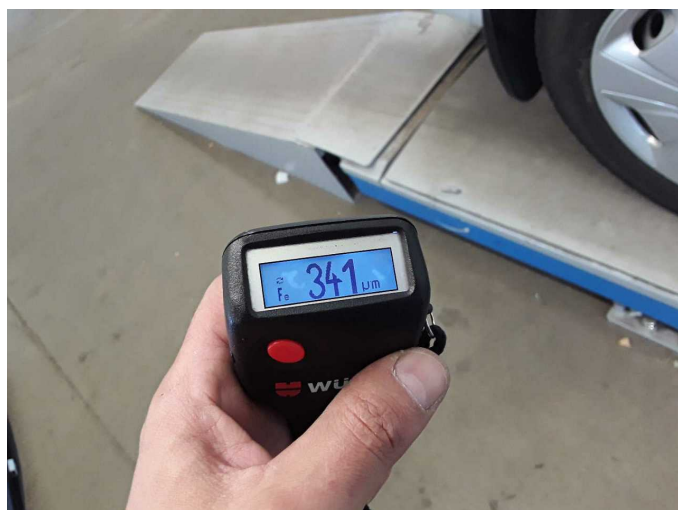
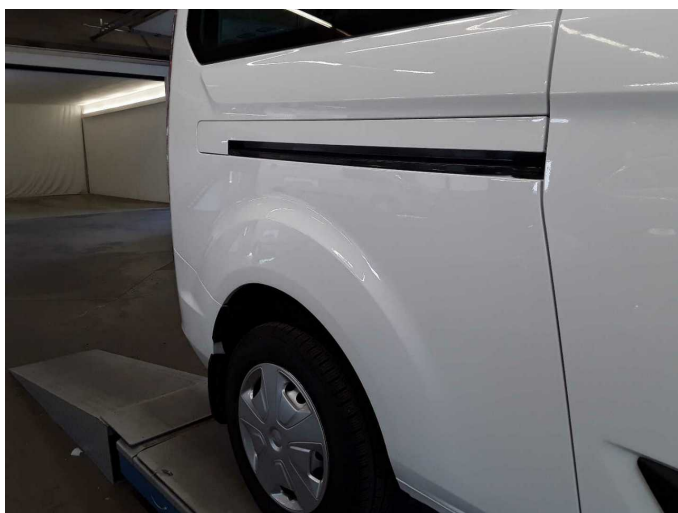
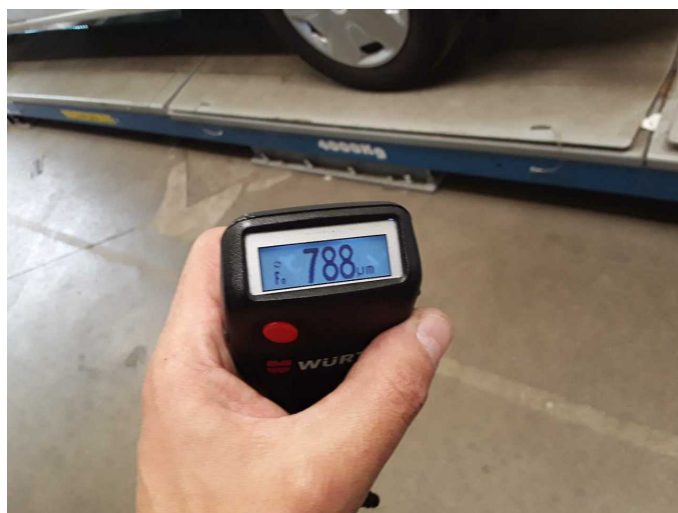
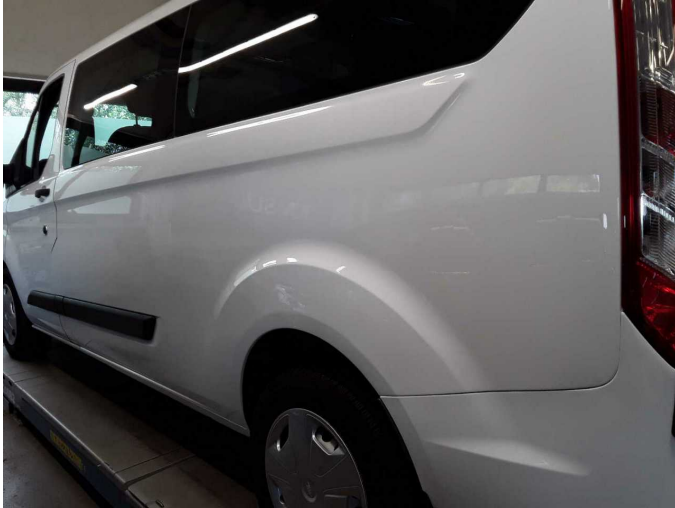
| No. | Repainting |
|---|---|
| 1 | Side panel - rear left side, Side panel - rear right side, Professionally carried out, Invoice of repair done Non-existent |

| Side panel - rear left side | 776 µm | Side panel - rear right side | 341 µm |

**Repainting 1:** Side panel - rear left side, Side panel - rear right side
