Expertise

Protocol number: 46532922  
Order No. / Reference: 26554380  
Inspection date: 10 Jul 2026

| Manufacturer: Opel | Model: Astra Sports Tourer 1.5 D Automatik Business Elegance |

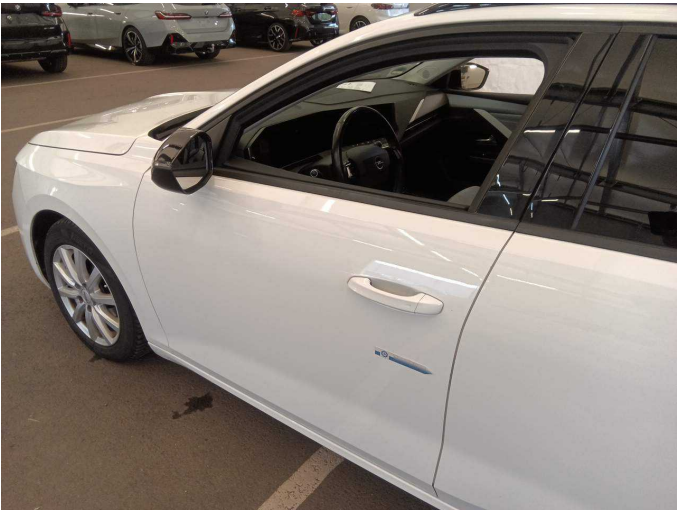
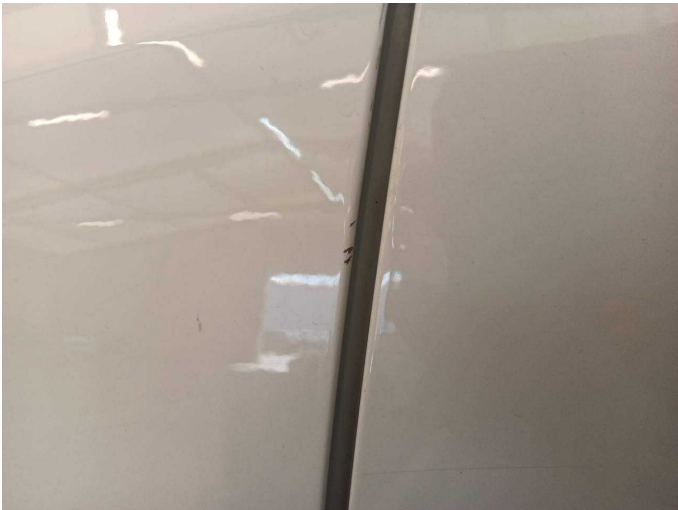
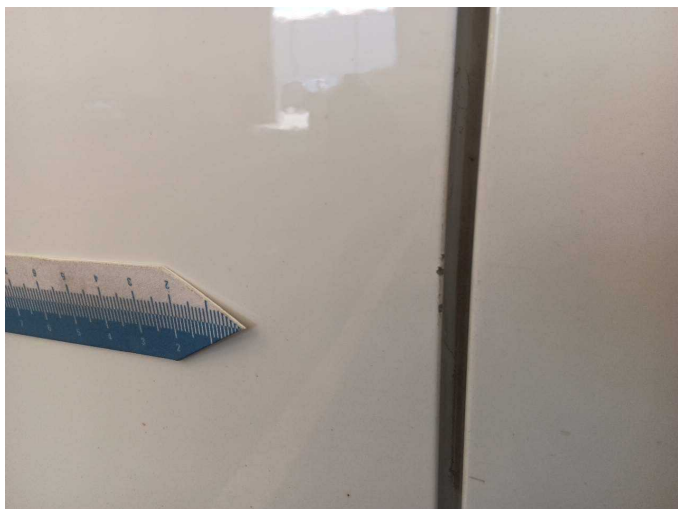
| No. | Component group | Description |
|---|---|---|
| 2 | Door - front left side | Door edge - Scratch(es) - Smart repair |

Damage 2: Door - front left side: Door edge - Scratch(es) - Smart repair

**Damage 2:** Door - front left side: Door edge - Scratch(es) - Smart repair

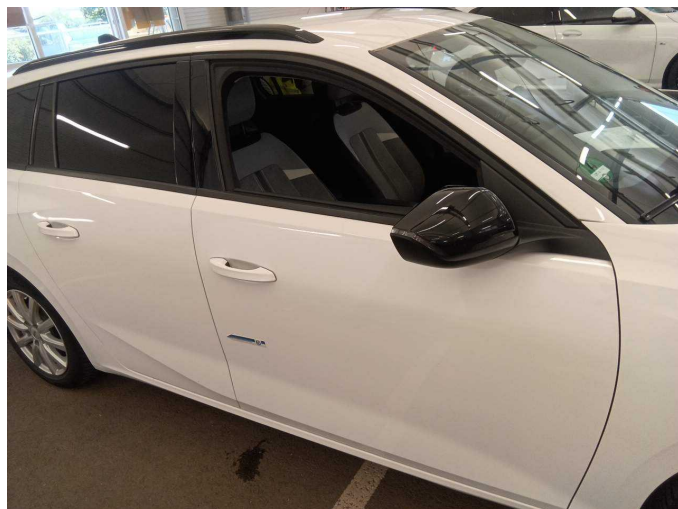
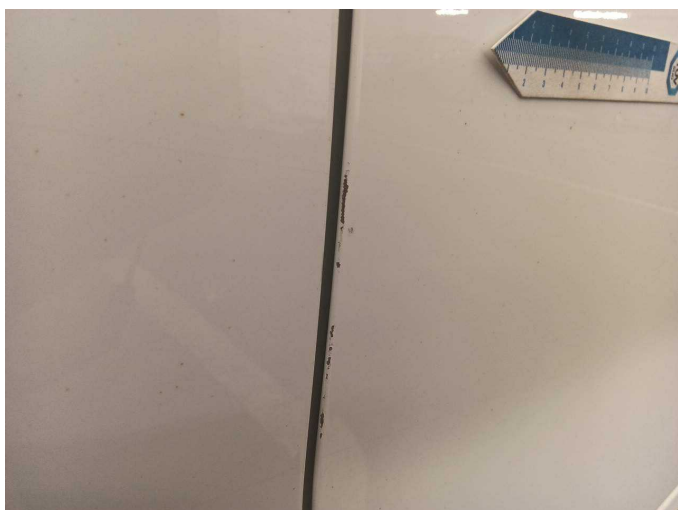
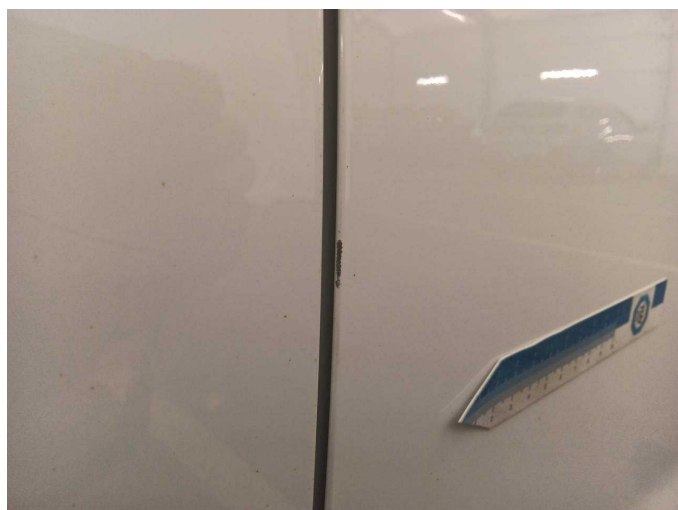
| No. | Component group | Description |
|---|---|---|
| 3 | Door - front right side | Door edge - Scratch(es) - Smart repair |

**Damage 3:** Door - front right side: Door edge - Scratch(es) - Smart repair

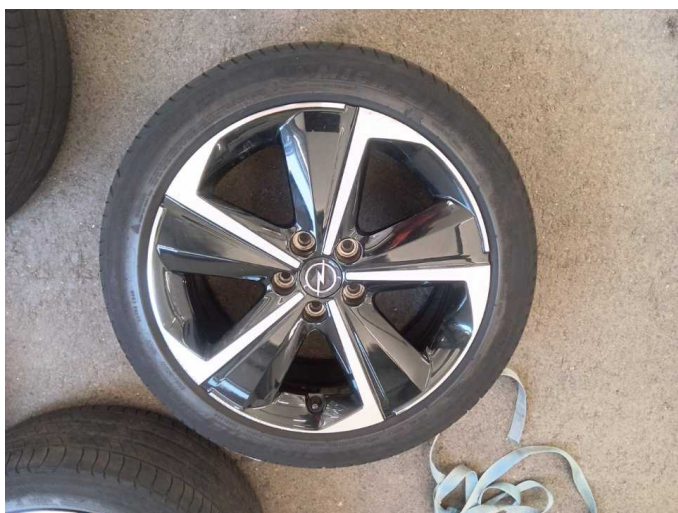
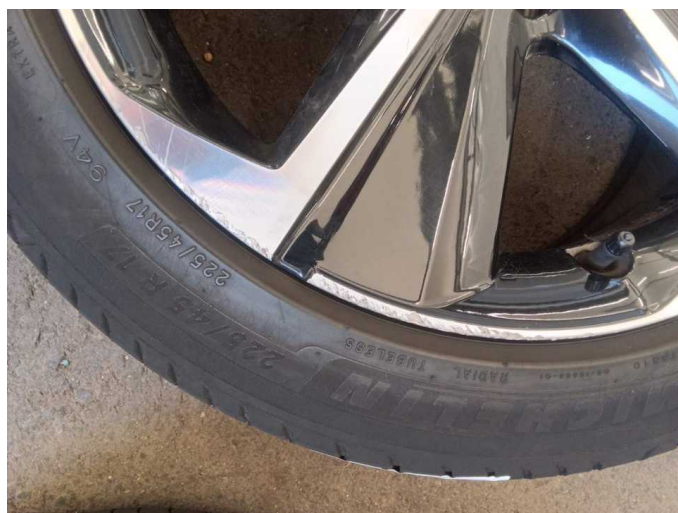
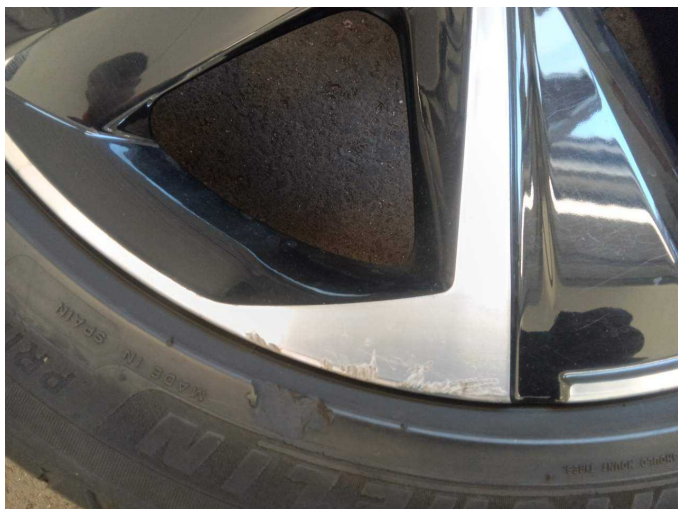
| No. | Component group | Description |
|---|---|---|
| 4 | 2nd wheel set | 1 alloy rim (Großflächig verkratzt) - Scratched - Replace |

**Damage 4:** 2nd wheel set: 1 alloy rim (Großflächig verkratzt) - Scratched - Replace

**Damage 4:** 2nd wheel set: 1 alloy rim (Großflächig verkratzt) - Scratched  
- Replace

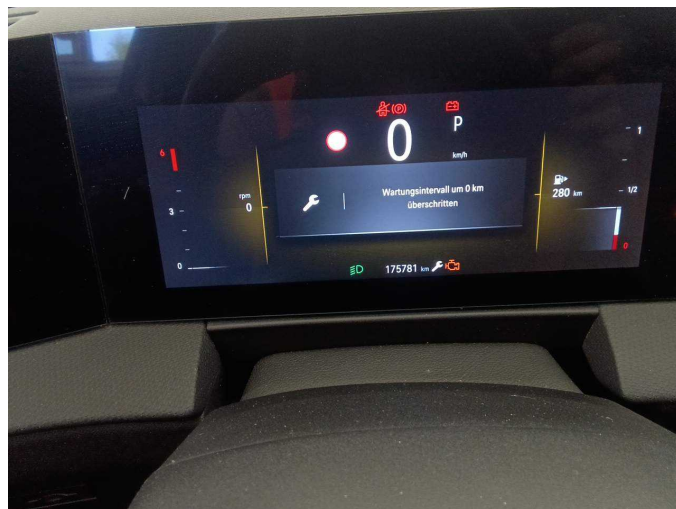
| No. | Component group | Description |
|---|---|---|
| 5 | Misc. | Inspection / maintenance (Motorölservice / Inspektion) - Due - Perform |

**Damage 5:** Misc.: Inspection / maintenance (Motorölservice / Inspektion)  
- Due - Perform

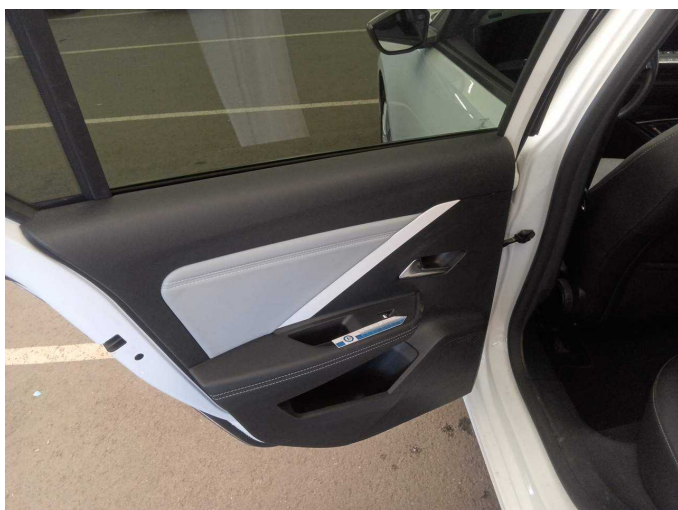
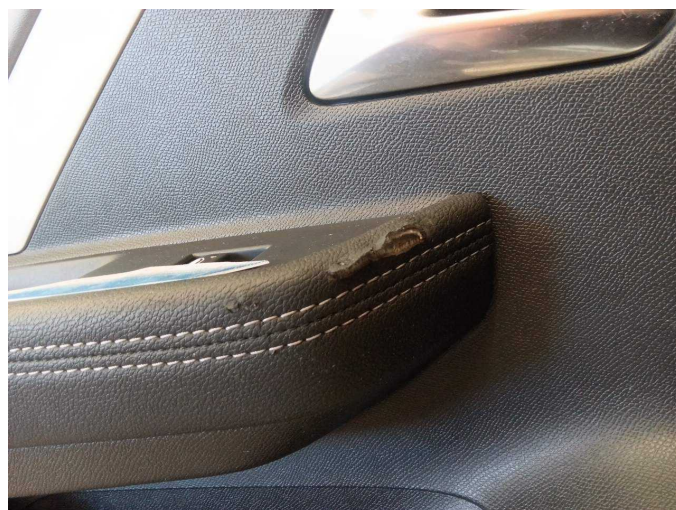
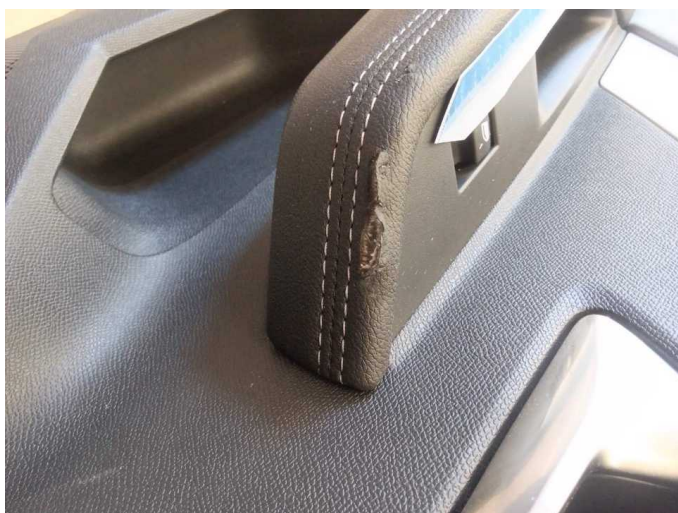
| No. | Component group | Description |
|---|---|---|
| 6 | Trim / covers | Door trim - rear left side (Armlehne verformt & gerissen) - Broken / torn - Replace |

**Damage 6:** Trim / covers: Door trim - rear left side (Armlehne verformt & gerissen) - Broken / torn - Replace

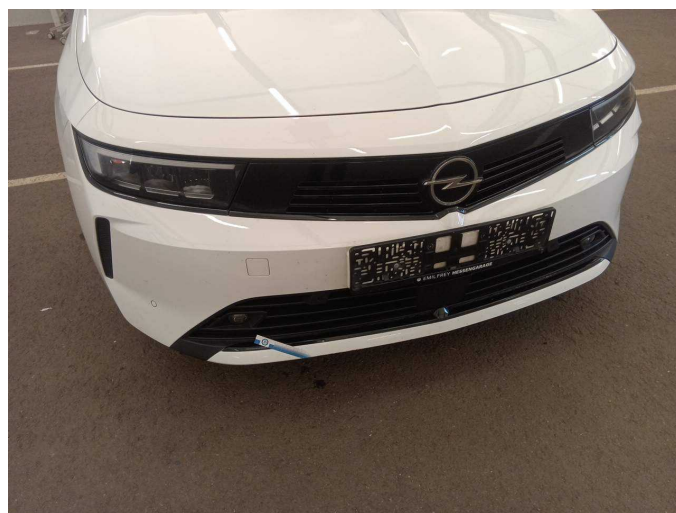
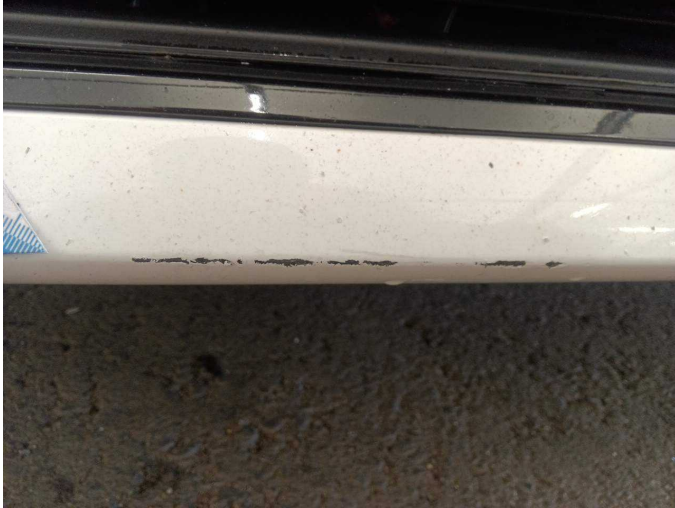
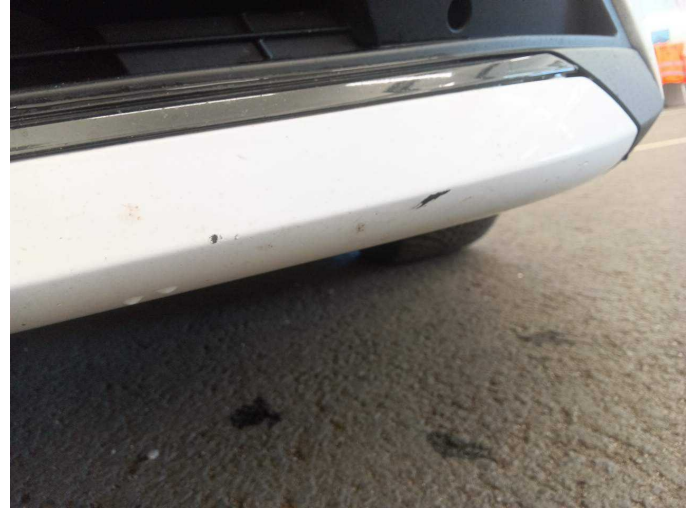
| No. | Component group | Description |
|---|---|---|
| 7 | Front bumper | Front bumper - Scratch(es) - Paint |

**Damage 7:** Front bumper: Front bumper - Scratch(es) - Paint

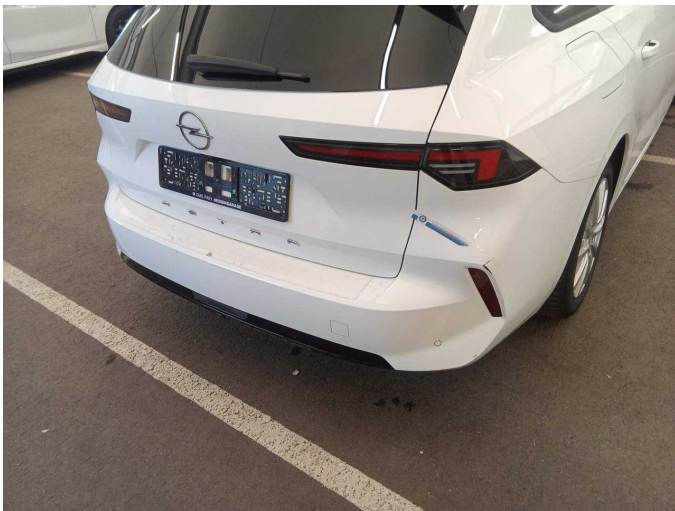
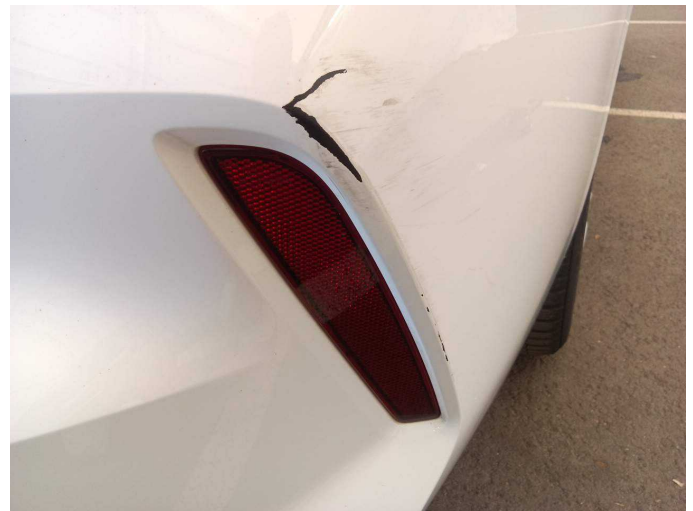
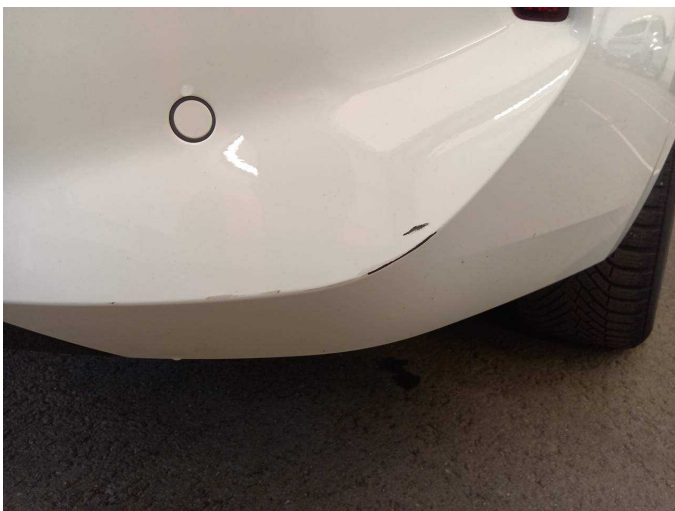
| No. | Component group | Description |
|---|---|---|
| 8 | Rear bumper | Rear bumper - Scratch(es) - Paint |

**Damage 8:** Rear bumper: Rear bumper - Scratch(es) - Paint

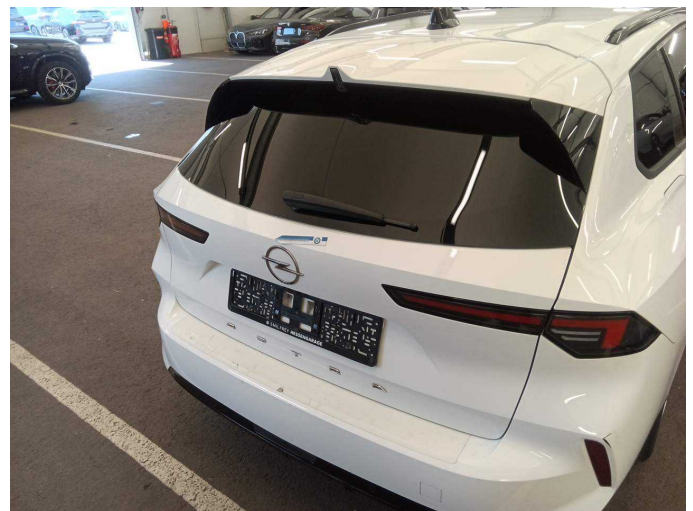
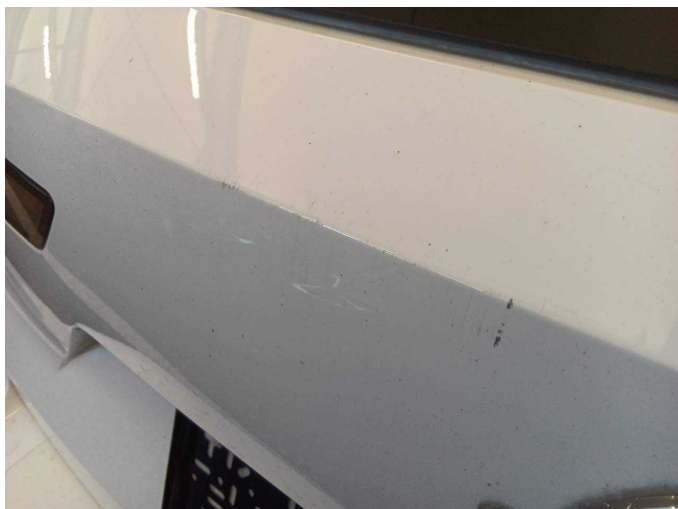
| No. | Component group | Description |
|---|---|---|
| 9 | Boot lid / rear door | Boot lid - Scratch(es) - Paint |

**Damage 9:** Boot lid / rear door: Boot lid - Scratch(es) - Paint

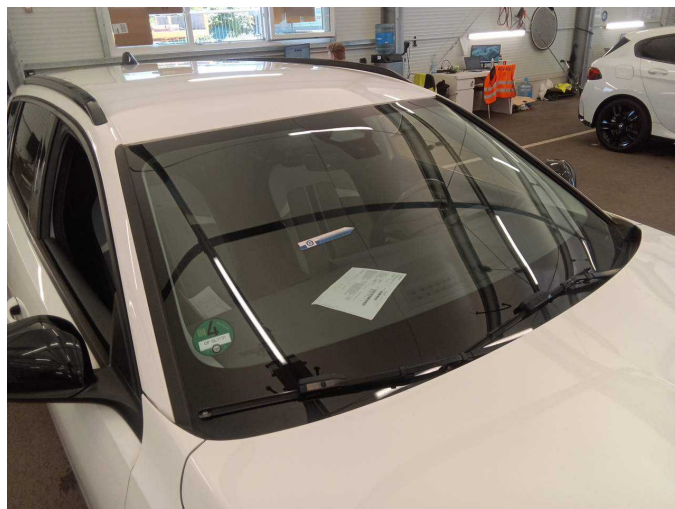
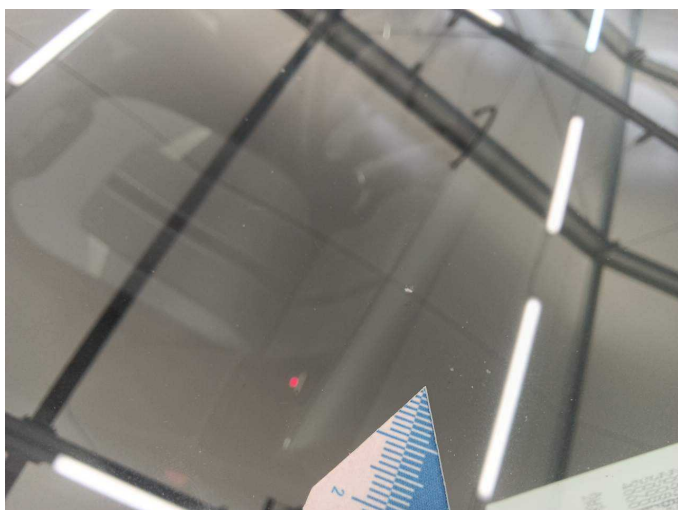
| No. | Component group | Description |
|---|---|---|
| 1 | Vehicle glazing | Windscreen - Stone chips - No deduction |

**Wear and tear 1:** Vehicle glazing: Windscreen - Stone chips - No deduction

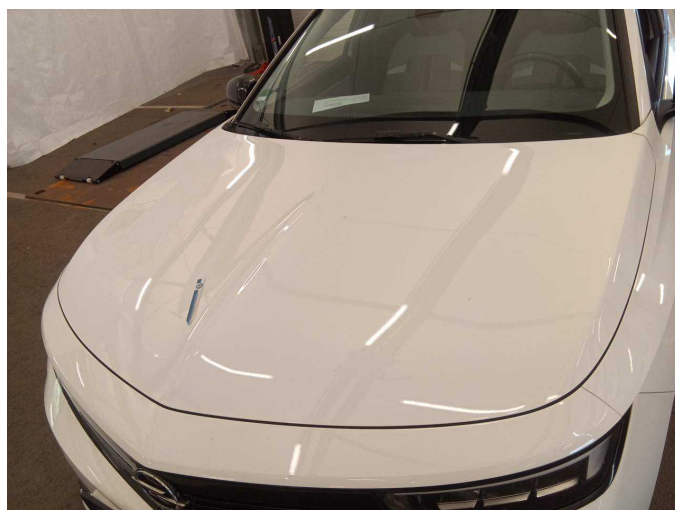
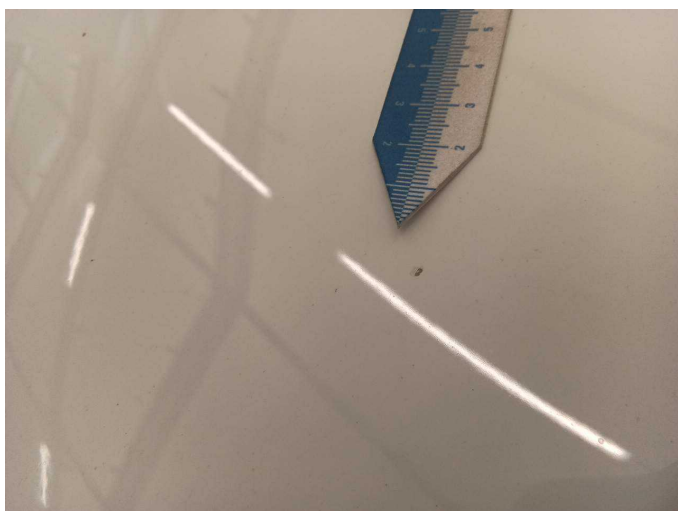
| No. | Component group | Description |
|---|---|---|
| 2 | Bonnet | Bonnet - Stone chips - No deduction |

**Wear and tear 2:** Bonnet: Bonnet - Stone chips - No deduction

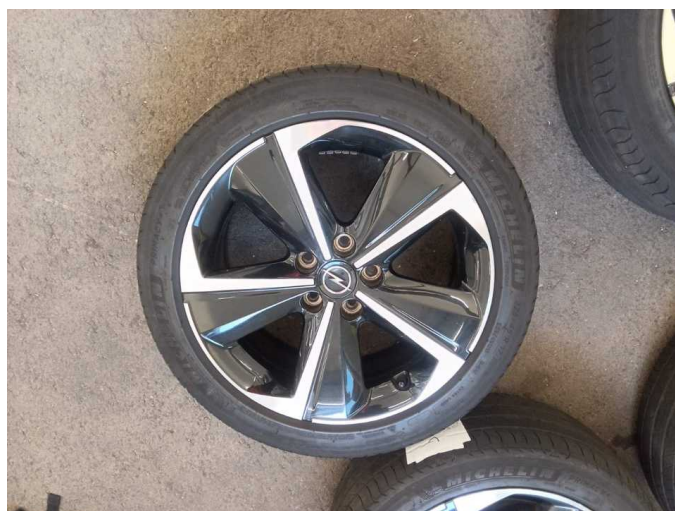
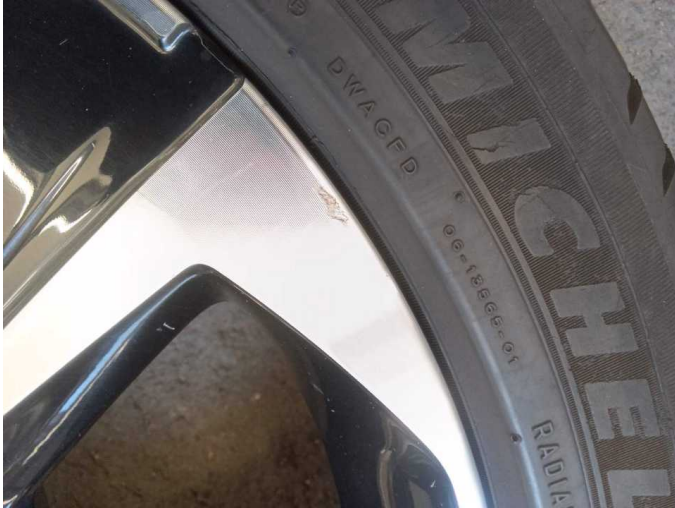
| No. | Component group | Description |
|---|---|---|
| 5 | 2nd wheel set | 1 alloy rim - Scratch(es) - No deduction |

**Wear and tear 5:** 2nd wheel set: 1 alloy rim - Scratch(es) - No deduction
