# MACDAM

## Ford \* Trans.Conne. FL'18

### Damage summary

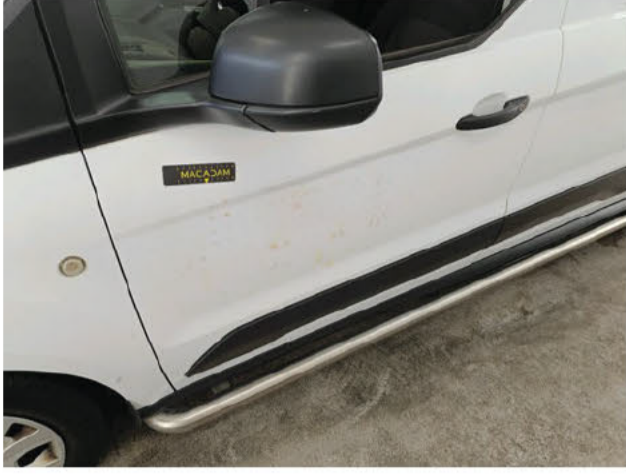
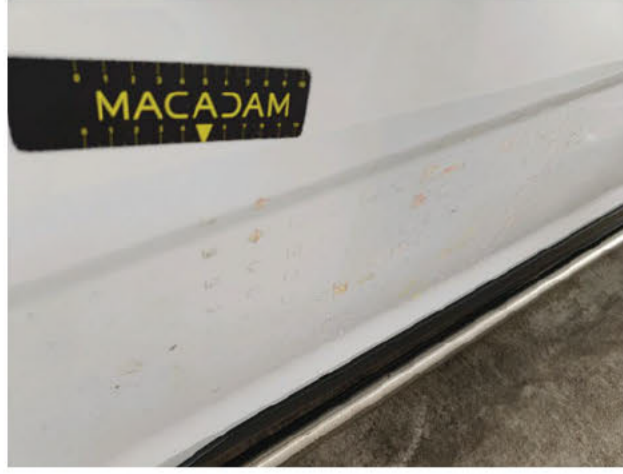
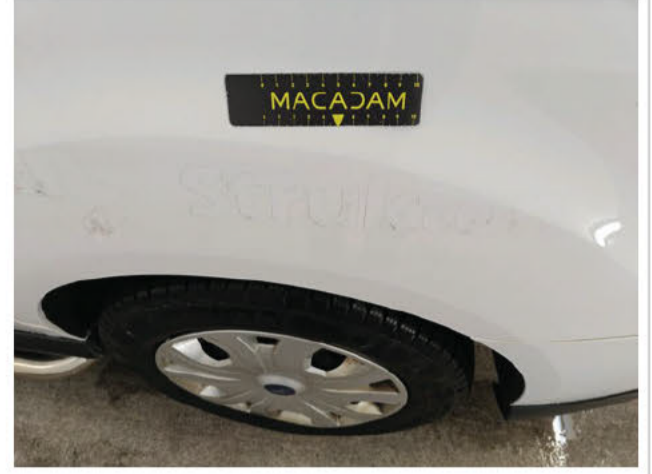
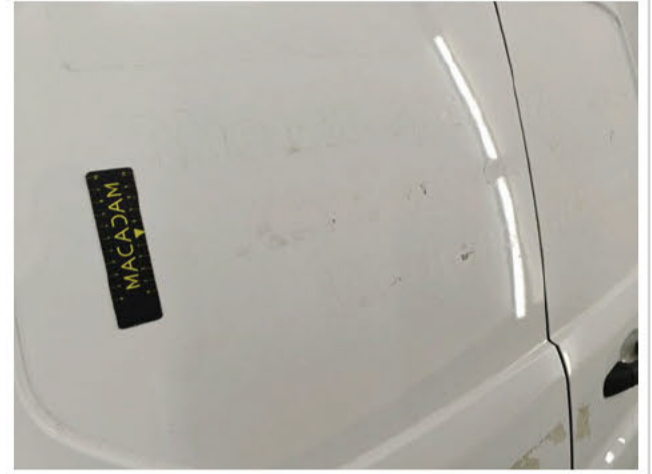
**Bodywork**

Not original part

Roof & others

Remove lettering

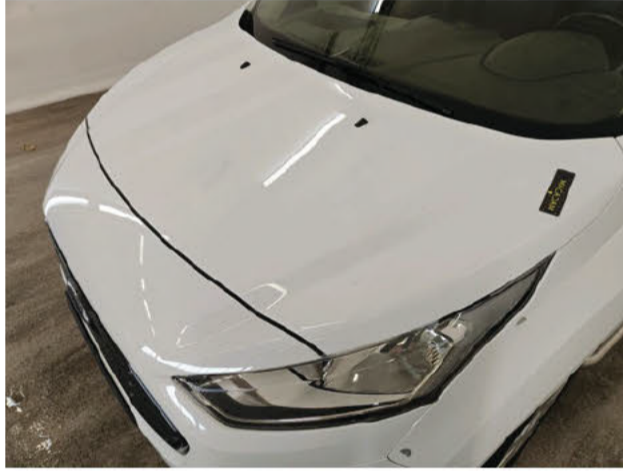
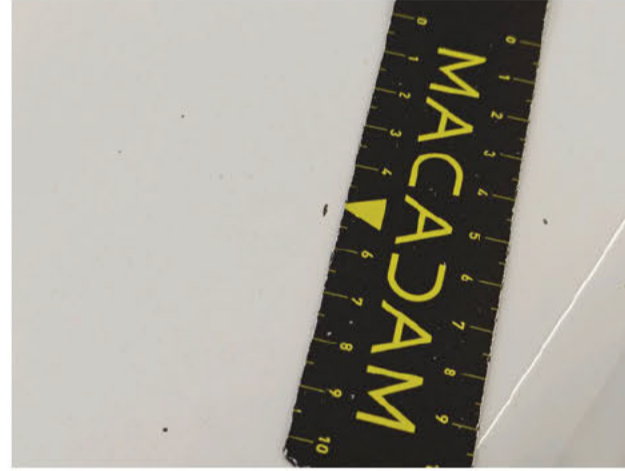
**Bonnet**

Stone chip(s)

Repair and paint (complete)

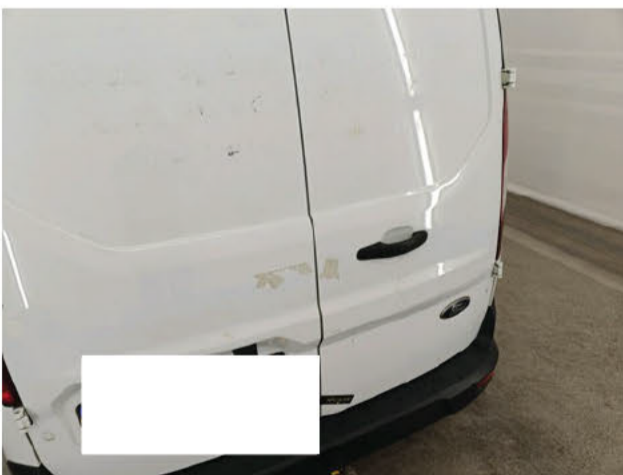
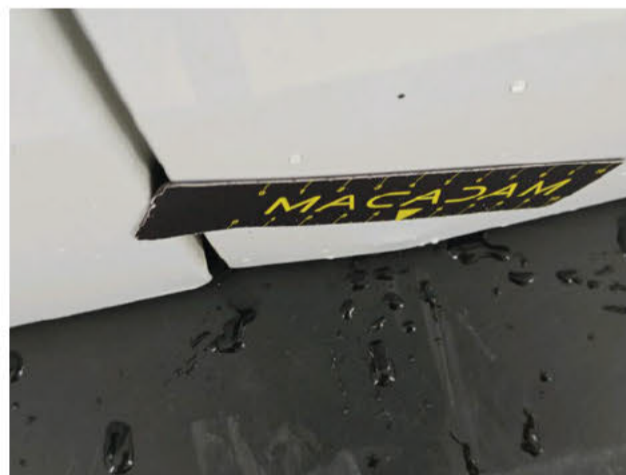
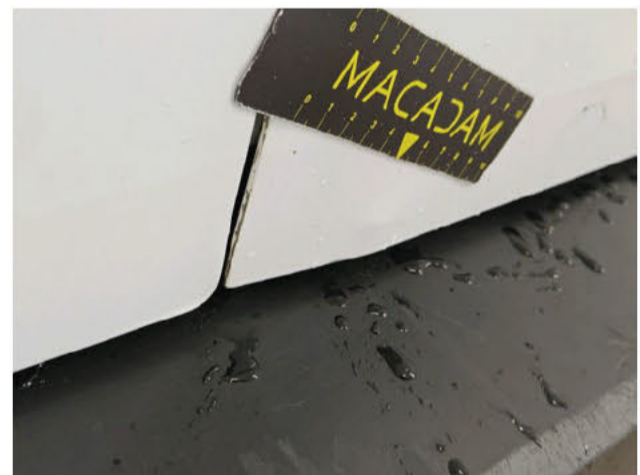
**Boot door panel RR**

Deformed / Strained

Repair and paint (complete)

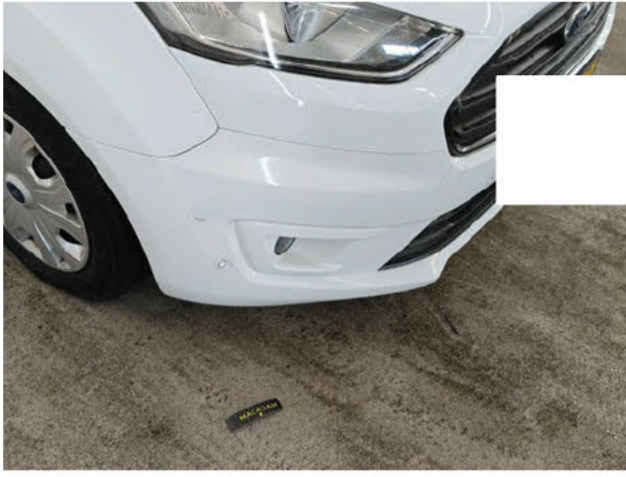
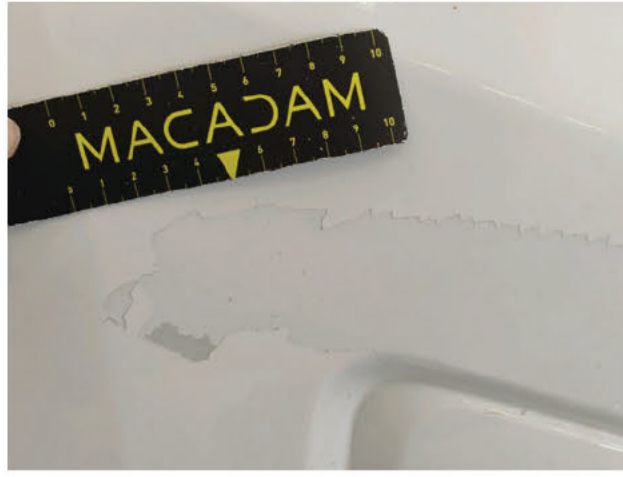
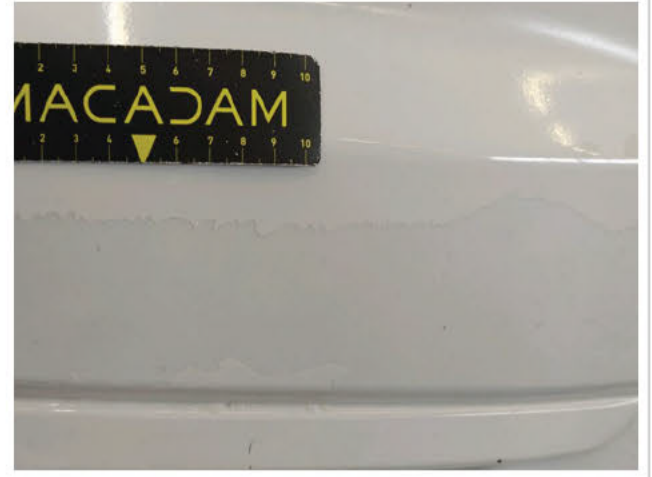
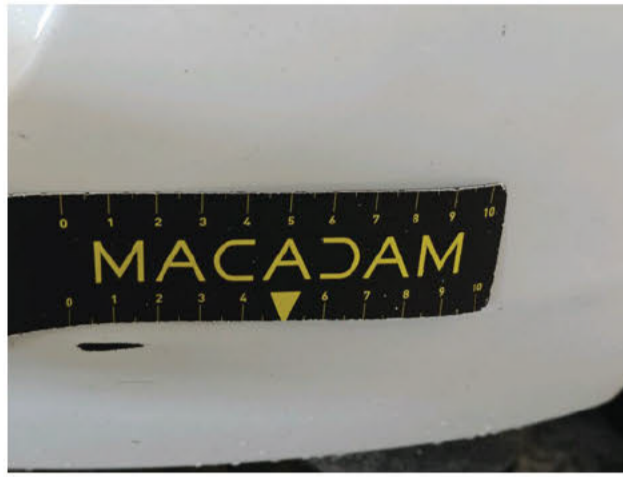
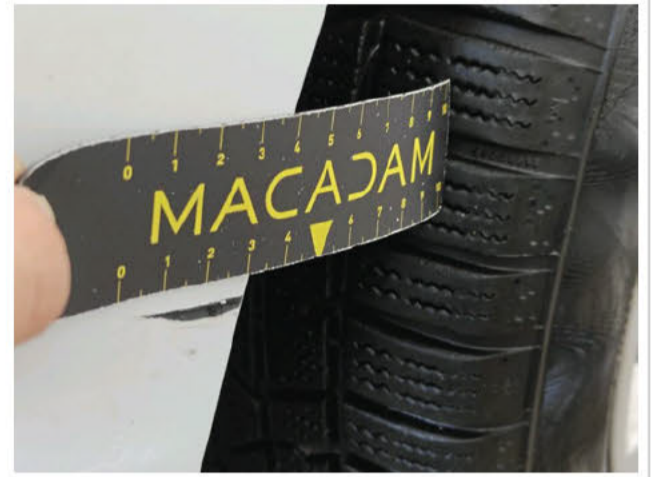
**Bumper F**

Scratch(es)

Repair and paint (complete)

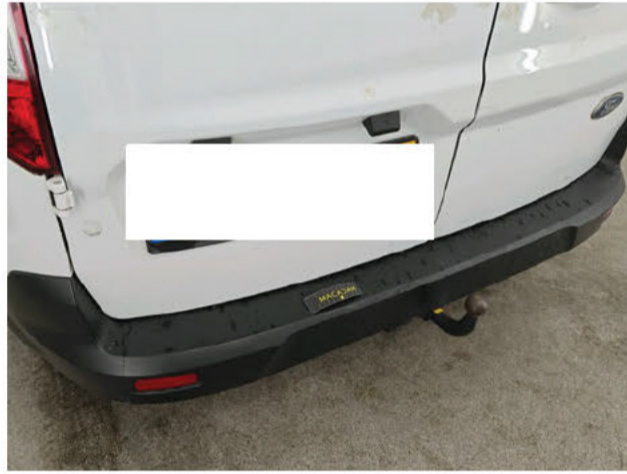
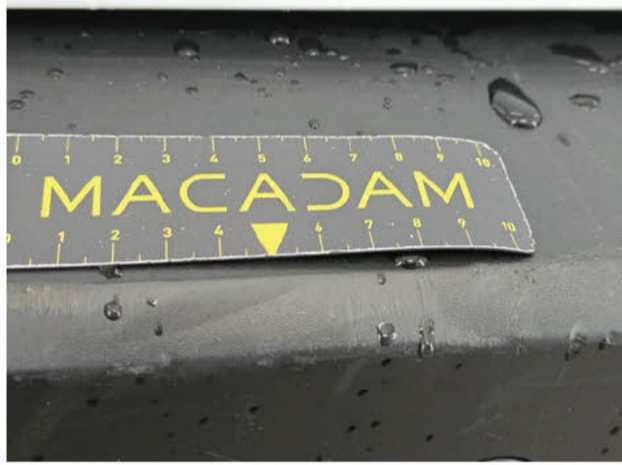
**Bumper R**

Scratch(es)

Replace

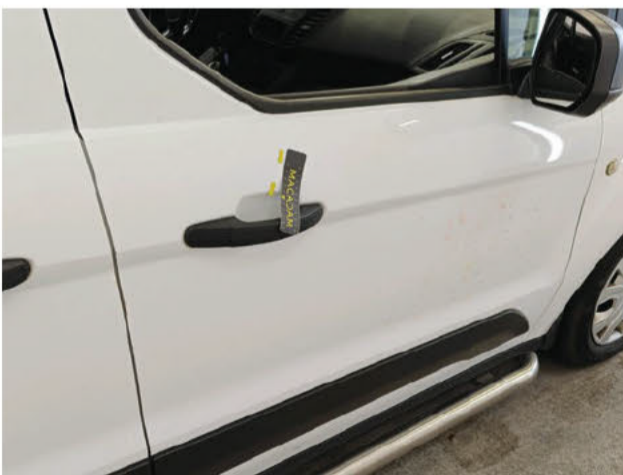
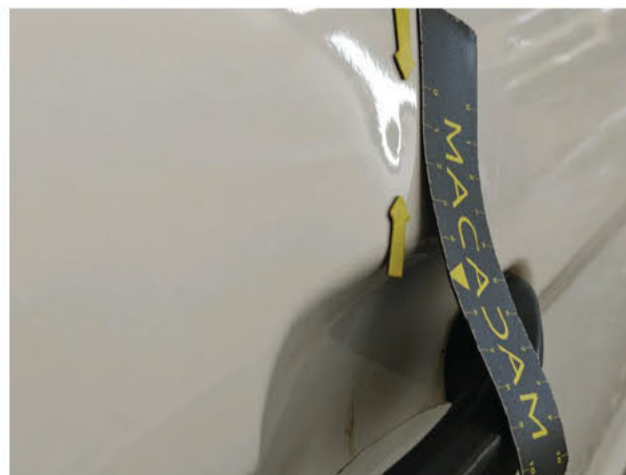
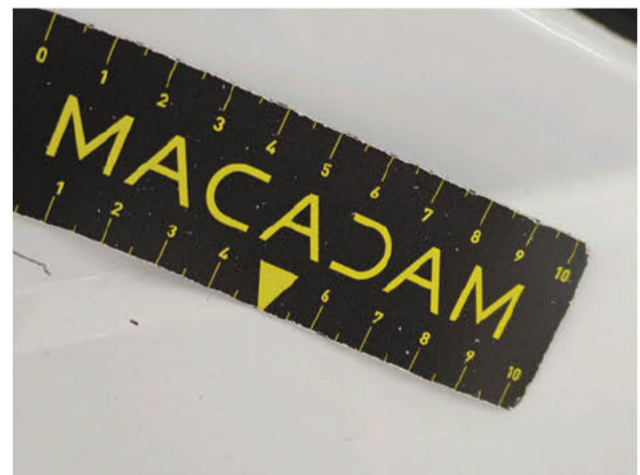
**Door FR**

Dent(s) and scratch(es)

Repair and paint (complete)

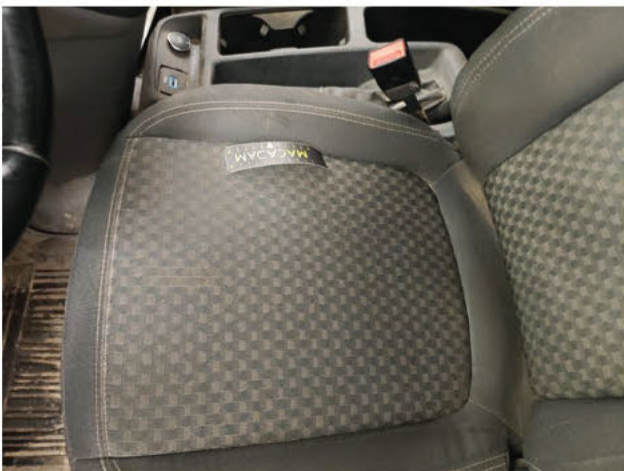
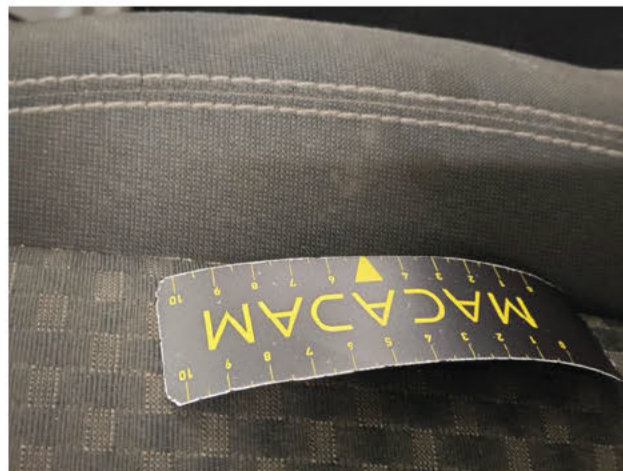
**Interior**

Stain

Cleaning

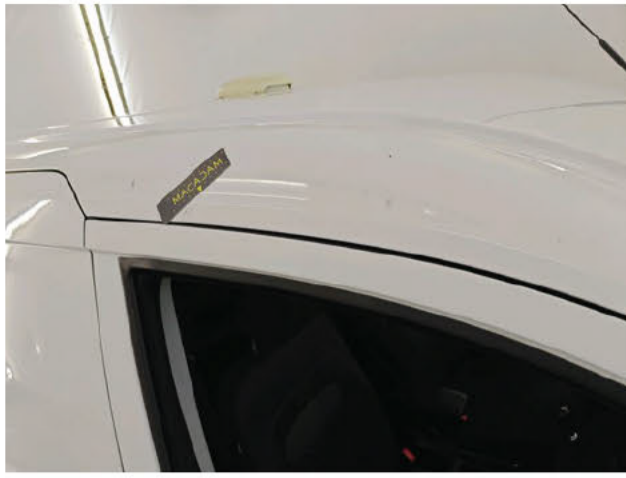
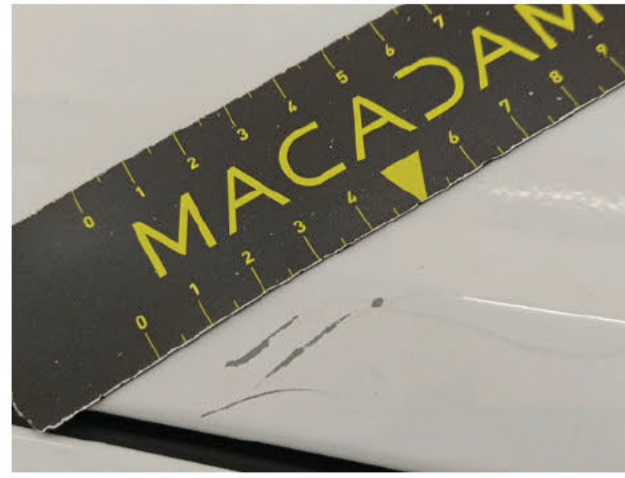
**Roof pillar R**

Scratch(es)  
Repair and paint (complete)  
Right

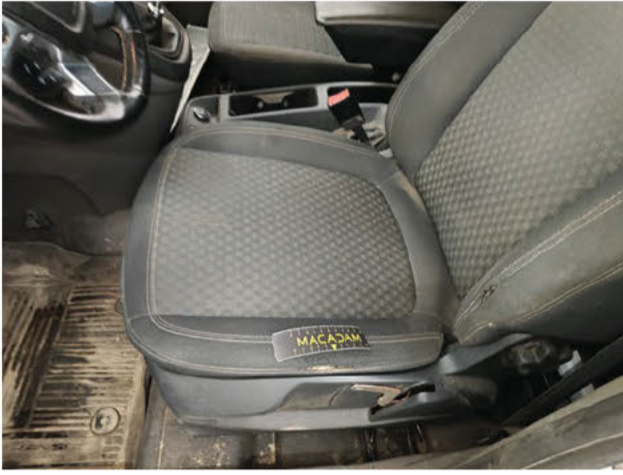
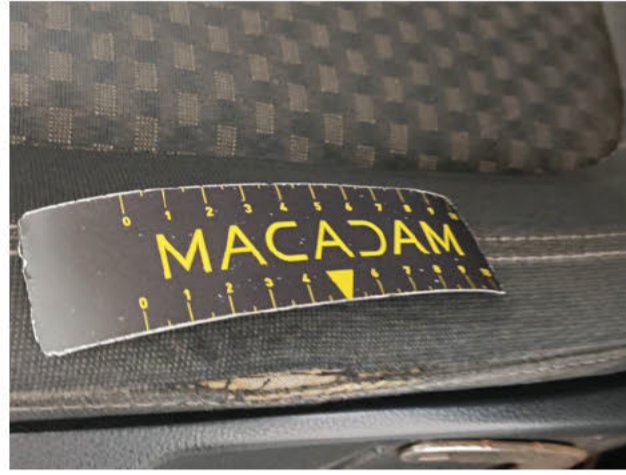
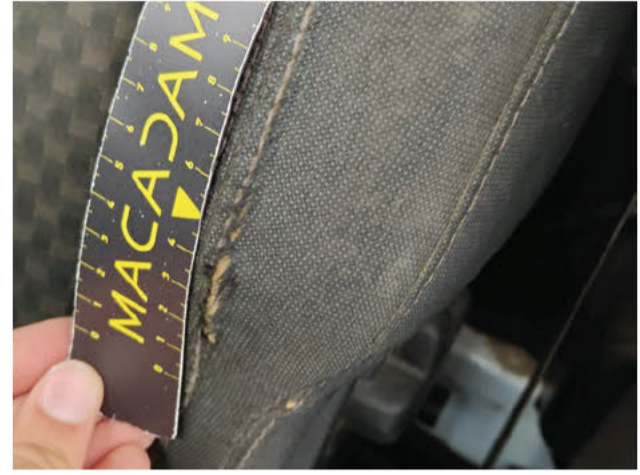
**Seat cover FL**

Worn  
Replace  
Interior

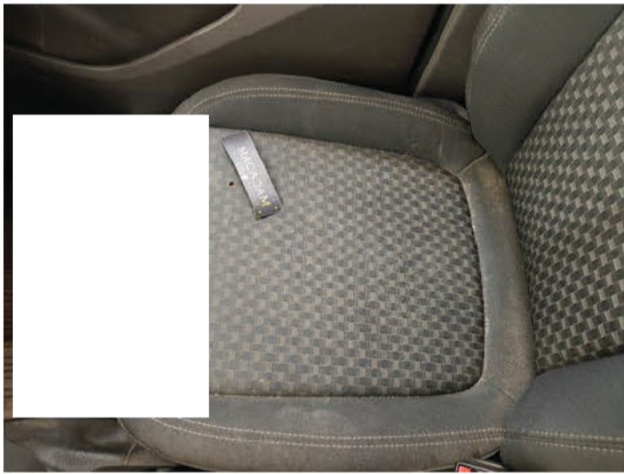
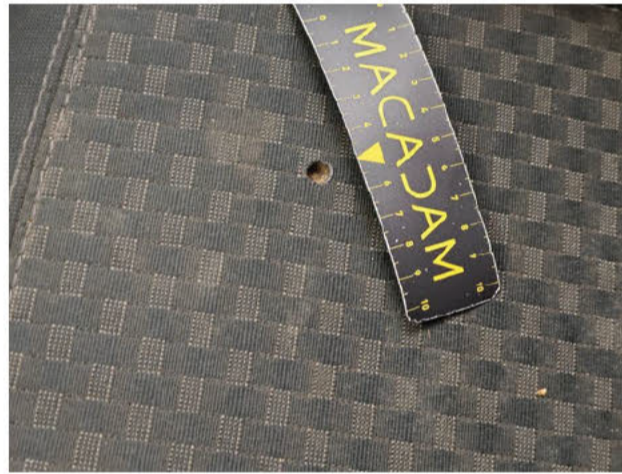
**Seat cover FR**

Burned  
Replace  
Interior

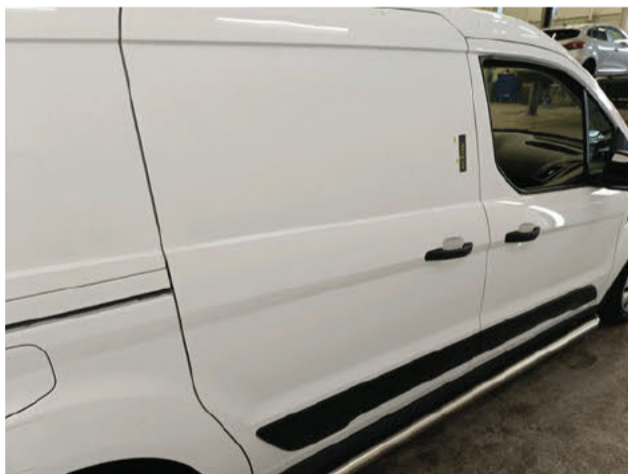
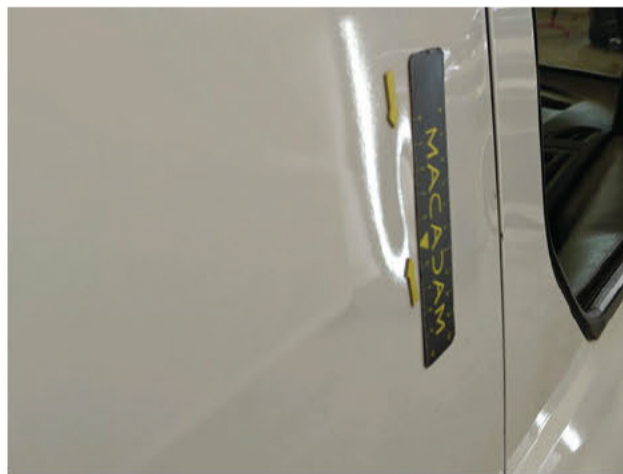
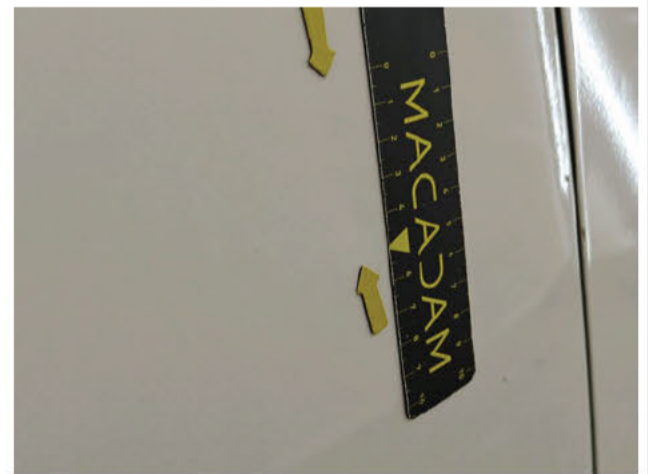
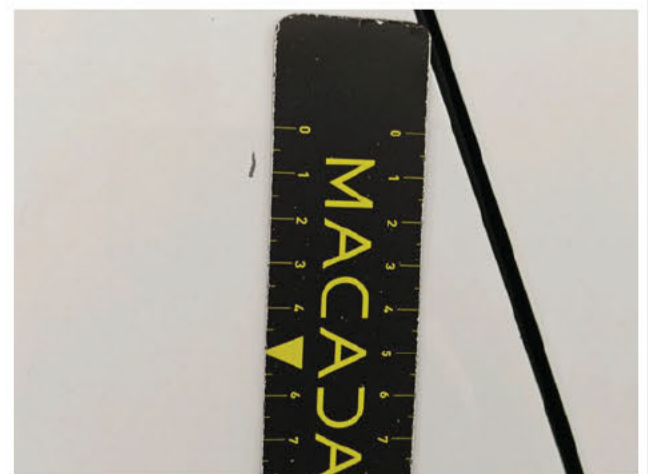
**Sliding door R**

Dent(s) and scratch(es)  
Repair and paint (complete)  
Right

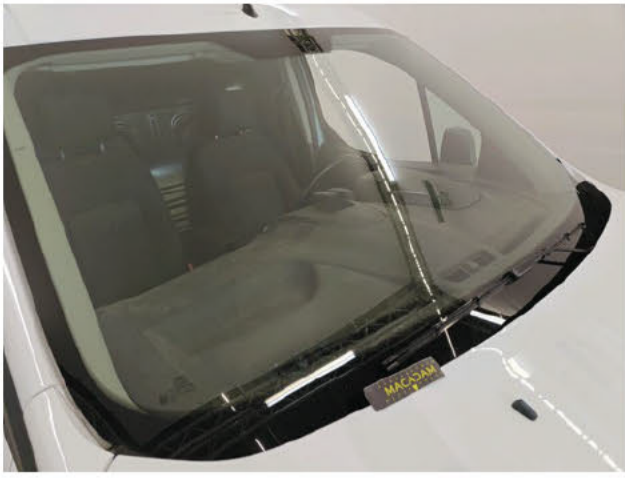
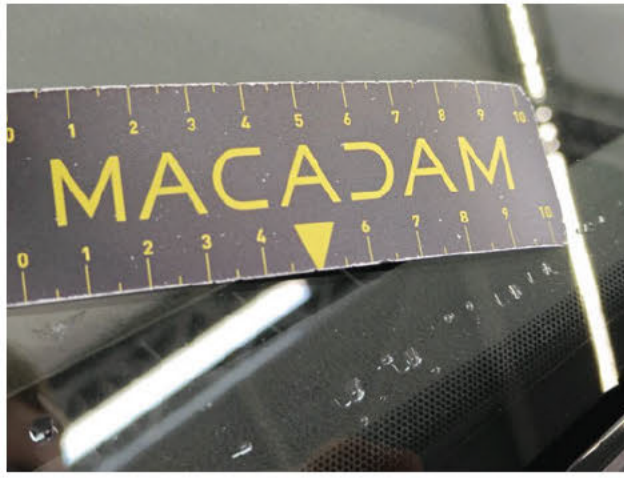
**Windscreen**  
Stone chip(s)  
Windscreen repair  
Front

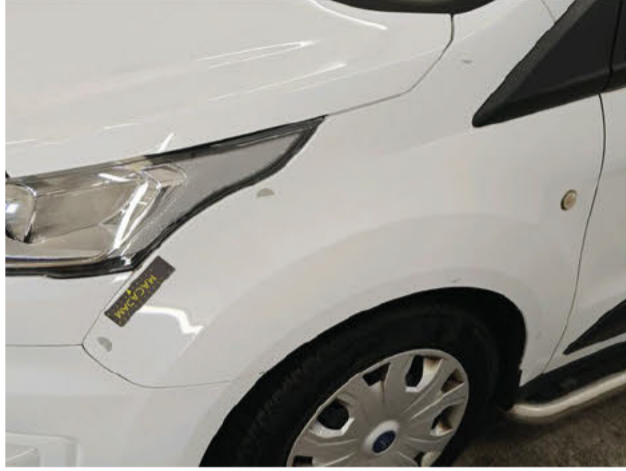
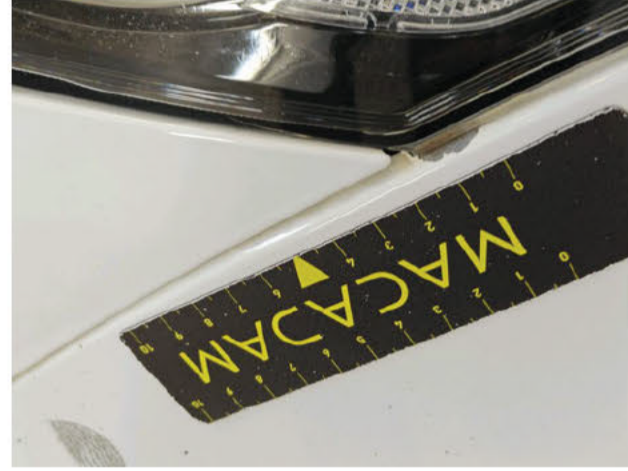
**Wing FL**  
Scratch(es)  
Repair and paint (complete)  
Left

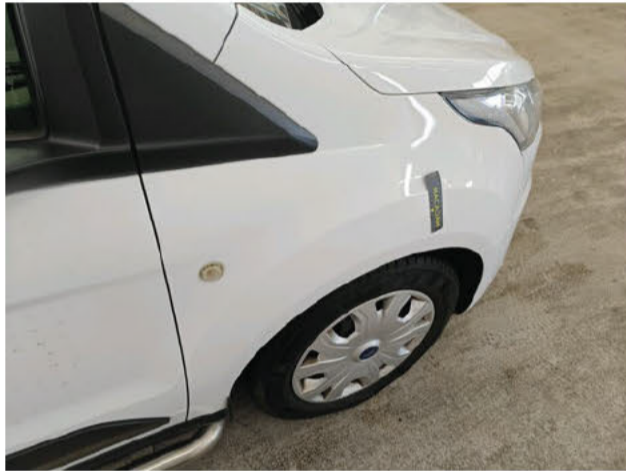
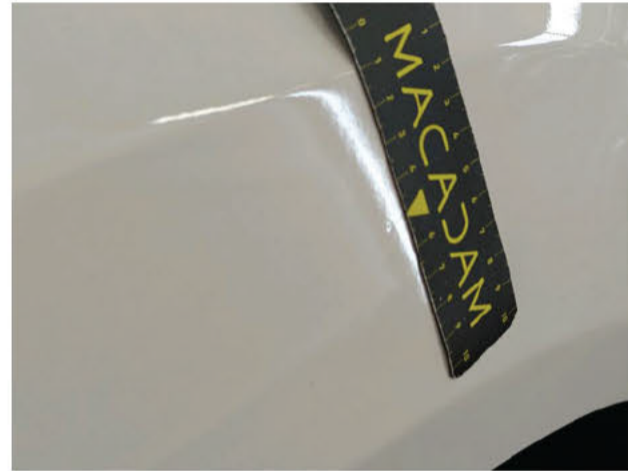
**Wing FR**  
Bad repair  
Repair and paint (complete)  
Right

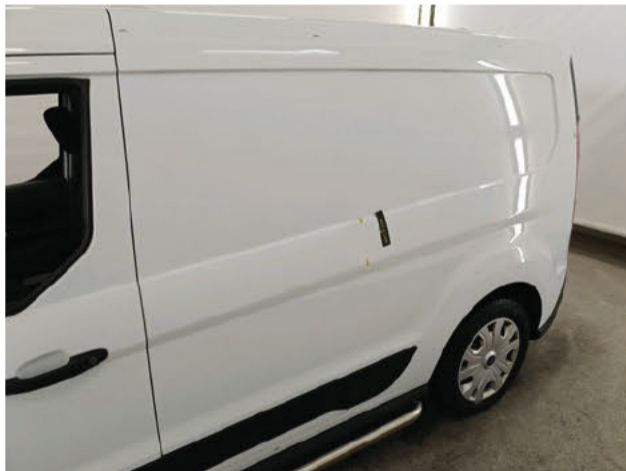
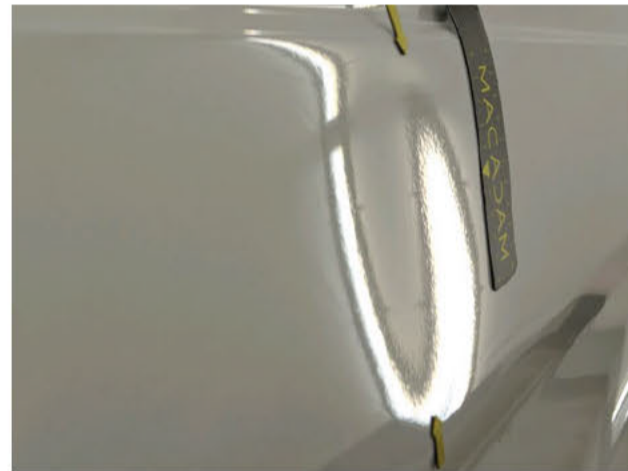
**Wing RL**  
Dent(s)  
Repair and paint (complete)  
Left

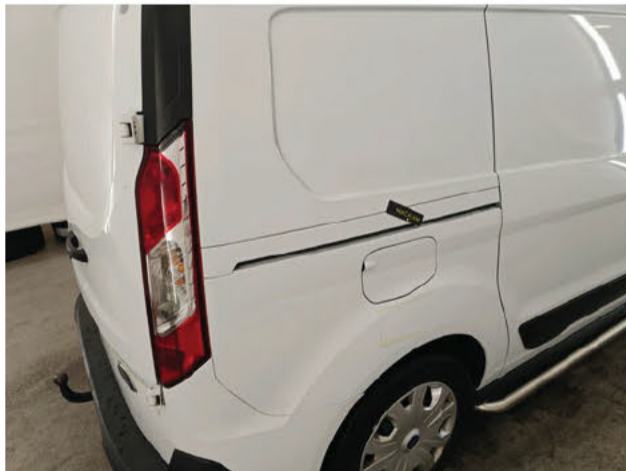
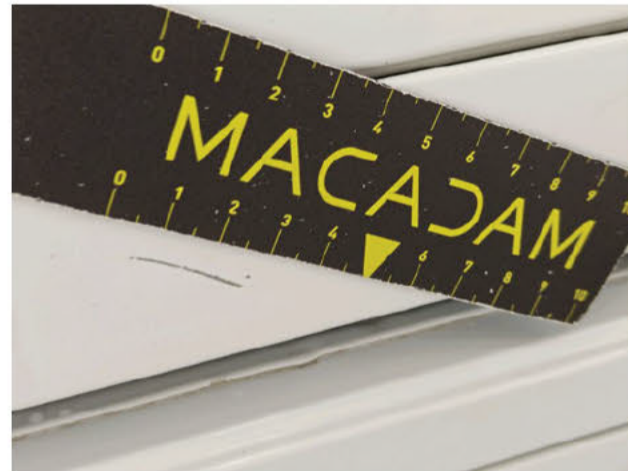
**Wing RR**  
Scratch(es)  
Repair and paint (complete)  
Right
