Expertise

Protocol number: 46357754  
Order No. / Reference: 26652521  
Inspection date: 6 Jul 2026

Manufacturer: Peugeot

Model: 5008 BlueHDi 180 EAT8 GT Pack

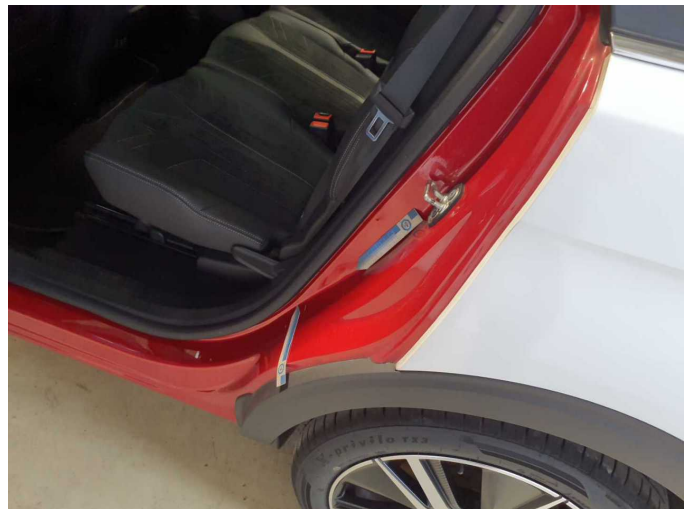
| No. | Component group | Description |
|---|---|---|
| 1 | Side panel - rear left side | Sill - Dent / paintcoat damage - Smart repair |

Damage 1: Side panel - rear left side: Sill - Dent / paintcoat damage - Smart repair

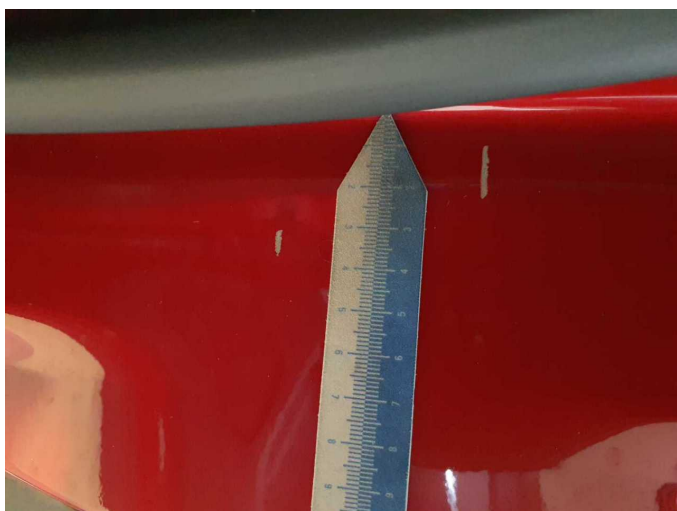
Damage 1: Side panel - rear left side: Sill - Dent / paintcoat damage - Smart repair

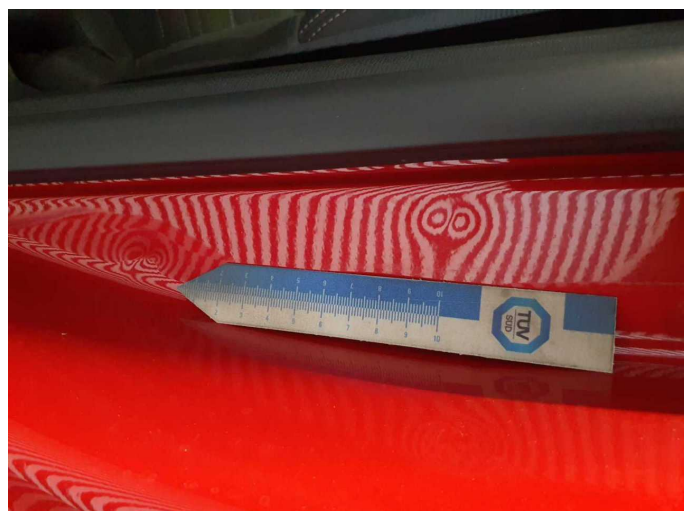
Damage 1: Side panel - rear left side: Sill - Dent / paintcoat damage - Smart repair

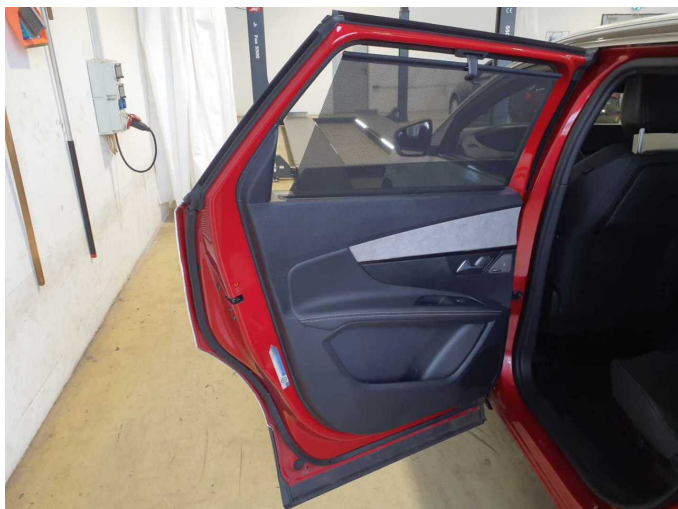
| No. | Component group | Description |
|---|---|---|
| 2 | Door - rear left side | Door - dent(s) - Smart repair |

**Damage 2:** Door - rear left side: Door - dent(s) - Smart repair

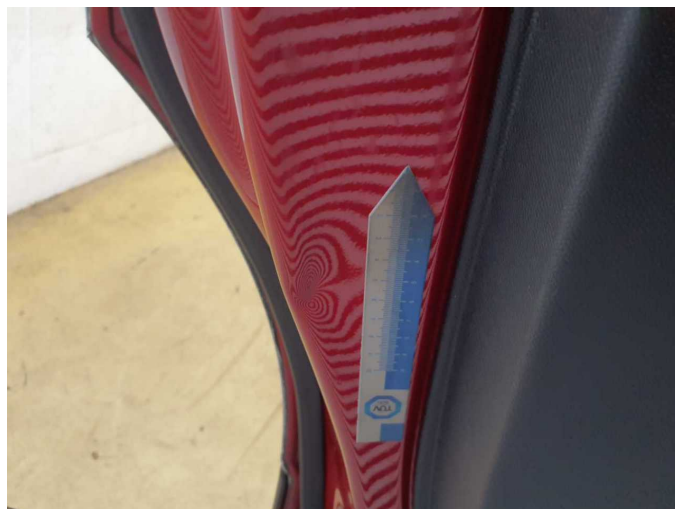
**Damage 2:** Door - rear left side: Door - dent(s) - Smart repair

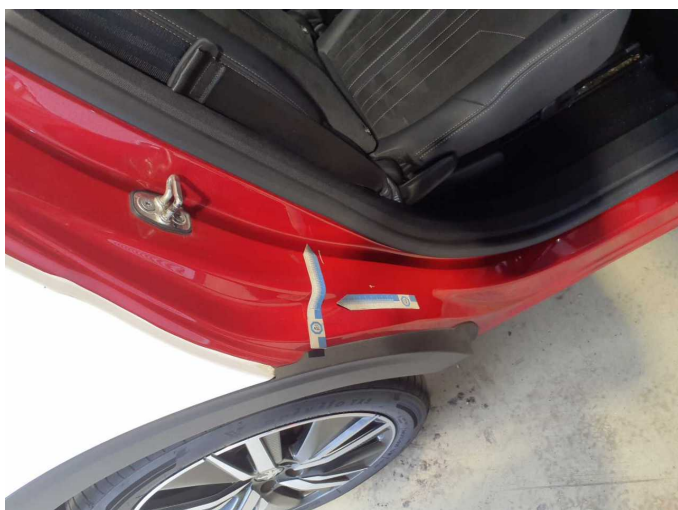
| No. | Component group | Description |
|---|---|---|
| 3 | Side panel - rear right side | Sill - Dent / paintcoat damage - Smart repair |

**Damage 3:** Side panel - rear right side: Sill - Dent / paintcoat damage - Smart repair

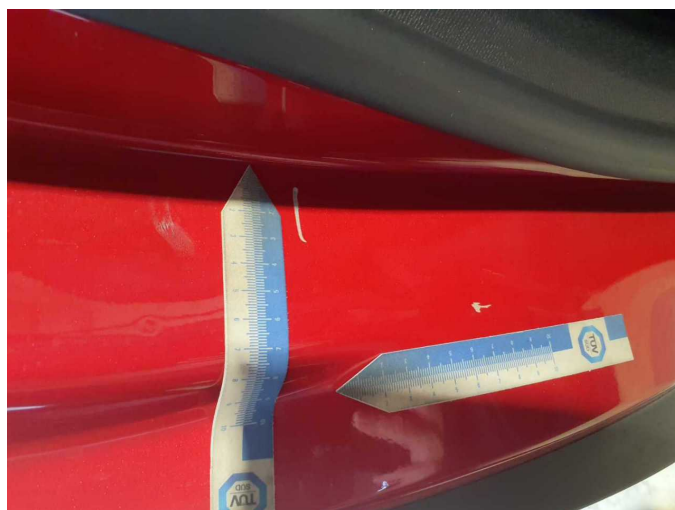
**Damage 3:** Side panel - rear right side: Sill - Dent / paintcoat damage - Smart repair

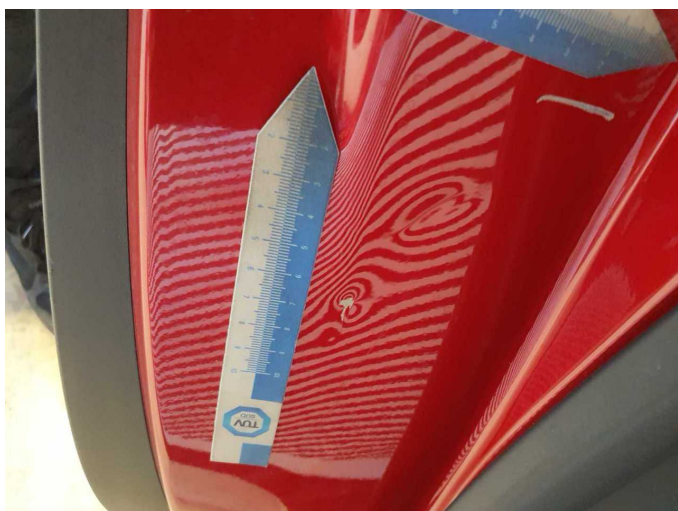
**Damage 3:** Side panel - rear right side: Sill - Dent / paintcoat damage - Smart repair

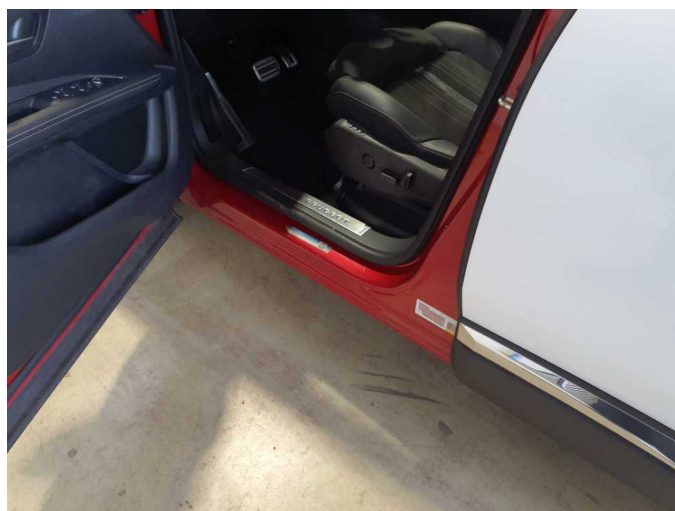
| No. | Component group | Description |
|---|---|---|
| 4 | Sill - left side | Sill - Scratch(es) - Smart repair |

**Damage 4:** Sill - left side: Sill - Scratch(es) - Smart repair

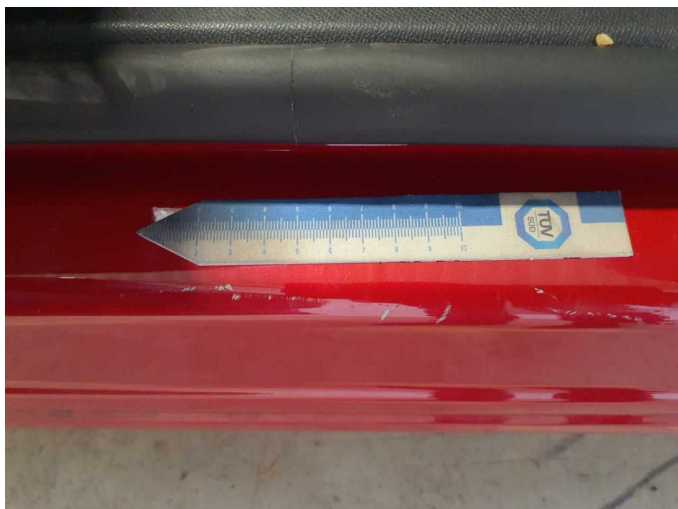
**Damage 4:** Sill - left side: Sill - Scratch(es) - Smart repair

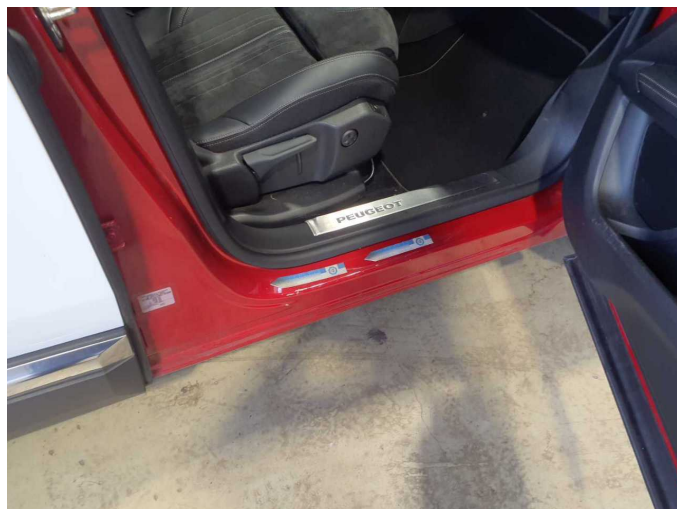
| No. | Component group | Description |
|---|---|---|
| 6 | Sill - right side | Sill - Scratch(es) - Paint |

**Damage 6:** Sill - right side: Sill - Scratch(es) - Paint

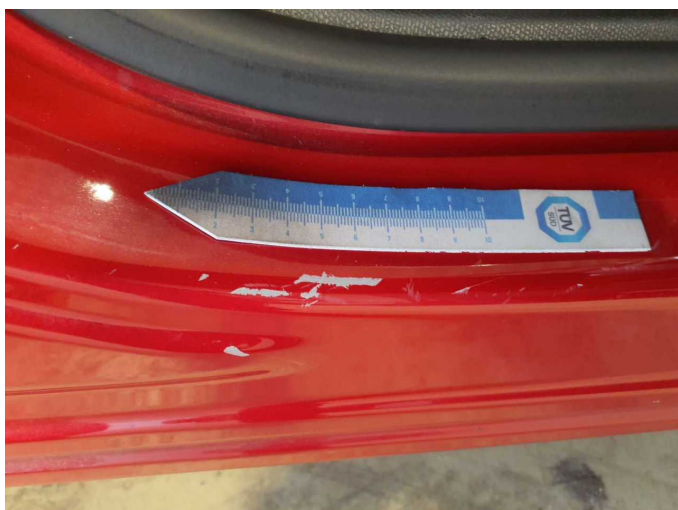
**Damage 6:** Sill - right side: Sill - Scratch(es) - Paint

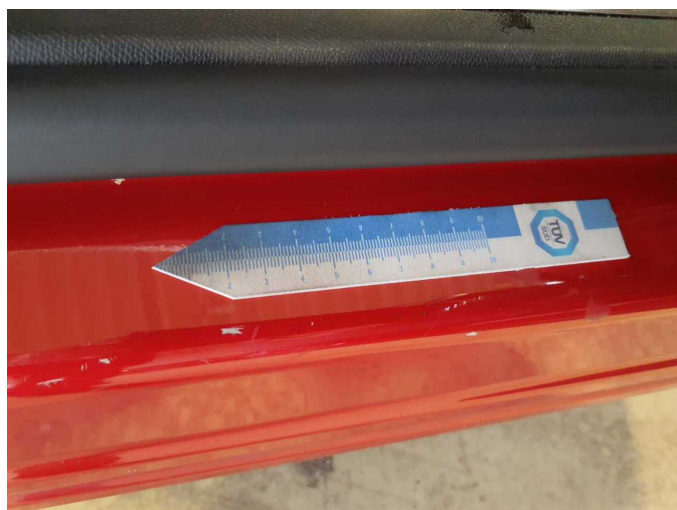
**Damage 6:** Sill - right side: Sill - Scratch(es) - Paint

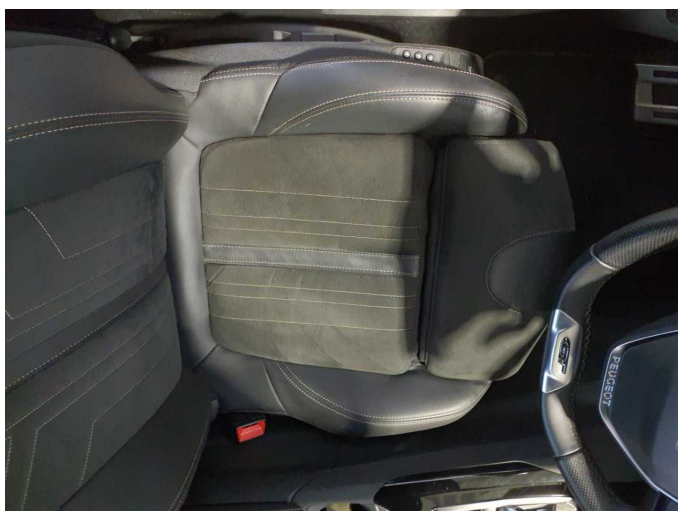
| No. | Component group | Description |
|---|---|---|
| 7 | Seat - front | Seat cover - left side - Scratch(es) - Replace |

**Damage 7:** Seat - front: Seat cover - left side - Scratch(es) - Replace

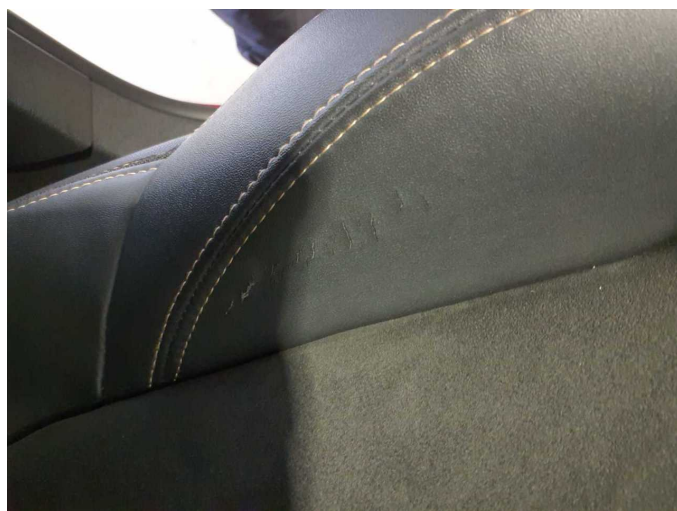
**Damage 7:** Seat - front: Seat cover - left side - Scratch(es) - Replace

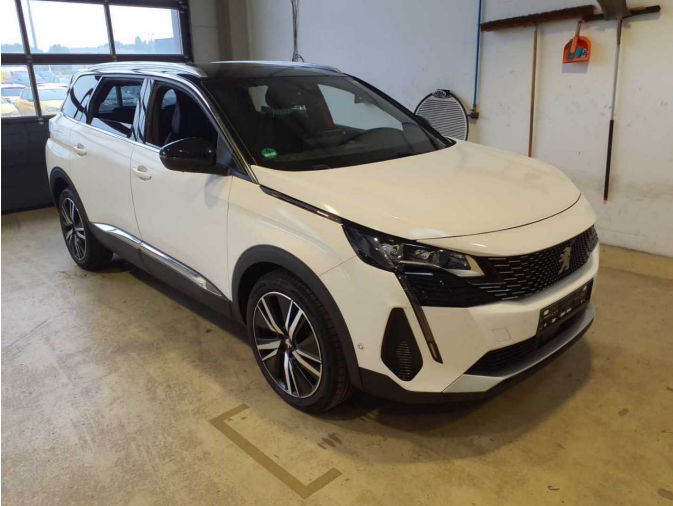
| No. | Component group | Description |
|---|---|---|
| 5 | Body | Body (Lt. Ausstattung/Rechnung Vollfolierung) - Glued / labelled - No deduction |

**Wear and tear 5:** Body: Body (Lt. Ausstattung/Rechnung Vollfolierung) -  
Glued / labelled - No deduction

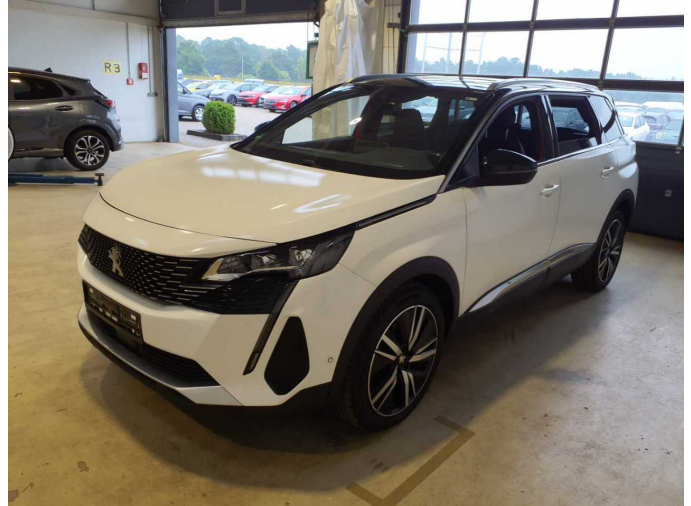
**Wear and tear 5:** Body: Body (Lt. Ausstattung/Rechnung Vollfolierung) -  
Glued / labelled - No deduction

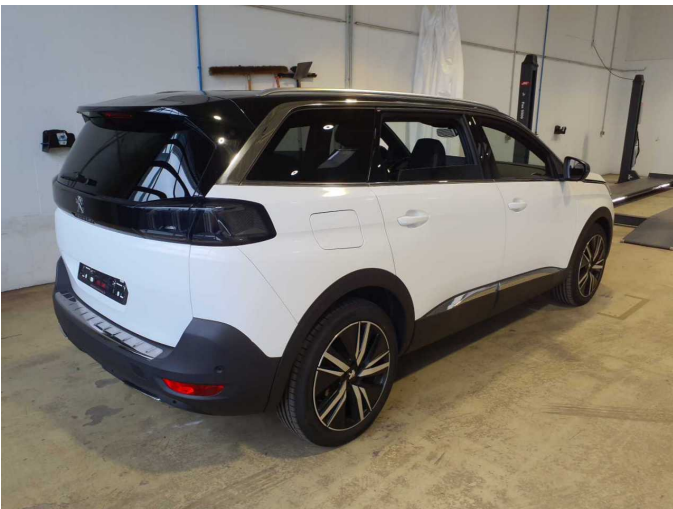
**Wear and tear 5:** Body: Body (Lt. Ausstattung/Rechnung Vollfolierung) -  
Glued / labelled - No deduction

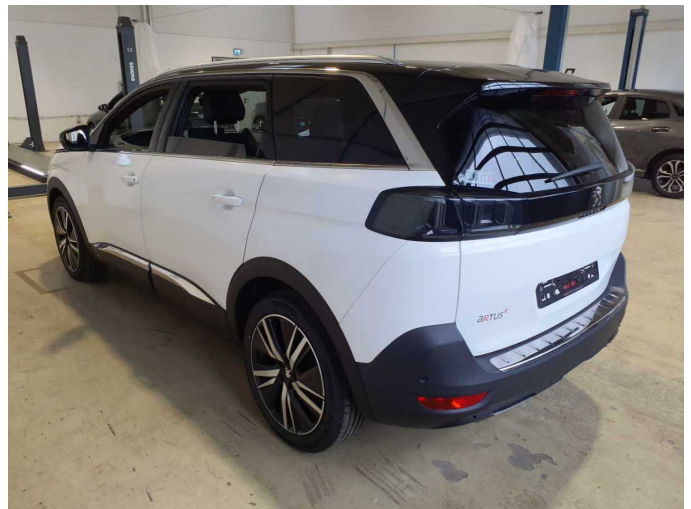
**Wear and tear 5:** Body: Body (Lt. Ausstattung/Rechnung Vollfolierung) -  
Glued / labelled - No deduction

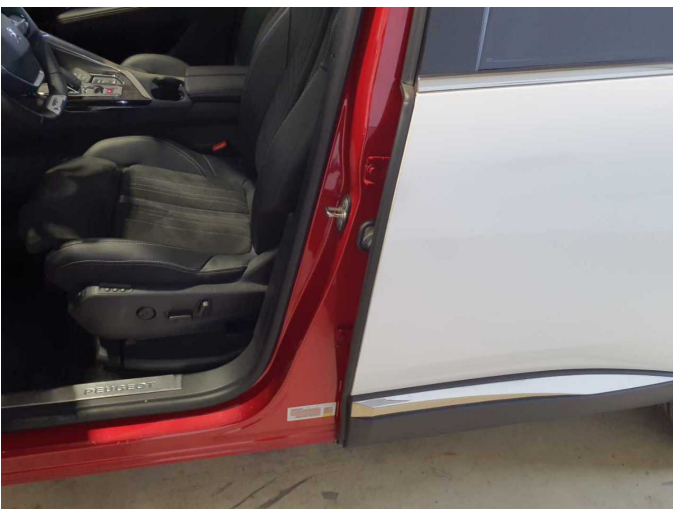
**Wear and tear 5:** Body: Body (Lt. Ausstattung/Rechnung Vollfolierung) -  
Glued / labelled - No deduction

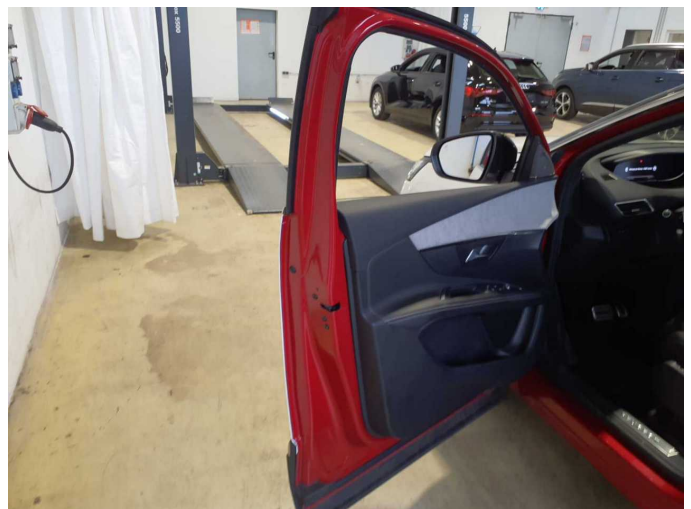
**Wear and tear 5:** Body: Body (Lt. Ausstattung/Rechnung Vollfolierung) -  
Glued / labelled - No deduction

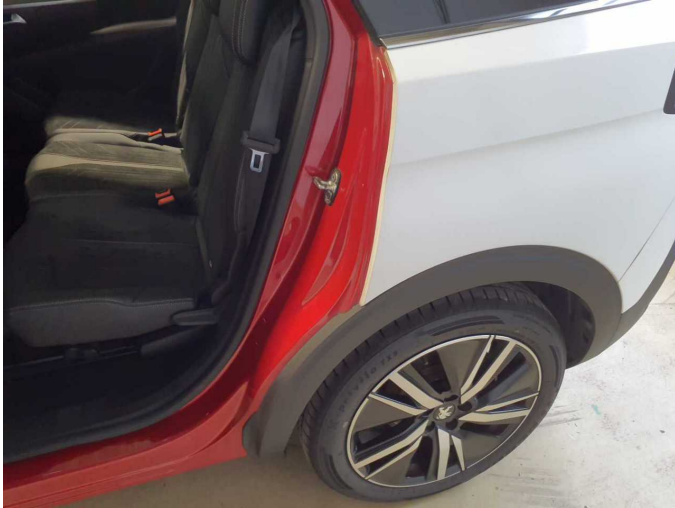
**Wear and tear 5:** Body: Body (Lt. Ausstattung/Rechnung Vollfolierung) -  
Glued / labelled - No deduction

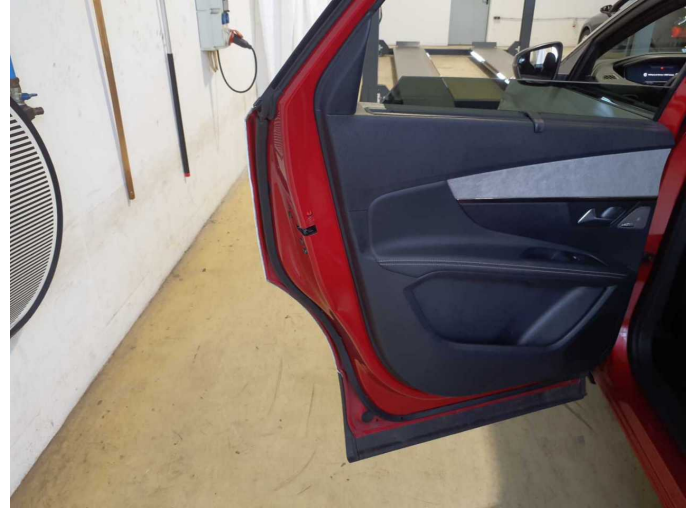
**Wear and tear 5:** Body: Body (Lt. Ausstattung/Rechnung Vollfolierung) -  
Glued / labelled - No deduction
