Expertise

Protocol number: 45759379
Order No. / Reference: 26479613
Inspection date: 3 Jun 2026

Manufacturer: Peugeot

Model: 5008 BlueHDi 180 EAT8 GT Pack

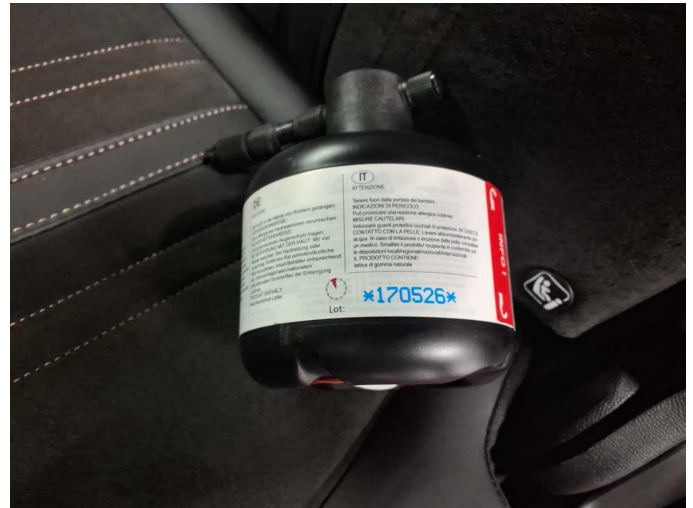
Damage 1: Equipment: Tirefit filler - Expired - Replace

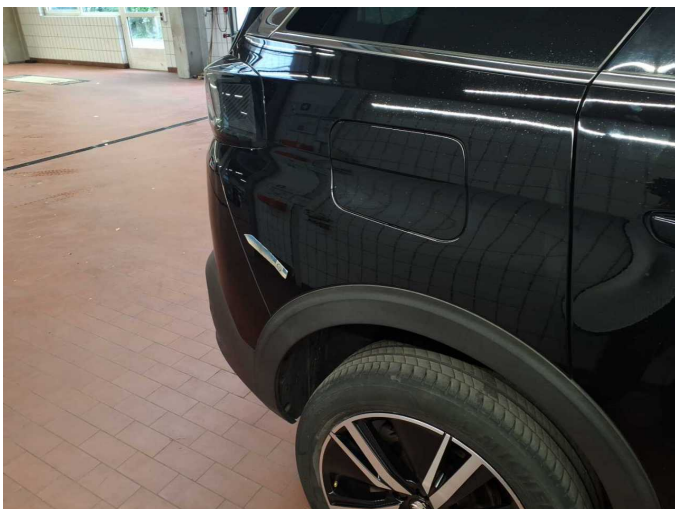
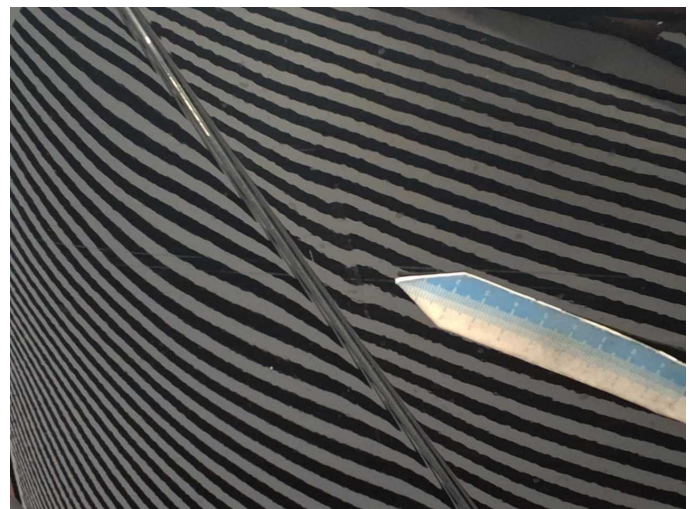
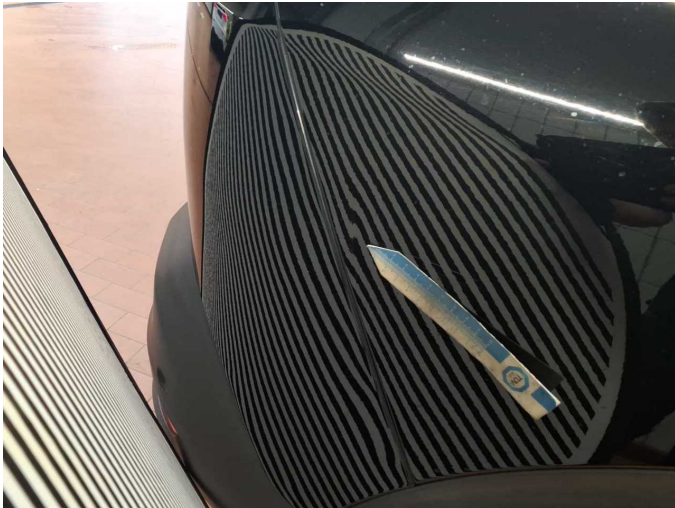
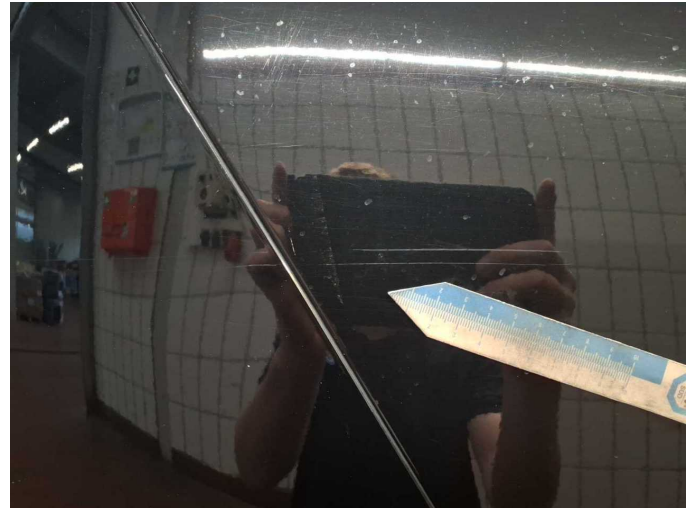
Damage 2: Side panel - rear right side: Side panel - dent(s) - Smooth repair work

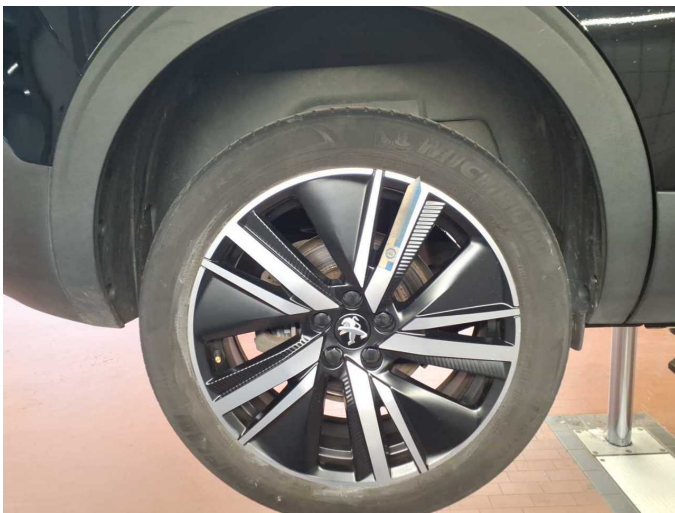
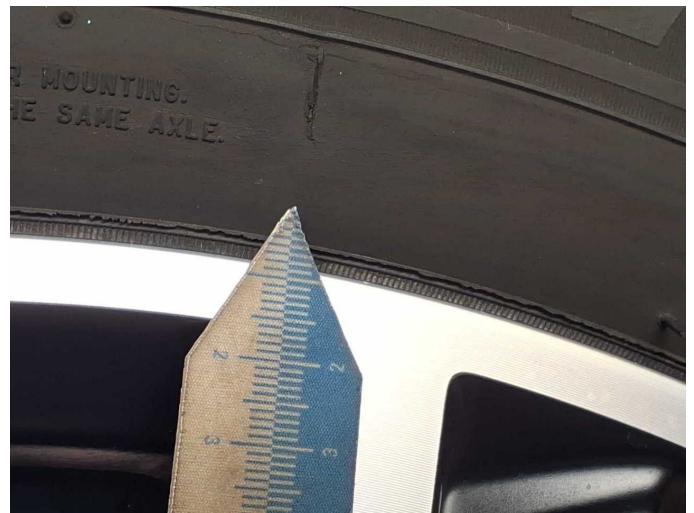
Damage 3: Wheel / tyres: Tyre - rear right side - Broken / torn - Replace

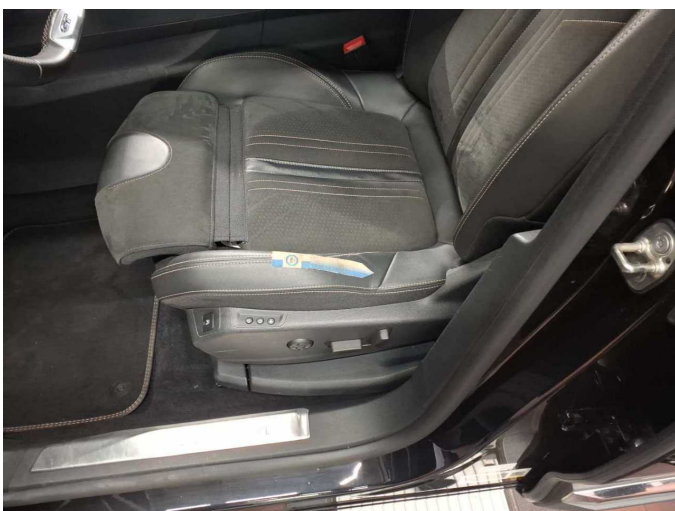
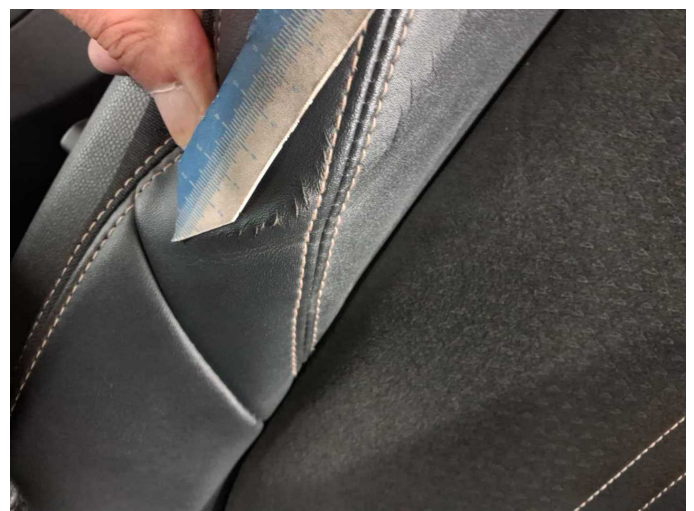
Damage 4: Seat - front: Seat cover - left side - Porous / cracked - Smart repair

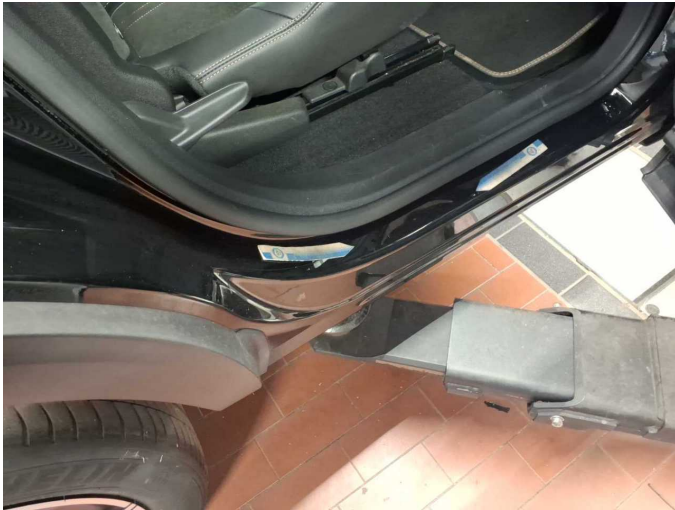
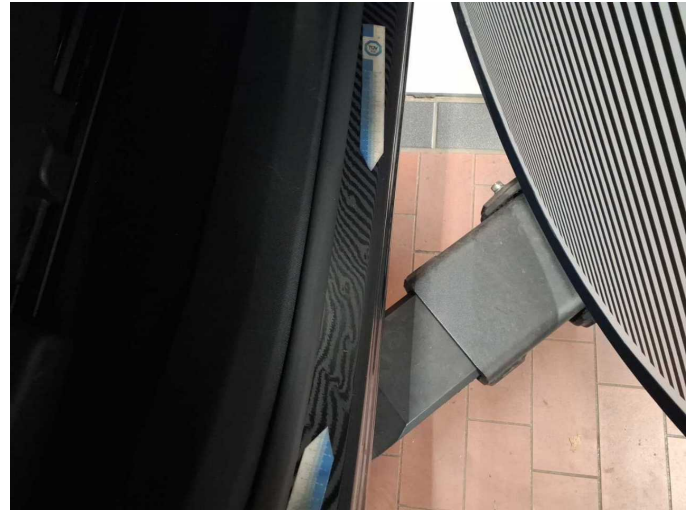
Damage 5: Side panel - rear right side: Sill - dent(s) - Smooth repair work

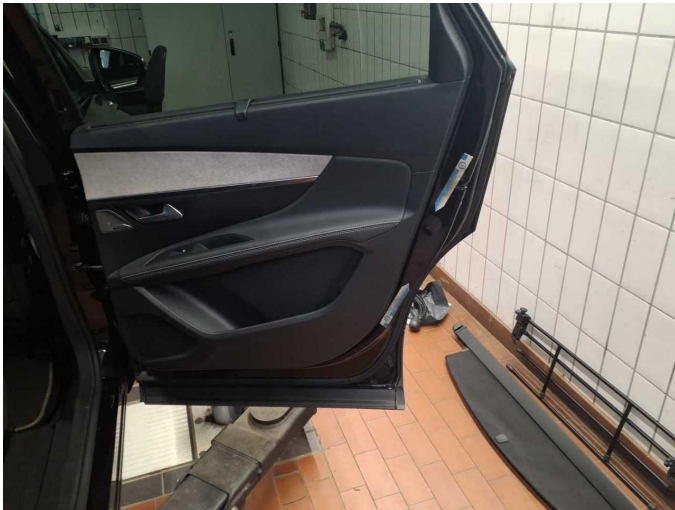
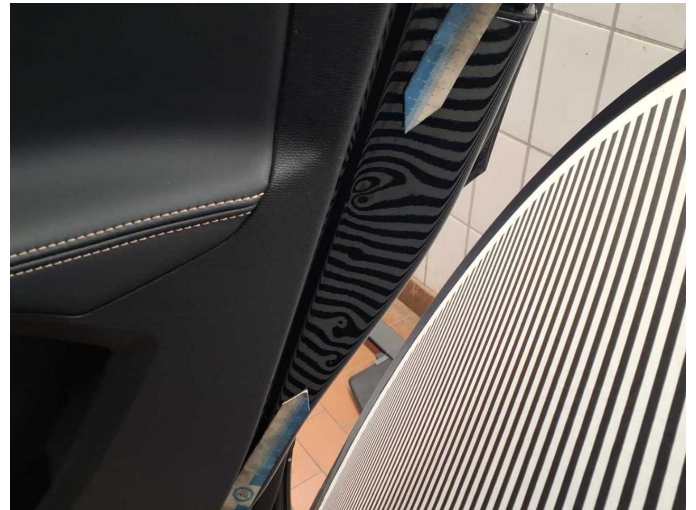
Damage 6: Door - rear right side: Door - dent(s) - Smooth repair work

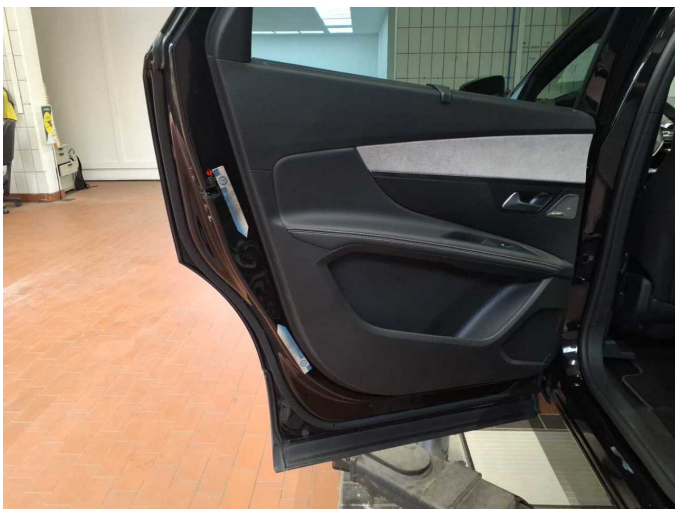
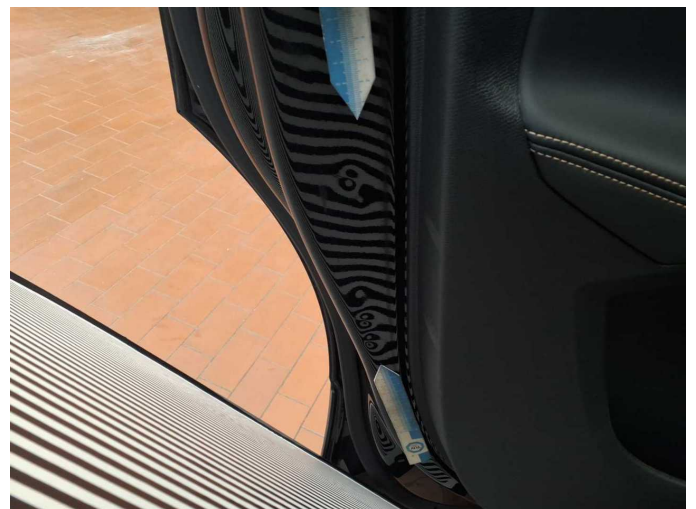
Damage 7: Door - rear left side: Door - dent(s) - Smooth repair work

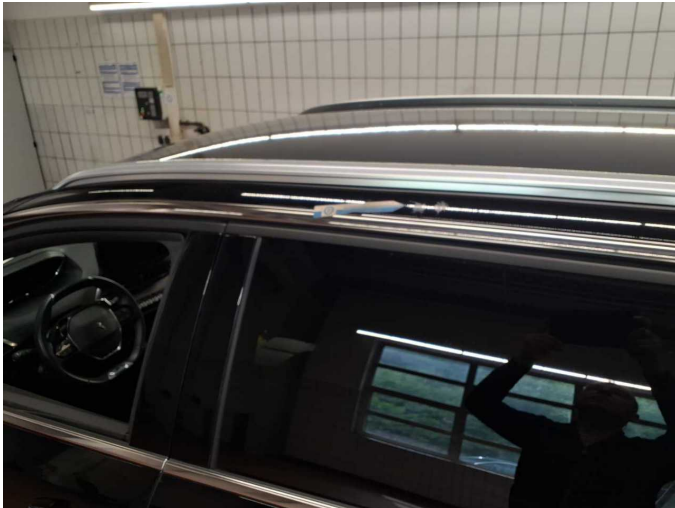
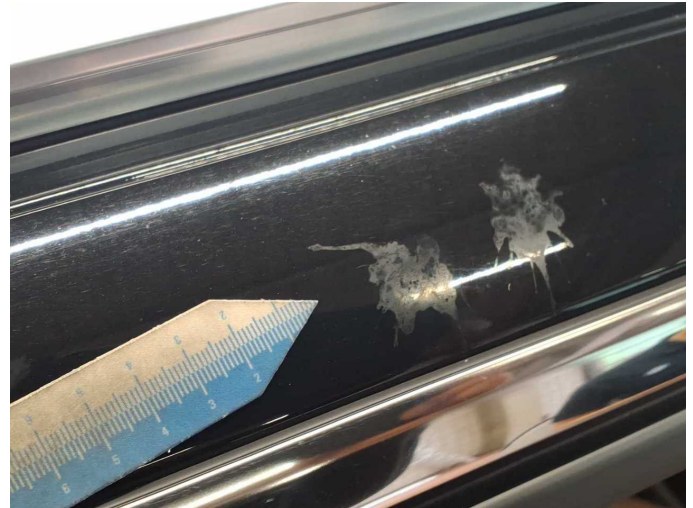
Damage 8: Roof: Roof rail - left side (Verätzungen) - Paint defect - Paint

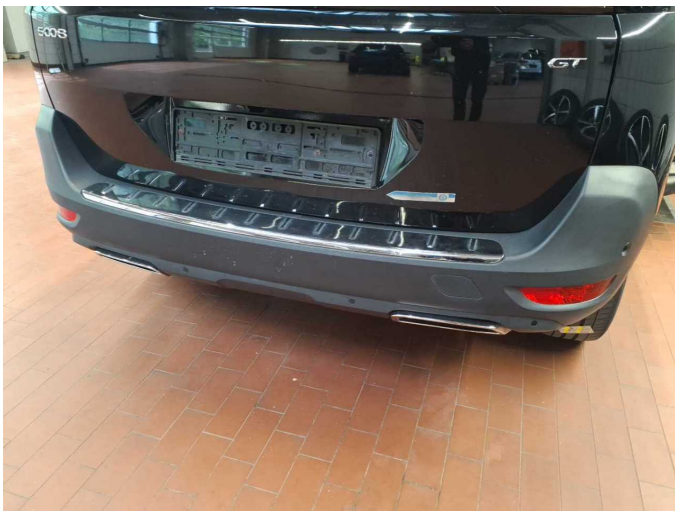
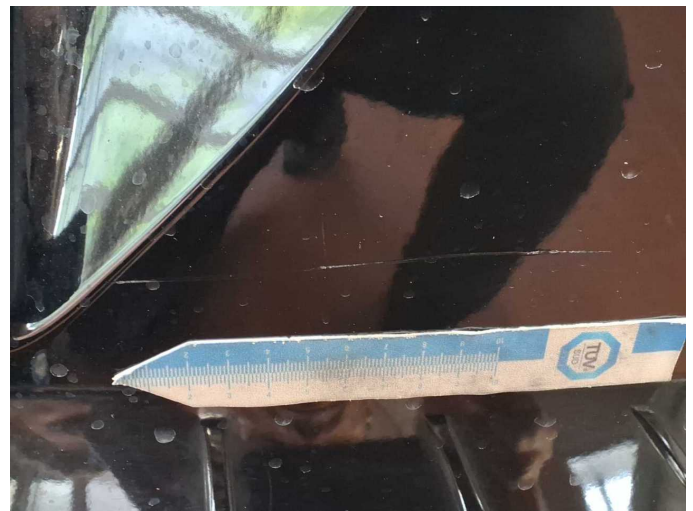
Damage 9: Boot lid / rear door: Boot lid - Scratch(es) - Paint

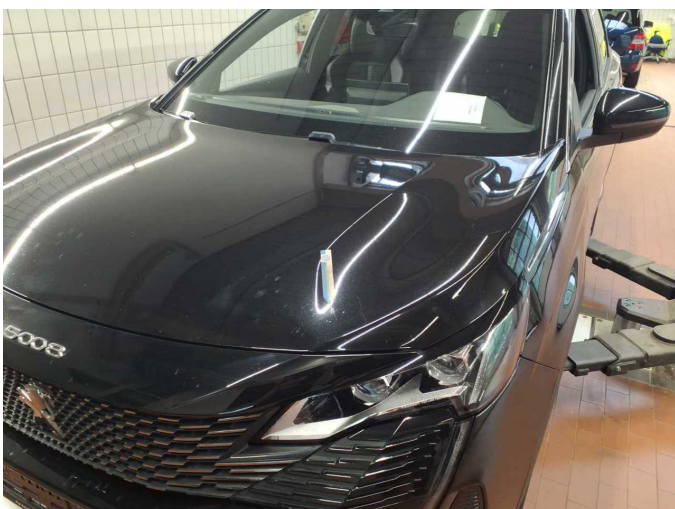
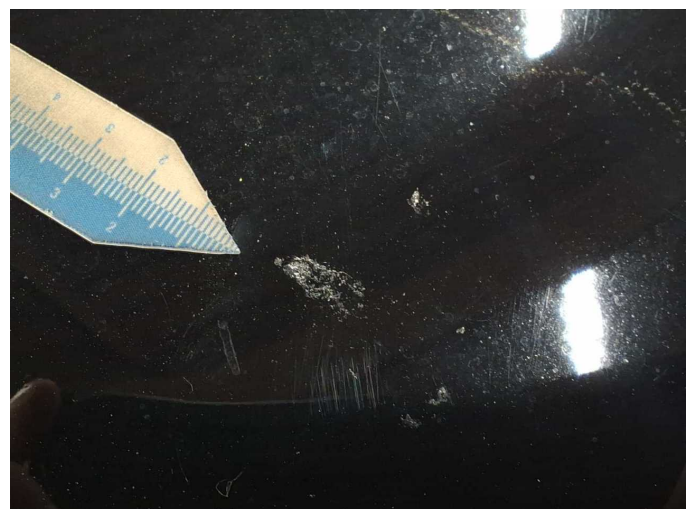
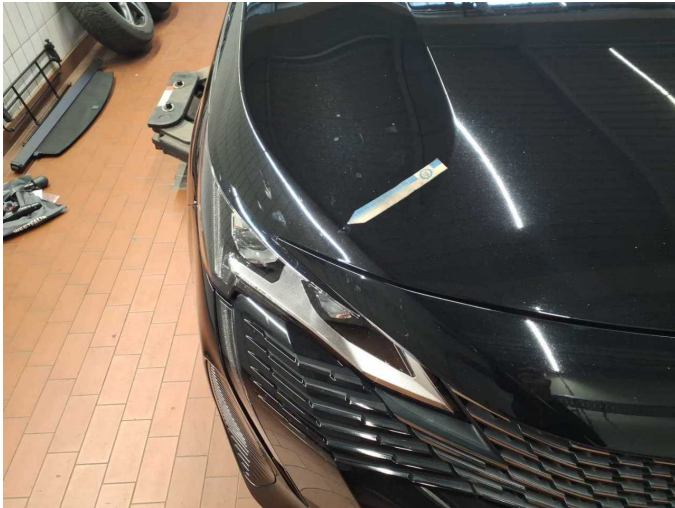
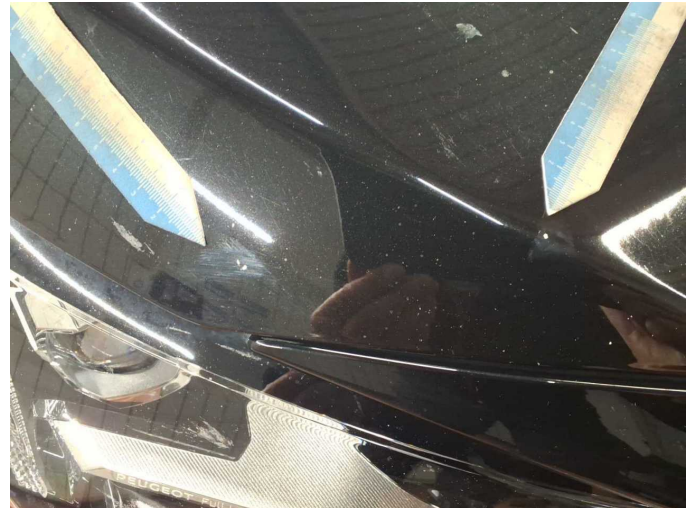
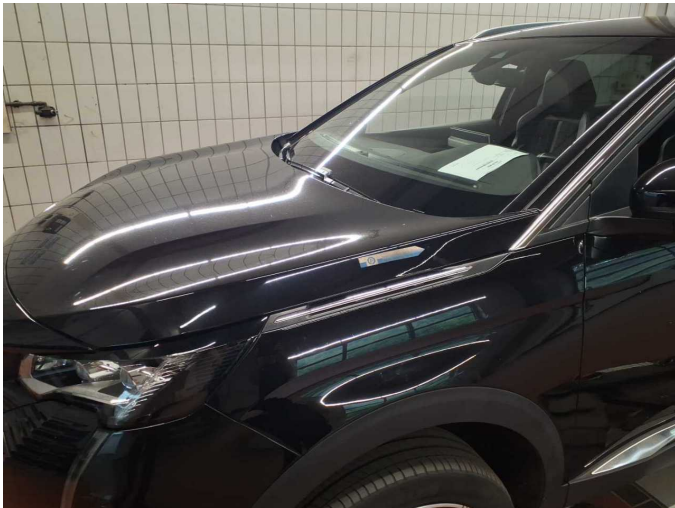
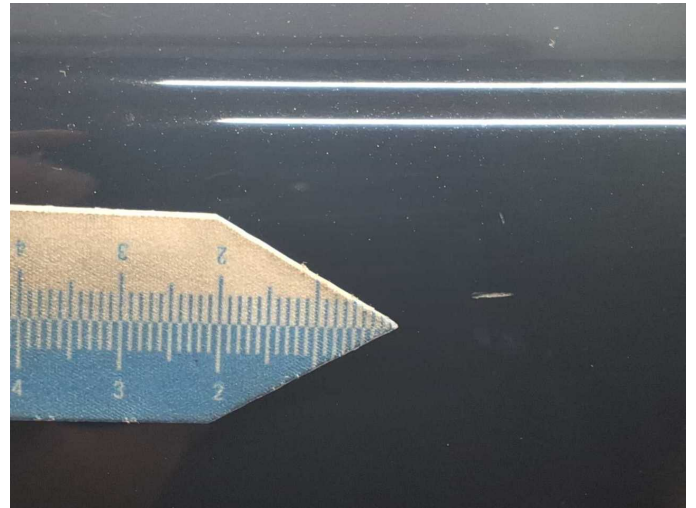
Damage 10: Bonnet: Bonnet (Verätzung, + Steinschläge) - Paint defect - Paint

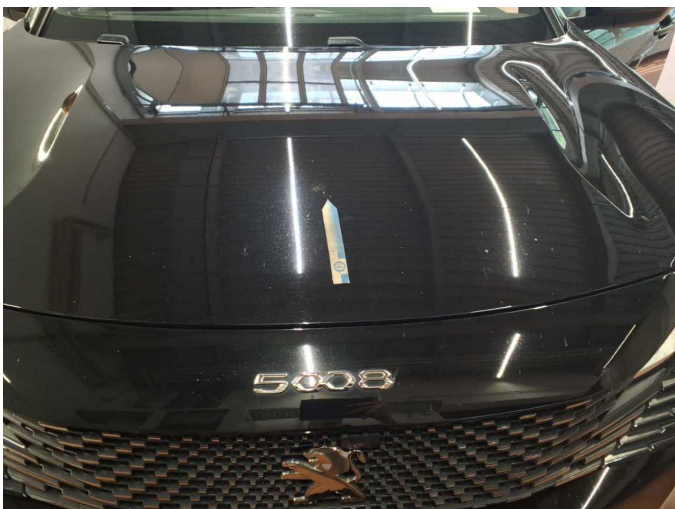
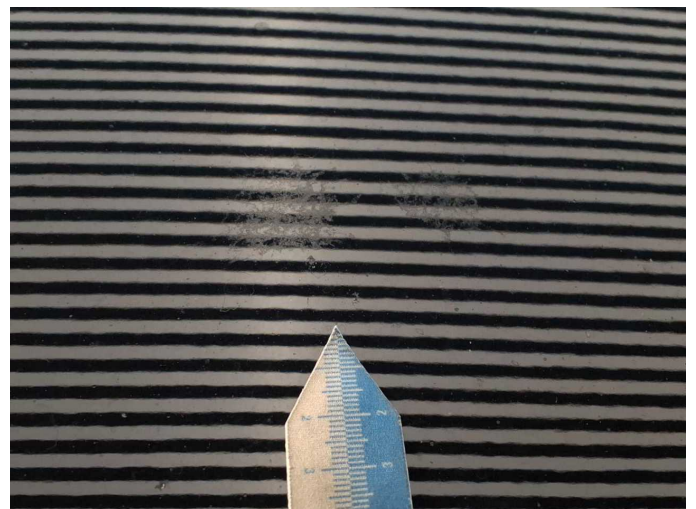
Damage 10: Bonnet: Bonnet (Verätzung, + Steinschläge) - Paint defect - Paint

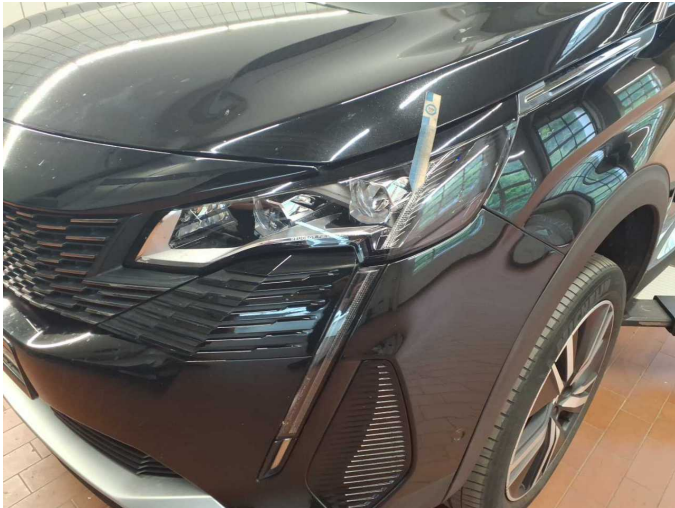
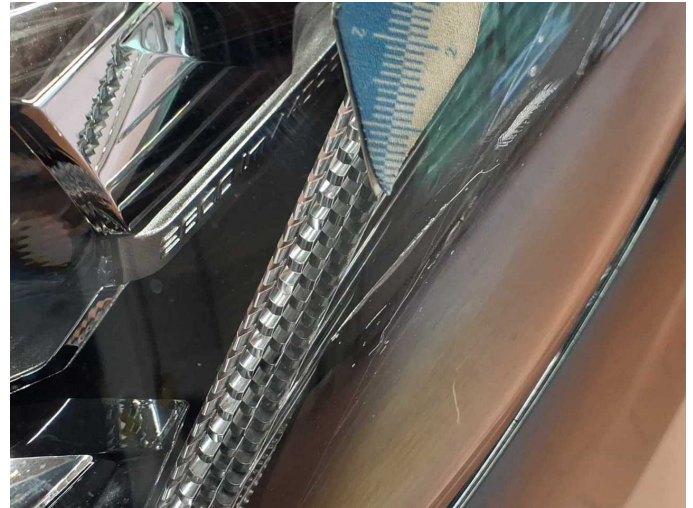
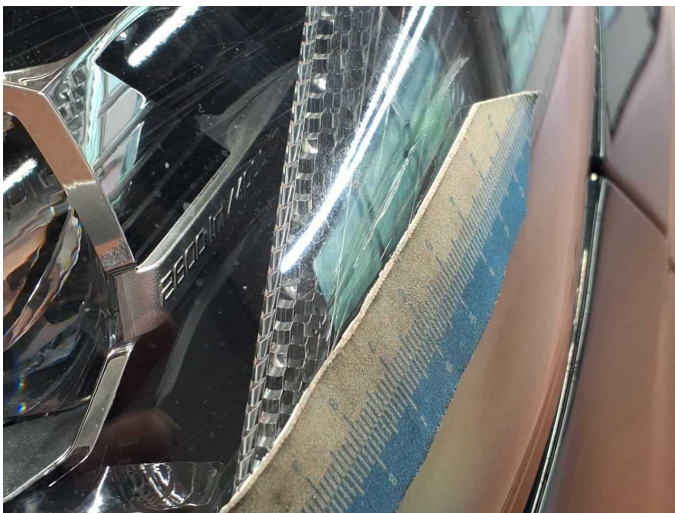
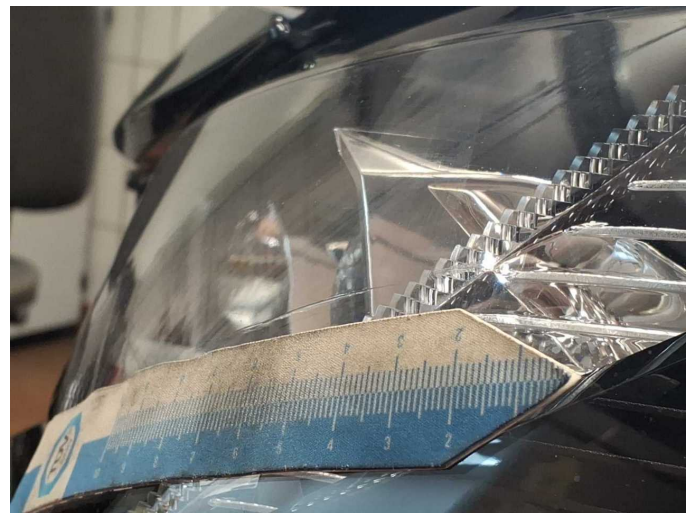
Damage 11: Headlight: Headlight - left side - Broken / torn - Replace

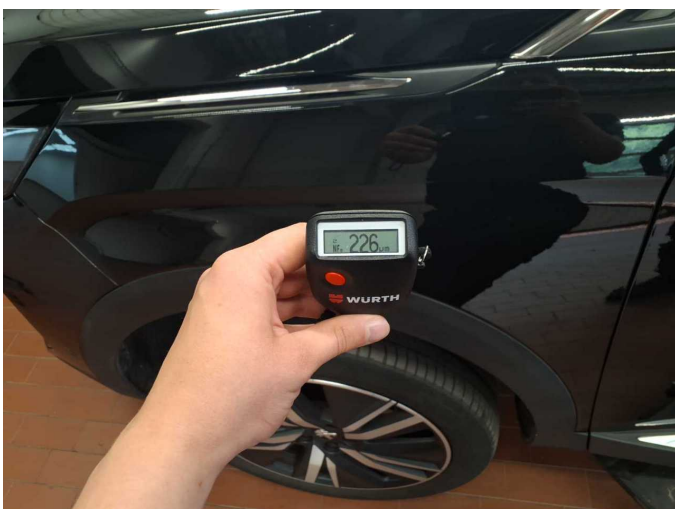
Repainting 1: Mudguard - left side

- 1 Mudguard - left side, Professionally carried out, Invoice of repair done Non-existent
- 2 Door - front left side, Professionally carried out, Invoice of repair done Non-existent

Mudguard - left side	226 µm	Door - front left side	162 µm
----------------------	--------	------------------------	--------
