Expertise

Protocol number: 46811409  
Order No. / Reference: 26746485  
Inspection date: 30 Jul 2026

Manufacturer: Skoda  
VIN: TMBJH7NP4N7041483

Model: Superb Combi 2.0 TDI DSG Ambition

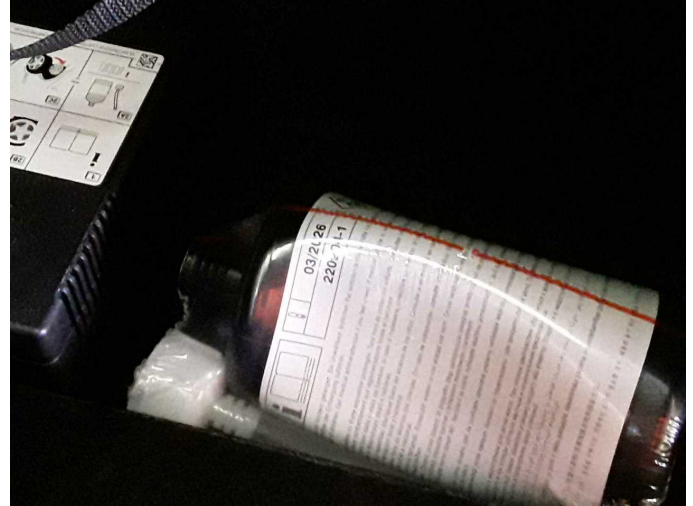
| No. | Component group | Description |
|---|---|---|
| 1 | Equipment | Tirefit filler - Expired - Replace |

**Damage 1:** Equipment: Tirefit filler - Expired - Replace

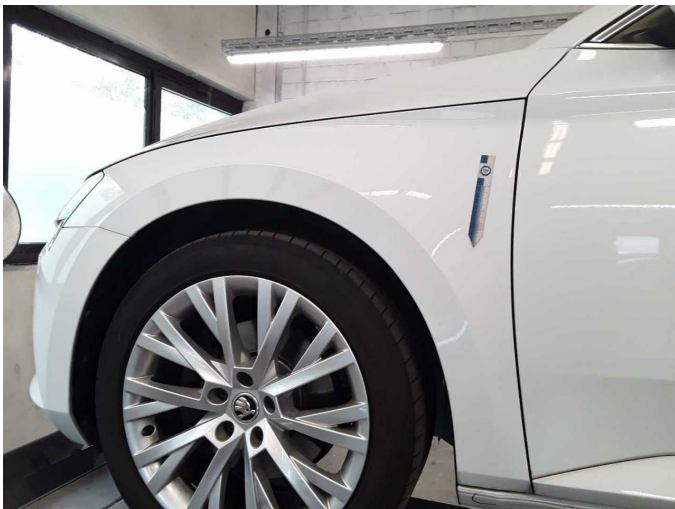
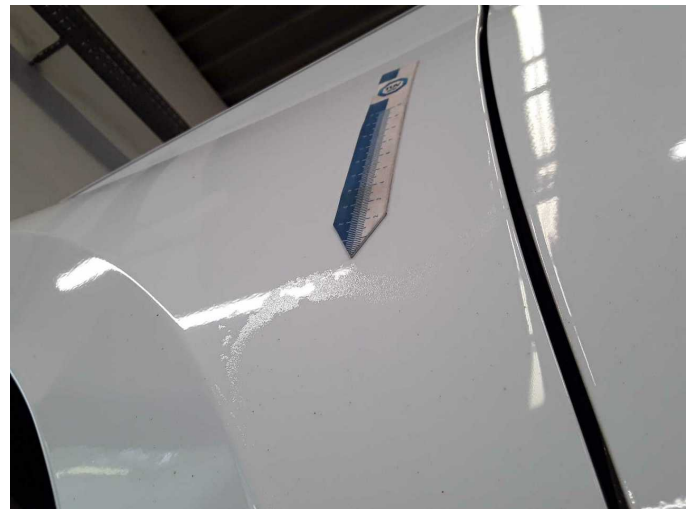
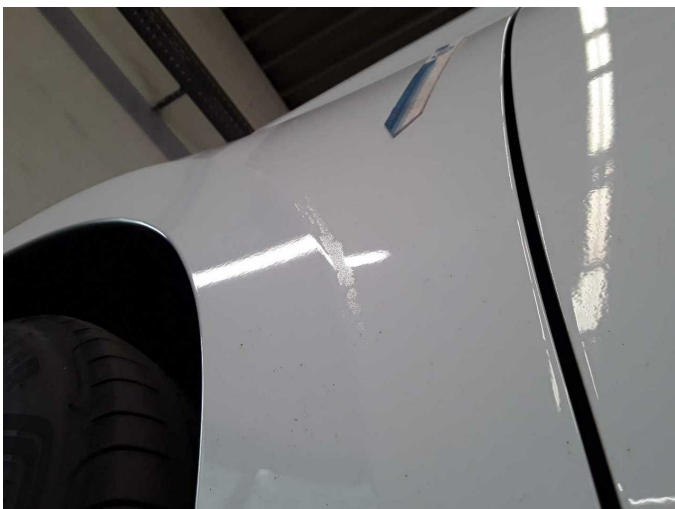
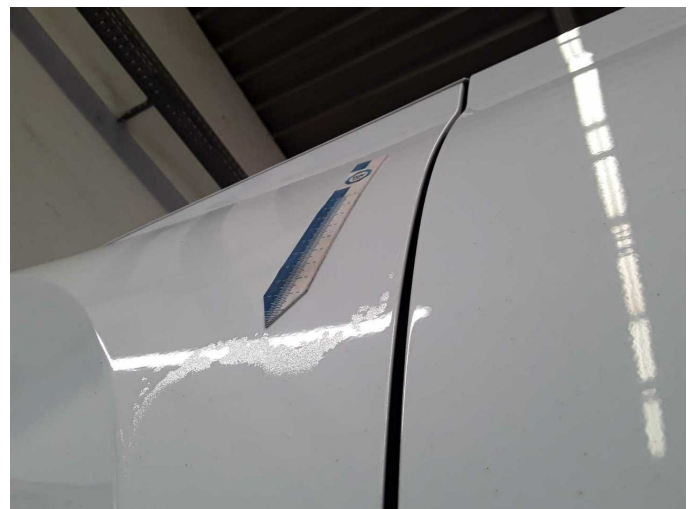
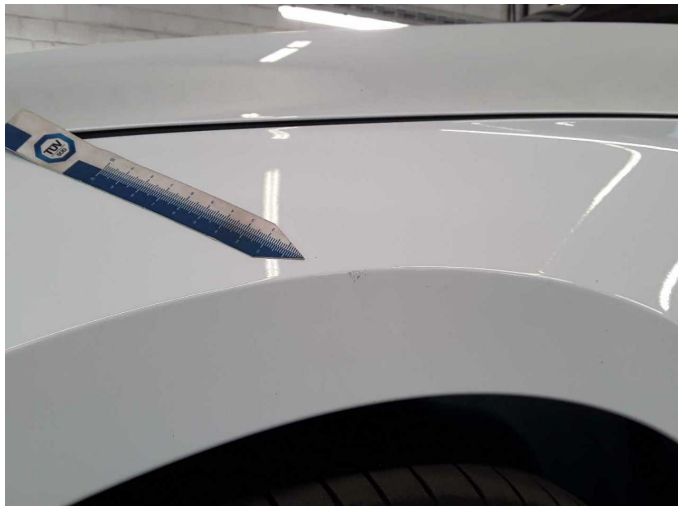
| No. | Component group | Description |
|---|---|---|
| 2 | Mudguard - left side | Mudguard - left side (Schleifspuren) - Unprofessionally repaired - Paint |

| Mudguard - left side | 146 µm | Door - front left side | 153 µm |

**Damage 2:** Mudguard - left side: Mudguard - left side (Schleifspuren) - Unprofessionally repaired - Paint

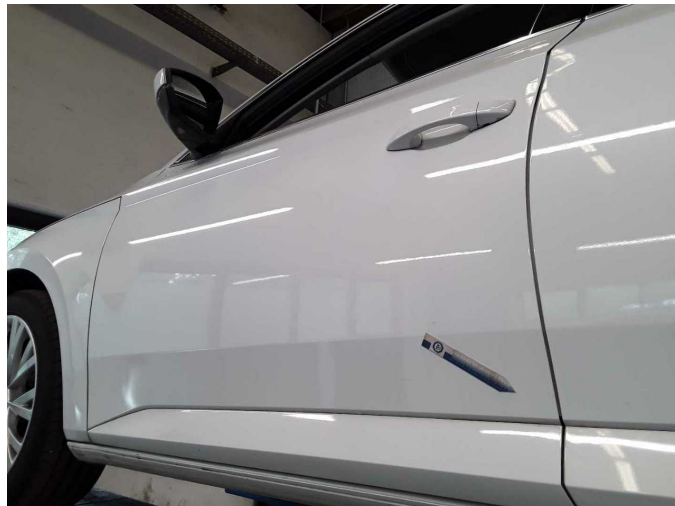
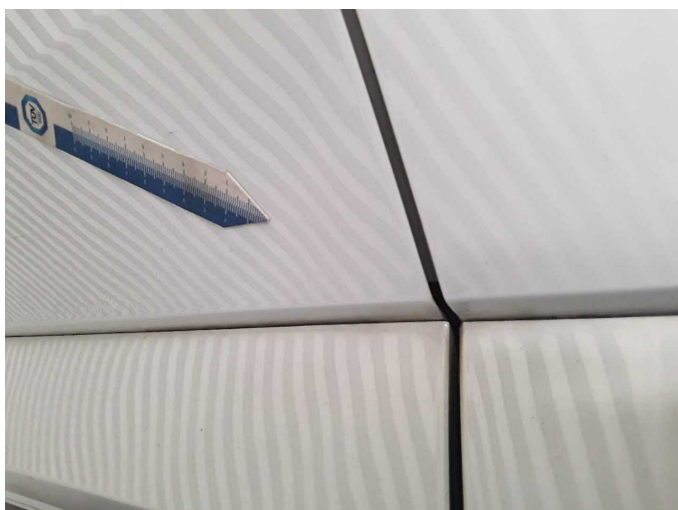
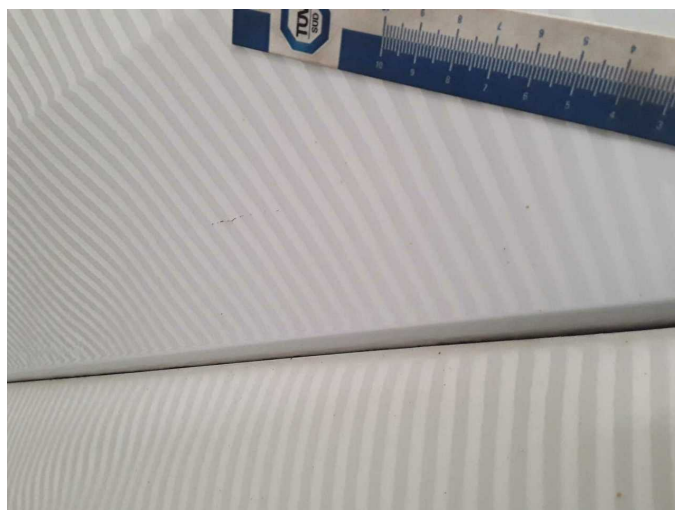
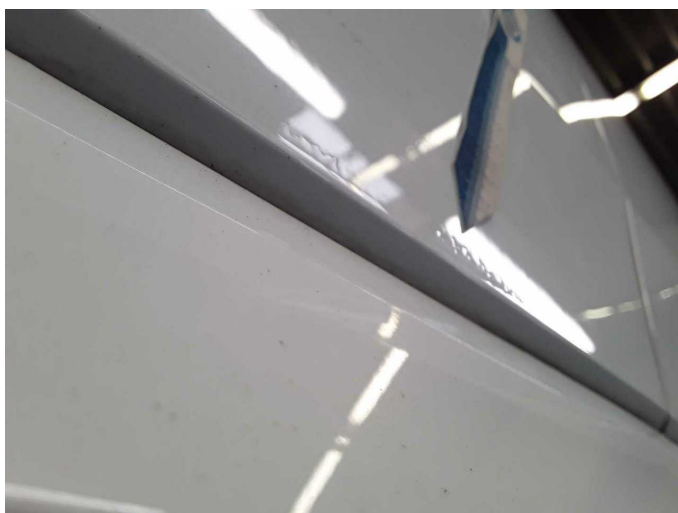
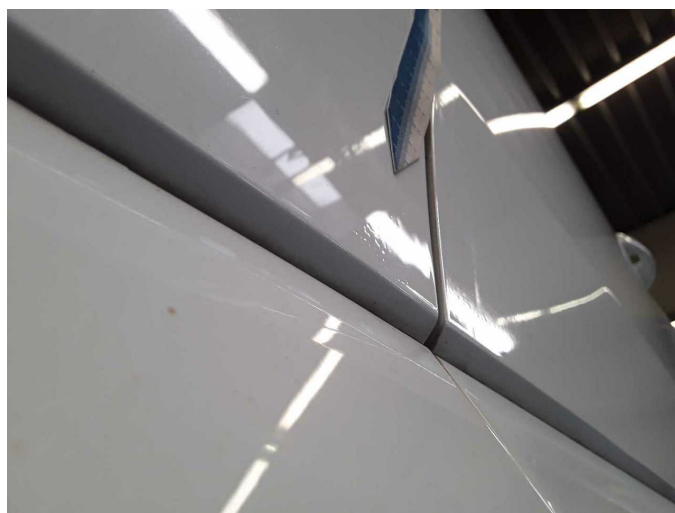
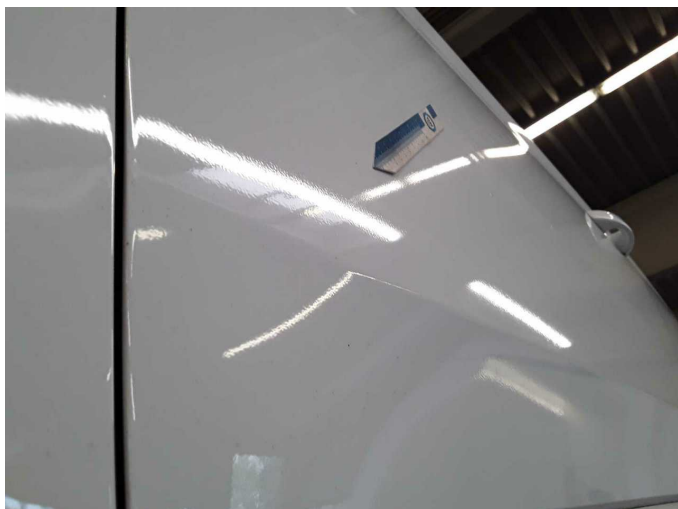
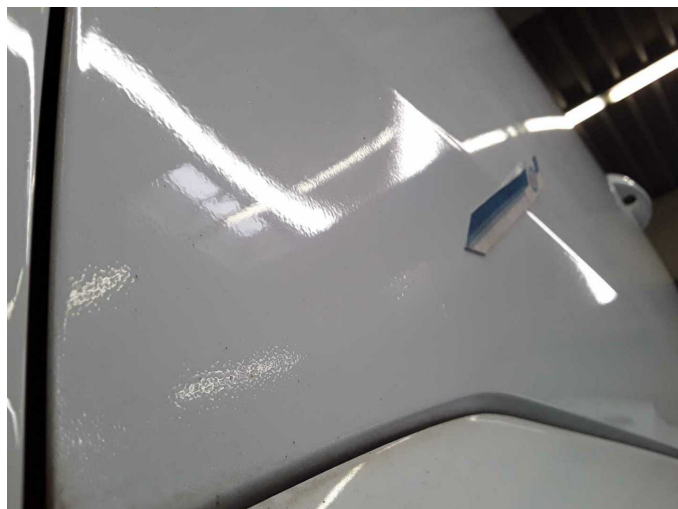
| No. | Component group | Description |
|---|---|---|
| 3 | Door - front left side | Door (Orangenhaut + Silikon Einschlüsse) - Unprofessionally repaired - Paint |

**Damage 3:** Door - front left side: Door (Orangenhaut + Silikon Einschlüsse) - Unprofessionally repaired - Paint

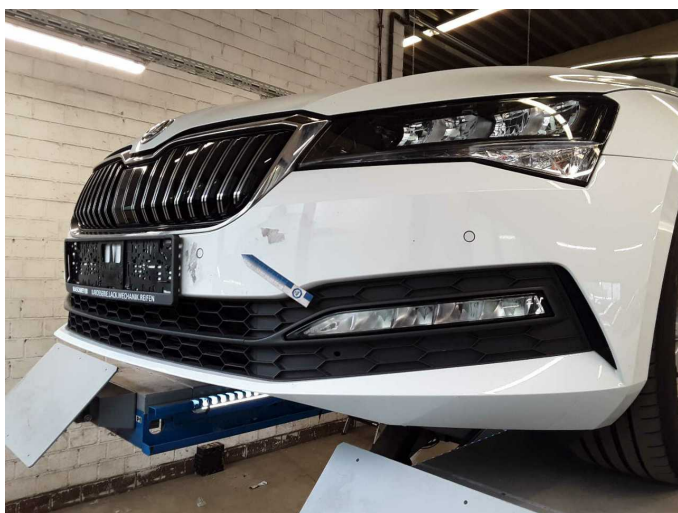
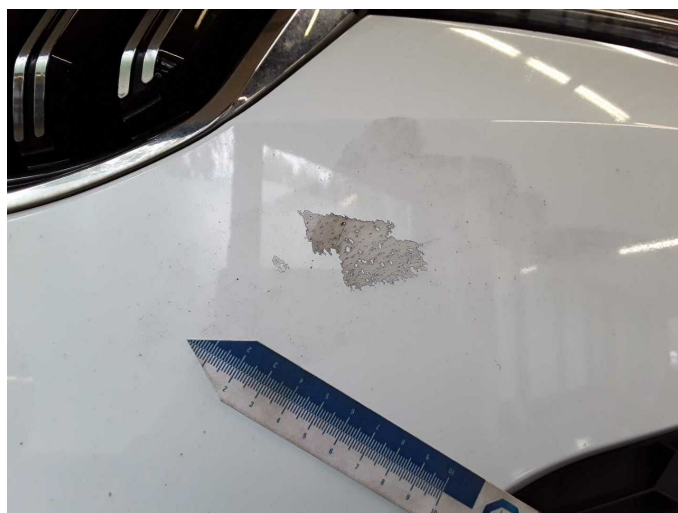
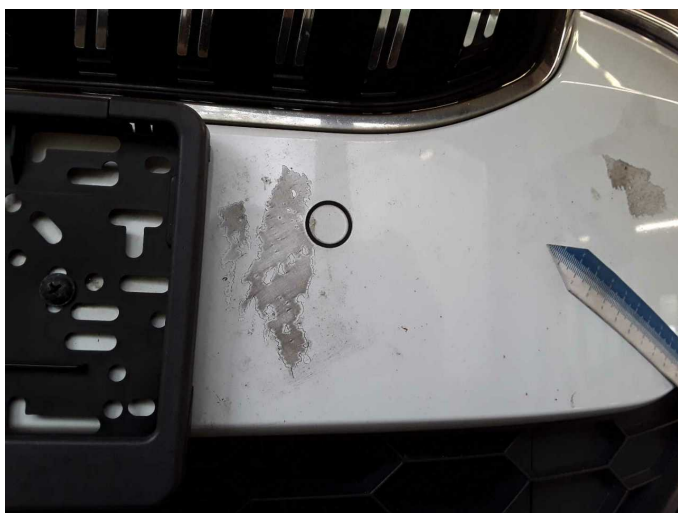
| No. | Component group | Description |
|---|---|---|
| 4 | Front bumper | Front bumper (Lackabplatzer) - Paint defect - Paint |

**Damage 4:** Front bumper: Front bumper (Lackabplatzer) - Paint defect - Paint

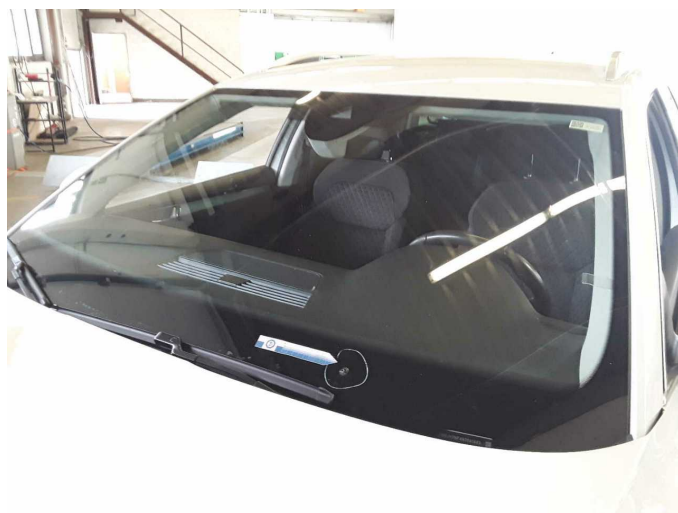
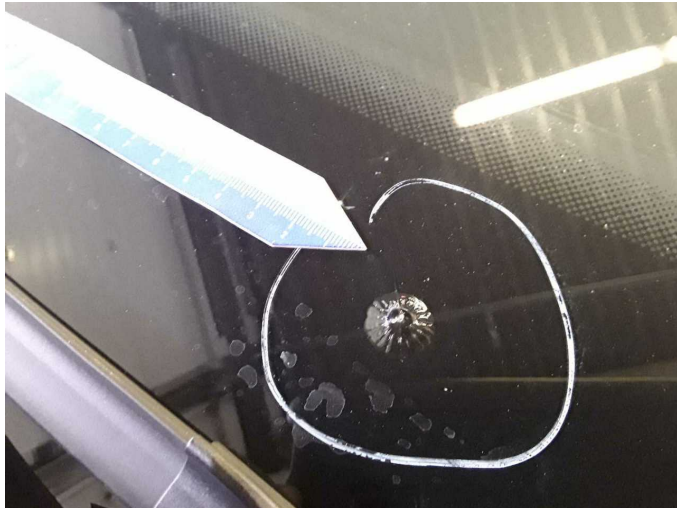
| No. | Component group | Description |
|---|---|---|
| 5 | Vehicle glazing | Windscreen - Broken / torn - repair according to calculation |

**Damage 5:** Vehicle glazing: Windscreen - Broken / torn - repair according to calculation

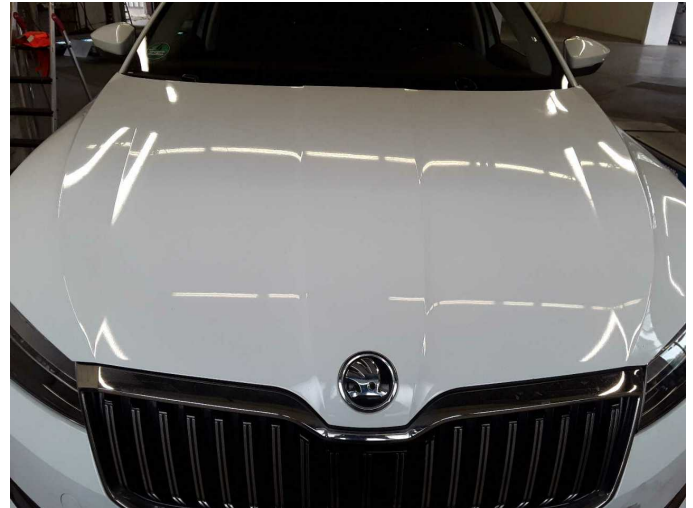
| No. | Component group | Description |
|---|---|---|
| 1 | Bonnet | Bonnet - Stone chips - No deduction |

**Wear and tear 1:** Bonnet: Bonnet - Stone chips - No deduction

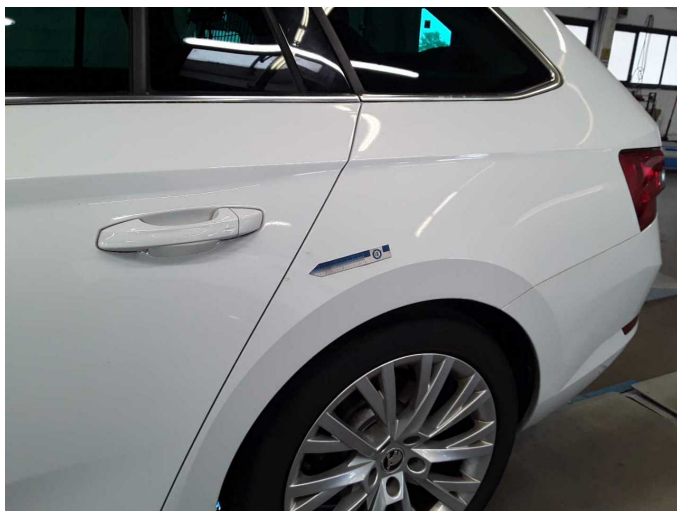
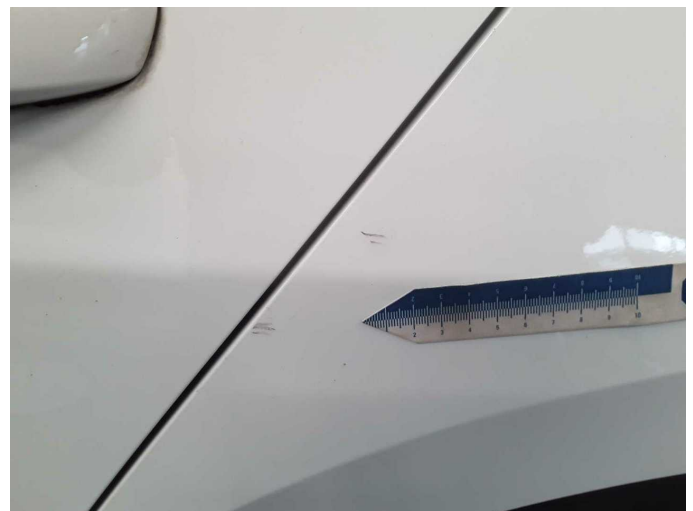
| No. | Component group | Description |
|---|---|---|
| 2 | Side panel - rear left side | Side panel - Soiled - No deduction |

**Wear and tear 2:** Side panel - rear left side: Side panel - Soiled - No deduction

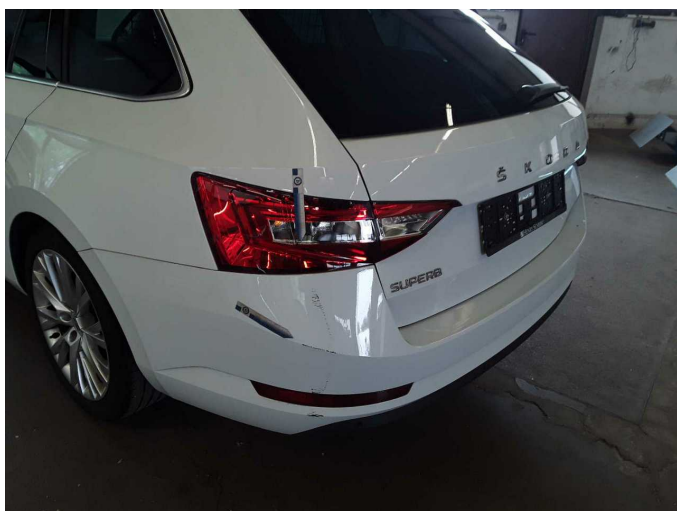
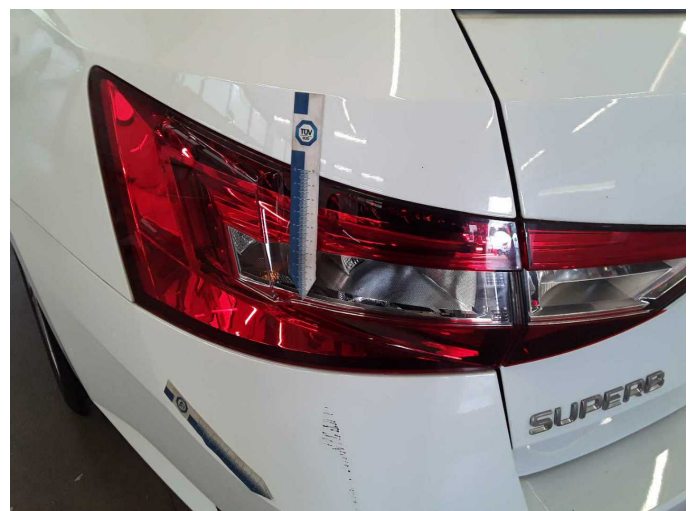
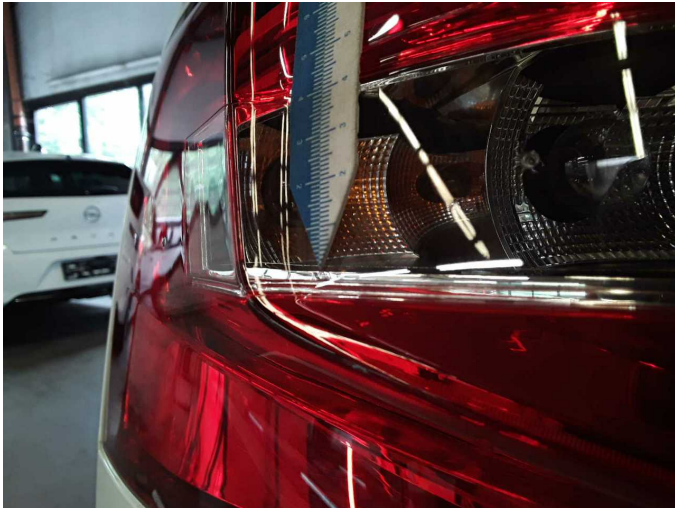
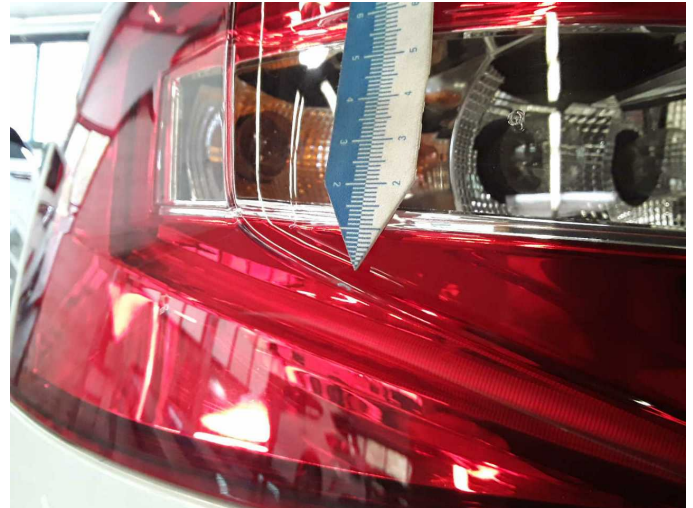
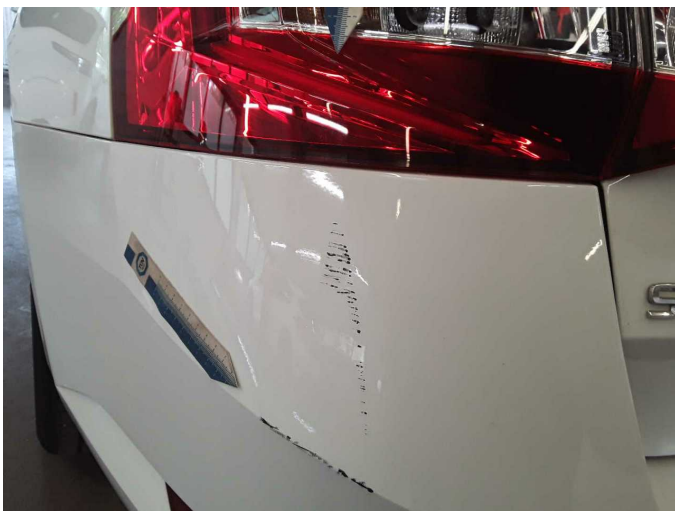
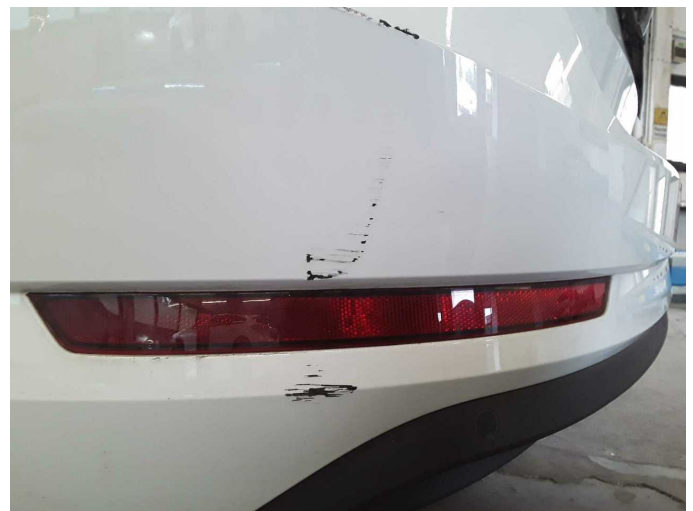
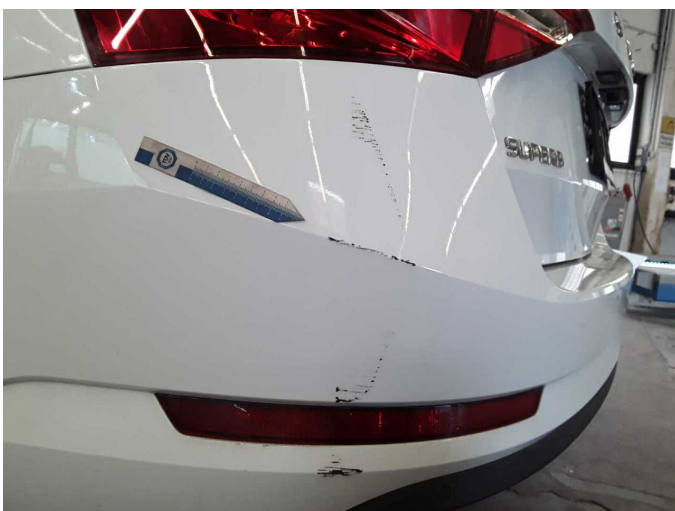
| No. | Accident |
|---|---|
| 1 | Rear |

**Accident 1:** Rear

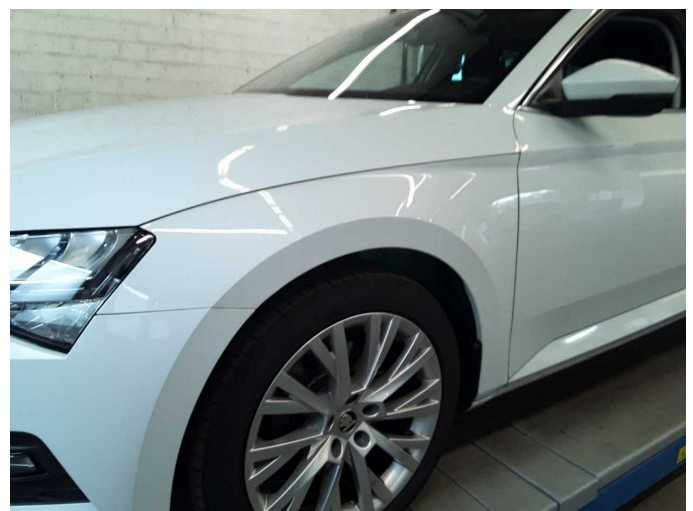
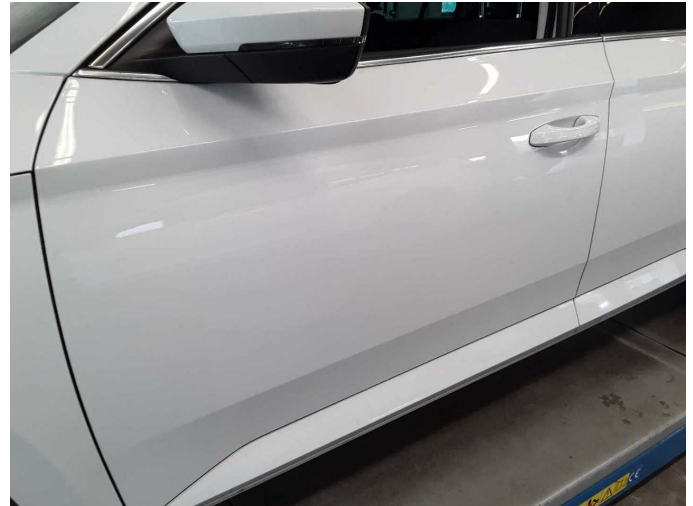
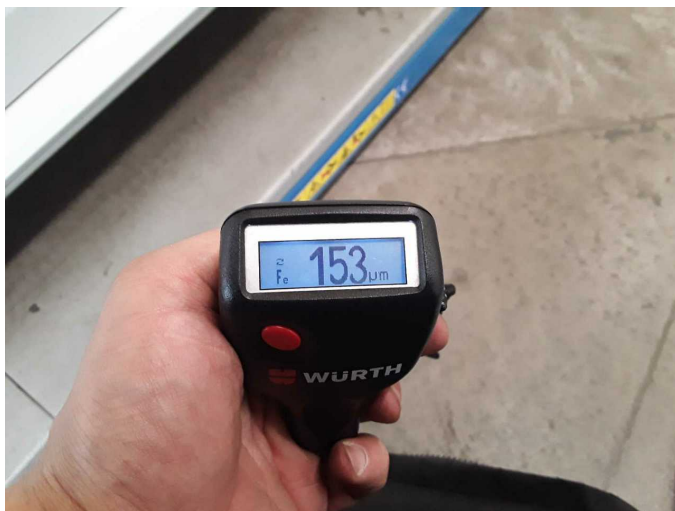
1 Mudguard - left side, Door - front left side, Unprofessionally carried out

**Repainting 1: Mudguard - left side, Door - front left side**
