## Expertise

Protocol number: 45386931  
Order No. / Reference: 26268680-2  
Inspection date: 8 May 2026

Manufacturer: Volvo

Model: XC90 T8 AWD Recharge Plus Bright

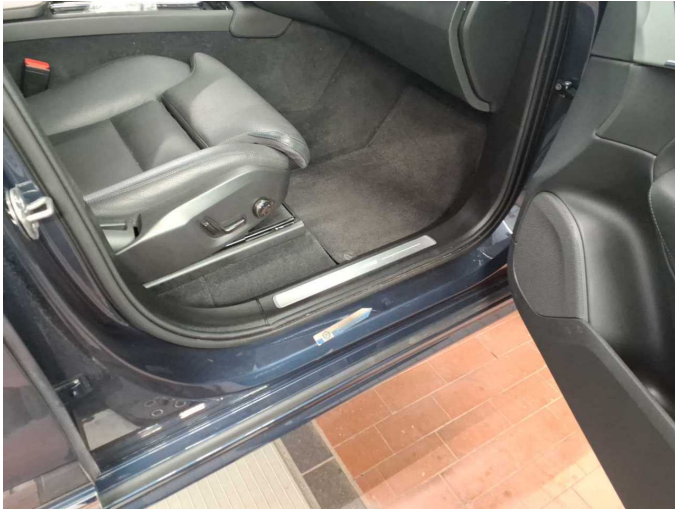
**Damage 1:** Sill - right side: Sill - dent(s) - Smart repair

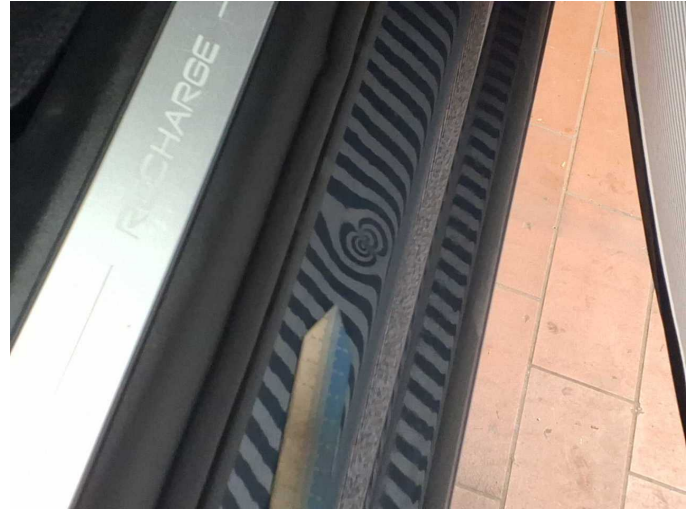
**Damage 1:** Sill - right side: Sill - dent(s) - Smart repair

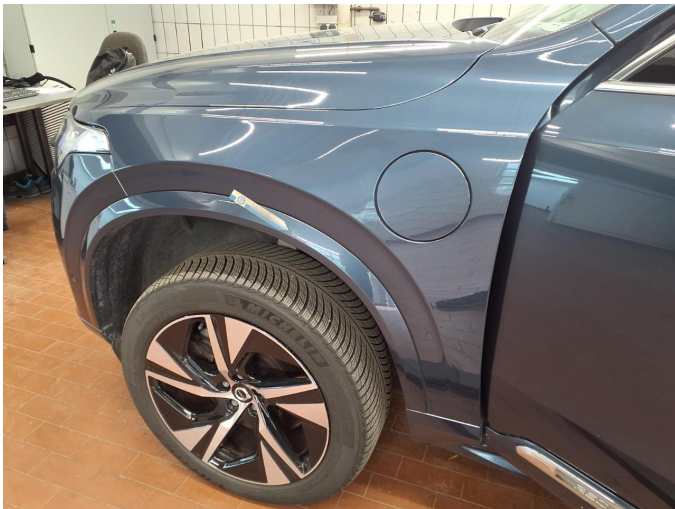
**Damage 2:** Mudguard - left side: Wheel well extension - Scratched - Smart repair

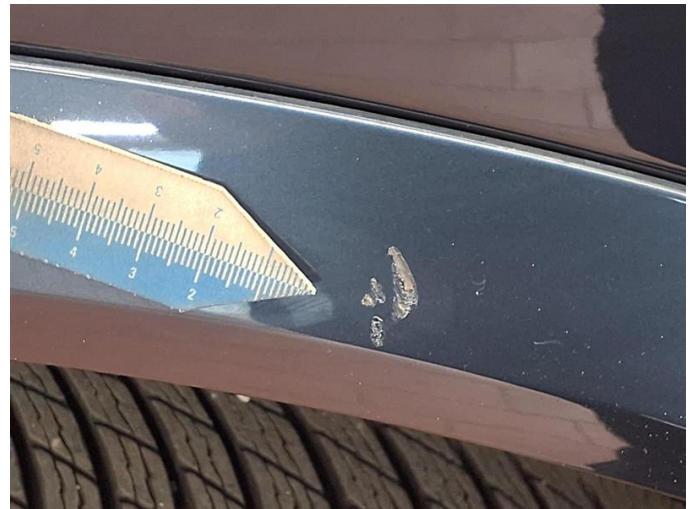
**Damage 2:** Mudguard - left side: Wheel well extension - Scratched - Smart repair

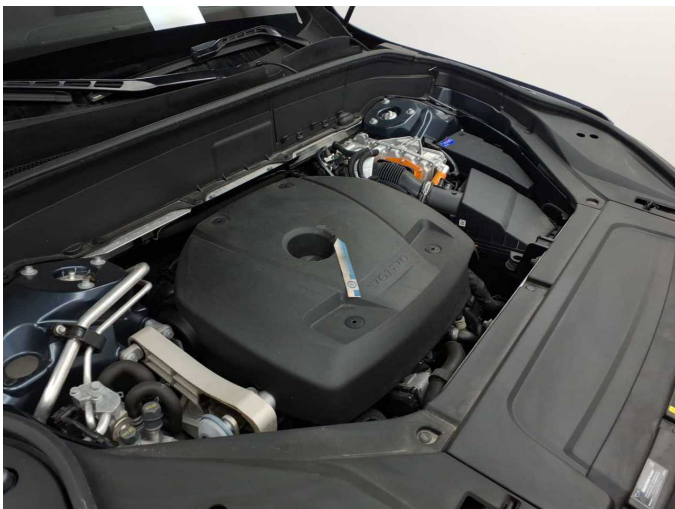
**Damage 3:** Engine: Engine cover - Damage caused by marten / rodent - Replace

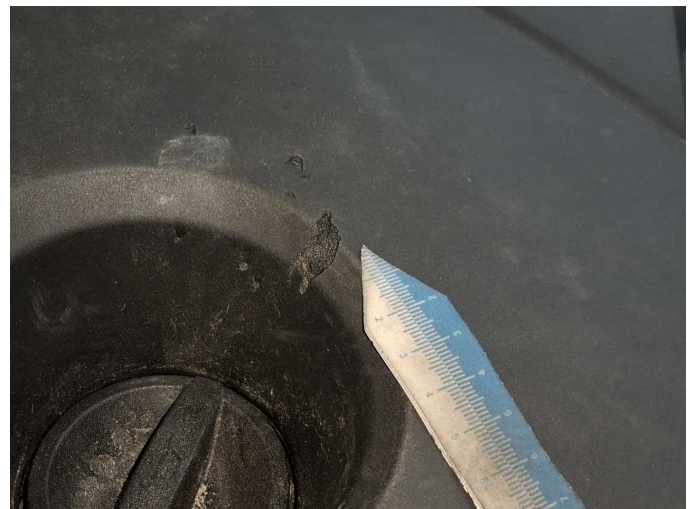
**Damage 3:** Engine: Engine cover - Damage caused by marten / rodent - Replace

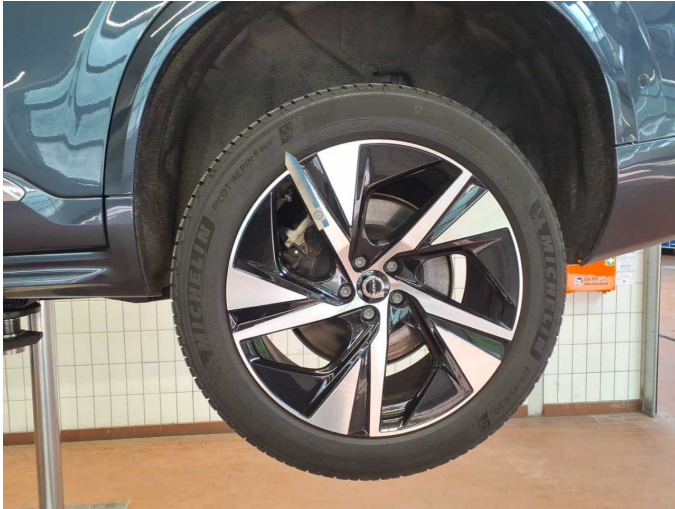
**Damage 4:** Wheel / tyres: Tyre - rear left side - Broken / torn - Replace

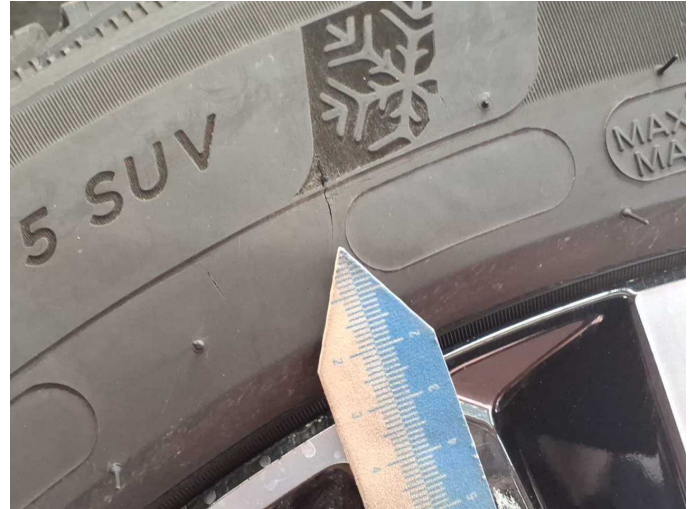
**Damage 4:** Wheel / tyres: Tyre - rear left side - Broken / torn - Replace

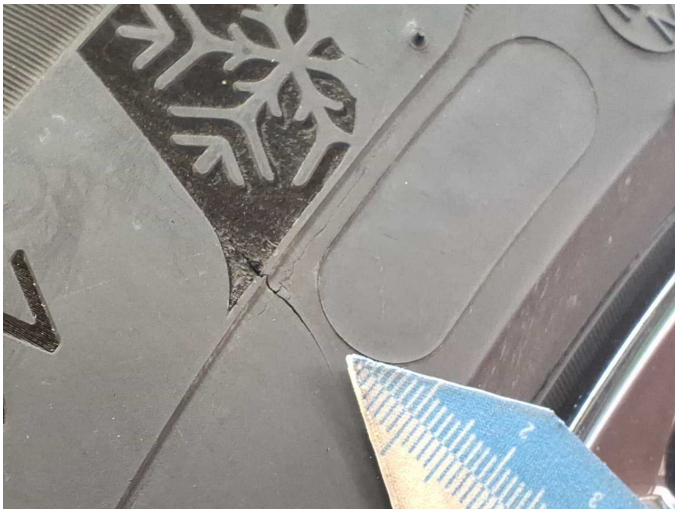
**Damage 4:** Wheel / tyres: Tyre - rear left side - Broken / torn - Replace

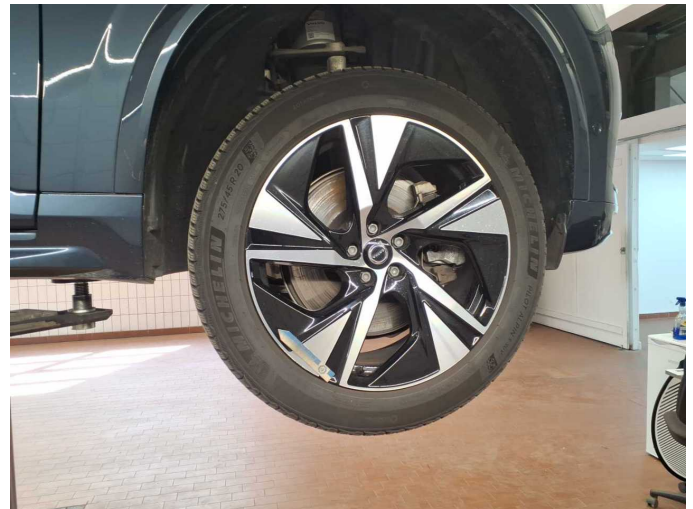
**Damage 5:** Wheel / tyres: Alloy rim - front right side - Scratched - Loss in value

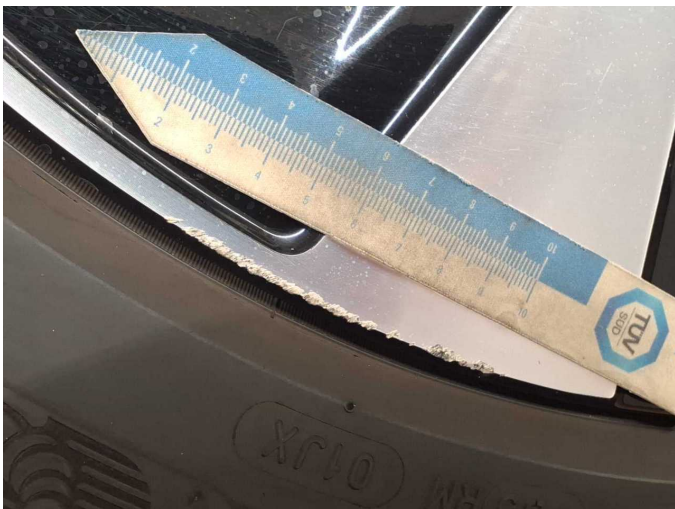
**Damage 5:** Wheel / tyres: Alloy rim - front right side - Scratched - Loss in value

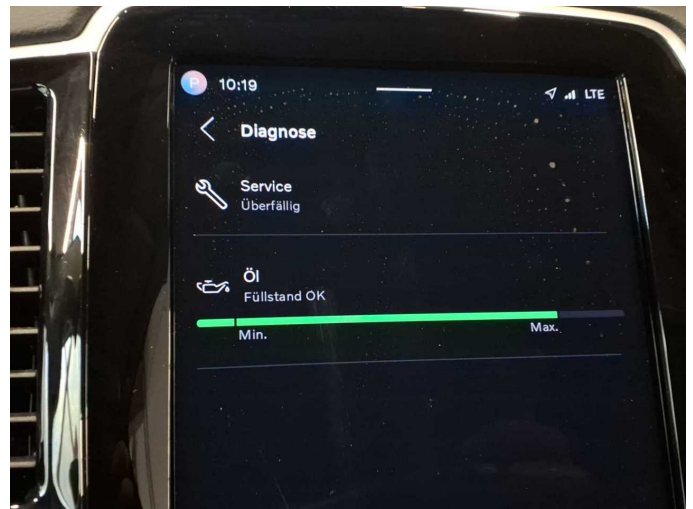
**Damage 6:** Misc.: Inspection / maintenance - Due - Perform

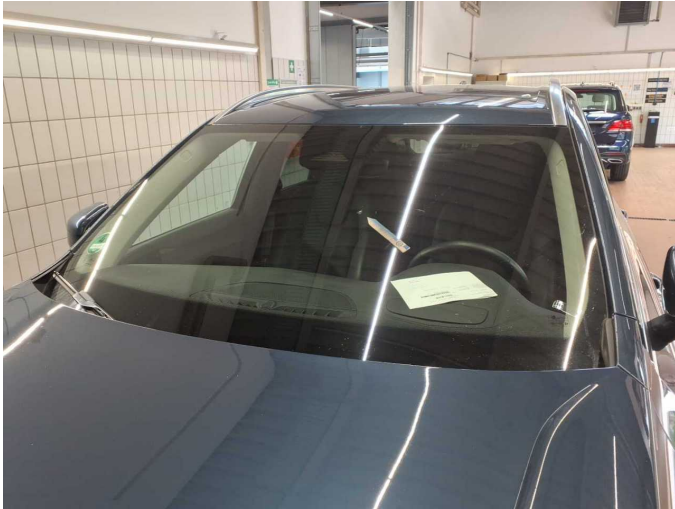
**Damage 7:** Vehicle glazing: Windscreen (mit Rissbildung) - Stone chips - Replace

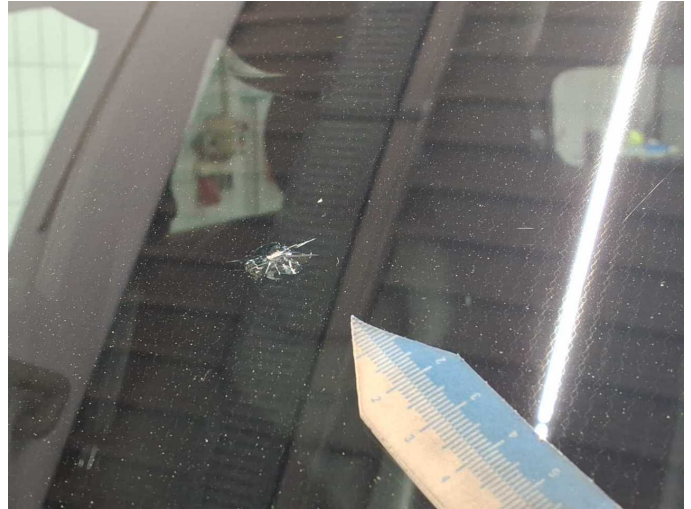
**Damage 7:** Vehicle glazing: Windscreen (mit Rissbildung) - Stone chips - Replace

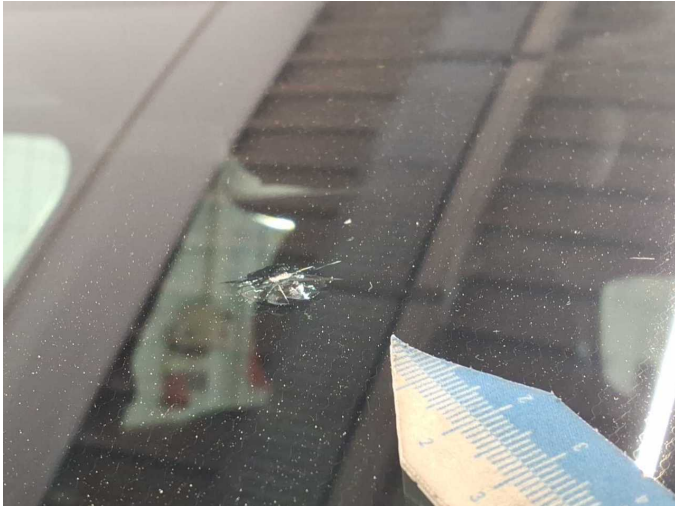
**Damage 7:** Vehicle glazing: Windscreen (mit Rissbildung) - Stone chips - Replace

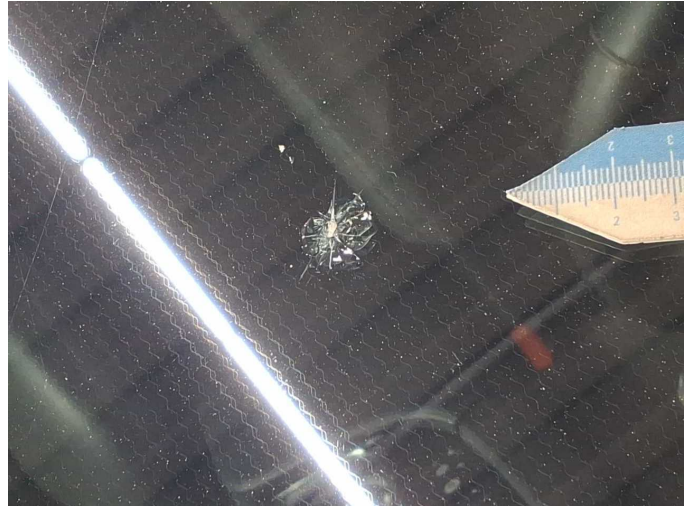
**Damage 7:** Vehicle glazing: Windscreen (mit Rissbildung) - Stone chips - Replace
