Expertise

Protocol number: 46479783  
Order No. / Reference: 26554824  
Inspection date: 13 Jul 2026

Manufacturer: Opel

Model: Crossland 1.5 Diesel Elegance

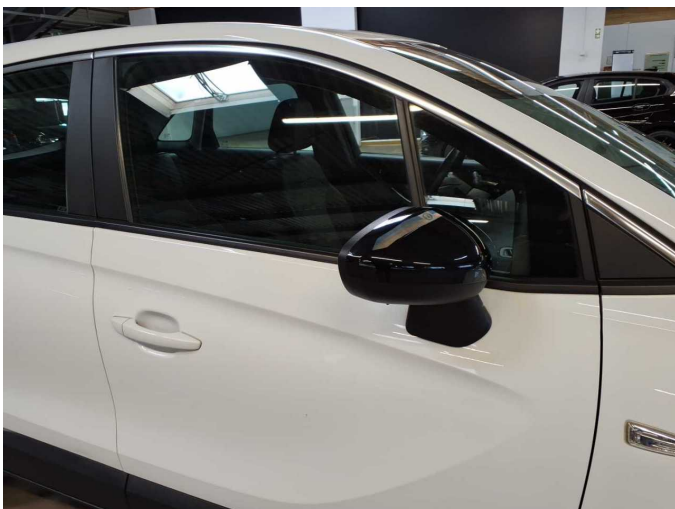
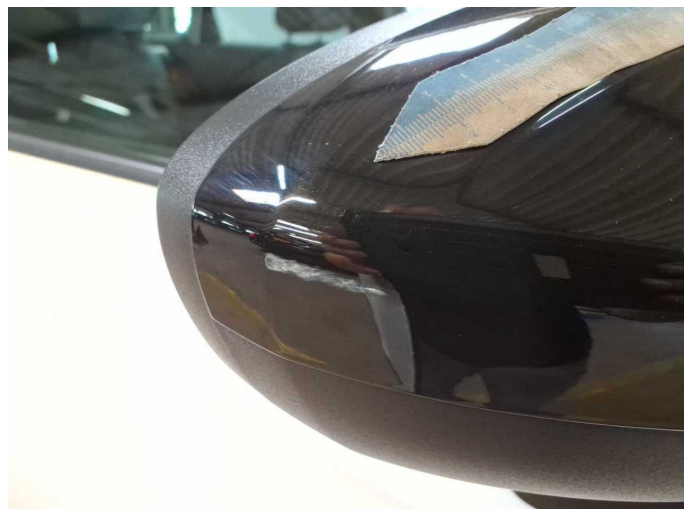
| No. | Component group | Description |
|---|---|---|
| 1 | Wing mirror - right side | Cap - Scratch(es) - Smart repair |

Damage 1: Wing mirror - right side: Cap - Scratch(es) - Smart repair

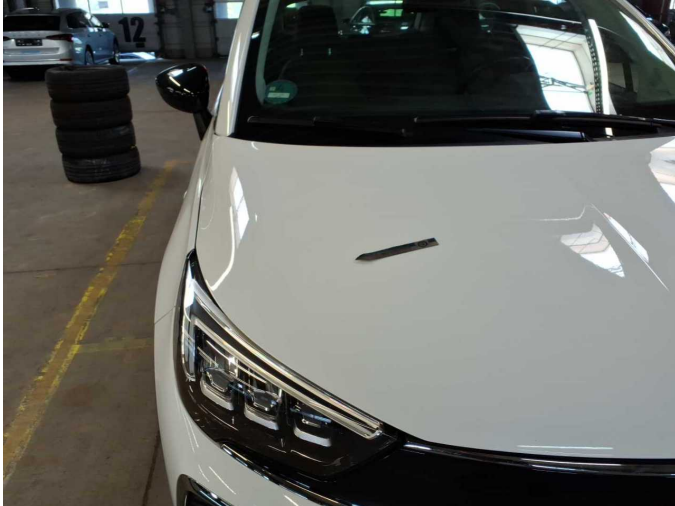
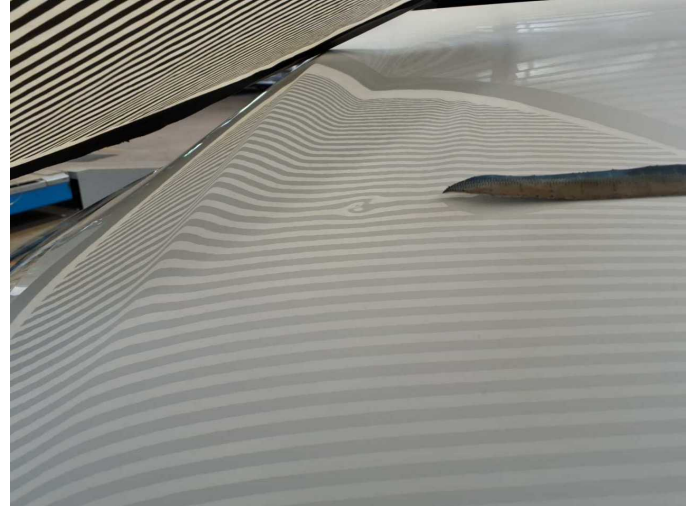
| No. | Component group | Description |
|---|---|---|
| 2 | Bonnet | Bonnet - dent(s) - Smooth repair work |

**Damage 2:** Bonnet: Bonnet - dent(s) - Smooth repair work

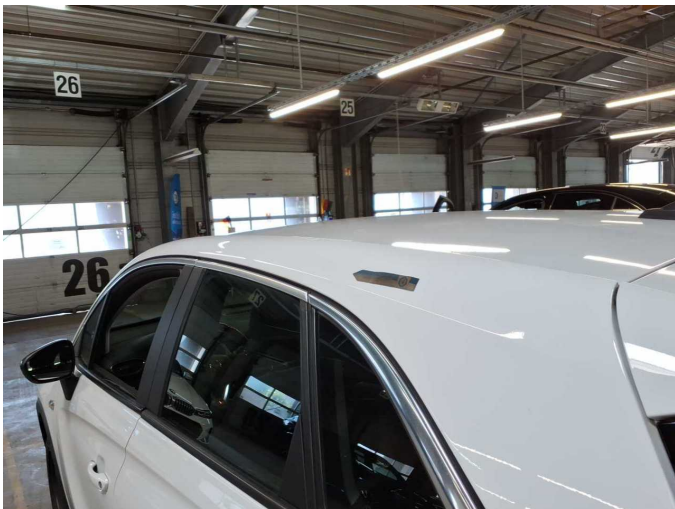
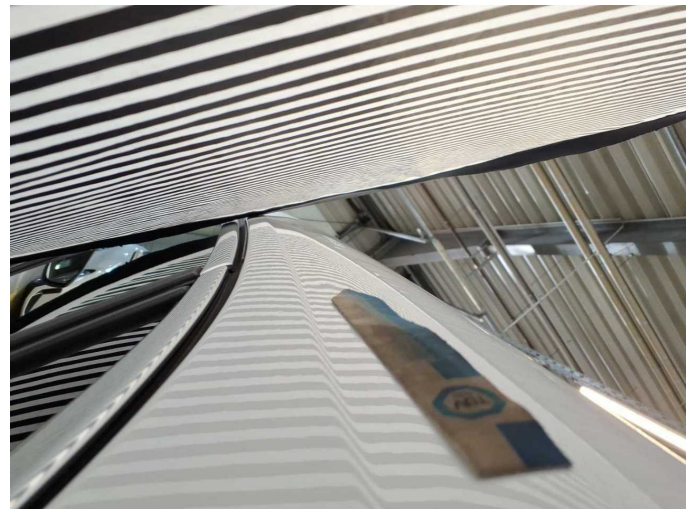
| No. | Component group | Description |
|---|---|---|
| 3 | Roof | Roof rail - left side - dent(s) - Smooth repair work |

**Damage 3:** Roof: Roof rail - left side - dent(s) - Smooth repair work

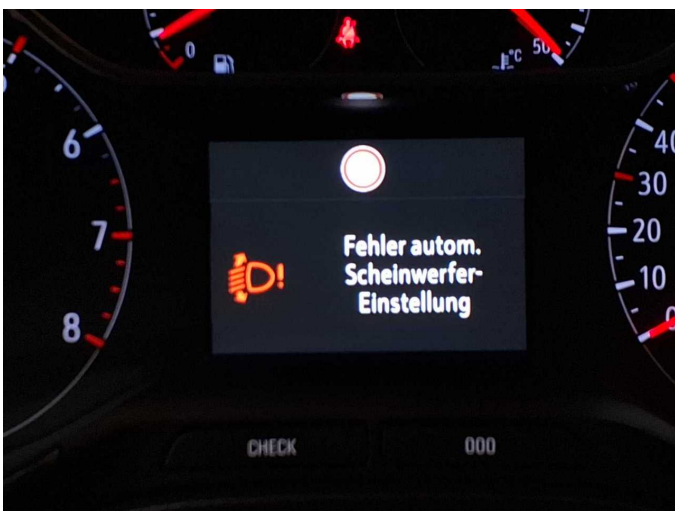
| No. | Component group | Description |
|---|---|---|
| 4 | Electrical system | Lighting system - Functional / admissibility - Perform diagnosis |

**Damage 4:** Electrical system: Lighting system - Functional / admissibility  
- Perform diagnosis

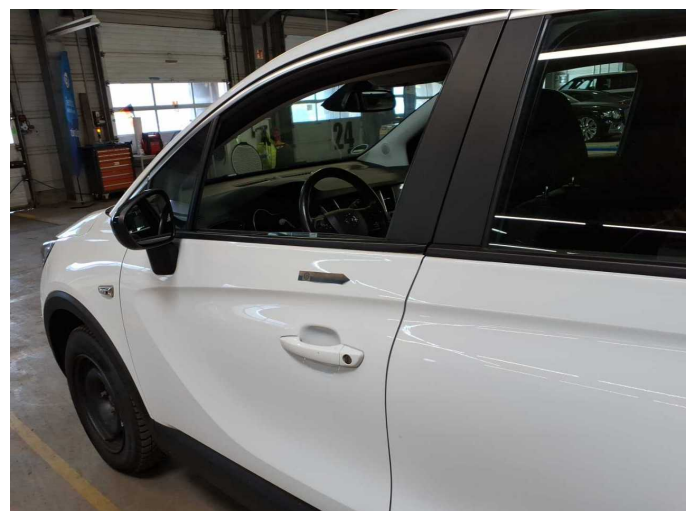
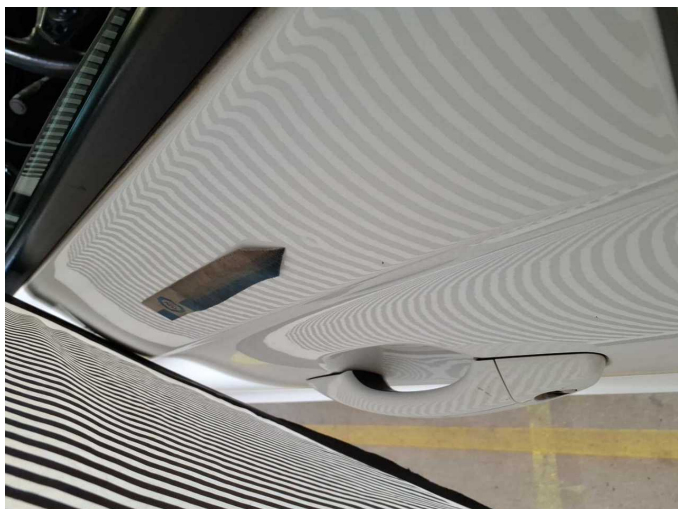
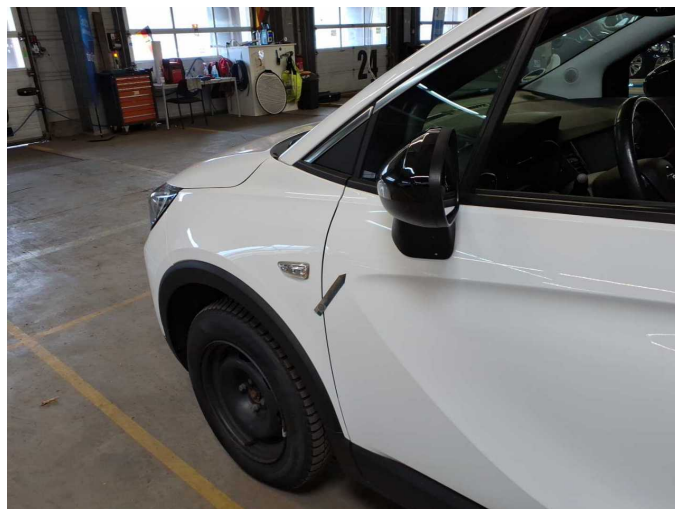
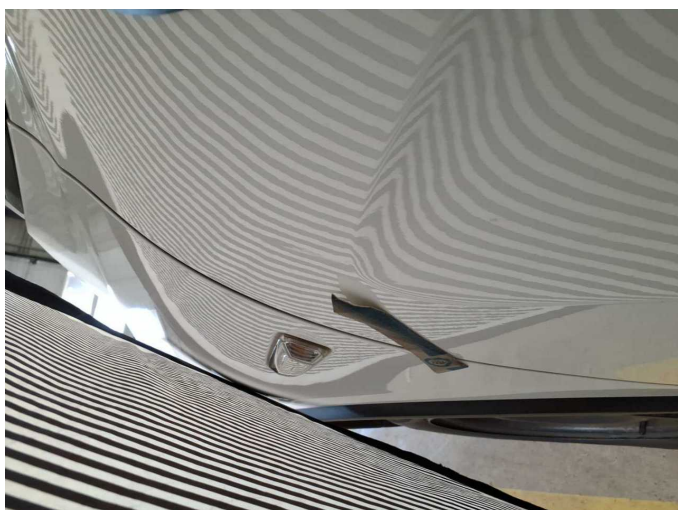
| No. | Component group | Description |
|---|---|---|
| 5 | Door - front left side | Door - dent(s) - Smooth repair work |

**Damage 5:** Door - front left side: Door - dent(s) - Smooth repair work

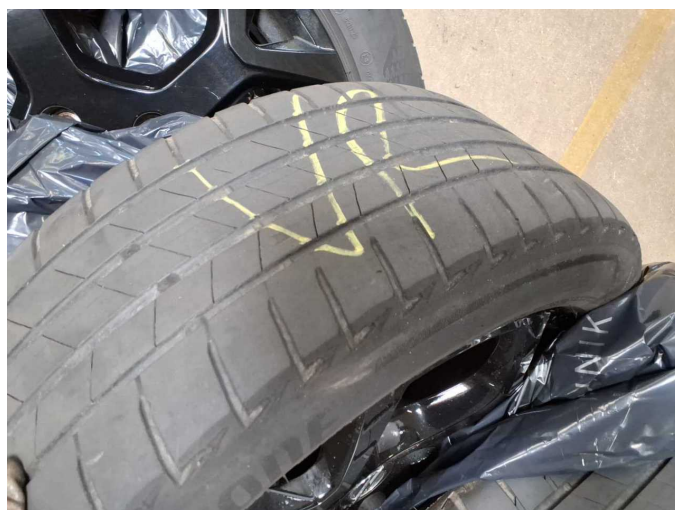
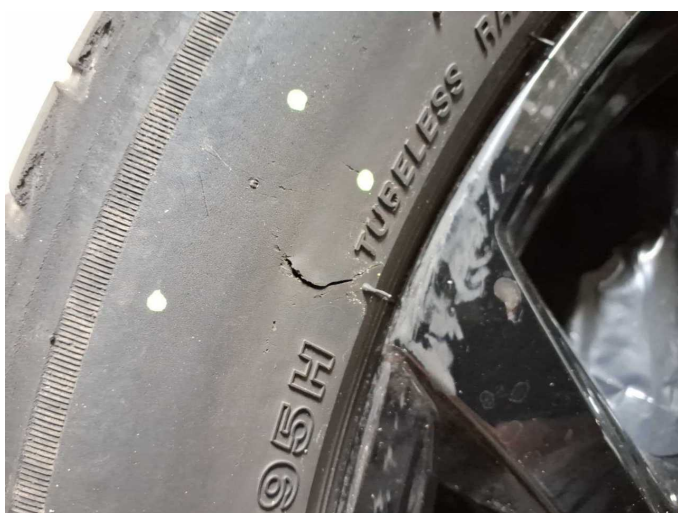
| No. | Component group | Description |
|---|---|---|
| 6 | 2nd wheel set | 1 tyre (Flanke) - Damaged - Replace |

**Damage 6:** 2nd wheel set: 1 tyre (Flanke) - Damaged - Replace

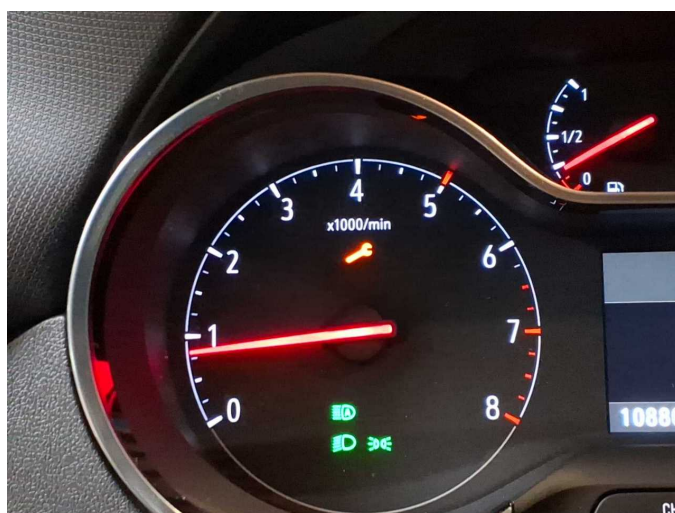
| Engine function test | An engine test run was performed, problem has been detected<br>This is due to the following reason.:<br>Motorkontrolle Leuchtet |

| No. | Component group | Description |
|---|---|---|
| 7 | Engine | Engine (Kontrollleuchte an) - Functional / admissibility - Perform diagnosis |

**Damage 7:** Engine: Engine (Kontrollleuchte an) - Functional / admissibility - Perform diagnosis

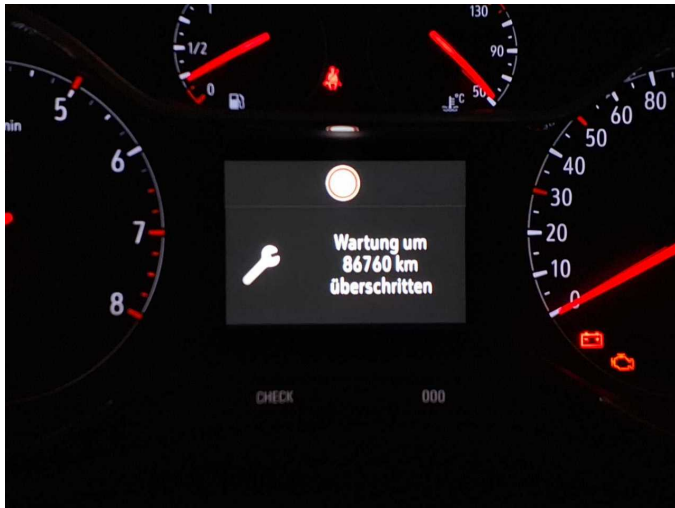
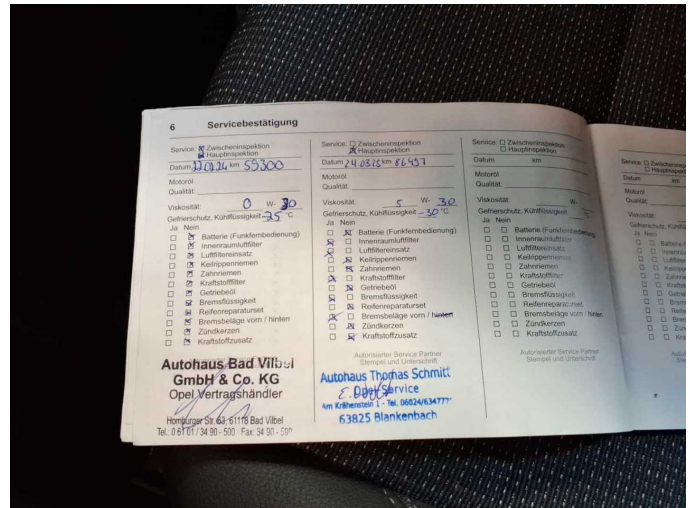
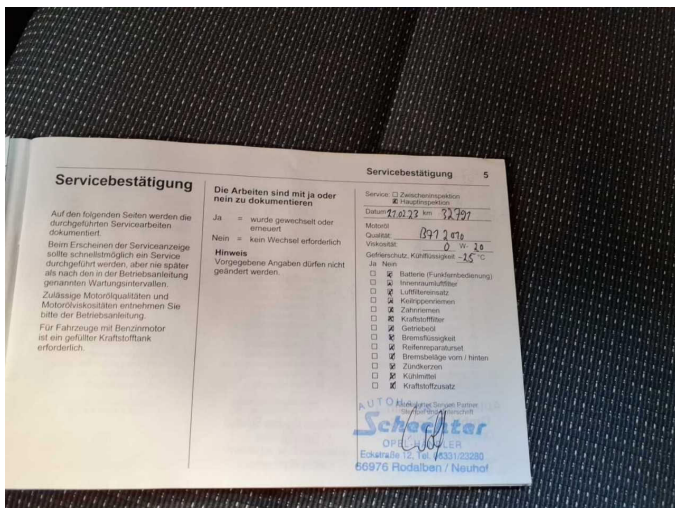
| No. | Component group | Description |
|---|---|---|
| 2 | Misc. | Inspection / maintenance (Nicht zurückgesetzt, Heft gestempelt) - No deduction |

**Wear and tear 2: Misc.: Inspection / maintenance (Nicht zurückgesetzt, Heft gestempelt) - No deduction**

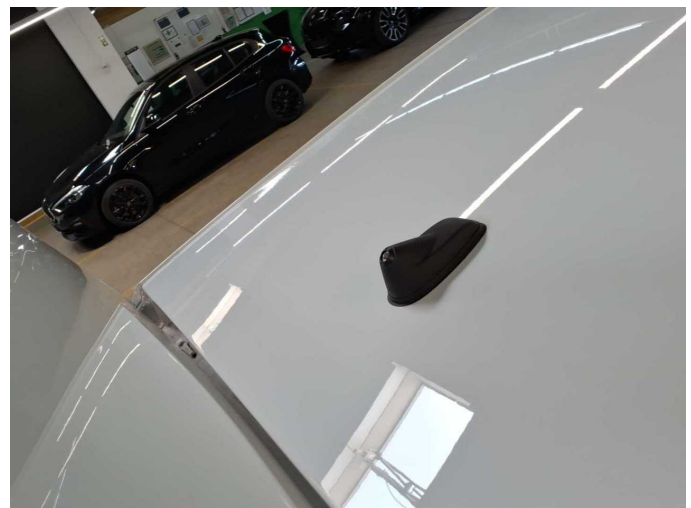
Roof - Stub aerial

**Missing part 1: Roof: Stub aerial - Missing - Replace**
