Expertise

Protocol number: 46381418  
Order No. / Reference: 26544027  
Inspection date: 7 Jul 2026

Manufacturer: Porsche  
VIN: WP1ZZZ95ZMLB03006

Model: Macan PDK

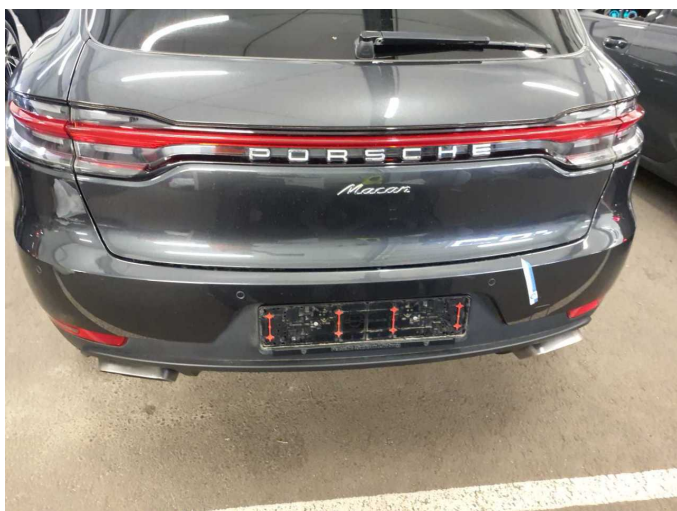
| No. | Component group | Description |
|---|---|---|
| 2 | Rear bumper | Rear bumper - Scratch(es) - Smart repair |

Damage 2: Rear bumper: Rear bumper - Scratch(es) - Smart repair

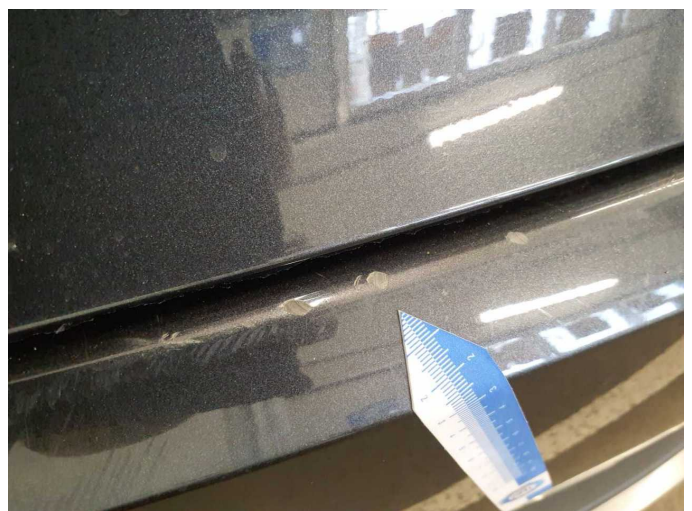
Damage 2: Rear bumper: Rear bumper - Scratch(es) - Smart repair

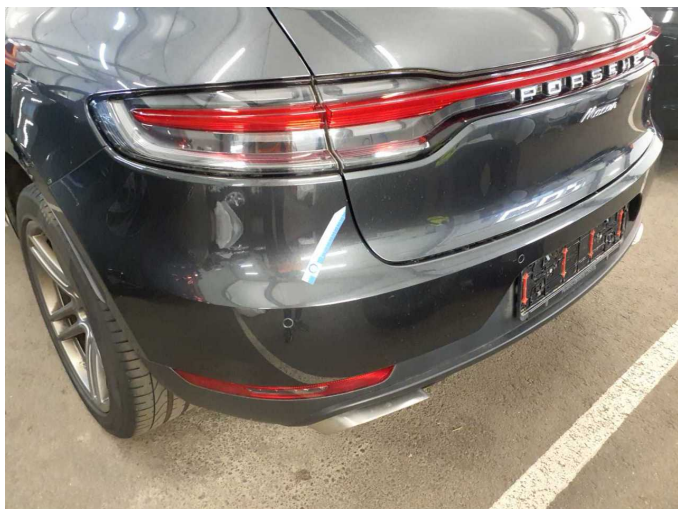
**Damage 2:** Rear bumper: Rear bumper - Scratch(es) - Smart repair

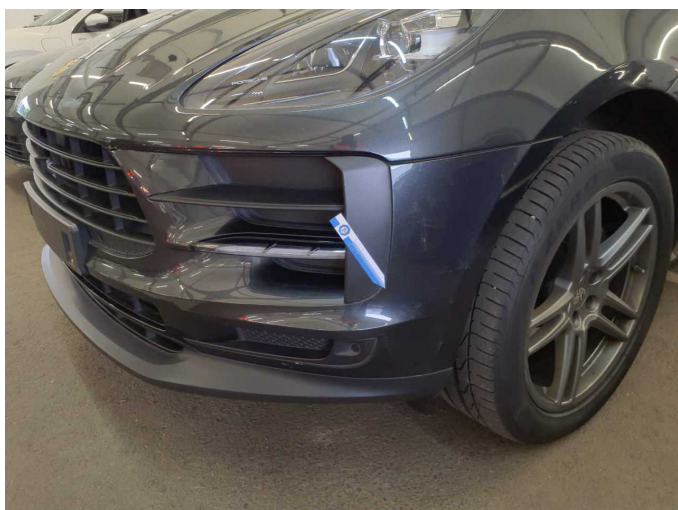
| No. | Component group | Description |
|---|---|---|
| 3 | Front bumper | Front bumper - Scratch(es) - Paint |

**Damage 3:** Front bumper: Front bumper - Scratch(es) - Paint

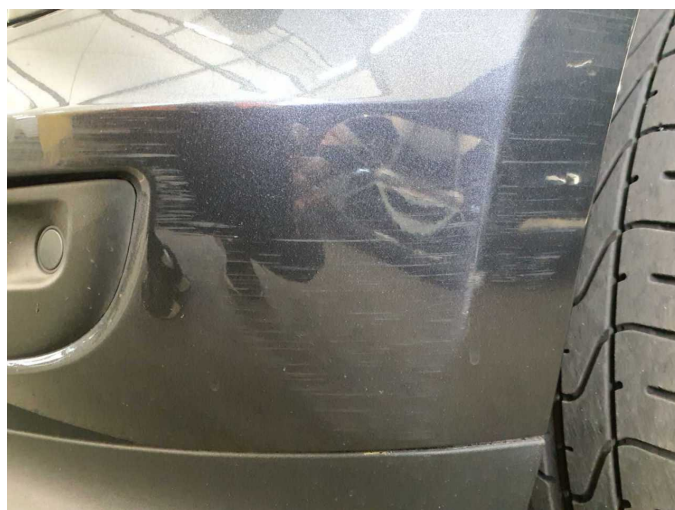
**Damage 3:** Front bumper: Front bumper - Scratch(es) - Paint

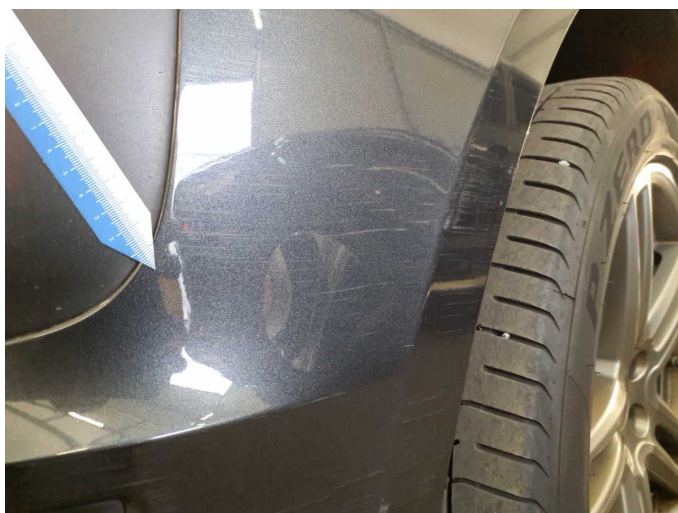
**Damage 3:** Front bumper: Front bumper - Scratch(es) - Paint

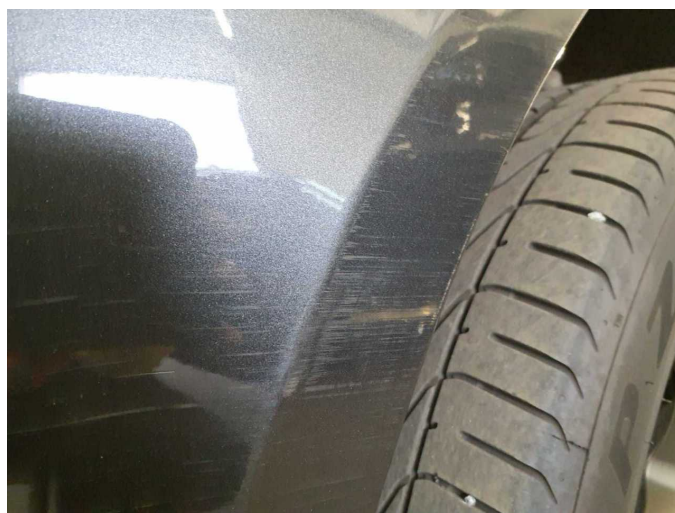
**Damage 3:** Front bumper: Front bumper - Scratch(es) - Paint

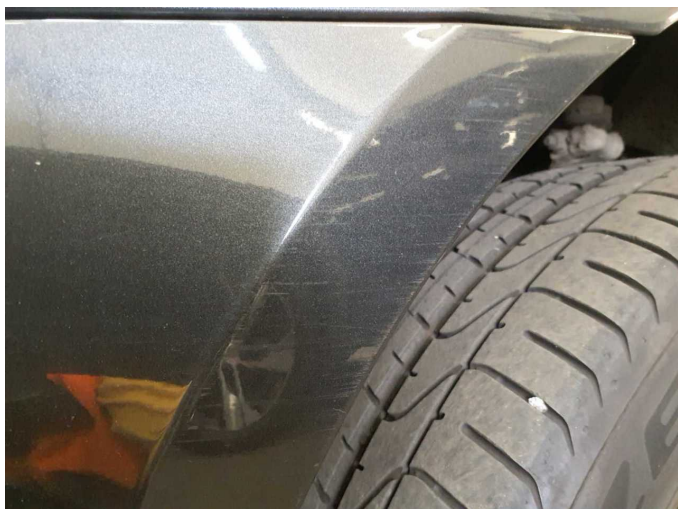
**Damage 3:** Front bumper: Front bumper - Scratch(es) - Paint

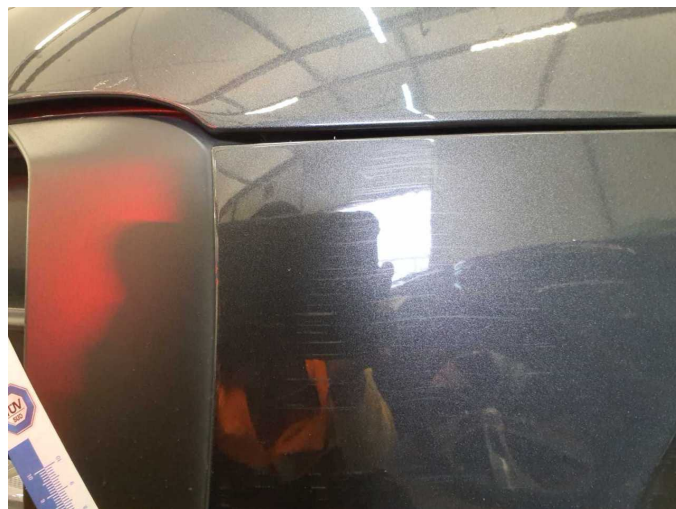
**Damage 3:** Front bumper: Front bumper - Scratch(es) - Paint

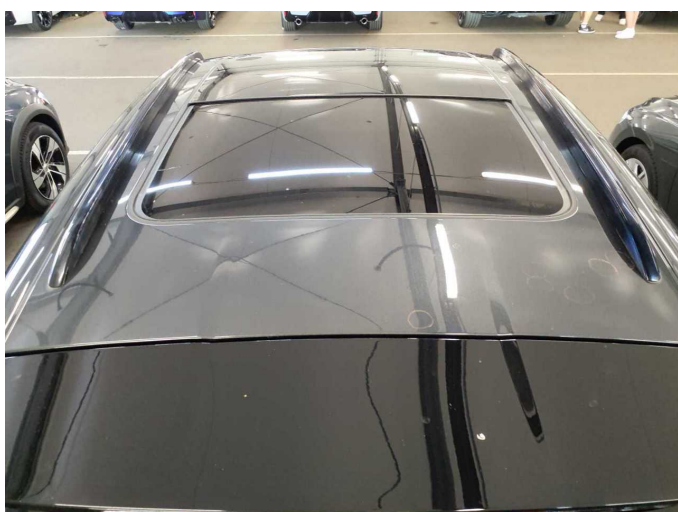
| No. | Component group | Description |
|---|---|---|
| 4 | Roof | Roof (inkl. Holm links & rechts) - dent(s) - Smooth repair work |

**Damage 4:** Roof: Roof (inkl. Holm links & rechts) - dent(s) - Smooth repair work

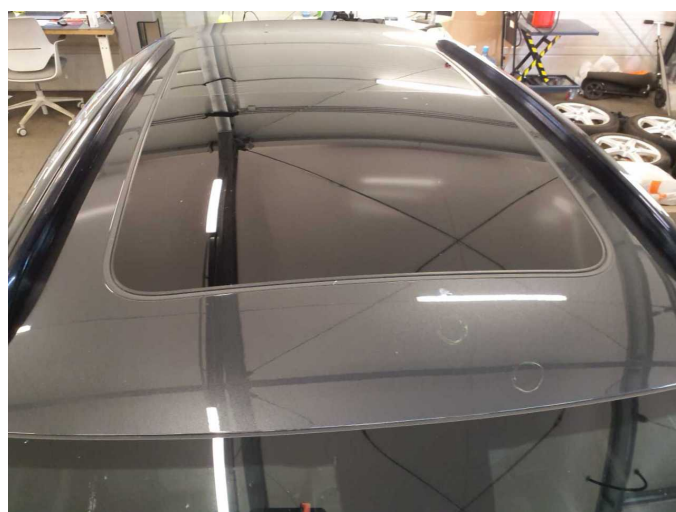
**Damage 4:** Roof: Roof (inkl. Holm links & rechts) - dent(s) - Smooth repair work

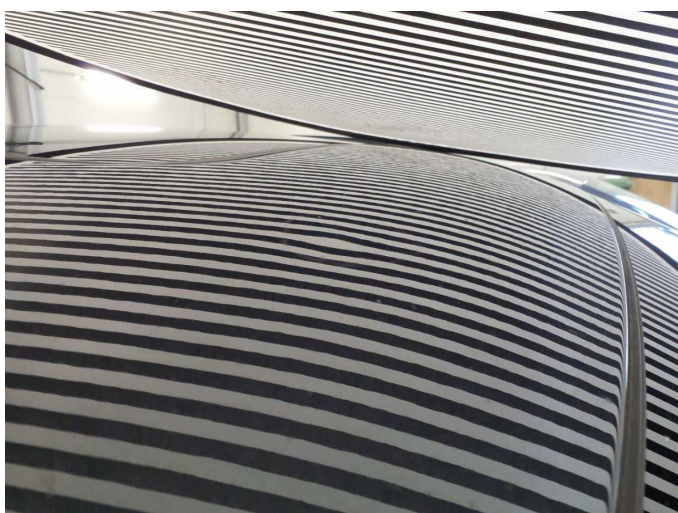
**Damage 4:** Roof: Roof (inkl. Holm links & rechts) - dent(s) - Smooth repair work

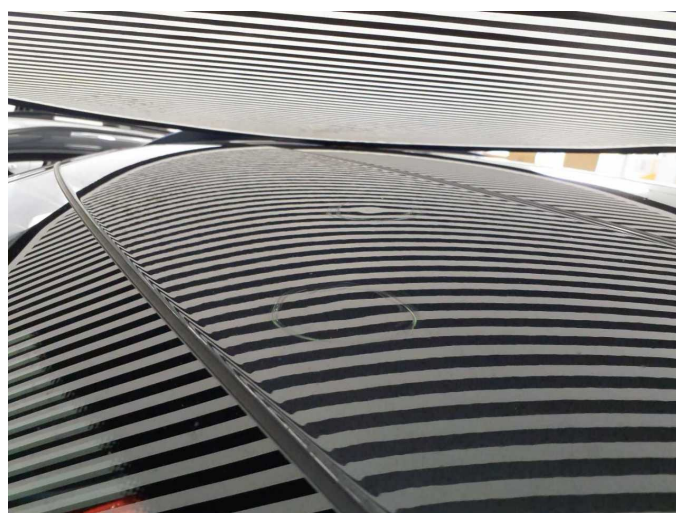
**Damage 4:** Roof: Roof (inkl. Holm links & rechts) - dent(s) - Smooth repair work

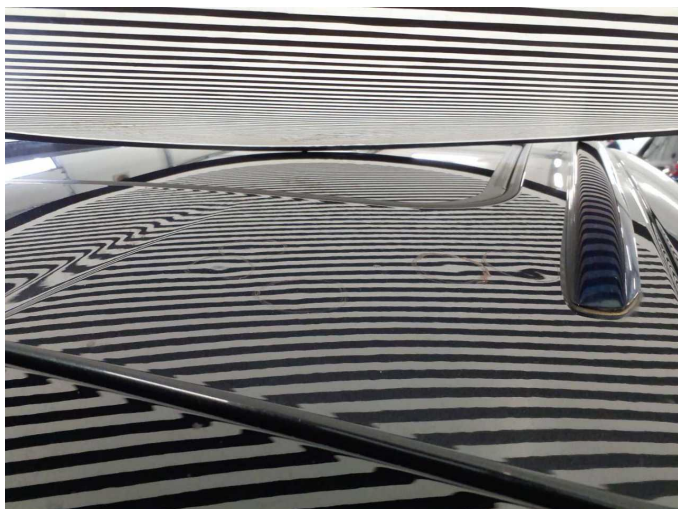
**Damage 4:** Roof: Roof (inkl. Holm links & rechts) - dent(s) - Smooth repair work

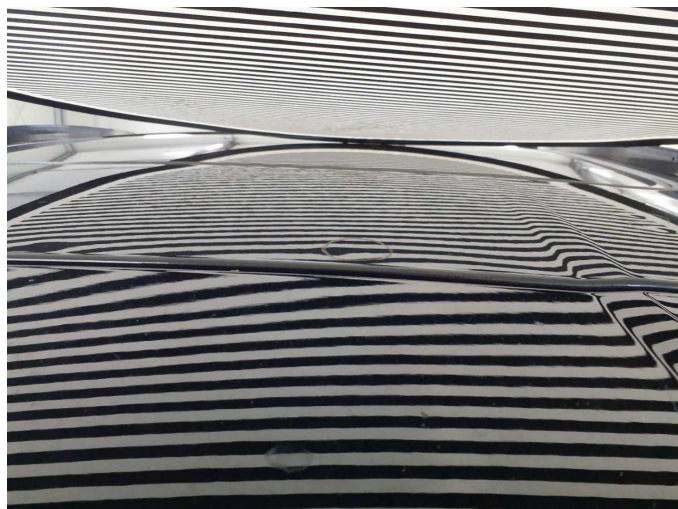
**Damage 4:** Roof: Roof (inkl. Holm links & rechts) - dent(s) - Smooth repair work

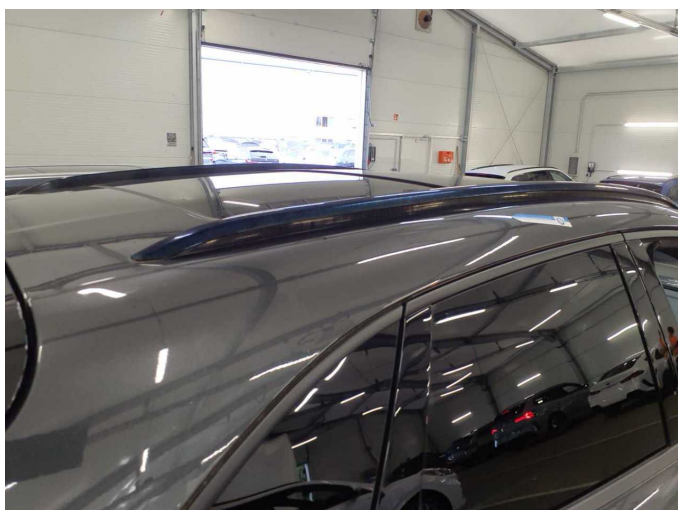
**Damage 4:** Roof: Roof (inkl. Holm links & rechts) - dent(s) - Smooth repair work

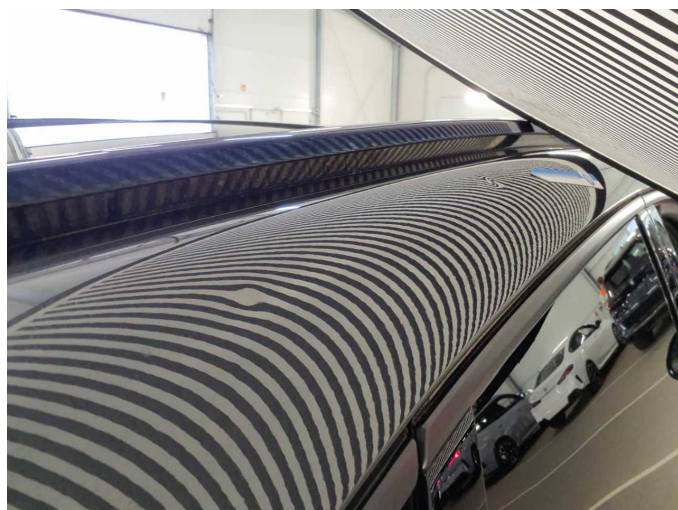
**Damage 4:** Roof: Roof (inkl. Holm links & rechts) - dent(s) - Smooth repair work

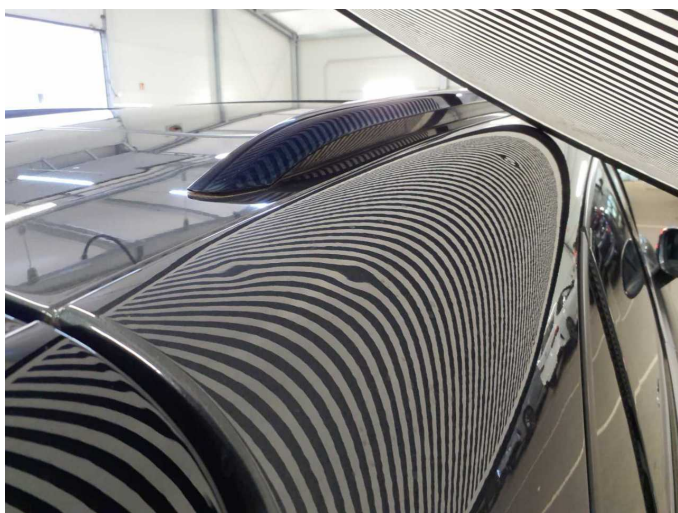
**Damage 4:** Roof: Roof (inkl. Holm links & rechts) - dent(s) - Smooth repair work

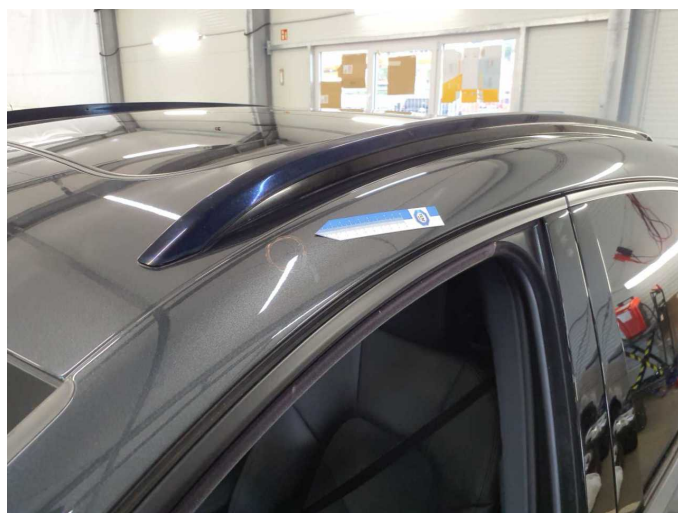
**Damage 4:** Roof: Roof (inkl. Holm links & rechts) - dent(s) - Smooth repair work

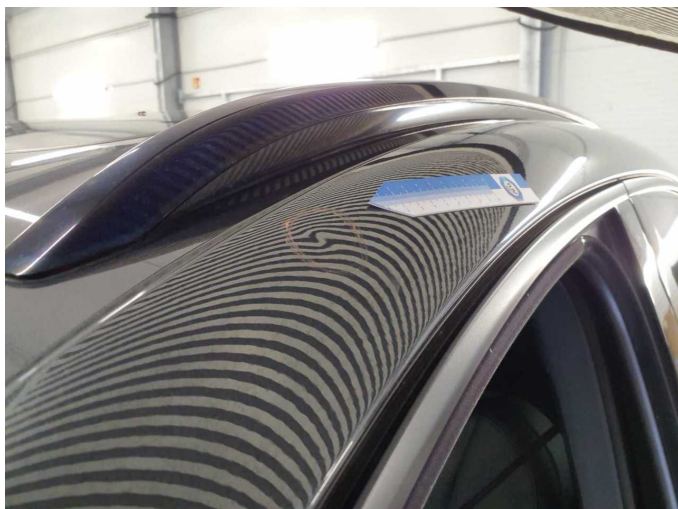
**Damage 4:** Roof: Roof (inkl. Holm links & rechts) - dent(s) - Smooth repair work

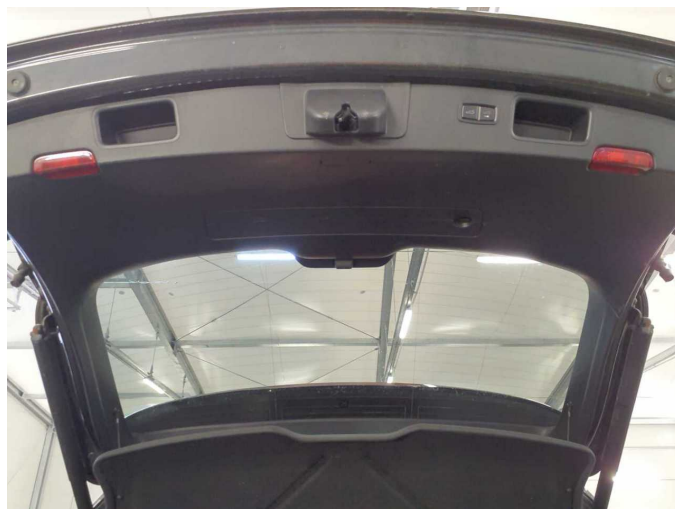
| No. | Component group | Description |
|---|---|---|
| 1 | Trim / covers | Boot lid - interior trim - Scratch(es) - No deduction |

**Wear and tear 1:** Trim / covers: Boot lid - interior trim - Scratch(es) - No deduction

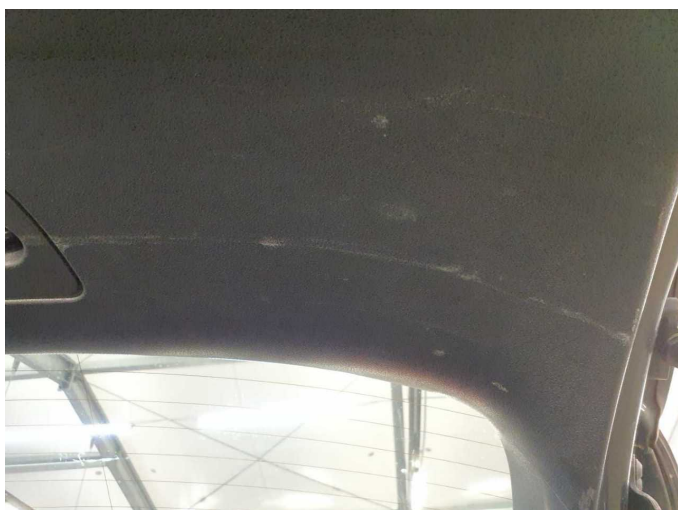
**Wear and tear 1:** Trim / covers: Boot lid - interior trim - Scratch(es) - No deduction

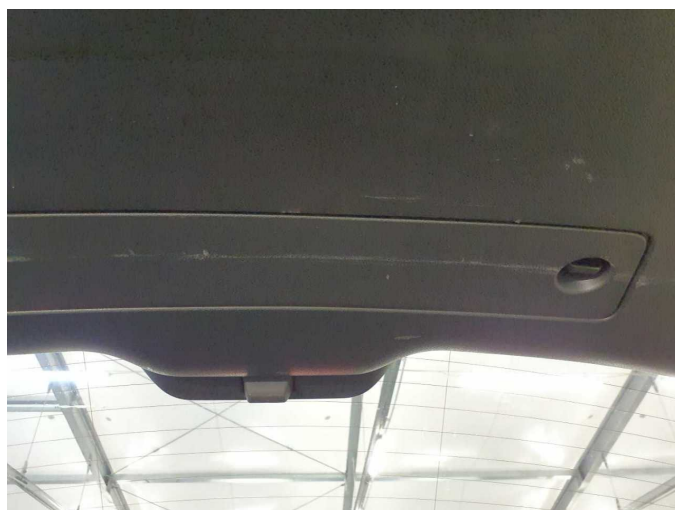
**Wear and tear 1:** Trim / covers: Boot lid - interior trim - Scratch(es) - No deduction

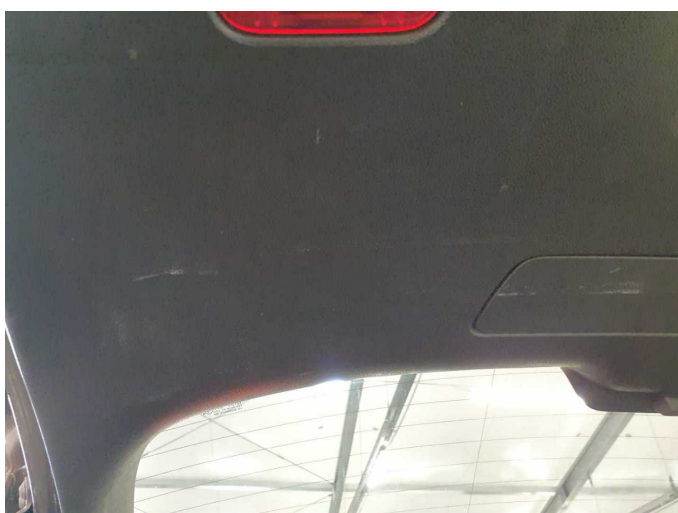
**Wear and tear 1:** Trim / covers: Boot lid - interior trim - Scratch(es) - No deduction
