Expertise

Protocol number: 46886975  
Order No. / Reference: 26782825  
Inspection date: 4 Aug 2026

Manufacturer: Opel

Model: Astra 1.5 D Start/Stop Sports Tourer Elegance

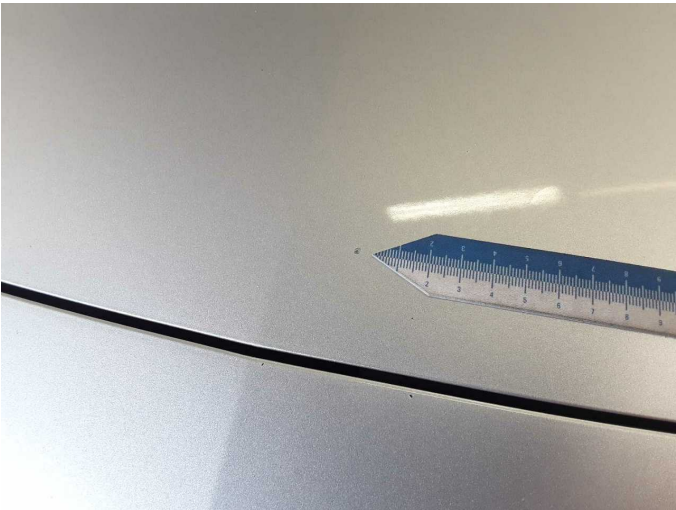
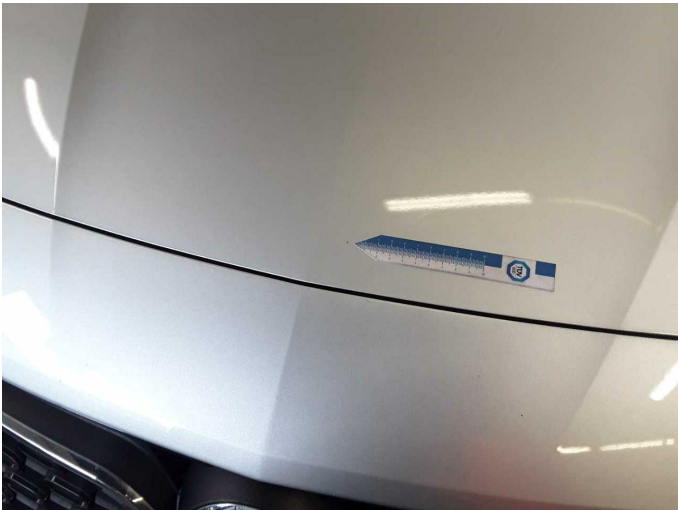
| No. | Component group | Description |
|---|---|---|
| 1 | Bonnet | Bonnet - Stone chips - Smart repair |

Damage 1: Bonnet: Bonnet - Stone chips - Smart repair

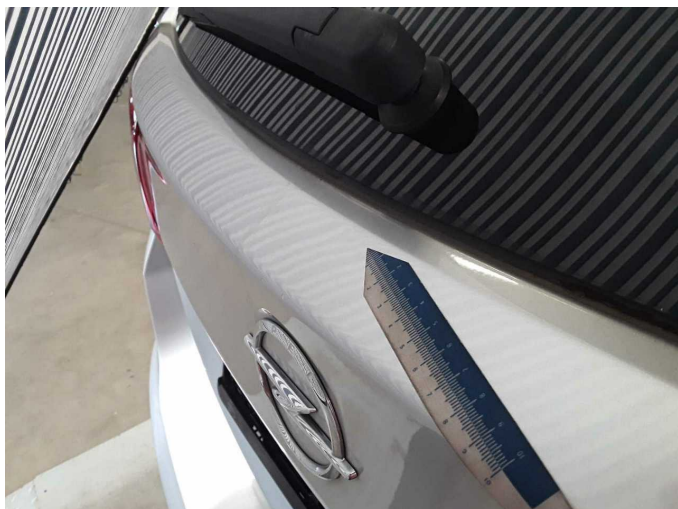
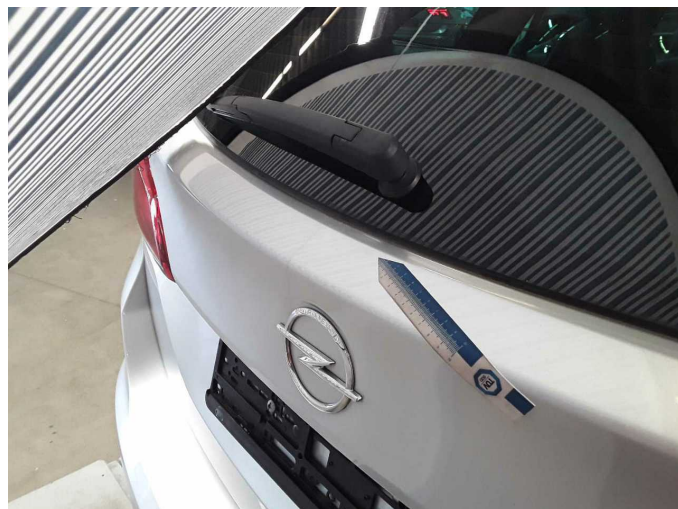
| No. | Component group | Description |
|---|---|---|
| 2 | Boot lid / rear door | Boot lid (Delle auf der Kante) - dent(s) - Smart repair |

**Damage 2:** Boot lid / rear door: Boot lid (Delle auf der Kante) - dent(s) - Smart repair

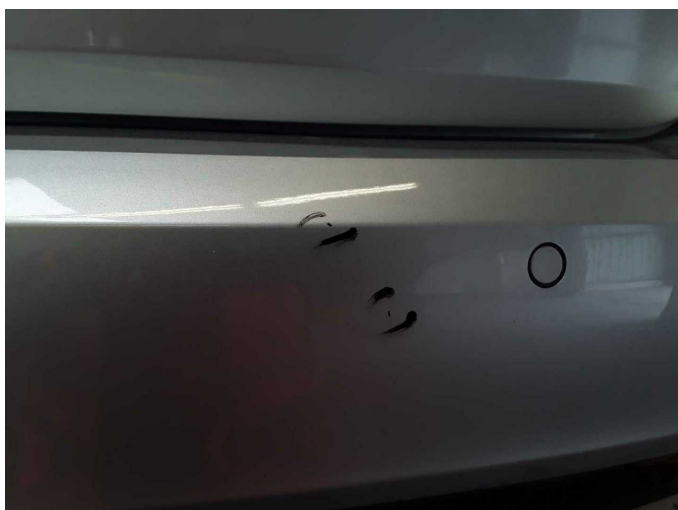
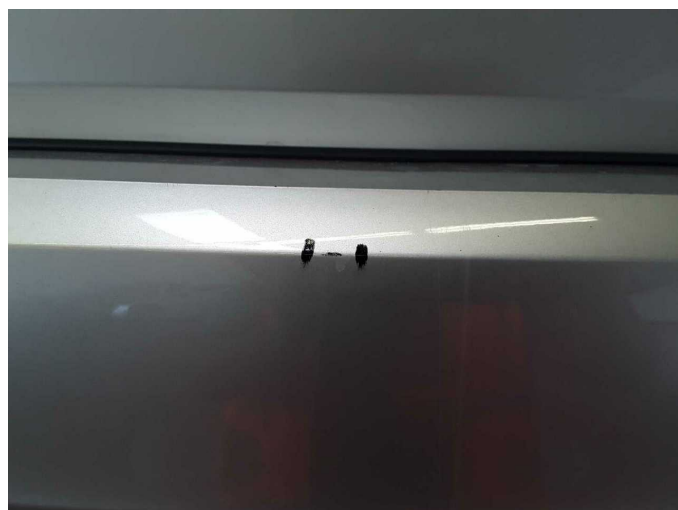
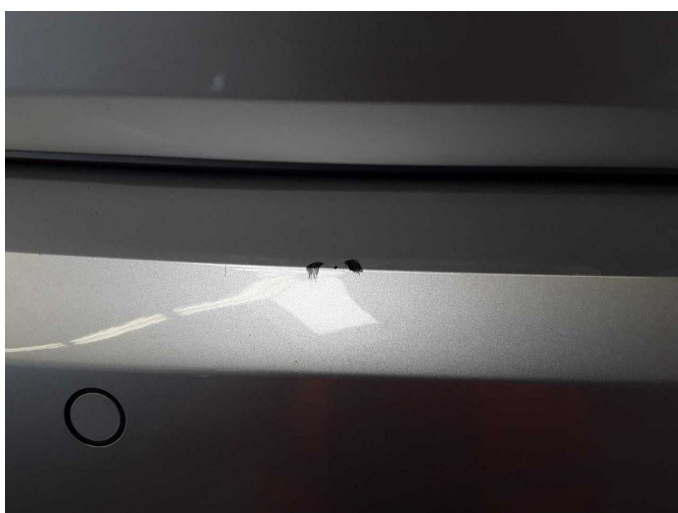
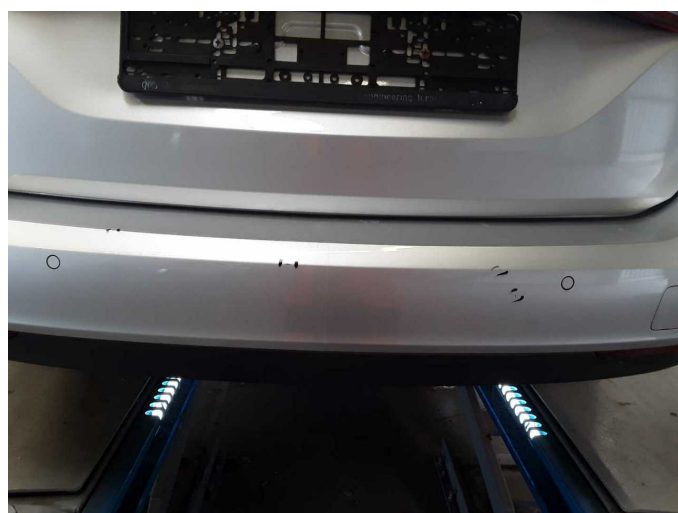
| No. | Component group | Description |
|---|---|---|
| 3 | Rear bumper | Rear bumper - Scratch(es) - Paint |

**Damage 3:** Rear bumper: Rear bumper - Scratch(es) - Paint

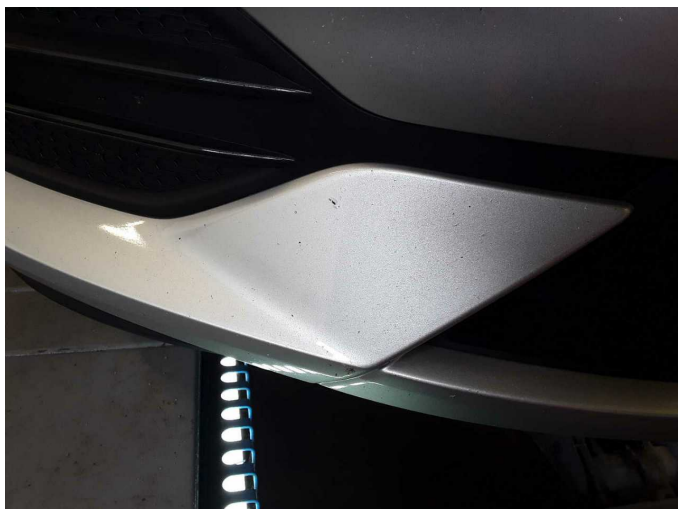
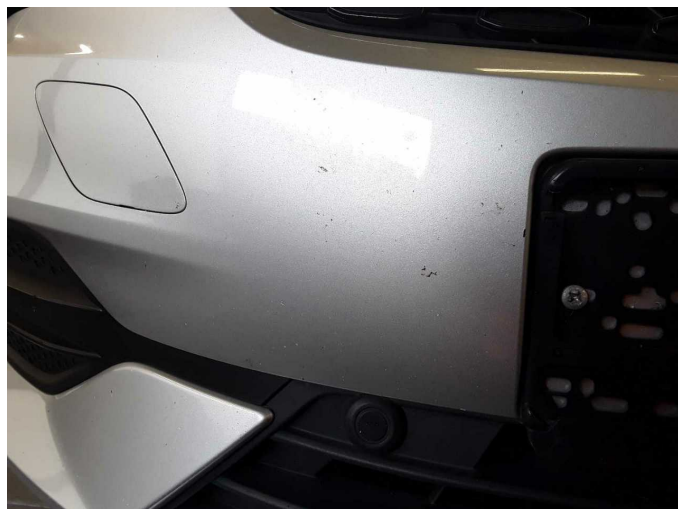
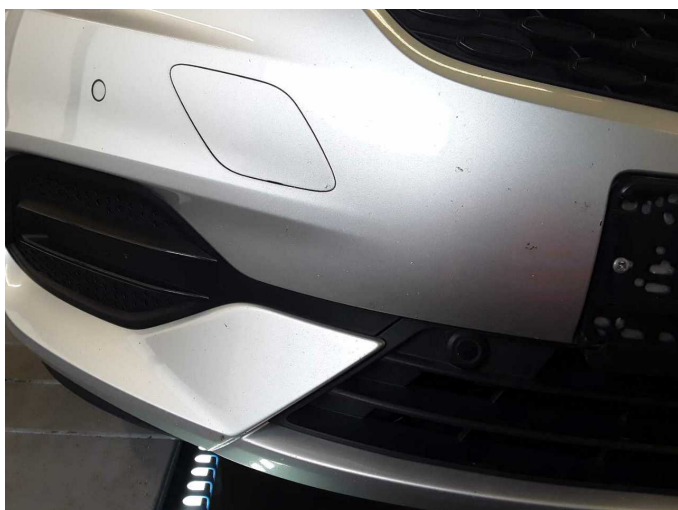
| No. | Component group | Description |
|---|---|---|
| 4 | Front bumper | Front bumper - Stone chips - Paint |

**Damage 4:** Front bumper: Front bumper - Stone chips - Paint

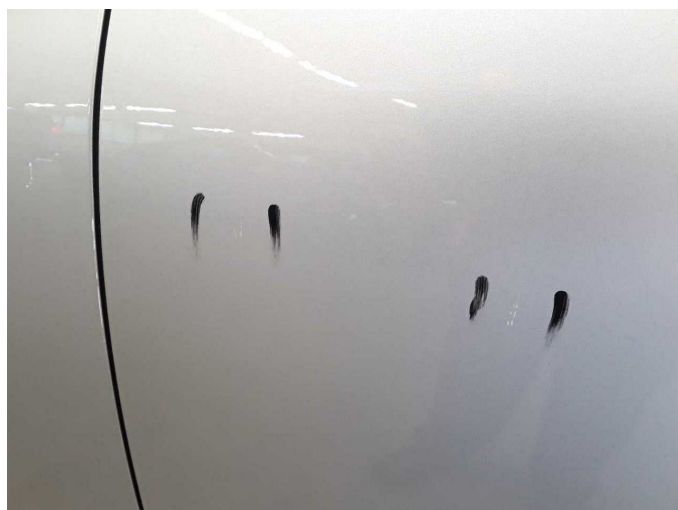
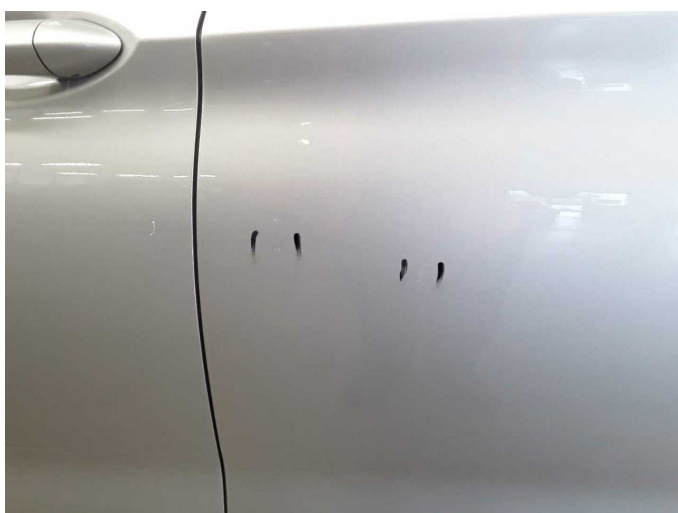
| No. | Component group | Description |
|---|---|---|
| 5 | Door - rear left side | Door - Scratch(es) - Paint |

**Damage 5:** Door - rear left side: Door - Scratch(es) - Paint

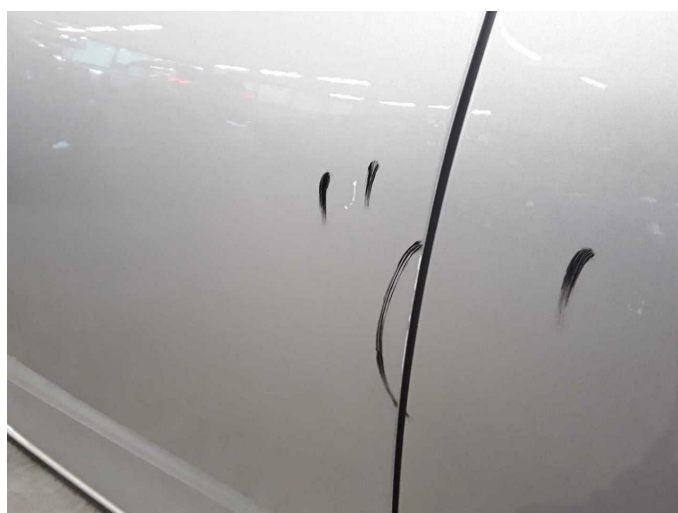
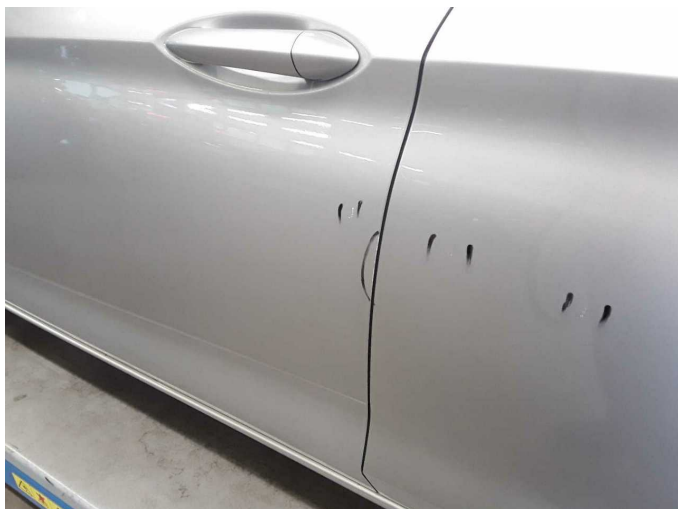
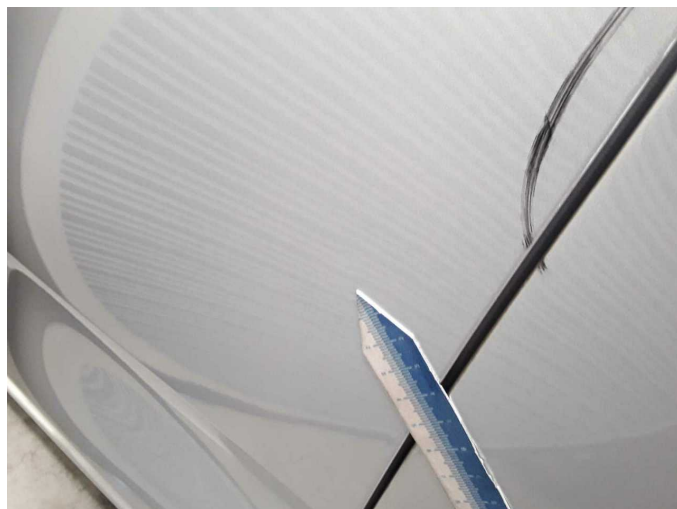
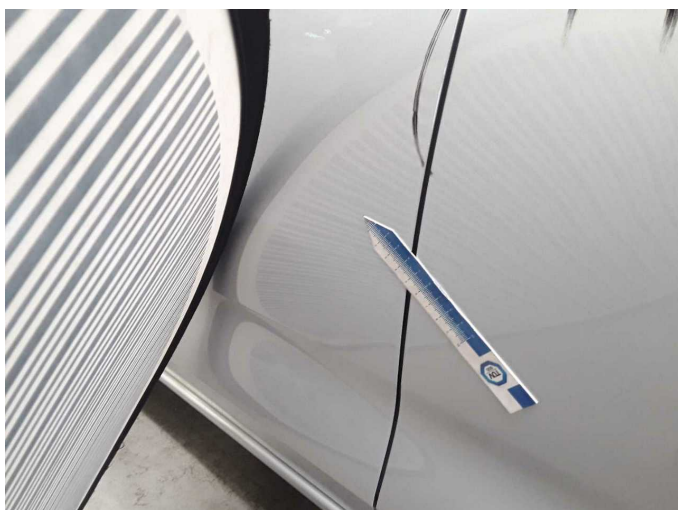
| No. | Component group | Description |
|---|---|---|
| 6 | Door - front left side | Door - Dent / paintcoat damage - Repair and paint |

**Damage 6:** Door - front left side: Door - Dent / paintcoat damage - Repair and paint

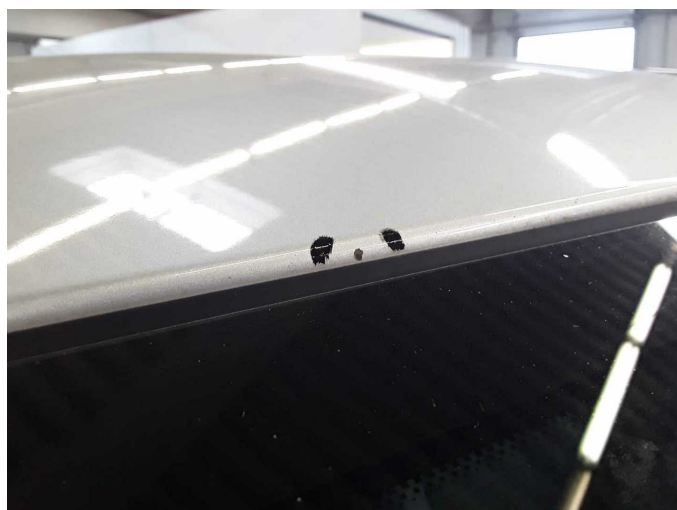
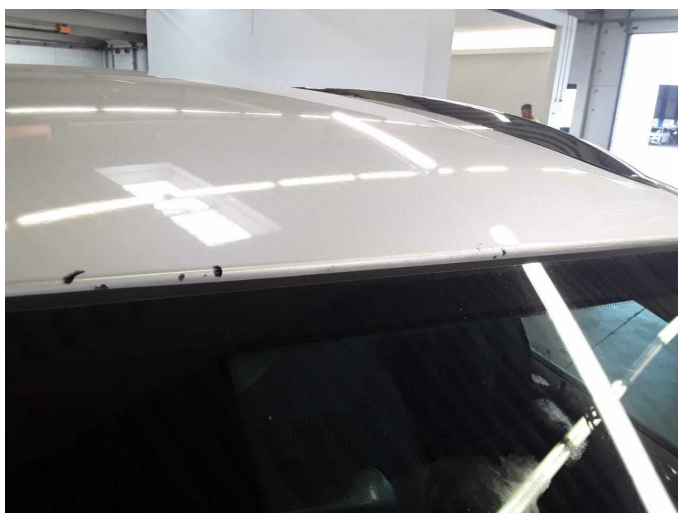
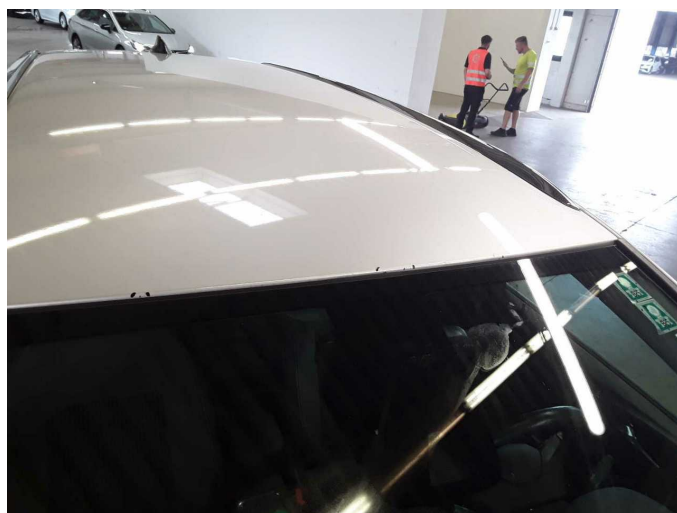
| No. | Component group | Description |
|---|---|---|
| 7 | Roof | Roof - Stone chips - Paint |

**Damage 7:** Roof: Roof - Stone chips - Paint

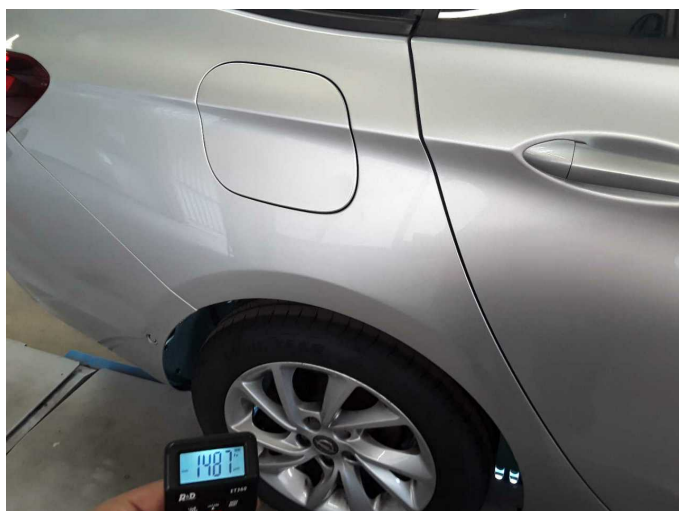
| No. | Repainting |
|---|---|
| 1 | Side panel - rear right side, Door - front right side, Professionally carried out |

**Side panel - rear right side:** 1,487  $\mu\text{m}$

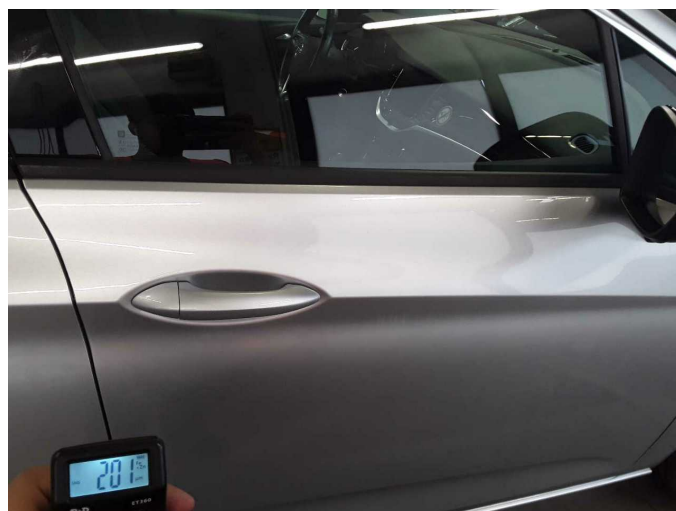
**Door - front right side:** 201  $\mu\text{m}$
