Expertise

Protocol number: 45485295
Order No. / Reference: 26234949
Inspection date: 11 May 2026

Manufacturer: Toyota

Model: Proace 2,0-I-D-4D L1 Comfort

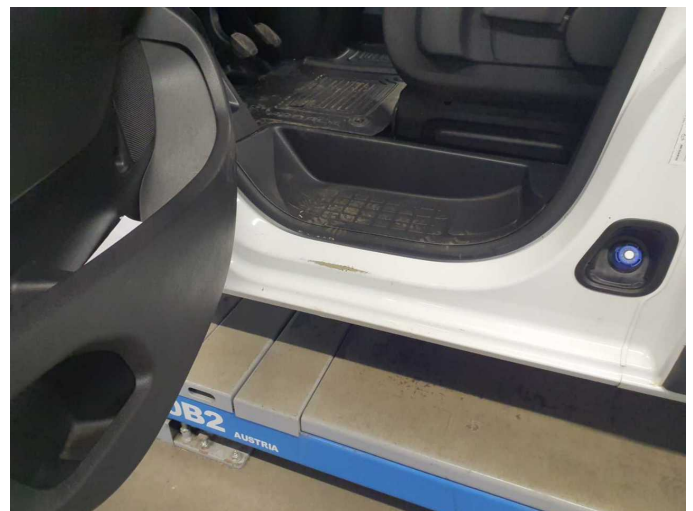
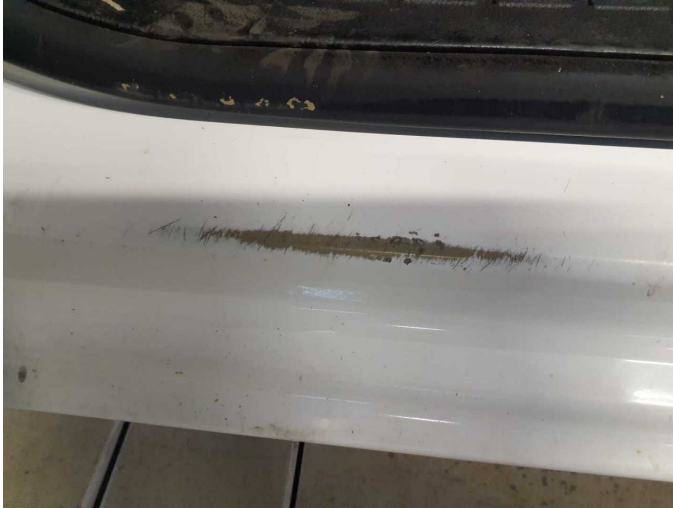
No.	Component group	Description
1	Sill - left side	Sill - Scratch(es) - Smart repair
2	Mudguard - left side	Mudguard - left side - Stone chips - Smart repair
3	Side panel - rear right side	Side panel - Dent / paintcoat damage - Smart repair
4	Boot lid / rear door	Rear door - left side - Deformed - Smart repair
5	Rear bumper	Rear bumper - Deformed - Loss in value
6	Front bumper	Front bumper (Zierleisten) - Scratched - Smart repair
7	Boot lid / rear door	Rear door - right side - Dent / paintcoat damage - Repair and paint
8	Side panel - rear left side	Side panel - Dent / paintcoat damage - Repair and paint

Damage 1: Sill - left side: Sill - Scratch(es) - Smart repair

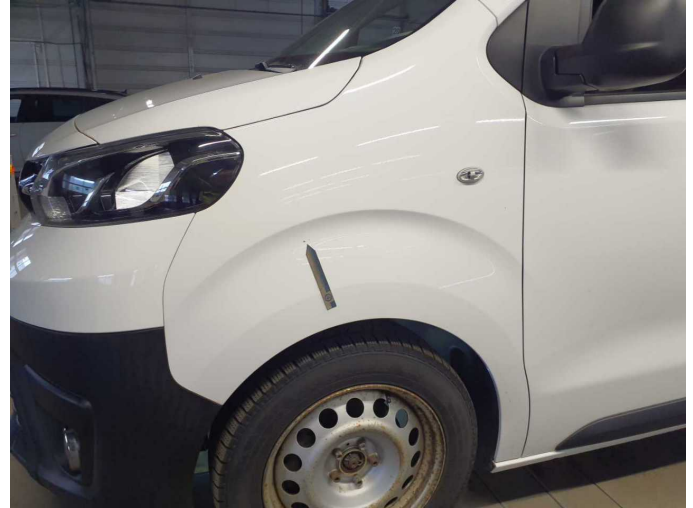
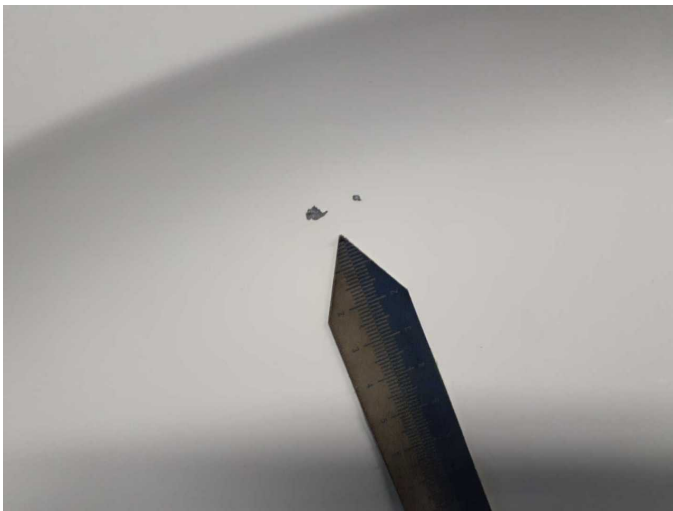
Damage 2: Mudguard - left side: Mudguard - left side - Stone chips - Smart repair

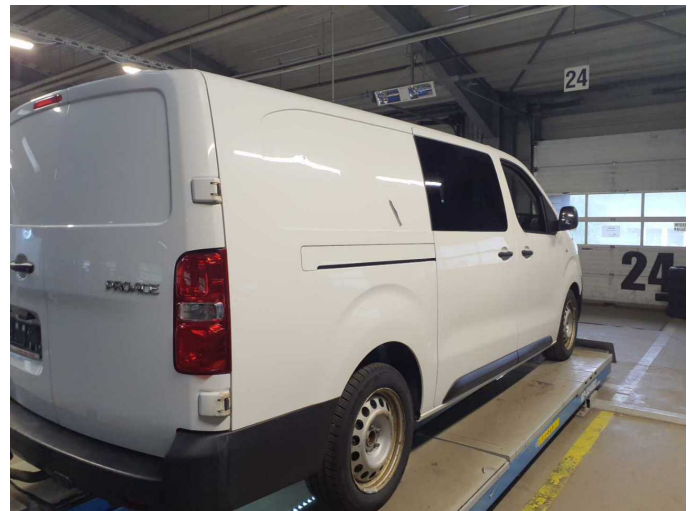
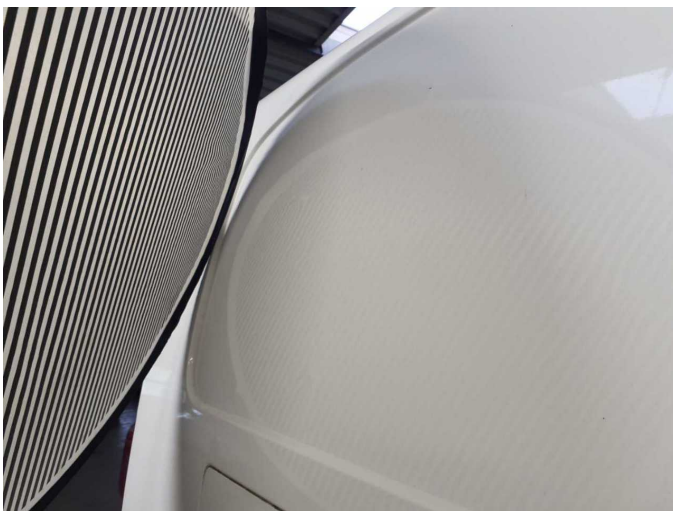
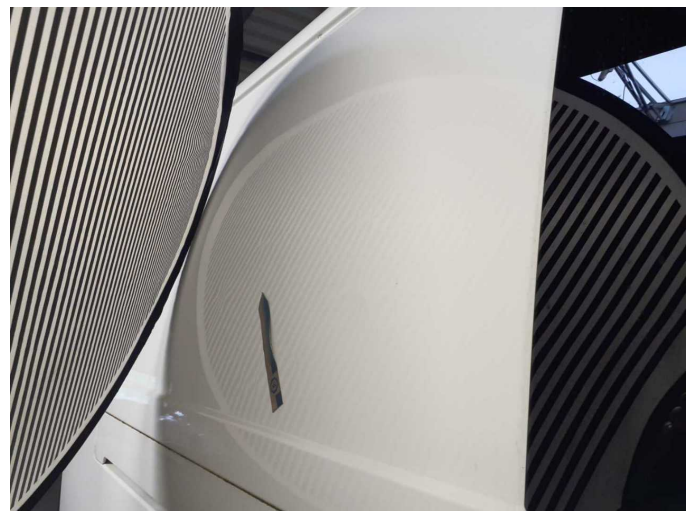
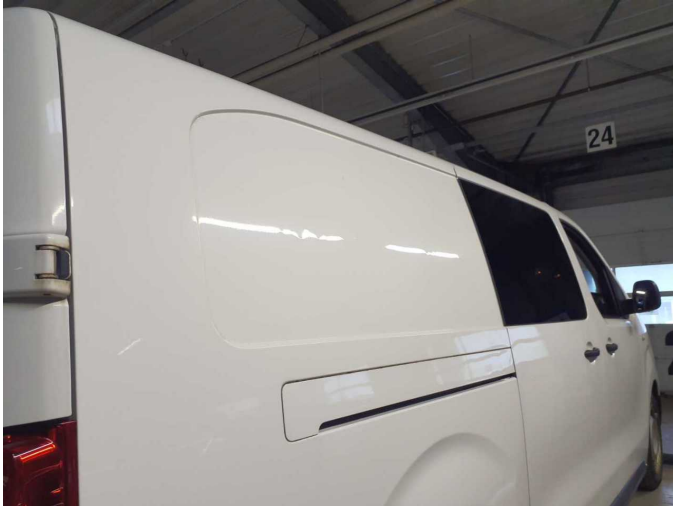
Damage 3: Side panel - rear right side: Side panel - Dent / paintcoat damage - Smart repair

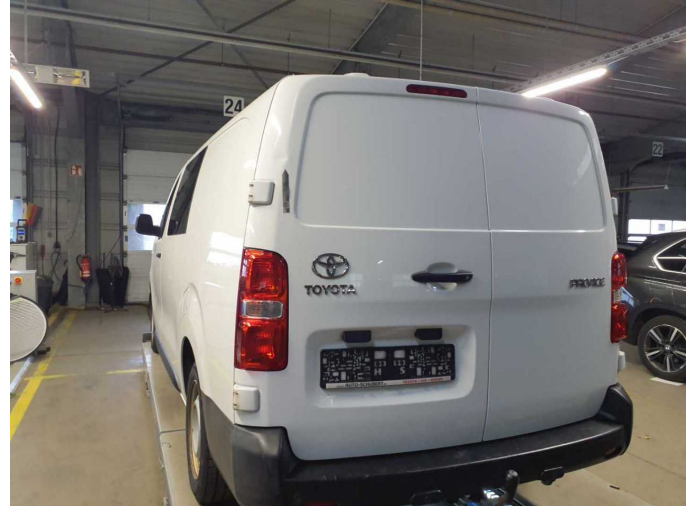
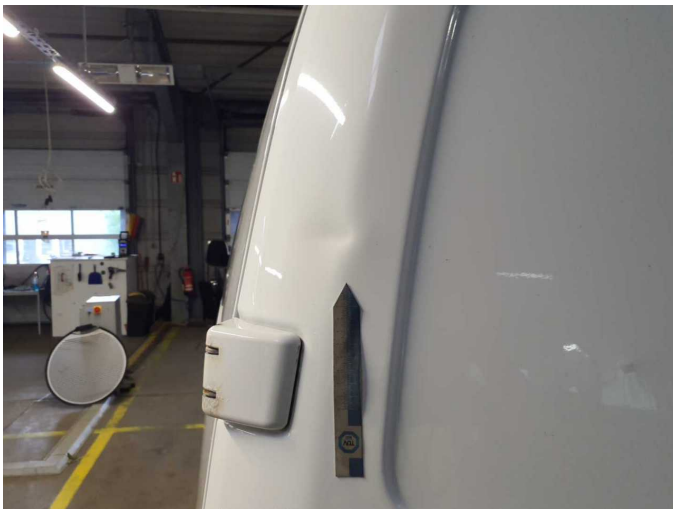
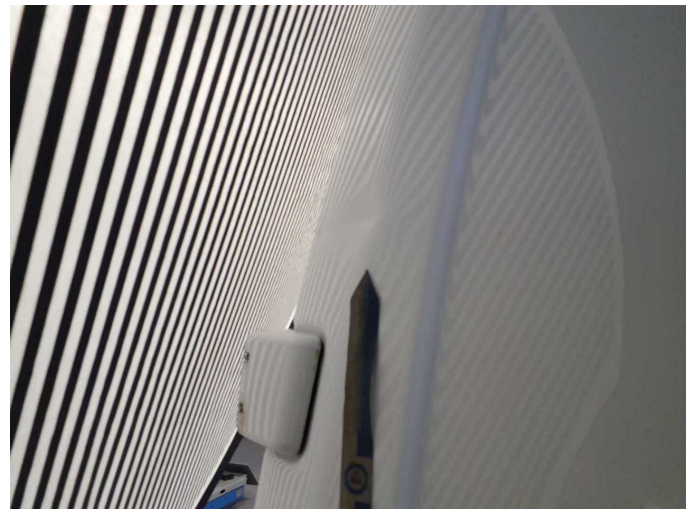
Damage 4: Boot lid / rear door: Rear door - left side - Deformed - Smart repair

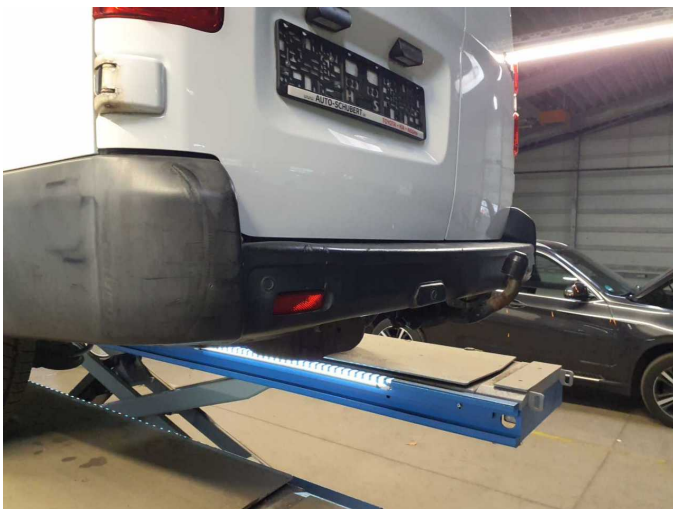
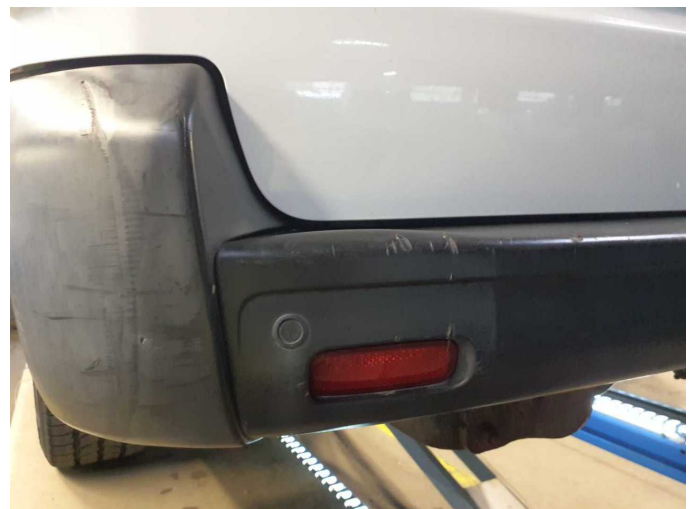
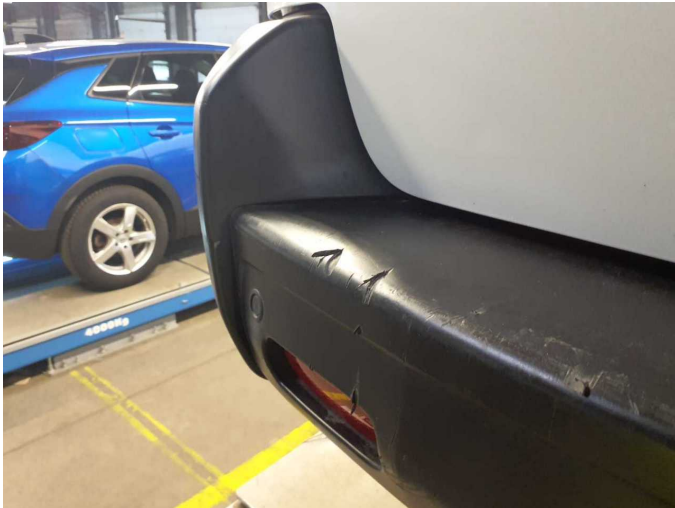
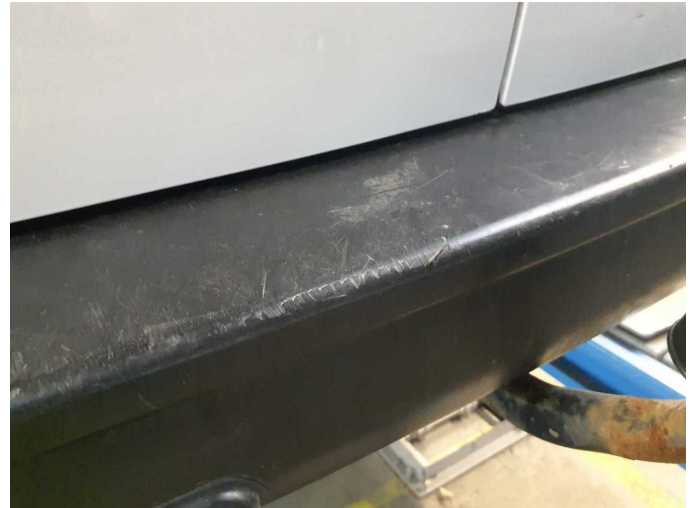
Damage 5: Rear bumper: Rear bumper - Deformed - Loss in value

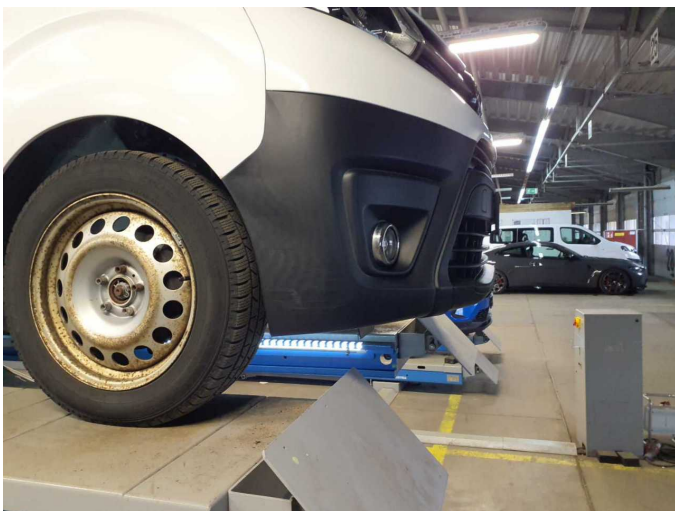
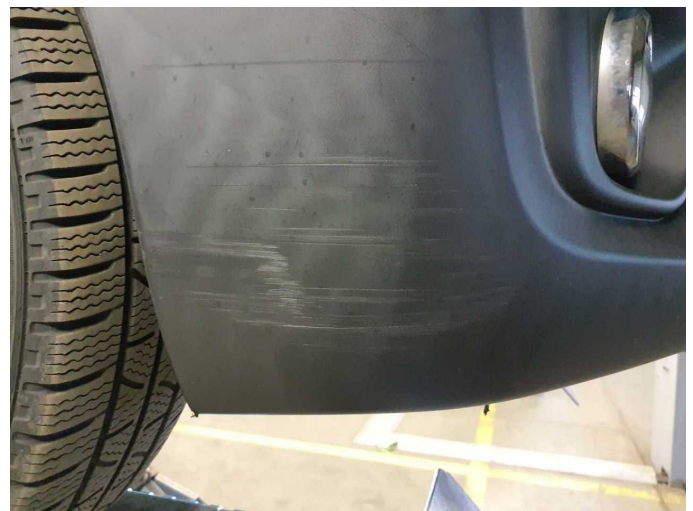
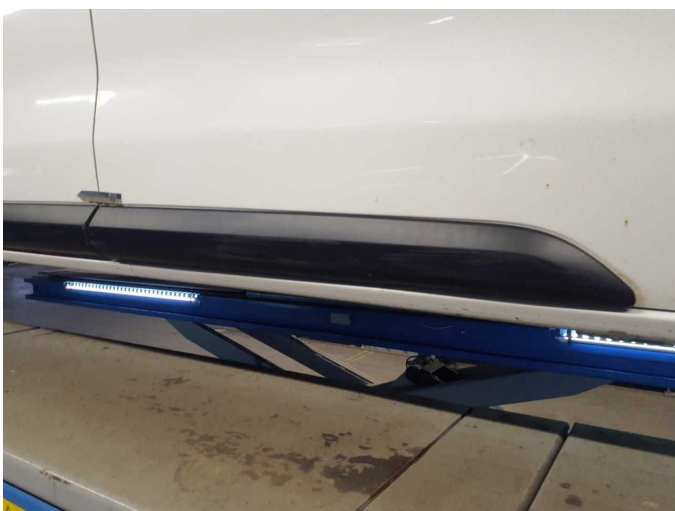
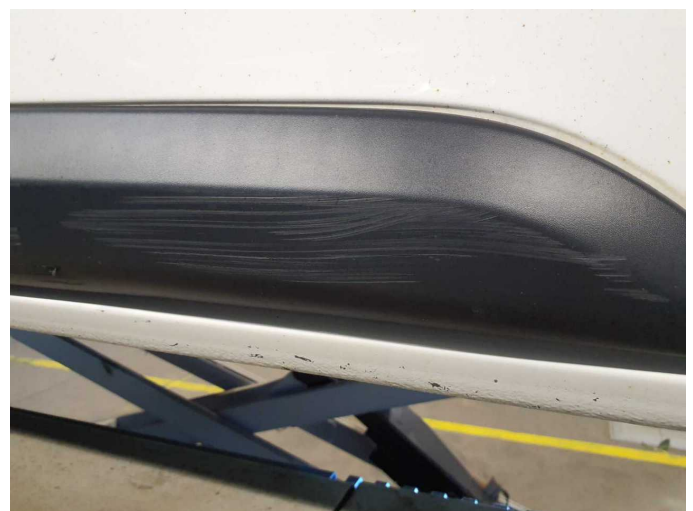
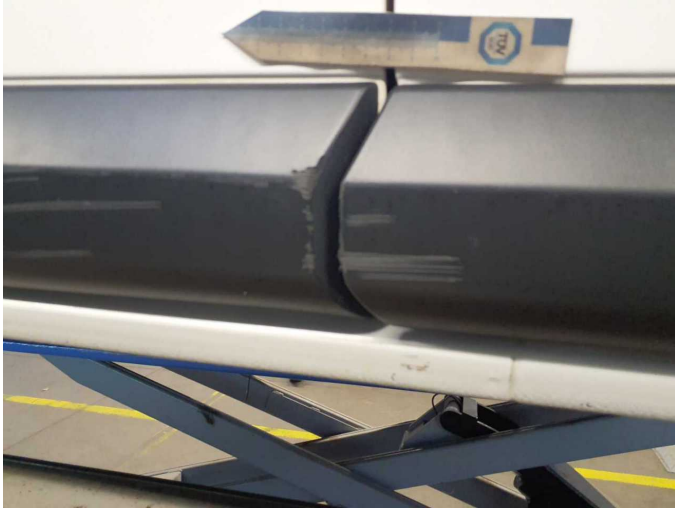
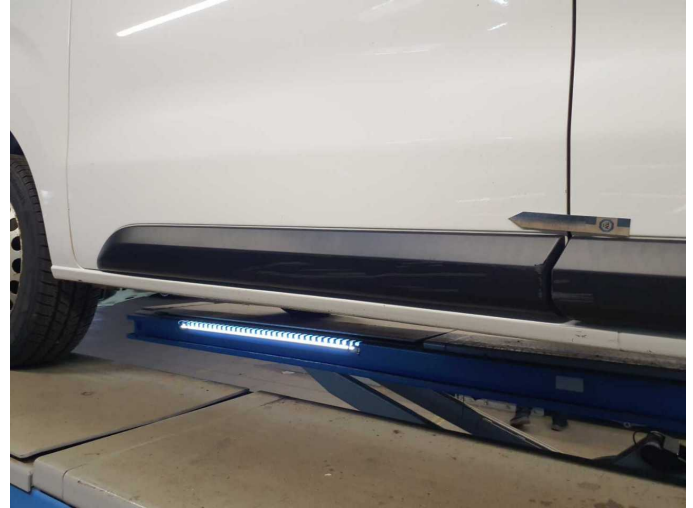
Damage 6: Front bumper: Front bumper (Zierleisten) - Scratched - Smart repair

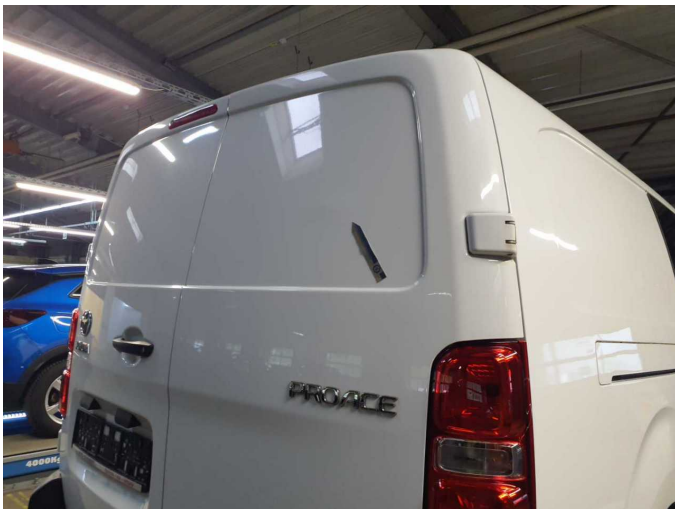
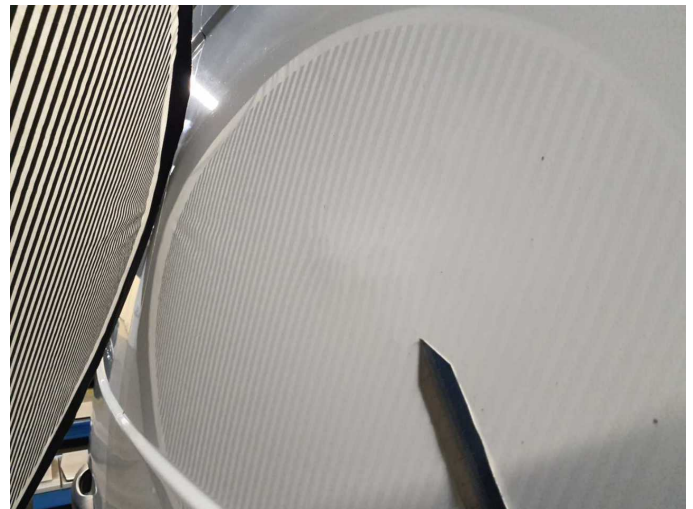
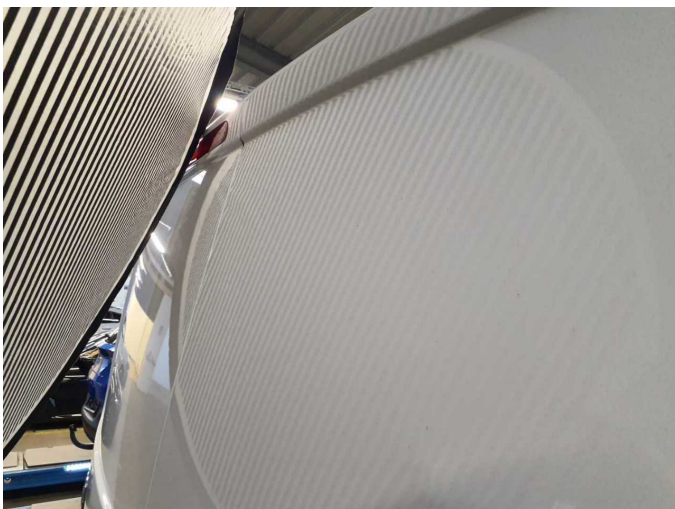
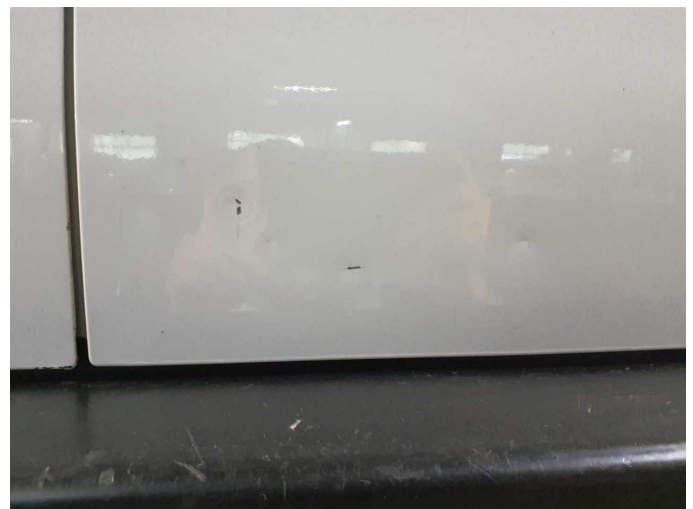
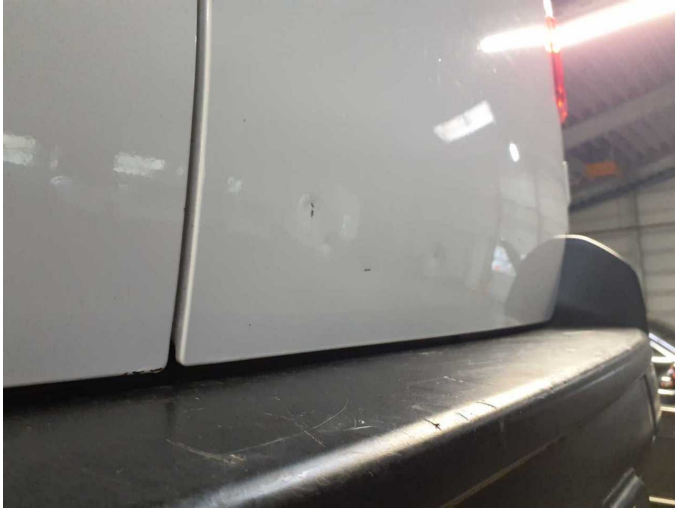
Damage 7: Boot lid / rear door: Rear door - right side - Dent / paintcoat damage - Repair and paint

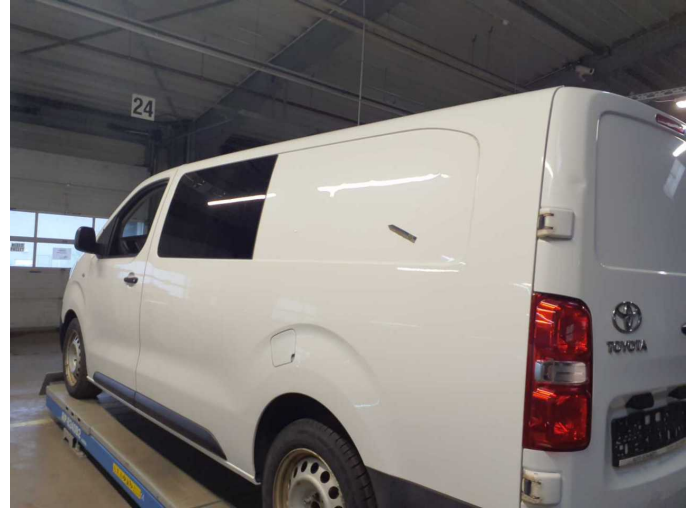
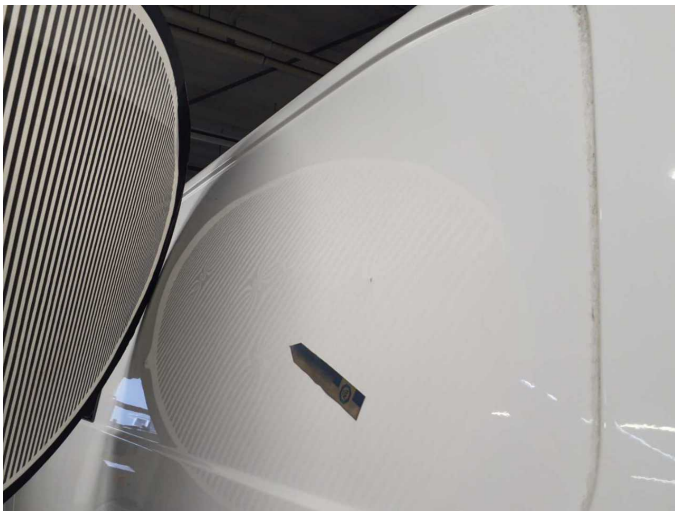
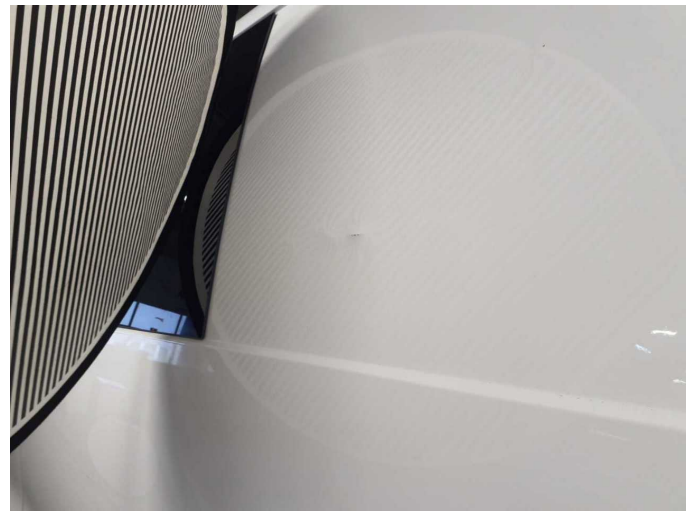
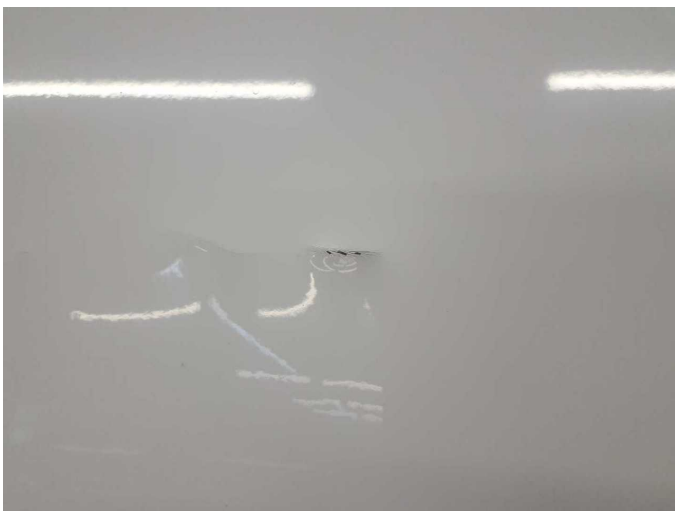
Damage 8: Side panel - rear left side: Side panel - Dent / paintcoat damage - Repair and paint
