Expertise

Protocol number: 46448175  
Order No. / Reference: 25930075  
Inspection date: 7 Jul 2026

Manufacturer: Mercedes-Benz

Model: Vito 116 CDI Extralang HA PRO

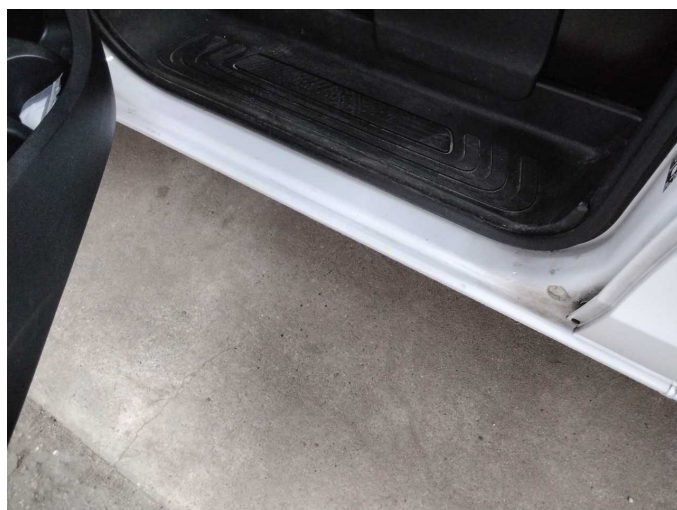
| No. | Component group | Description |
|---|---|---|
| 1 | Sill - left side | Sill - Scratch(es) - Smart repair |

**Damage 1:** Sill - left side: Sill - Scratch(es) - Smart repair

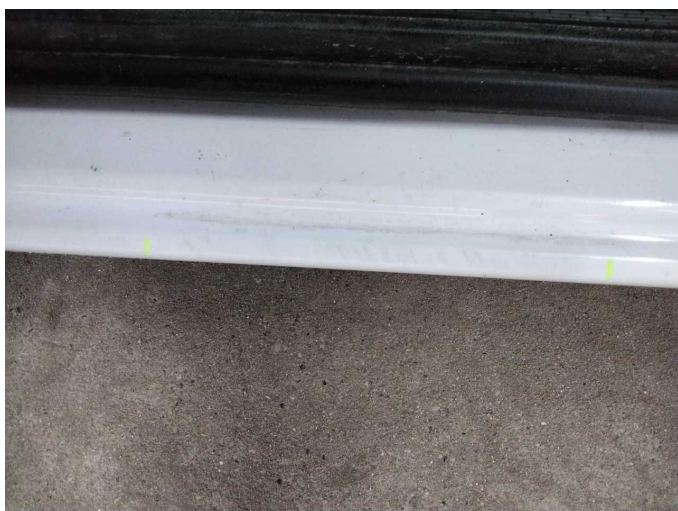
**Damage 1:** Sill - left side: Sill - Scratch(es) - Smart repair

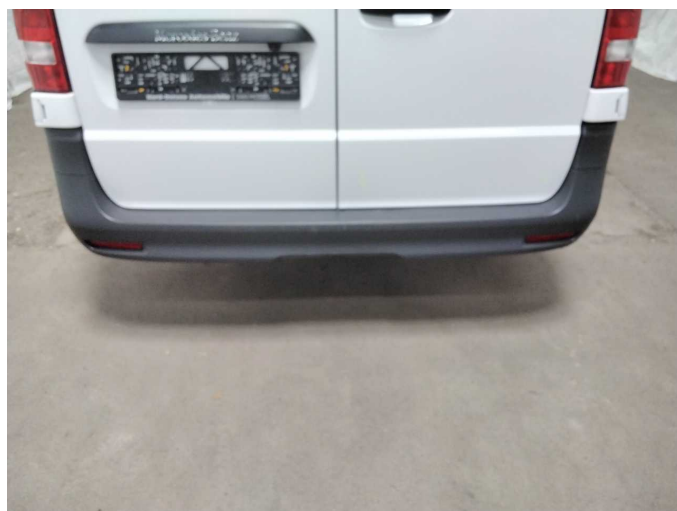
| No. | Component group | Description |
|---|---|---|
| 2 | Rear bumper | Rear bumper (Blende) - Missing - Replace |

**Damage 2:** Rear bumper: Rear bumper (Blende) - Missing - Replace

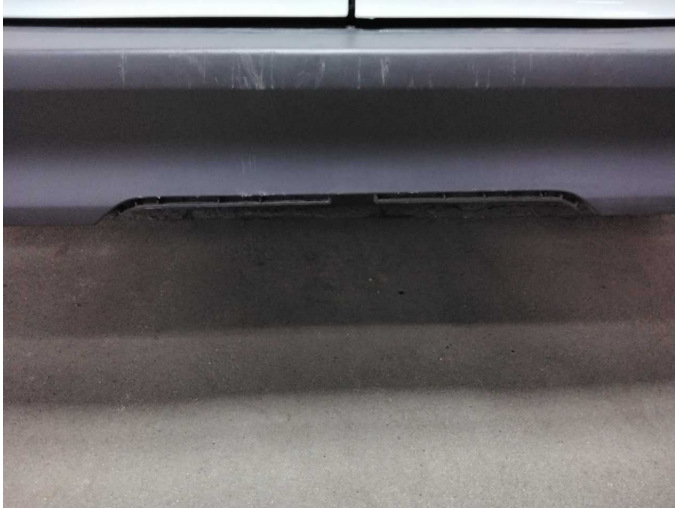
**Damage 2:** Rear bumper: Rear bumper (Blende) - Missing - Replace

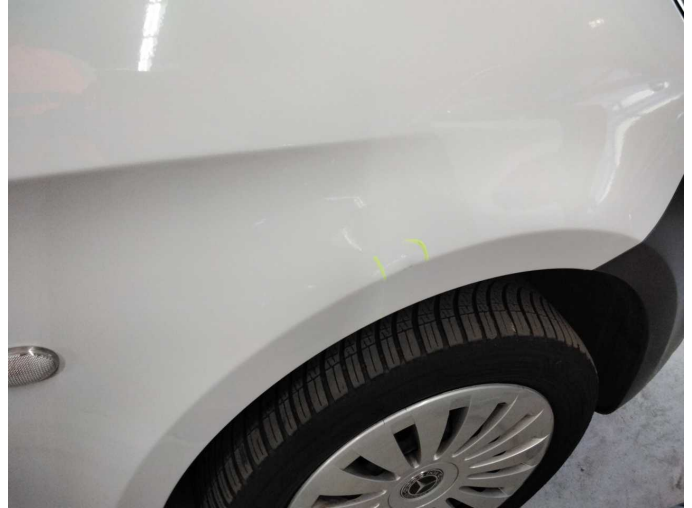
| No. | Component group | Description |
|---|---|---|
| 3 | Mudguard - right side | Mudguard - right side - Dent / paintcoat damage - Smart repair |

**Damage 3:** Mudguard - right side: Mudguard - right side - Dent / paintcoat damage - Smart repair

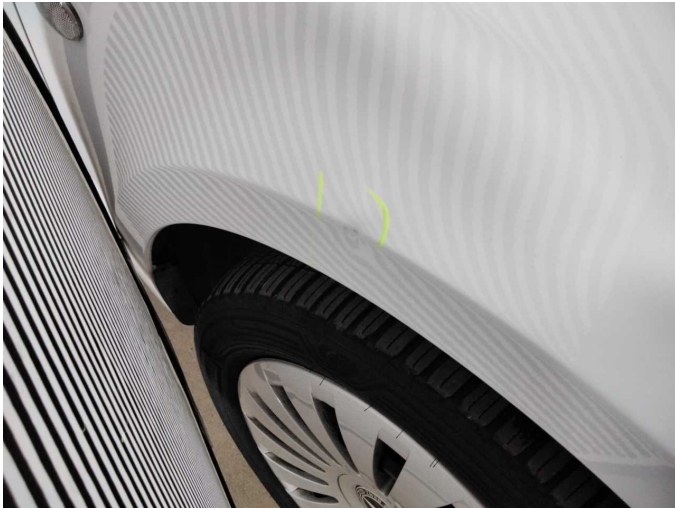
**Damage 3:** Mudguard - right side: Mudguard - right side - Dent / paintcoat damage - Smart repair

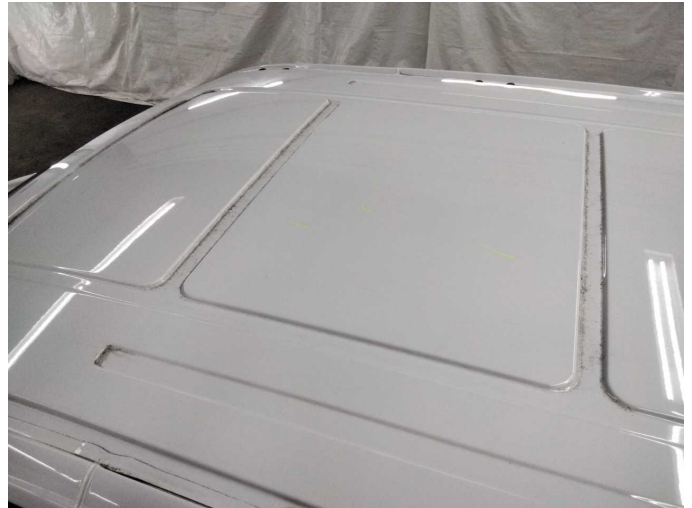
| No. | Component group | Description |
|---|---|---|
| 4 | Roof | Roof - dent(s) - Smooth repair work |

**Damage 4:** Roof: Roof - dent(s) - Smooth repair work

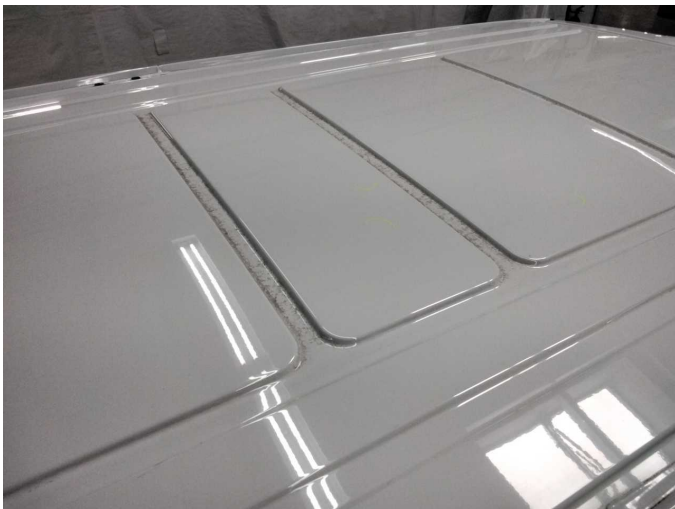
**Damage 4:** Roof: Roof - dent(s) - Smooth repair work

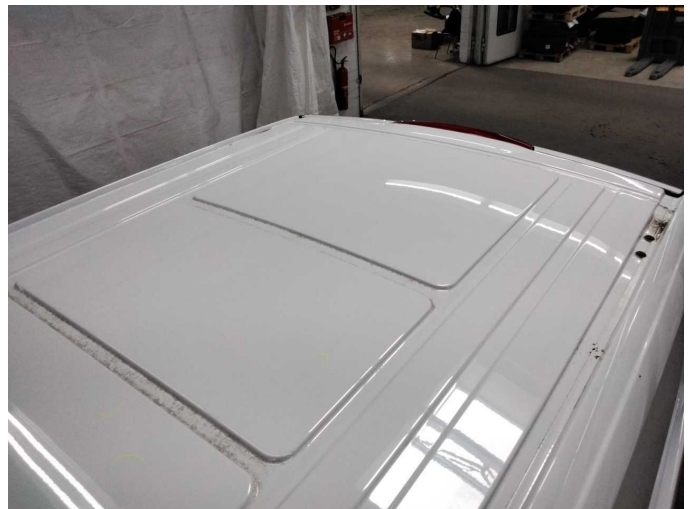
**Damage 4:** Roof: Roof - dent(s) - Smooth repair work

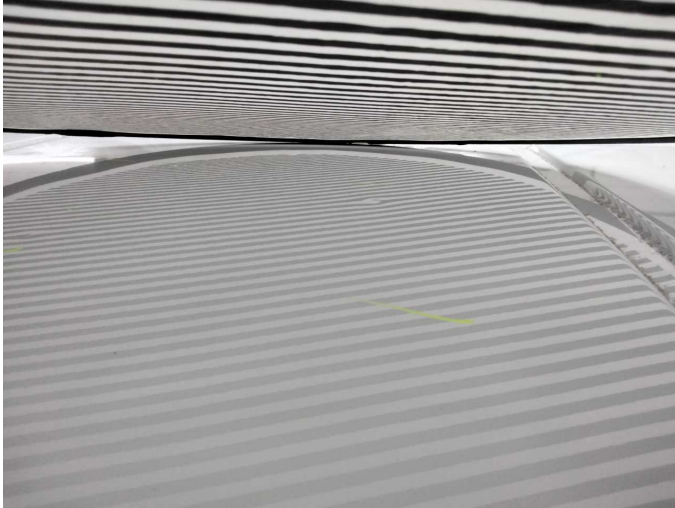
**Damage 4:** Roof: Roof - dent(s) - Smooth repair work

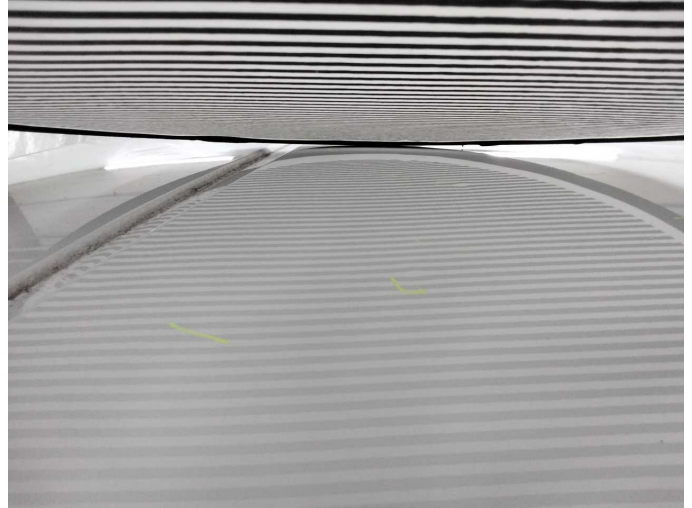
**Damage 4:** Roof: Roof - dent(s) - Smooth repair work

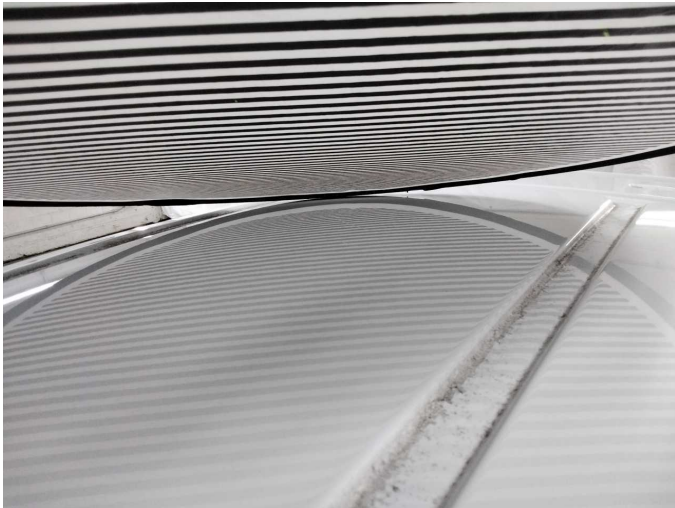
**Damage 4:** Roof: Roof - dent(s) - Smooth repair work

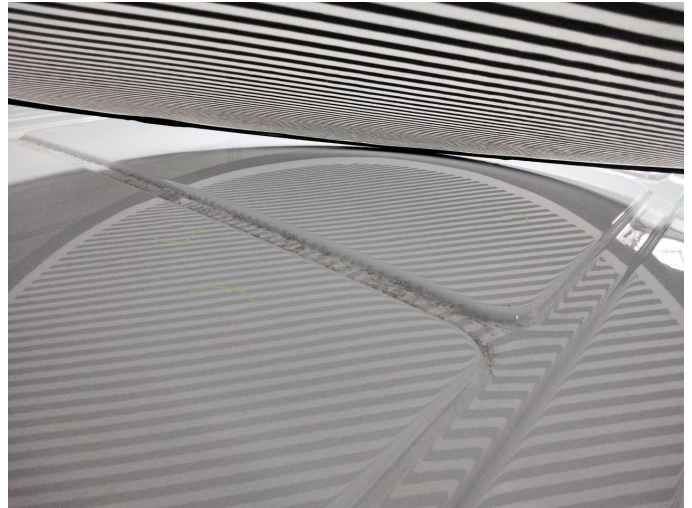
**Damage 4:** Roof: Roof - dent(s) - Smooth repair work

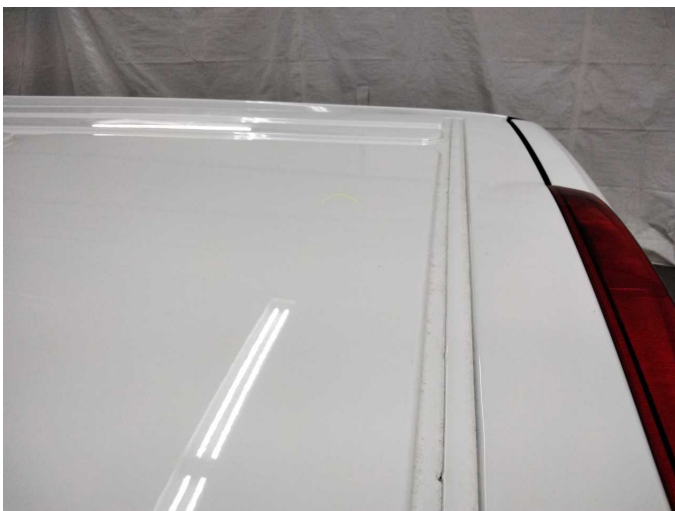
**Damage 4:** Roof: Roof - dent(s) - Smooth repair work

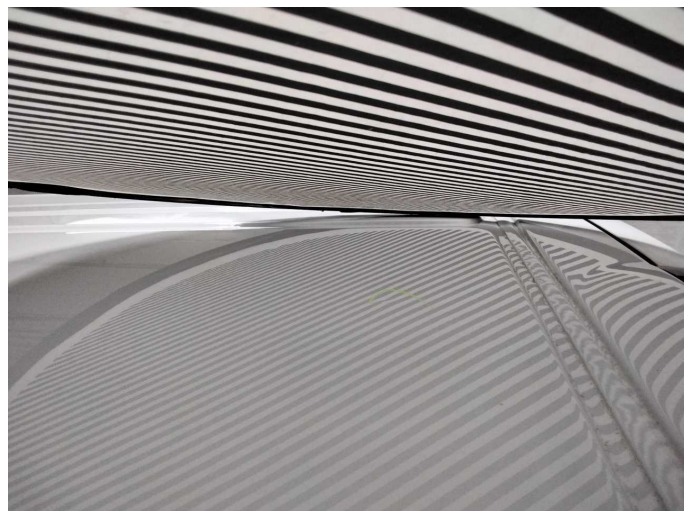
**Damage 4:** Roof: Roof - dent(s) - Smooth repair work

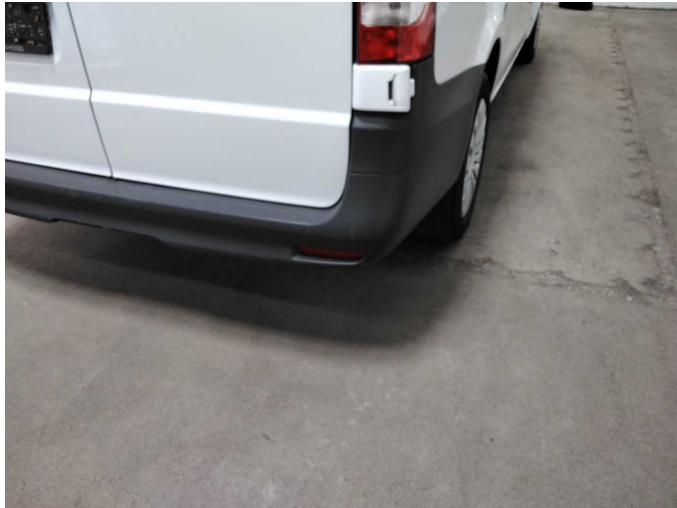
| No. | Component group | Description |
|---|---|---|
| 5 | Rear bumper | Rear bumper - Scratch(es) - Replace |

**Damage 5:** Rear bumper: Rear bumper - Scratch(es) - Replace

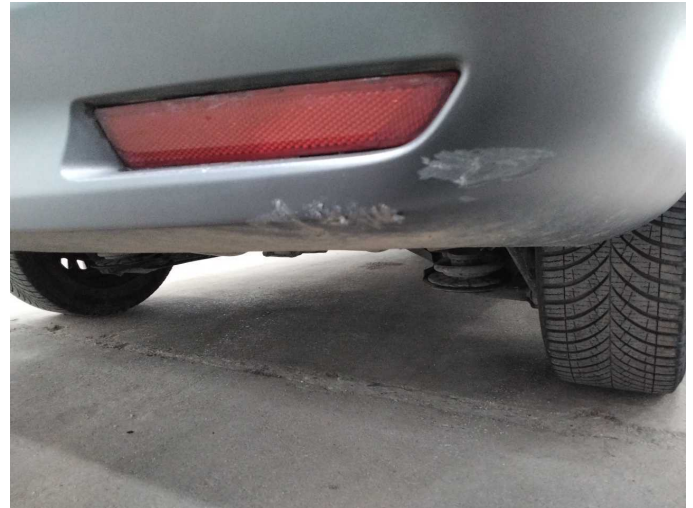
**Damage 5:** Rear bumper: Rear bumper - Scratch(es) - Replace

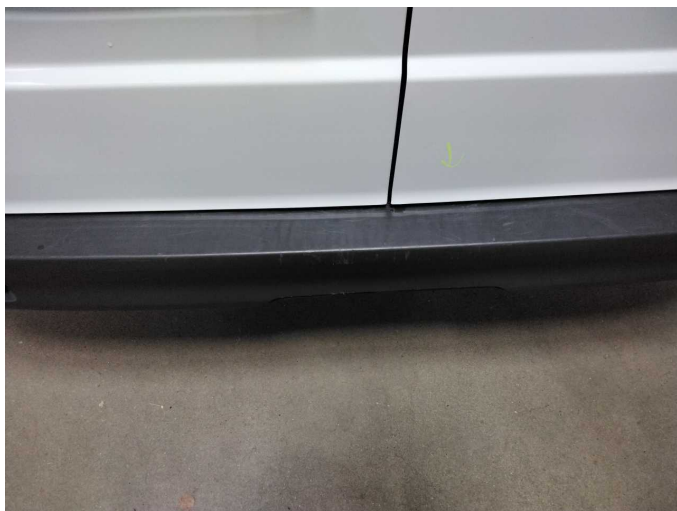
**Damage 5:** Rear bumper: Rear bumper - Scratch(es) - Replace

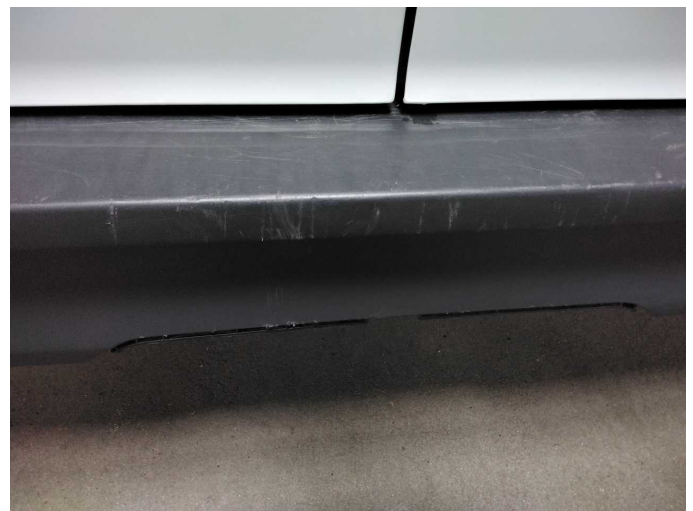
**Damage 5:** Rear bumper: Rear bumper - Scratch(es) - Replace
