Expertise

Protocol number: 44261509
Order number / reference: 25921506
Inspection date: 6 Mar 2026

Model: 317 CDI Sprinter Standard HA 9G-TRONIC PRO

VIN: W1V3KBFZ8TP864579

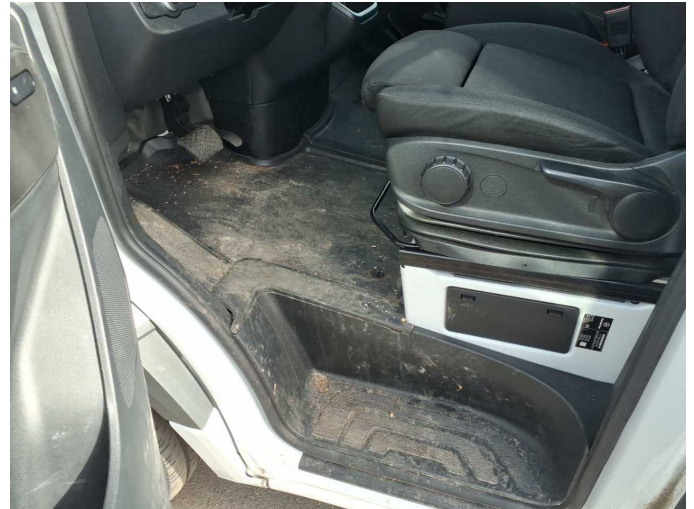
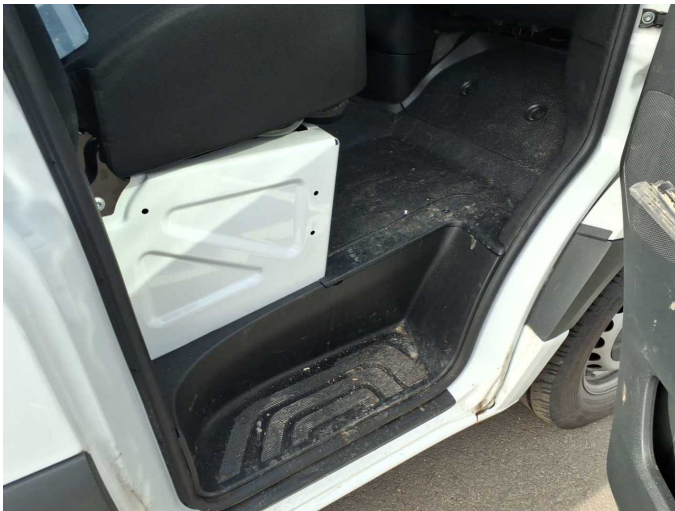
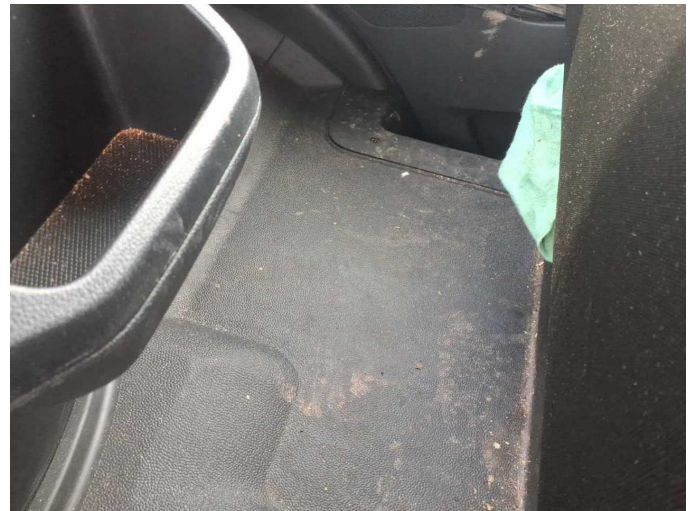
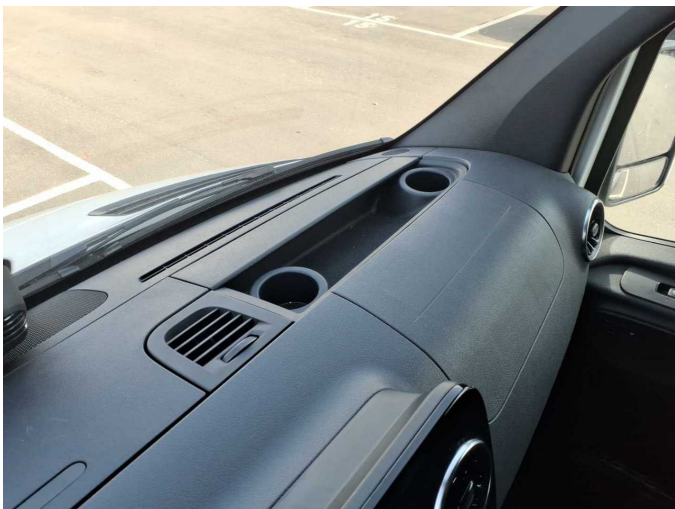
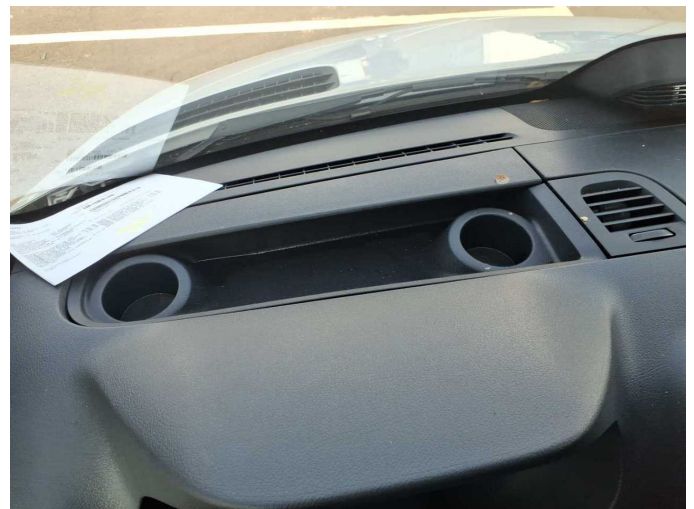
Damage 1: Interior: Interior - Soiled - Clean

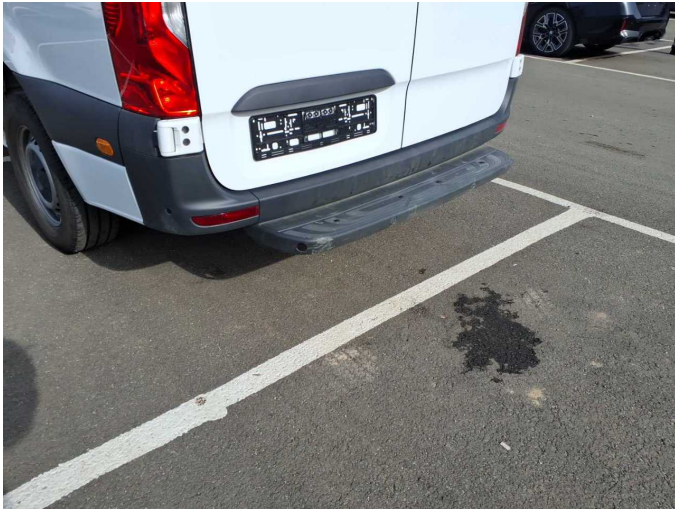
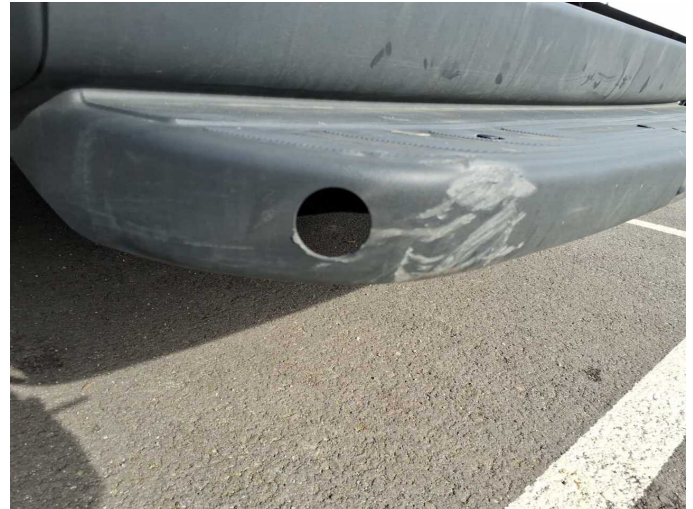
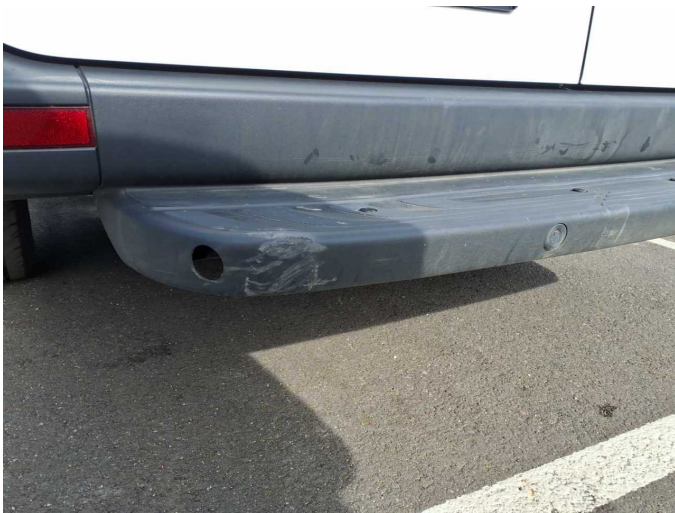
Damage 2: Rear bumper: Parking sensors - left side (Außen, inkl. Halter)
- Missing - Replace

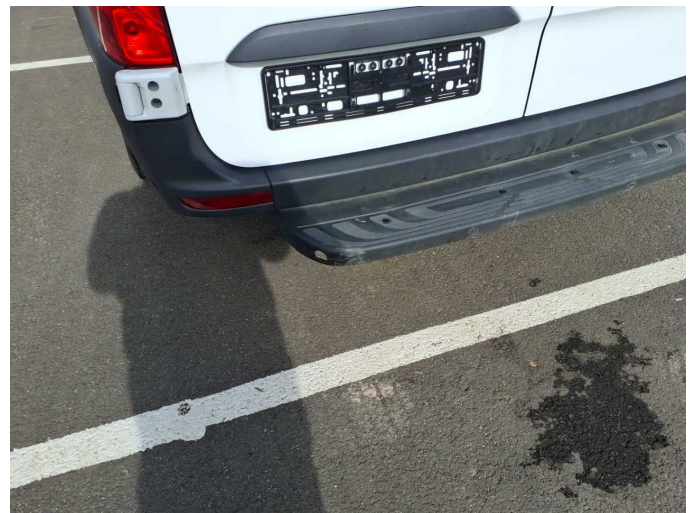
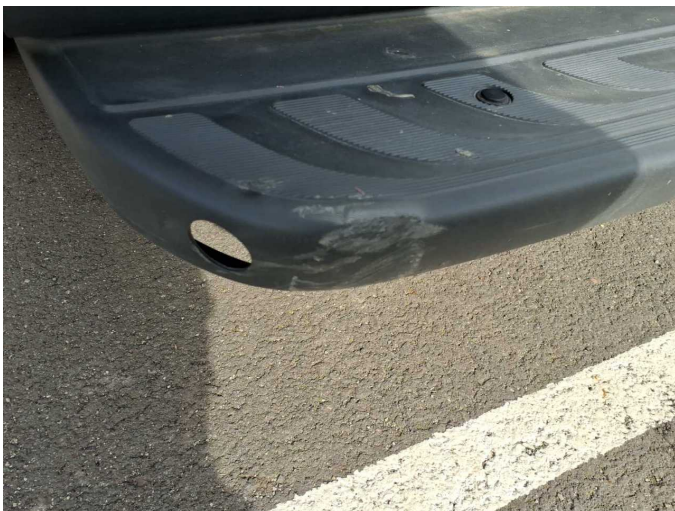
Damage 3: Rear of vehicle: Foot plate (Kunststoffbauteil) - Scratched -
Loss in value

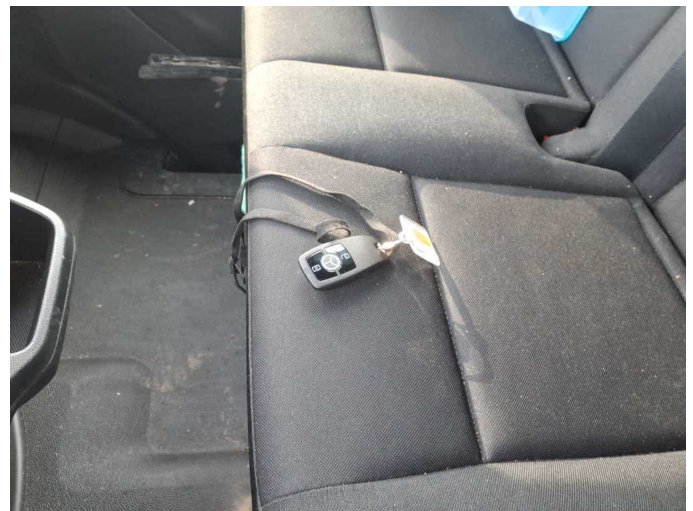
Missing part 1: Documents: Log book - Missing - Replace

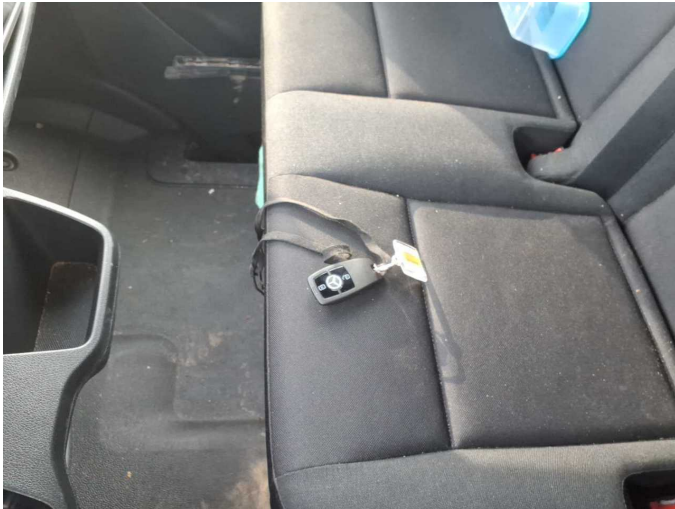
Missing part 2: Equipment: Vehicle key - Missing - Replace
