Expertise

Protocol number: 46402550  
Order No. / Reference: 26576591  
Inspection date: 8 Jul 2026

Manufacturer: Ford

Model: Transit Custom 320 L1H1 LKW VA Autm. Trend

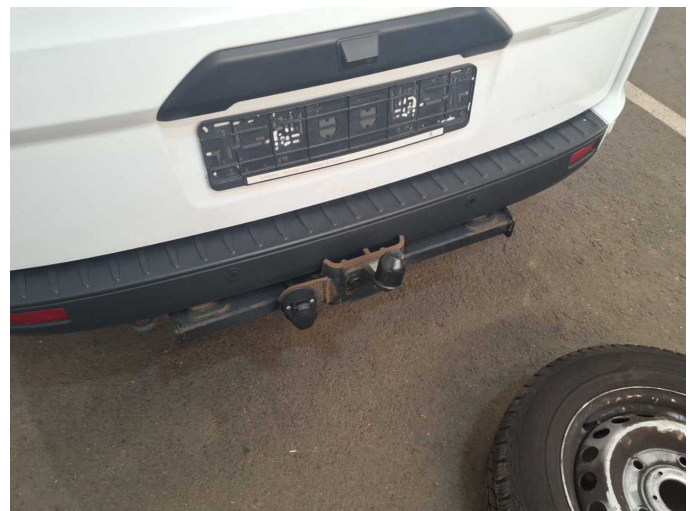
| No. | Component group | Description |
|---|---|---|
| 1 | Rear of vehicle | Trailer hitch - Corrosion - Loss in value |

Damage 1: Rear of vehicle: Trailer hitch - Corrosion - Loss in value

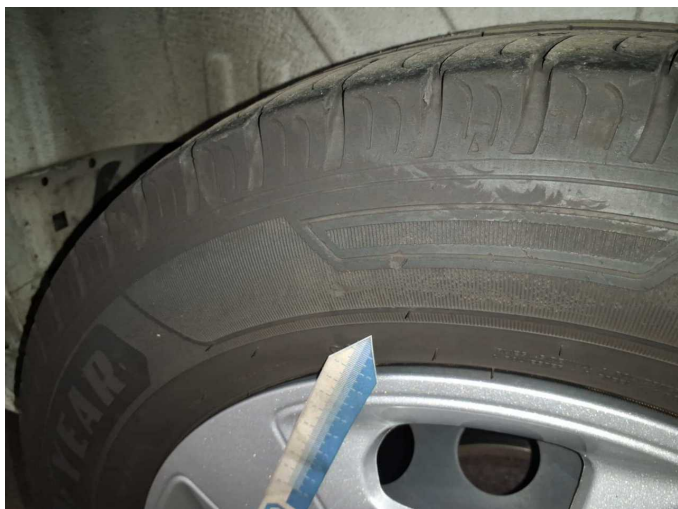
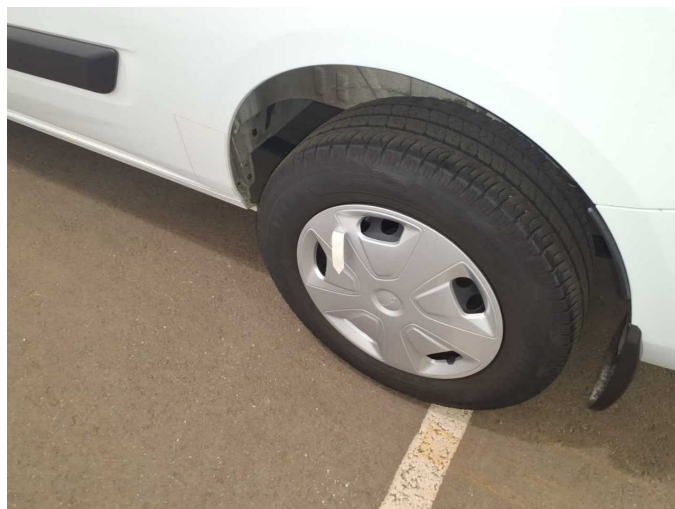
| No. | Component group | Description |
|---|---|---|
| 2 | Wheel / tyres | Tyre - rear left side (nicht fahrbereit) - Broken / torn - Replace |

**Damage 2:** Wheel / tyres: Tyre - rear left side (nicht fahrbereit) - Broken / torn - Replace

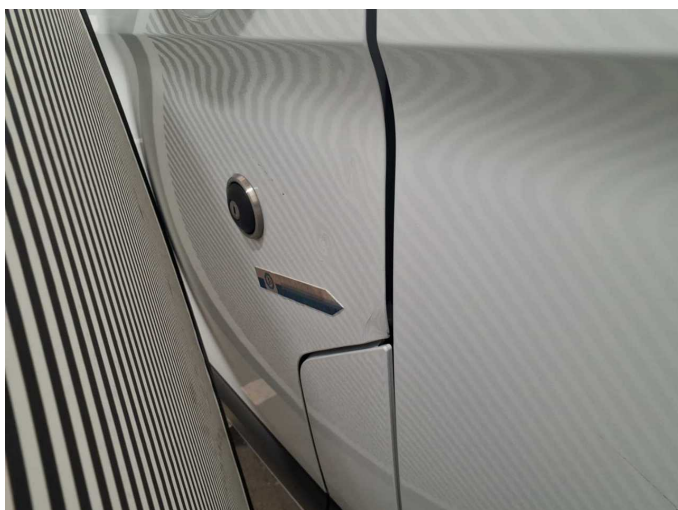
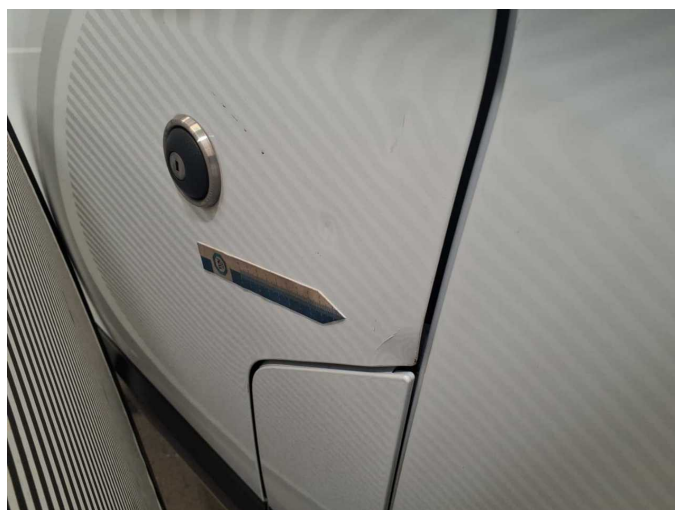
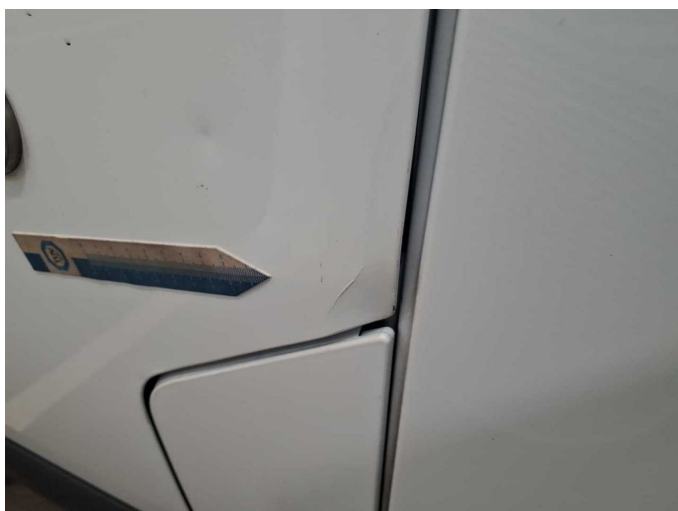
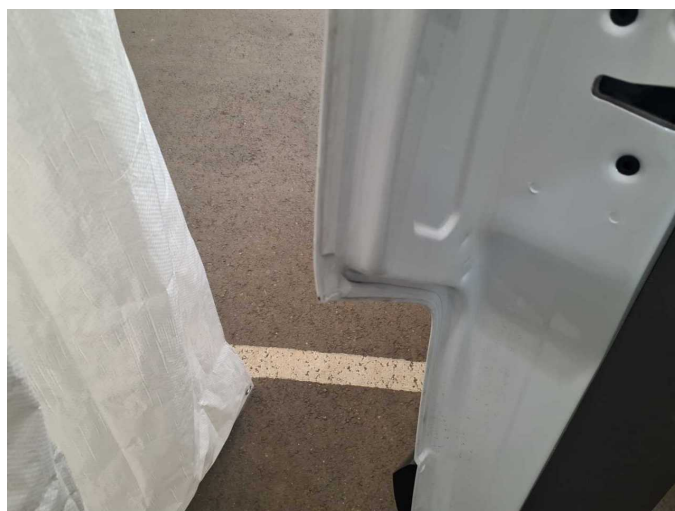
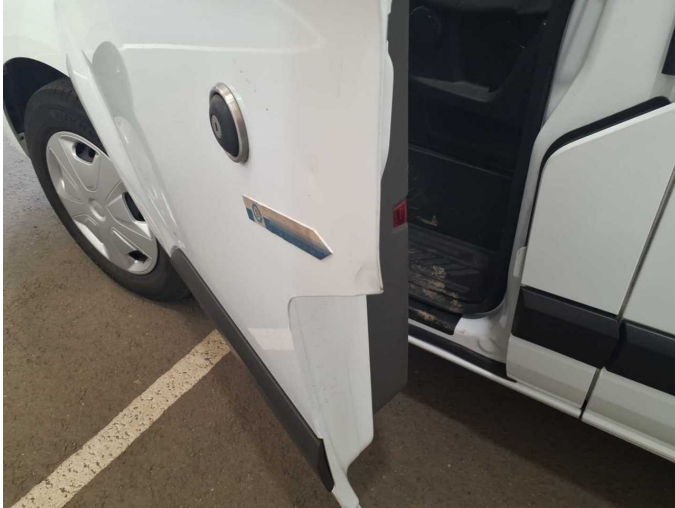
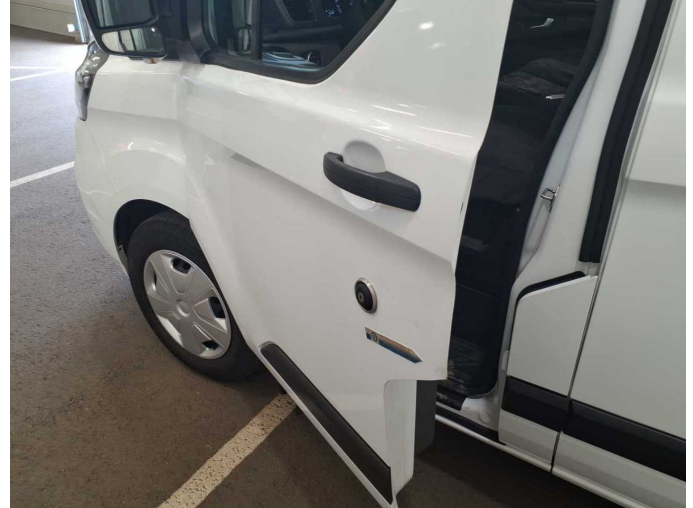
| No. | Component group | Description |
|---|---|---|
| 3 | Door - front left side | Door - Deformed - Repair and paint |

**Damage 3:** Door - front left side: Door - Deformed - Repair and paint

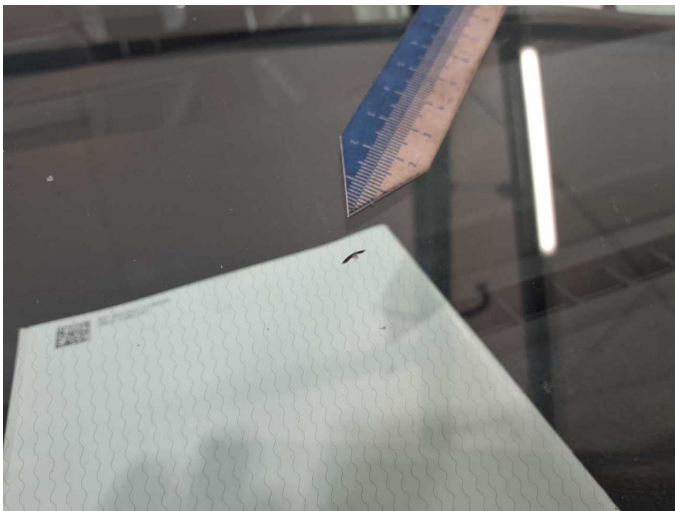
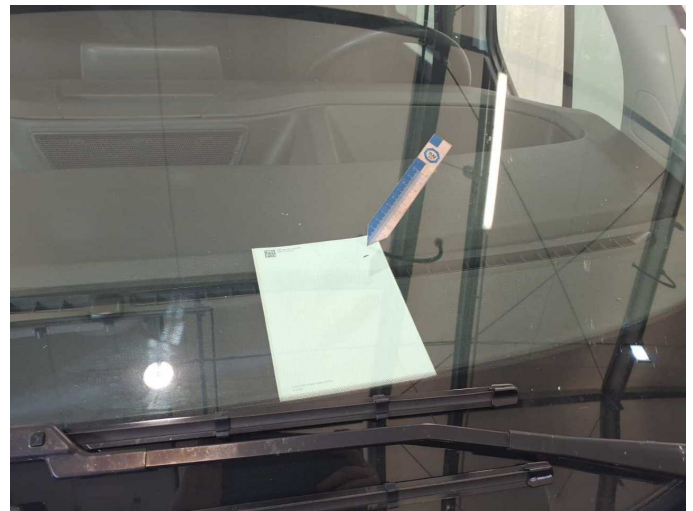
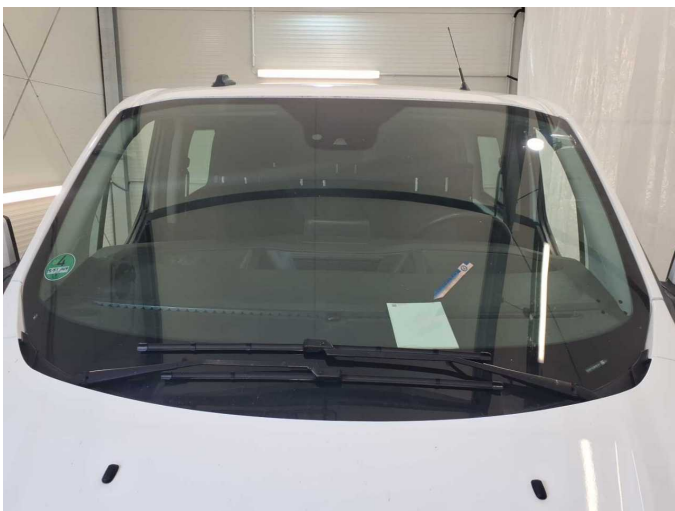
| No. | Component group | Description |
|---|---|---|
| 4 | Vehicle glazing | Windscreen (kein Staubschutz) - Stone chips - repair according to calculation |

**Damage 4:** Vehicle glazing: Windscreen (kein Staubschutz) - Stone chips - repair according to calculation

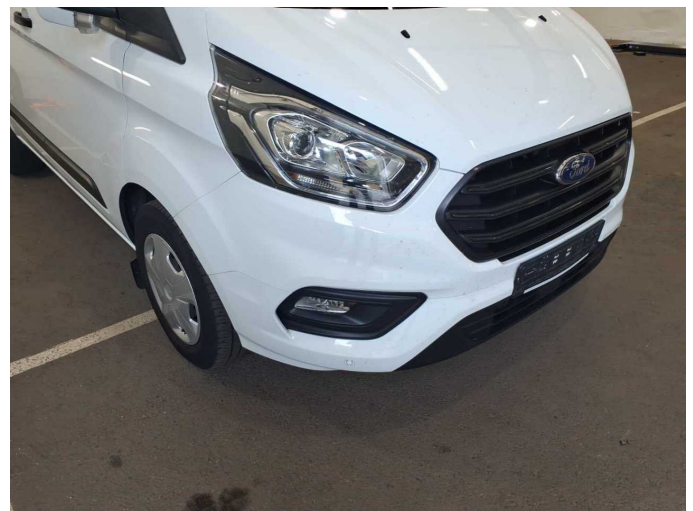
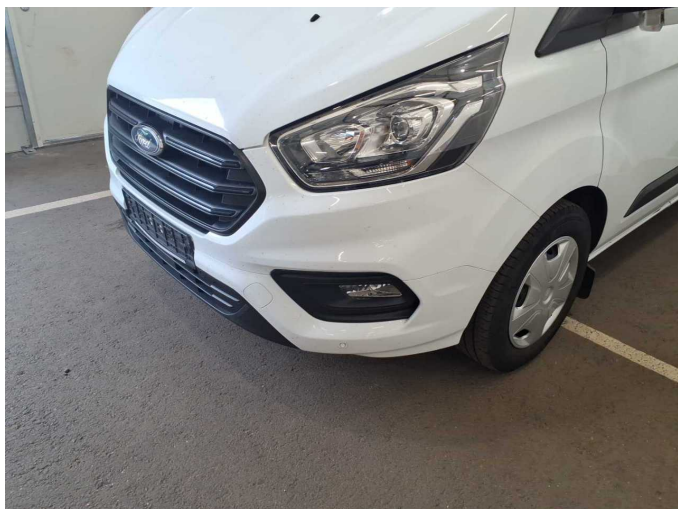
| No. | Component group | Description |
|---|---|---|
| 2 | Front bumper | Front bumper - Stone chips - No deduction |

**Wear and tear 2:** Front bumper: Front bumper - Stone chips - No deduction

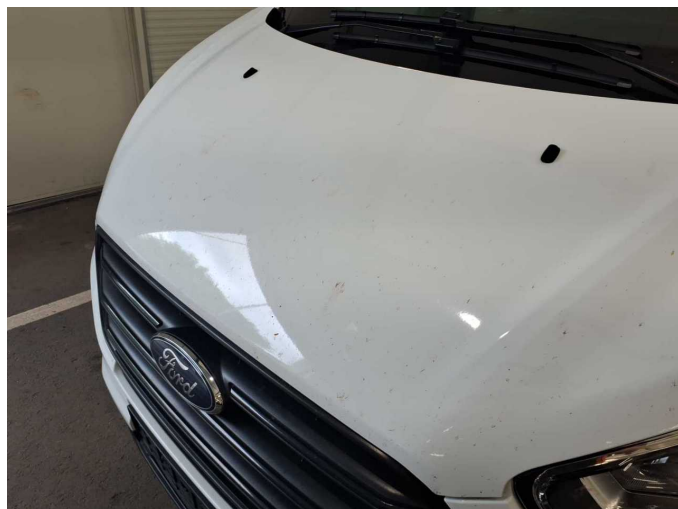
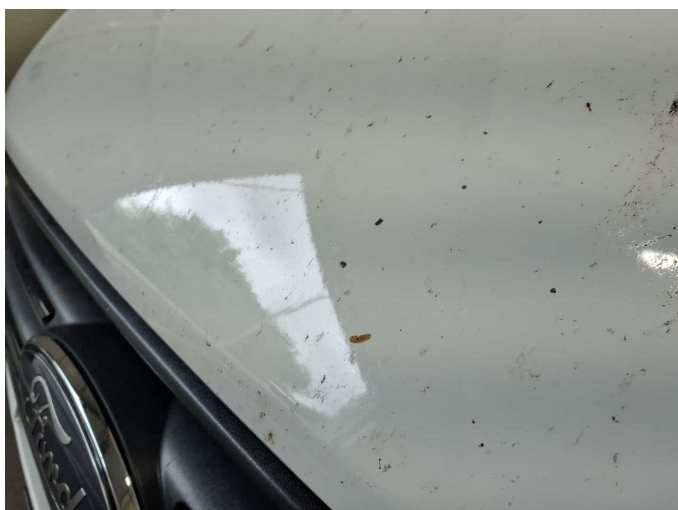
| No. | Component group | Description |
|---|---|---|
| 3 | Bonnet | Bonnet - Stone chips - No deduction |

**Wear and tear 3:** Bonnet: Bonnet - Stone chips - No deduction

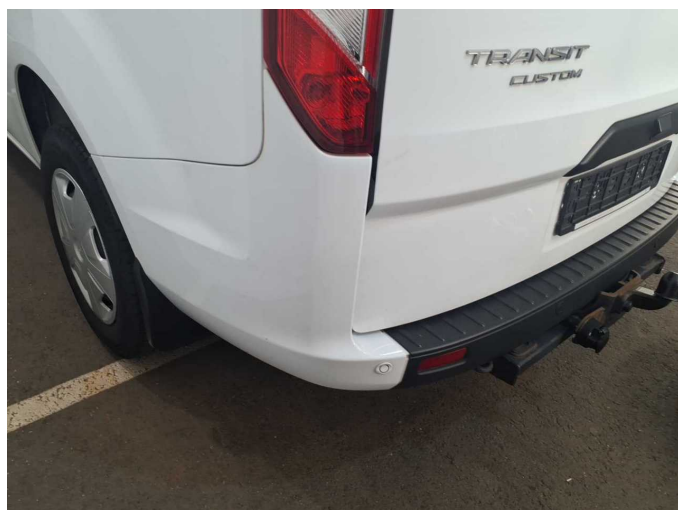
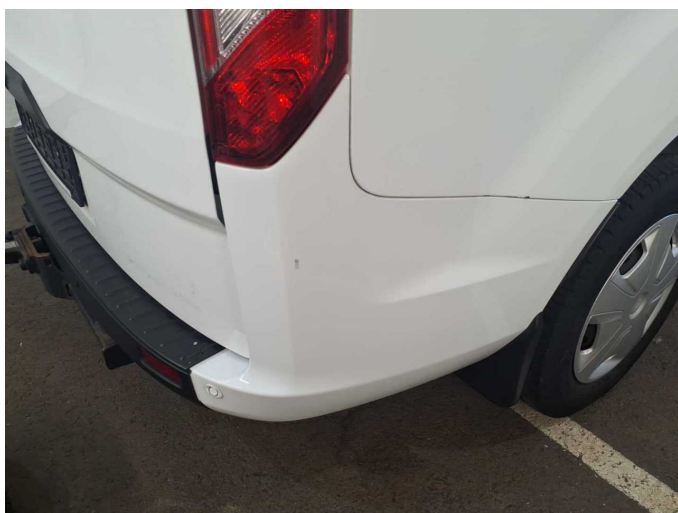
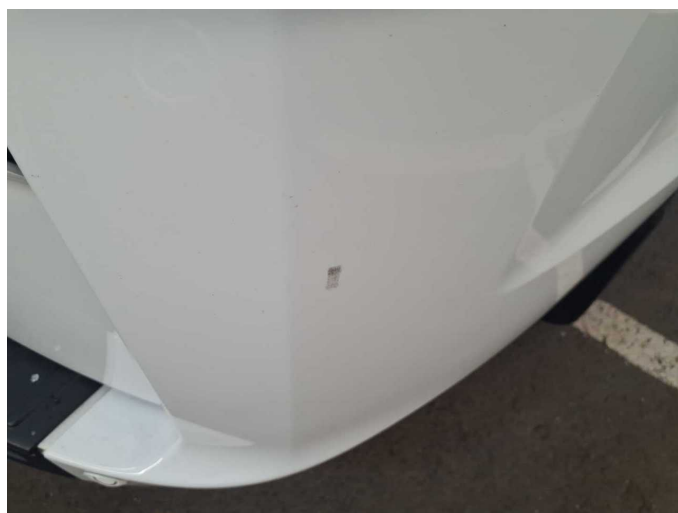
| No. | Component group | Description |
|---|---|---|
| 4 | Rear bumper | Rear bumper - Scratch(es) - No deduction |

**Wear and tear 4:** Rear bumper: Rear bumper - Scratch(es) - No deduction

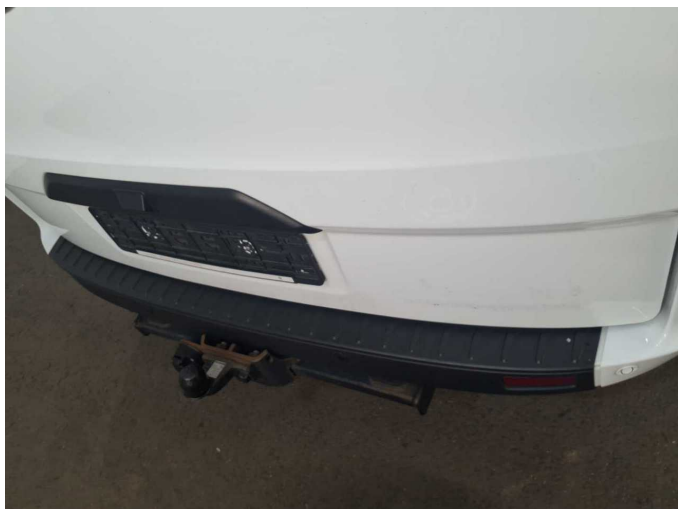
| No. | Component group | Description |
|---|---|---|
| 5 | Rear bumper | Rear bumper (unpainted) - Scratch(es) - No deduction |

**Wear and tear 5:** Rear bumper: Rear bumper (unpainted) - Scratch(es) -  
No deduction
