## Expertise

Protocol number: 46185940  
Order No. / Reference: 26151838  
Inspection date: 27 May 2026

Manufacturer: Mercedes-Benz

Model: Vito 116 CDI Lang HA Aut. PRO

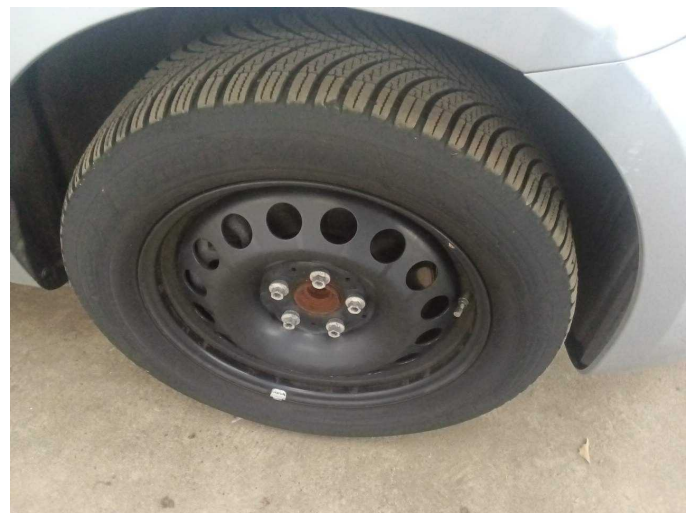
Damage 1: Wheel / tyres: Wheel cover - front right side - Missing - Replace

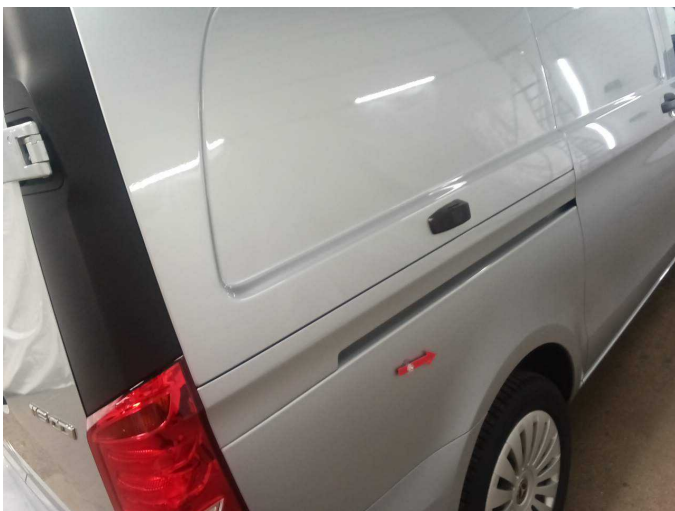
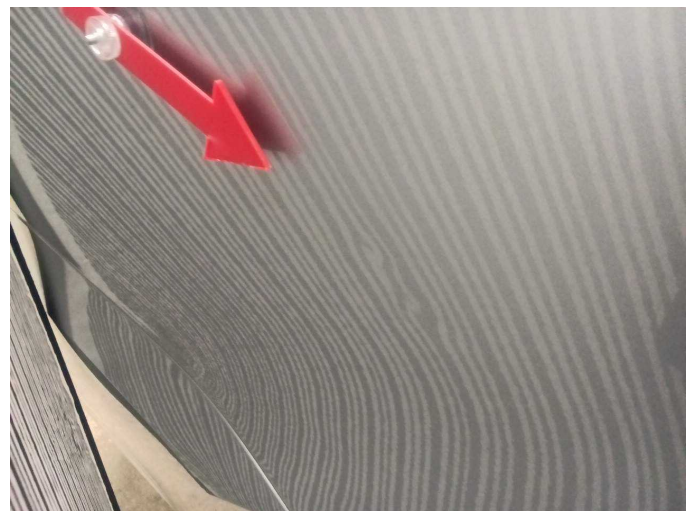
Damage 2: Side panel - rear right side: Side panel - dent(s) - Smooth repair work

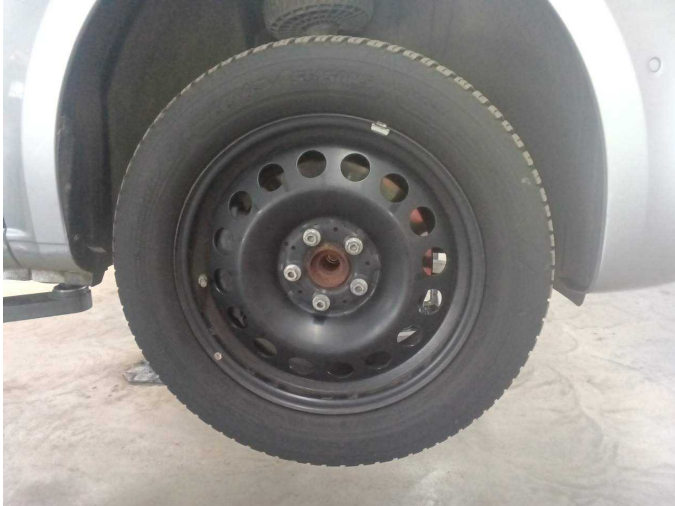
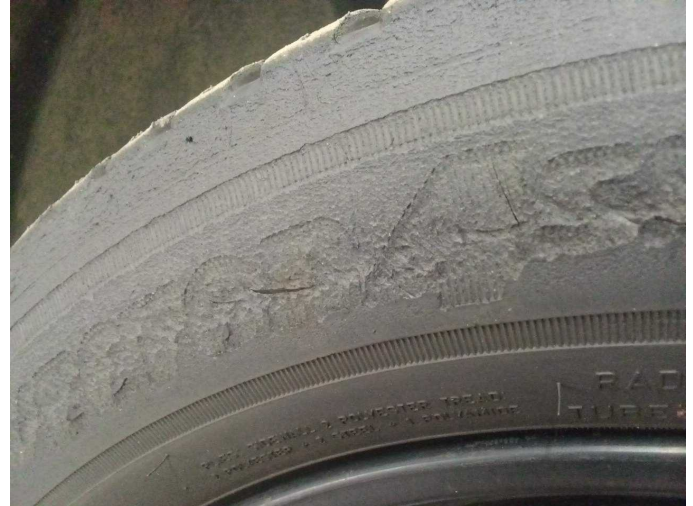
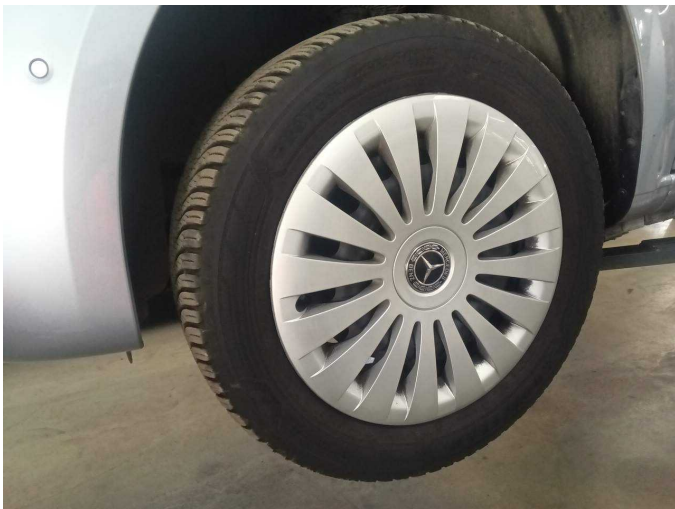
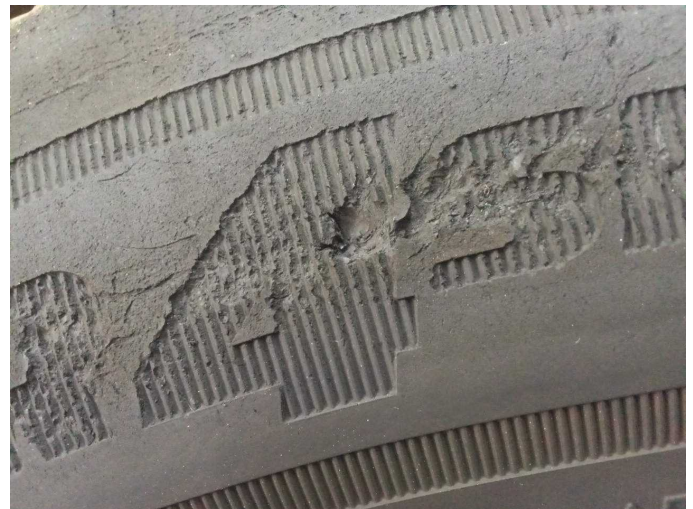
**Damage 3:** Wheel / tyres: Tyre - front (Allwetterreifen) - Porous / cracked  
- Replace

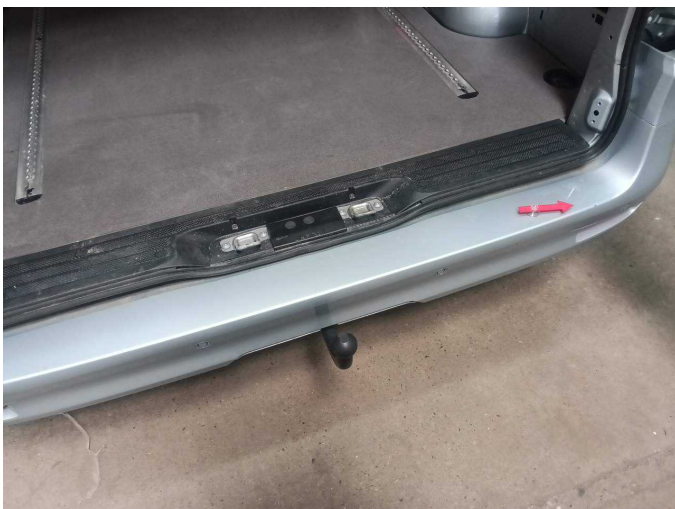
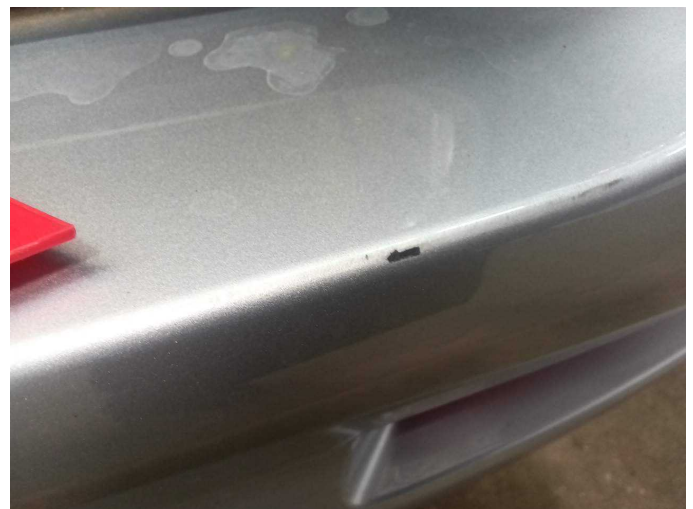
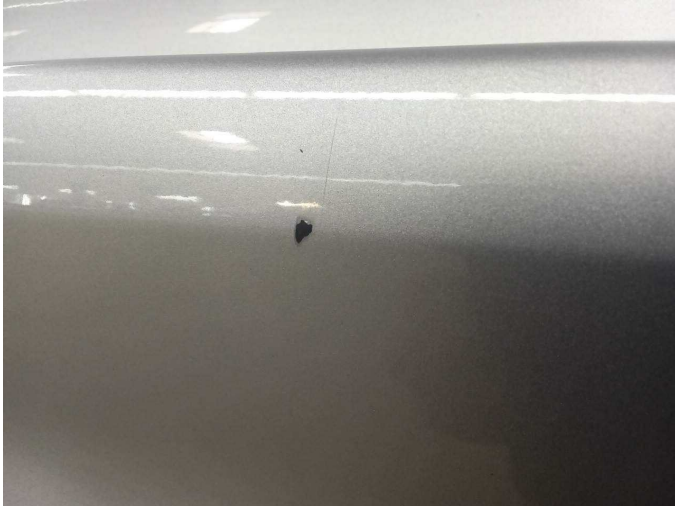
**Damage 4:** Rear bumper: Rear bumper - Scratch(es) - Paint

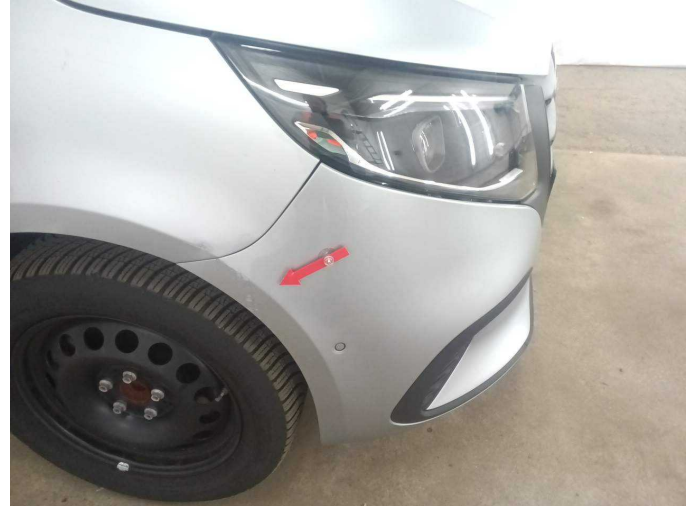
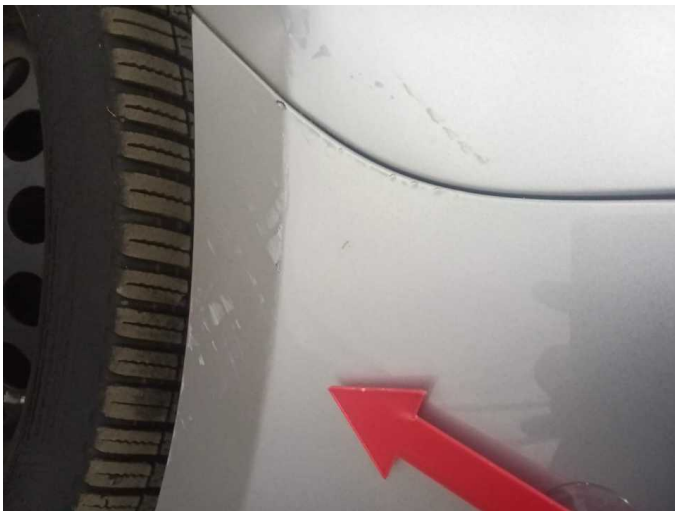
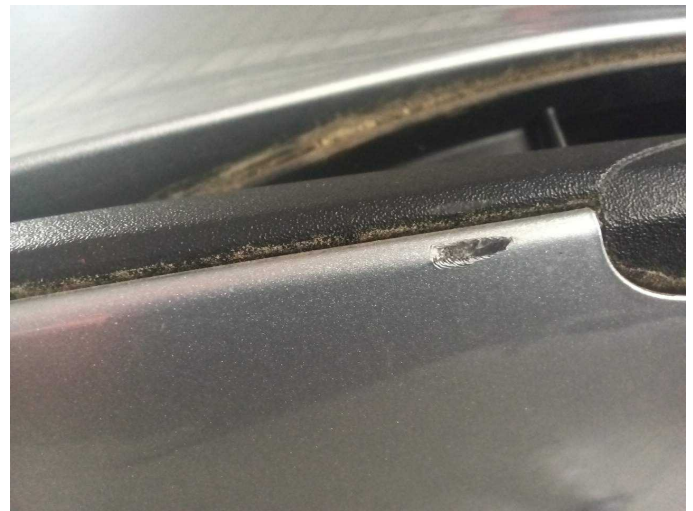
**Damage 5:** Front bumper: Front bumper - Scratch(es) - Paint

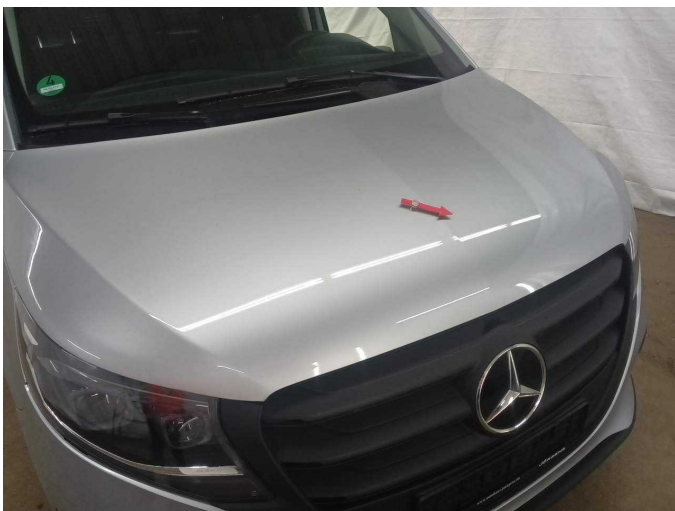
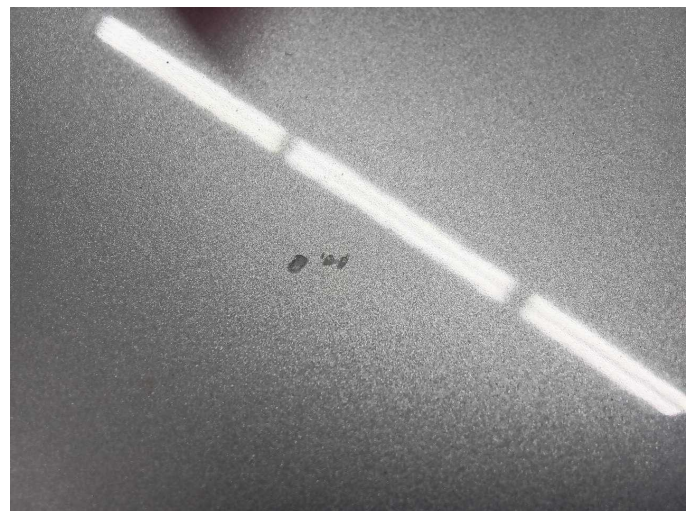
**Damage 6:** Bonnet: Bonnet - Stone chips - Paint

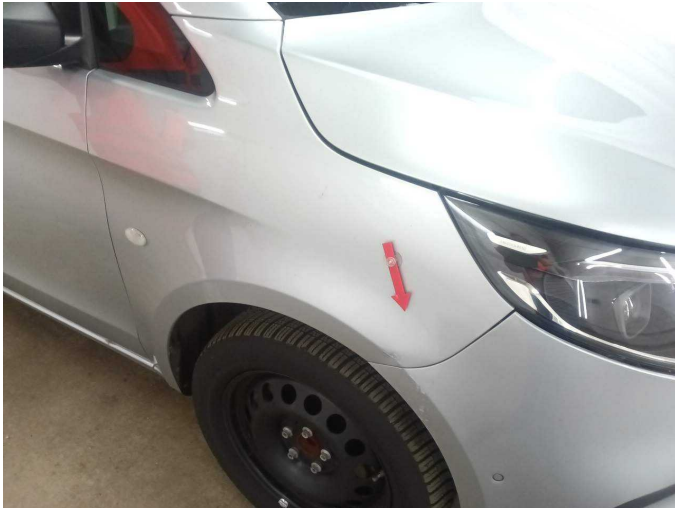
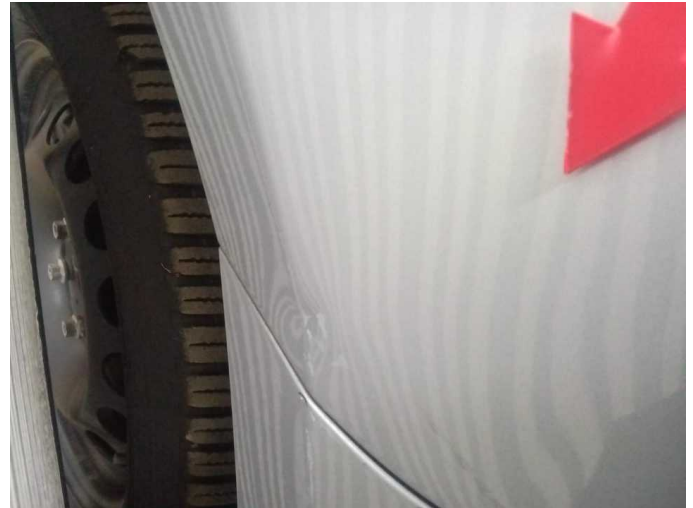
**Damage 7:** Mudguard - right side: Mudguard - right side - Dent / paintcoat damage - Replace

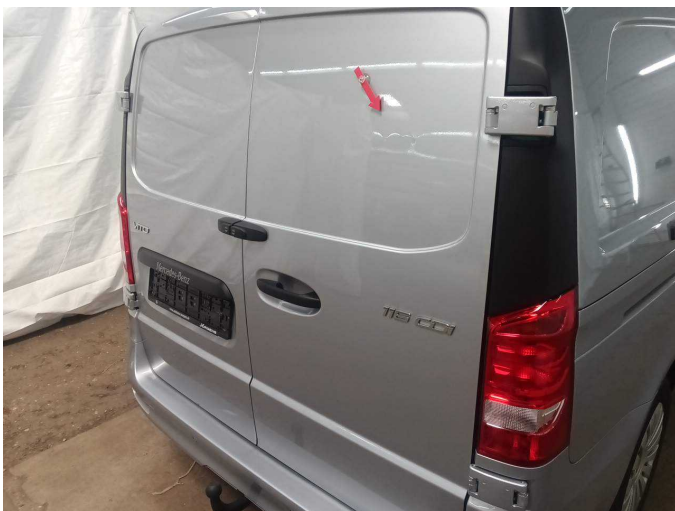
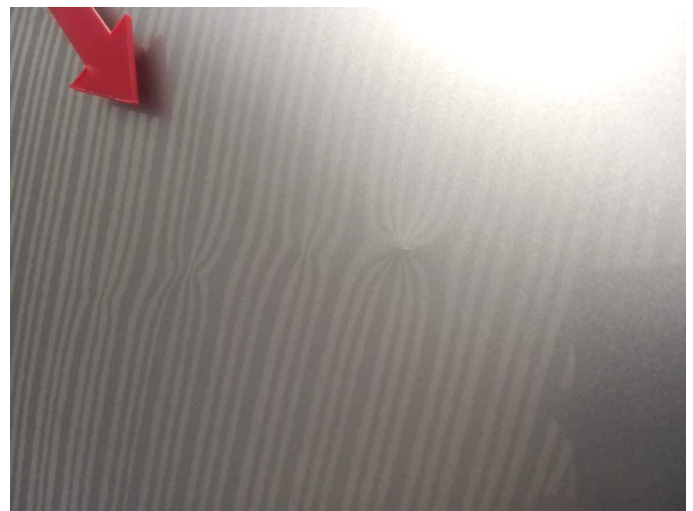
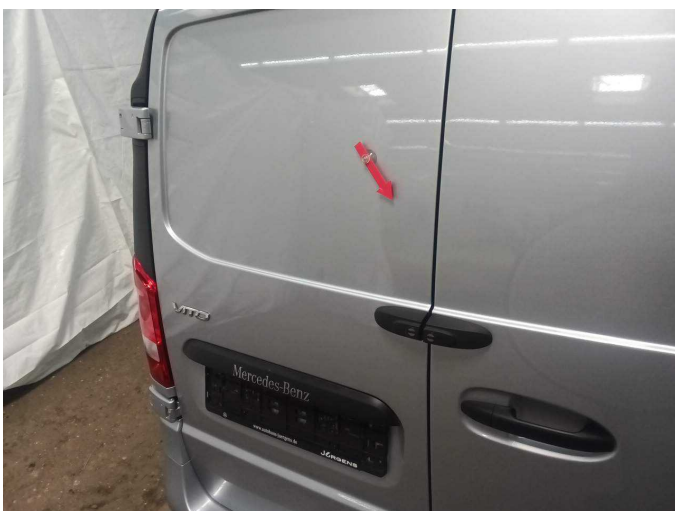
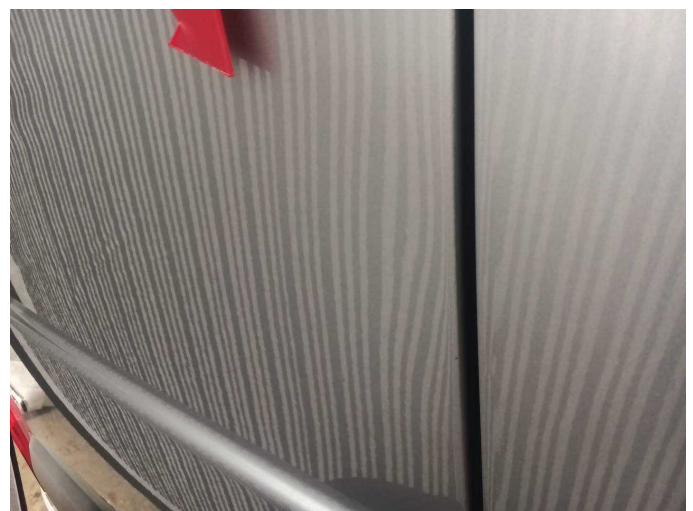
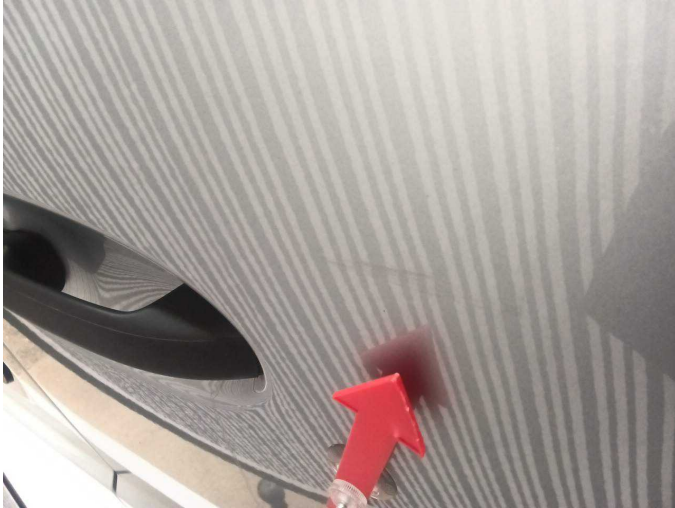
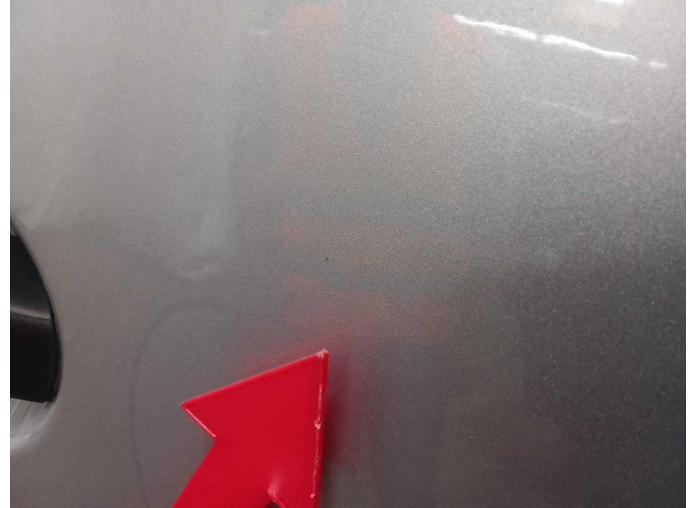
**Damage 8:** Boot lid / rear door: Boot lid - Dent / paintcoat damage - Repair and paint

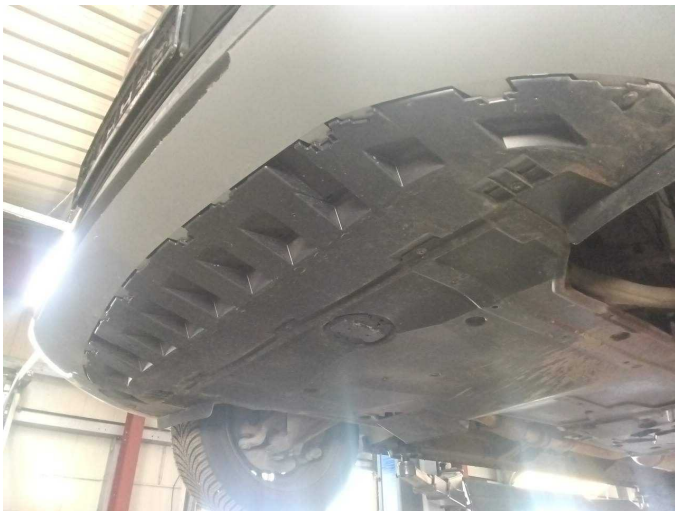
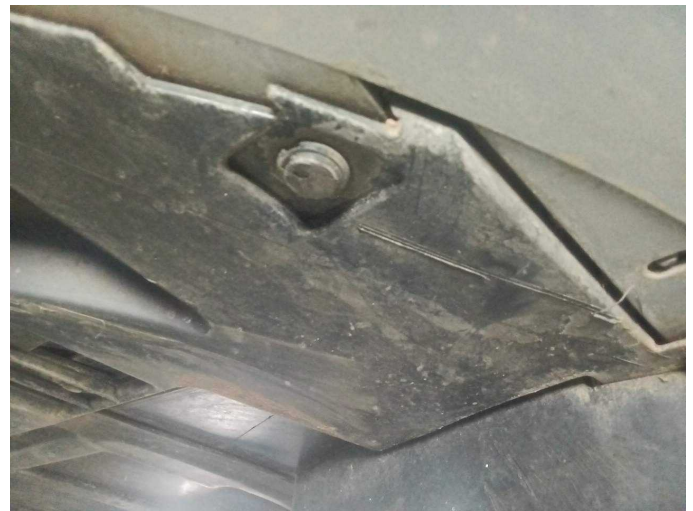
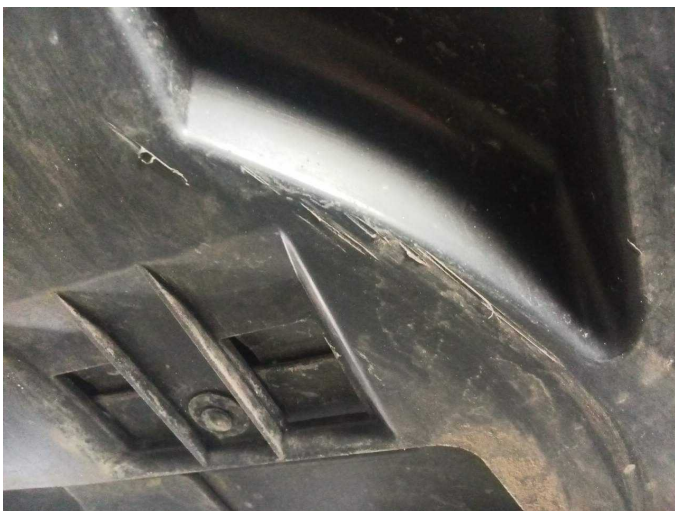
**Wear and tear 7:** Body: Underbody panelling - Scratched - No deduction

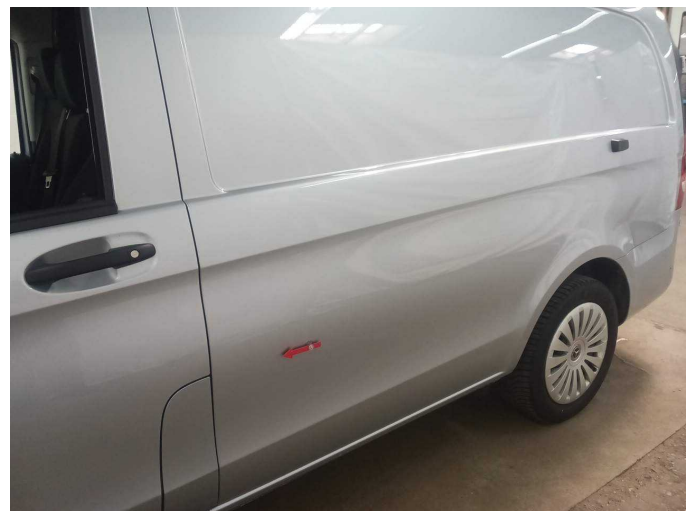
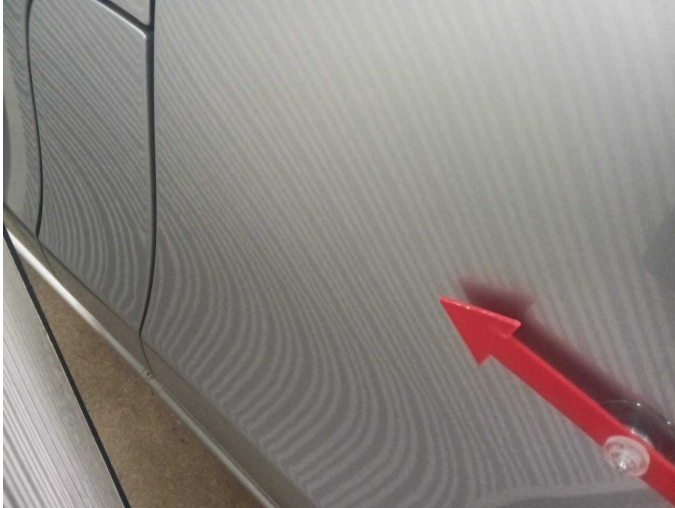
**Wear and tear 8:** Side panel - rear left side: Side panel - dent(s) - No deduction

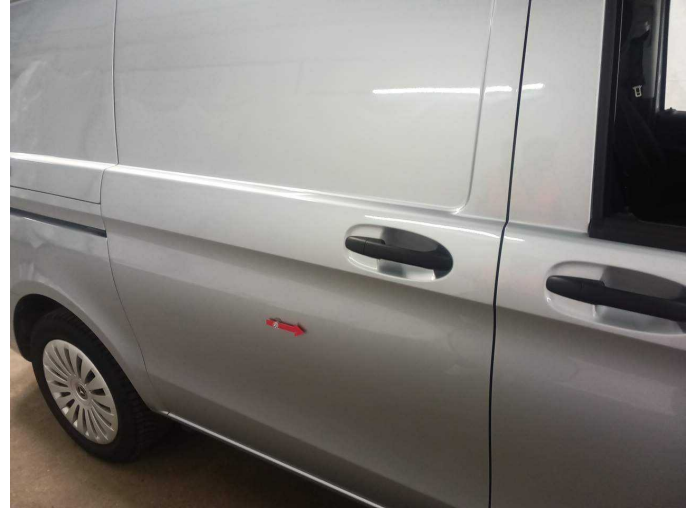
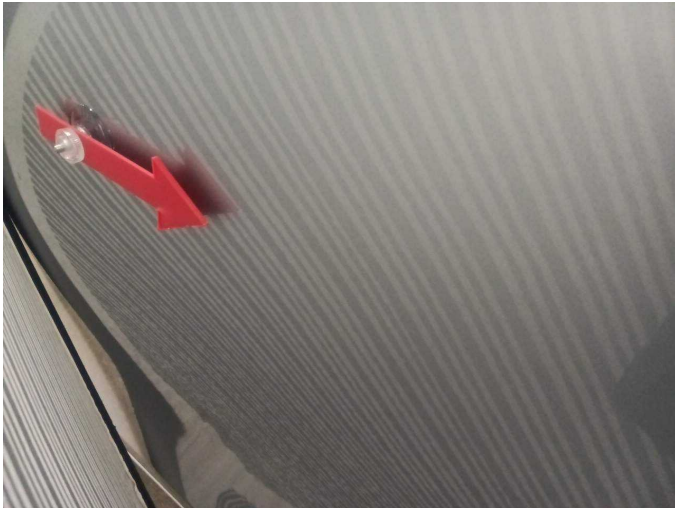
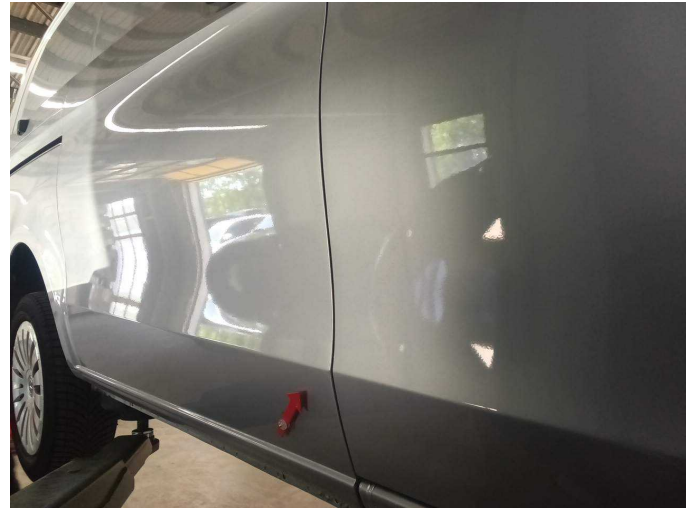
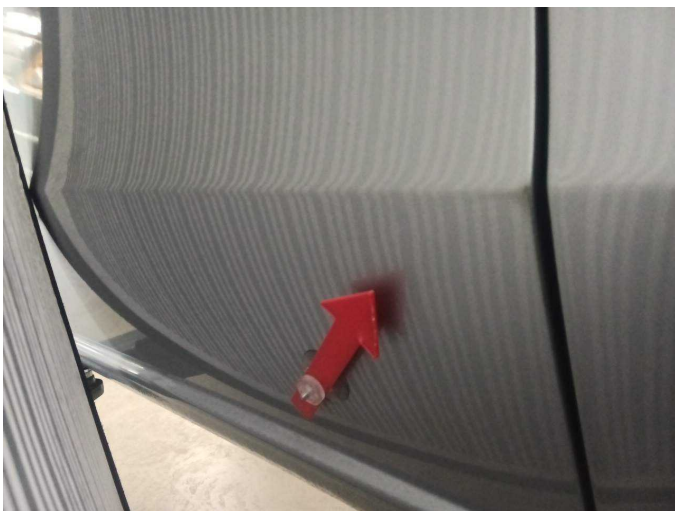
**Wear and tear 9:** Sliding door, right: Sliding door - dent(s) - No deduction
