# Assessment

- Vehicle Inspection Report -

Number: 10295951  
From: 25.03.2026

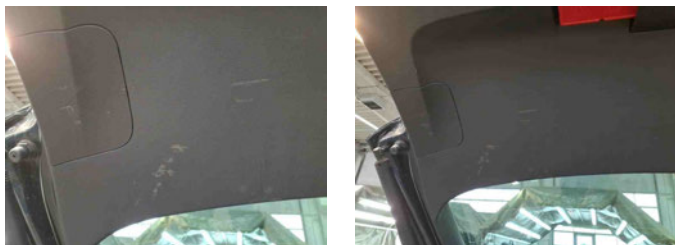
| 5 - Boot lid covering R - Scratch(es) - Replace | | Repaircosts: | € 159.00 |

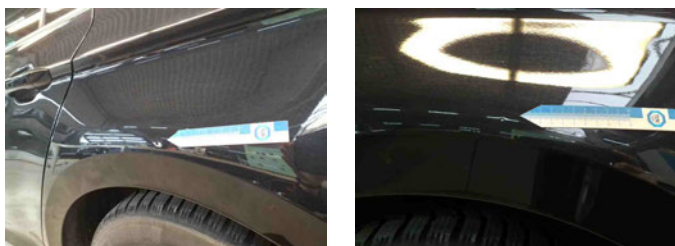
| 6 - Side wall RL - Dent(s) - Spot repair | | Repaircosts: | € 150.00 |

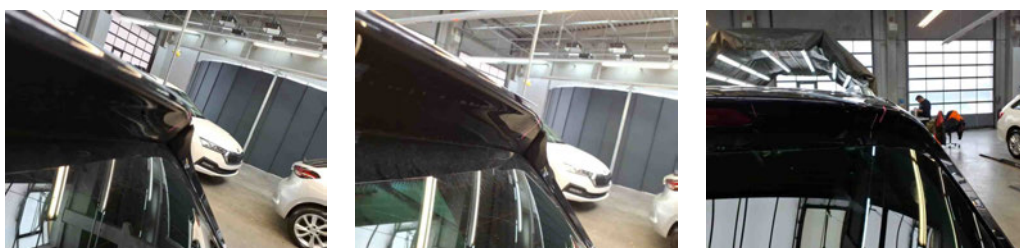
| 7 - Rear spoiler - Dent(s) and scratch(es) - Repair and paint (complete) | | Repaircosts: | € 144.50 |

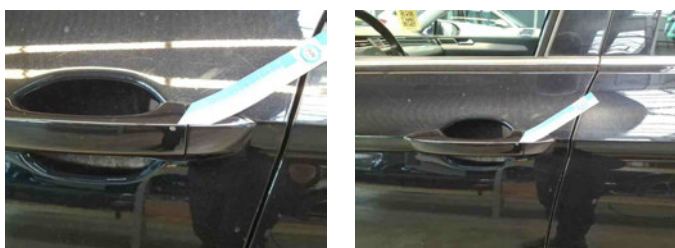
| 8 - Outer door handle FL - Scratch(es) - Paint | | Repaircosts: | € 74.83 |
