Expertise

Protocol number: 46365605  
Order No. / Reference: 26681115  
Inspection date: 3 Jul 2026

Manufacturer: Ford

Model: Focus Turnier 1.5 EcoBlue Start-Stopp-System Aut.  
COOL&CONNECT

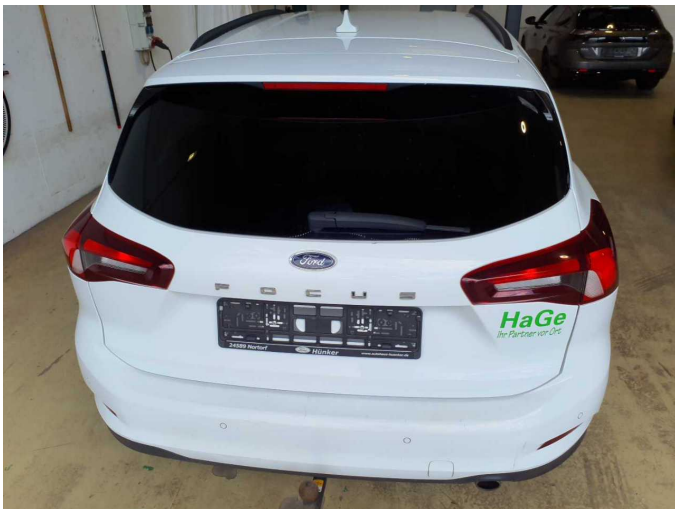
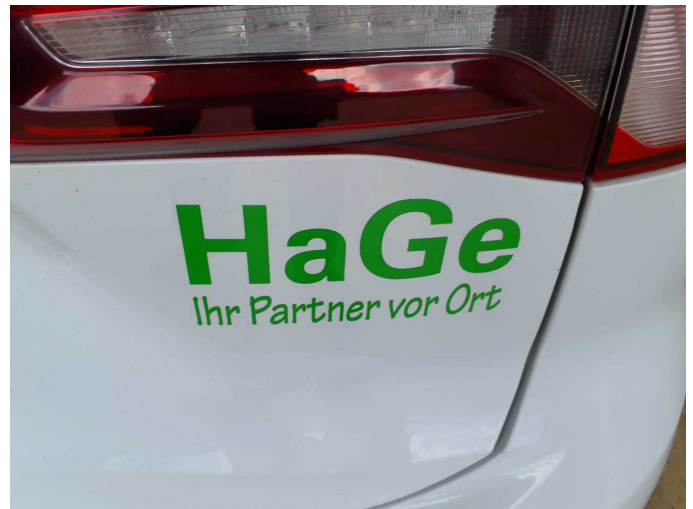
| No. | Component group | Description |
|---|---|---|
| 2 | Boot lid / rear door | Boot lid - Glued / labelled - De-glue / neutralise |

Damage 2: Boot lid / rear door: Boot lid - Glued / labelled - De-glue / neutralise

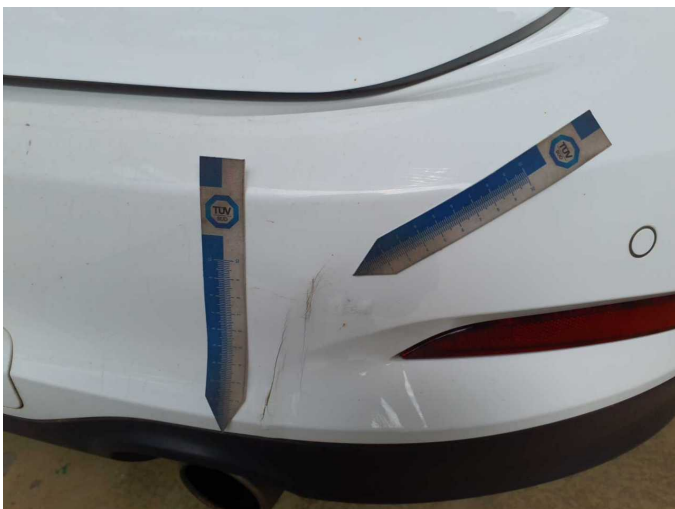
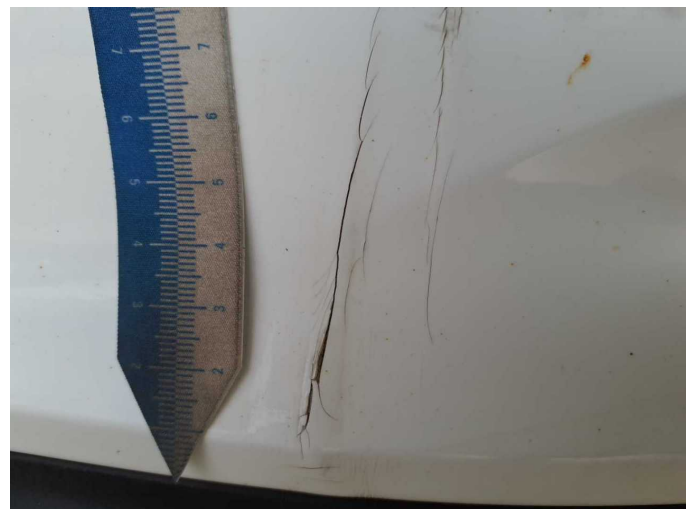
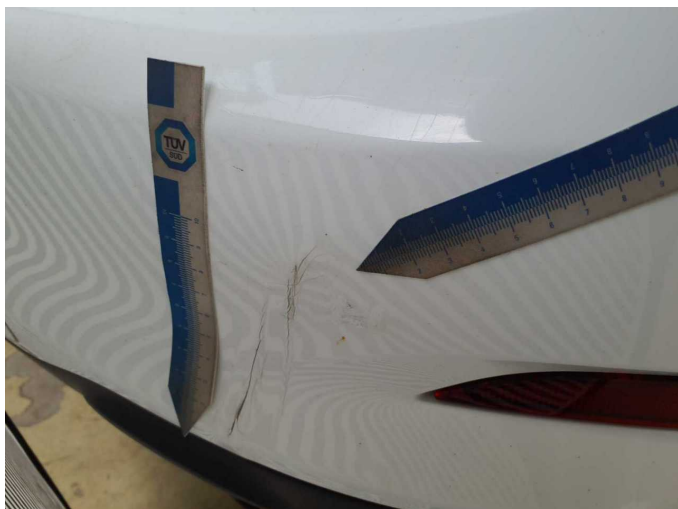
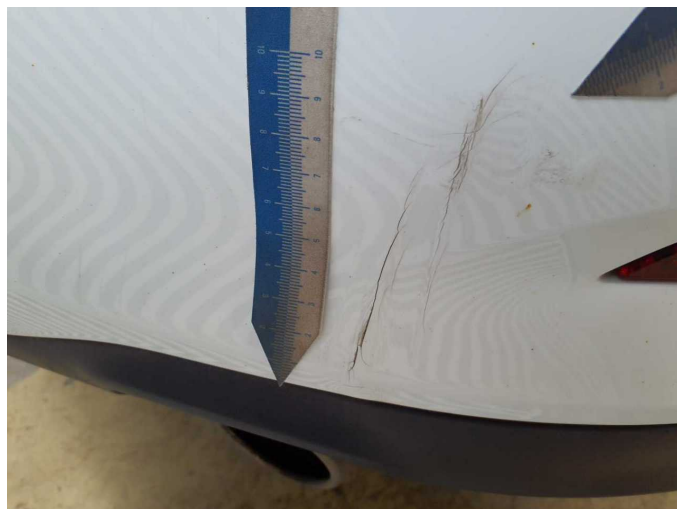
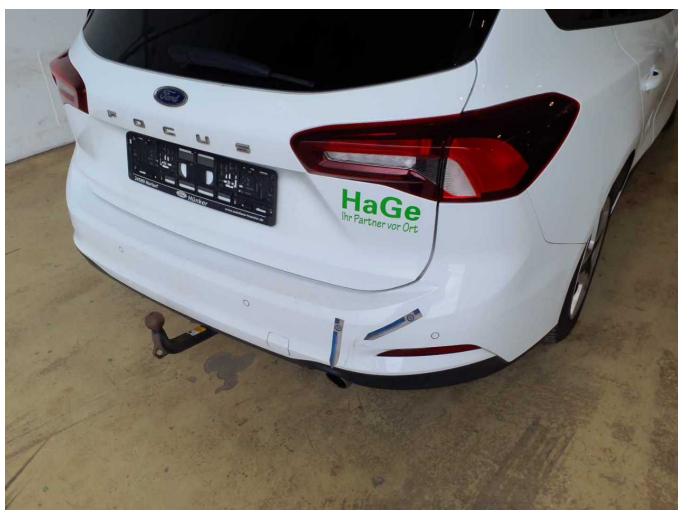
| No. | Component group | Description |
|---|---|---|
| 3 | Rear bumper | Rear bumper - Deformed - Replace |

Damage 3: Rear bumper: Rear bumper - Deformed - Replace

**Damage 3:** Rear bumper: Rear bumper - Deformed - Replace

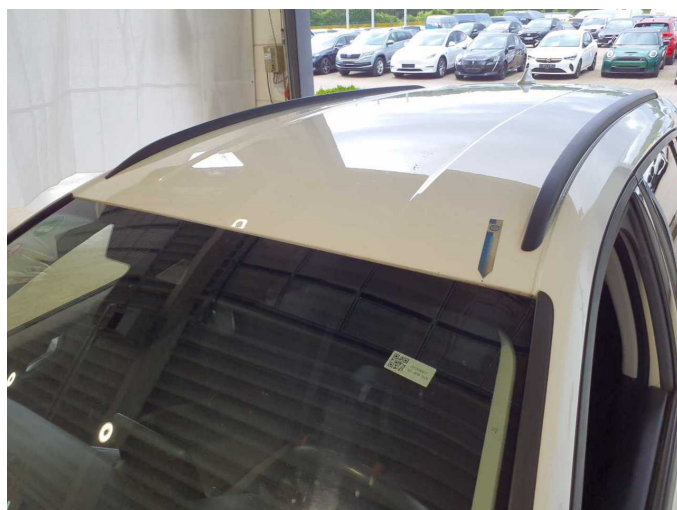
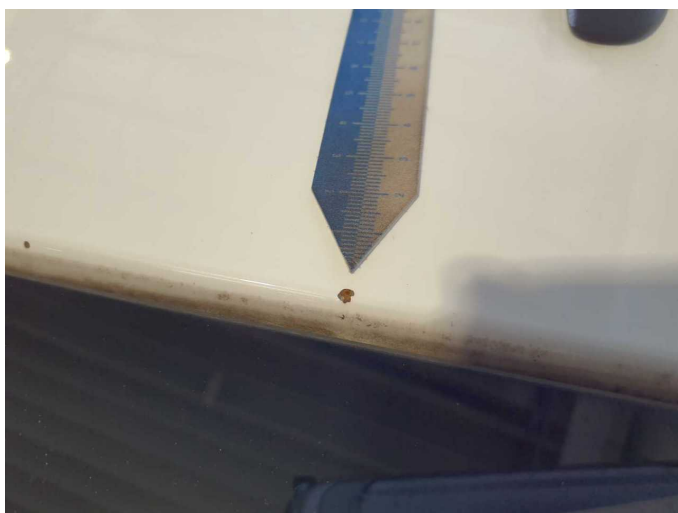
| No. | Component group | Description |
|---|---|---|
| 4 | Roof | Roof (Dachkante) - Corrosion - Paint |

**Damage 4:** Roof: Roof (Dachkante) - Corrosion - Paint

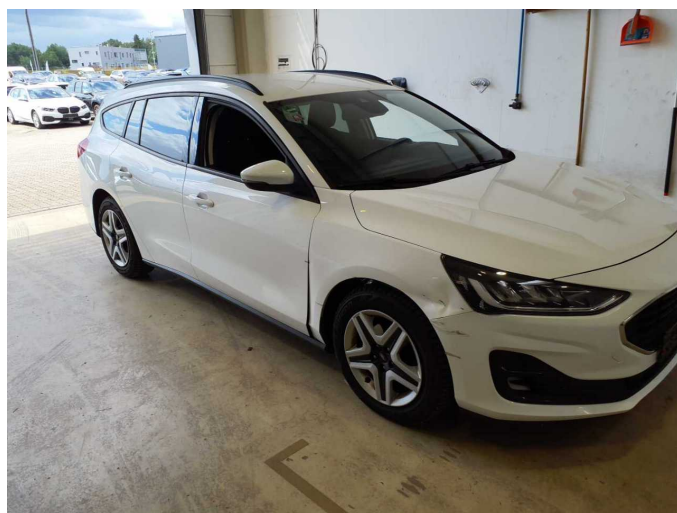
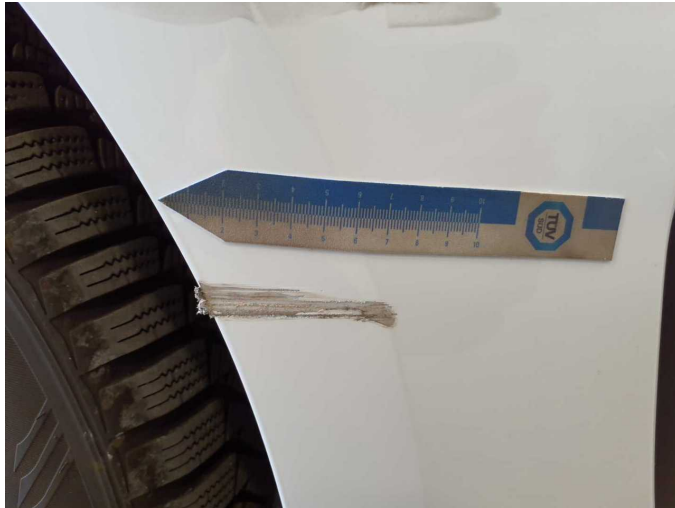
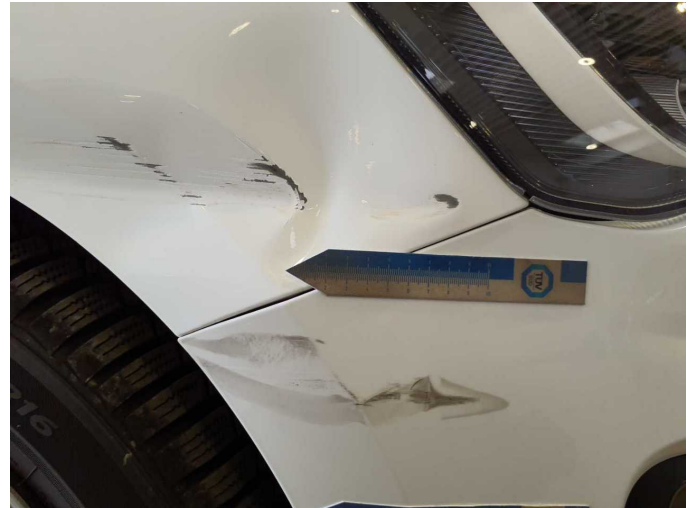
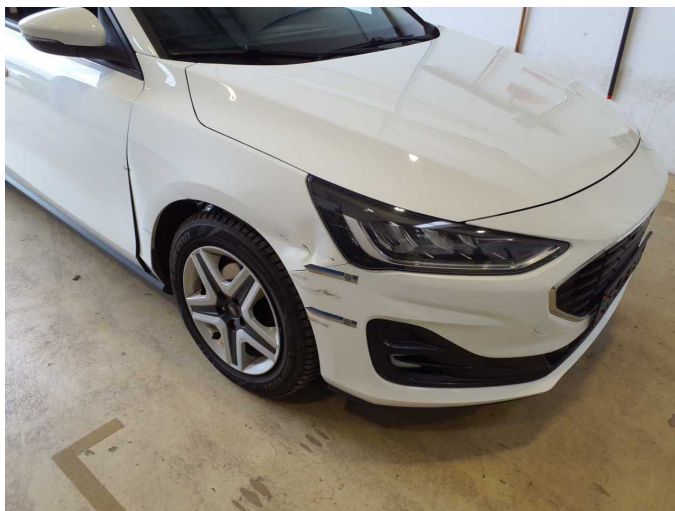
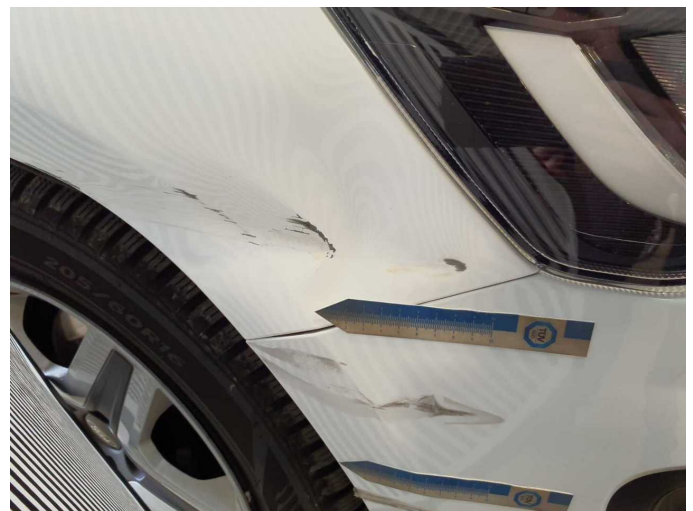
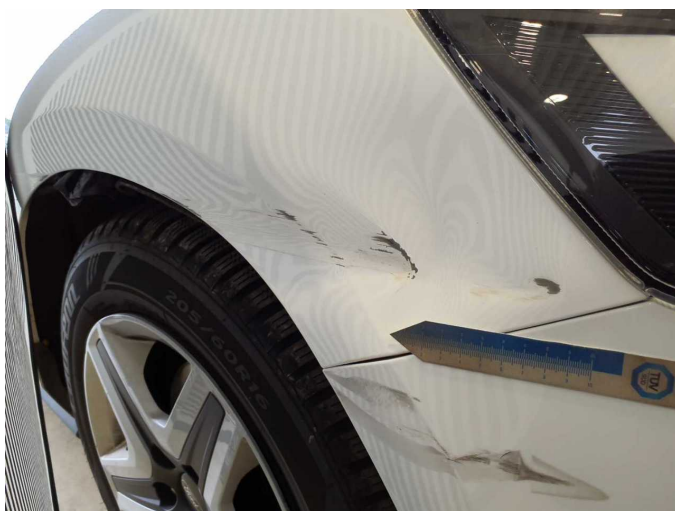
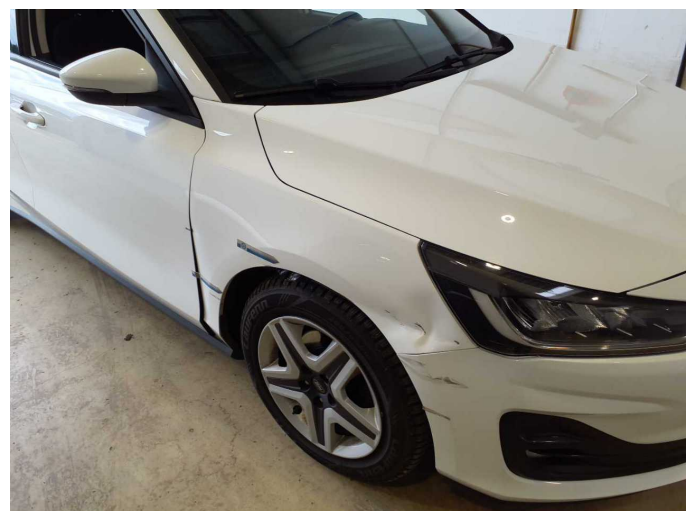
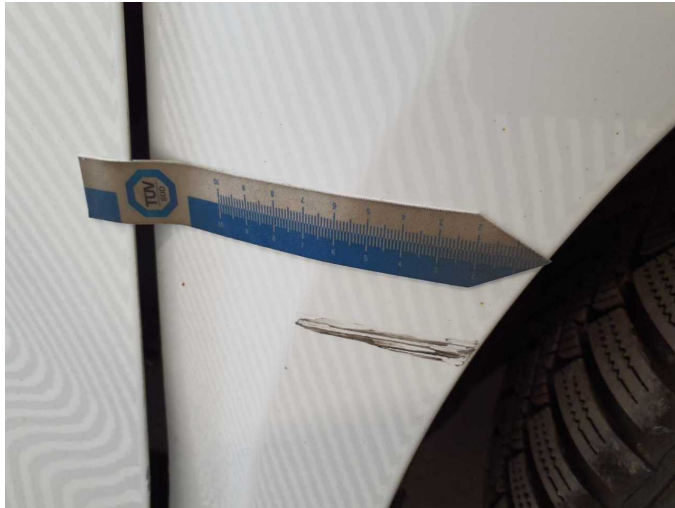
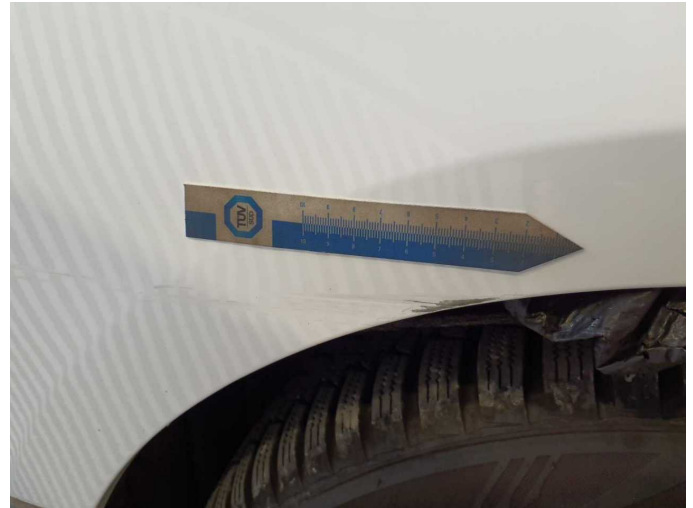
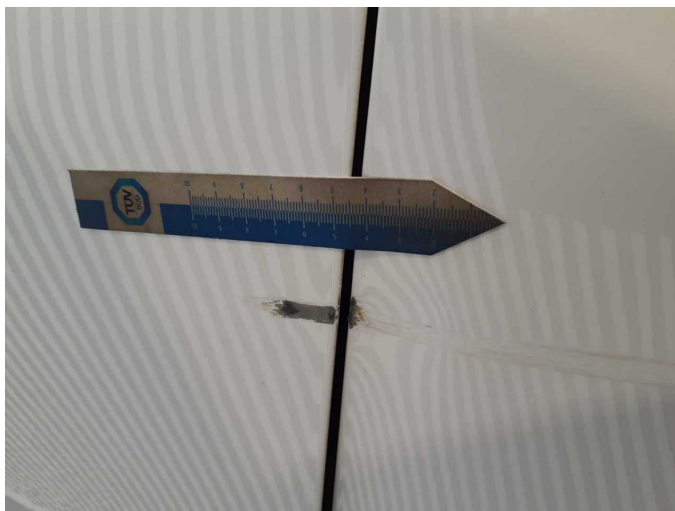
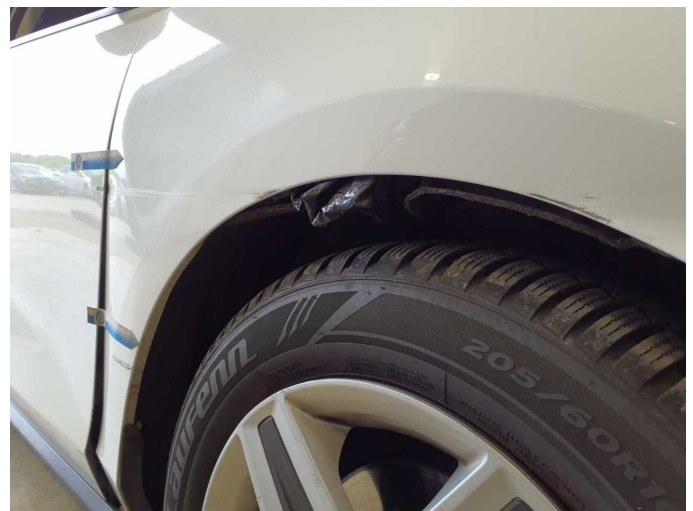
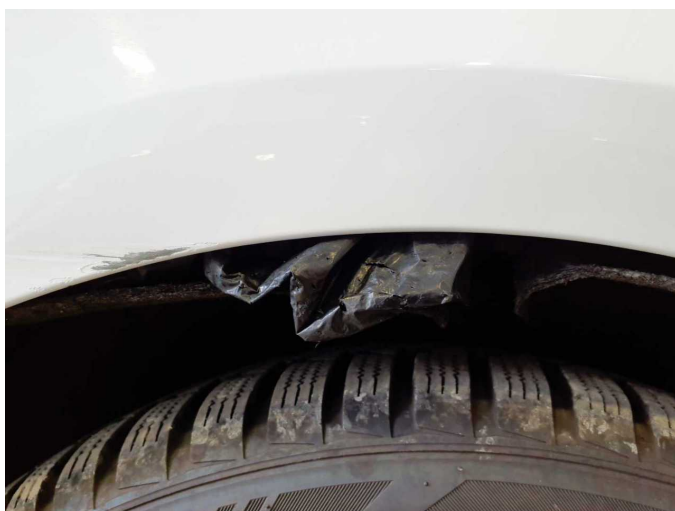
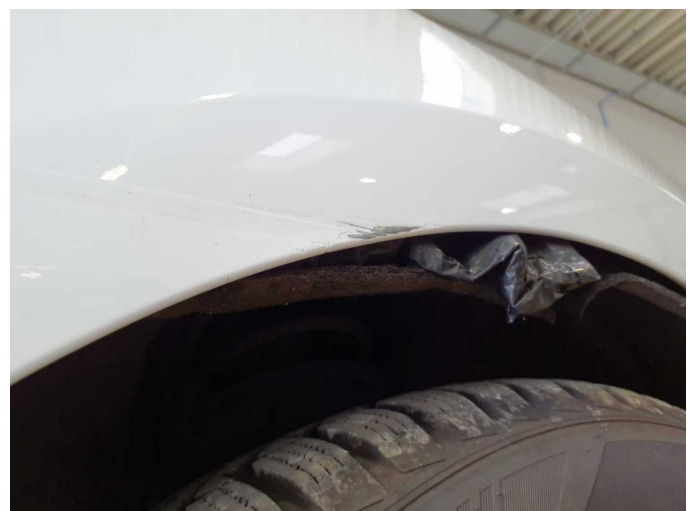
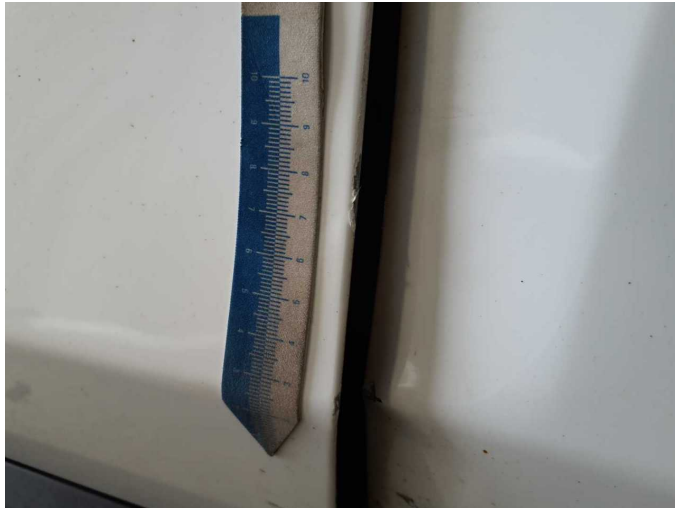
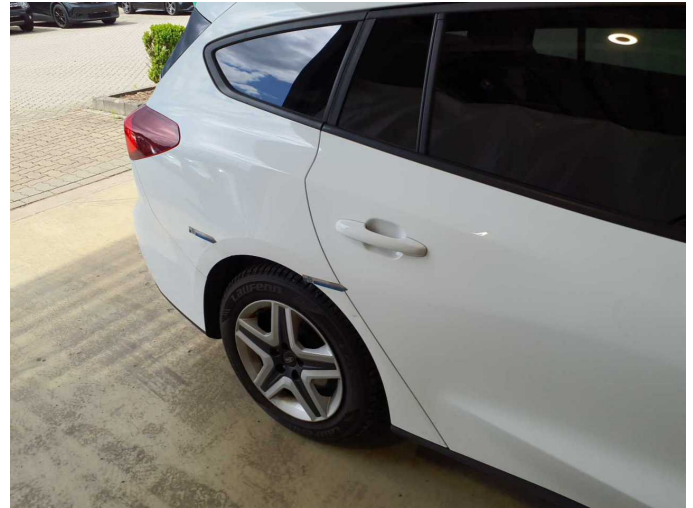
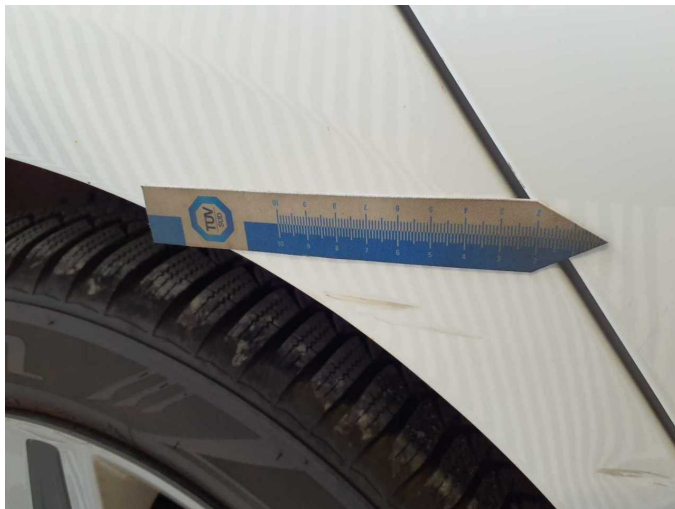
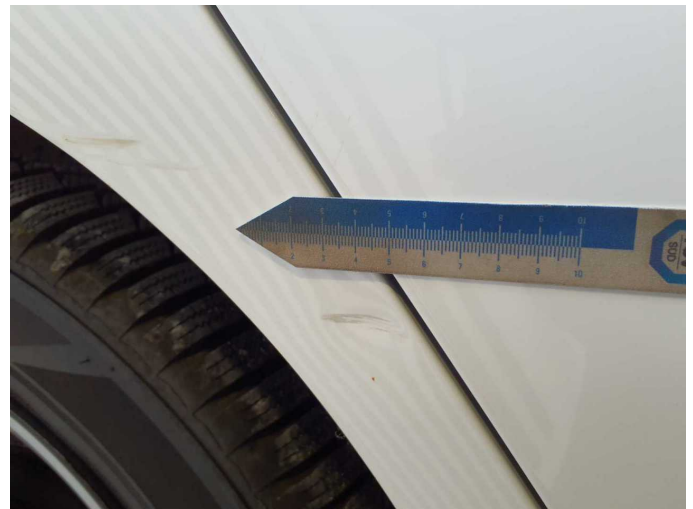
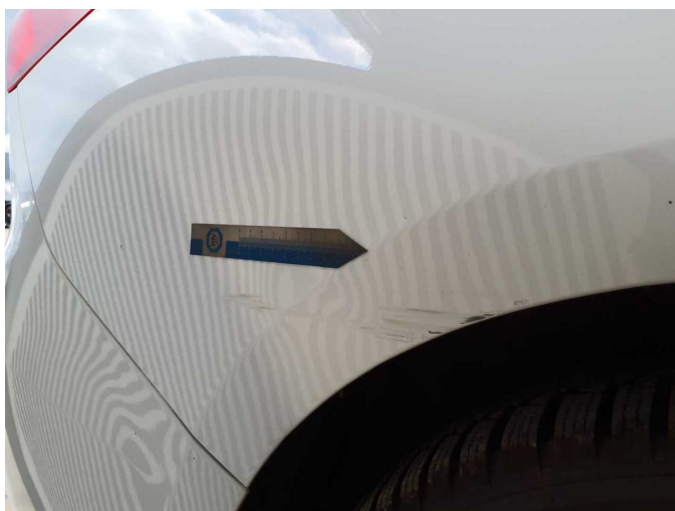
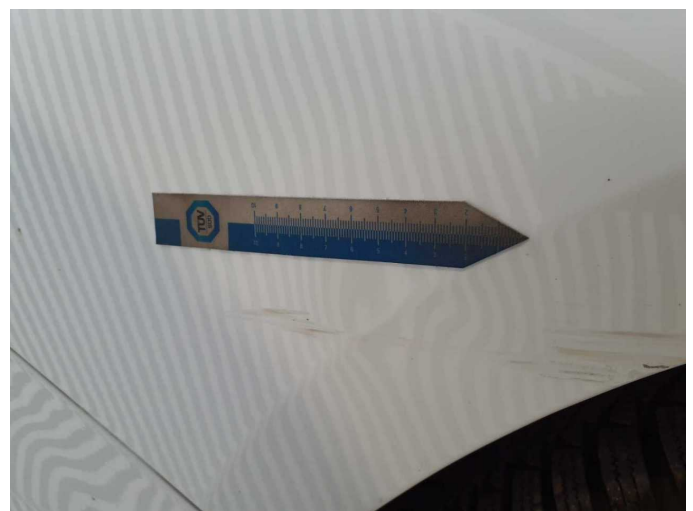
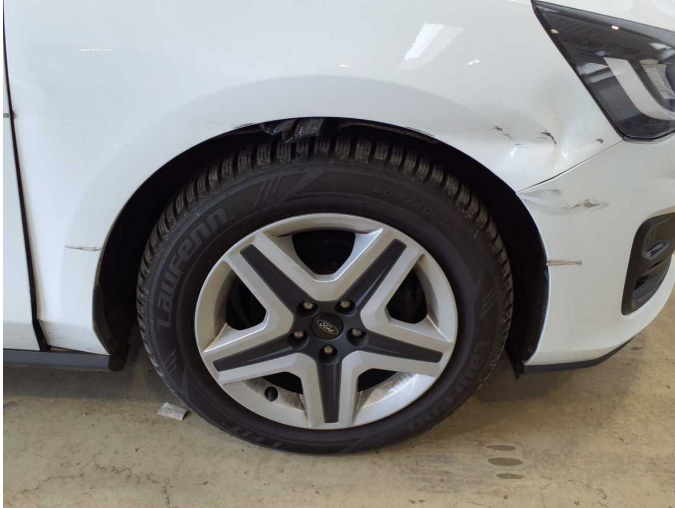
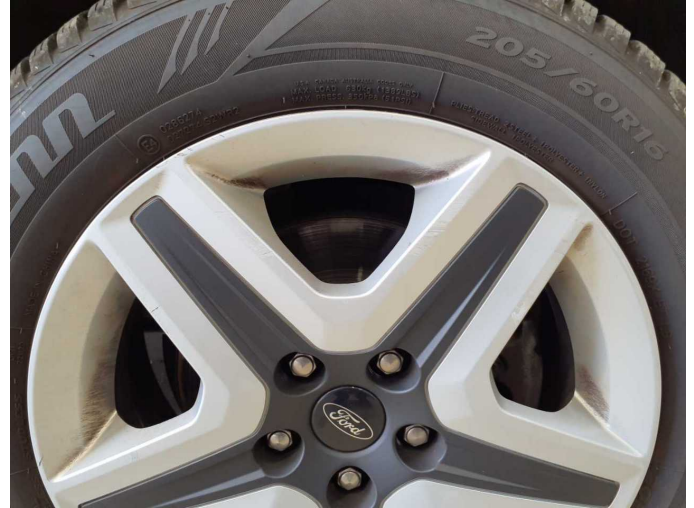
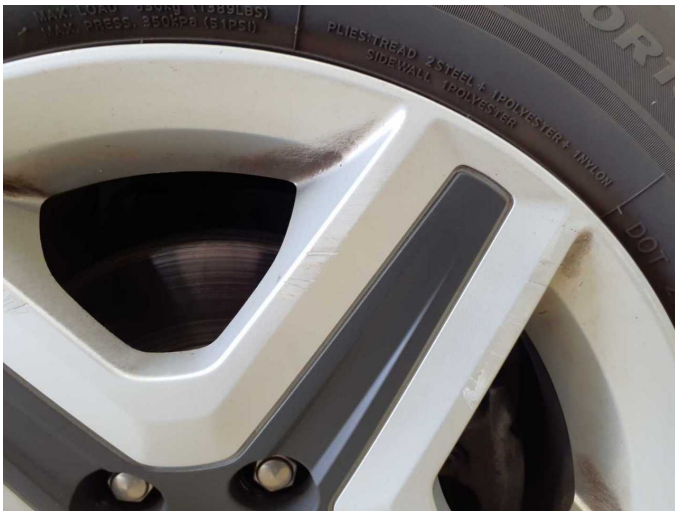
| No. | Accident |
|---|---|
| 1 | Side right |

**Accident 1:** Side right
