Expertise

Protocol number: 46413293  
Order No. / Reference: 26609179  
Inspection date: 9 Jul 2026

Manufacturer: Ford

Model: Focus Turnier 1.5 EcoBlue Start-Stopp-System  
COOL&CONNECT

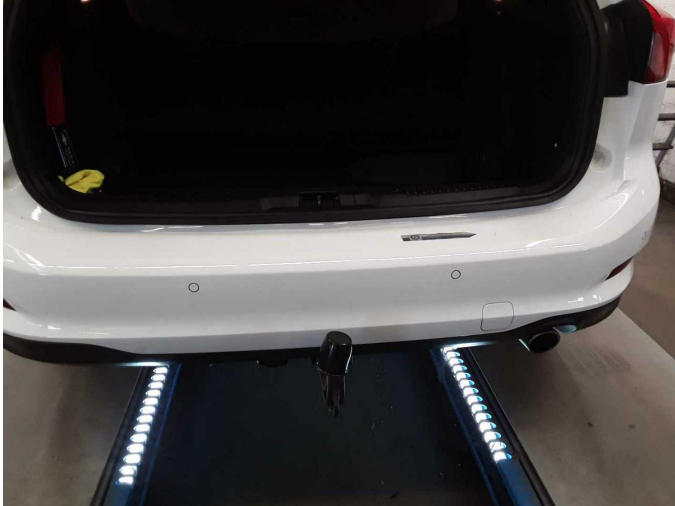
| No. | Component group | Description |
|---|---|---|
| 1 | Rear bumper | Rear bumper - Scratch(es) - Smart repair |

**Damage 1:** Rear bumper: Rear bumper - Scratch(es) - Smart repair

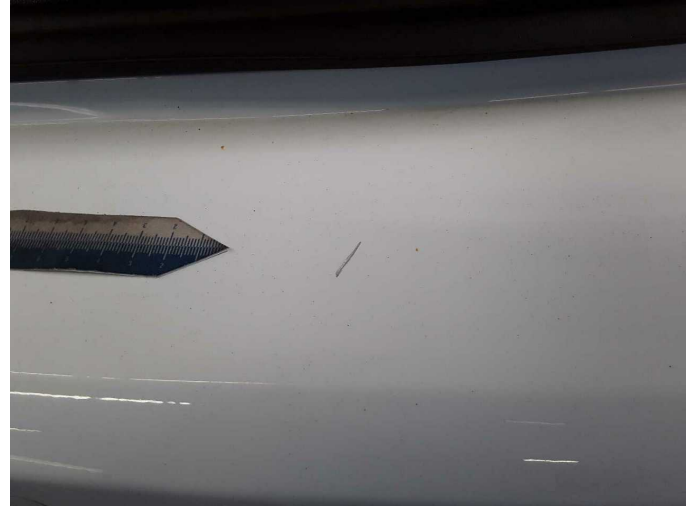
**Damage 1:** Rear bumper: Rear bumper - Scratch(es) - Smart repair

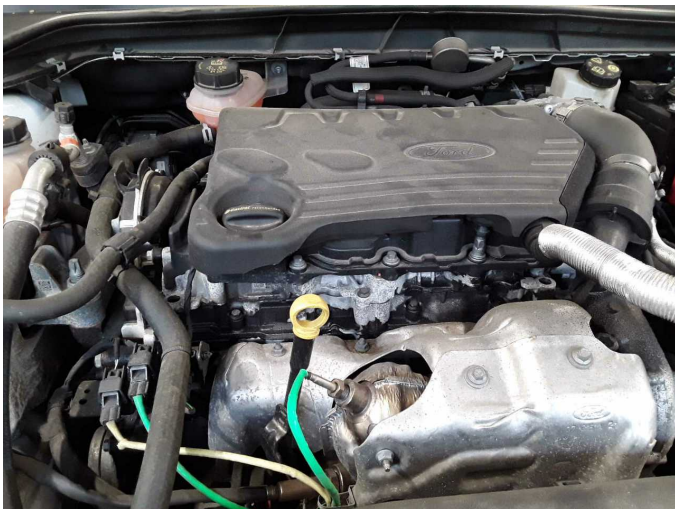
| No. | Component group | Description |
|---|---|---|
| 2 | Engine | Engine - Leaking - Perform diagnosis |

**Damage 2:** Engine: Engine - Leaking - Perform diagnosis

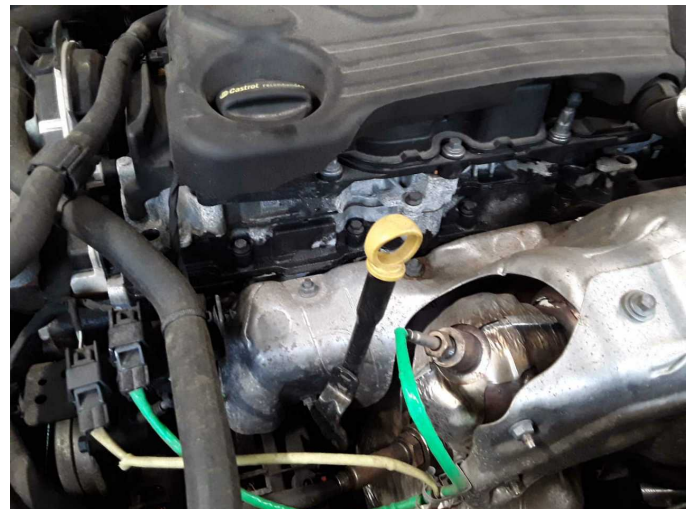
**Damage 2:** Engine: Engine - Leaking - Perform diagnosis

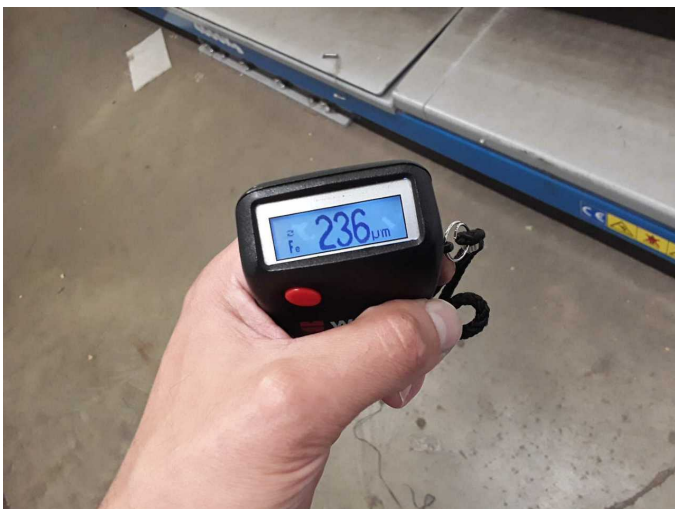
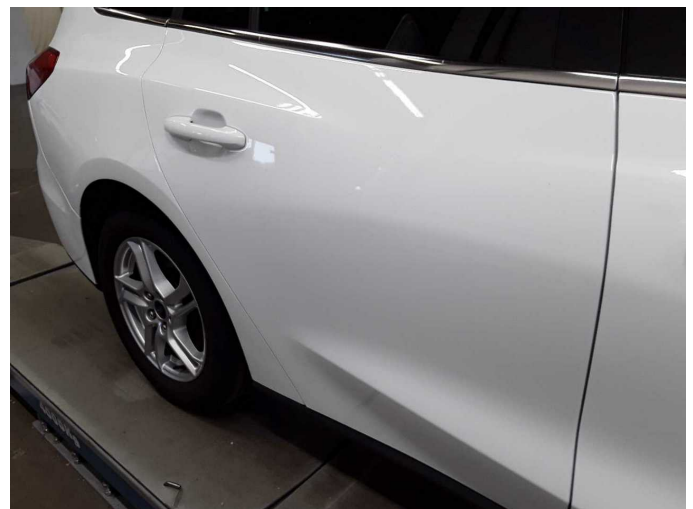
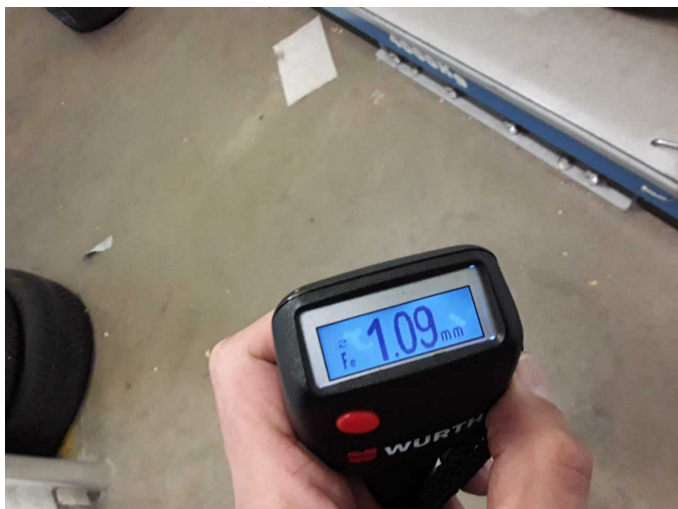
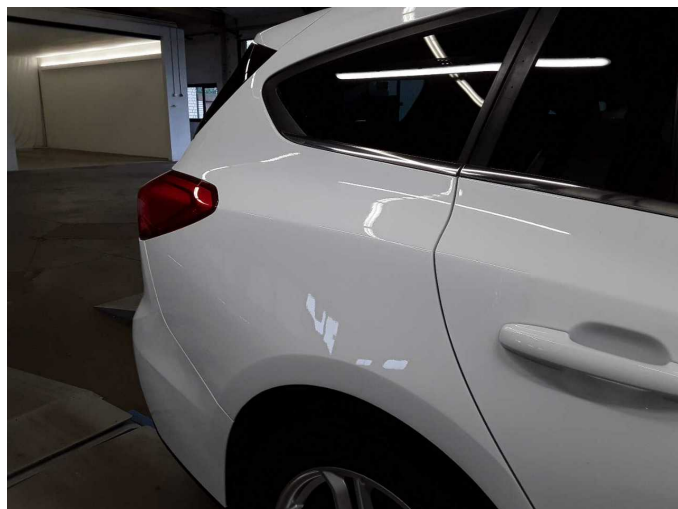
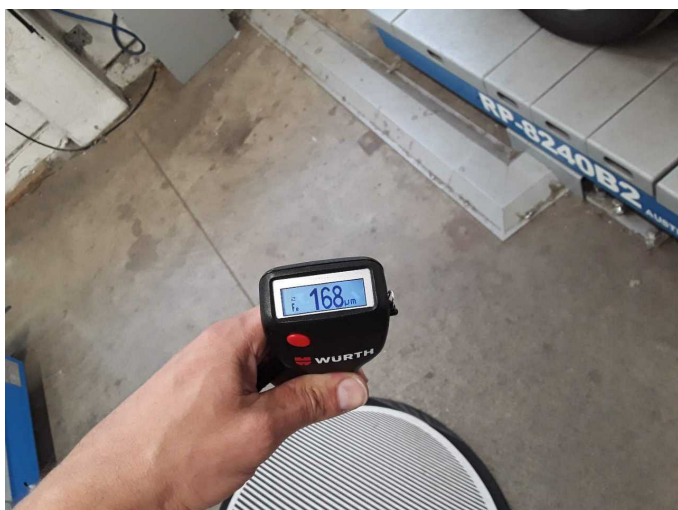
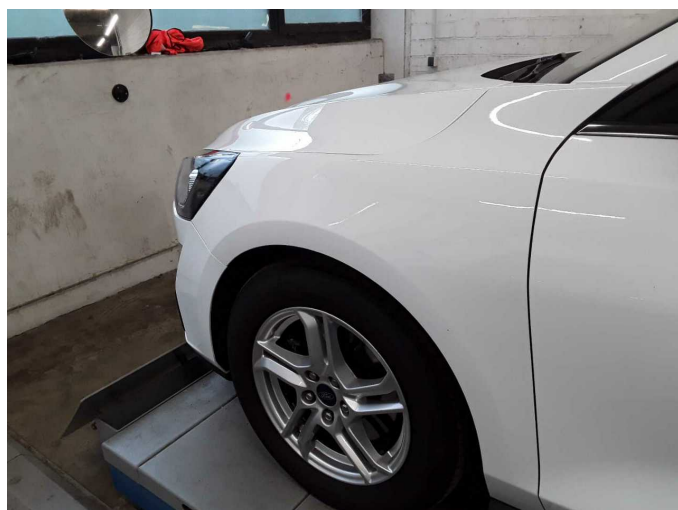
1 Mudguard - left side, Side panel - rear right side, Door - rear right side, Professionally carried out, Invoice of repair done Non-existent

**Repainting 1:** Mudguard - left side, Side panel - rear right side, Door - rear right side
