## Expertise

Protocol number: 46315642  
Order No. / Reference: 26505061  
Inspection date: 3 Jul 2026

Manufacturer: Volkswagen

Model: Touran 1.5 TSI ACT OPF DSG Comfortline

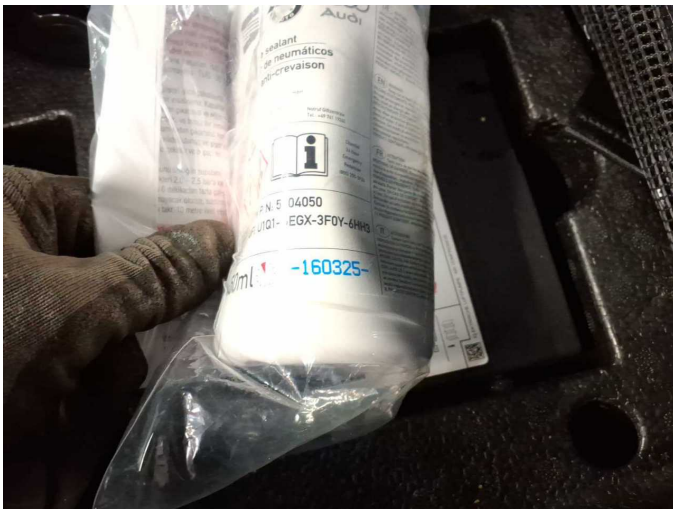
Damage 1: Equipment: Tirefit filler - Expired - Replace

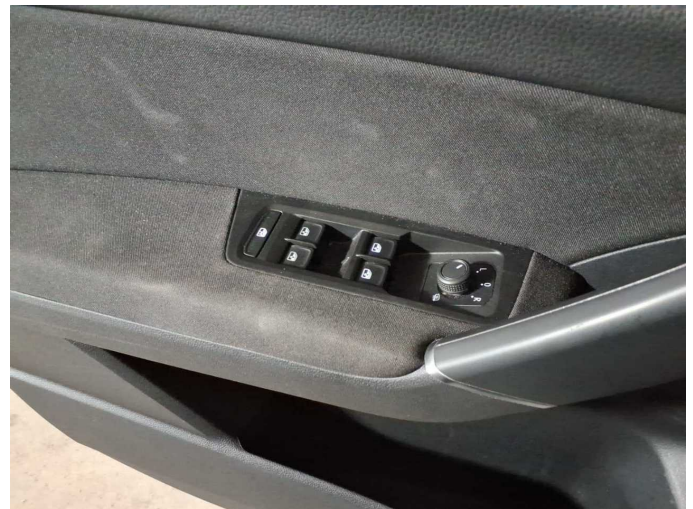
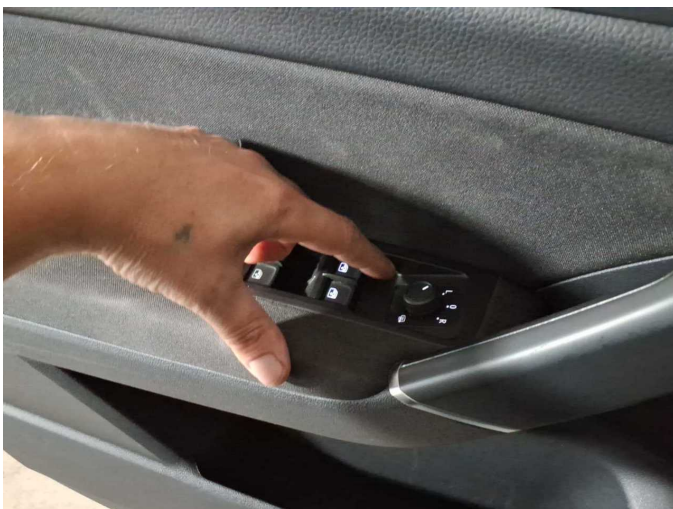
Damage 2: Door - front left side: Window regulator (+ rechts, Schalter ausgeleiert, Fenster fahren nicht aut.) - Sub-function - Perform diagnosis

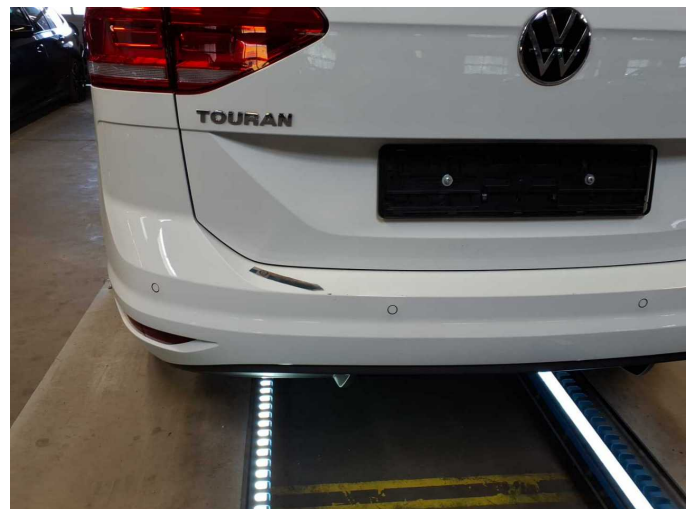
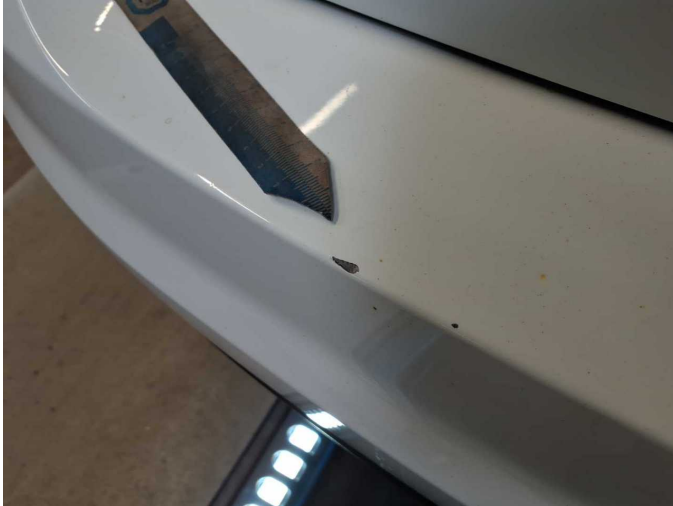
Damage 3: Rear bumper: Rear bumper (Verladebereich) - Scratch(es) - Smart repair

**Damage 3:** Rear bumper: Rear bumper (Verladebereich) - Scratch(es) - Smart repair

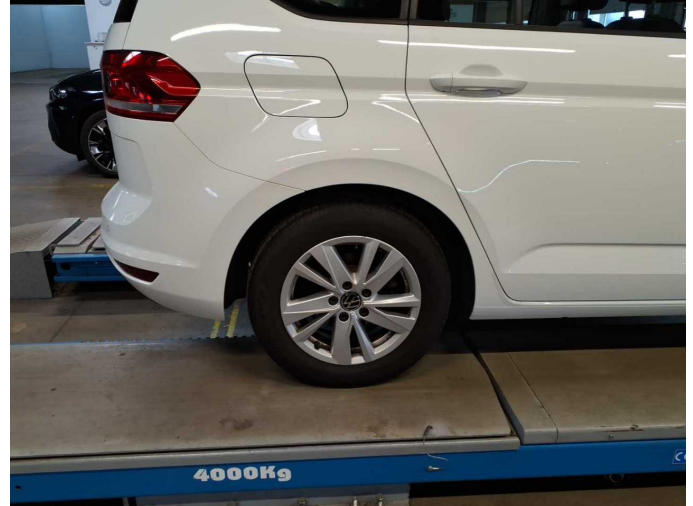
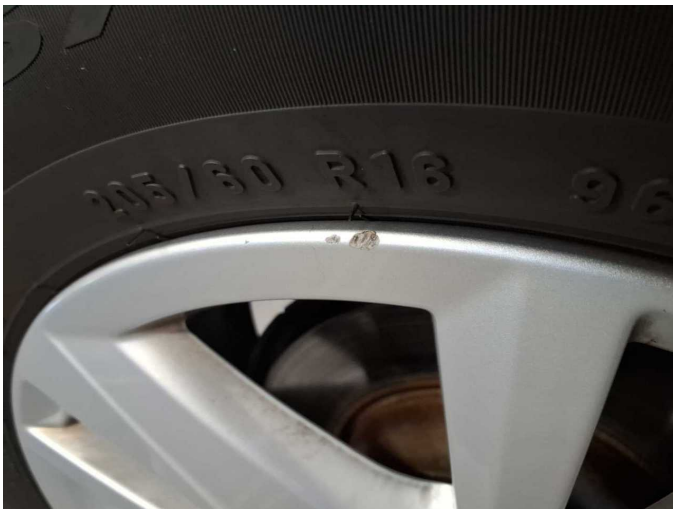
**Damage 4:** Wheel / tyres: Alloy rim - rear right side - Scratch(es) - Loss in value

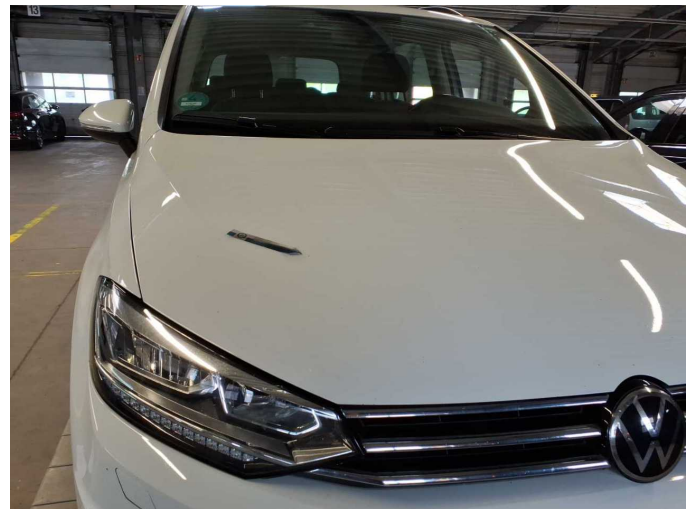
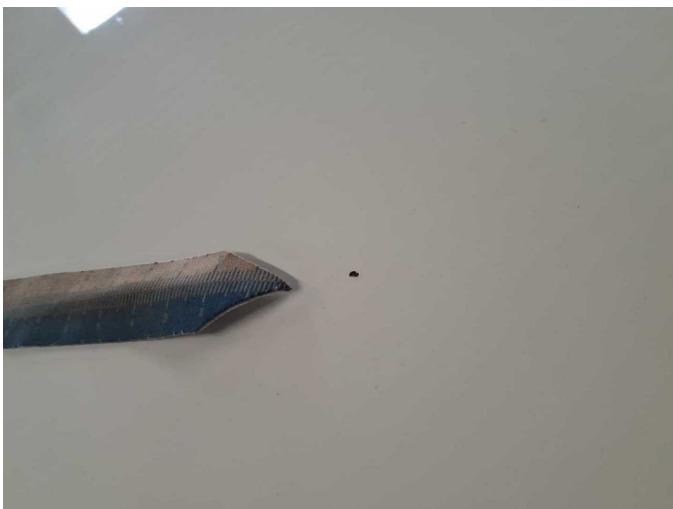
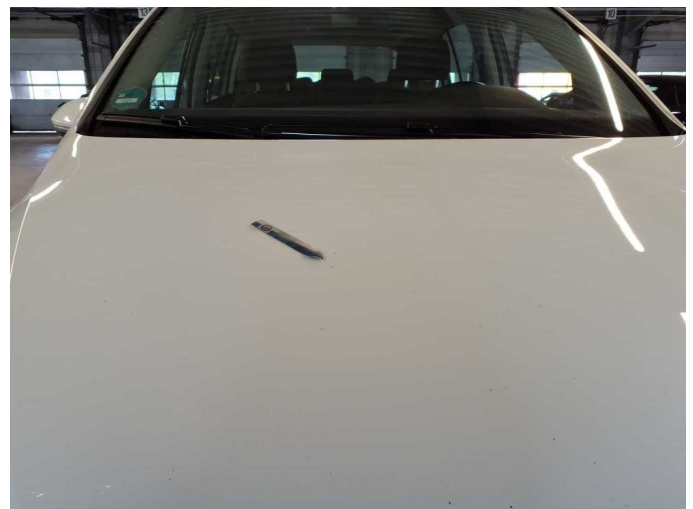
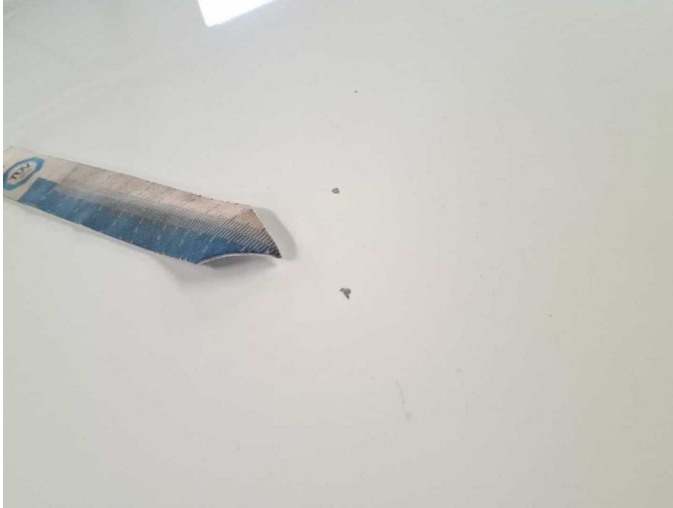
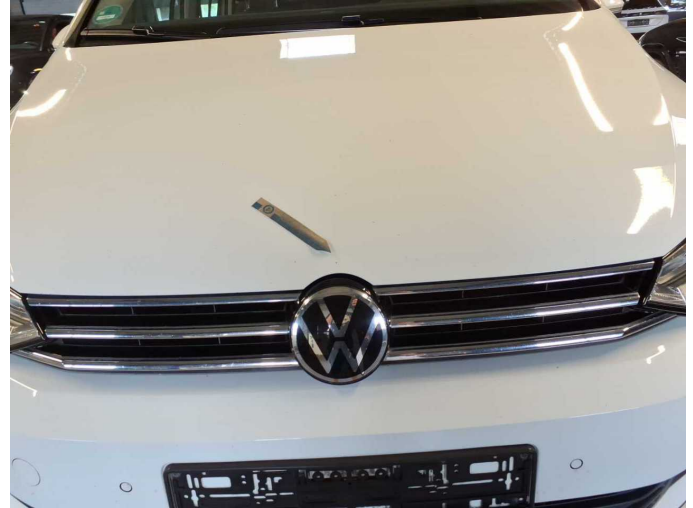
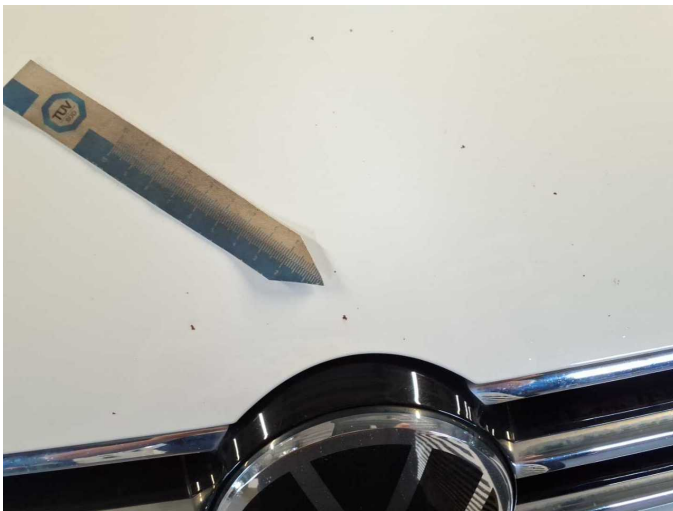
**Damage 5:** Bonnet: Bonnet (Sandstrahleffekt) - Stone chips - Paint

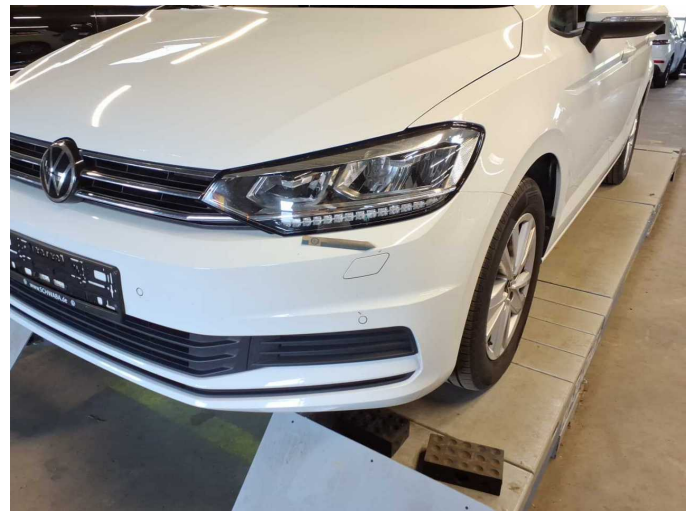
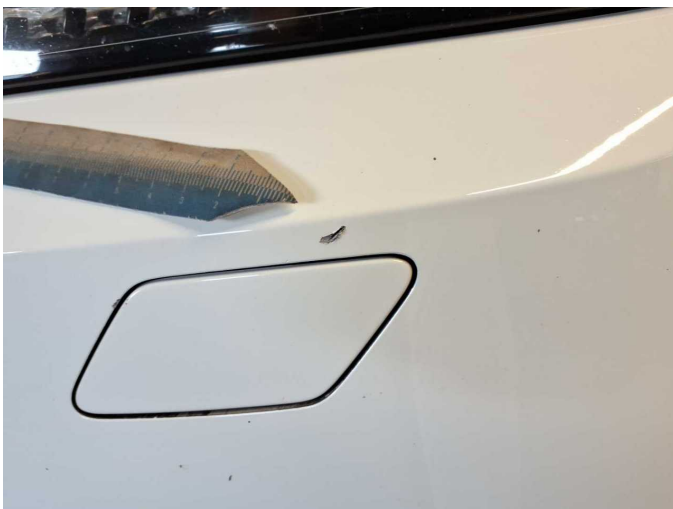
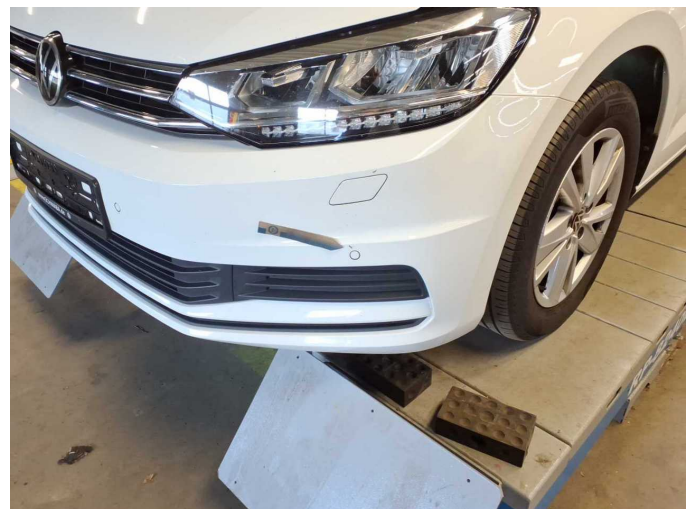
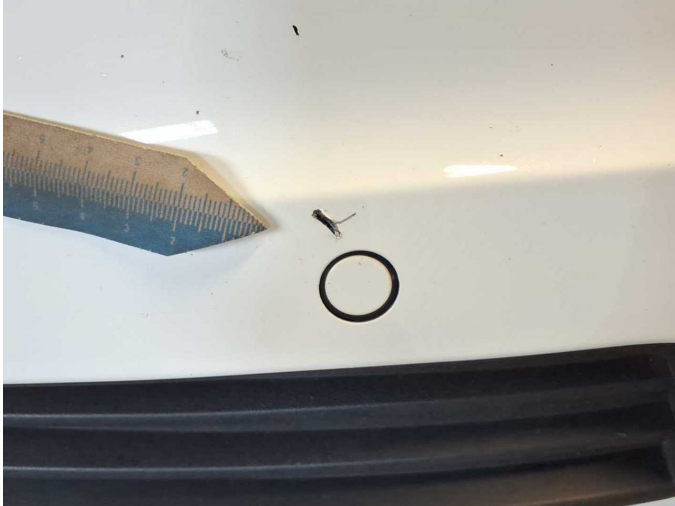
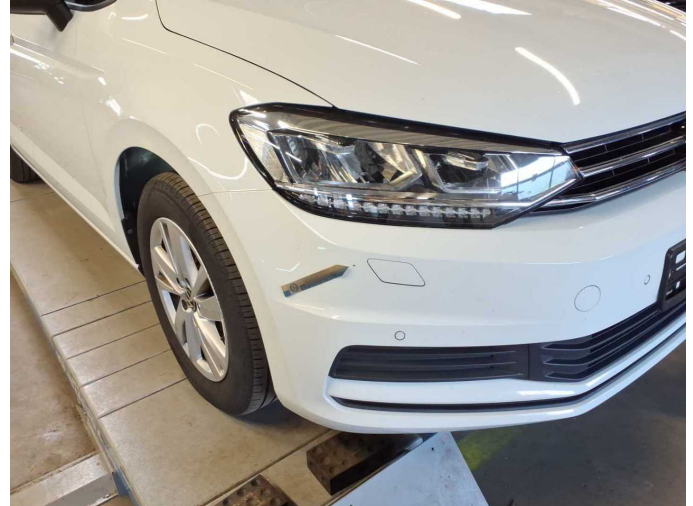
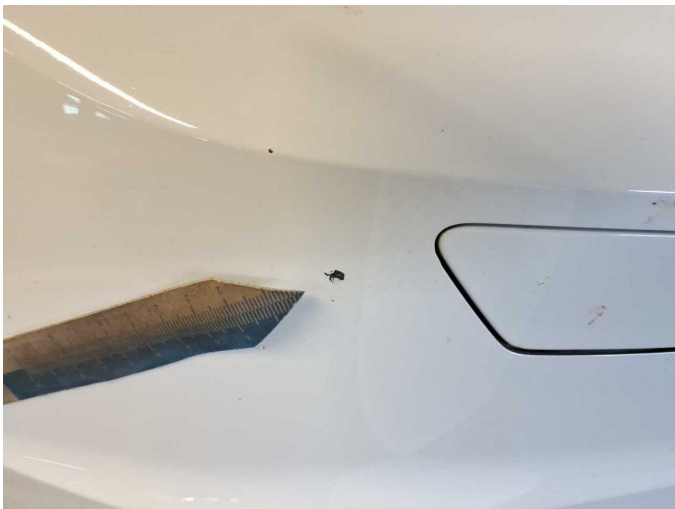
**Damage 6:** Front bumper: Front bumper - Stone chips - Paint

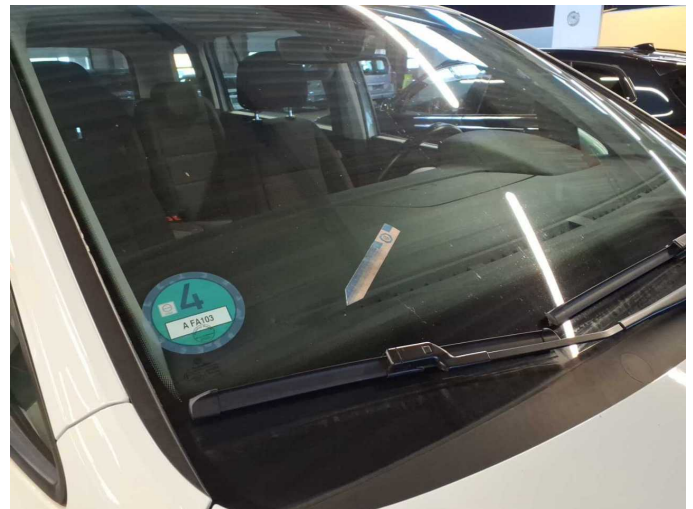
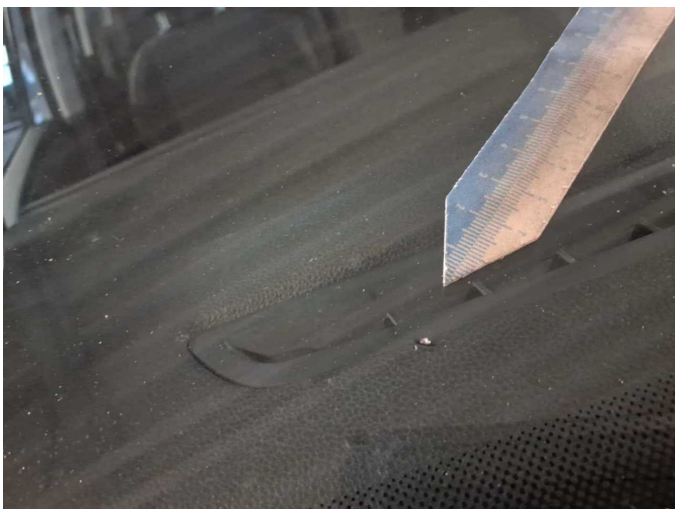
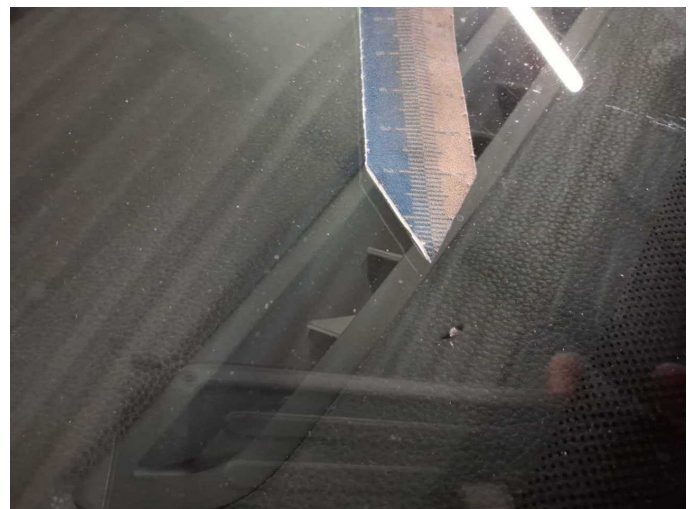
**Damage 7:** Vehicle glazing: Windscreen - Stone chips - Replace

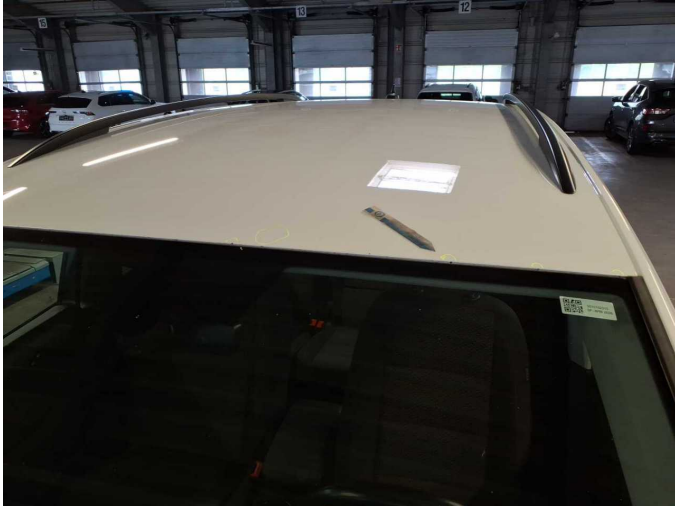
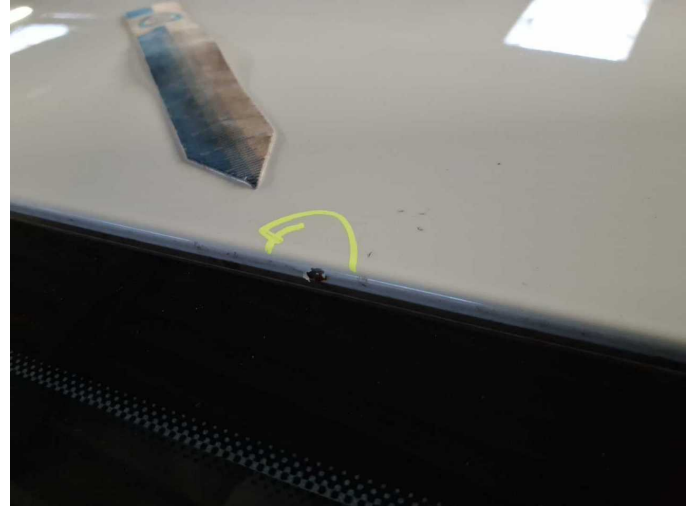
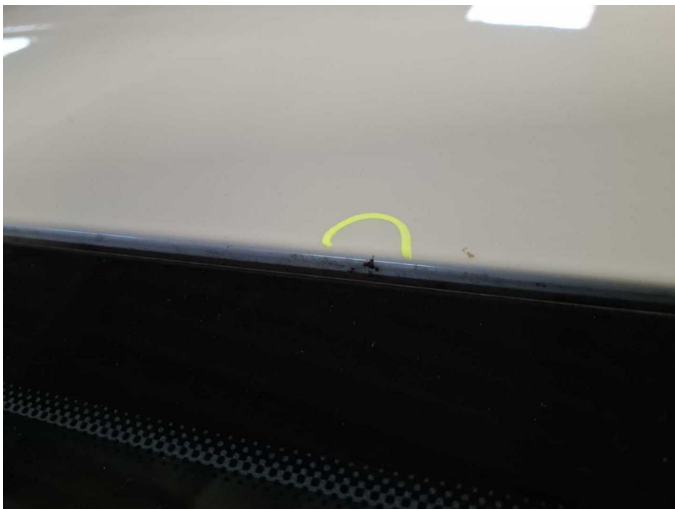
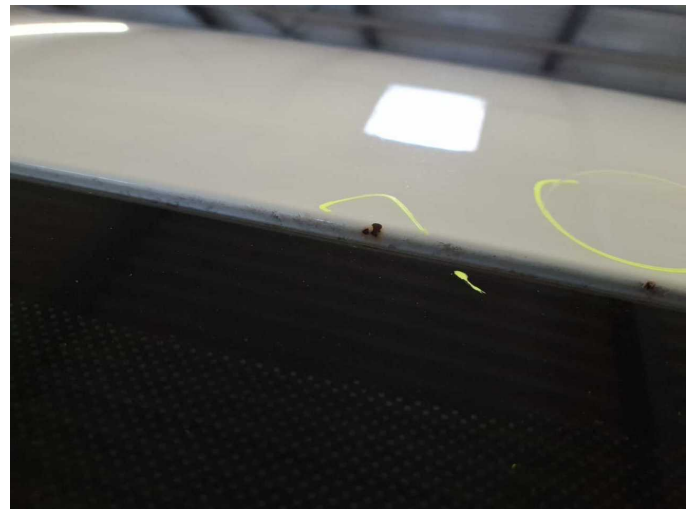
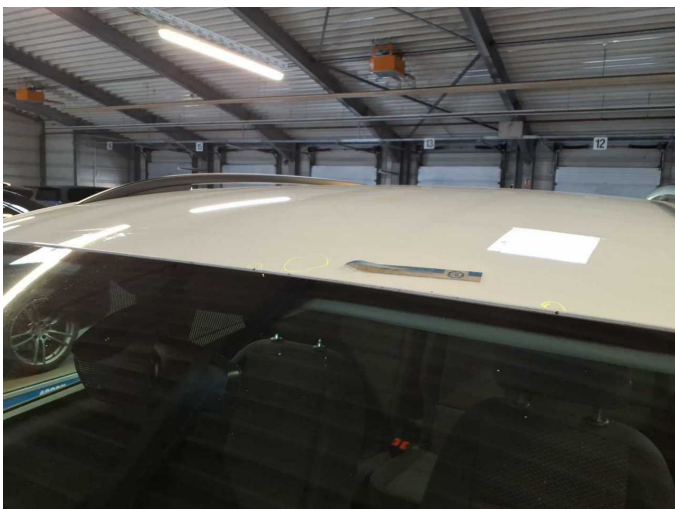
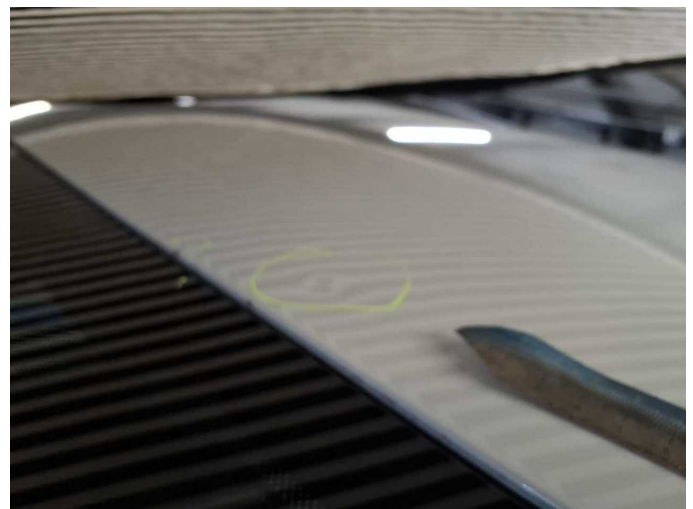
**Damage 8:** Roof: Roof - Dent / paintcoat damage - Repair and paint
