Expertise

Protocol number: 46351642
Order No. / Reference: 26521714
Inspection date: 7 Jul 2026

Model: Octavia Combi 2.0 TDI Ambition

VIN: TMBJG7NX4NY051072

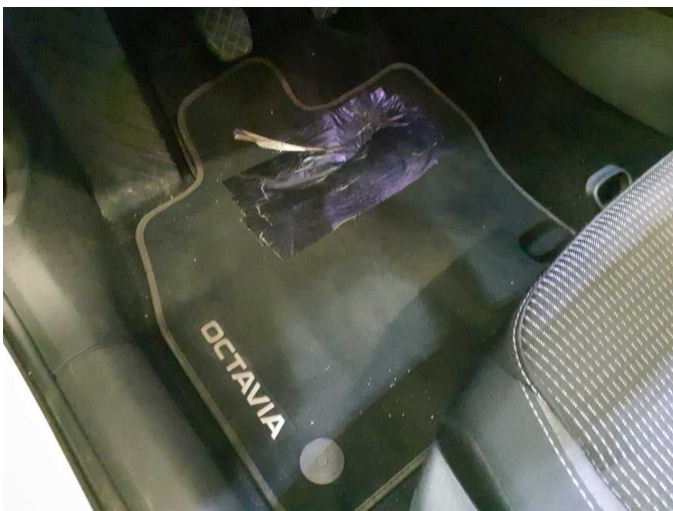
Damage 1: Trim / covers: Floor mats - Broken / torn - Replace

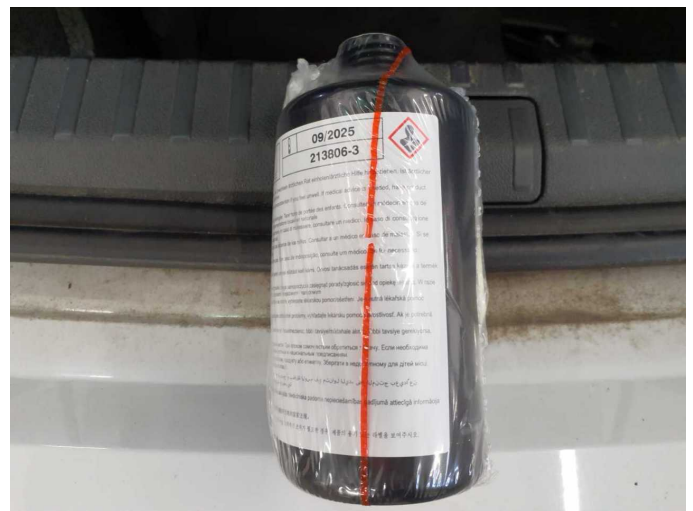
Damage 2: Equipment: Tirefit filler - Expired - Replace

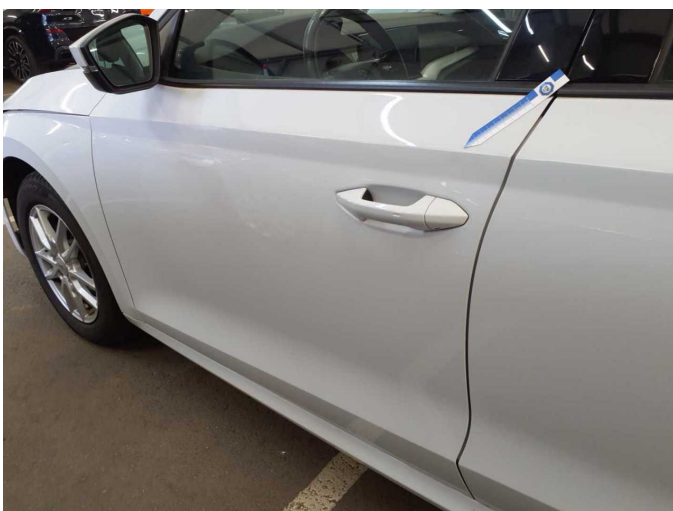
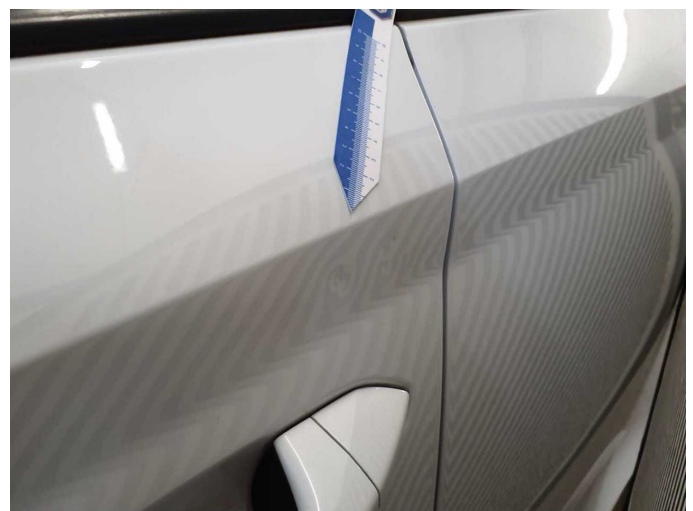
Damage 3: Door - front left side: Door - dent(s) - Smart repair

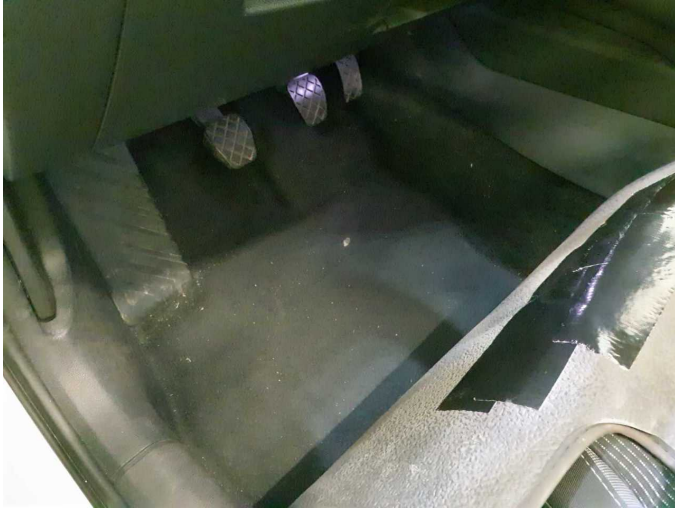
Damage 4: Trim / covers: Carpet - front left side - Broken / torn - Smart repair

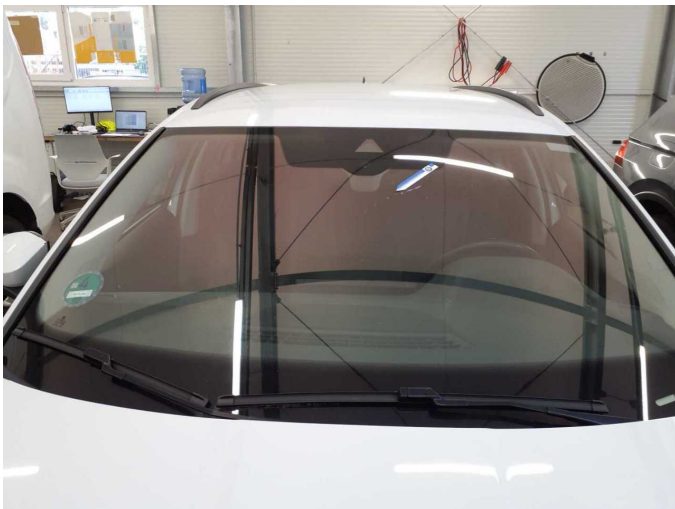
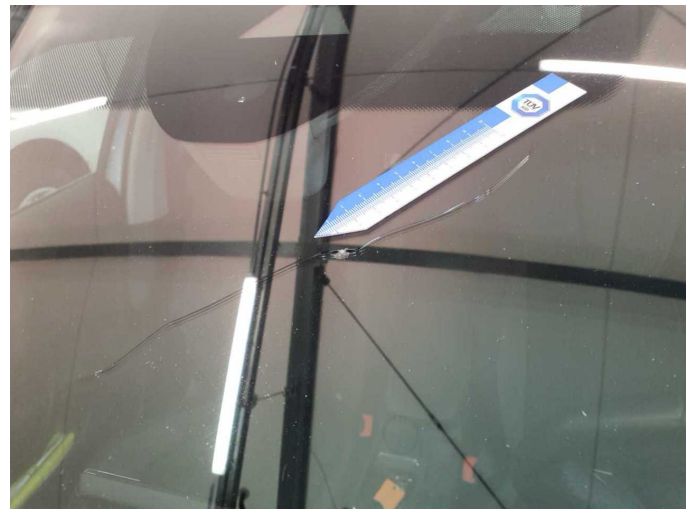
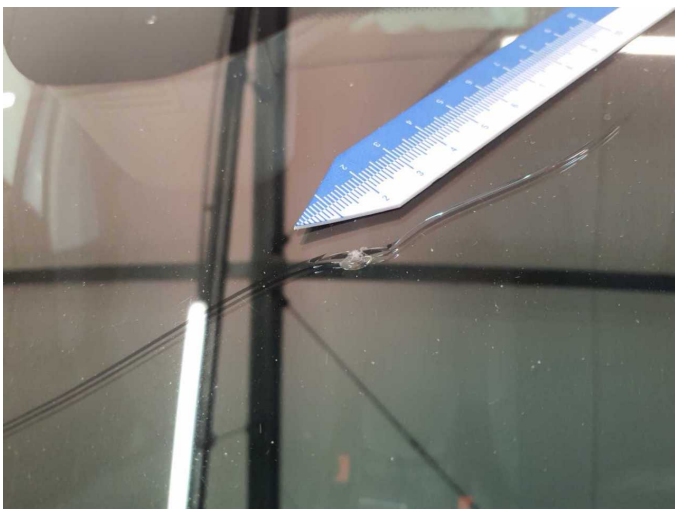
Damage 5: Vehicle glazing: Windscreen with lane departure assistant - Broken / torn - Replace
