Expertise

Protocol number: 46316514  
Order No. / Reference: 26533188  
Inspection date: 3 Jul 2026

Manufacturer: Opel

Model: Astra Sports Tourer 1.5 D Business Elegance

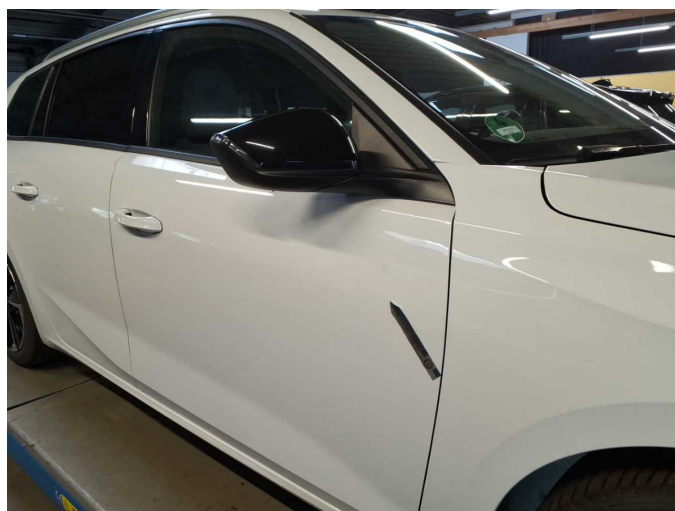
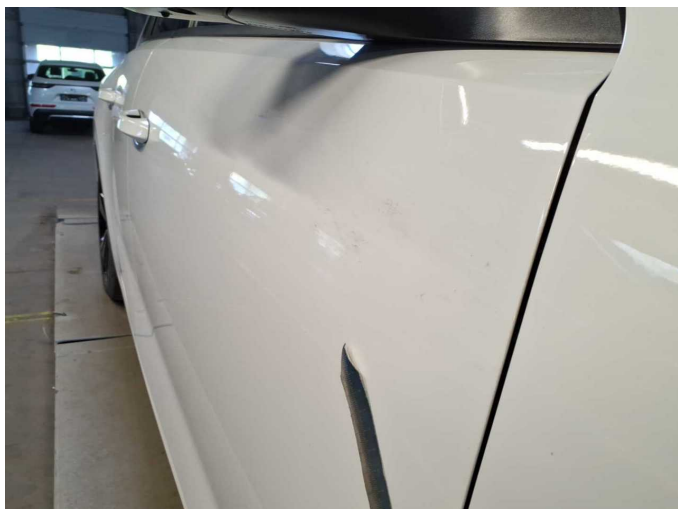
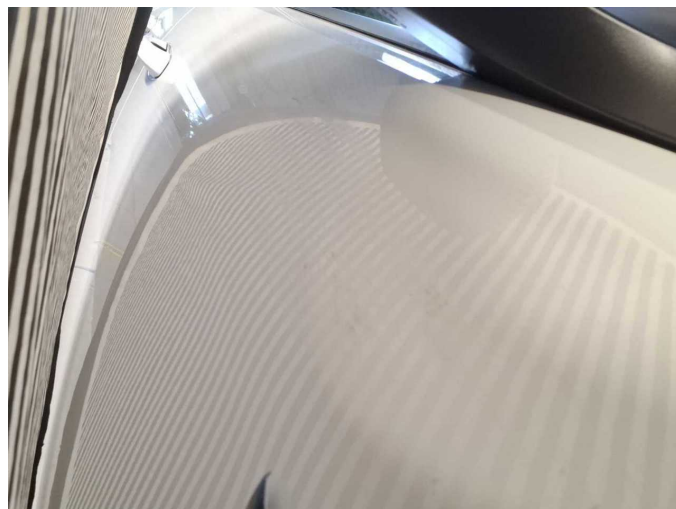
| No. | Component group | Description |
|---|---|---|
| 2 | Door - front right side | Door (Kleberreste) - Smart repair |

**Damage 2:** Door - front right side: Door (Kleberreste) - Smart repair

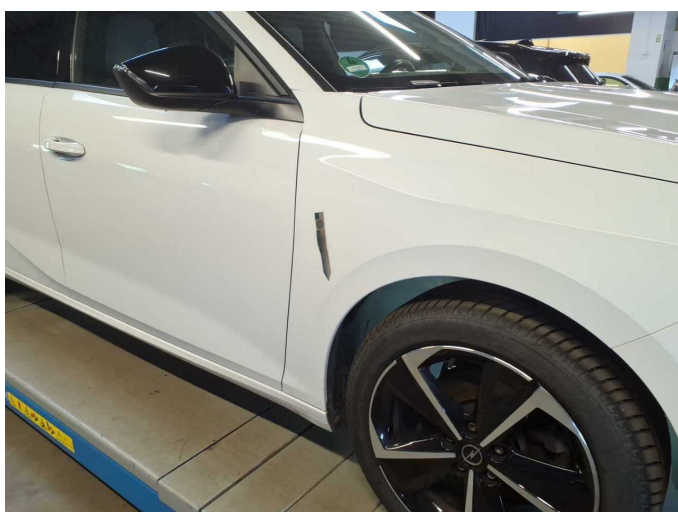
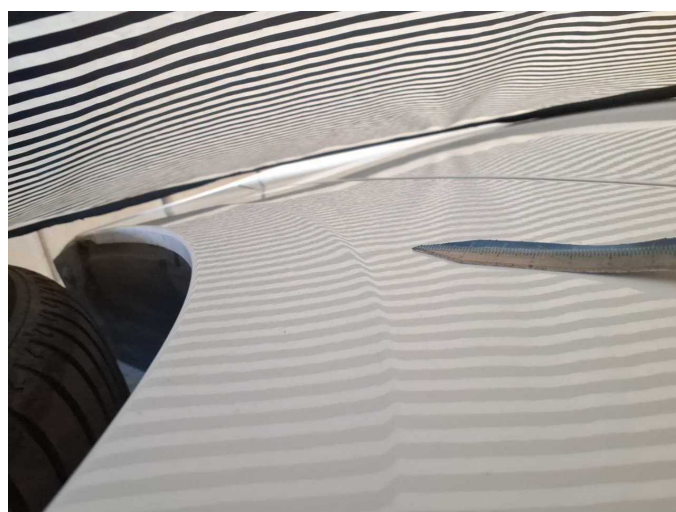
| No. | Component group | Description |
|---|---|---|
| 3 | Mudguard - right side | Mudguard - right side - dent(s) - Smooth repair work |

**Damage 3:** Mudguard - right side: Mudguard - right side - dent(s) - Smooth repair work

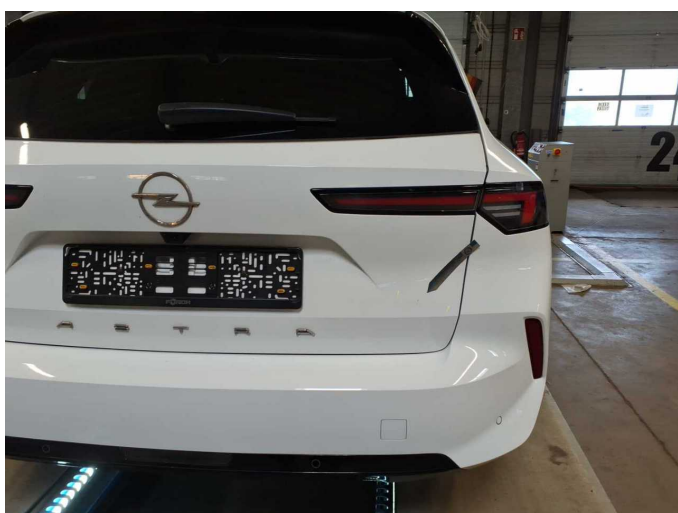
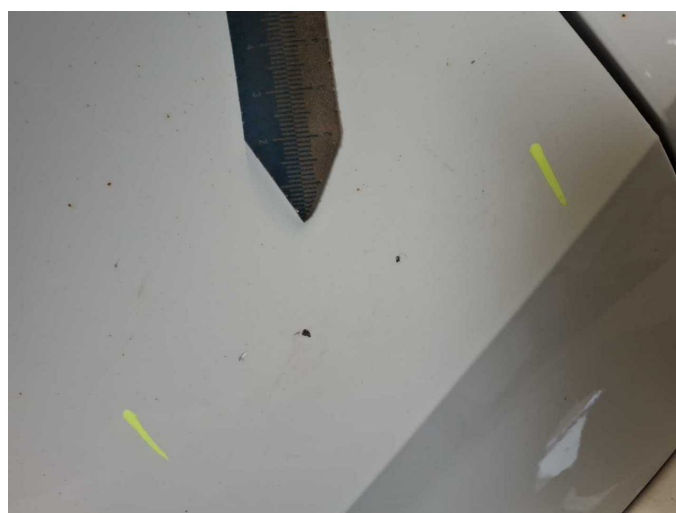
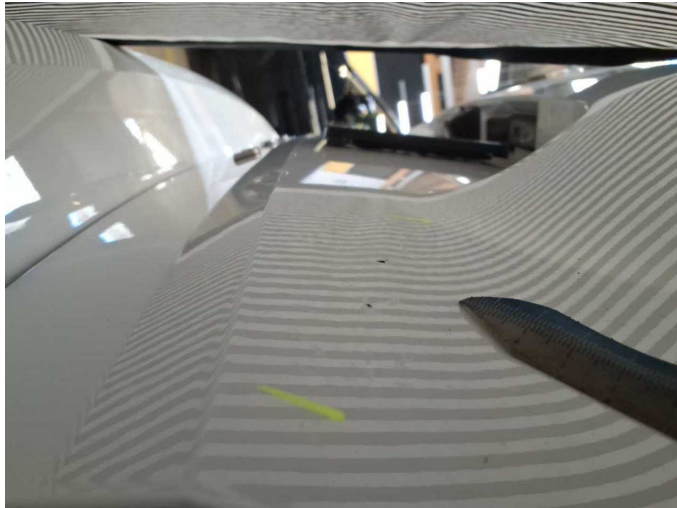
| No. | Component group | Description |
|---|---|---|
| 4 | Boot lid / rear door | Boot lid - Scratch(es) - Smart repair |

**Damage 4:** Boot lid / rear door: Boot lid - Scratch(es) - Smart repair

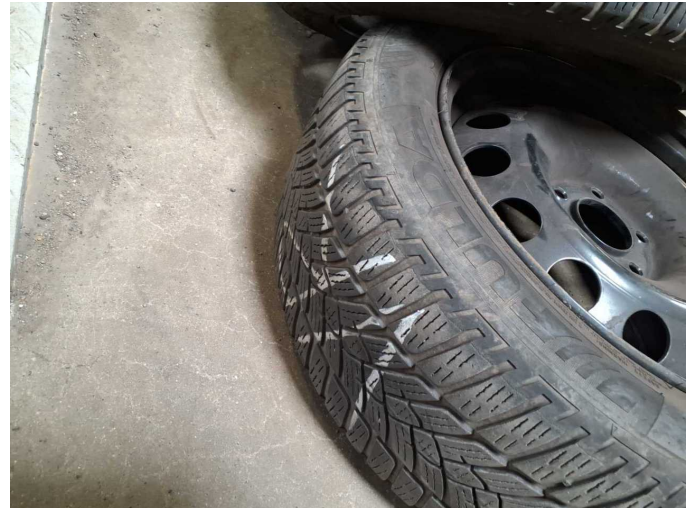
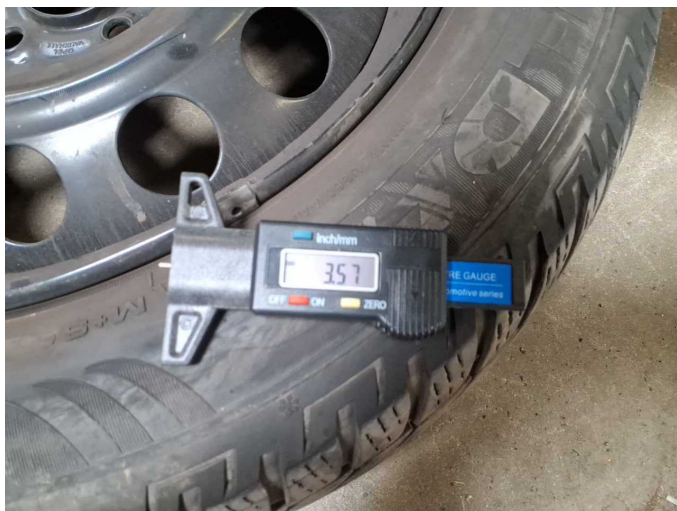
| No. | Component group | Description |
|---|---|---|
| 5 | 2nd wheel set | 1 tyre (Rest über 4mm.) - Does not meet the leasing specifications - Replace |

**Damage 5:** 2nd wheel set: 1 tyre (Rest über 4mm.) - Does not meet the leasing specifications - Replace

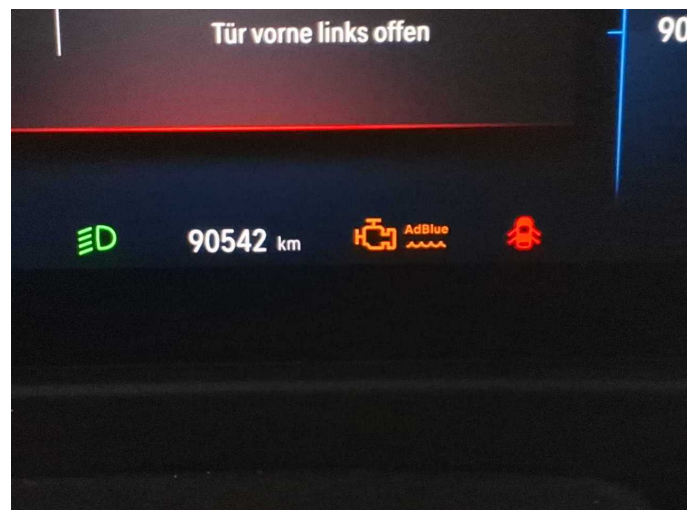
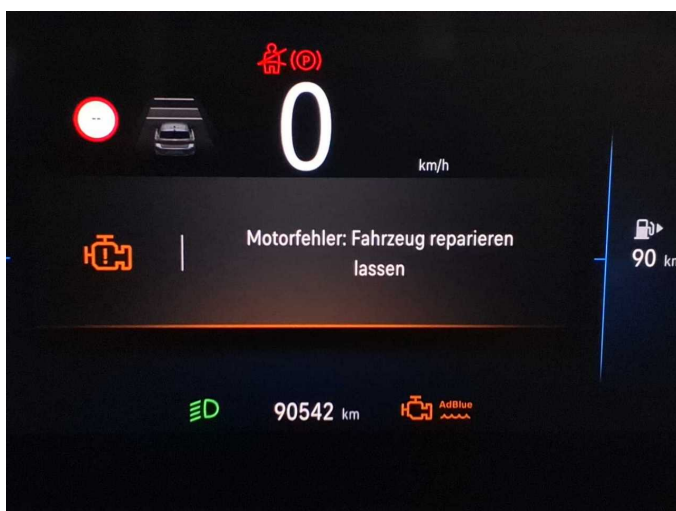
| No. | Component group | Description |
|---|---|---|
| 6 | Engine | Engine (MKL an) - Functional / admissibility - Perform diagnosis |

**Damage 6:** Engine: Engine (MKL an) - Functional / admissibility - Perform diagnosis
