Expertise

Protocol number: 46035805
Order No. / Reference: 26488706
Inspection date: 19 Jun 2026

Manufacturer: MAN

Model: TGE 3.140 4X2F SB

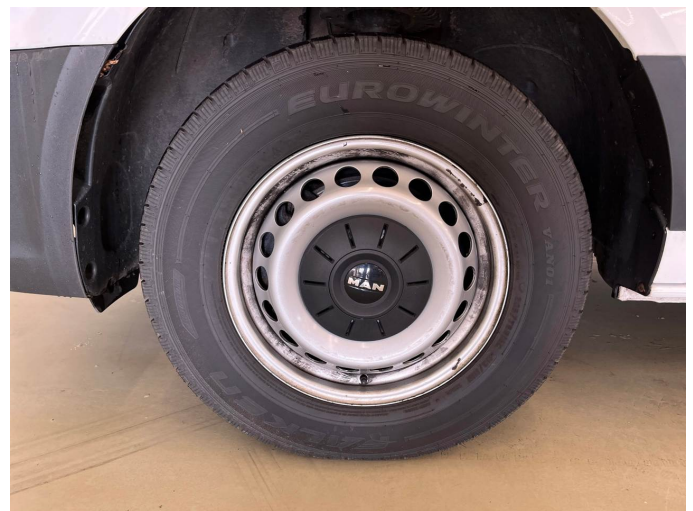
Figure 12: Mounted tyres

No.	Component group	Description
1	Wheel / tyres	Tyres - complete set (WR statt GJR) - Differs from the original configuration - No deduction
