## Expertise

Protocol number: 46161572  
Order No. / Reference: 26623460  
Inspection date: 23 Jun 2026

Model: Mondeo Turnier 2.0 EcoBlue Titanium

VIN: WF0FXXWPCFNY70349

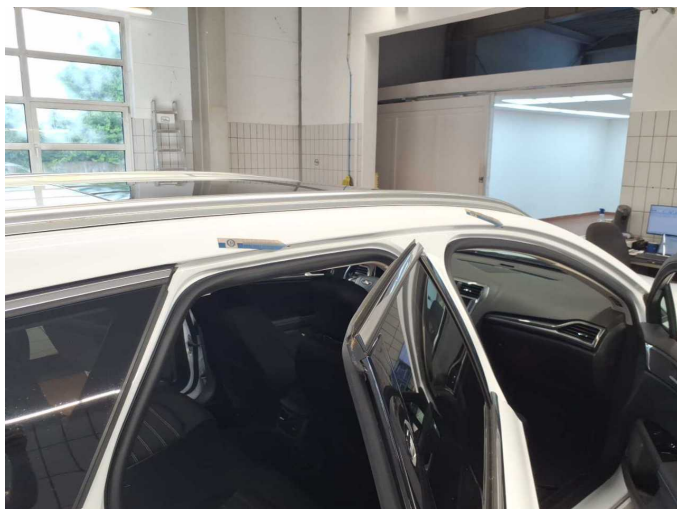
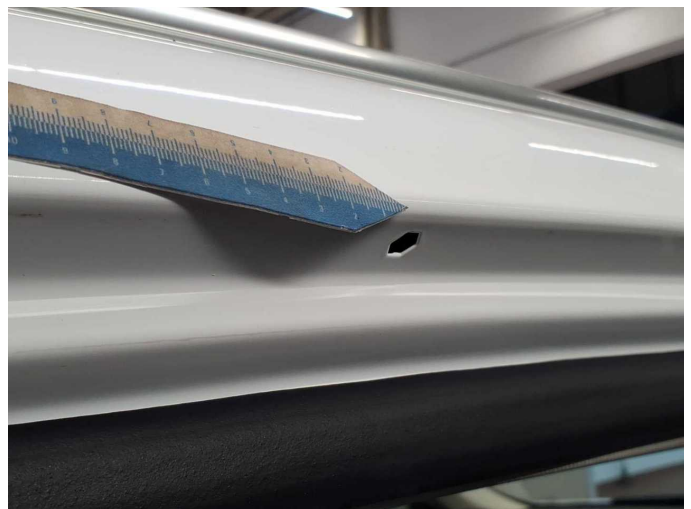
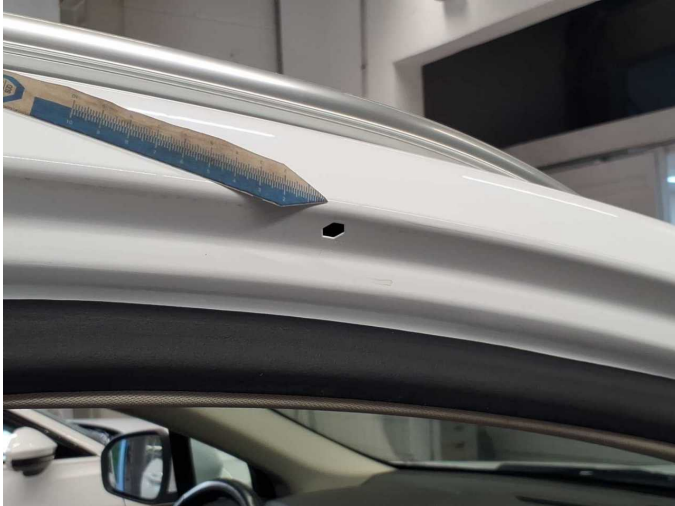
Damage 1: Roof: Roof rail - right side (Dichtstopfen) - Missing - Replace

**Damage 1:** Roof: Roof rail - right side (Dichtstopfen) - Missing - Replace

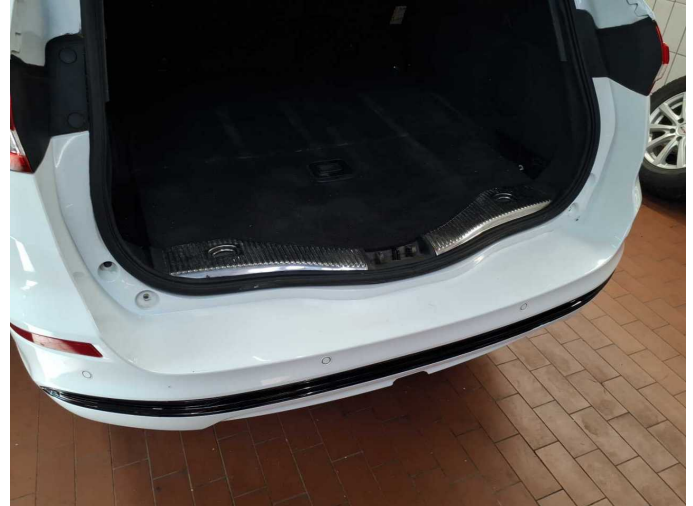
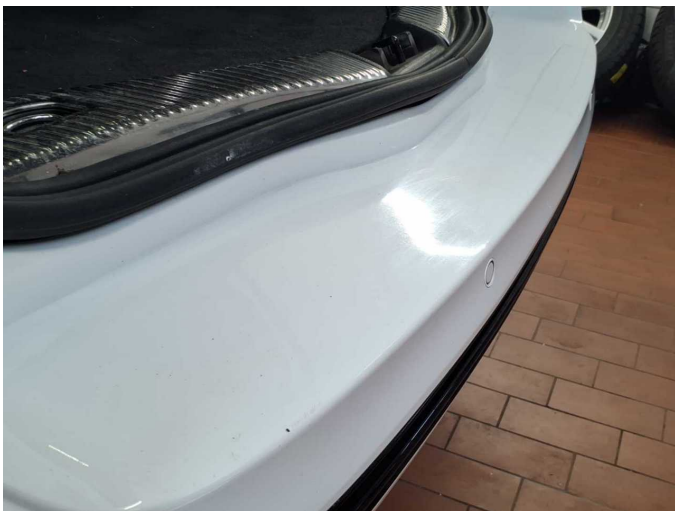
**Damage 2:** Rear bumper: Rear bumper (Schutzfolie) - Missing - Replace

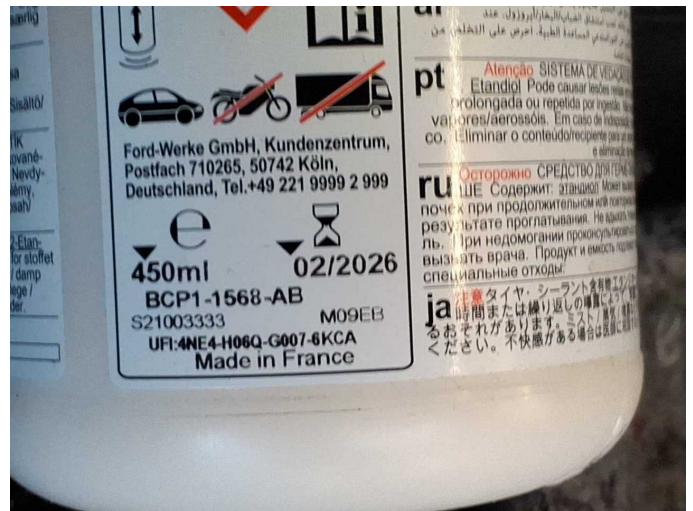
**Damage 3:** Equipment: Tirefit filler - Expired - Replace

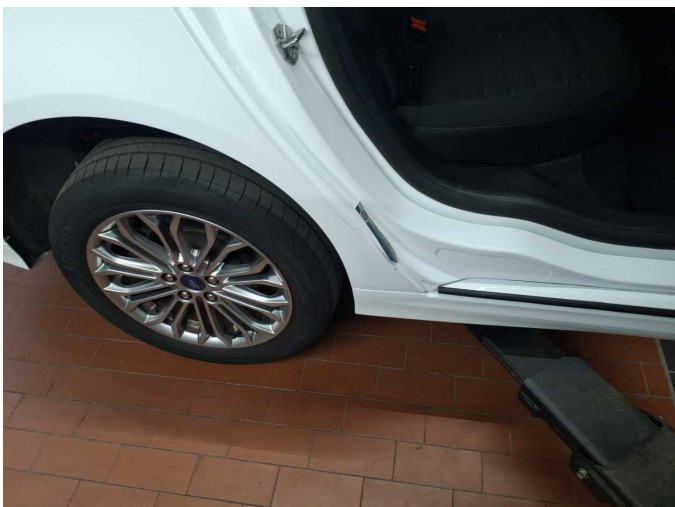
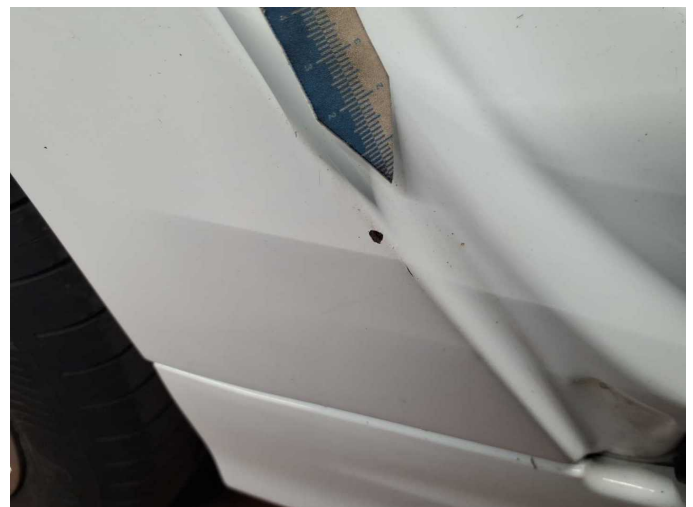
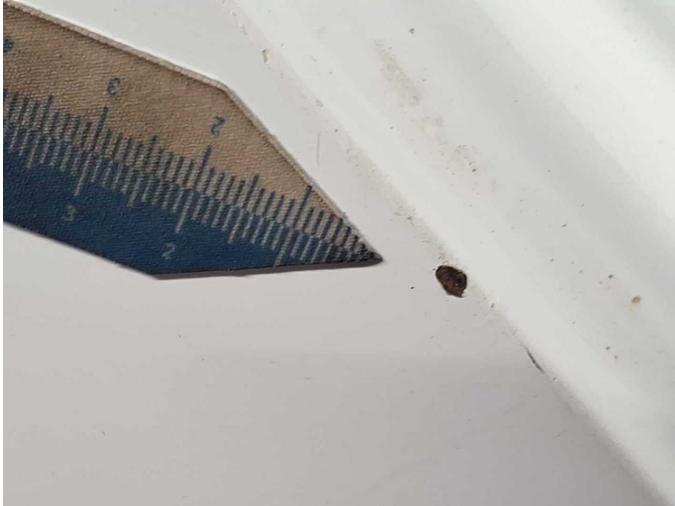
**Damage 4:** Side panel - rear right side: Side panel - Scratch(es) - Smart repair

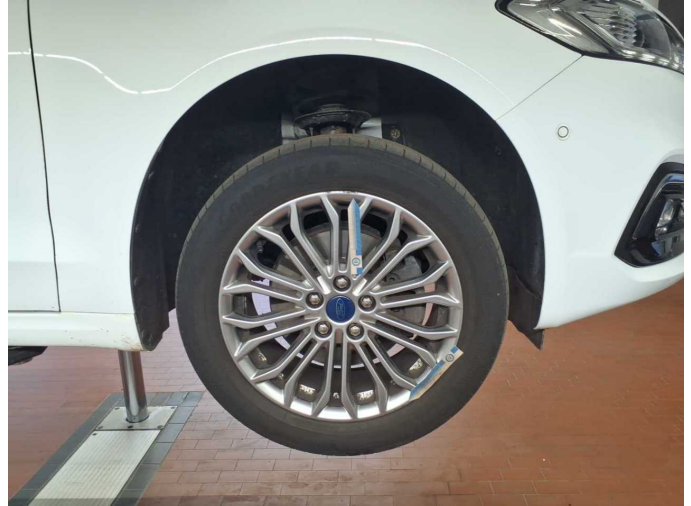
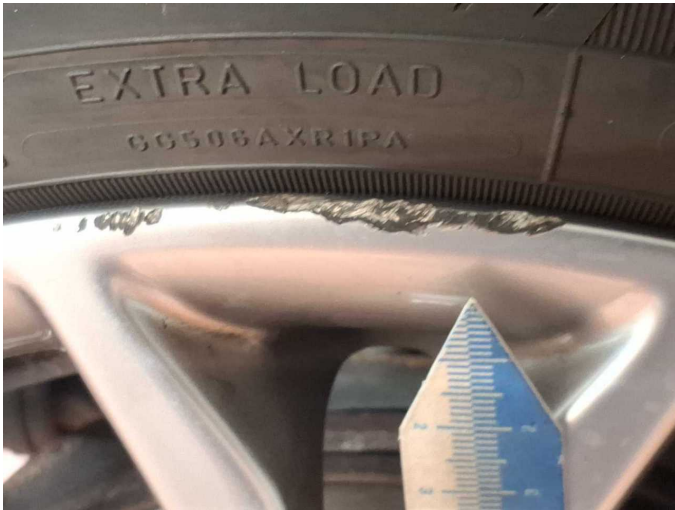
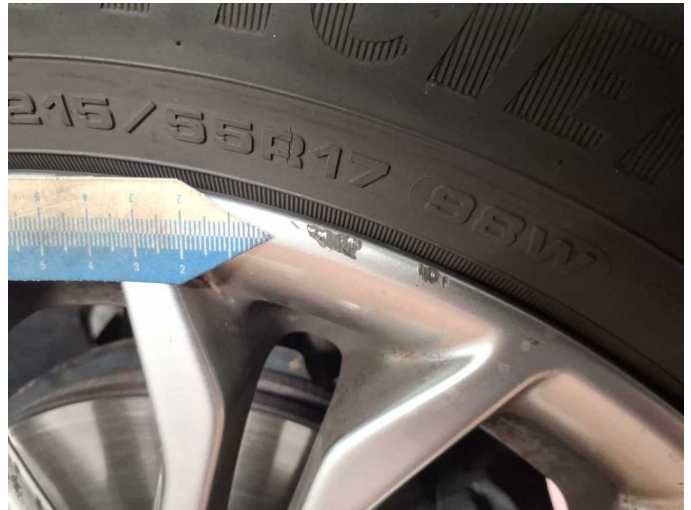
**Damage 5:** Wheel / tyres: Alloy rim - front right side (Materialabtrag) - Scratched - Replace

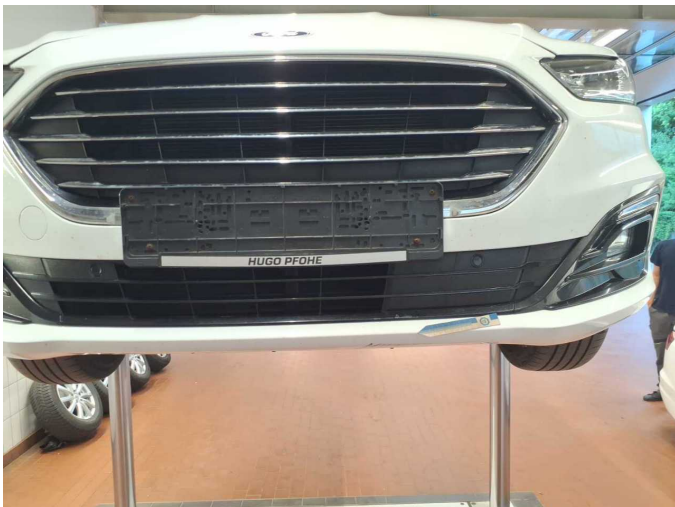
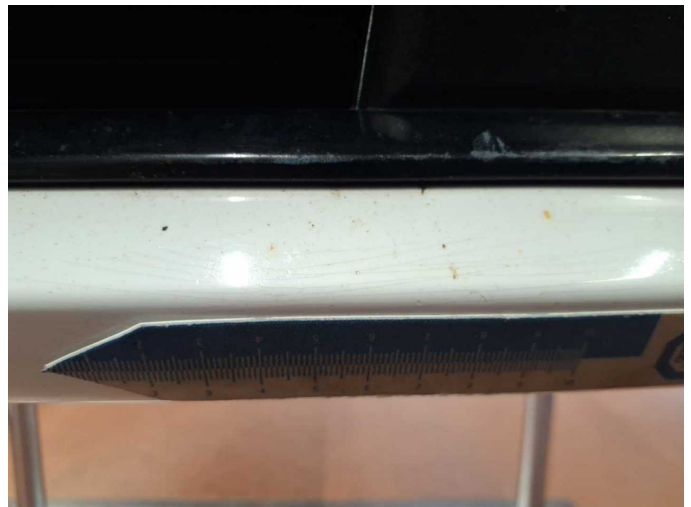
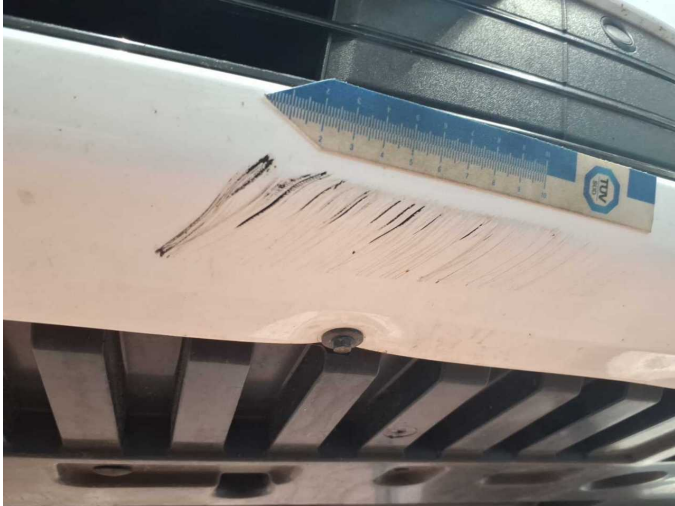
**Damage 6:** Front bumper: Front bumper - Scratched - Paint

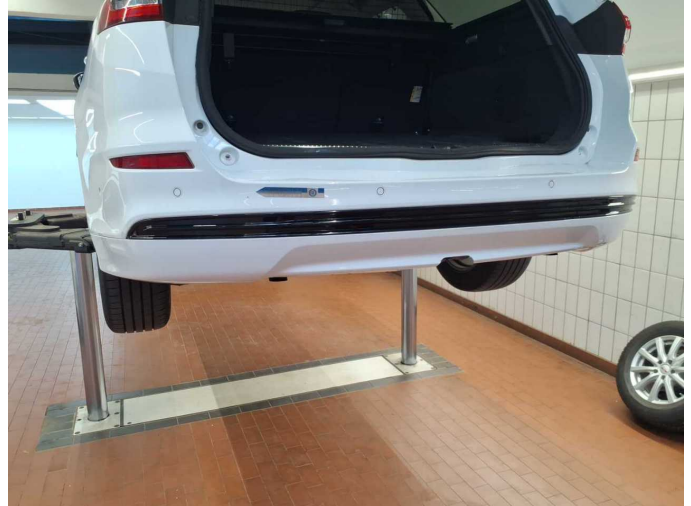
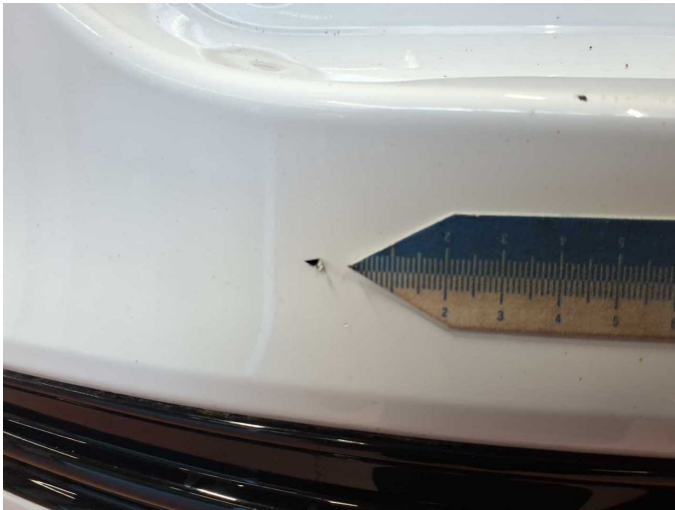
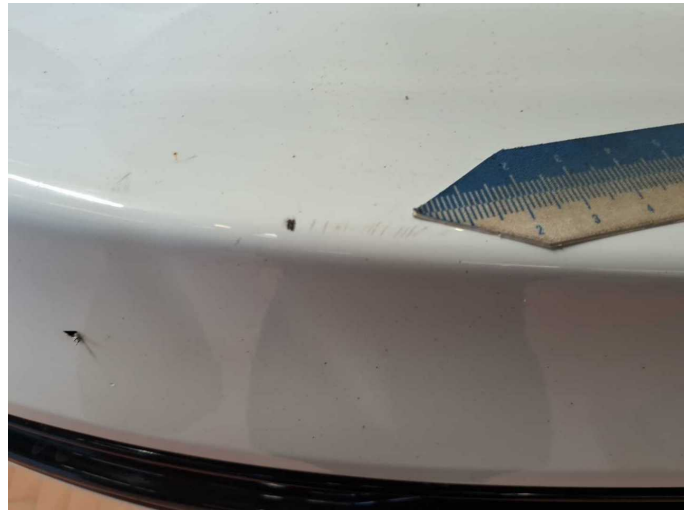
**Damage 7:** Rear bumper: Rear bumper - Scratch(es) - Paint

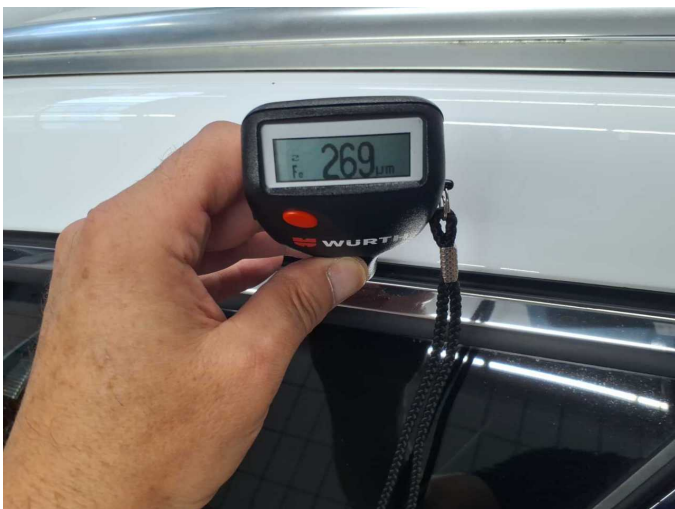
Roof rail - right side	269 µm	Side panel - rear right side	891 µm
------------------------	--------	------------------------------	--------

**Repainting 1:** Roof rail - right side

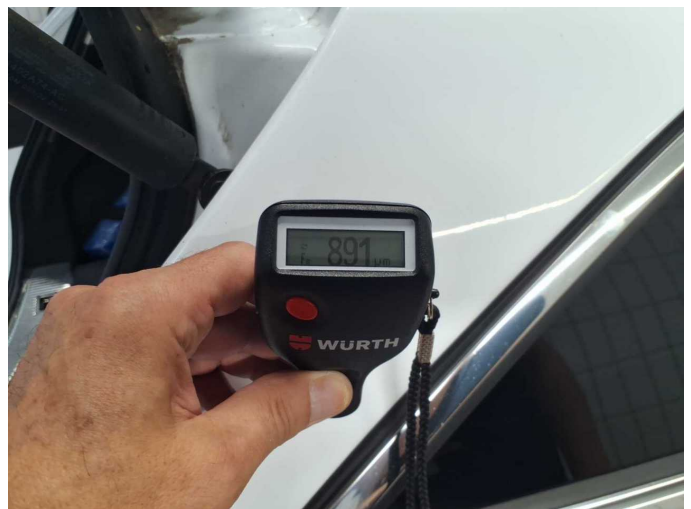
**Repainting 2:** Side panel - rear right side
