Expertise

Protocol number: 45996598
Order No. / Reference: 26451736
Inspection date: 16 Jun 2026

Model: Vivaro 2.0 D Cargo L EHZ Autm. Elegance

Brief expert findings

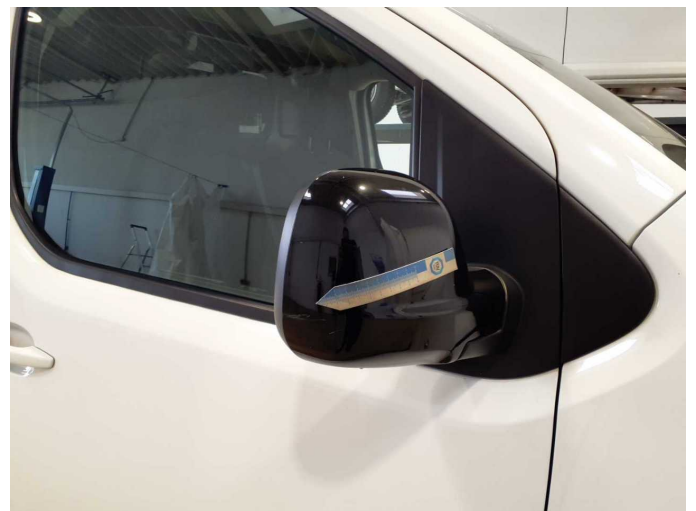
Damage 2: Wing mirror - right side: Cap - Scratched - Smart repair

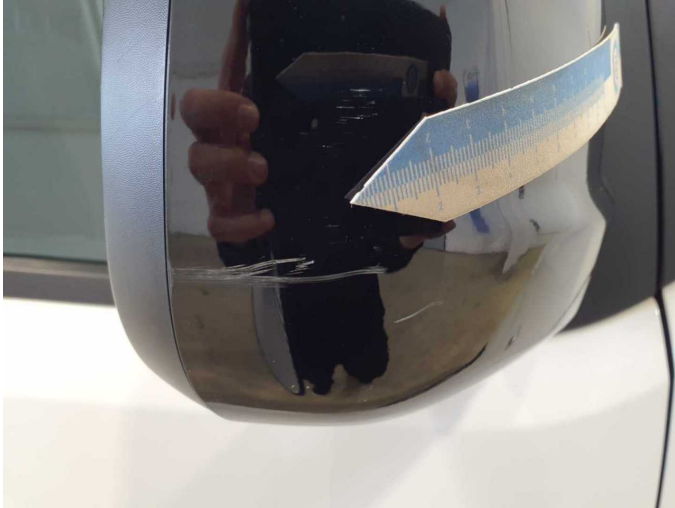
Damage 2: Wing mirror - right side: Cap - Scratched - Smart repair

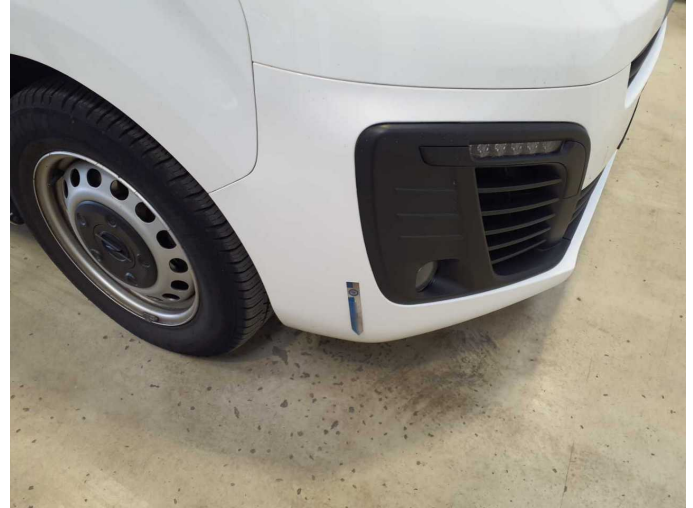
Damage 3: Front bumper: Front bumper - Scratched - Smart repair

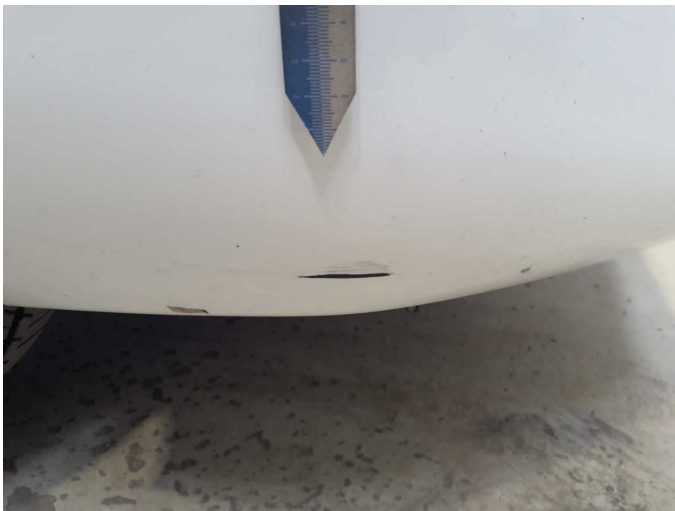
Damage 3: Front bumper: Front bumper - Scratched - Smart repair

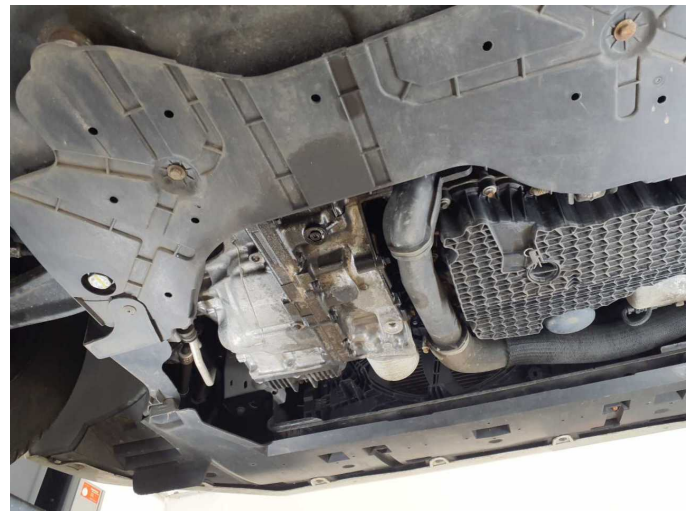
Damage 4: Engine: Engine - Leaking - Perform diagnosis

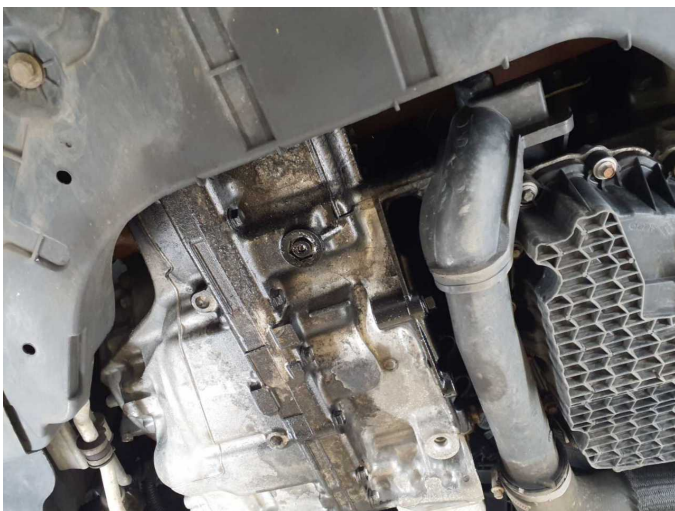
Damage 4: Engine: Engine - Leaking - Perform diagnosis

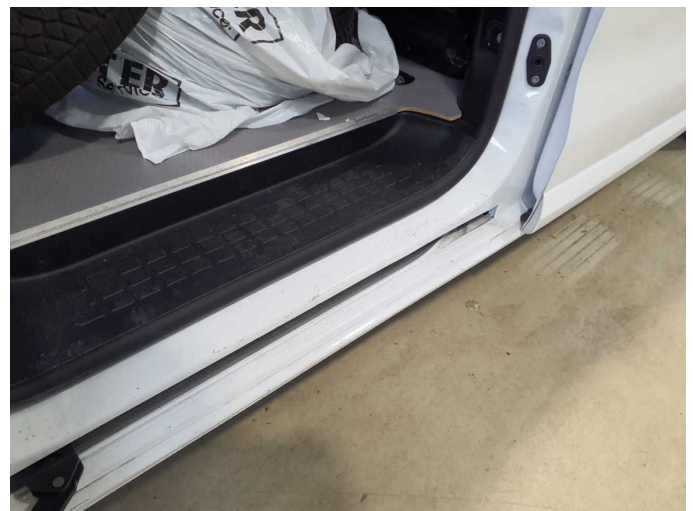
Damage 5: Side panel - rear right side: Sill - Scratched - Smart repair

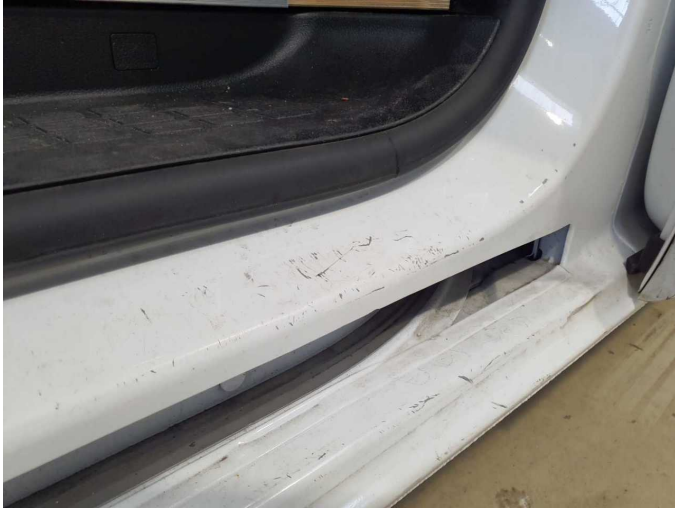
Damage 5: Side panel - rear right side: Sill - Scratched - Smart repair

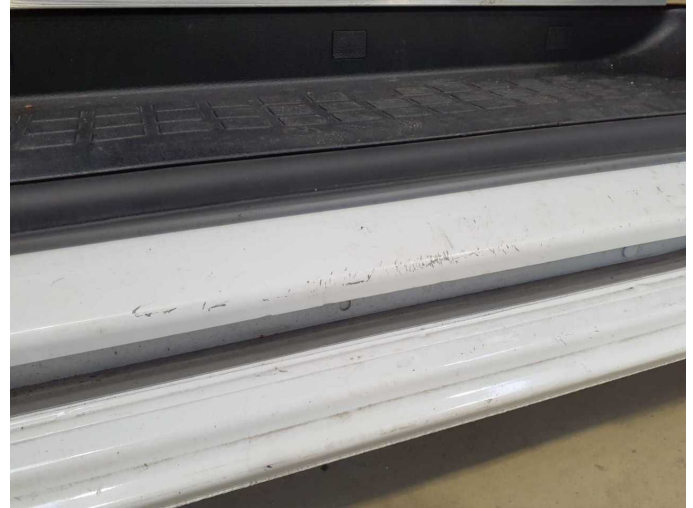
Damage 5: Side panel - rear right side: Sill - Scratched - Smart repair

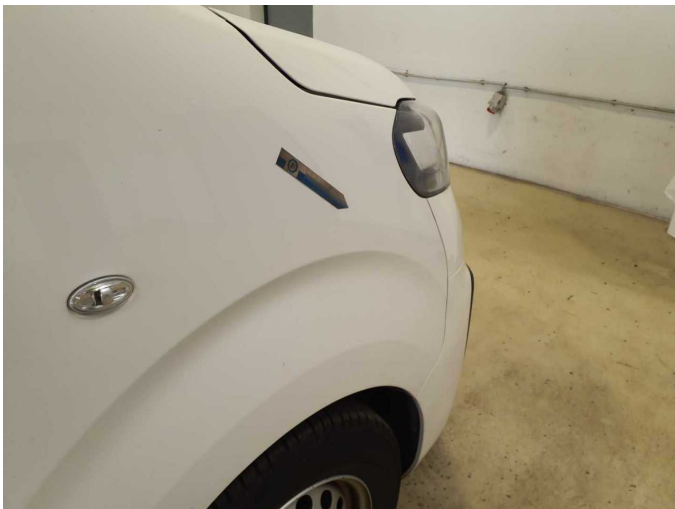
Damage 6: Mudguard - right side: Mudguard - right side - dent(s) - Smart repair

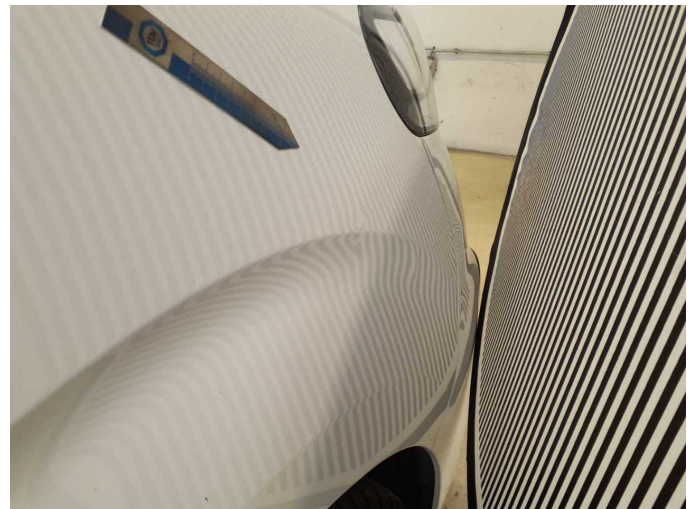
Damage 6: Mudguard - right side: Mudguard - right side - dent(s) - Smart repair

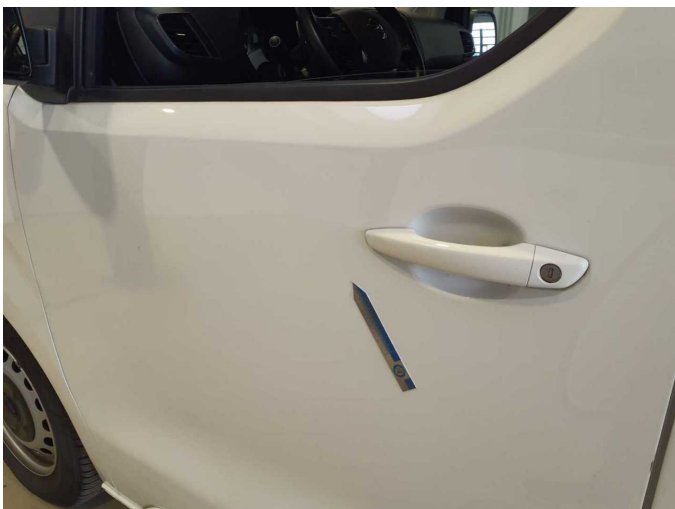
Damage 7: Door - front left side: Door - Scratch(es) - Smart repair

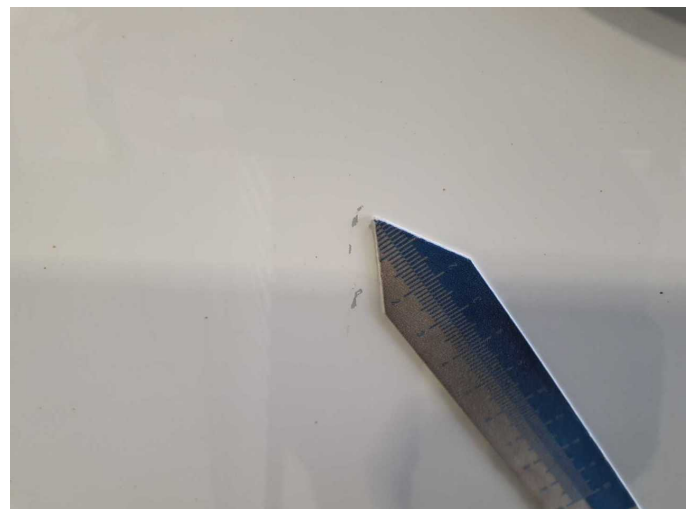
Damage 7: Door - front left side: Door - Scratch(es) - Smart repair

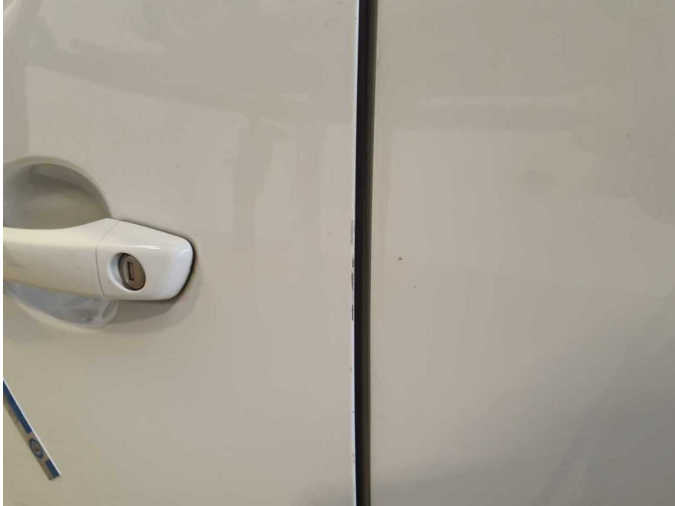
Damage 7: Door - front left side: Door - Scratch(es) - Smart repair

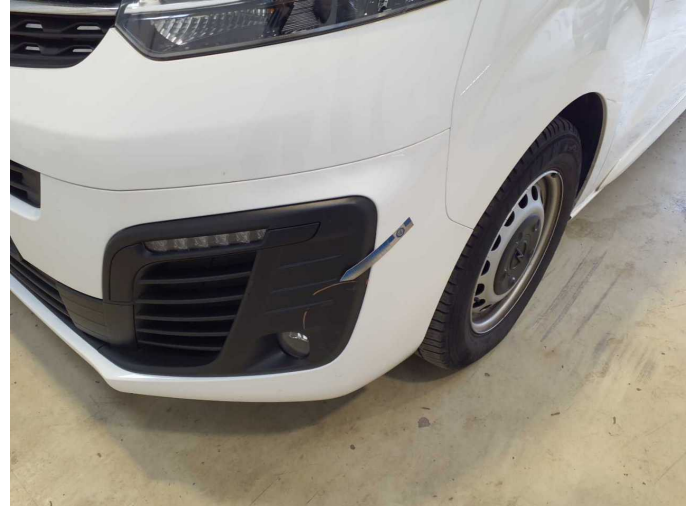
Damage 8: Front bumper: Cover bumper - front (Links) - Scratched - Replace

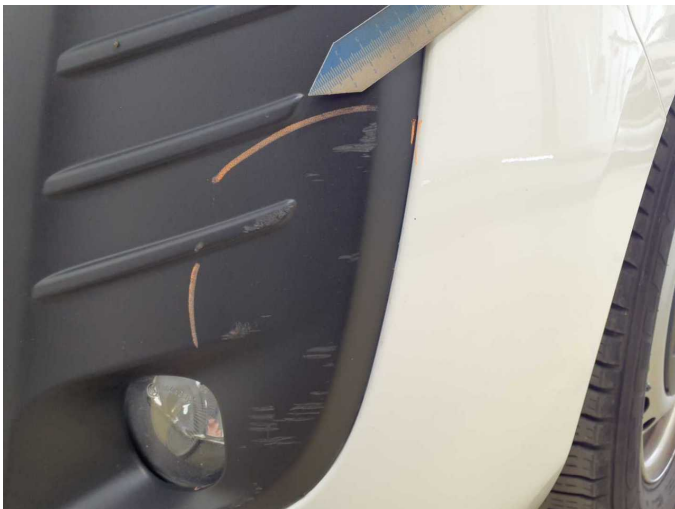
Damage 8: Front bumper: Cover bumper - front (Links) - Scratched - Replace

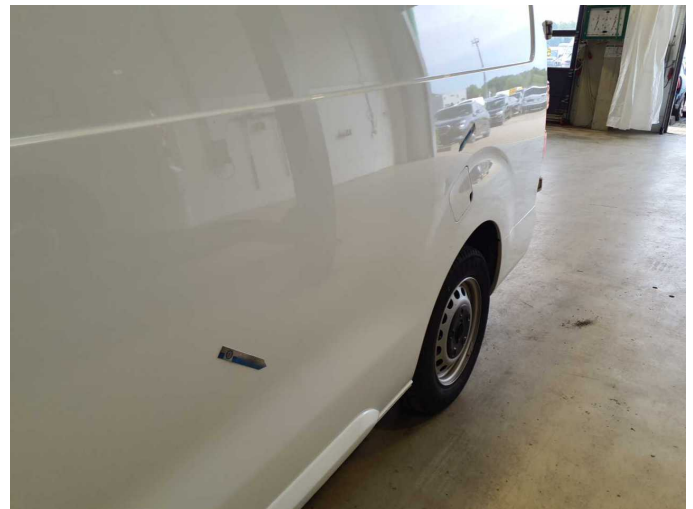
Damage 9: Side panel - rear left side: Side panel (Unterhalb) - dent(s) - Repair and paint

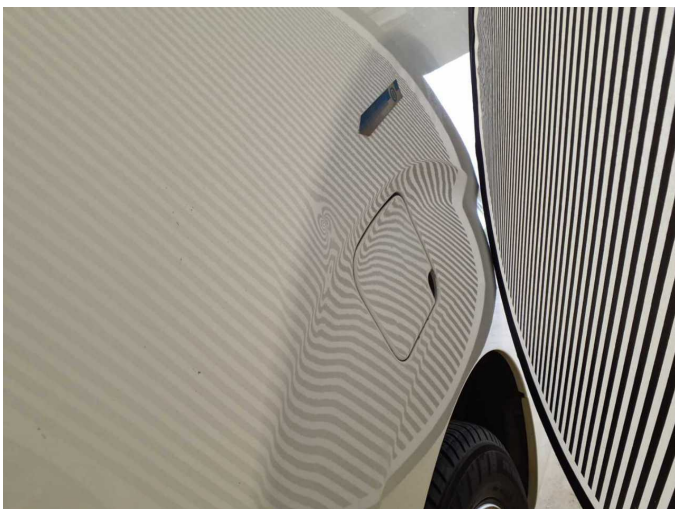
Damage 9: Side panel - rear left side: Side panel (Unterhalb) - dent(s) - Repair and paint

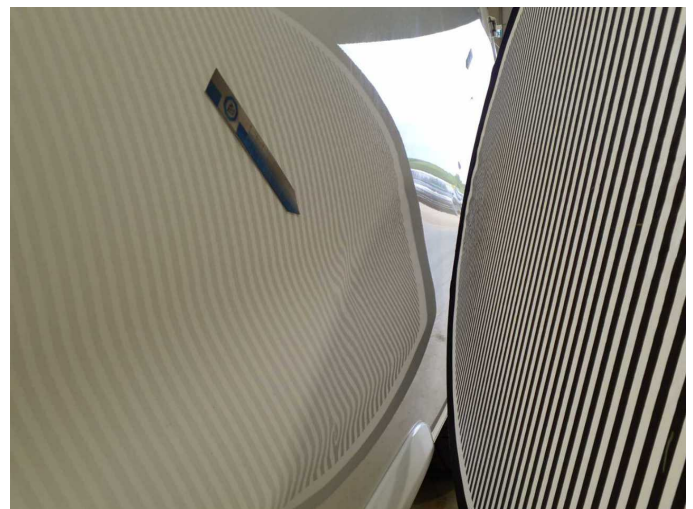
Damage 9: Side panel - rear left side: Side panel (Unterhalb) - dent(s) - Repair and paint

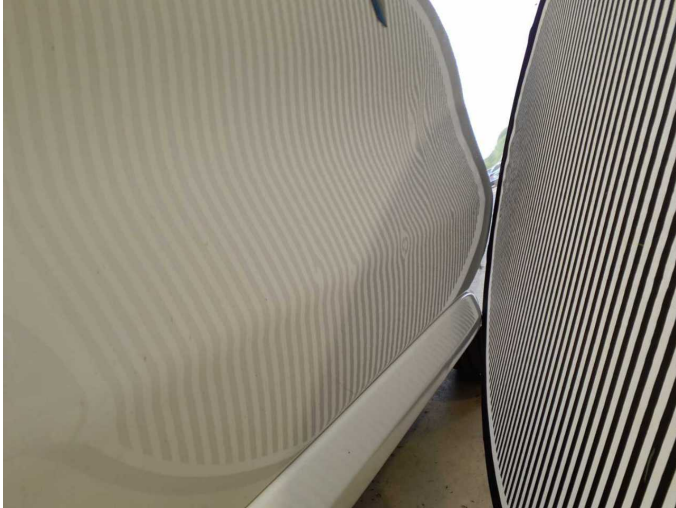
Damage 9: Side panel - rear left side: Side panel (Unterhalb) - dent(s) - Repair and paint

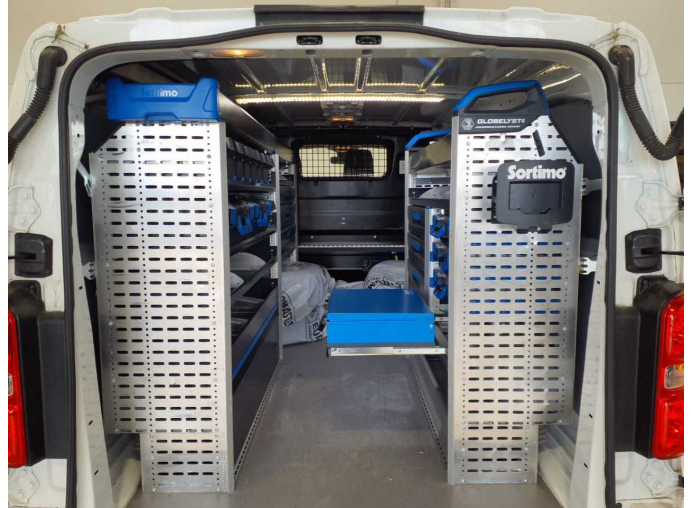
Wear and tear 1: Shelf installation: Shelf installation - Differs from the original configuration - No deduction

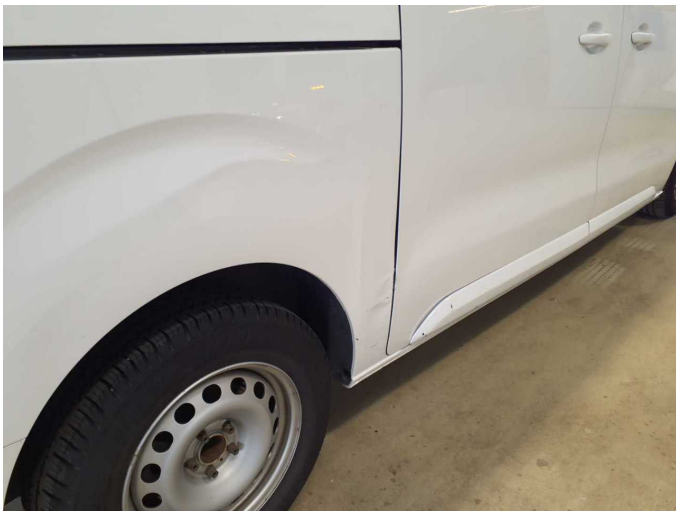
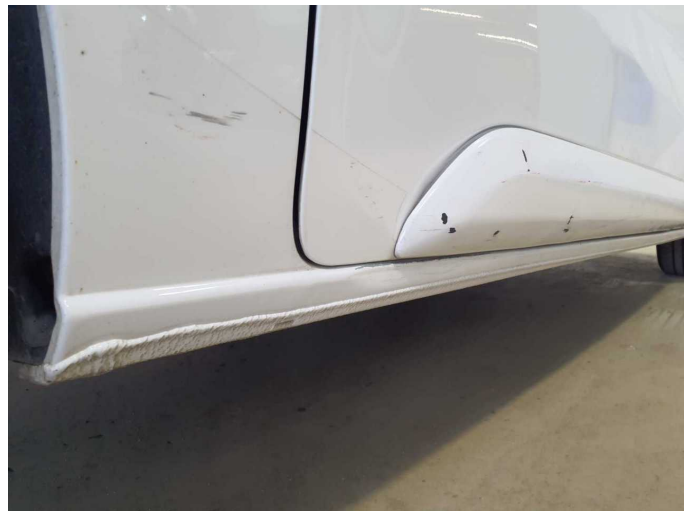
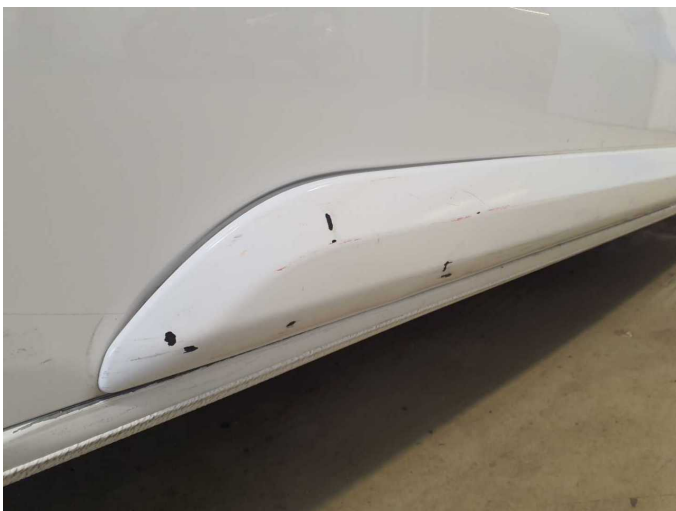
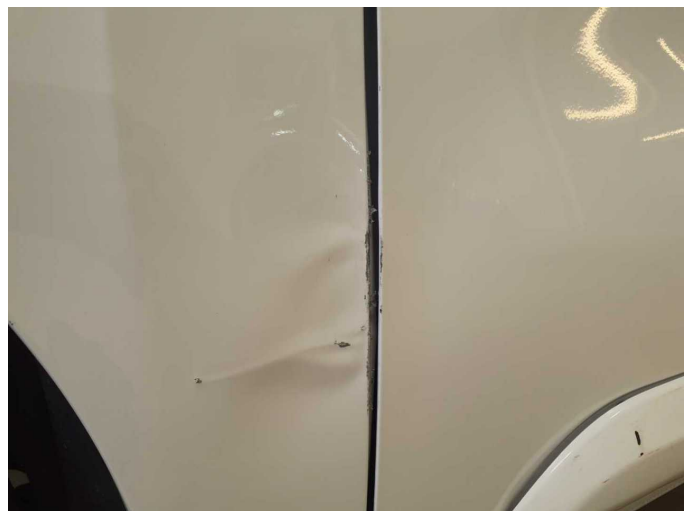
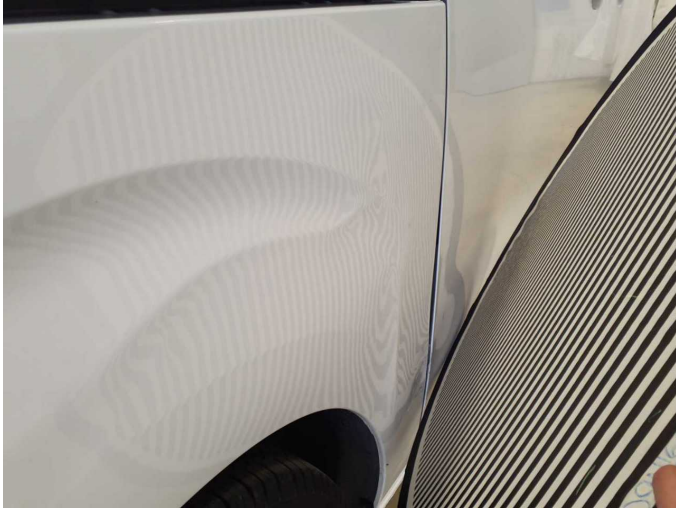
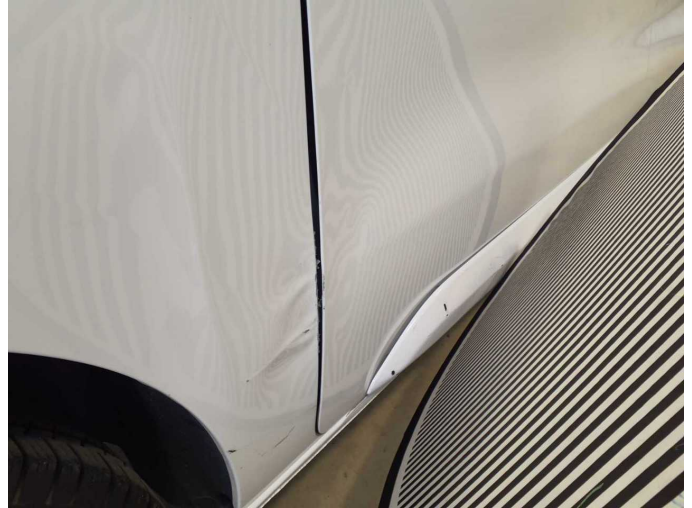
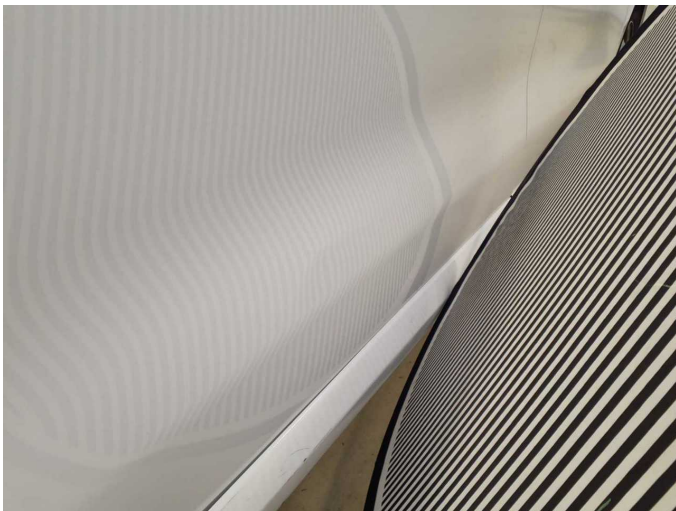
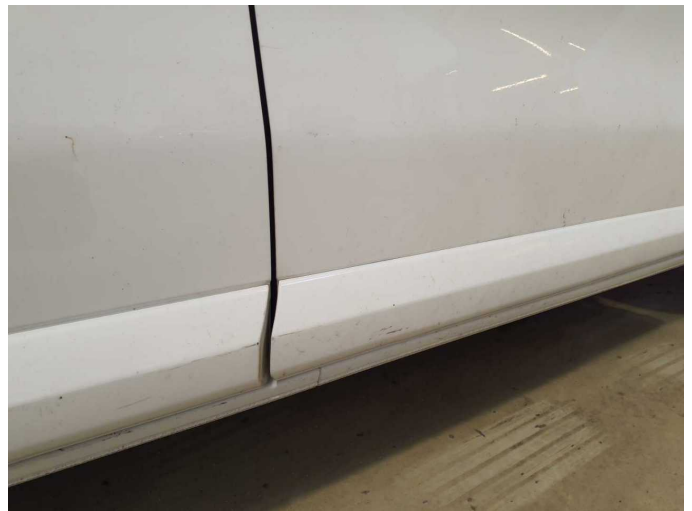
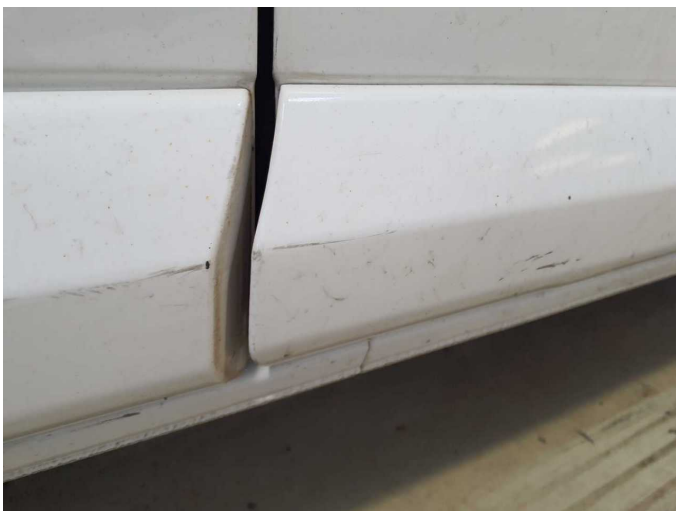
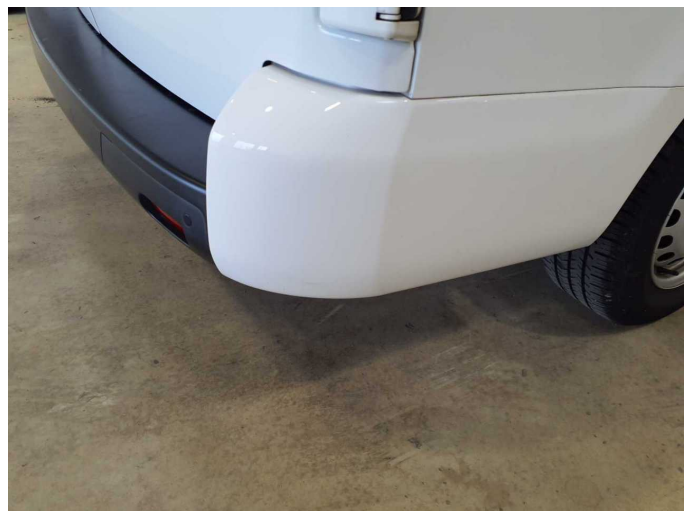
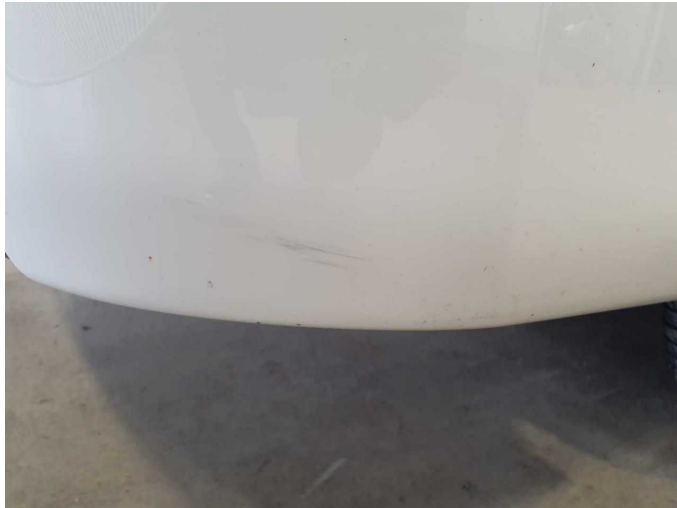
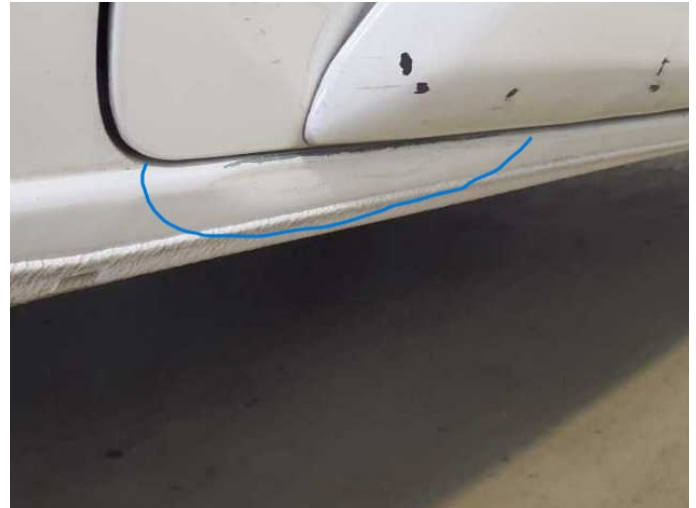
Non-repaired previous damages were found at the vehicle. The necessary repair costs are listed in the expert report or if necessary, are listed in detail in a separately enclosed repair cost calculation.

Accident 1: Side right
