Expertise

Protocol number: 46661667  
Order No. / Reference: 26644465  
Inspection date: 22 Jul 2026

Manufacturer: Skoda  
VIN: TMBJH9NP2M7075108

Model: Superb Combi 2.0 TDI Ambition

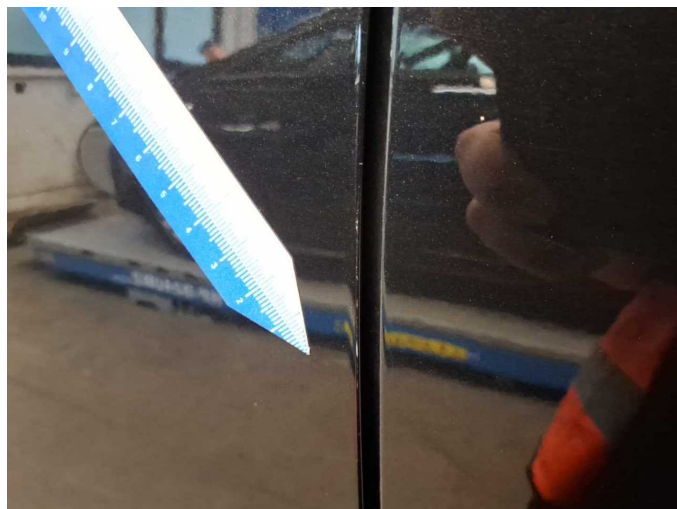
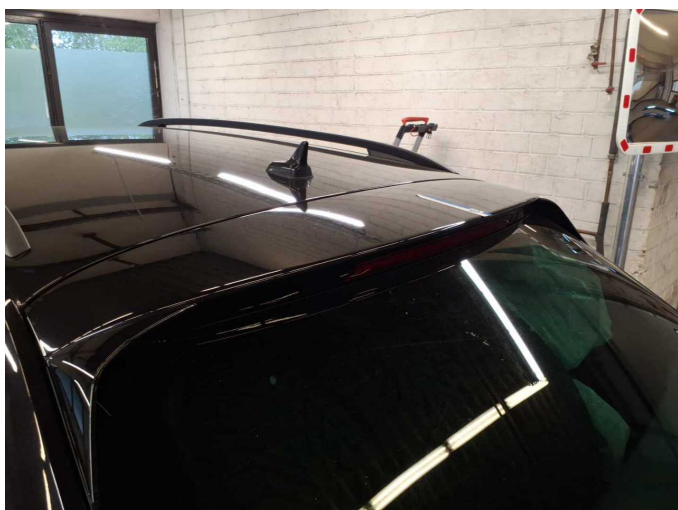
| No. | Component group | Description |
|---|---|---|
| 2 | Door - front left side | Door edge - Scratched - Smart repair |

**Damage 2:** Door - front left side: Door edge - Scratched - Smart repair

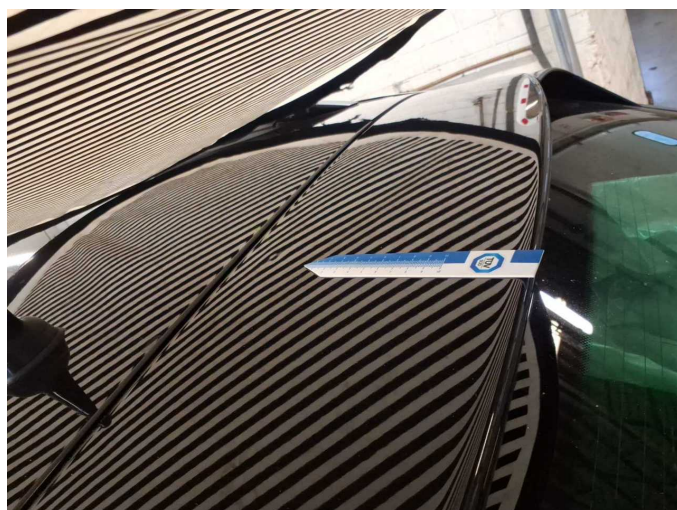
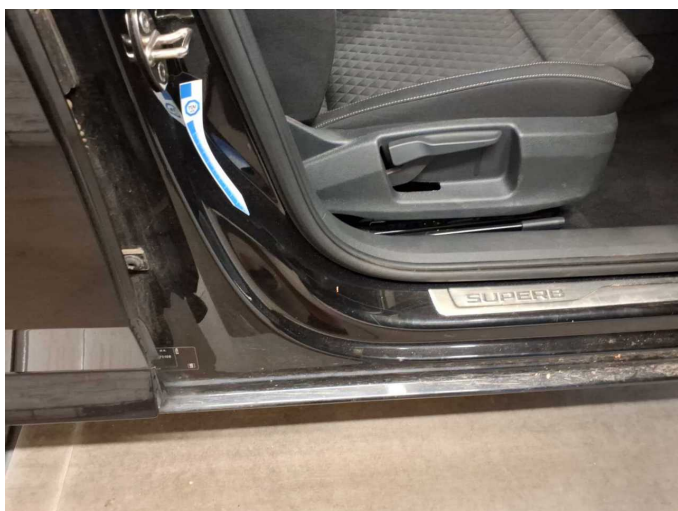
| No. | Component group | Description |
|---|---|---|
| 3 | Boot lid / rear door | Rear spoiler - dent(s) - Smooth repair work |

**Damage 3:** Boot lid / rear door: Rear spoiler - dent(s) - Smooth repair work

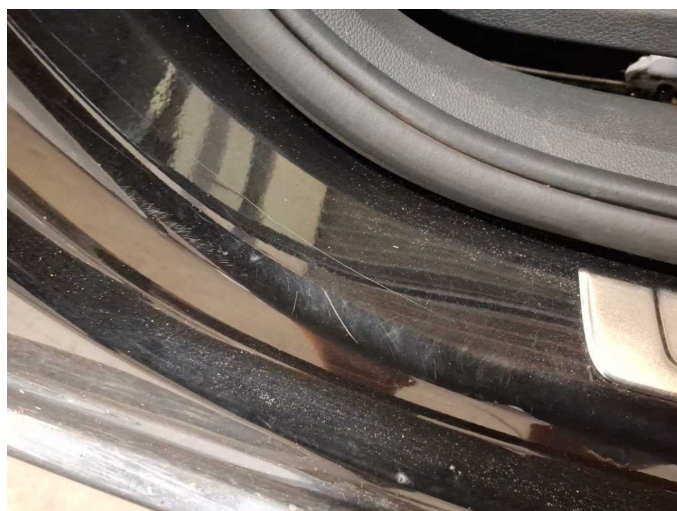
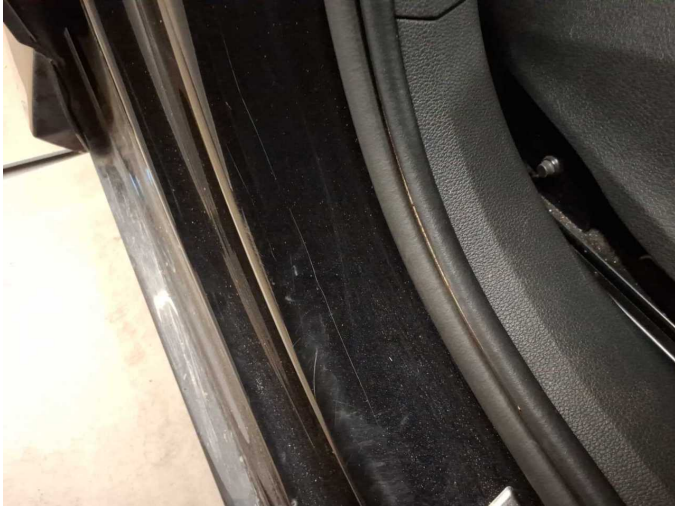
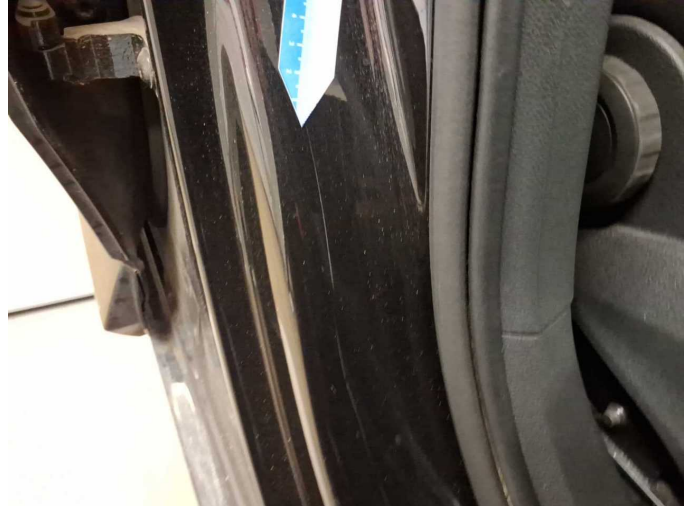
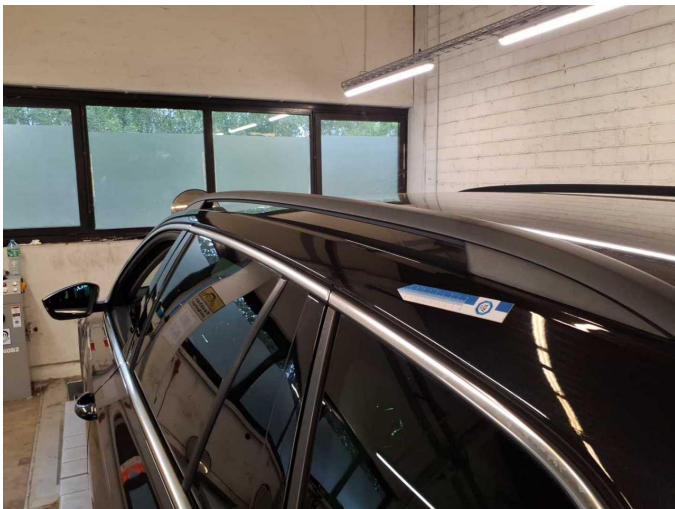
| No. | Component group | Description |
|---|---|---|
| 4 | Sill - right side | Sill - Scratched - Smart repair |

**Damage 4:** Sill - right side: Sill - Scratched - Smart repair

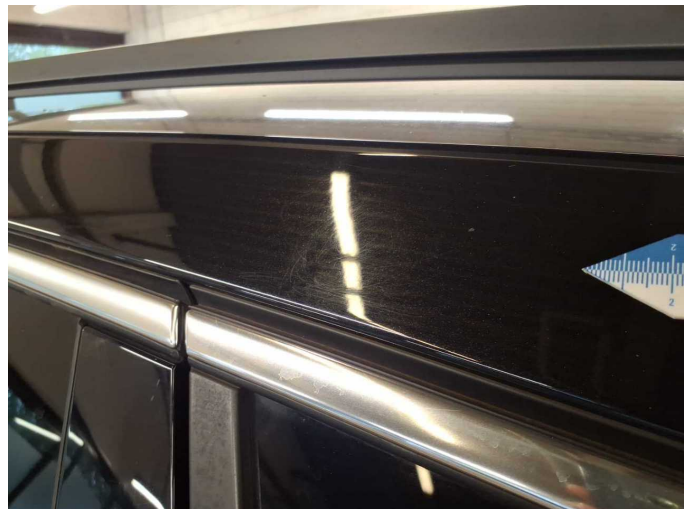
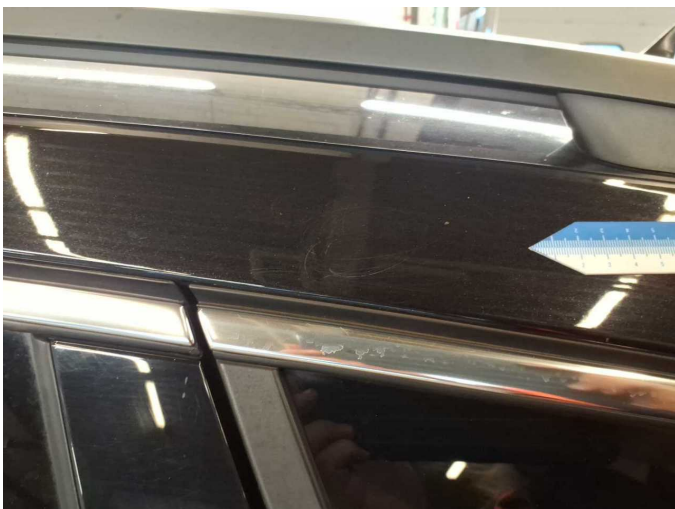
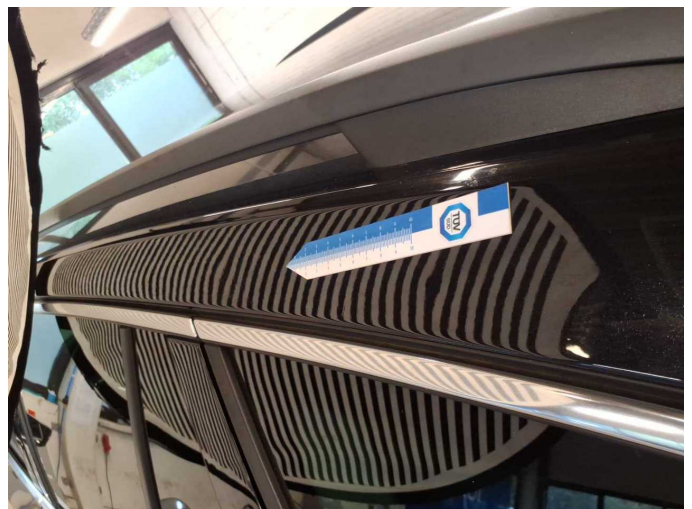
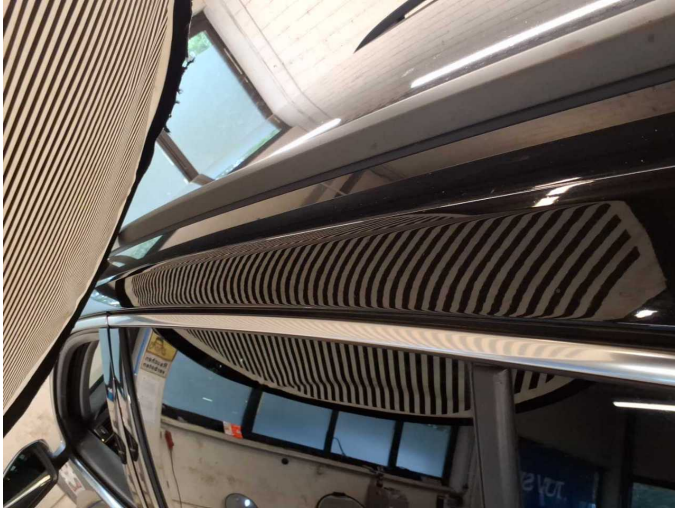
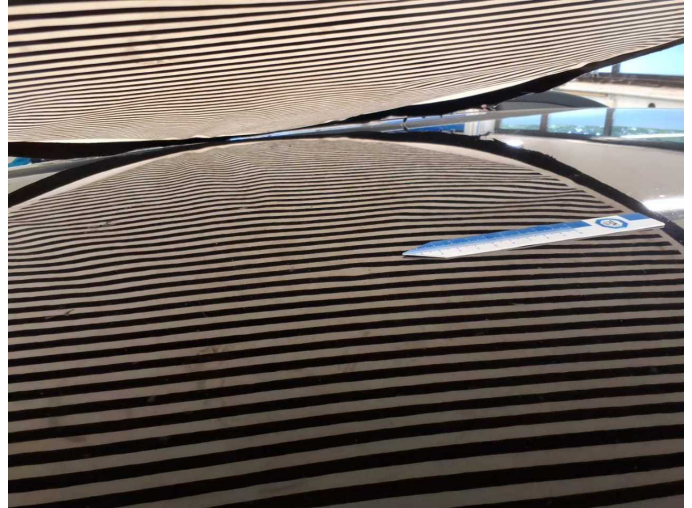
| No. | Component group | Description |
|---|---|---|
| 5 | Roof | Roof rail - left side - Dent / paintcoat damage - Smart repair |

**Damage 5:** Roof: Roof rail - left side - Dent / paintcoat damage - Smart repair

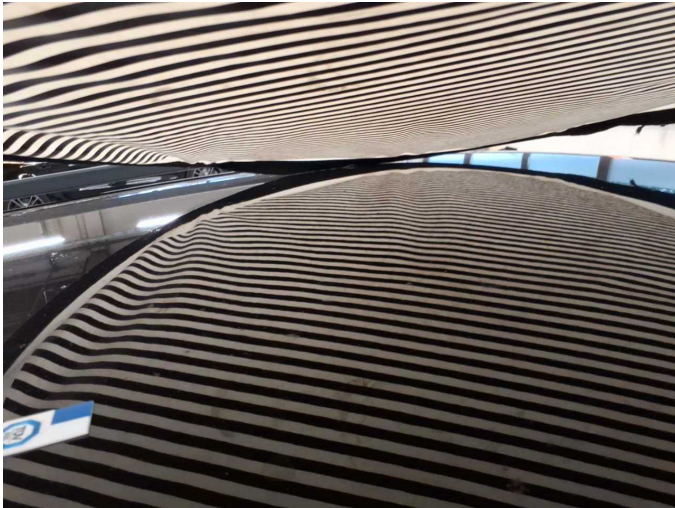
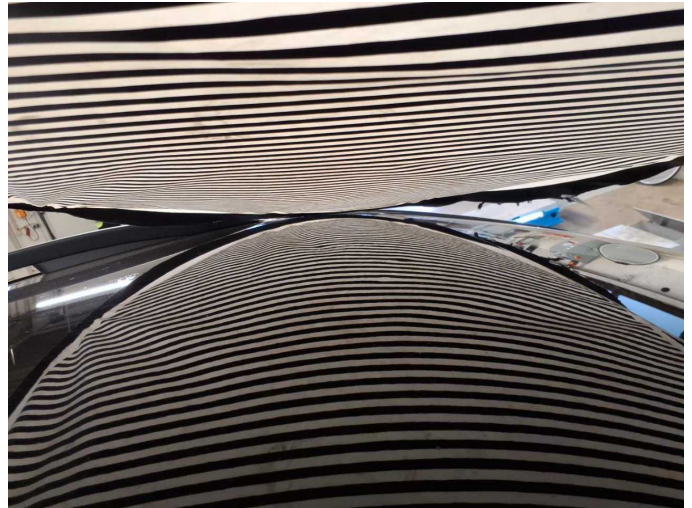
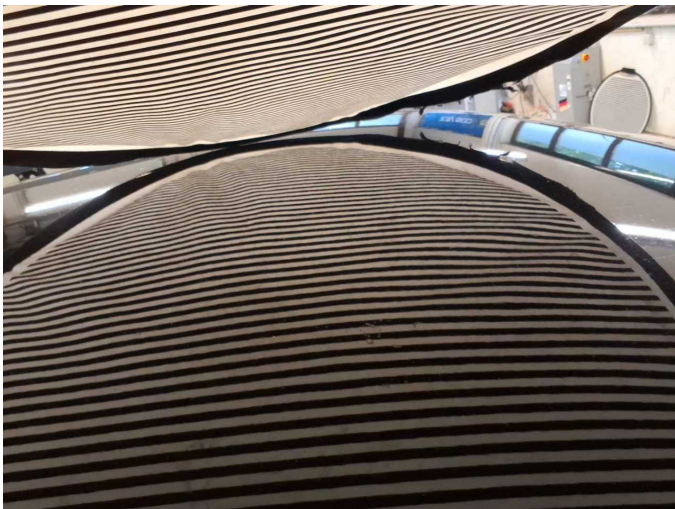
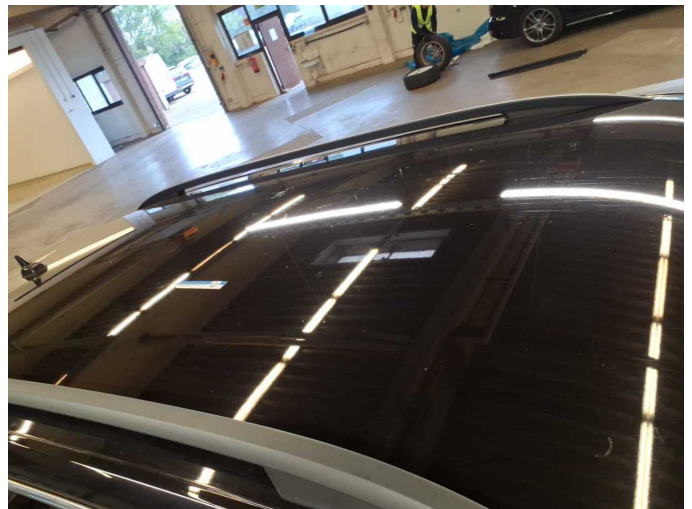
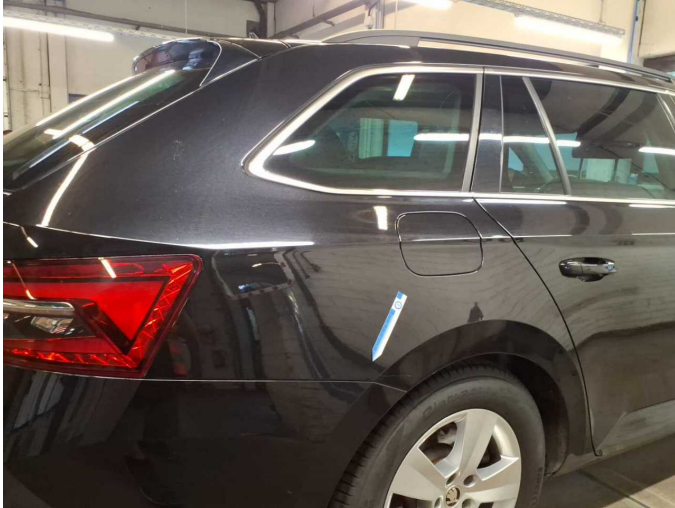
| No. | Component group | Description |
|---|---|---|
| 6 | Roof | Roof - dent(s) - Smooth repair work |

**Damage 6:** Roof: Roof - dent(s) - Smooth repair work

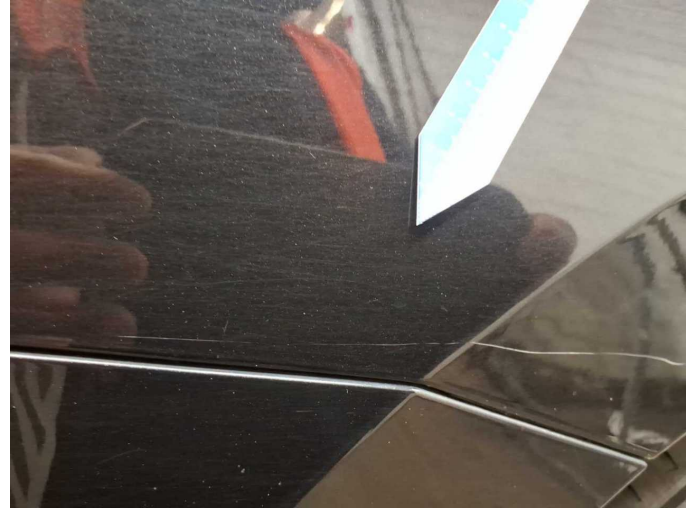
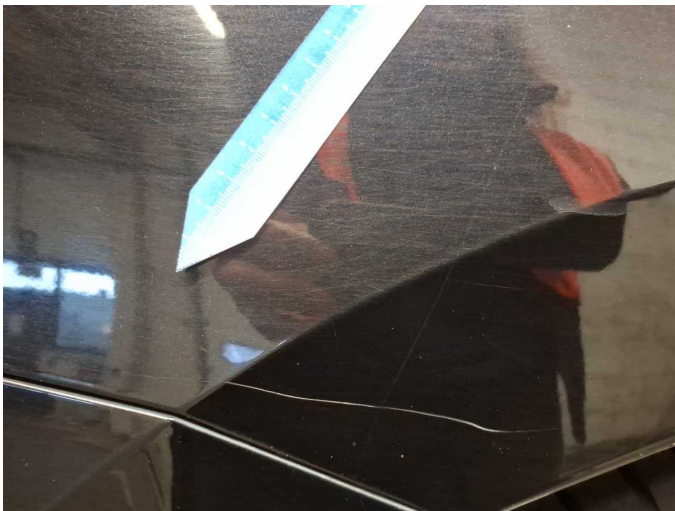
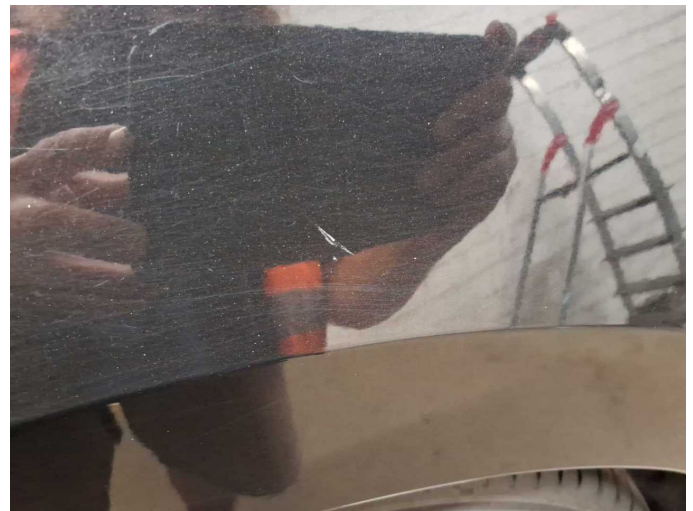
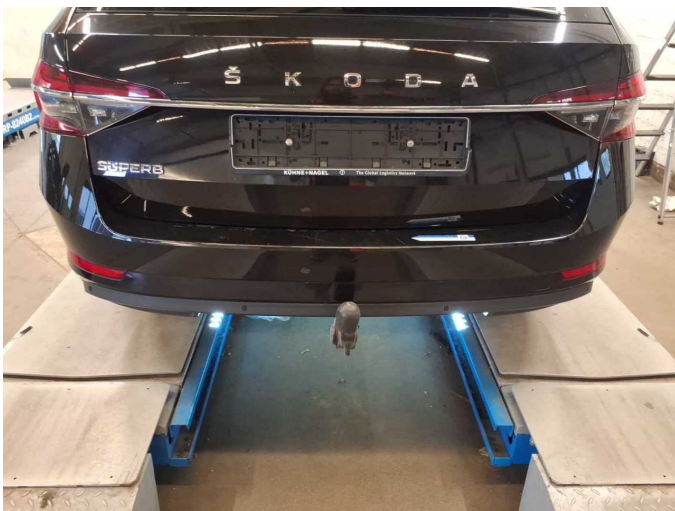
| No. | Component group | Description |
|---|---|---|
| 7 | Side panel - rear right side | Side panel - Scratched - Paint |

**Damage 7:** Side panel - rear right side: Side panel - Scratched - Paint

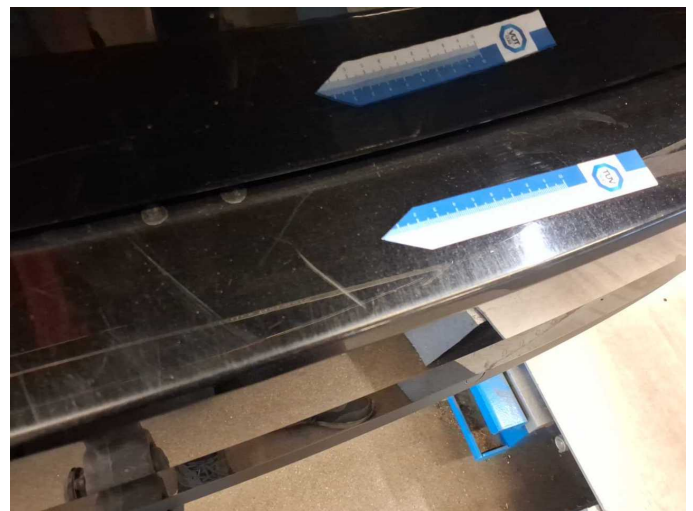
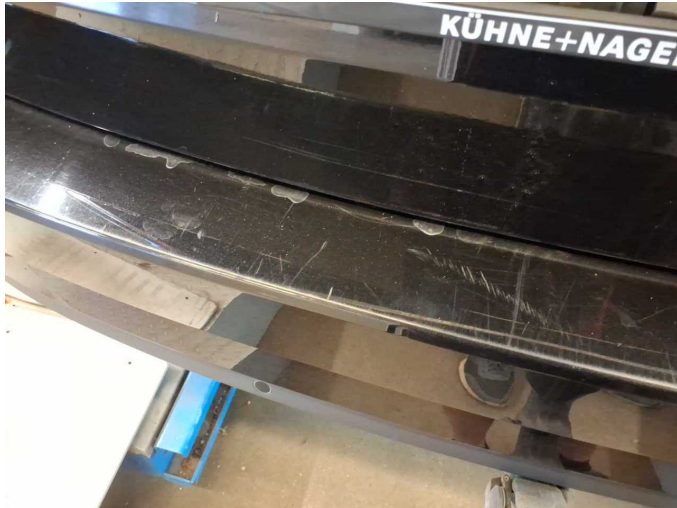
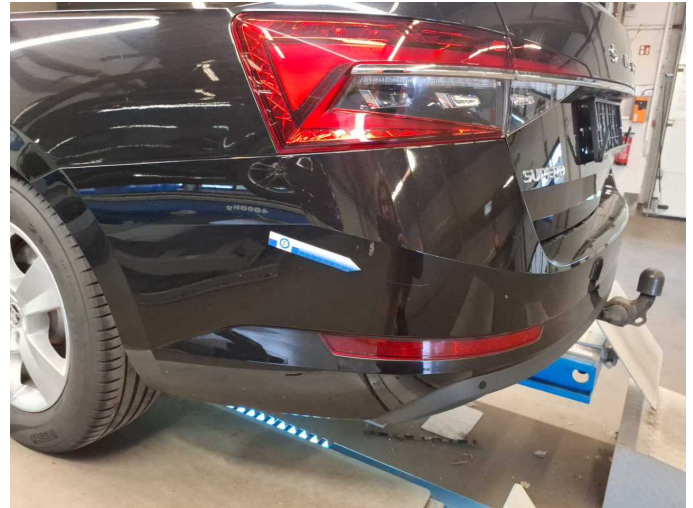
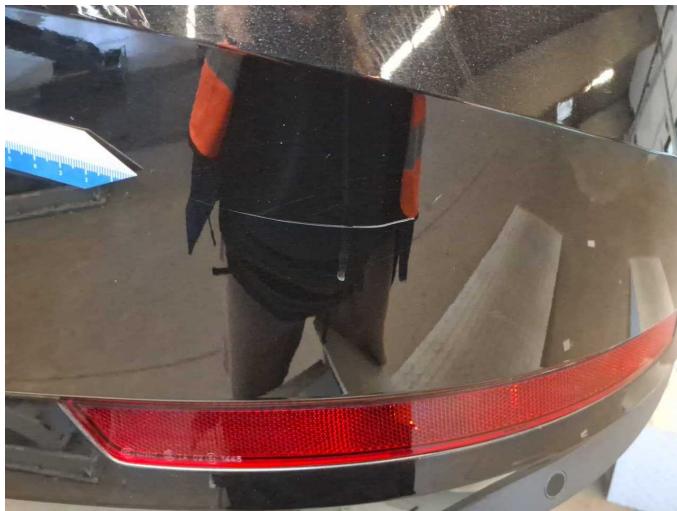
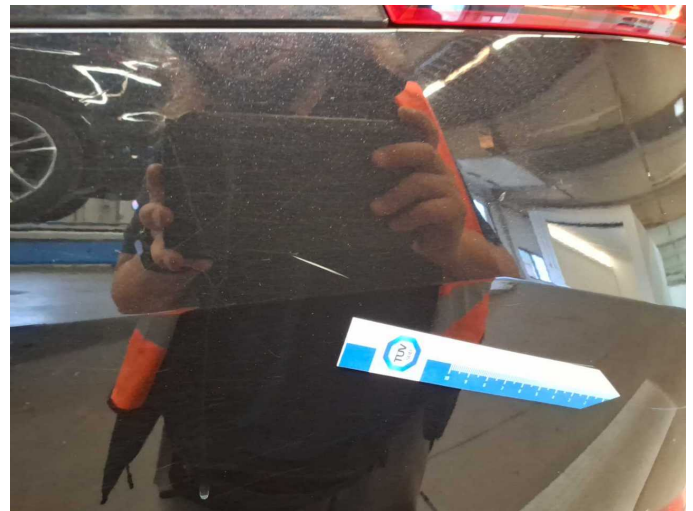
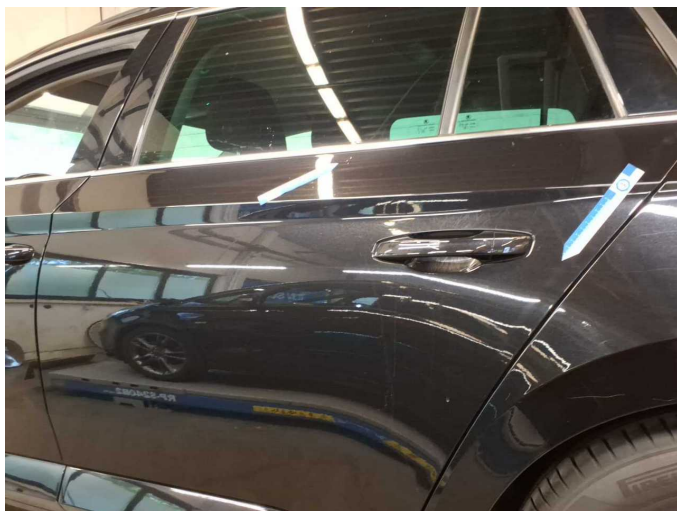
| No. | Component group | Description |
|---|---|---|
| 8 | Rear bumper | Rear bumper - Scratched - Paint |

**Damage 8:** Rear bumper: Rear bumper - Scratched - Paint

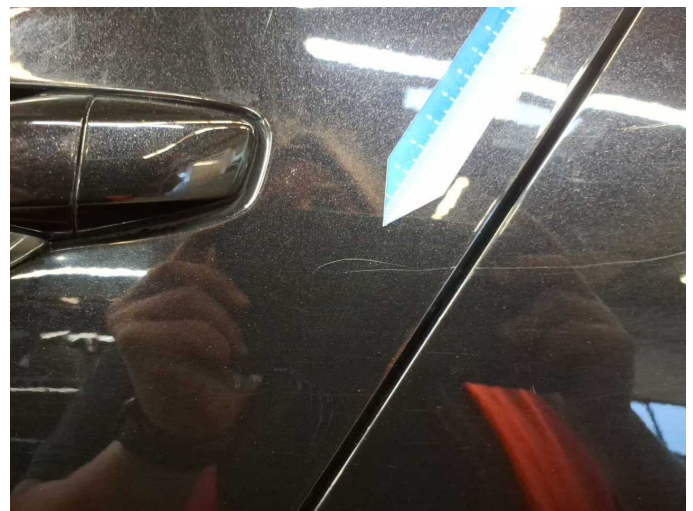
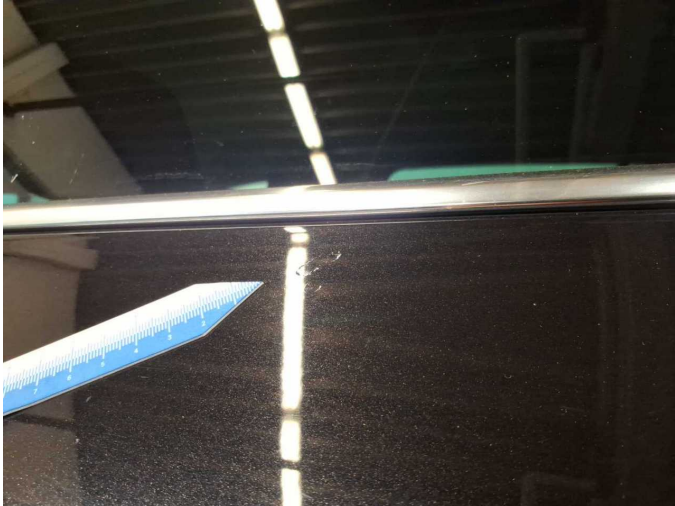
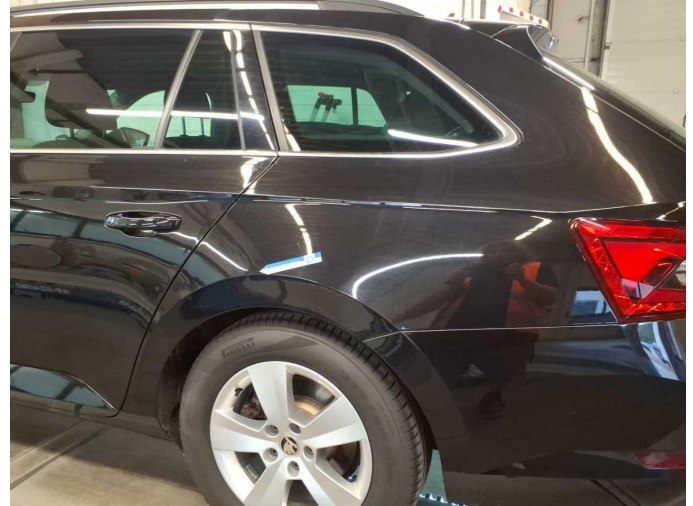
| No. | Component group | Description |
|---|---|---|
| 9 | Door - rear left side | Door - Scratched - Paint |

**Damage 9:** Door - rear left side: Door - Scratched - Paint

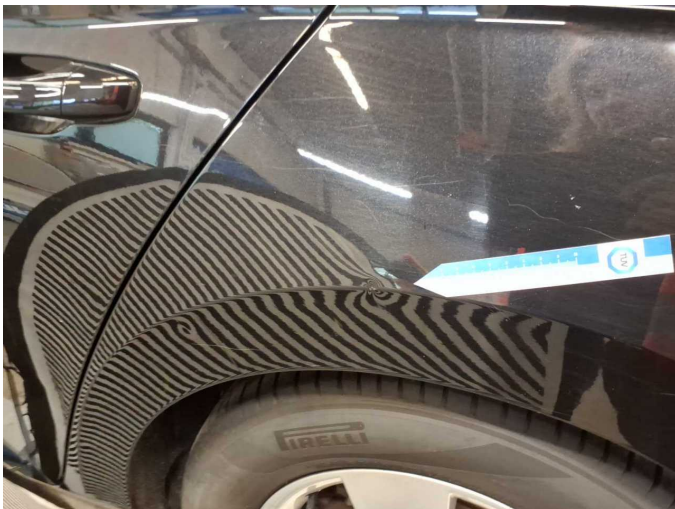
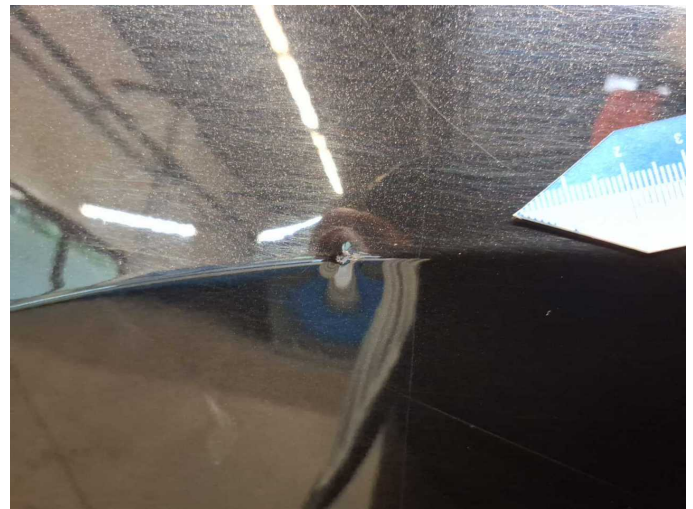
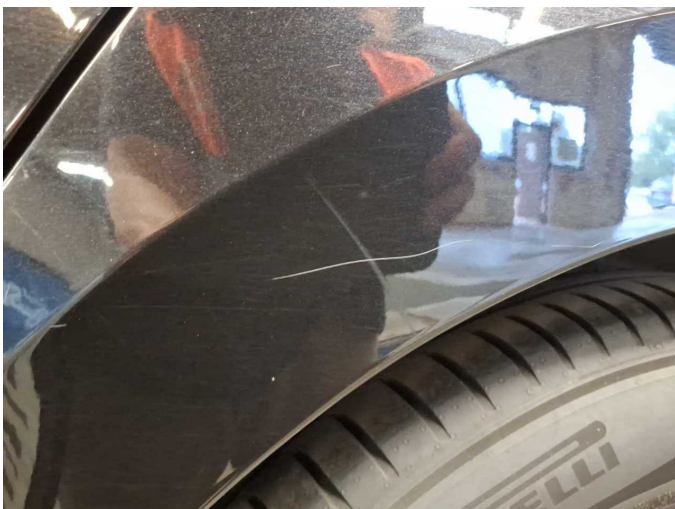
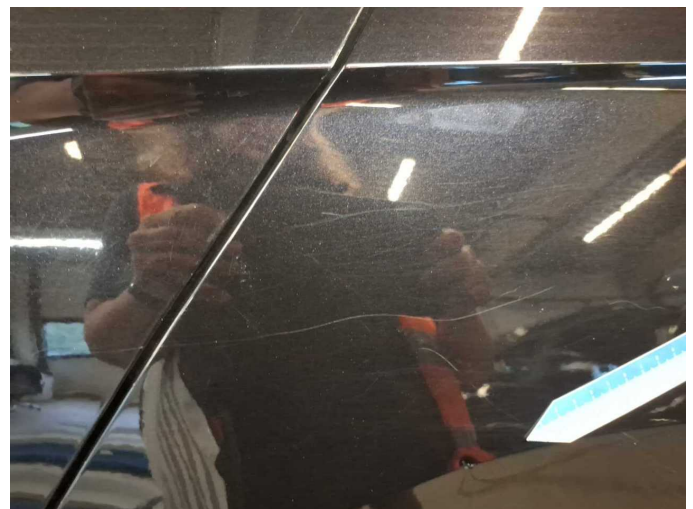
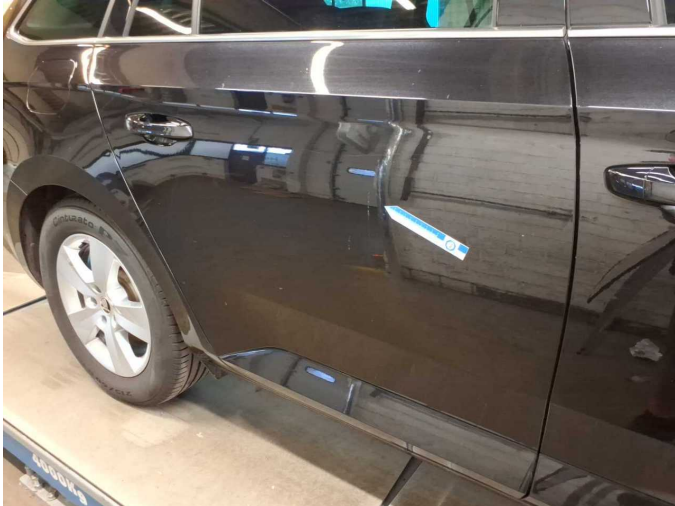
| No. | Component group | Description |
|---|---|---|
| 10 | Side panel - rear left side | Side panel - Dent / paintcoat damage - Repair and paint |

**Damage 10:** Side panel - rear left side: Side panel - Dent / paintcoat damage - Repair and paint

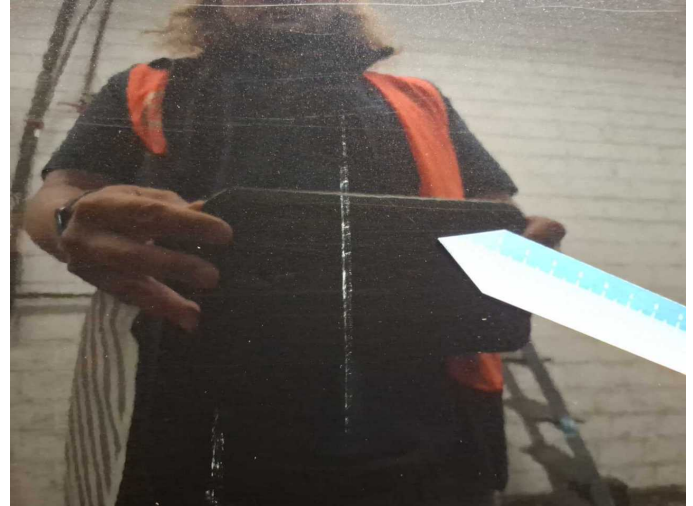
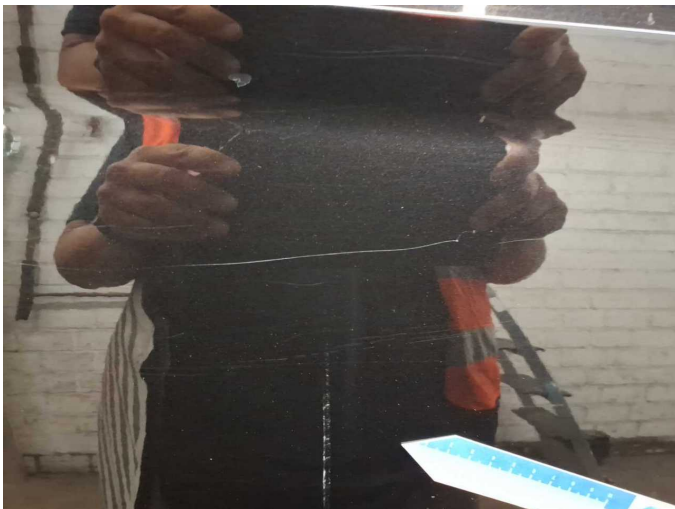
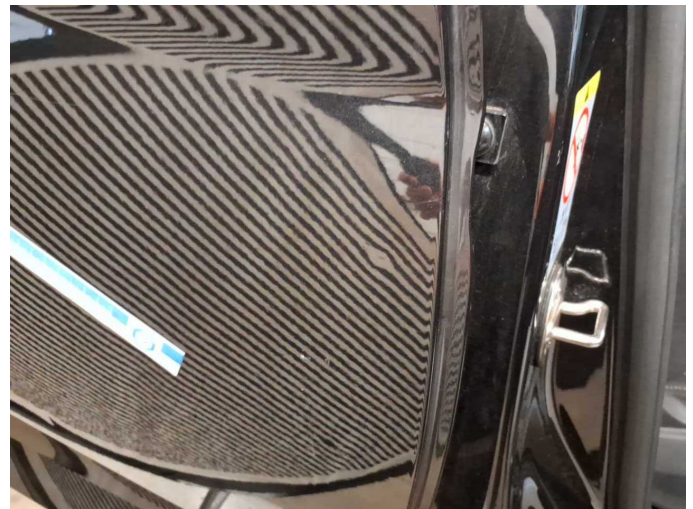
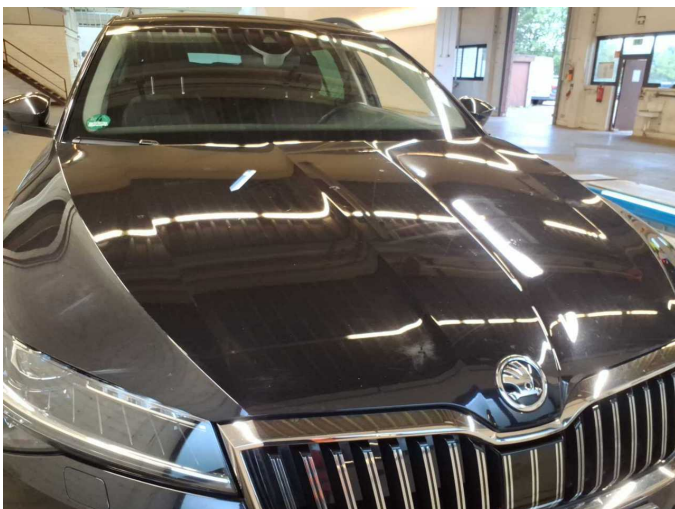
| No. | Component group | Description |
|---|---|---|
| 11 | Door - rear right side | Door - Dent / paintcoat damage - Repair and paint |

**Damage 11:** Door - rear right side: Door - Dent / paintcoat damage - Repair and paint

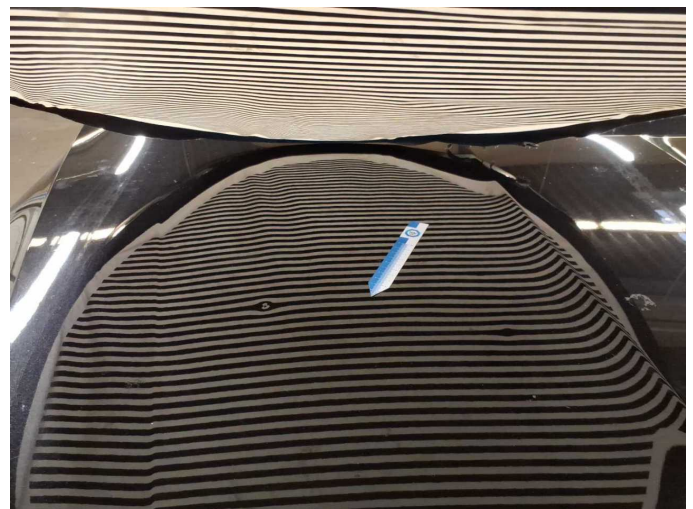
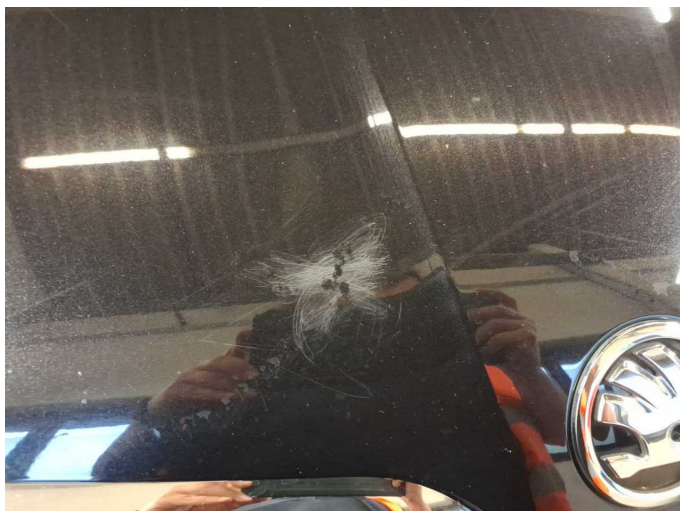
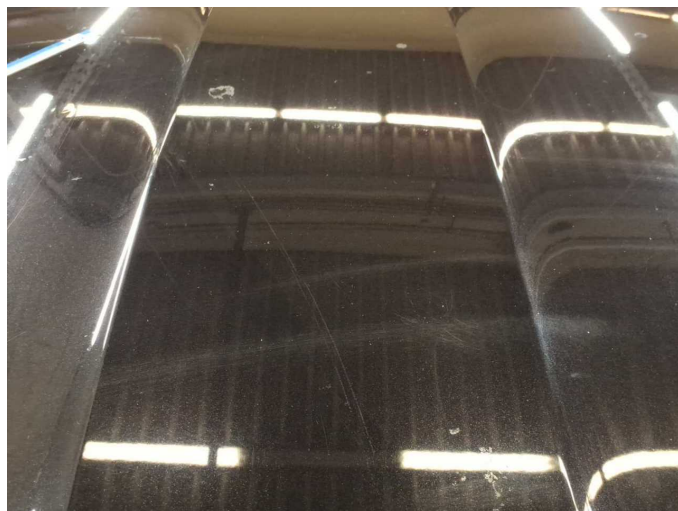
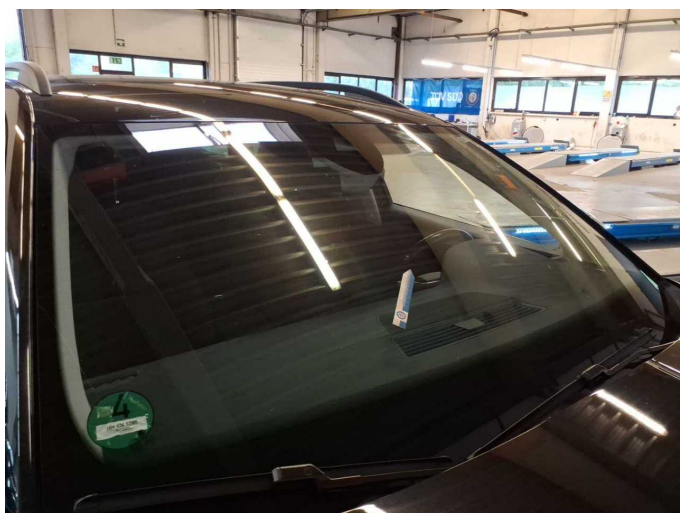
| No. | Component group | Description |
|---|---|---|
| 12 | Bonnet | Bonnet - Dent / paintcoat damage - Repair and paint |

**Damage 12:** Bonnet: Bonnet - Dent / paintcoat damage - Repair and paint

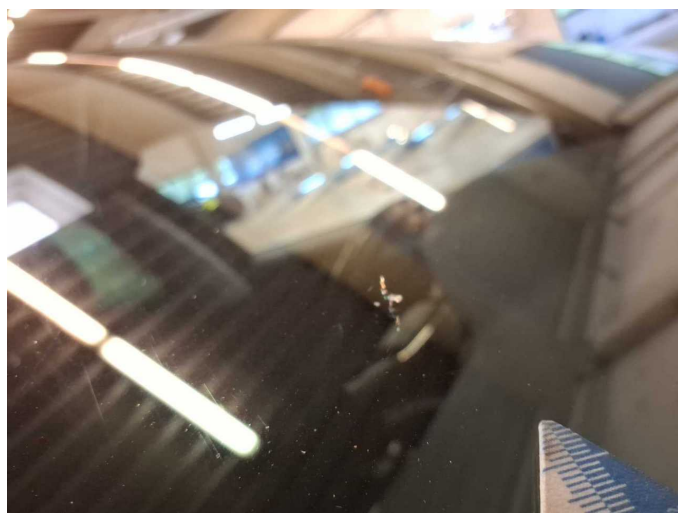
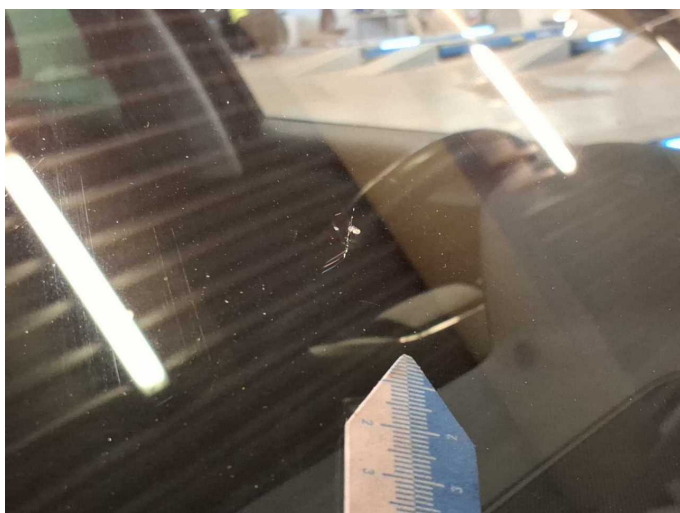
| No. | Component group | Description |
|---|---|---|
| 13 | Vehicle glazing | Windscreen - Broken / torn - Replace |

**Damage 13:** Vehicle glazing: Windscreen - Broken / torn - Replace
