Expertise

Protocol number: 46388221
Order No. / Reference: 26527577
Inspection date: 7 Jul 2026

Manufacturer: Opel

Model: Movano 2.3 D (CDTI) L2H2 DPF 2WD VA

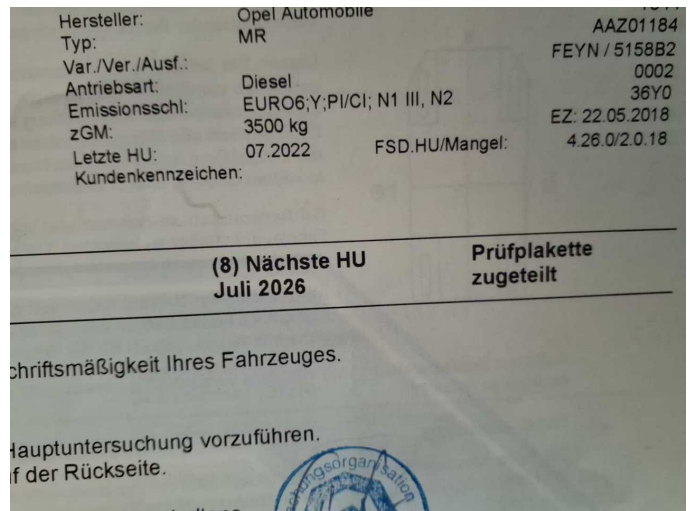
Damage 2: Misc.: Main inspection (Fälligkeit 07.2026) - No evidence - No deduction

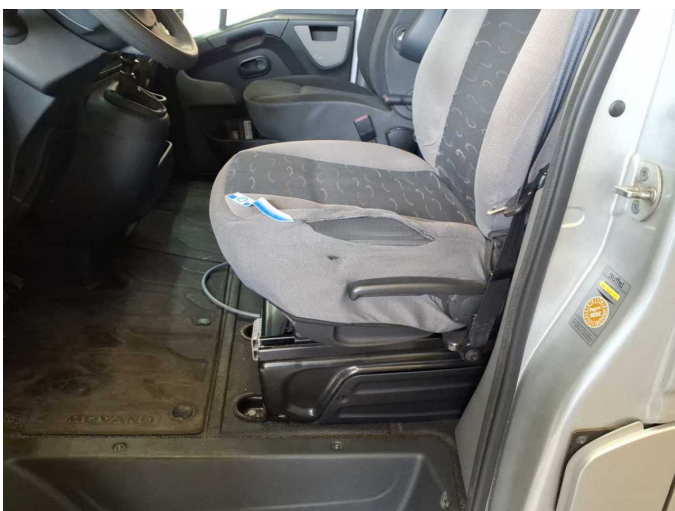
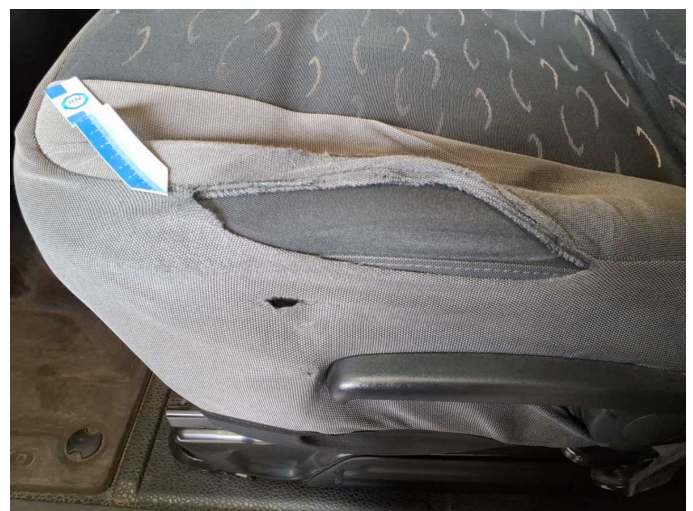
Damage 3: Seat - front: Protective Cover - left side - Damaged - Replace

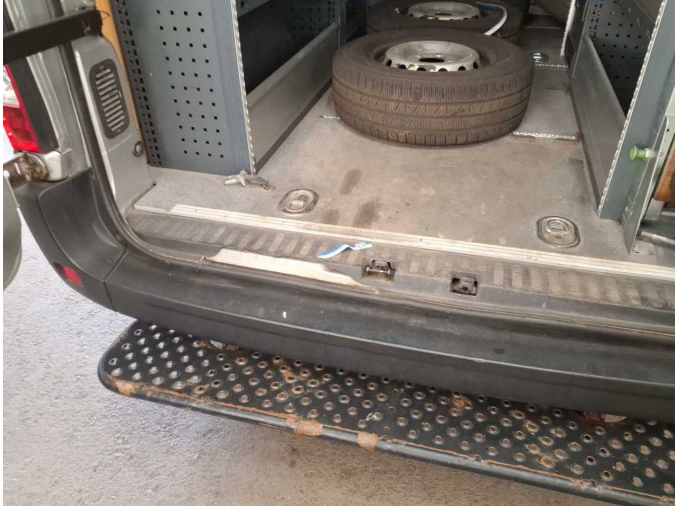
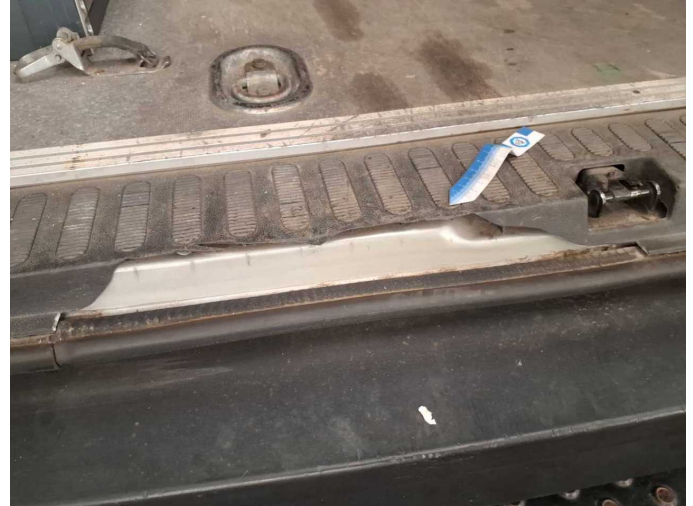
Damage 4: Rear of vehicle: Rear panel (Verkleidung Abschlussblech Innen) - Broken / torn - Replace

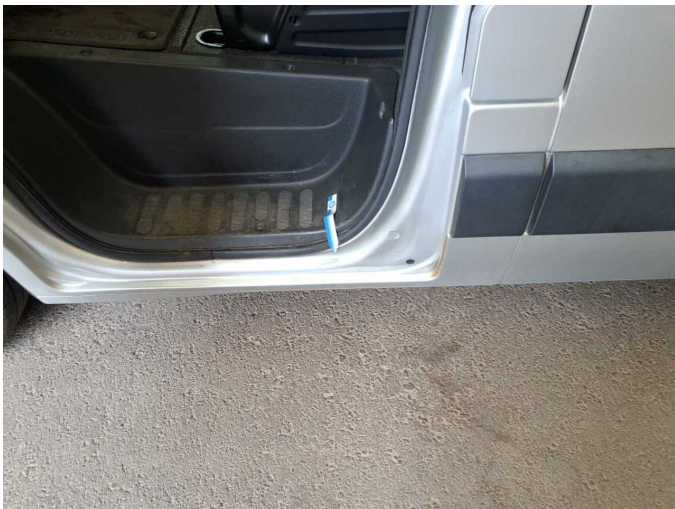
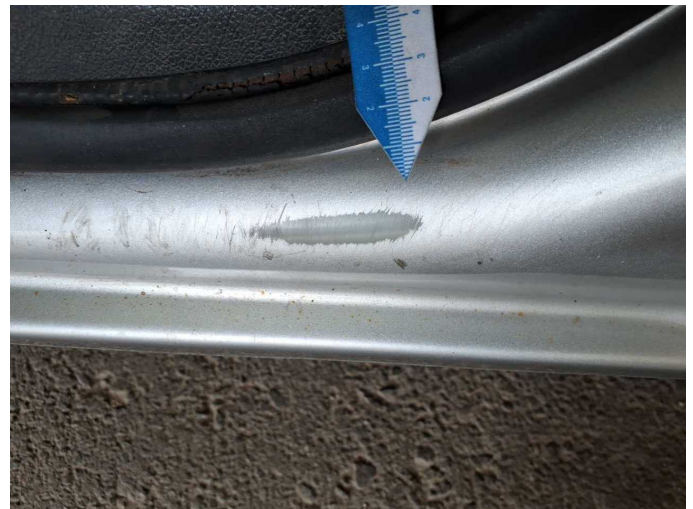
Damage 5: Sill - left side: Sill - Scratched - Smart repair

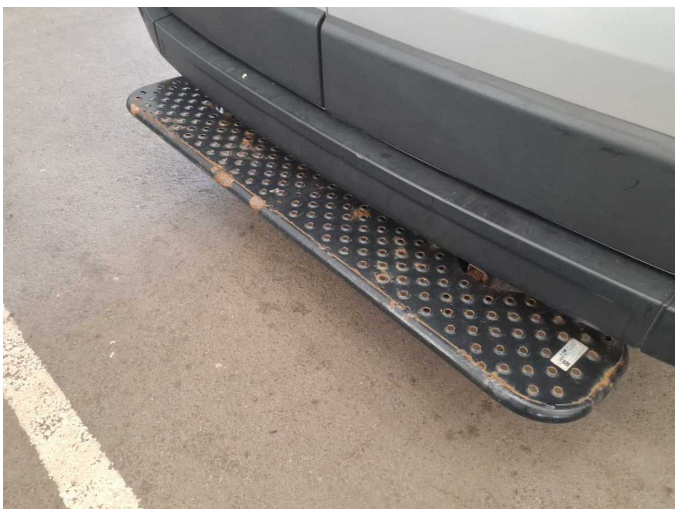
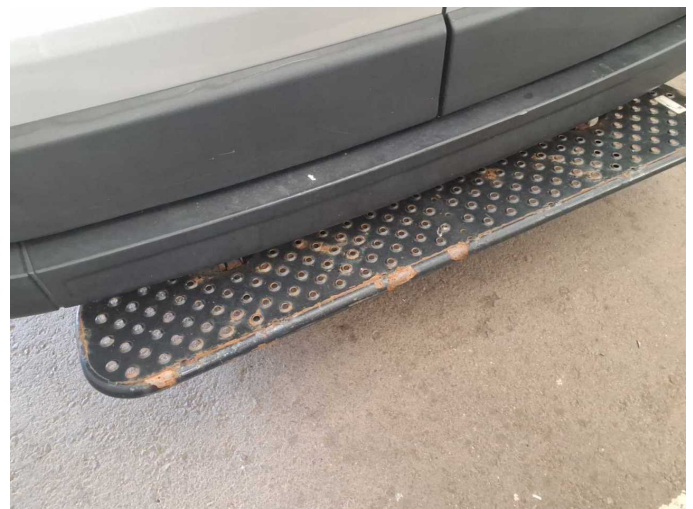
Damage 6: Rear of vehicle: Foot plate - Corrosion - Loss in value

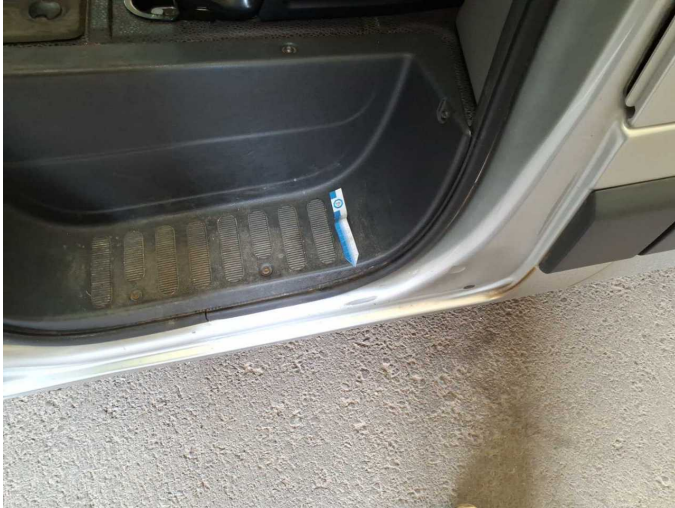
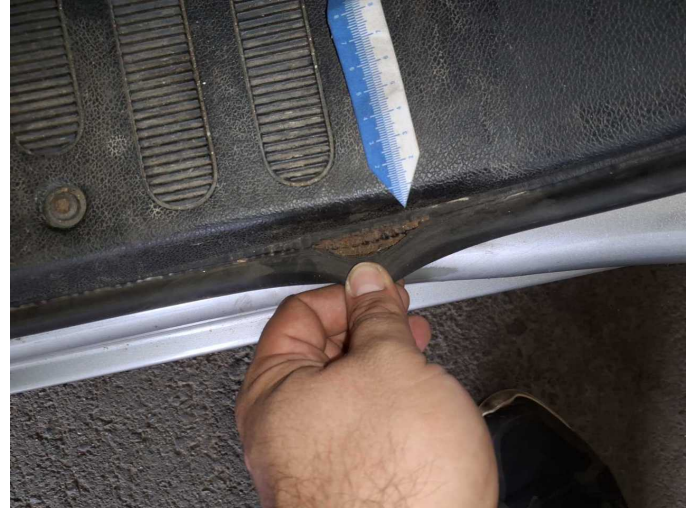
Damage 7: Door - front left side: Door seal - Damaged - Replace

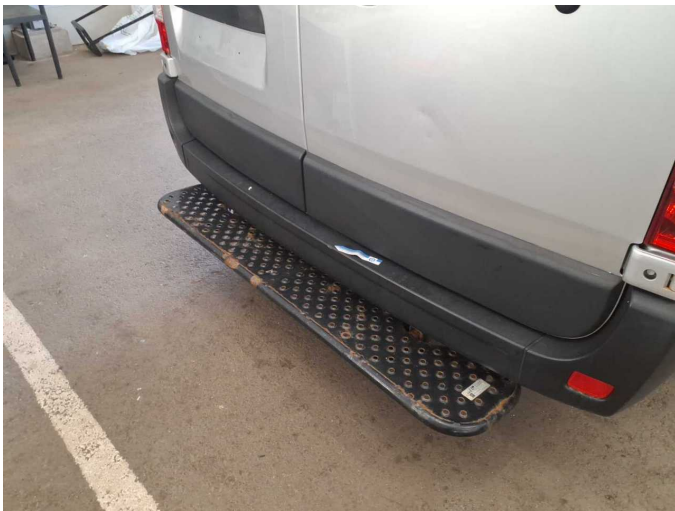
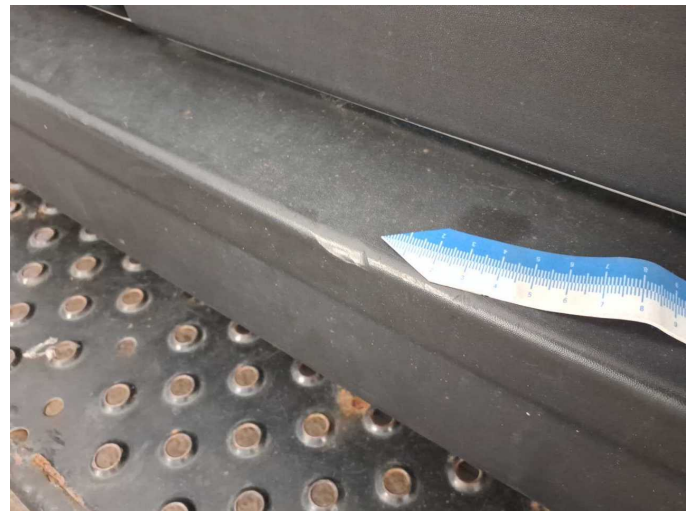
Damage 8: Rear bumper: Rear bumper - Scratched - Loss in value

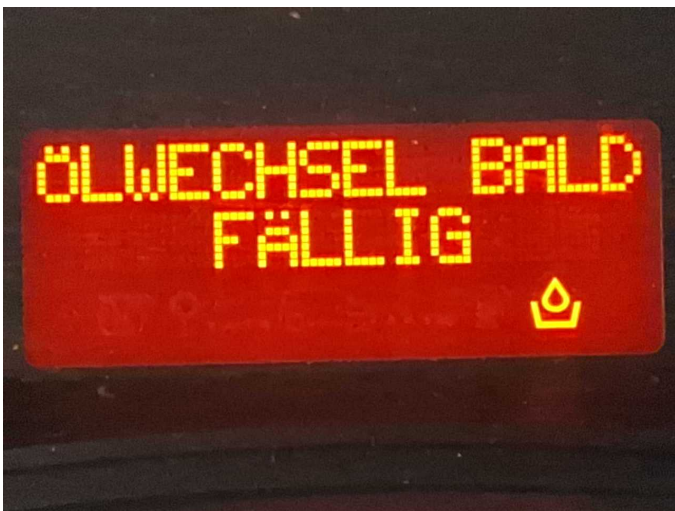
Damage 9: Misc.: Inspection / maintenance (Motorölservice) - Due - Perform

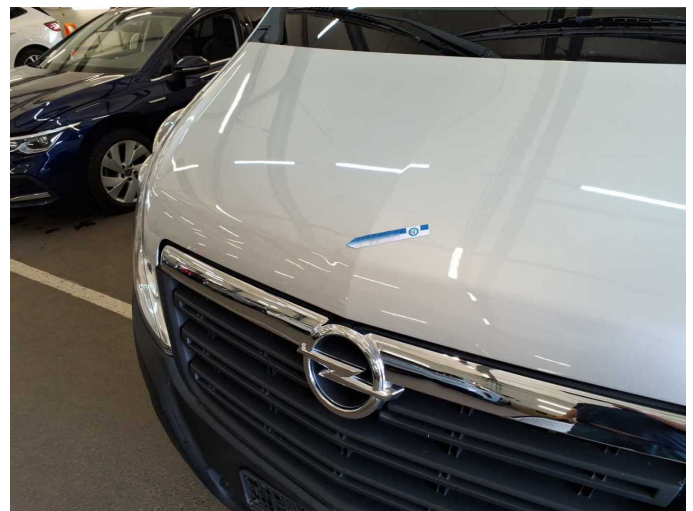
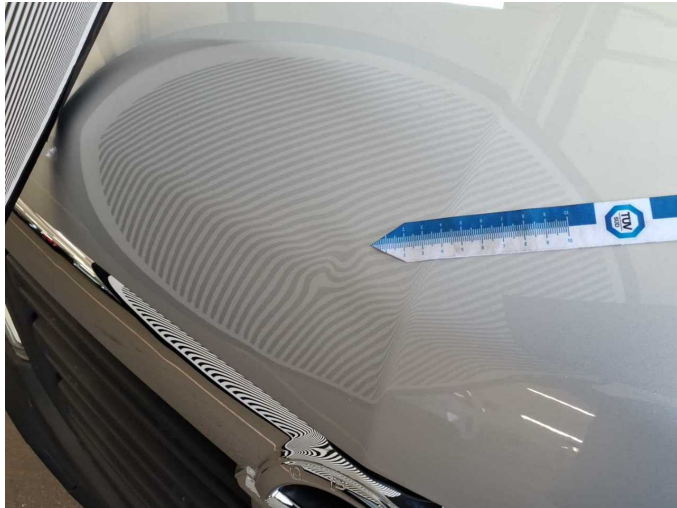
Damage 10: Bonnet: Bonnet - Deformed - Repair and paint

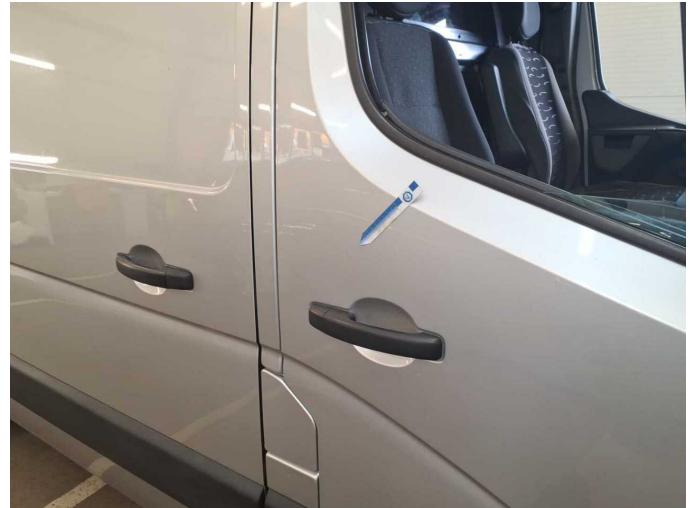
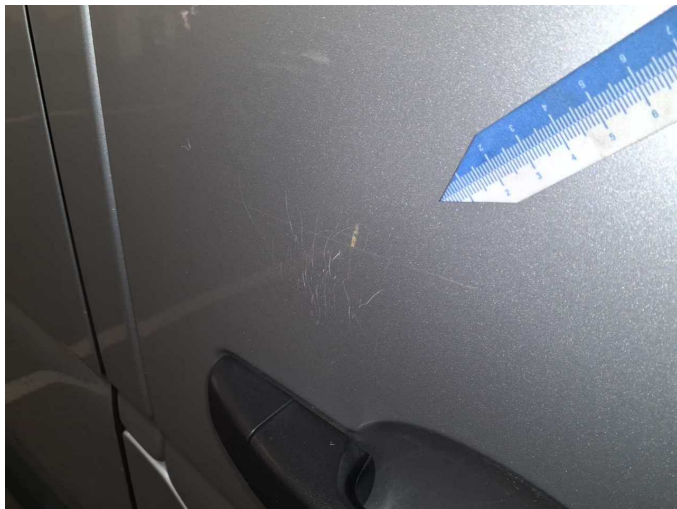
Damage 11: Door - front right side: Door - Scratched - Paint

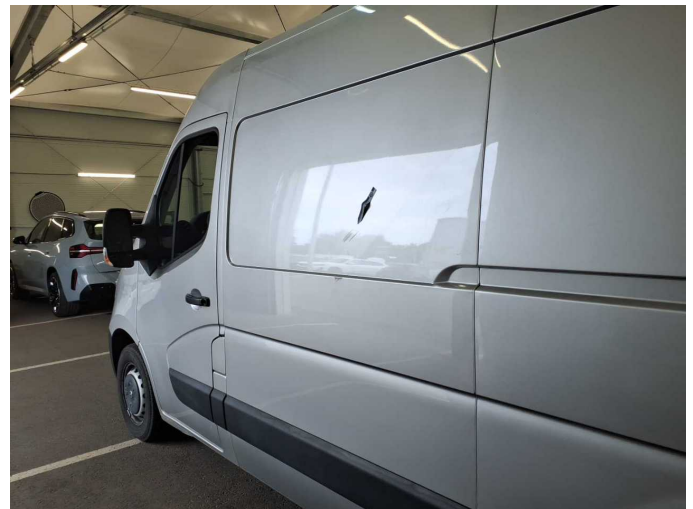
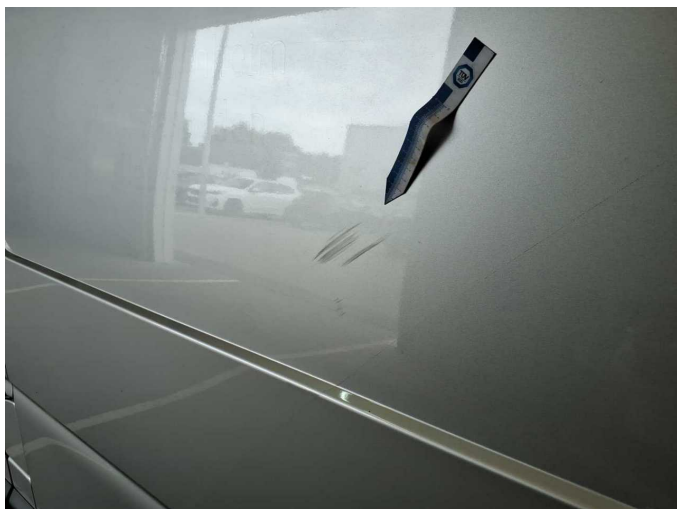
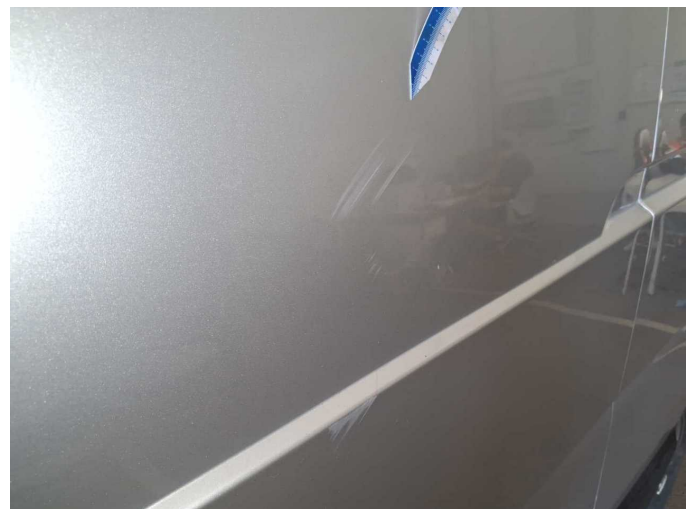
Damage 12: Side panel - rear left side: Side panel - Scratched - Paint

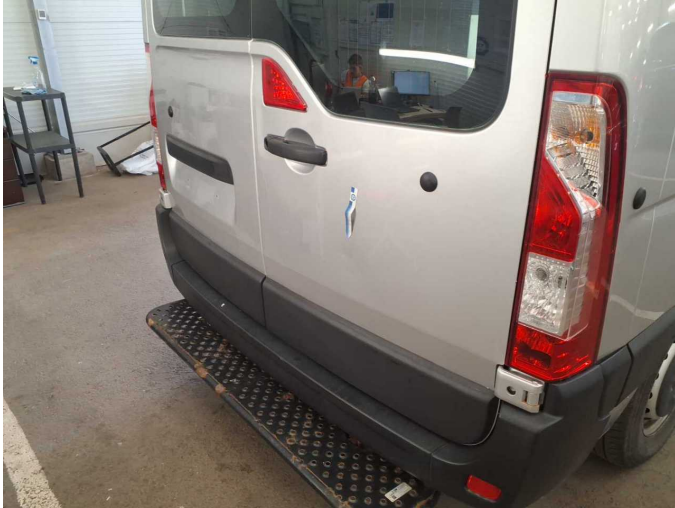
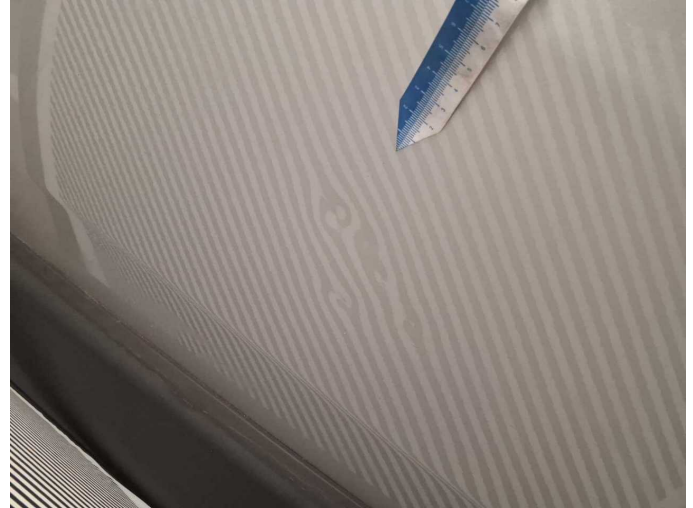
Damage 13: Boot lid / rear door: Rear door - right side - Deformed - Repair and paint
