Expertise

Protocol number: 46407830  
Order No. / Reference: 26550885  
Inspection date: 8 Jul 2026

Manufacturer: Mercedes-Benz

Model: GLC 220 d 4Matic 9G-TRONIC Exclusive

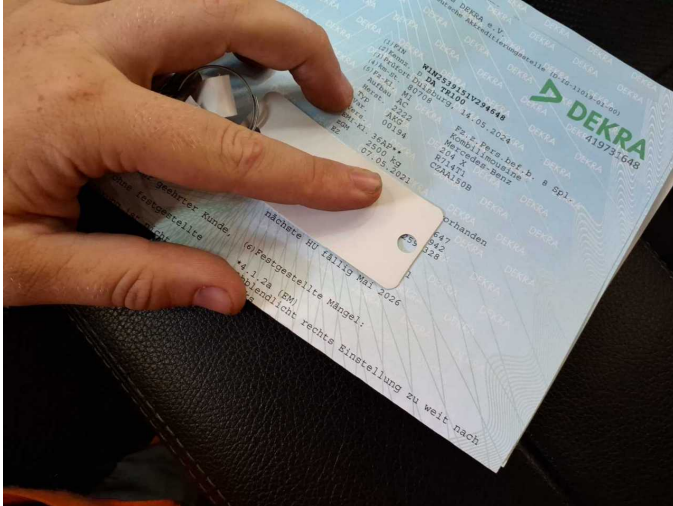
| No. | Component group | Description |
|---|---|---|
| 1 | Misc. | Main inspection - Expired - Perform |

**Damage 1:** Misc.: Main inspection - Expired - Perform

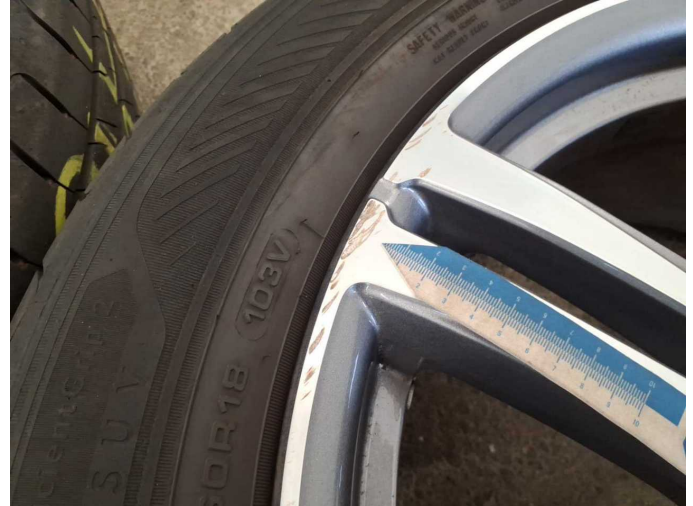
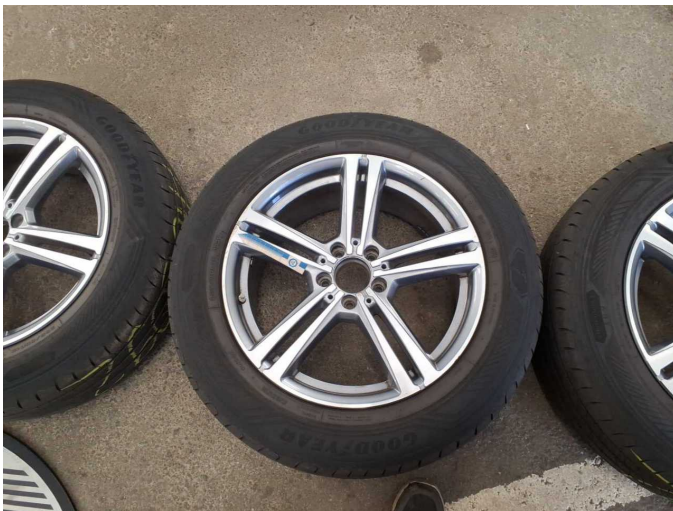
| No. | Component group | Description |
|---|---|---|
| 2 | 2nd wheel set | 1 alloy rim - Scratch(es) - Loss in value |

**Damage 2:** 2nd wheel set: 1 alloy rim - Scratch(es) - Loss in value

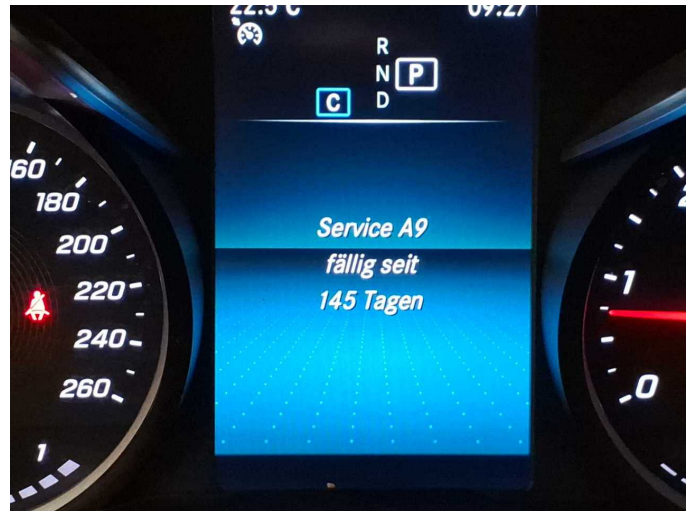
| No. | Component group | Description |
|---|---|---|
| 3 | Misc. | Inspection / maintenance - Expired - Perform |

**Damage 3:** Misc.: Inspection / maintenance - Expired - Perform

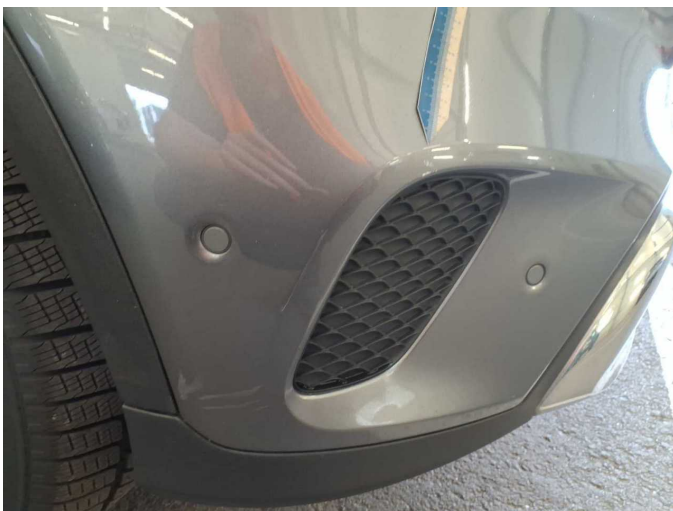
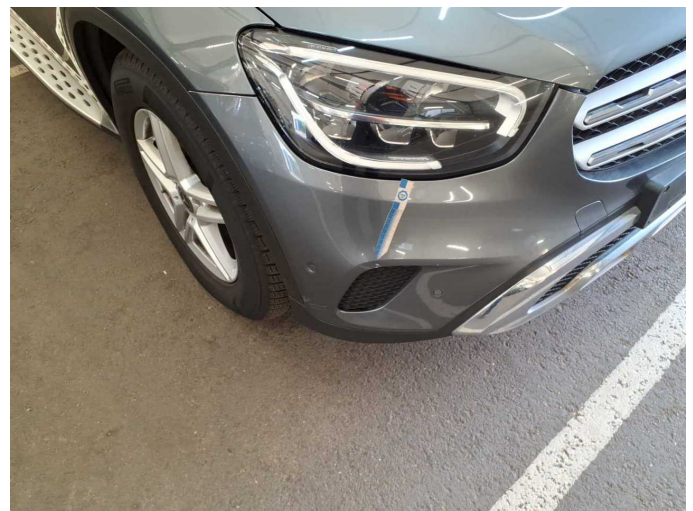
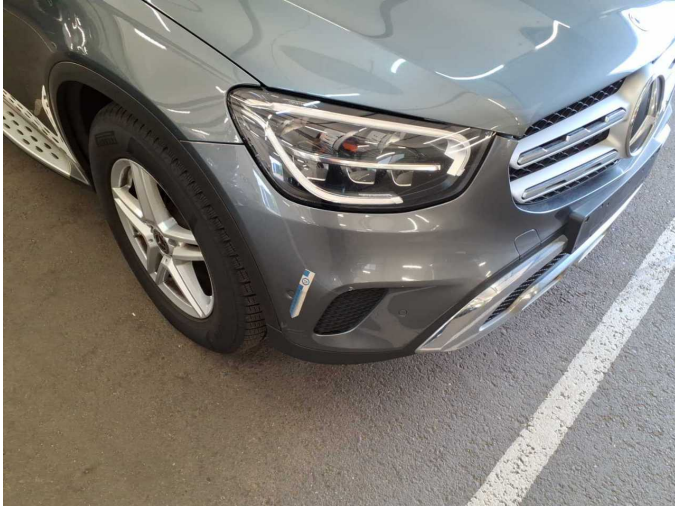
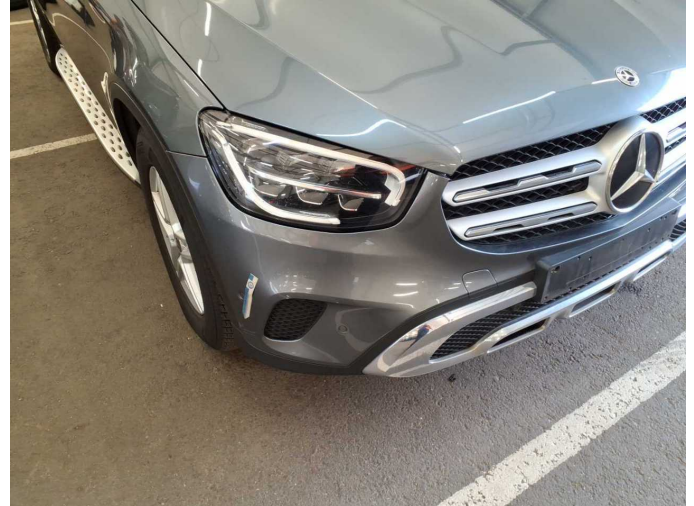
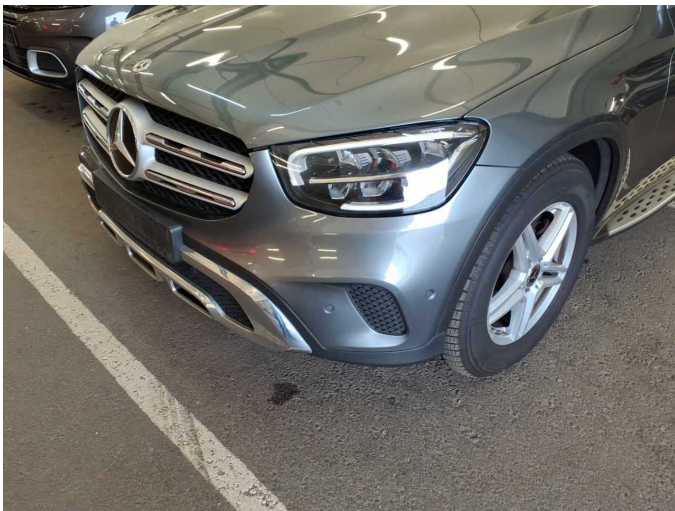
| No. | Component group | Description |
|---|---|---|
| 4 | Front bumper | Front bumper - Scratched - Paint |

**Damage 4:** Front bumper: Front bumper - Scratched - Paint

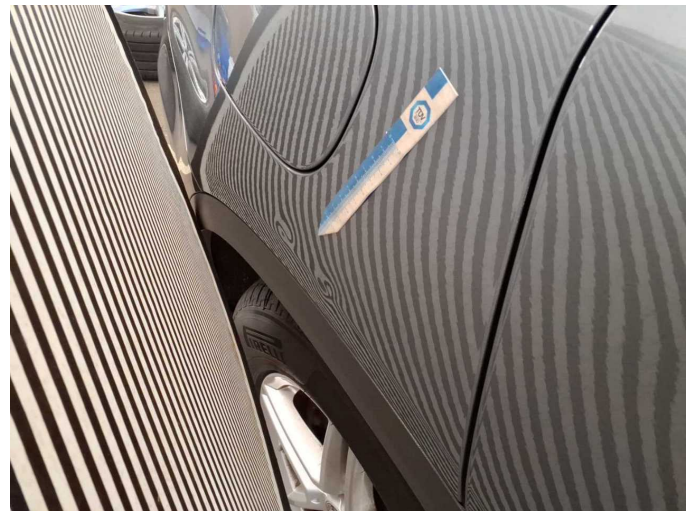
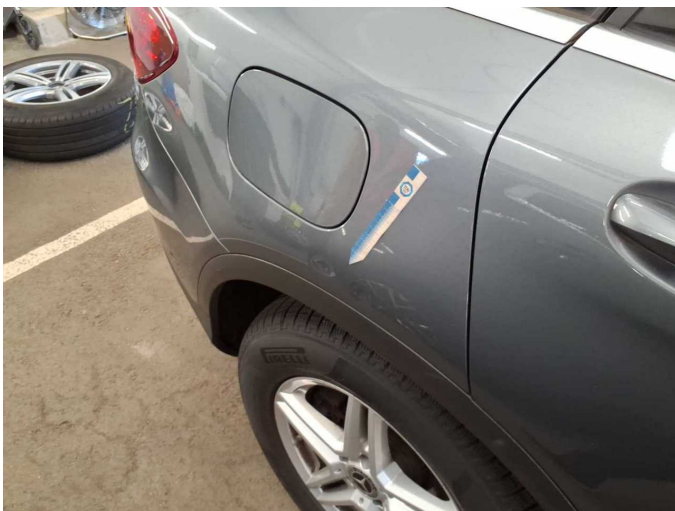
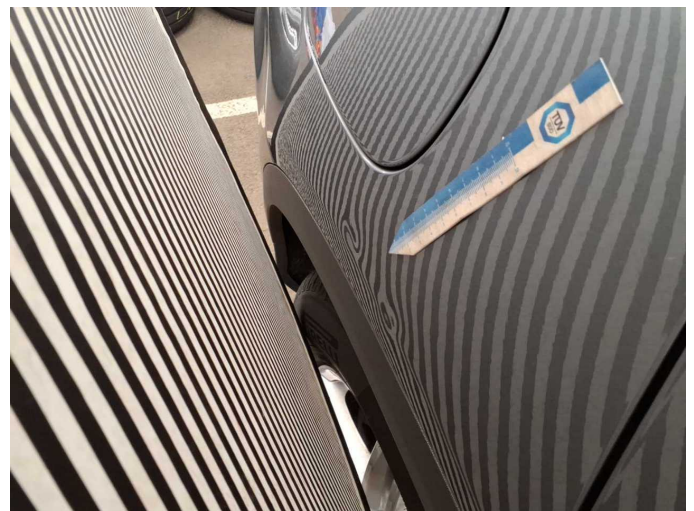
| No. | Component group | Description |
|---|---|---|
| 5 | Side panel - rear right side | Side panel - dent(s) - Repair and paint |

**Damage 5:** Side panel - rear right side: Side panel - dent(s) - Repair and paint

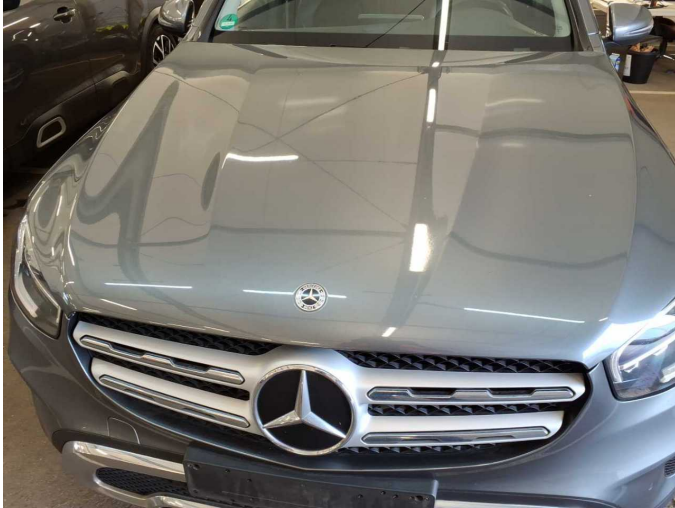
| No. | Component group | Description |
|---|---|---|
| 1 | Bonnet | Bonnet - Stone chips - No deduction |

**Wear and tear 1:** Bonnet: Bonnet - Stone chips - No deduction

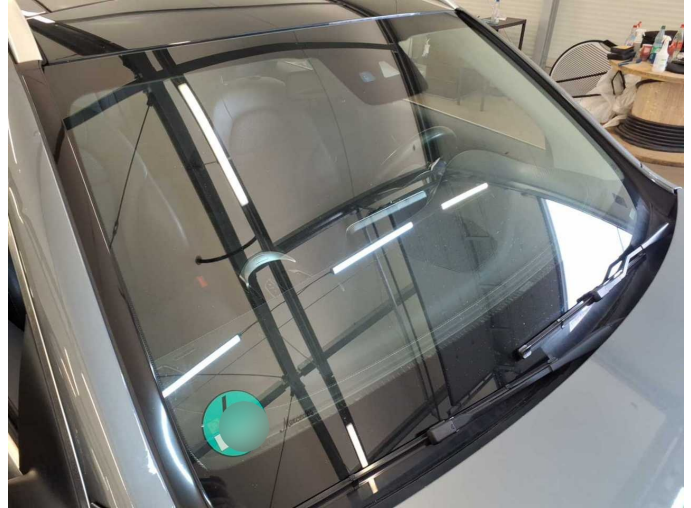
| No. | Component group | Description |
|---|---|---|
| 3 | Vehicle glazing | Windscreen - Stone chips - No deduction |

**Wear and tear 3:** Vehicle glazing: Windscreen - Stone chips - No deduction

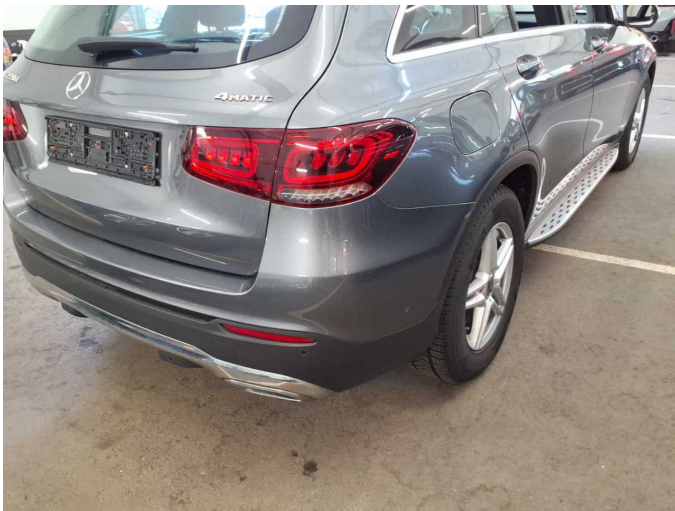
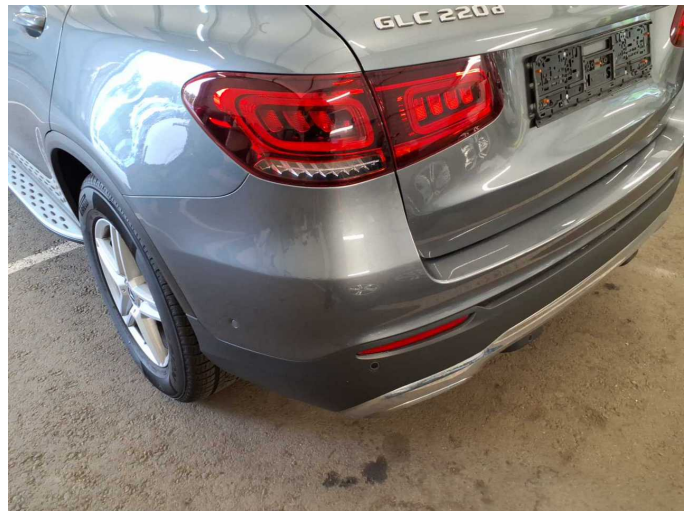
| No. | Component group | Description |
|---|---|---|
| 4 | Rear bumper | Rear bumper - Scratch(es) - No deduction |

**Wear and tear 4:** Rear bumper: Rear bumper - Scratch(es) - No deduction

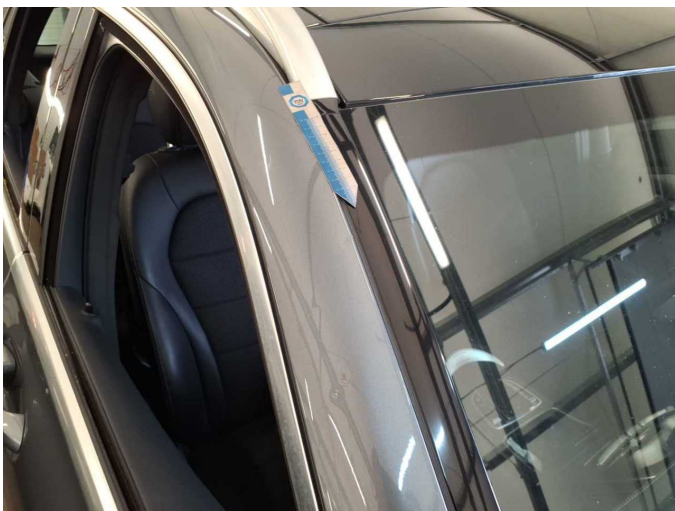
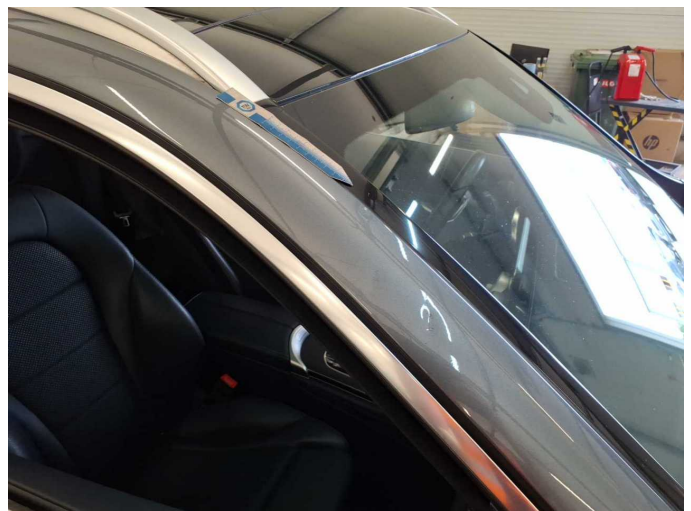
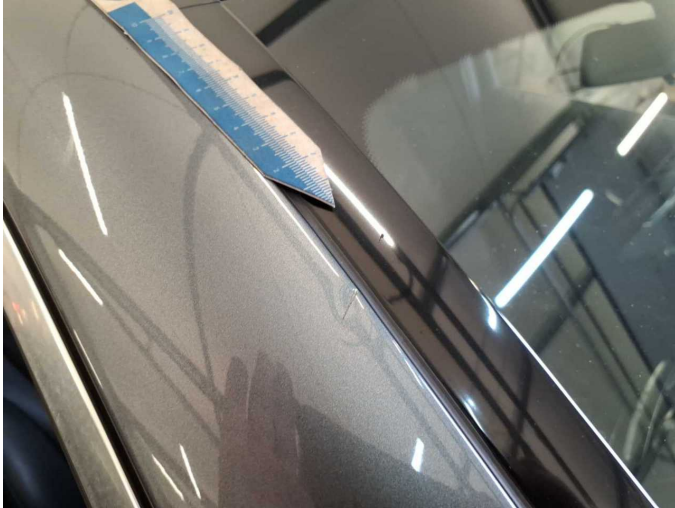
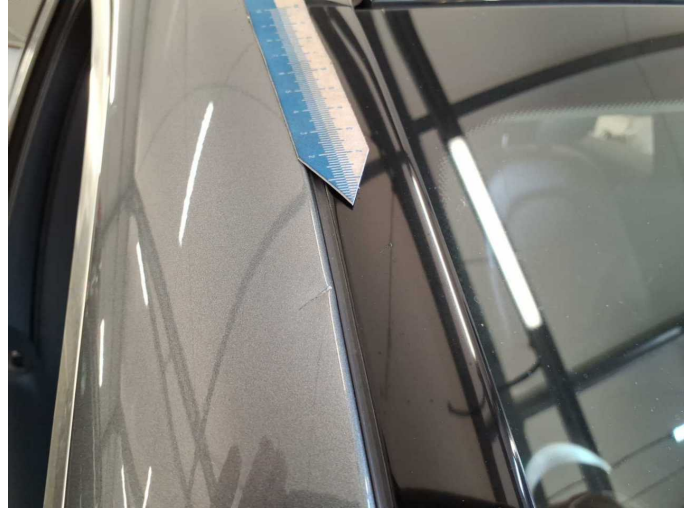
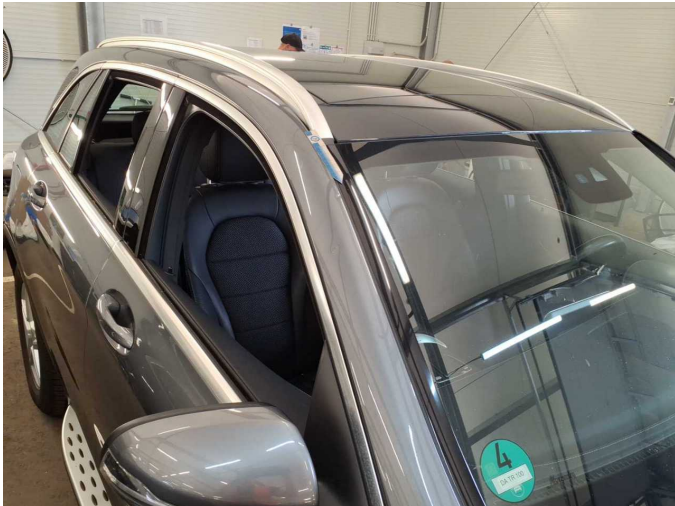
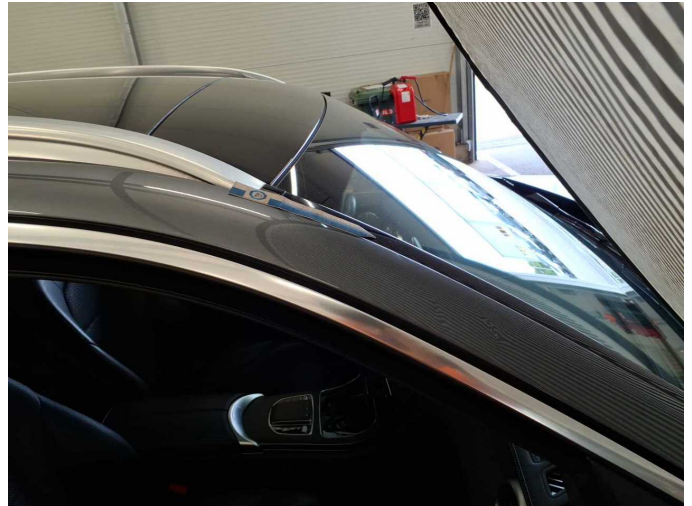
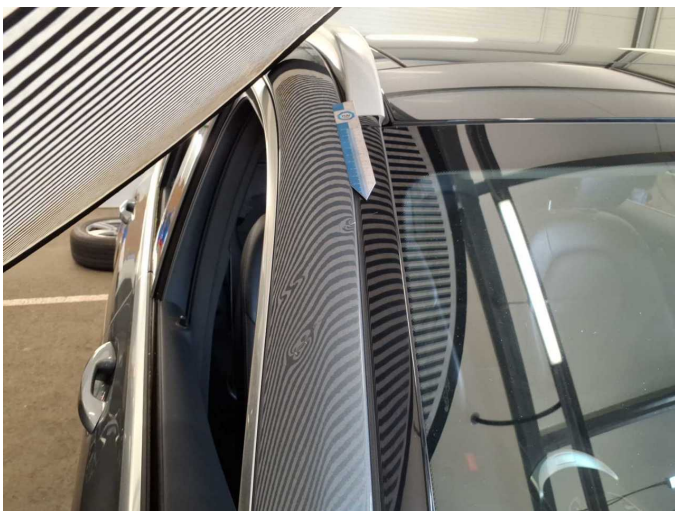
- 1 Side right

**Accident 1:** Side right

**Accident 1: Side right**
