Expertise

Protocol number: 46702878  
Order No. / Reference: 26556337  
Inspection date: 24 Jul 2026

Manufacturer: Mazda

Model: 2 e-SKYACTIV G 90 M HYBRID Homura

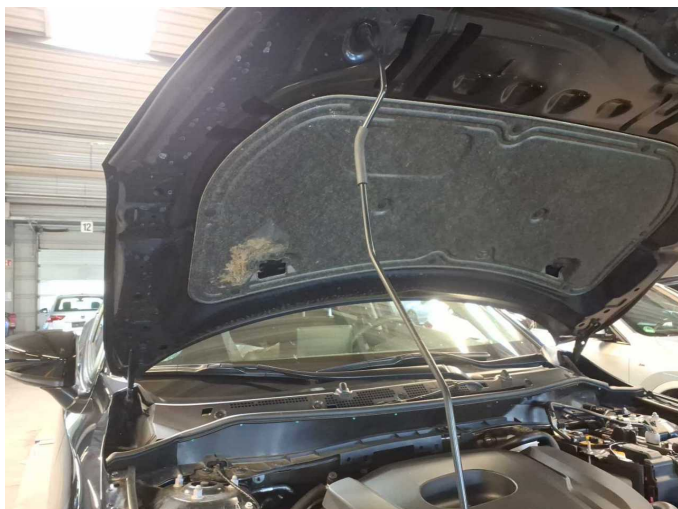
| No. | Component group | Description |
|---|---|---|
| 1 | Bonnet | Insulation lining - Damage caused by marten / rodent - Replace |

**Damage 1:** Bonnet: Insulation lining - Damage caused by marten / rodent - Replace

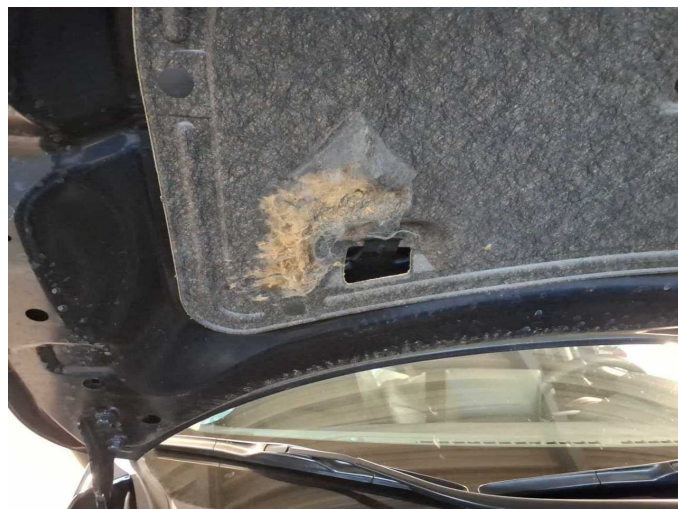
**Damage 1:** Bonnet: Insulation lining - Damage caused by marten / rodent - Replace

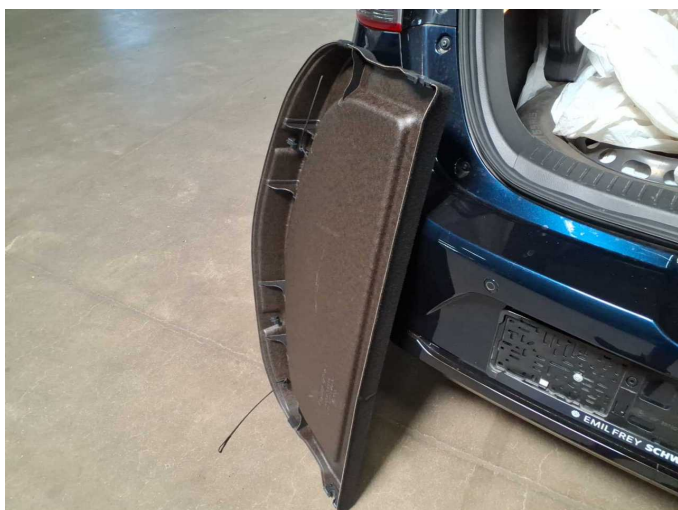
| No. | Component group | Description |
|---|---|---|
| 2 | Interior | Rear shelf - Broken / torn - Replace |

**Damage 2:** Interior: Rear shelf - Broken / torn - Replace

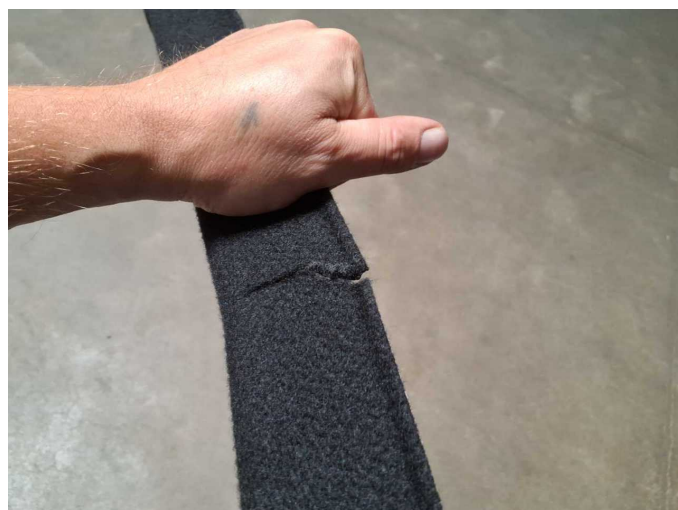
**Damage 2:** Interior: Rear shelf - Broken / torn - Replace

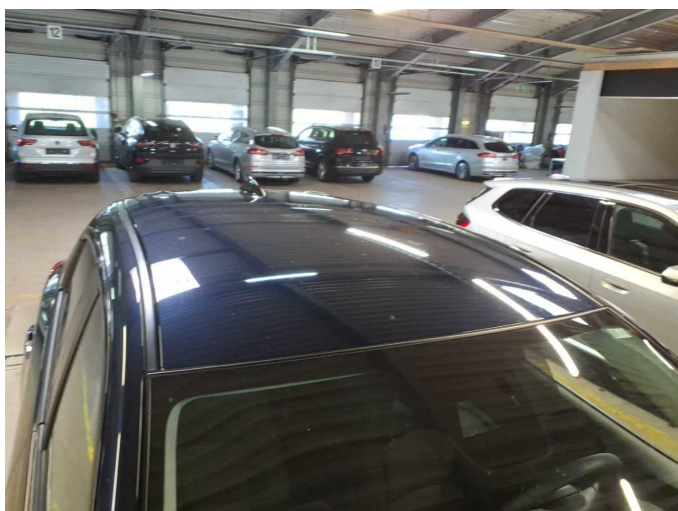
| No. | Component group | Description |
|---|---|---|
| 3 | Body | Body - Damage by hail - Smooth repair work |

**Damage 3:** Body: Body - Damage by hail - Smooth repair work

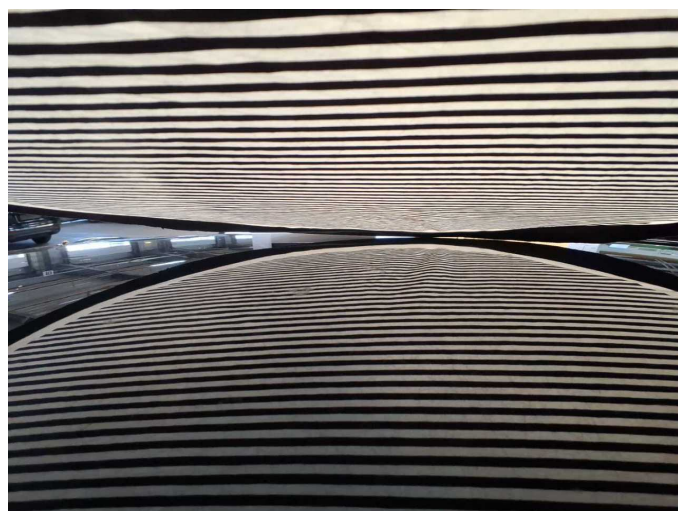
**Damage 3:** Body: Body - Damage by hail - Smooth repair work

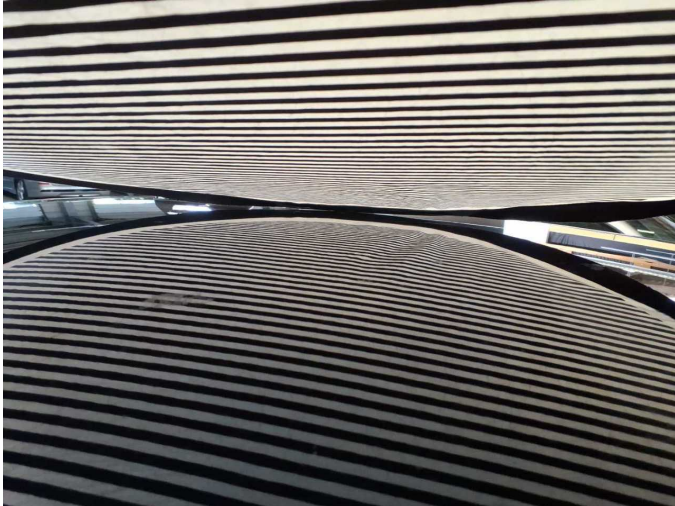
**Damage 3:** Body: Body - Damage by hail - Smooth repair work

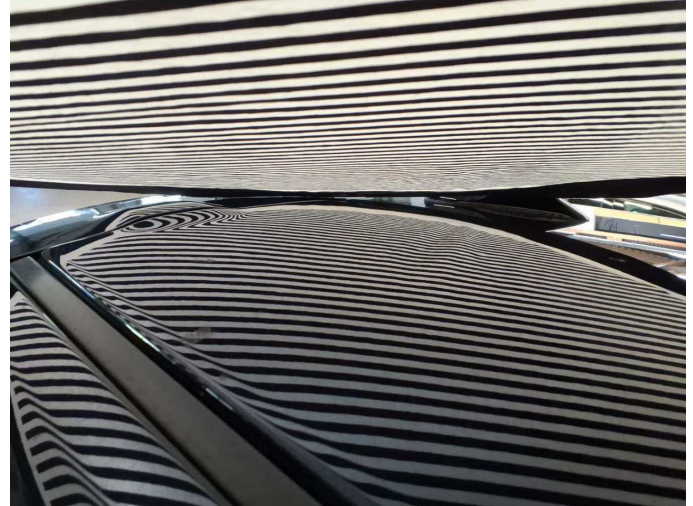
**Damage 3:** Body: Body - Damage by hail - Smooth repair work

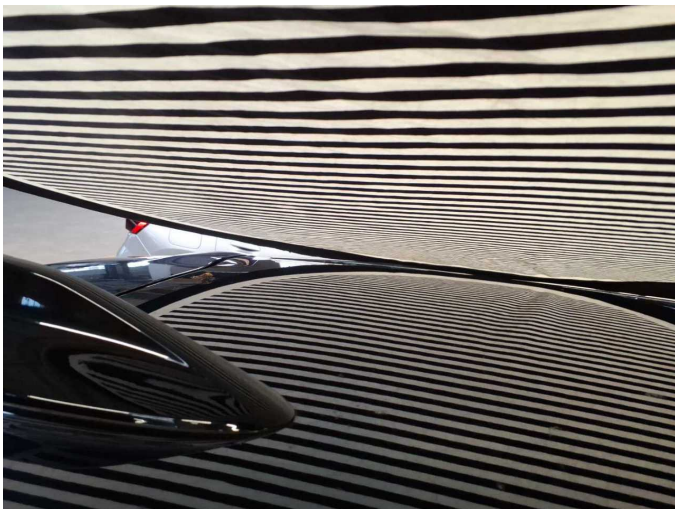
**Damage 3:** Body: Body - Damage by hail - Smooth repair work

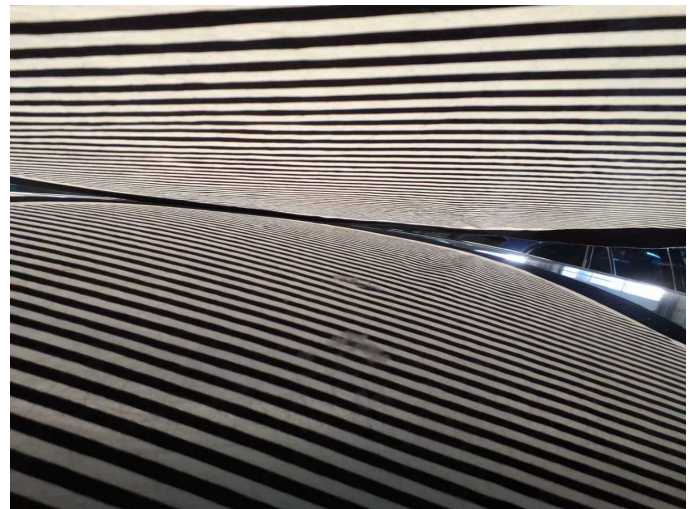
**Damage 3:** Body: Body - Damage by hail - Smooth repair work
