## Expertise

Protocol number: 46293318  
Order No. / Reference: 26394639  
Inspection date: 24 Jun 2026

Model: Traveller L3 2.0 BlueHDi 180 S&S EAT8 Business VIP

VIN: VF3VEEHZ7PZ029439

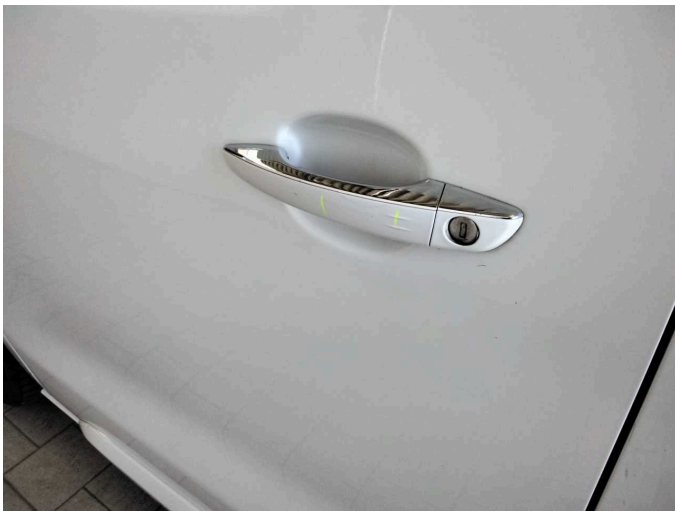
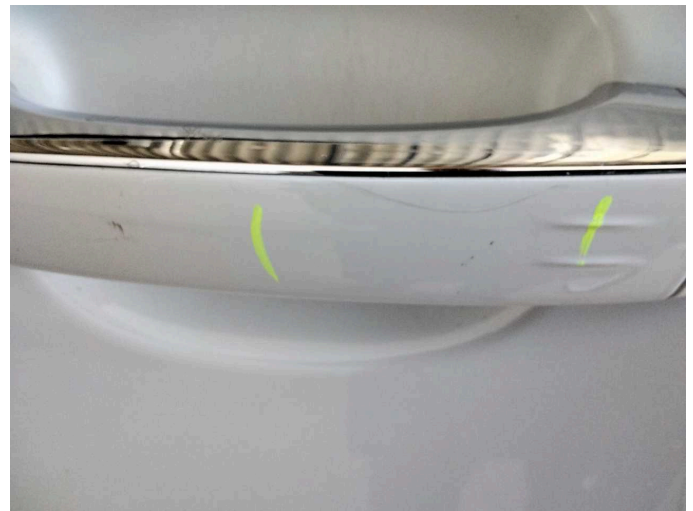
Damage 1: Door - front left side: Door handle - outside - Scratch(es) - Smart repair

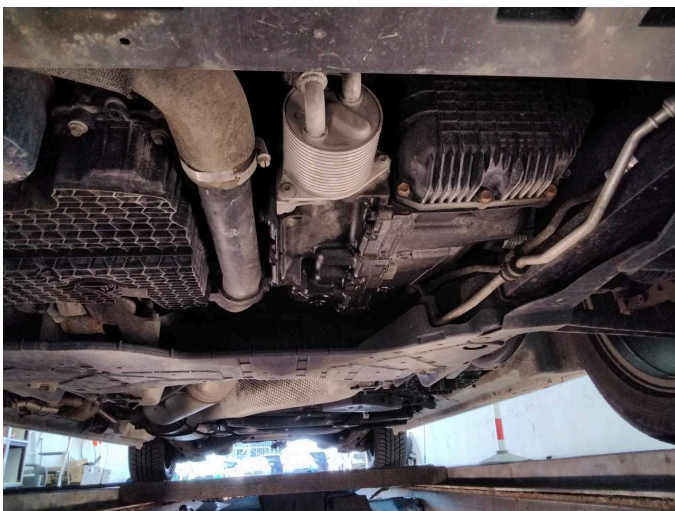
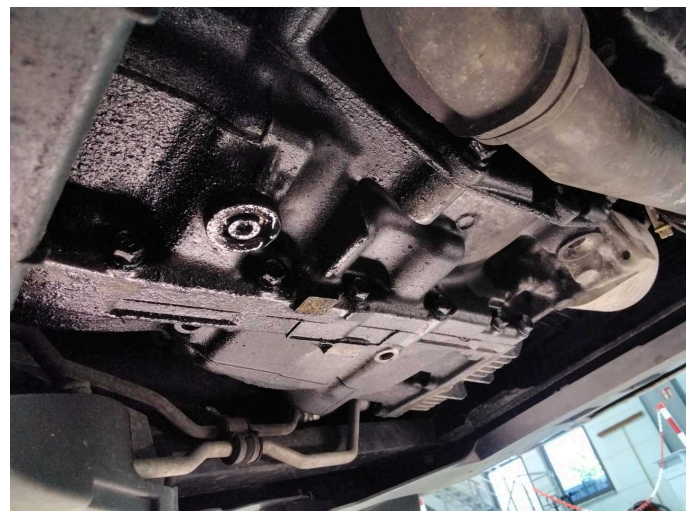
Damage 2: Body: Underbody (Getriebe Ölfeucht) - Perform diagnosis

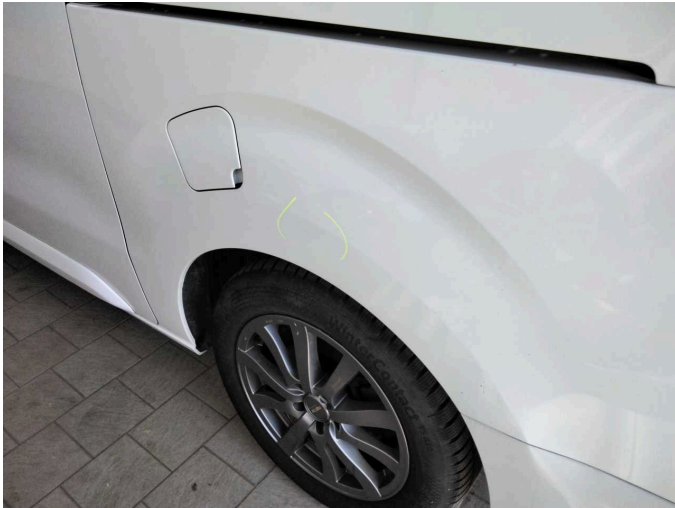
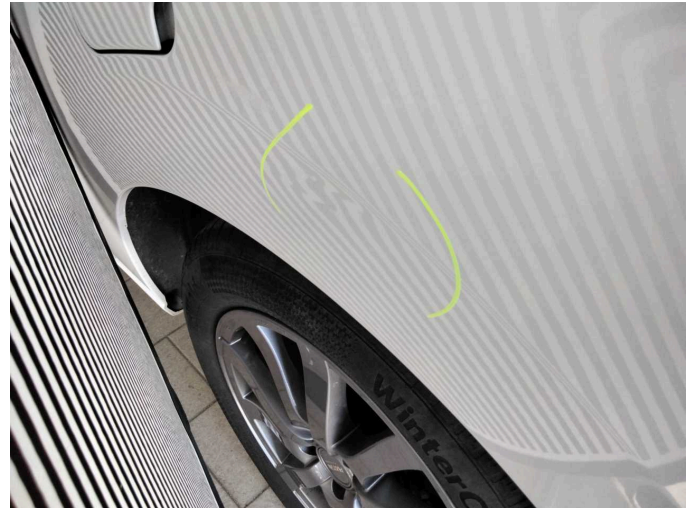
**Damage 3:** Side panel - rear left side: Side panel - dent(s) - Smooth repair work

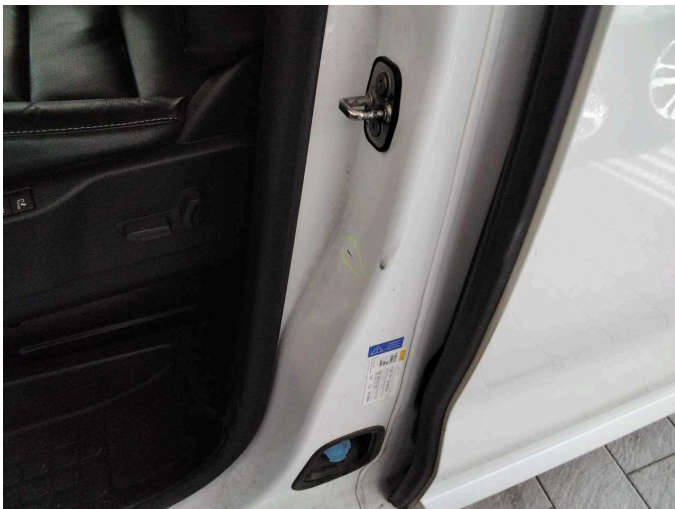
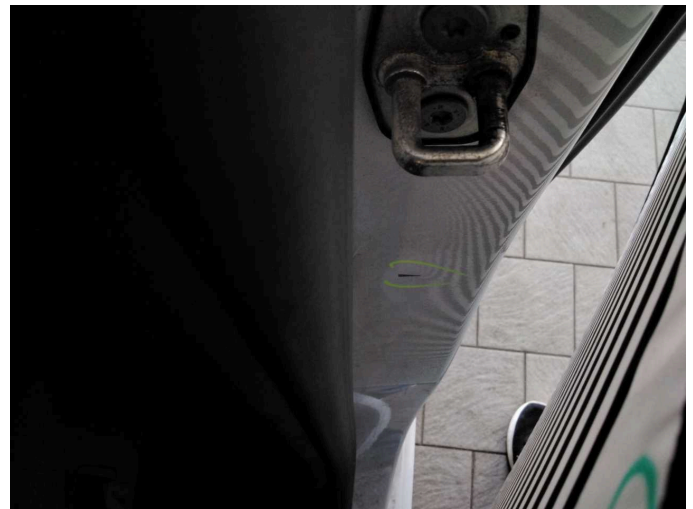
**Damage 4:** Body: B-pillar - left side - Dent / paintcoat damage - Smart repair

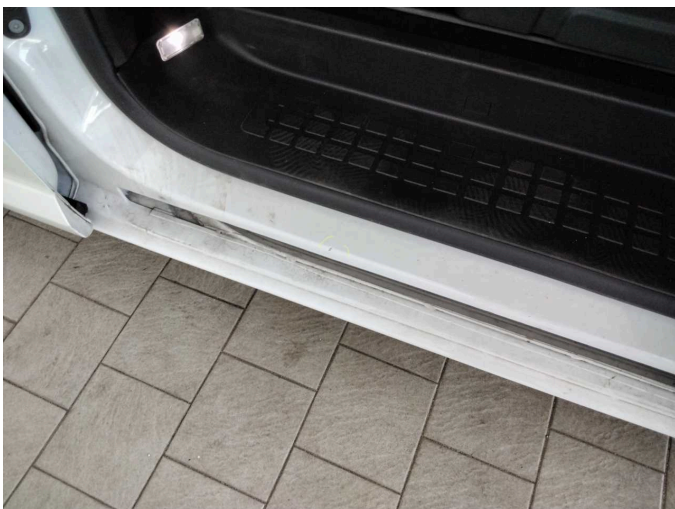
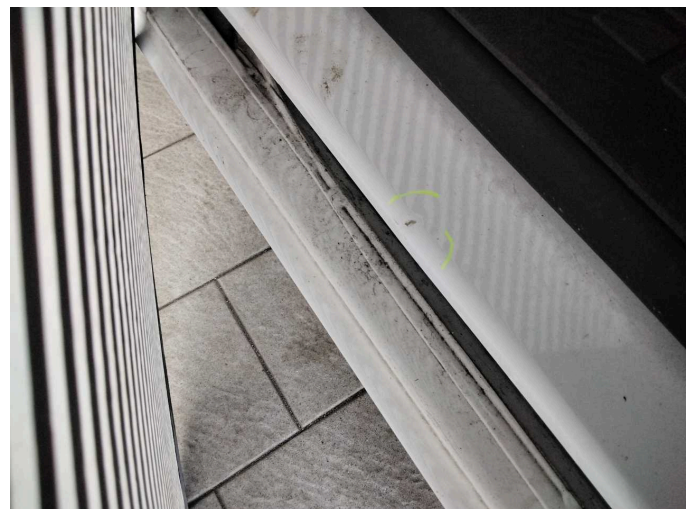
**Damage 5:** Side panel - rear left side: Sill - Dent / paintcoat damage - Smart repair

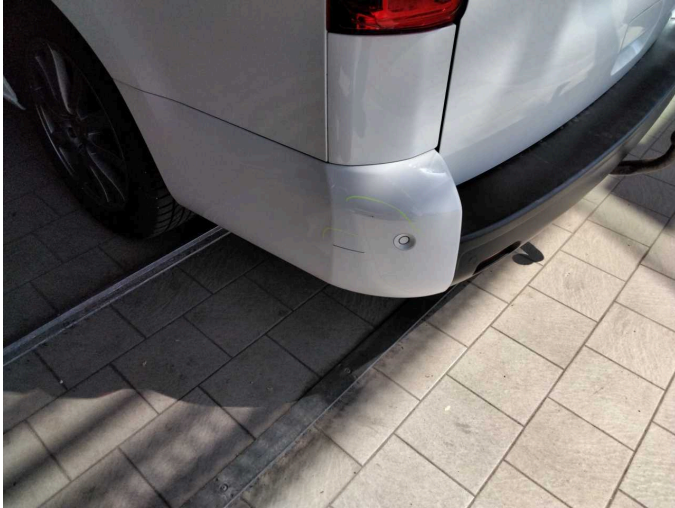
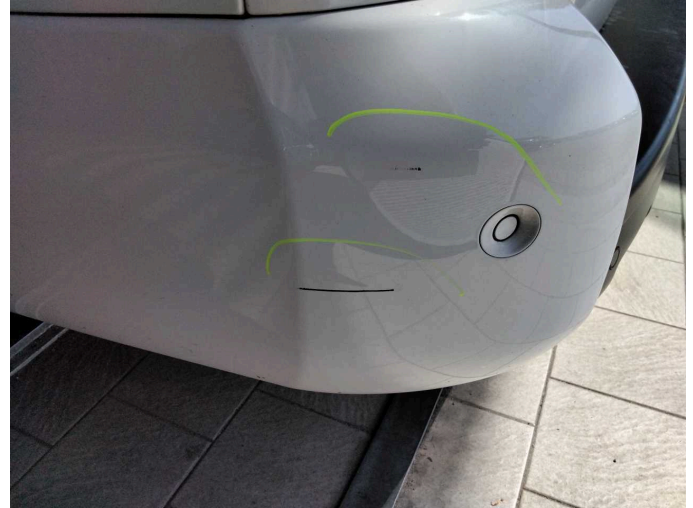
**Damage 6:** Rear bumper: Bumper - rear left side - Scratch(es) - Smart repair

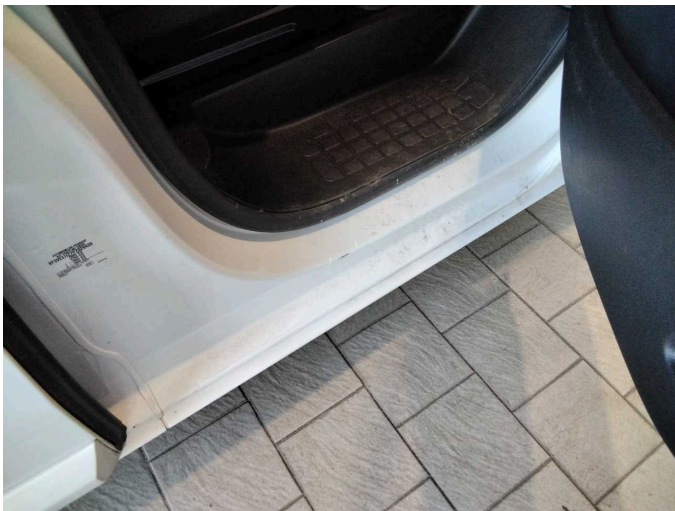
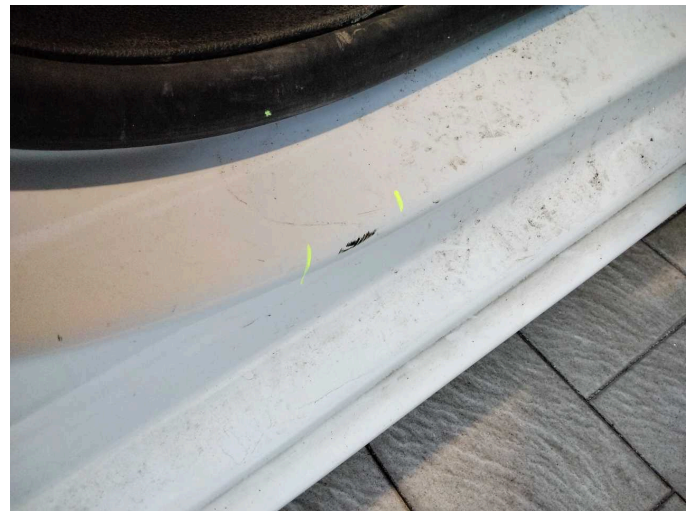
**Damage 7:** Sill - right side: Sill - Scratch(es) - Smart repair

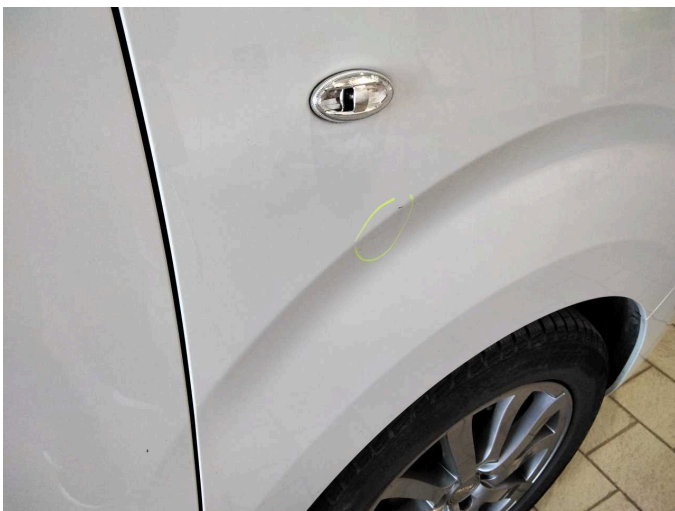
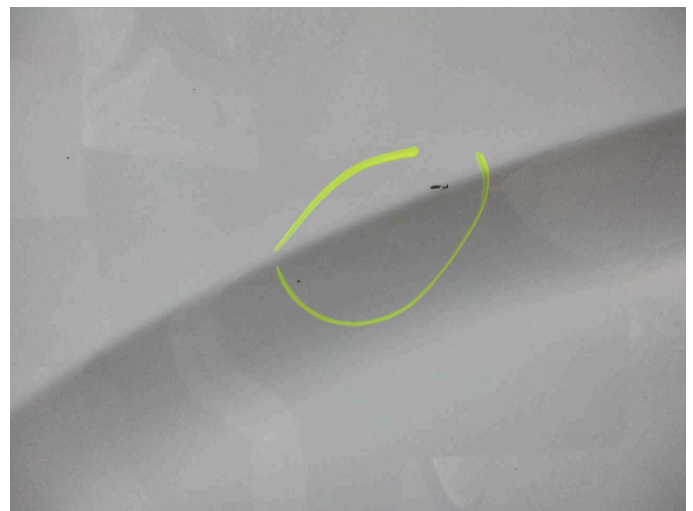
**Damage 8:** Mudguard - right side: Mudguard - right side - Scratch(es) - Smart repair

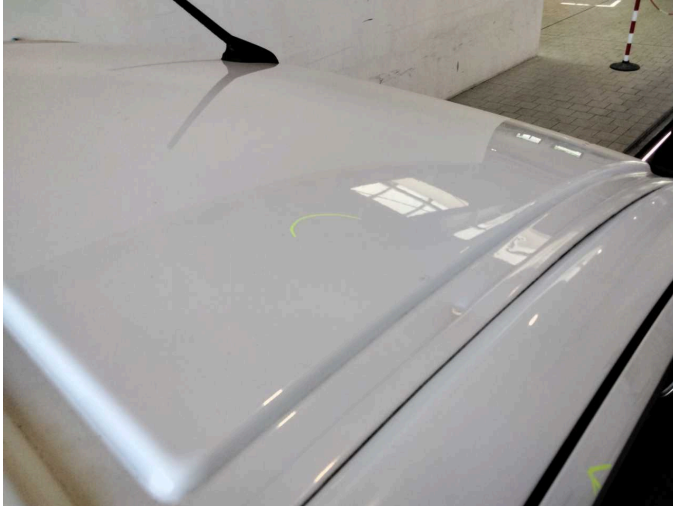
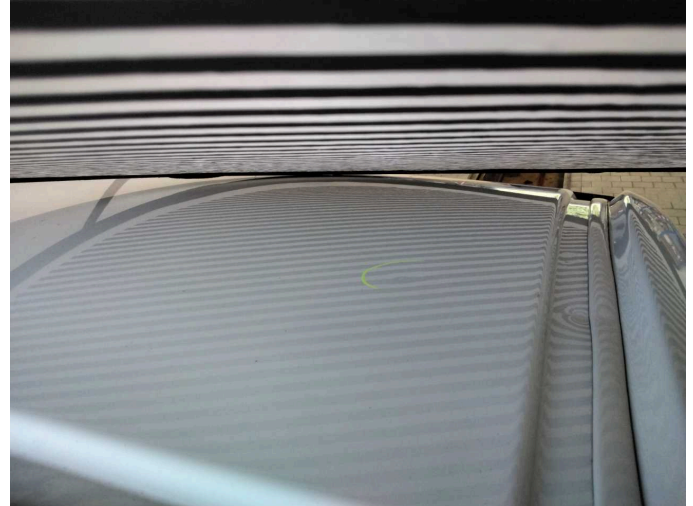
**Damage 9:** Roof: Roof - dent(s) - Paint

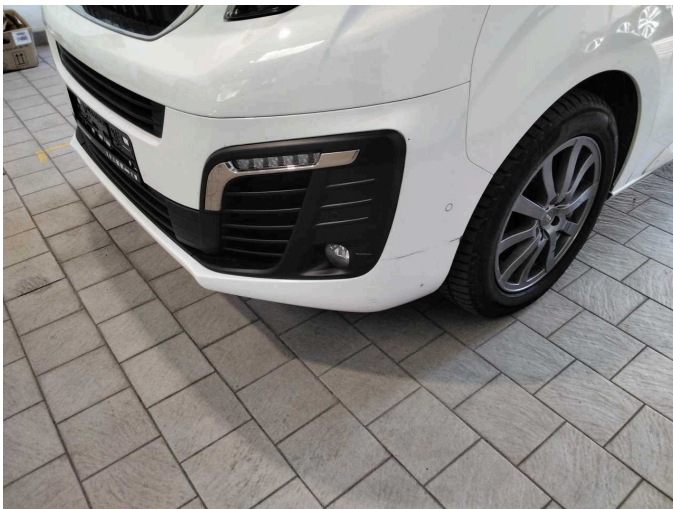
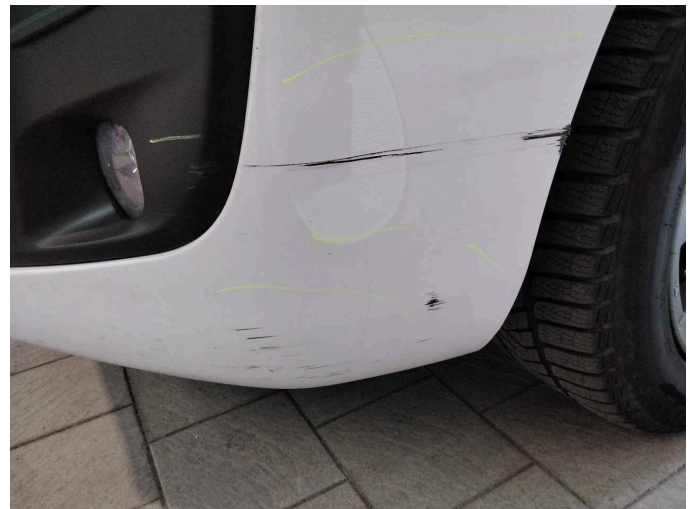
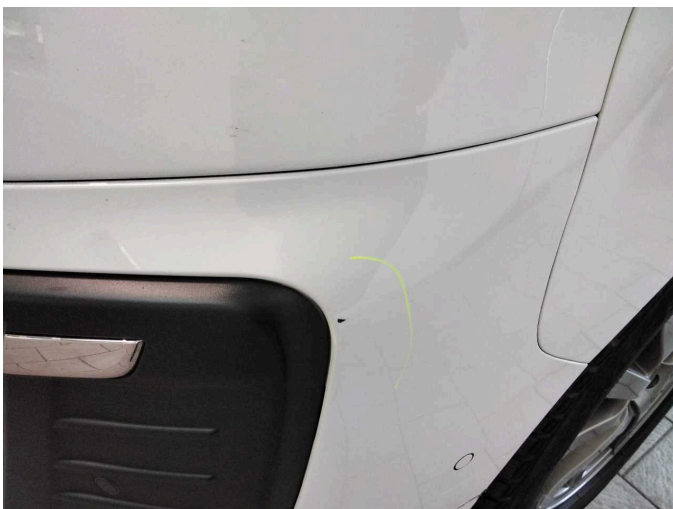
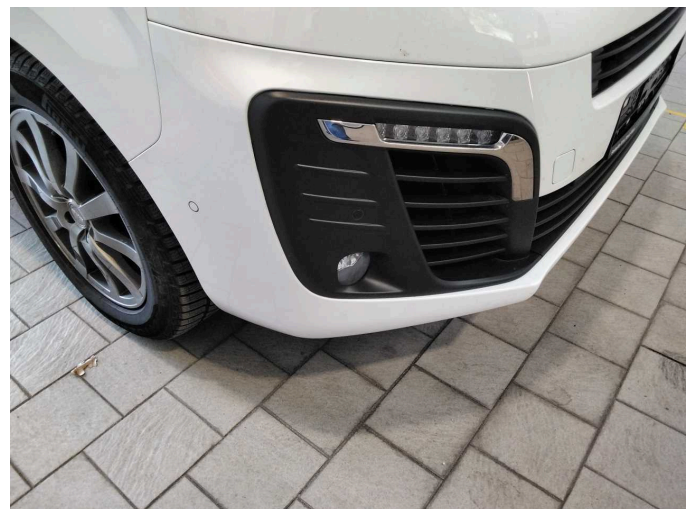
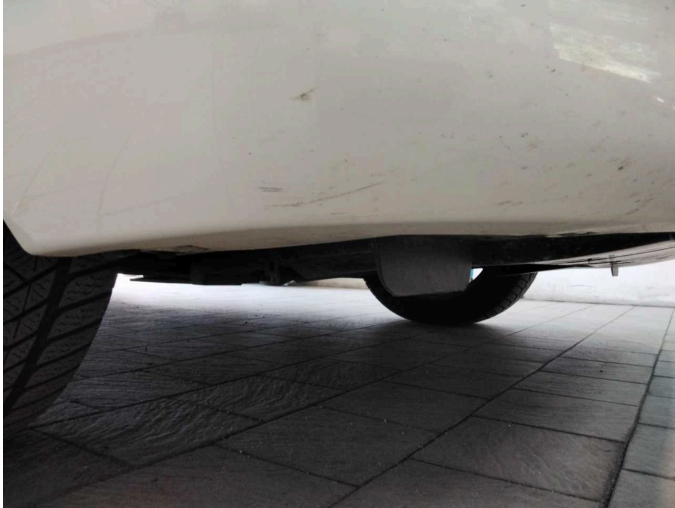
**Damage 10:** Front bumper: Front bumper (+ Zierleiste links erneuern) - Scratch(es) - Paint

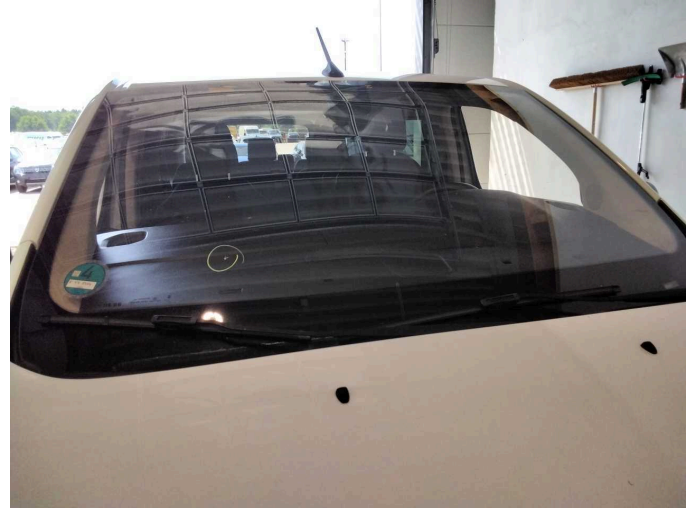
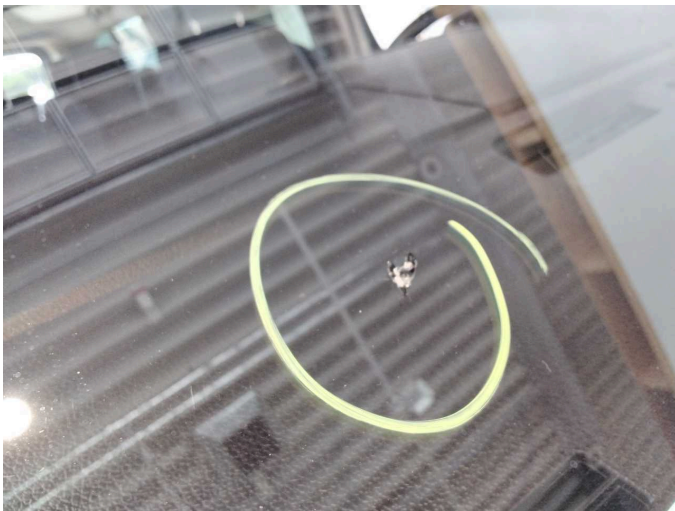
**Damage 11:** Vehicle glazing: Windscreen - Stone chips - Replace
