Expertise

Protocol number: 46401776  
Order No. / Reference: 26698861  
Inspection date: 8 Jul 2026

| Manufacturer: Opel | Model: Astra Sports Tourer 1.5 D Automatik Business Elegance |
| VIN: VXKFCYHZTP1100806 | |

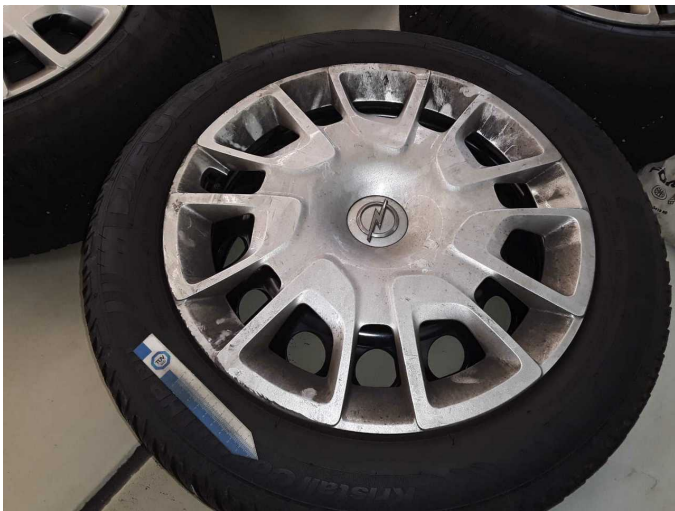
| No. | Component group | Description |
|---|---|---|
| 1 | 2nd wheel set | 1 wheel cover - Scratched - Replace |

**Damage 1:** 2nd wheel set: 1 wheel cover - Scratched - Replace

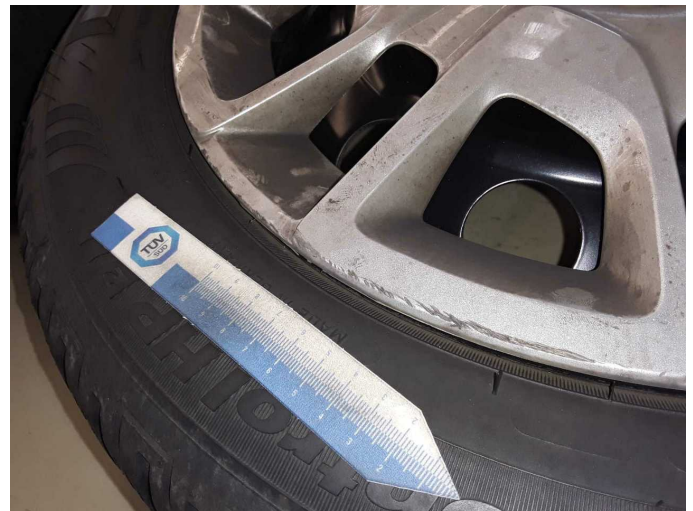
**Damage 1:** 2nd wheel set: 1 wheel cover - Scratched - Replace

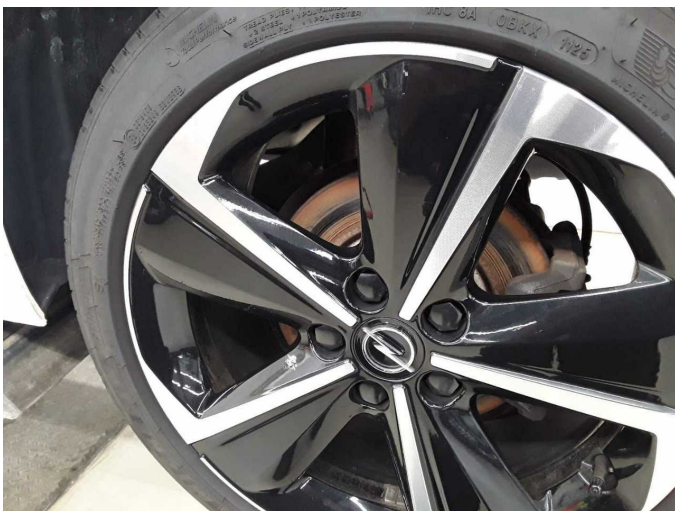
| No. | Component group | Description |
|---|---|---|
| 2 | Braking system | Brake discs - rear (Freibremsen-Mehrkosten möglich) - Corrosion - Perform |

**Damage 2:** Braking system: Brake discs - rear (Freibremsen-Mehrkosten möglich) - Corrosion - Perform

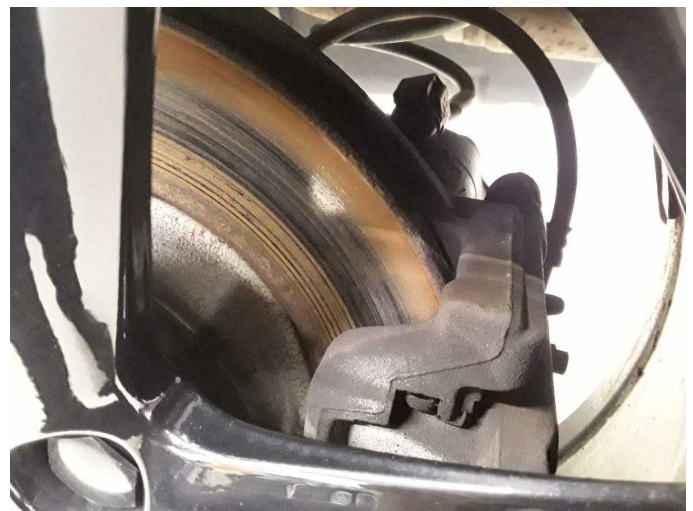
**Damage 2:** Braking system: Brake discs - rear (Freibremsen-Mehrkosten möglich) - Corrosion - Perform

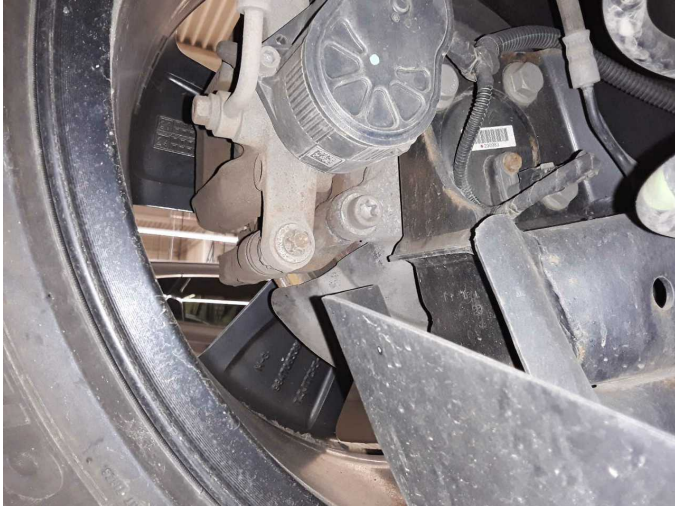
**Damage 2:** Braking system: Brake discs - rear (Freibremesen-Mehrkosten möglich) - Corrosion - Perform

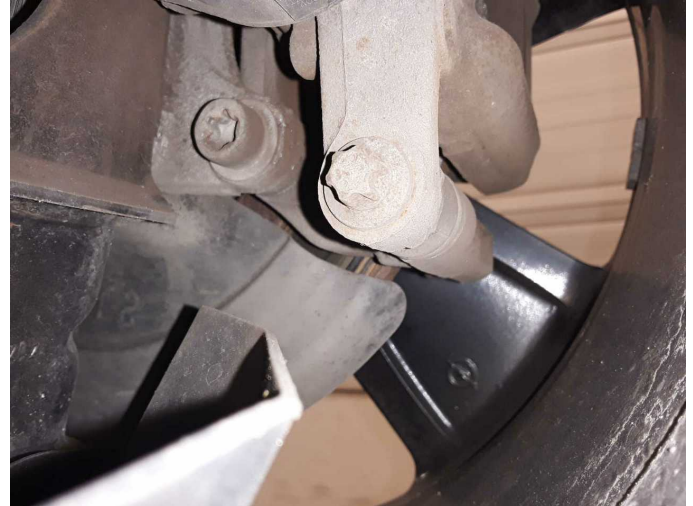
**Damage 2:** Braking system: Brake discs - rear (Freibremesen-Mehrkosten möglich) - Corrosion - Perform

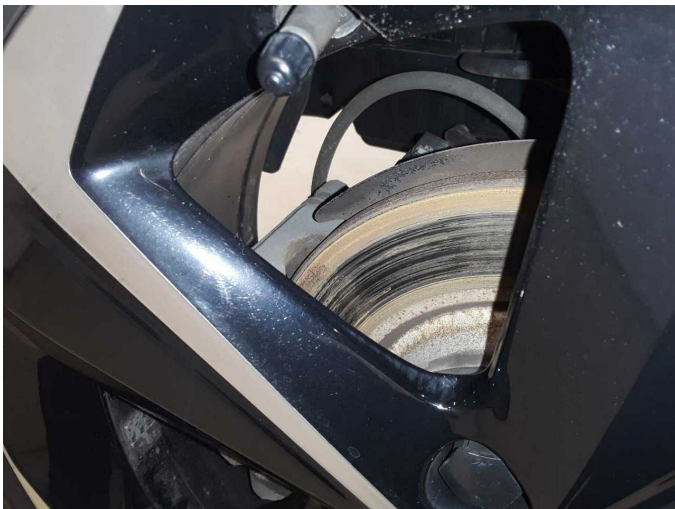
**Damage 2:** Braking system: Brake discs - rear (Freibremesen-Mehrkosten möglich) - Corrosion - Perform

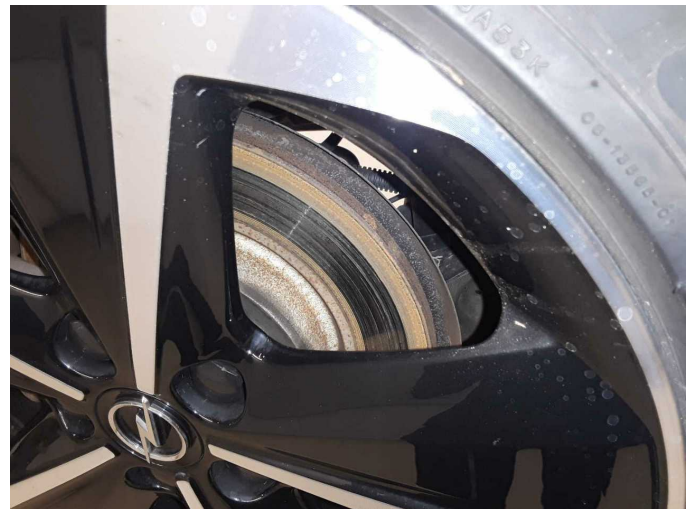
**Damage 2:** Braking system: Brake discs - rear (Freibremesen-Mehrkosten möglich) - Corrosion - Perform

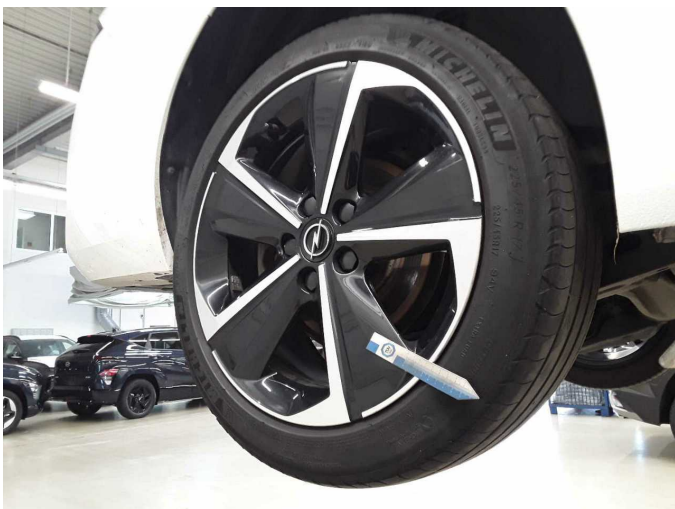
| No. | Component group | Description |
|---|---|---|
| 3 | Wheel / tyres | Tyre - rear right side (Einfahrschaden, nicht fahrbereit) - Leaking - Replace |

**Damage 3:** Wheel / tyres: Tyre - rear right side (Einfahrschaden, nicht fahrbereit) - Leaking - Replace

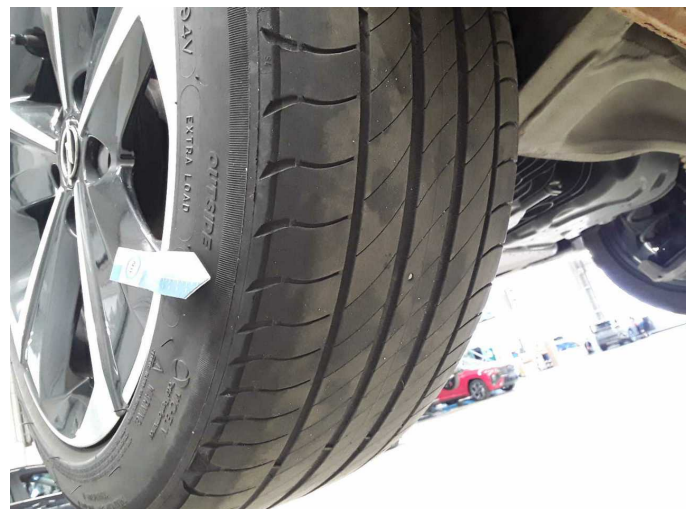
**Damage 3:** Wheel / tyres: Tyre - rear right side (Einfahrschaden, nicht fahrbereit) - Leaking - Replace

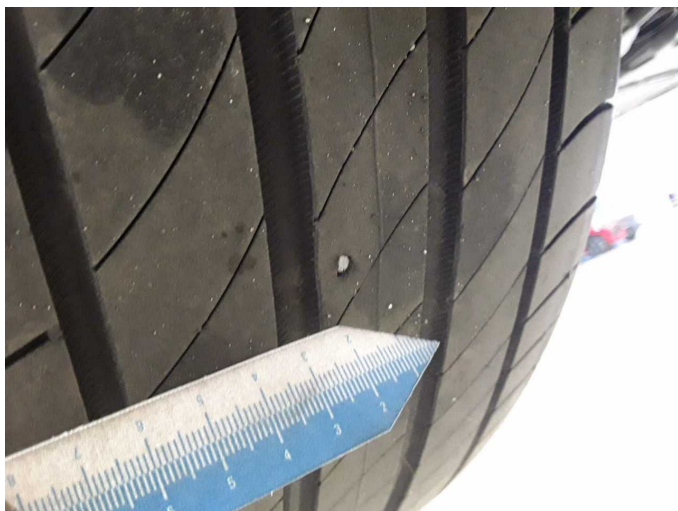
**Damage 3:** Wheel / tyres: Tyre - rear right side (Einfahr Schaden, nicht fahrbereit) - Leaking - Replace

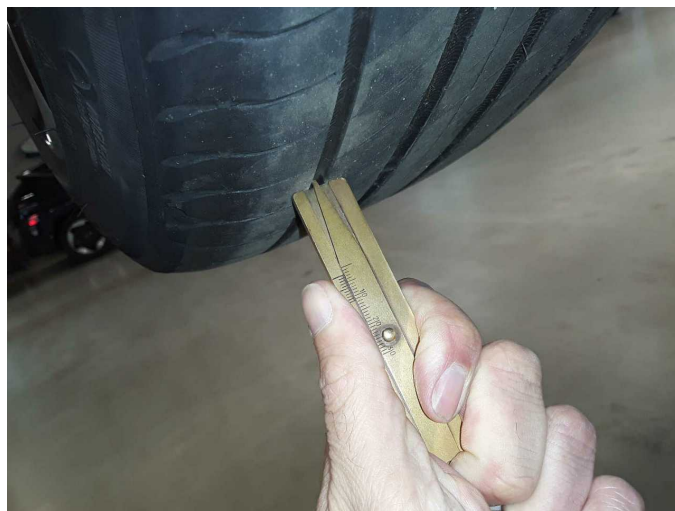
**Damage 3:** Wheel / tyres: Tyre - rear right side (Einfahr Schaden, nicht fahrbereit) - Leaking - Replace

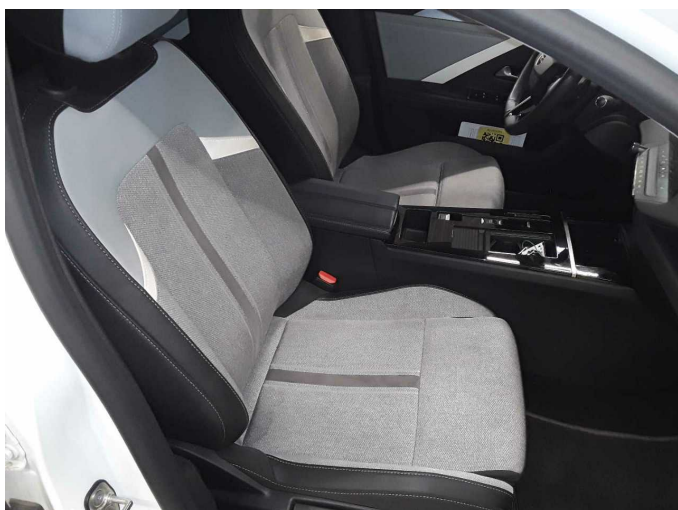
| No. | Component group | Description |
|---|---|---|
| 4 | Seat - front | Seat cover - right side (Sitze) - Soiled - Clean |

**Damage 4:** Seat - front: Seat cover - right side (Sitze) - Soiled - Clean

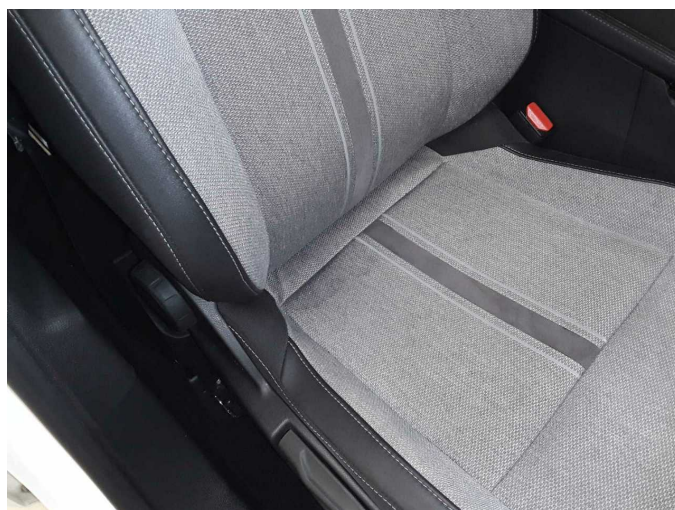
**Damage 4:** Seat - front: Seat cover - right side (Sitze) - Soiled - Clean

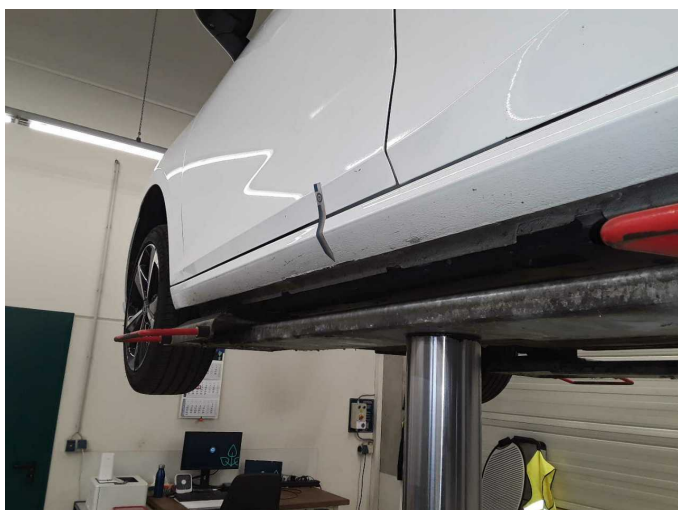
| No. | Component group | Description |
|---|---|---|
| 5 | Sill - left side | Sill - front - Scratched - Smart repair |

**Damage 5:** Sill - left side: Sill - front - Scratched - Smart repair

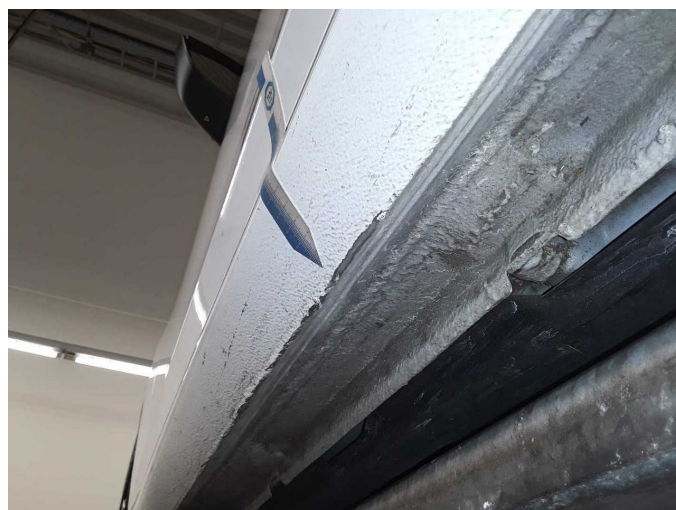
**Damage 5:** Sill - left side: Sill - front - Scratched - Smart repair

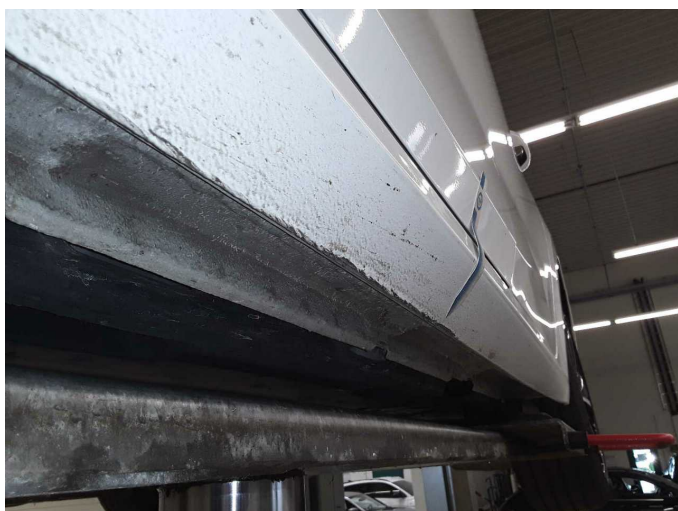
**Damage 5:** Sill - left side: Sill - front - Scratched - Smart repair

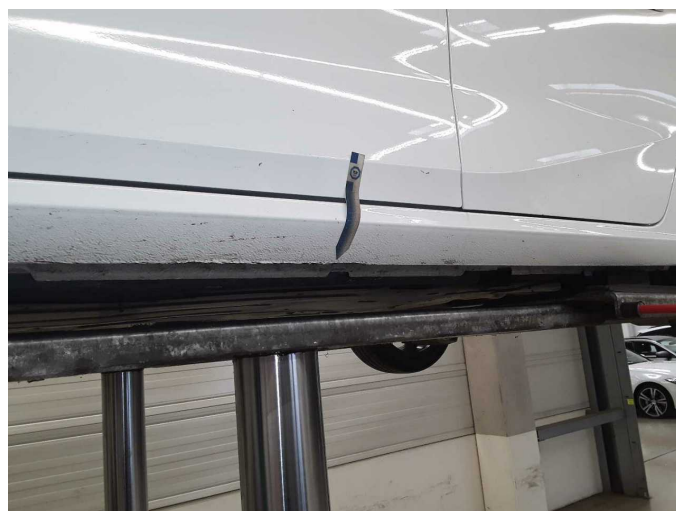
**Damage 5:** Sill - left side: Sill - front - Scratched - Smart repair

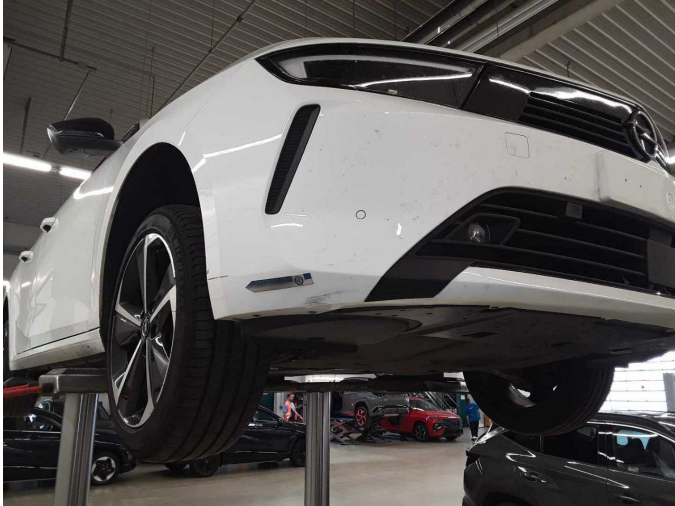
| No. | Component group | Description |
|---|---|---|
| 6 | Front bumper | Front bumper - Scratch(es) - Smart repair |

**Damage 6:** Front bumper: Front bumper - Scratch(es) - Smart repair

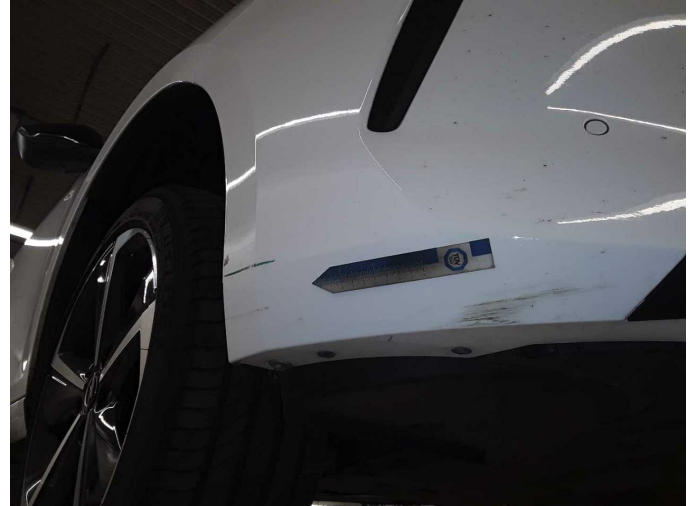
**Damage 6:** Front bumper: Front bumper - Scratch(es) - Smart repair

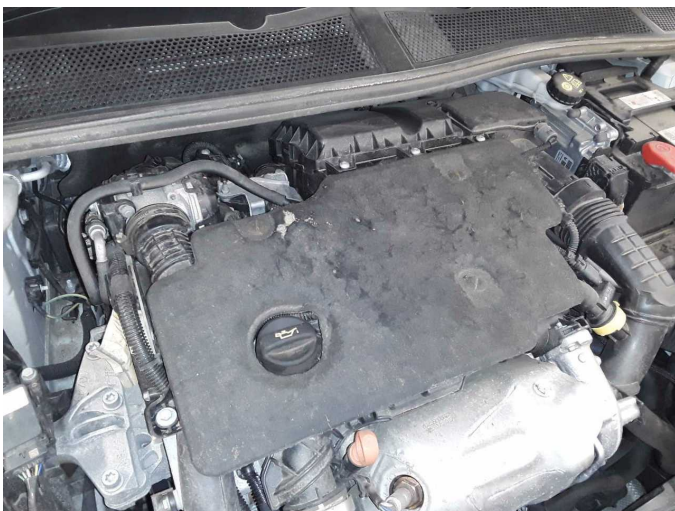
| No. | Component group | Description |
|---|---|---|
| 7 | Engine | Engine cover - Broken / torn - Replace |

**Damage 7:** Engine: Engine cover - Broken / torn - Replace

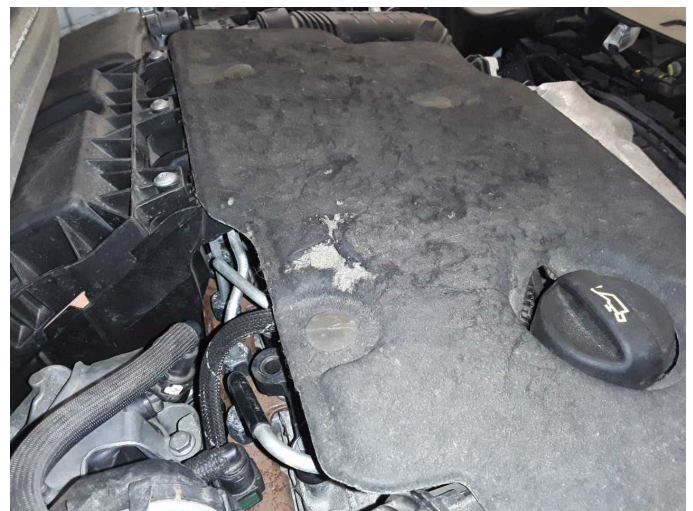
**Damage 7:** Engine: Engine cover - Broken / torn - Replace

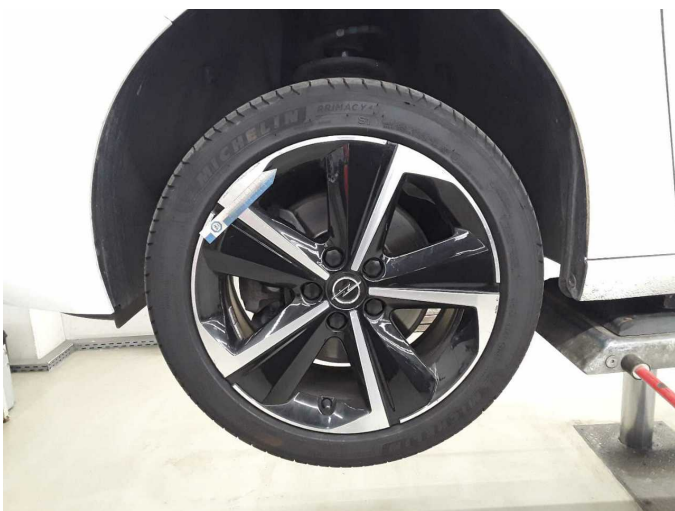
| No. | Component group | Description |
|---|---|---|
| 8 | Wheel / tyres | Alloy rim - front left side - Scratched - Loss in value |

**Damage 8:** Wheel / tyres: Alloy rim - front left side - Scratched - Loss in value

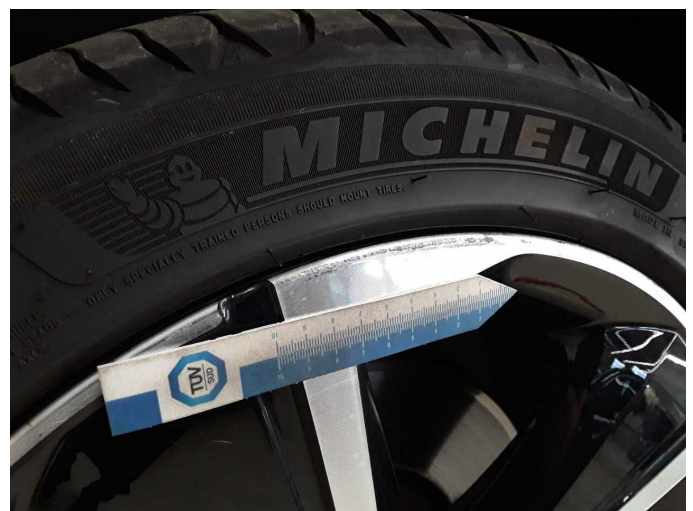
**Damage 8:** Wheel / tyres: Alloy rim - front left side - Scratched - Loss in value

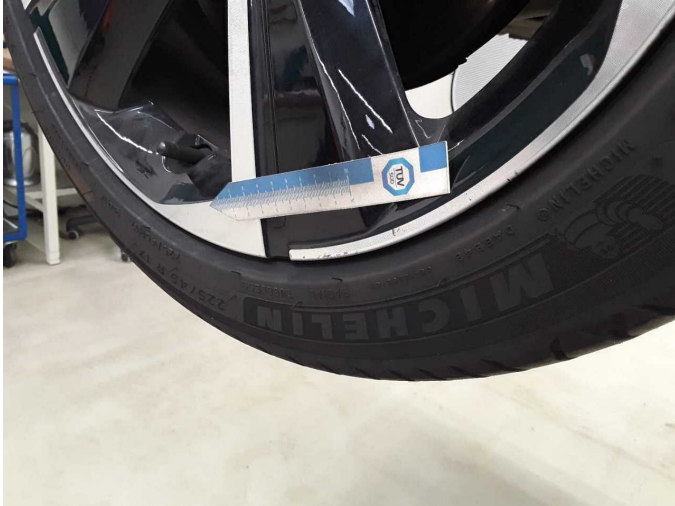
**Damage 8:** Wheel / tyres: Alloy rim - front left side - Scratched - Loss in value

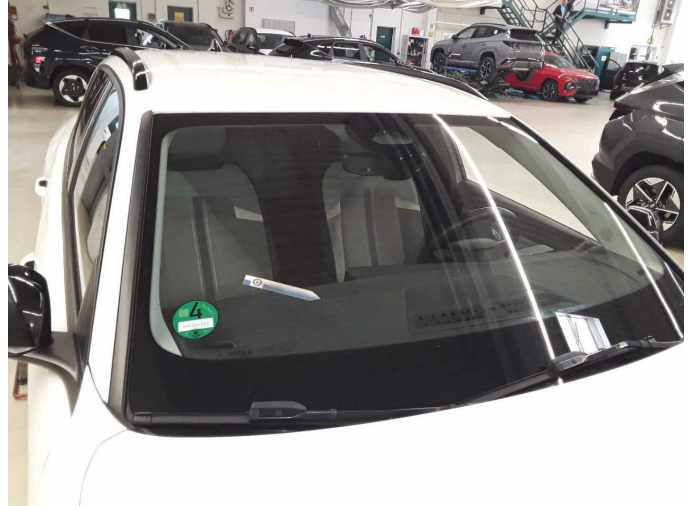
| No. | Component group | Description |
|---|---|---|
| 9 | Vehicle glazing | Windscreen - Stone chips - Replace |

**Damage 9:** Vehicle glazing: Windscreen - Stone chips - Replace

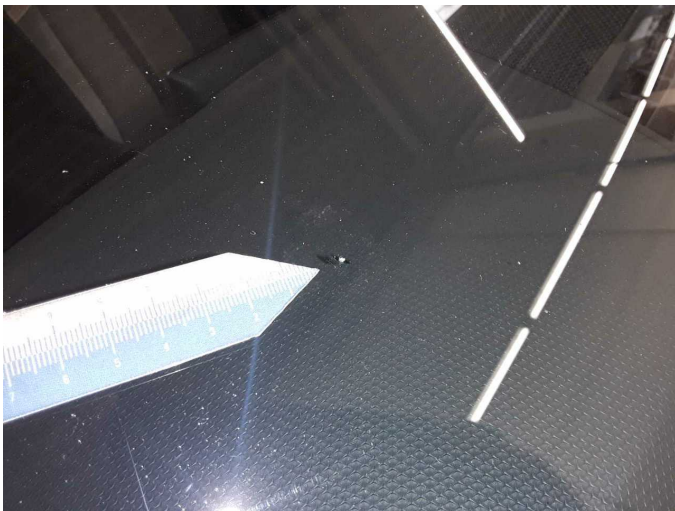
**Damage 9:** Vehicle glazing: Windscreen - Stone chips - Replace

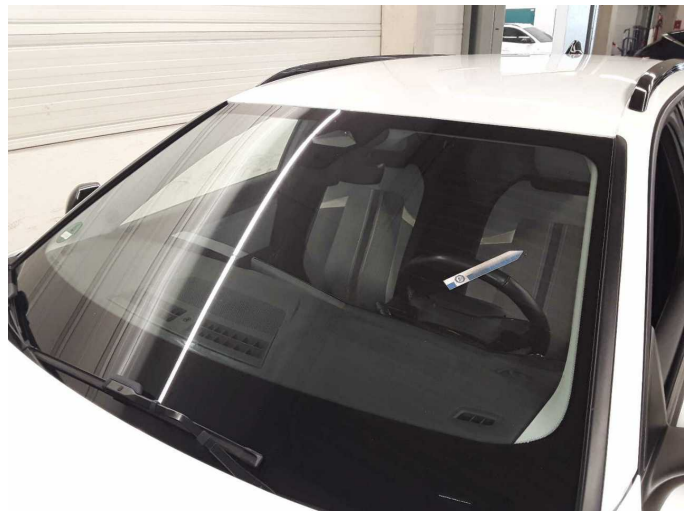
**Damage 9:** Vehicle glazing: Windscreen - Stone chips - Replace

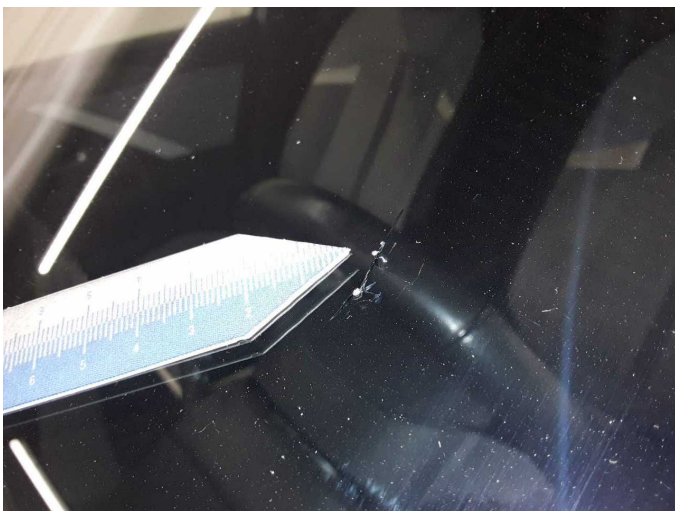
**Damage 9:** Vehicle glazing: Windscreen - Stone chips - Replace

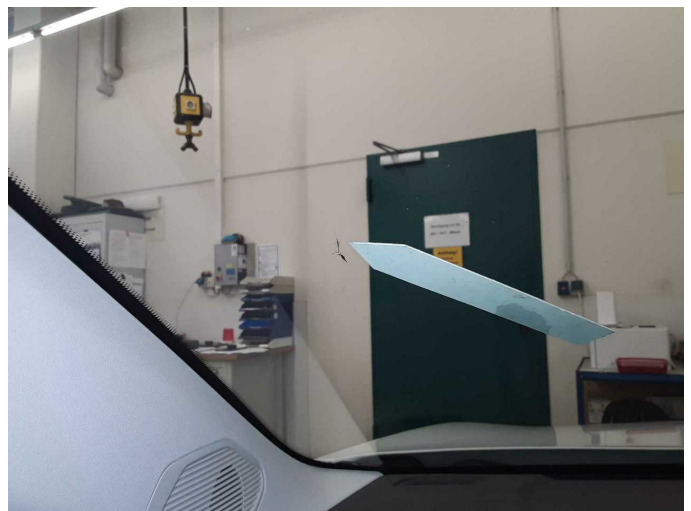
**Damage 9:** Vehicle glazing: Windscreen - Stone chips - Replace

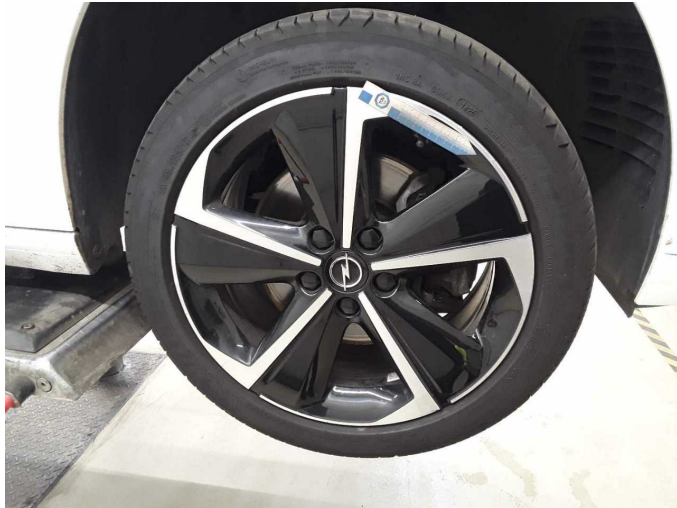
| No. | Component group | Description |
|---|---|---|
| 1 | Wheel / tyres | Alloy rim - front right side - Scratch(es) - No deduction |

**Wear and tear 1:** Wheel / tyres: Alloy rim - front right side - Scratch(es) - No deduction

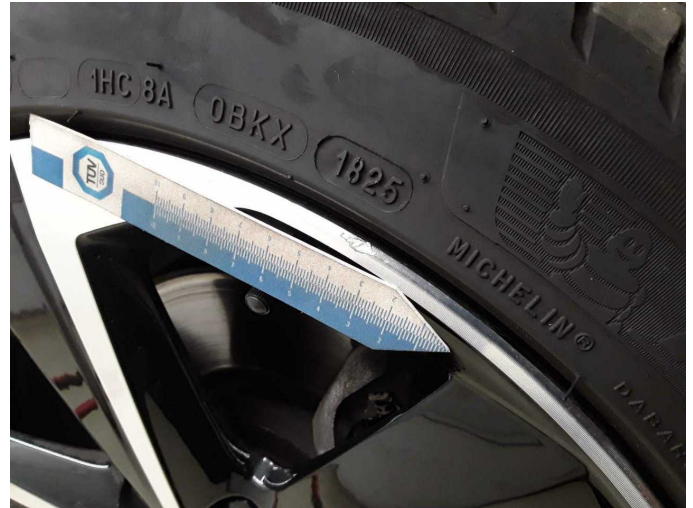
**Wear and tear 1:** Wheel / tyres: Alloy rim - front right side - Scratch(es) - No deduction

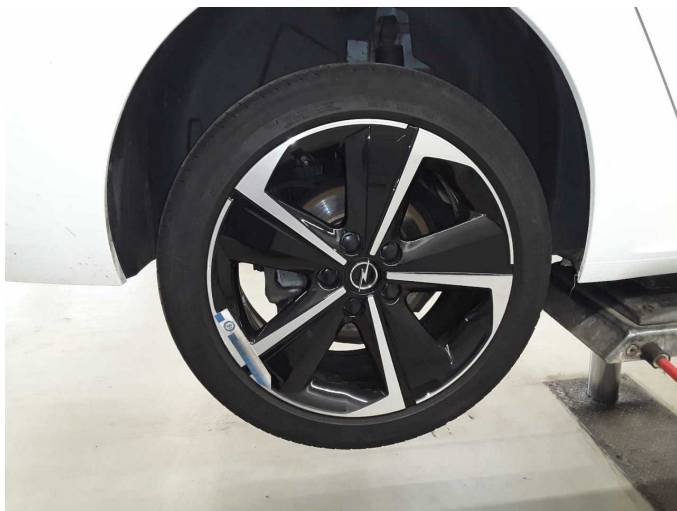
| No. | Component group | Description |
|---|---|---|
| 2 | Wheel / tyres | Alloy rim - rear right side - Scratch(es) - No deduction |

**Wear and tear 2:** Wheel / tyres: Alloy rim - rear right side - Scratch(es) - No deduction

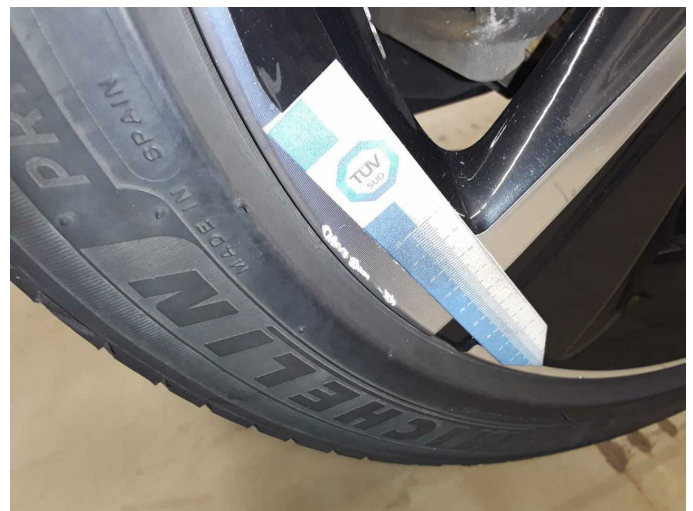
**Wear and tear 2:** Wheel / tyres: Alloy rim - rear right side - Scratch(es) - No deduction

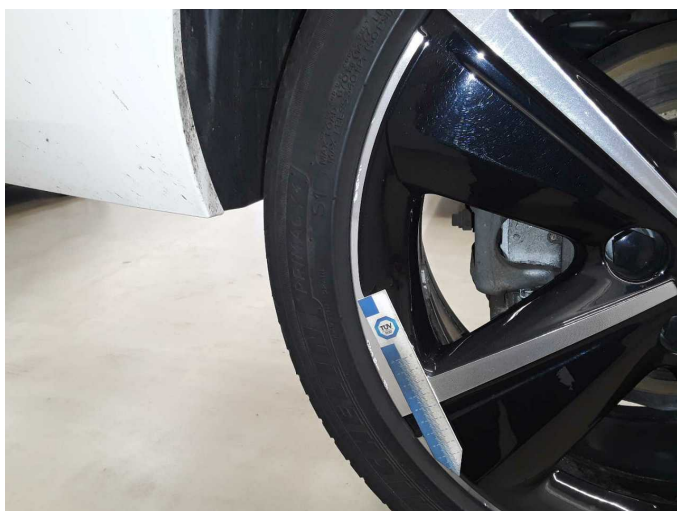
**Wear and tear 2:** Wheel / tyres: Alloy rim - rear right side - Scratch(es) - No deduction

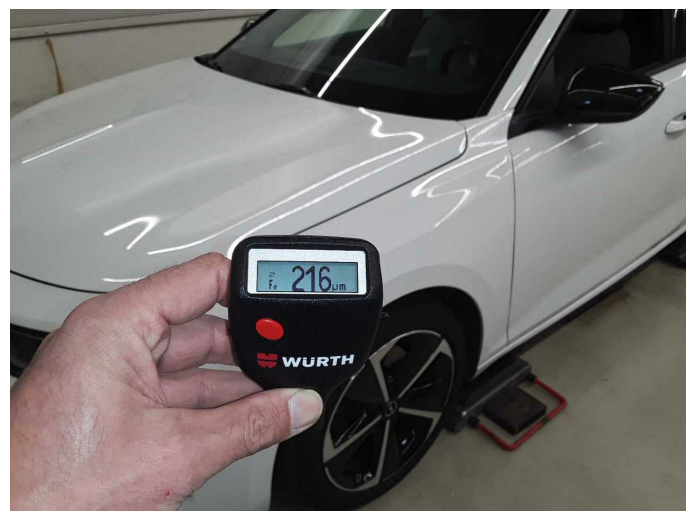
| No. | Repainting |
|---|---|
| 1 | Mudguard - left side, Professionally carried out |

**Mudguard - left side:** 216 µm
