## Expertise

Protocol number: 46283700  
Order No. / Reference: 26444195  
Inspection date: 1 Jul 2026

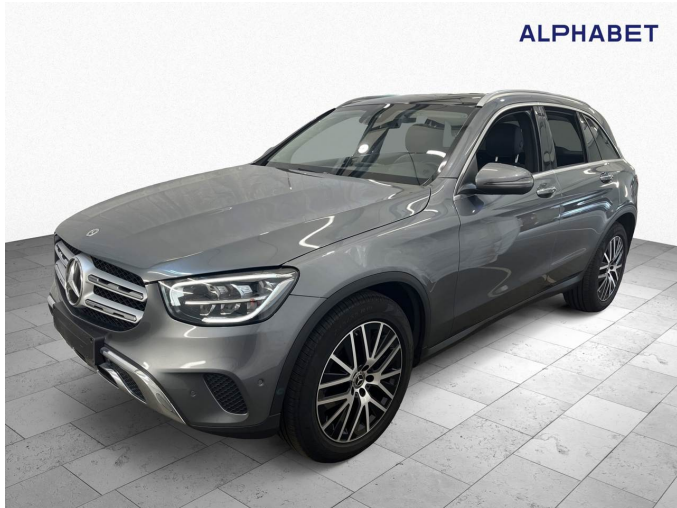
Figure 1: Diagonal front (left)

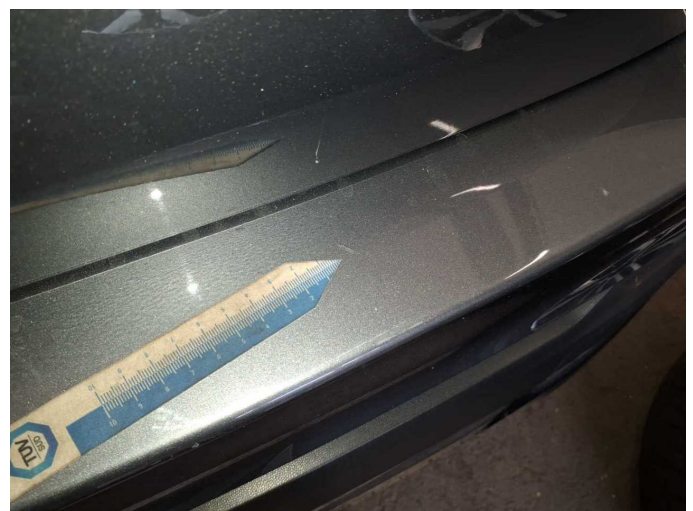
Damage 1: Rear bumper: Rear bumper - Scratched - Paint

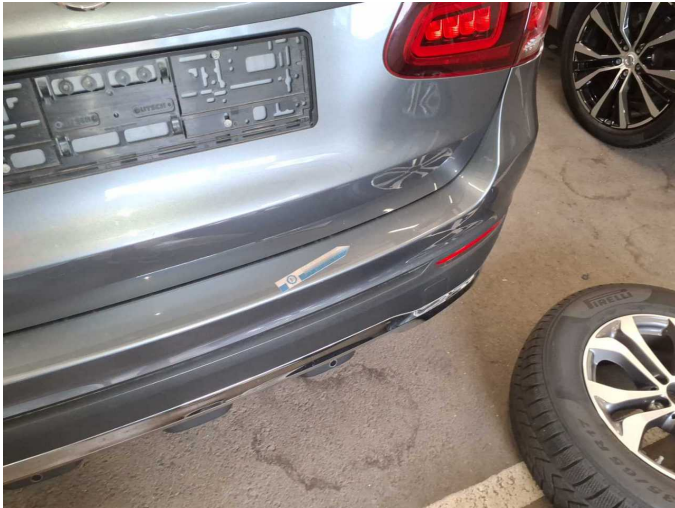
**Damage 1:** Rear bumper: Rear bumper - Scratched - Paint

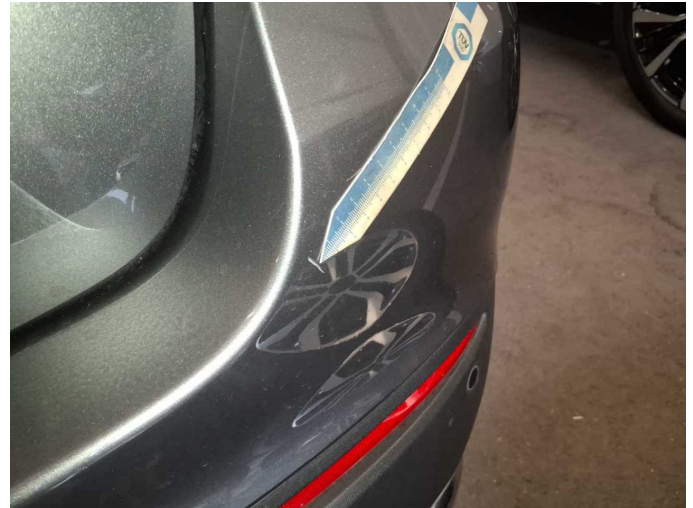
**Damage 1:** Rear bumper: Rear bumper - Scratched - Paint

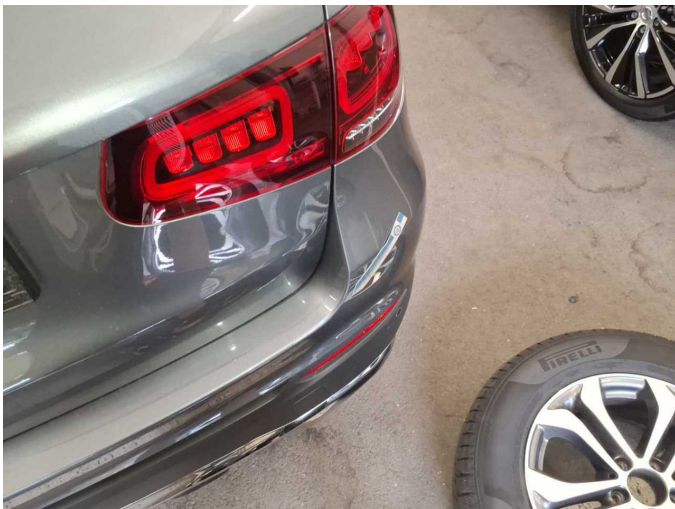
**Damage 1:** Rear bumper: Rear bumper - Scratched - Paint

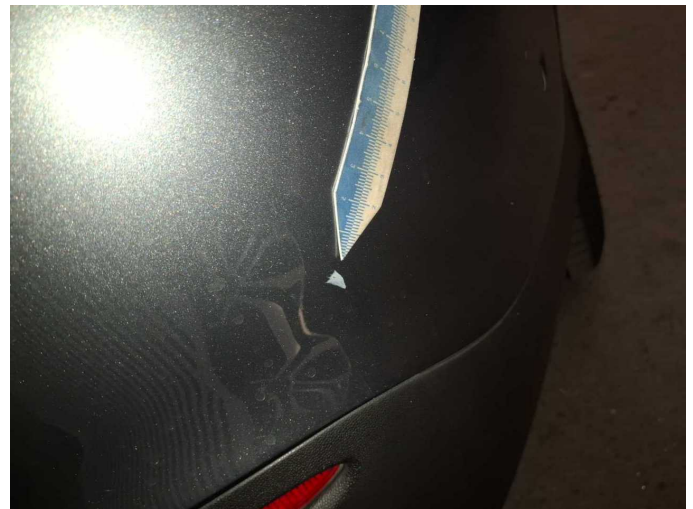
**Damage 1:** Rear bumper: Rear bumper - Scratched - Paint

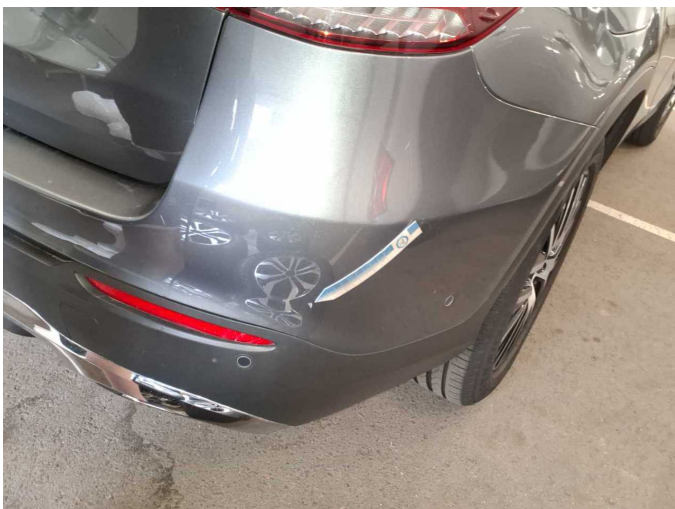
**Damage 1:** Rear bumper: Rear bumper - Scratched - Paint

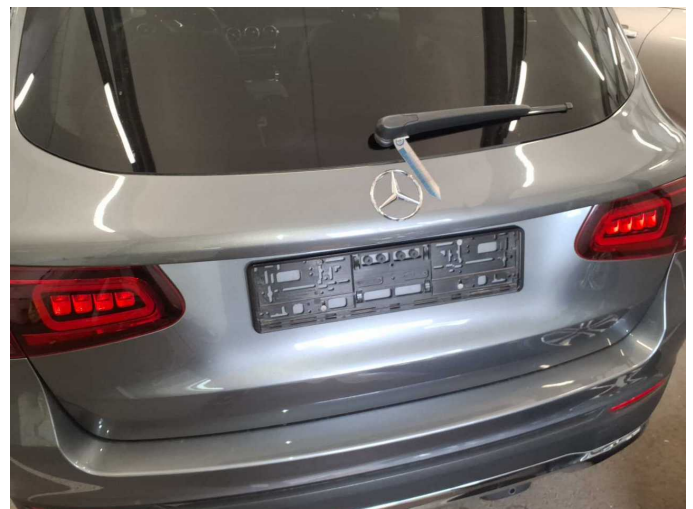
**Damage 2:** Boot lid / rear door: Boot lid - Dent / paintcoat damage - Repair and paint

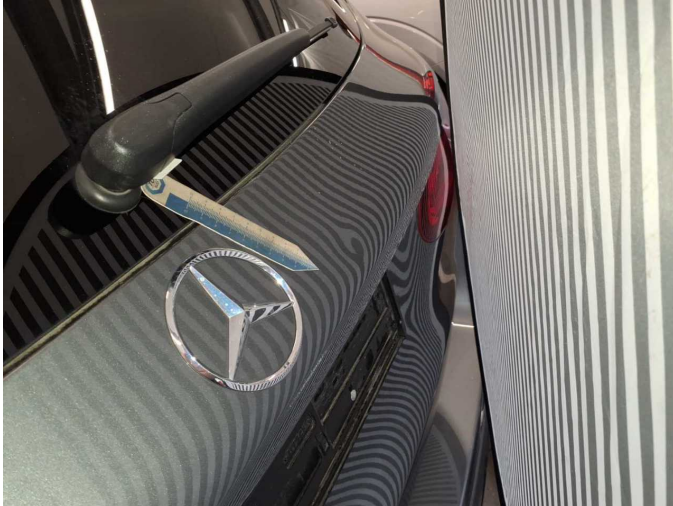
**Damage 2:** Boot lid / rear door: Boot lid - Dent / paintcoat damage - Repair and paint

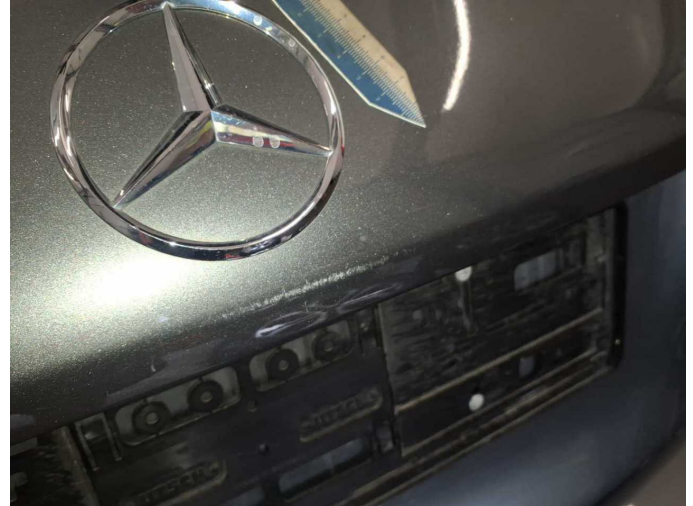
**Damage 2:** Boot lid / rear door: Boot lid - Dent / paintcoat damage - Repair and paint

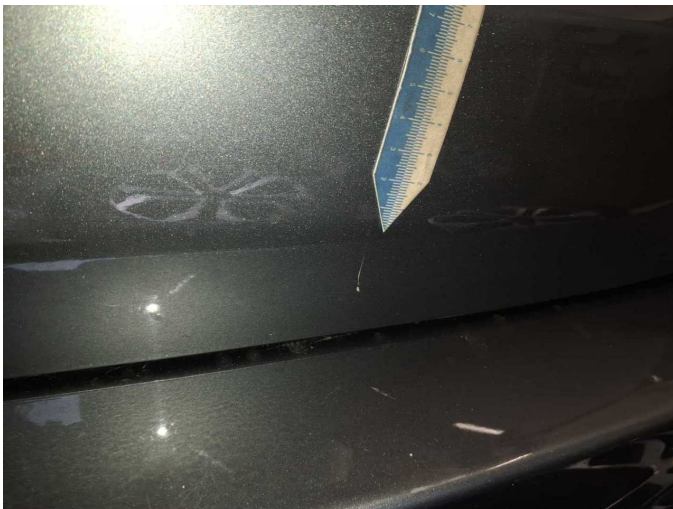
**Damage 2:** Boot lid / rear door: Boot lid - Dent / paintcoat damage - Repair and paint

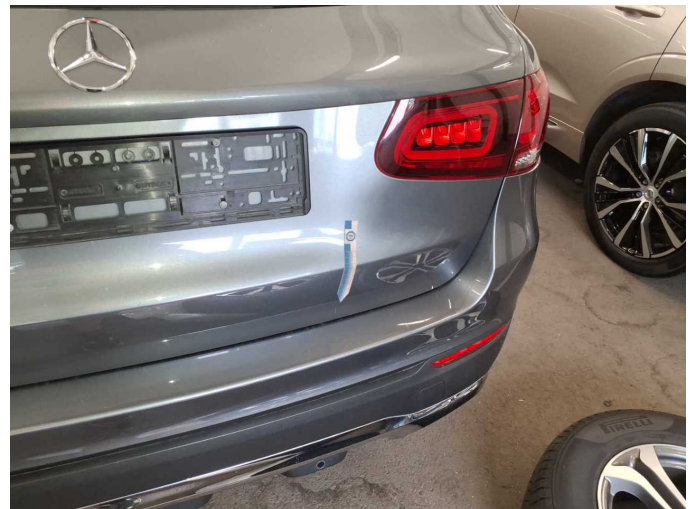
**Damage 2:** Boot lid / rear door: Boot lid - Dent / paintcoat damage - Repair and paint

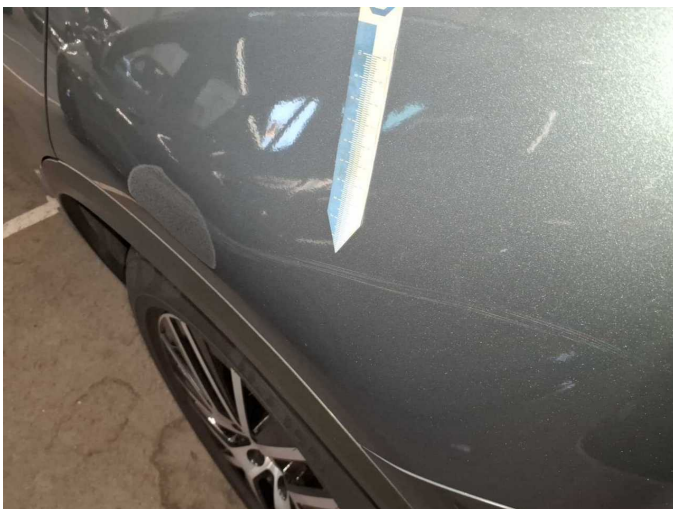
**Damage 3:** Side panel - rear left side: Side panel - Scratch(es) - Paint

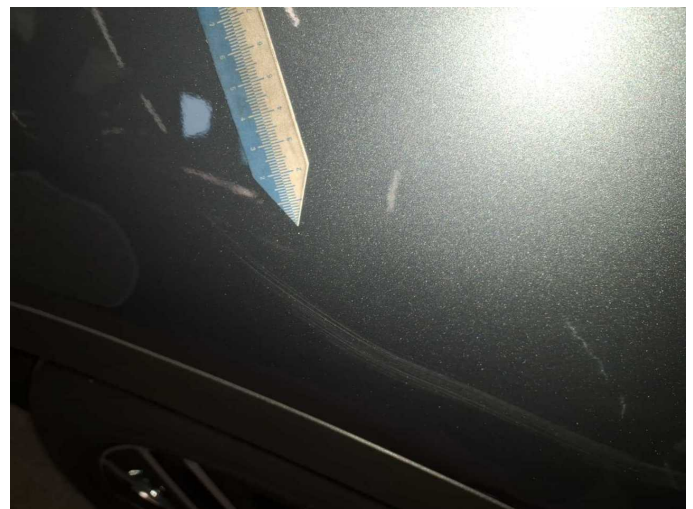
**Damage 3:** Side panel - rear left side: Side panel - Scratch(es) - Paint

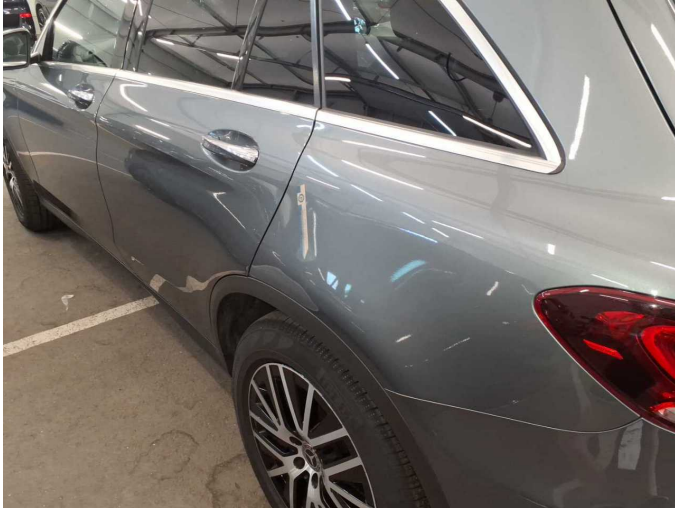
**Damage 3:** Side panel - rear left side: Side panel - Scratch(es) - Paint

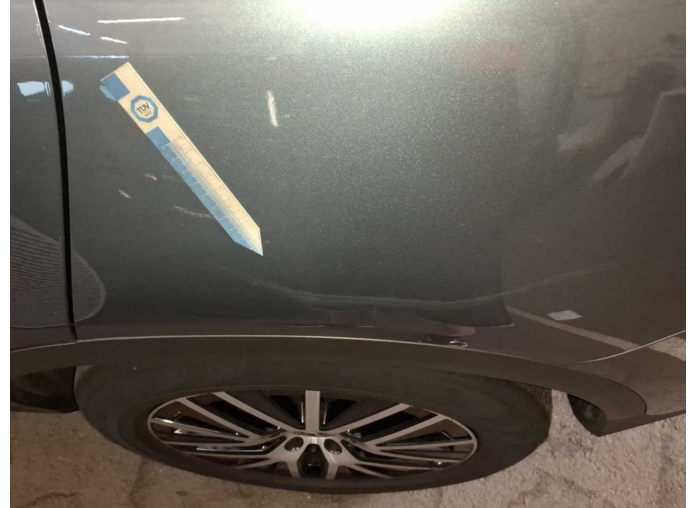
**Damage 3:** Side panel - rear left side: Side panel - Scratch(es) - Paint

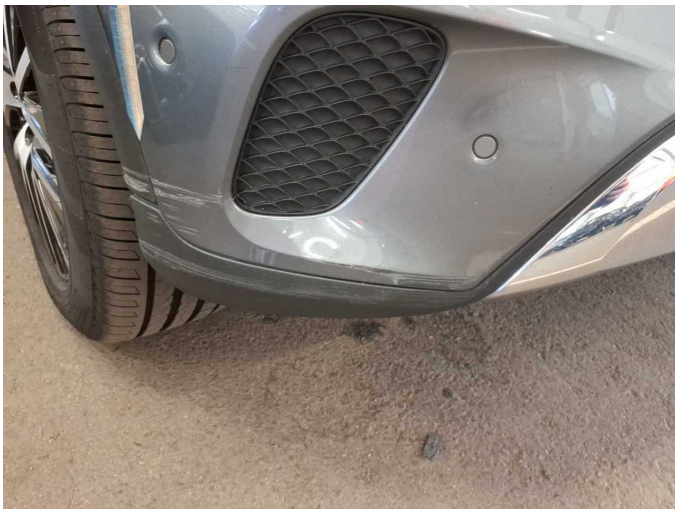
**Damage 4:** Front bumper: Front bumper (+Spoiler+Radlauf) - Damaged - repair according to calculation

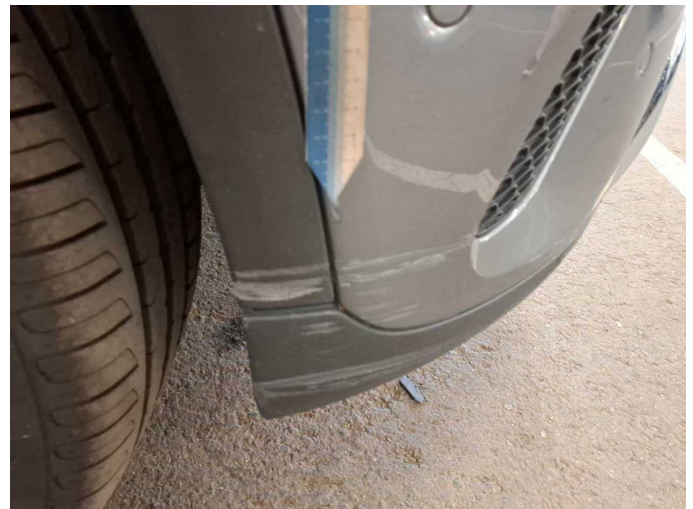
**Damage 4:** Front bumper: Front bumper (+Spoiler+Radlauf) - Damaged - repair according to calculation

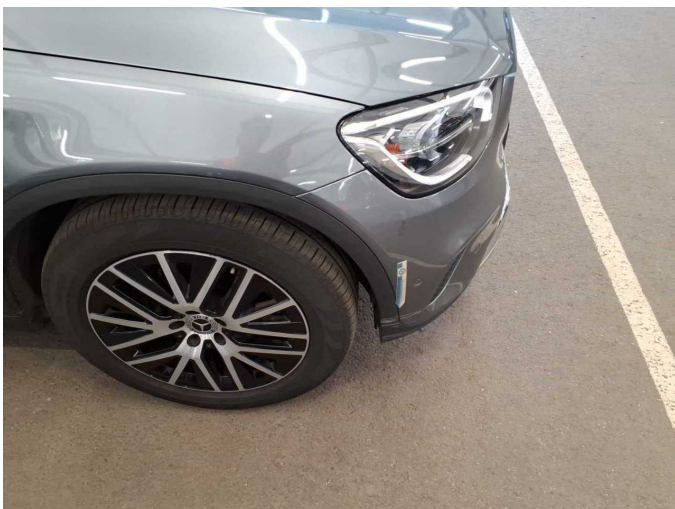
**Damage 4:** Front bumper: Front bumper (+Spoiler+Radlauf) - Damaged - repair according to calculation

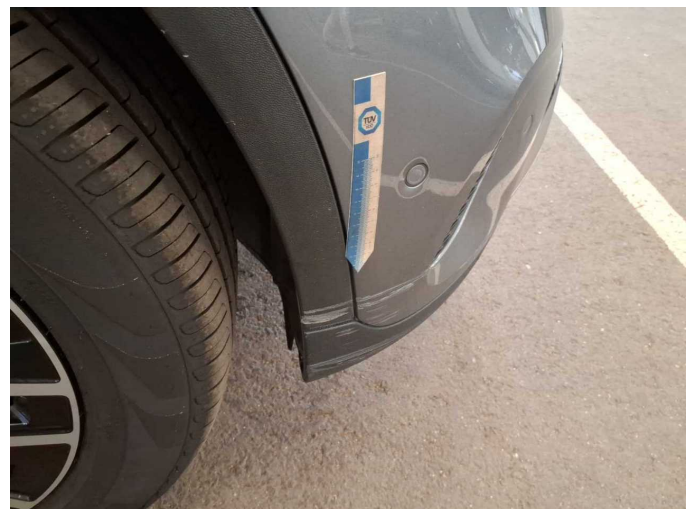
**Damage 4:** Front bumper: Front bumper (+Spoiler+Radlauf) - Damaged - repair according to calculation

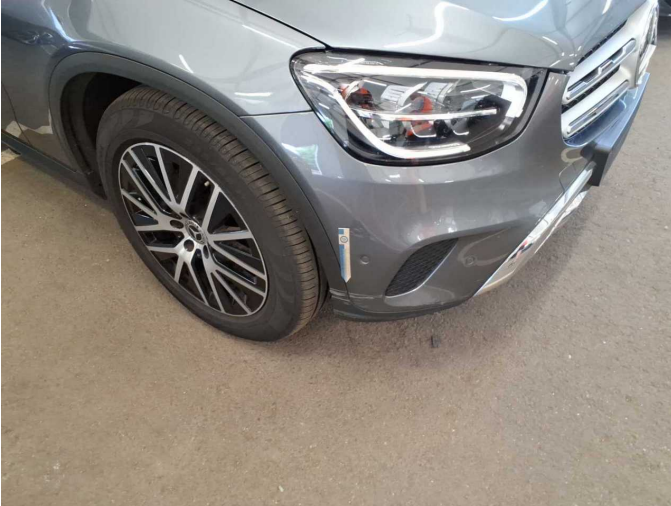
**Damage 4:** Front bumper: Front bumper (+Spoiler+Radlauf) - Damaged - repair according to calculation

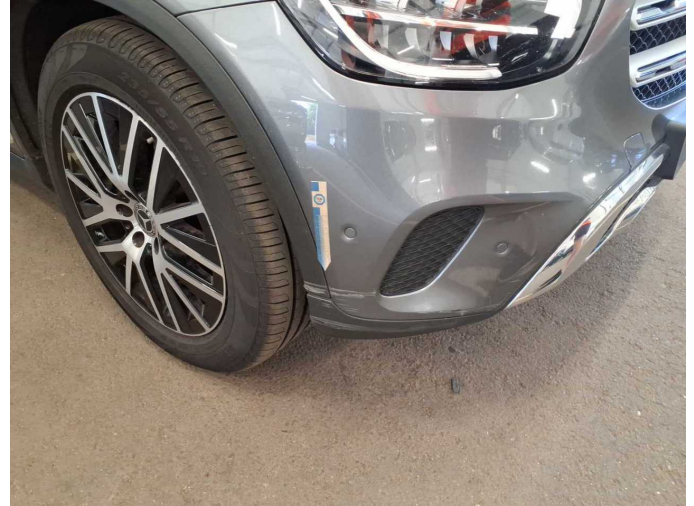
**Damage 4:** Front bumper: Front bumper (+Spoiler+Radlauf) - Damaged - repair according to calculation

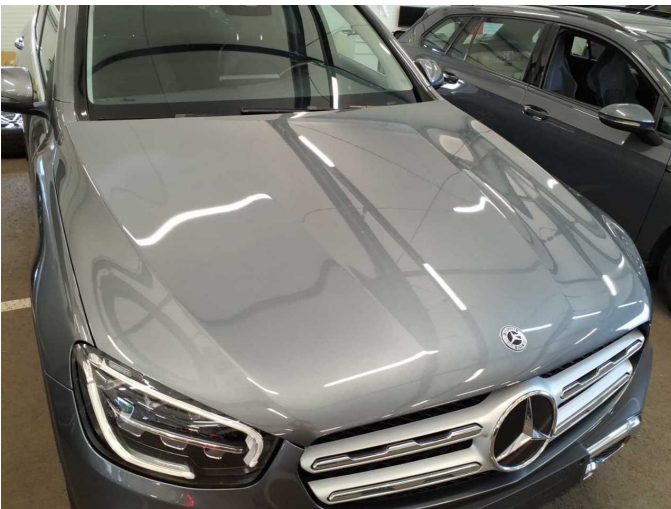
**Wear and tear 1:** Bonnet: Bonnet - Stone chips - No deduction

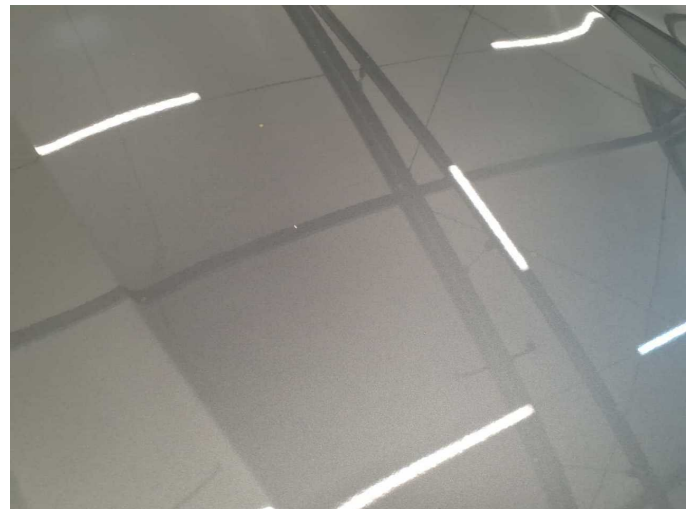
**Wear and tear 1:** Bonnet: Bonnet - Stone chips - No deduction

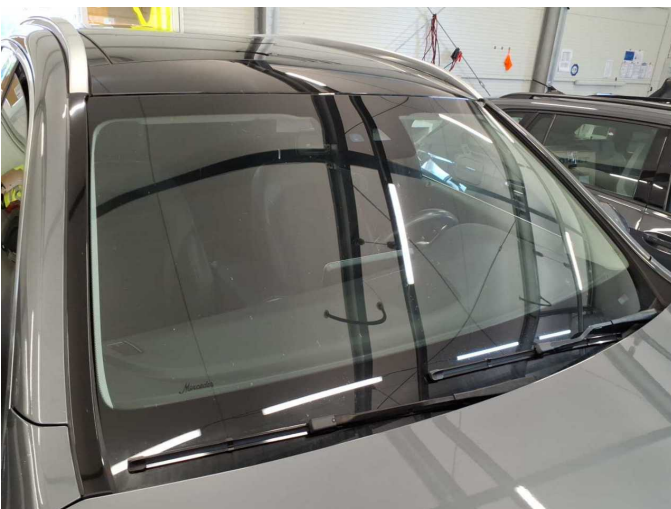
**Wear and tear 2:** Vehicle glazing: Windscreen - Stone chips - No deduction

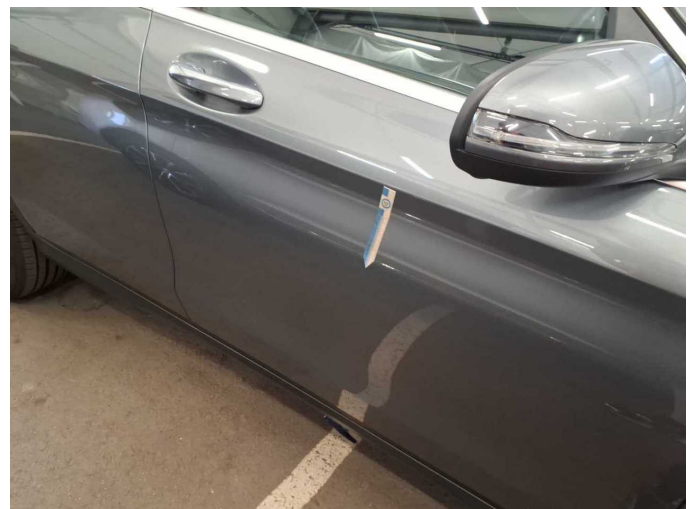
**Wear and tear 3:** Door - front right side: Door - dent(s) - Smooth repair work

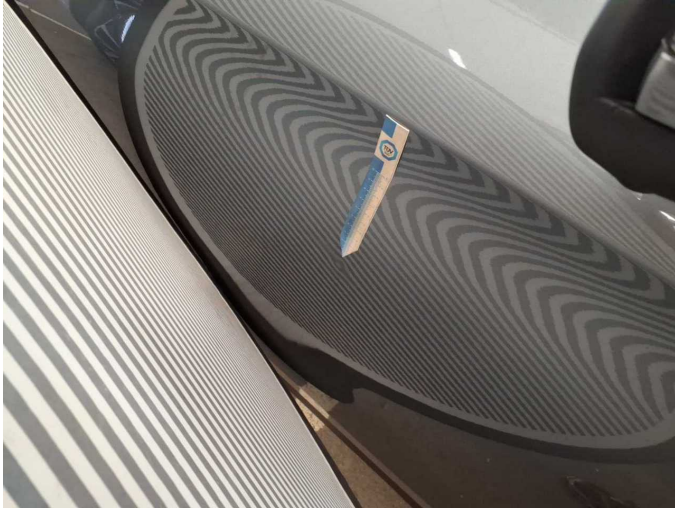
**Wear and tear 3:** Door - front right side: Door - dent(s) - Smooth repair work

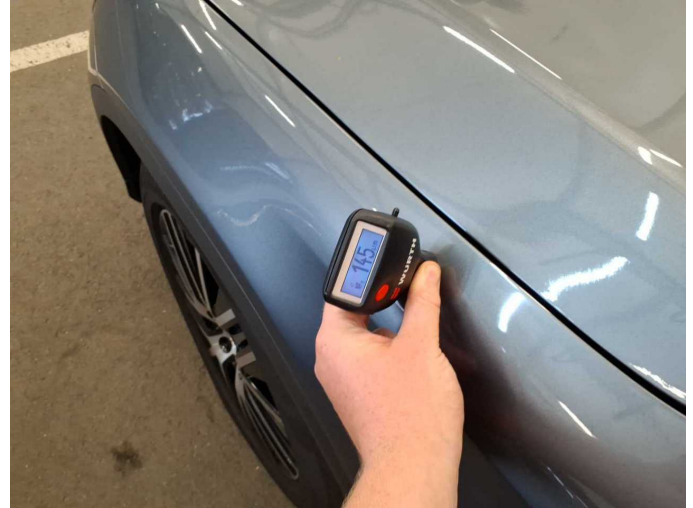
**Repainting 1:** Mudguard - left side
