Expertise

Protocol number: 45949477
Order No. / Reference: 26482979
Inspection date: 15 Jun 2026

Manufacturer: Skoda

Model: Kodiaq 2.0 TDI 4x4 DSG L&K

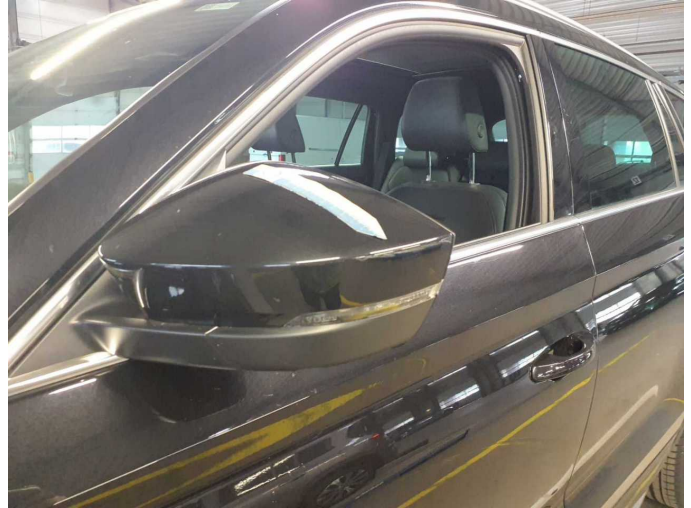
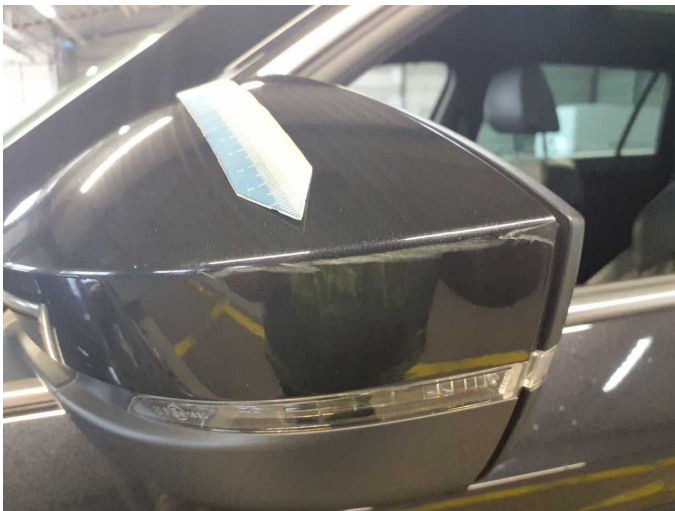
Damage 1: Wing mirror - left side: Cap - Scratched - Smart repair

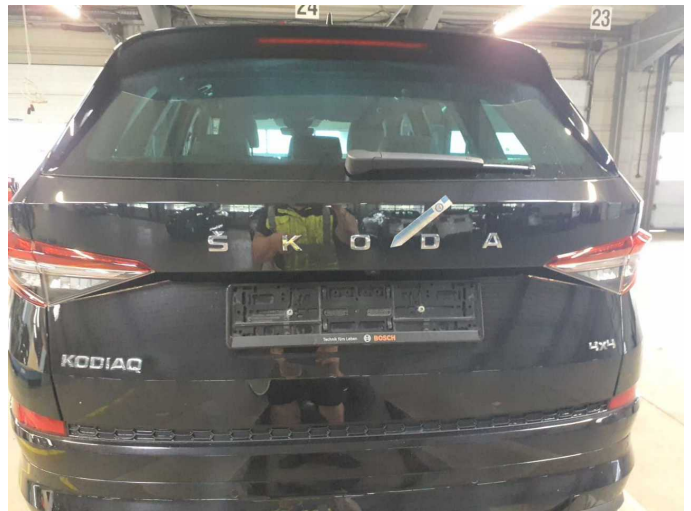
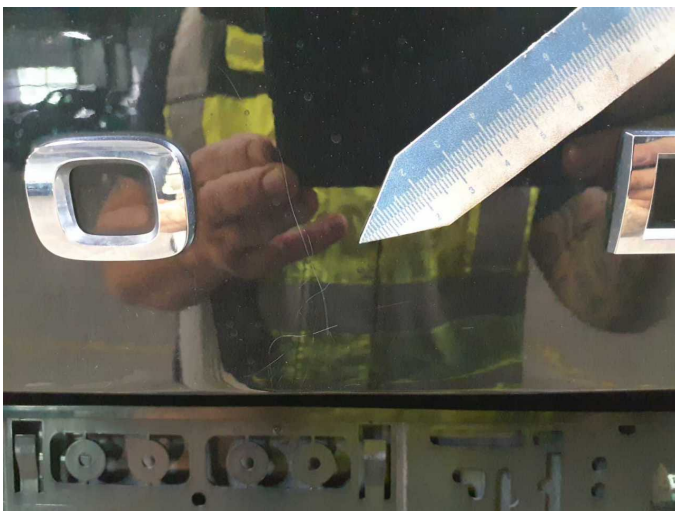
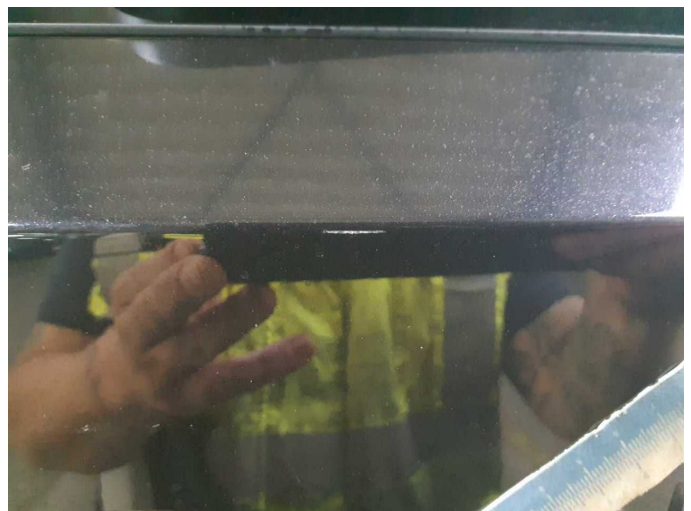
Damage 2: Boot lid / rear door: Boot lid - Scratch(es) - Smart repair

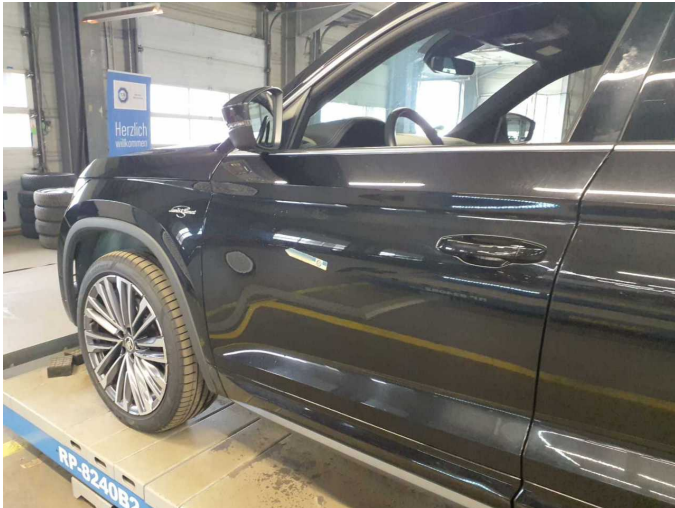
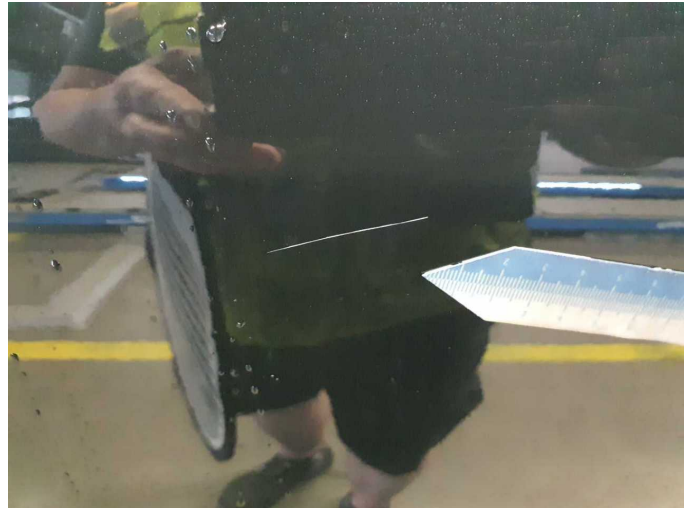
Damage 3: Door - front left side: Door (erhöhter Aufbereitungsaufwand (schleifen/ polieren)) - Scratch(es) - Smart repair

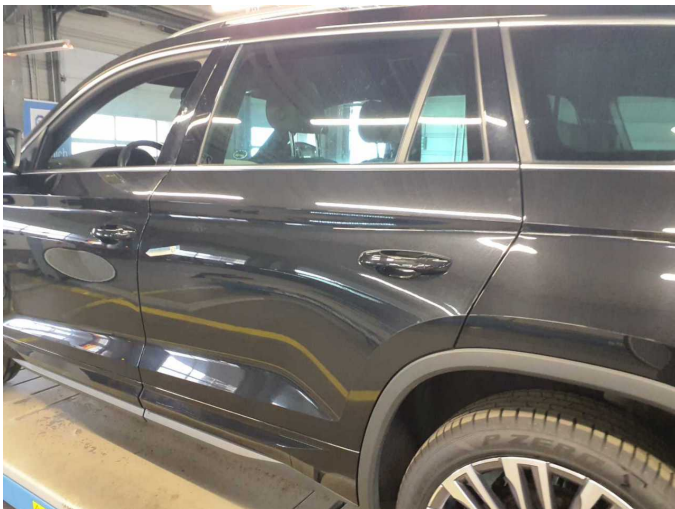
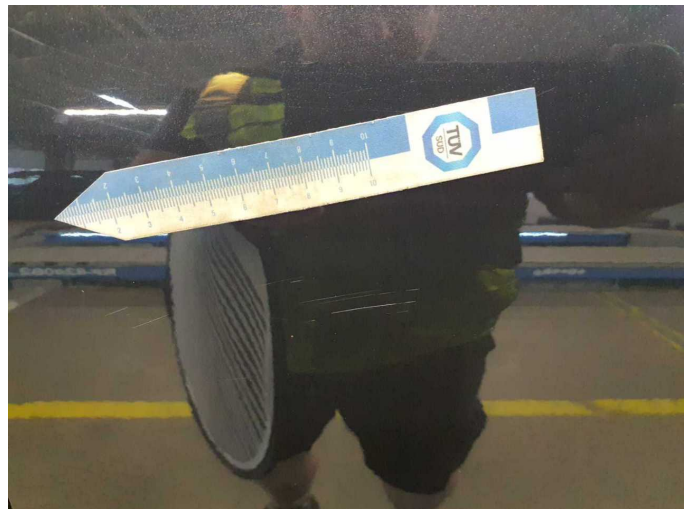
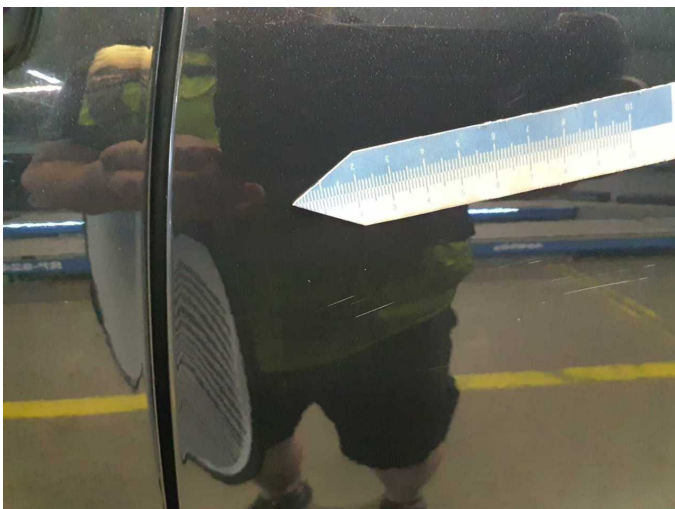
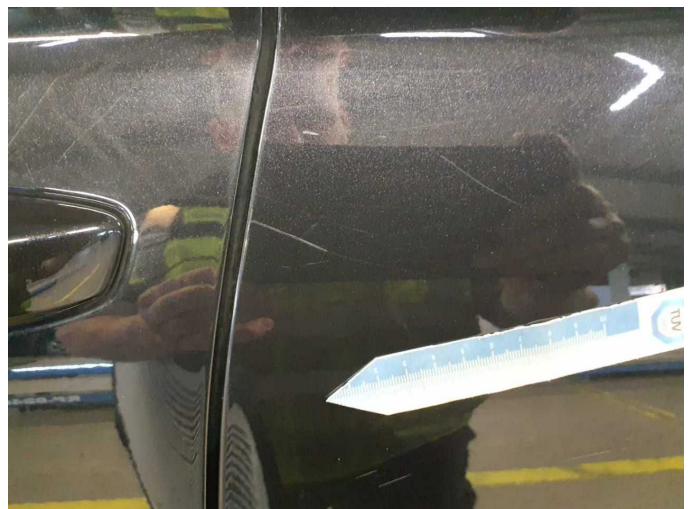
Damage 4: Door - rear left side: Door (erhöhter Aufbereitungsaufwand (schleifen/ polieren)) - Scratch(es) - Smart repair

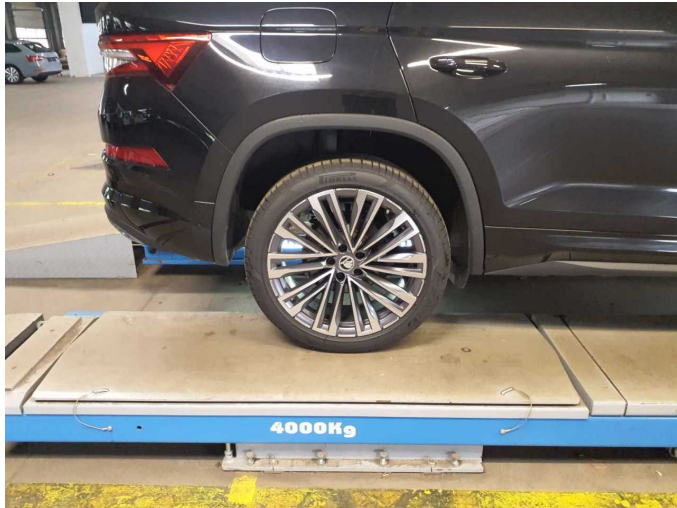
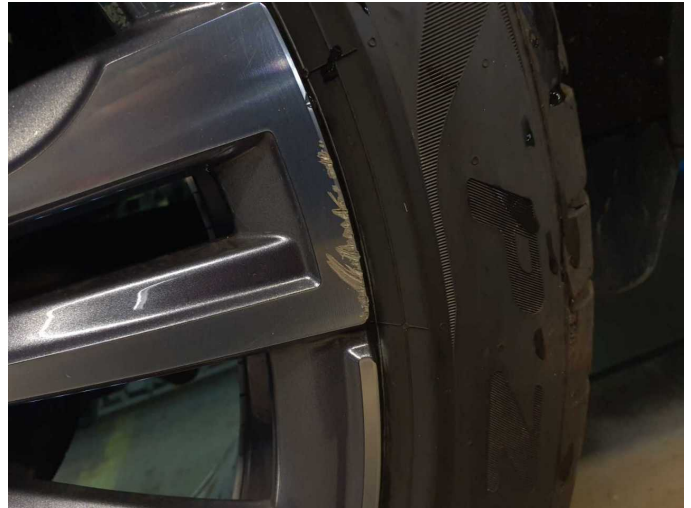
Damage 5: Wheel / tyres: Alloy rim - rear right side - Scratched - Loss in value

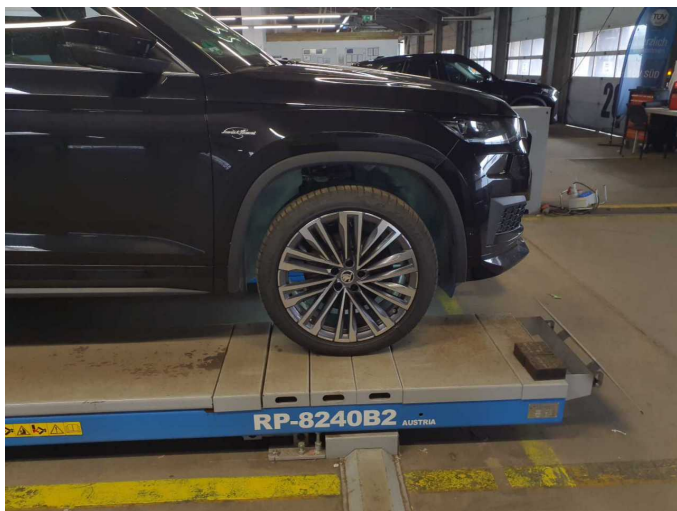
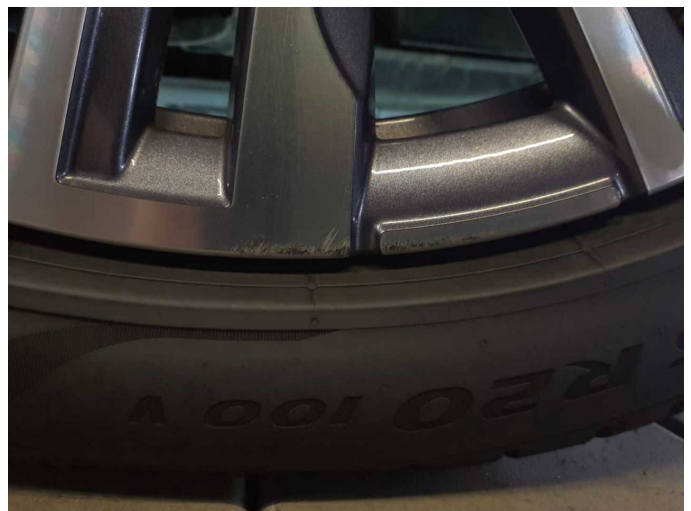
Damage 6: Wheel / tyres: Alloy rim - front right side - Scratched - Loss in value

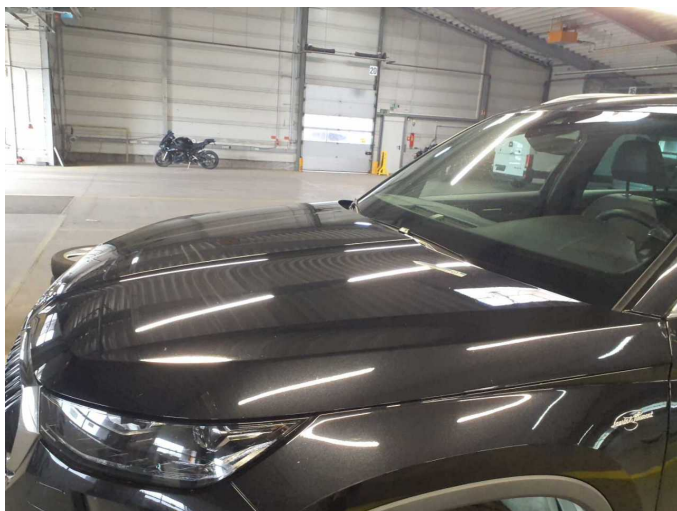
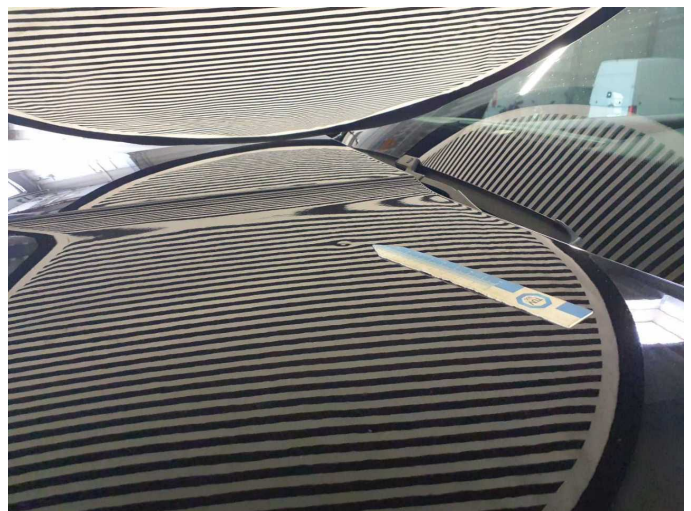
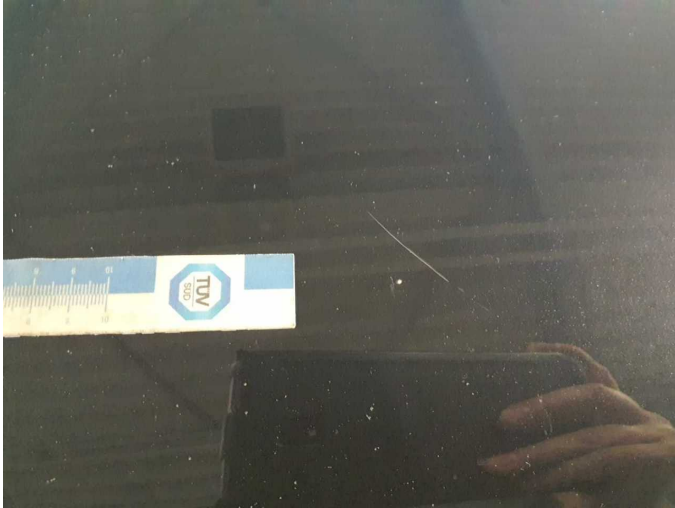
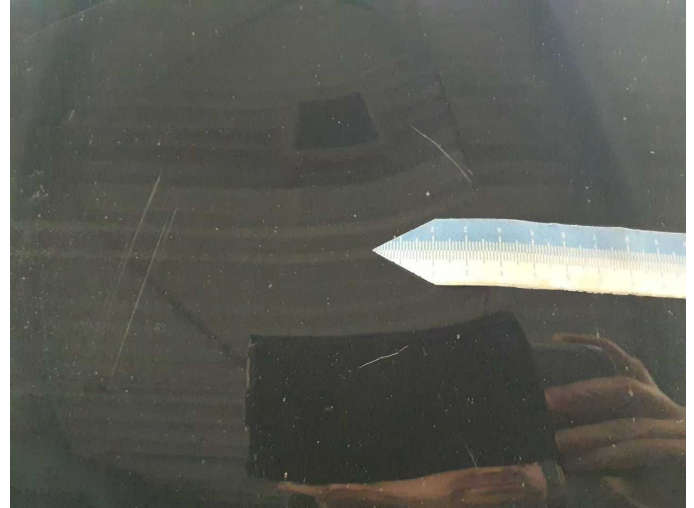
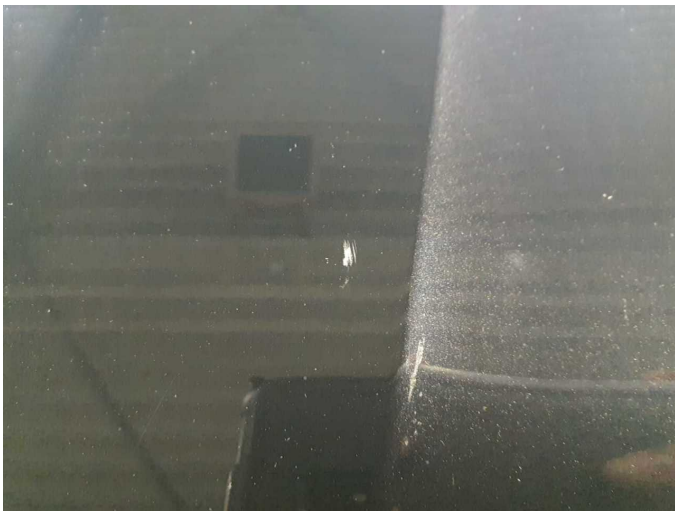
Damage 7: Bonnet: Bonnet - Dent / paintcoat damage - Repair and paint

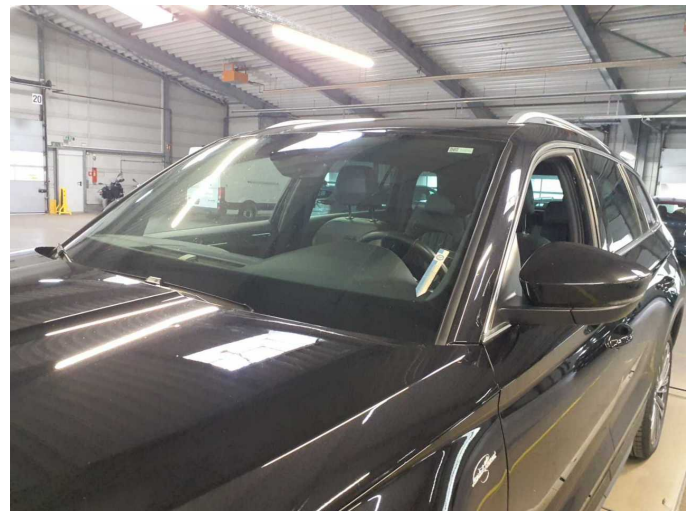
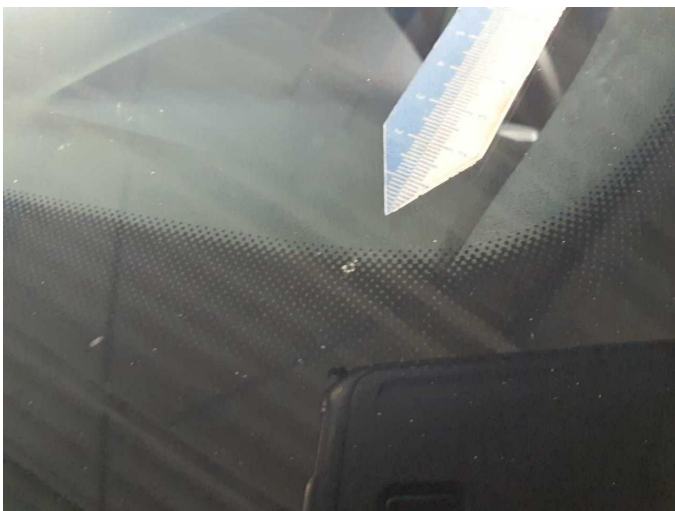
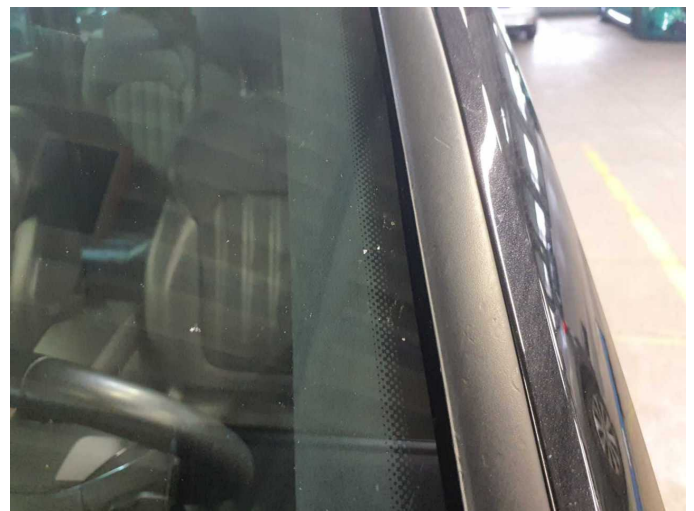
Damage 8: Vehicle glazing: Windscreen with rain sensor - Stone chips - Replace

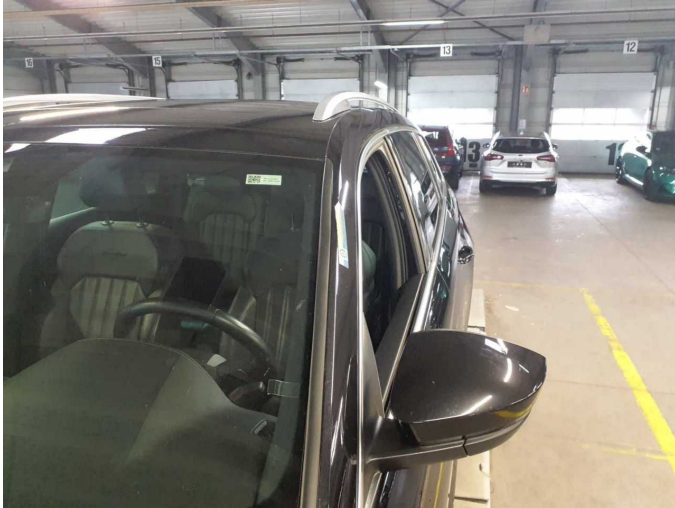
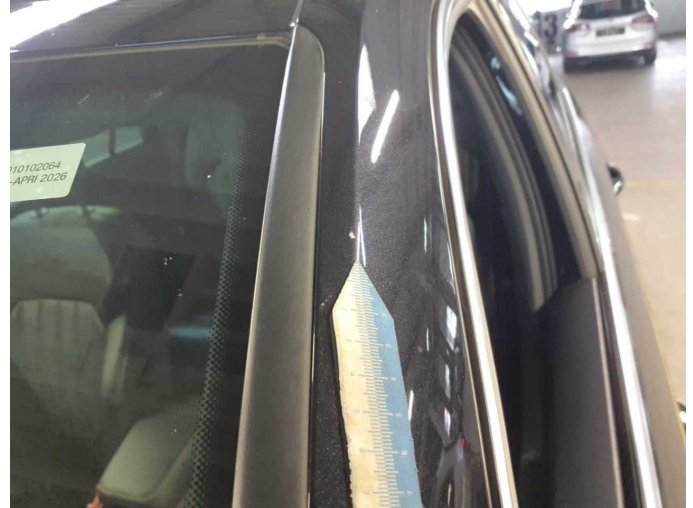
Wear and tear 1: Roof: Roof rail - left side - Stone chips

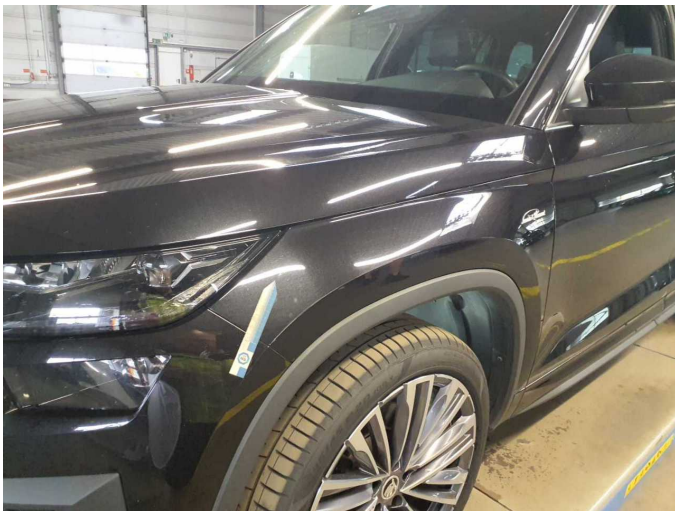
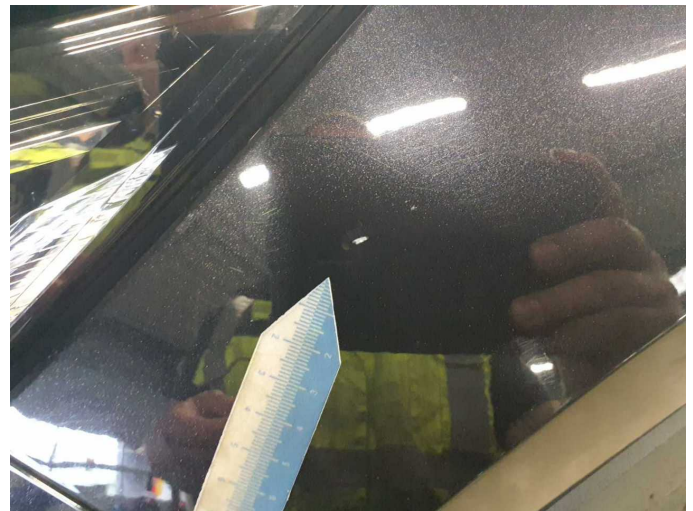
Wear and tear 2: Mudguard - left side: Mudguard - left side - Stone chips
