Expertise

Protocol number: 46145979
Order No. / Reference: 26559419
Inspection date: 22 Jun 2026

Manufacturer: Skoda

Model: Octavia Combi 2.0 TDI DSG 4x4 Scout

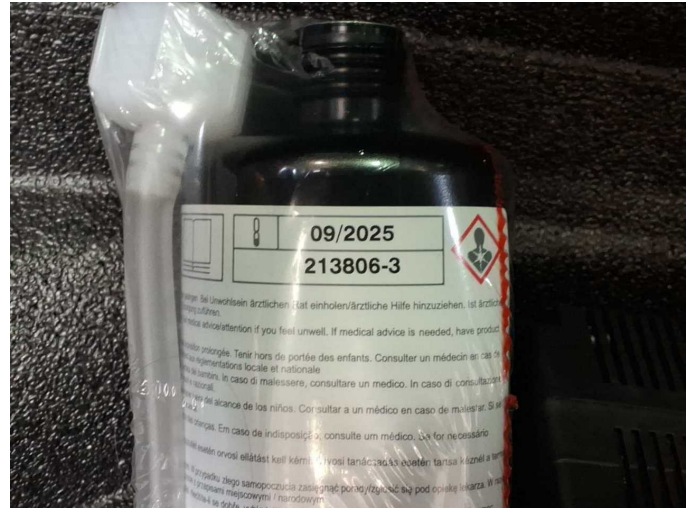
Damage 1: Equipment: Tirefit filler - Expired - Replace

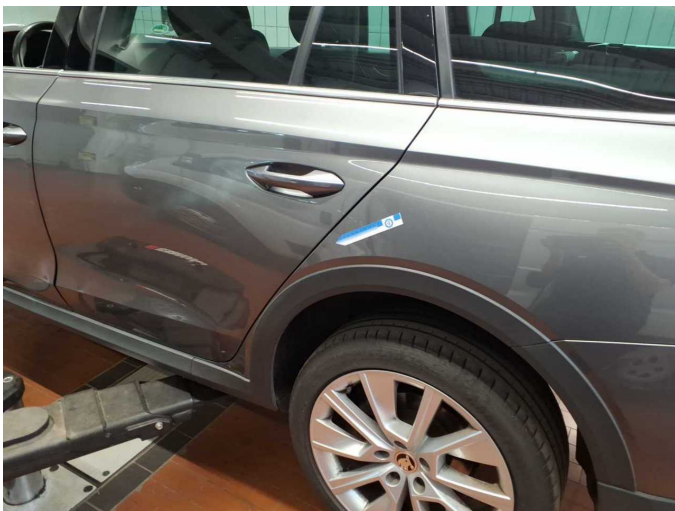
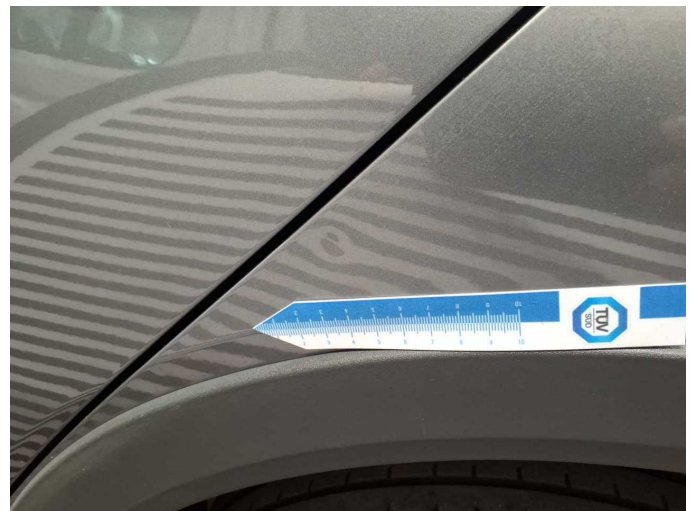
Damage 2: Side panel - rear left side: Side panel - dent(s) - Smart repair

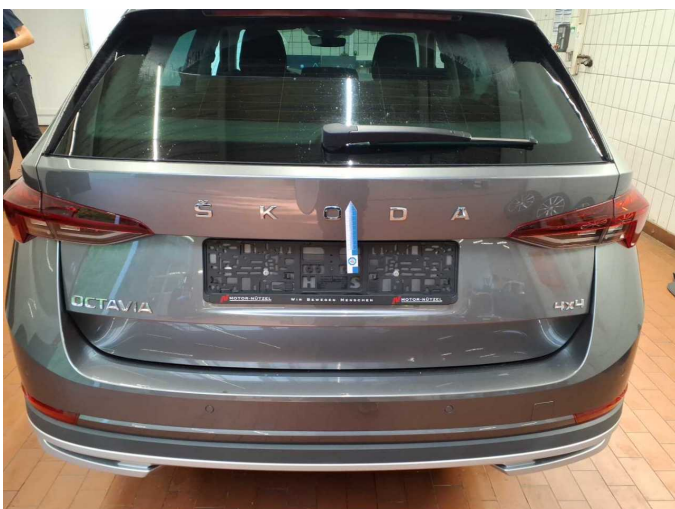
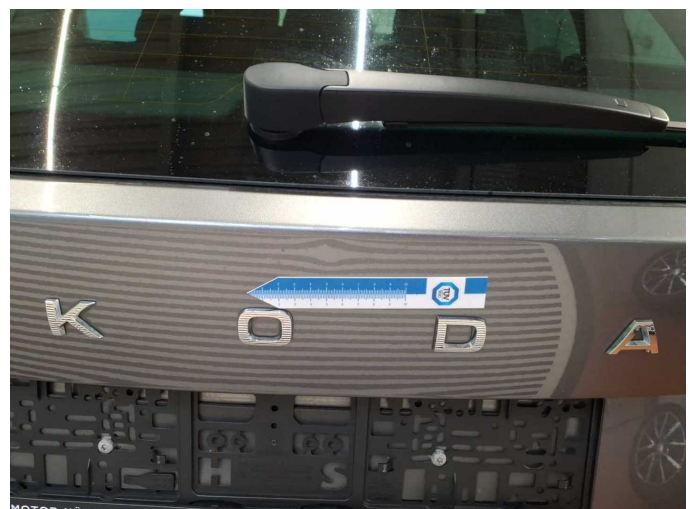
Damage 3: Boot lid / rear door: Boot lid - dent(s) - Smart repair

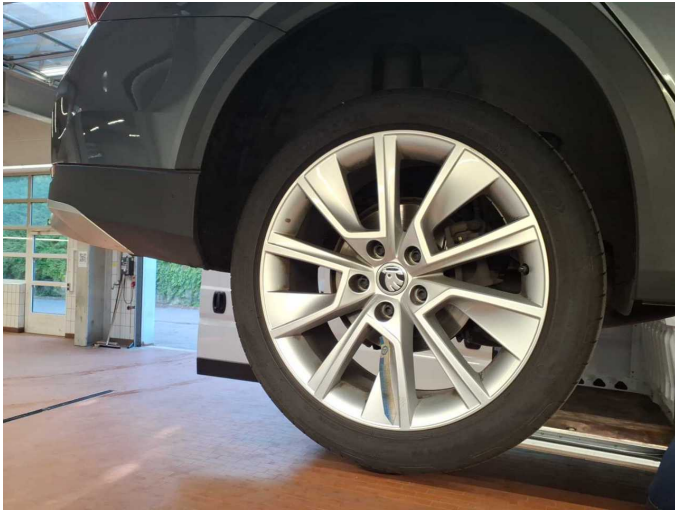
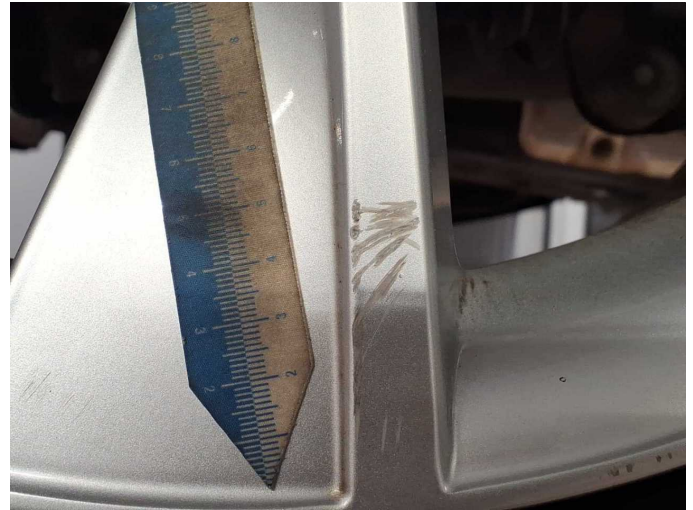
Damage 4: Wheel / tyres: Alloy rim - rear right side - Scratch(es) - Loss in value

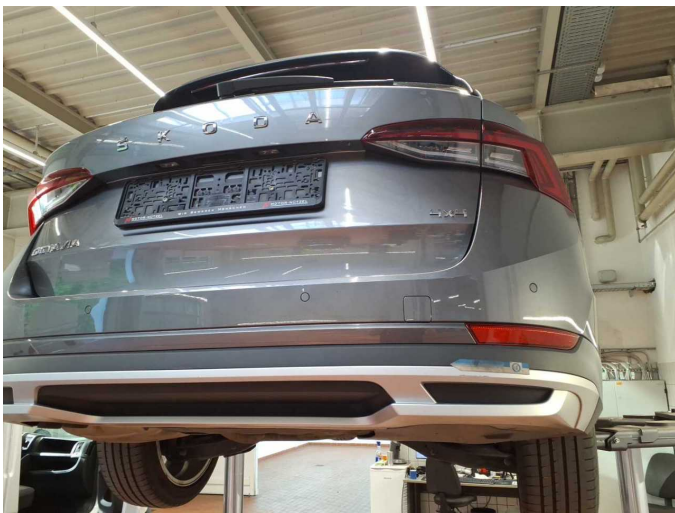
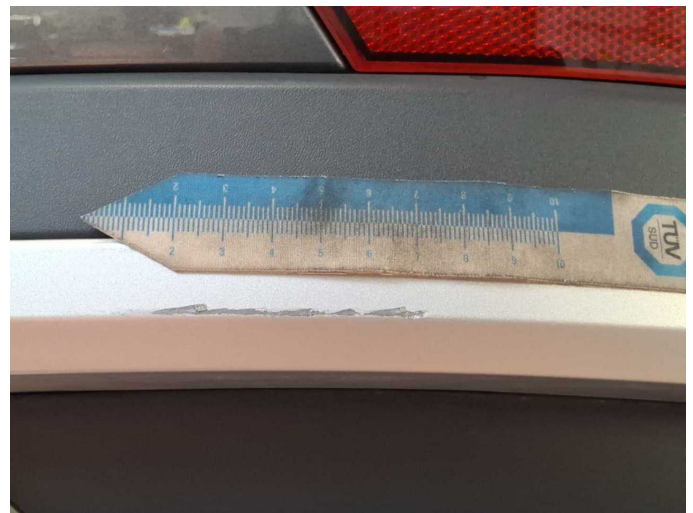
Damage 5: Rear bumper: Spoiler - Scratch(es) - Smart repair

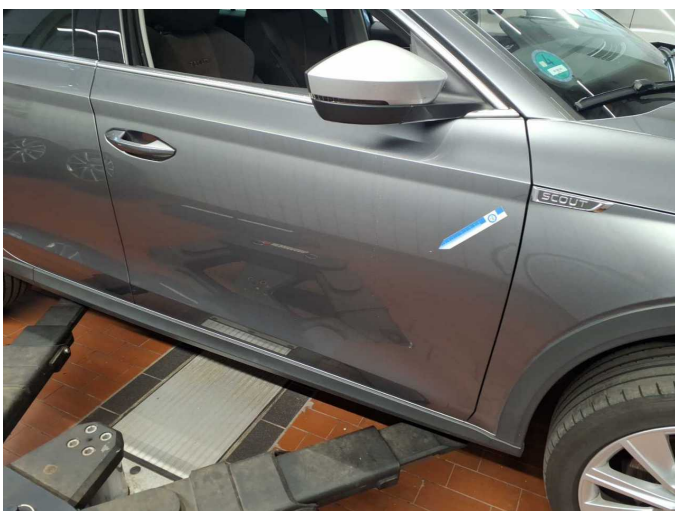
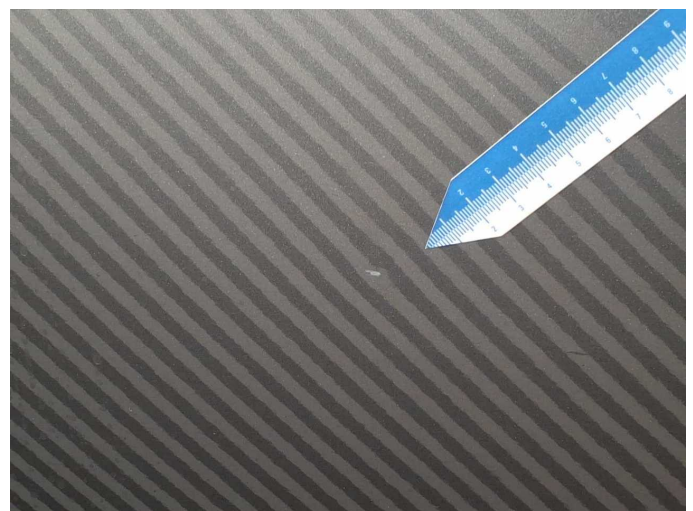
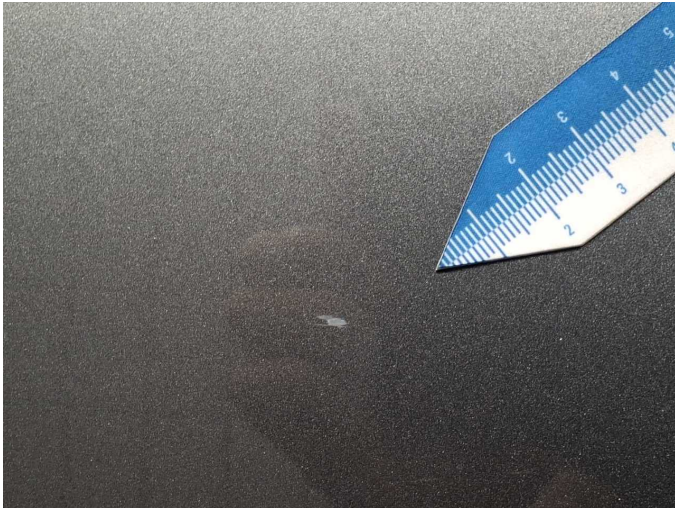
Damage 6: Door - front right side: Door - Dent / paintcoat damage - Smart repair

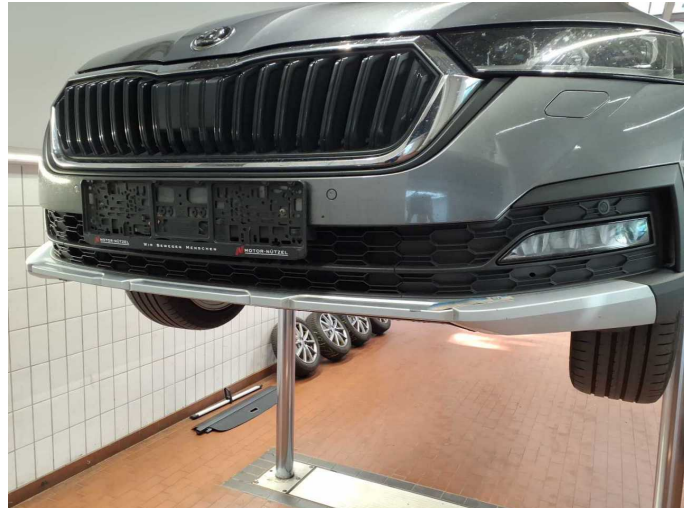
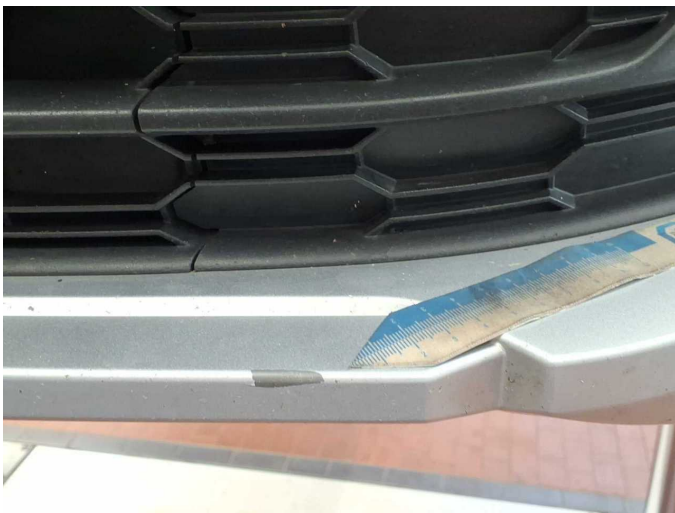
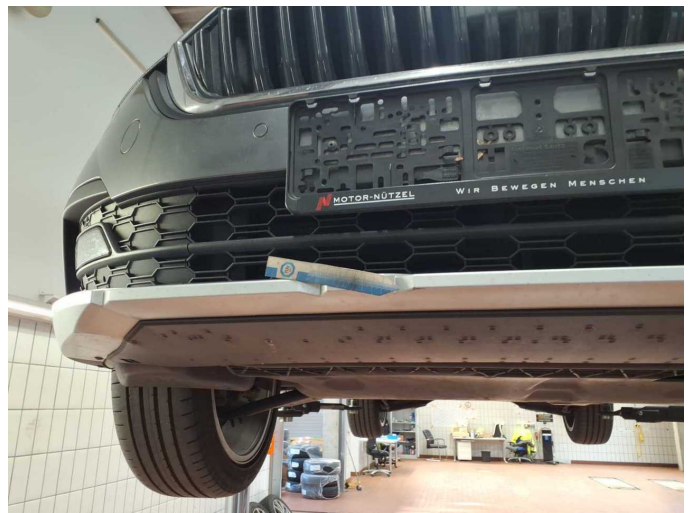
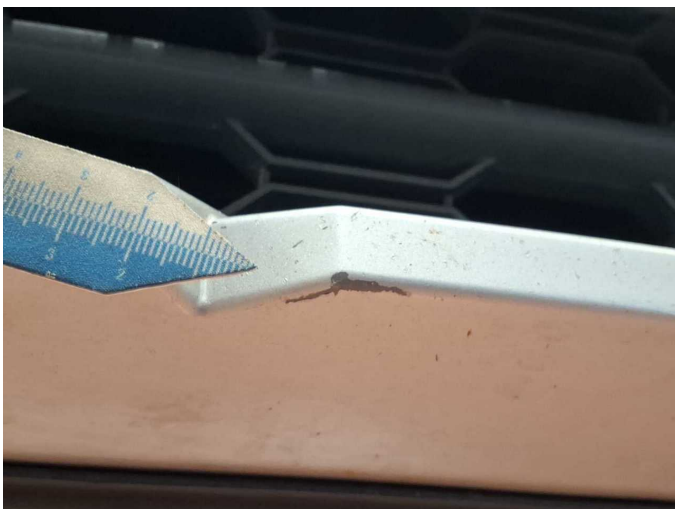
Damage 7: Front bumper: Spoiler - Scratch(es) - Smart repair

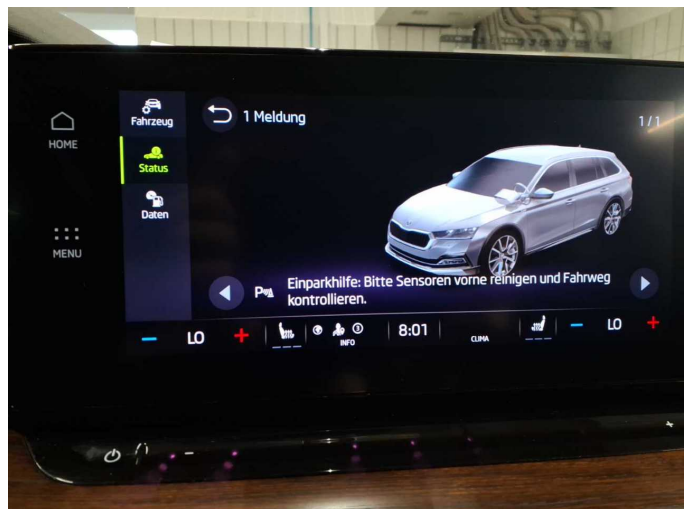
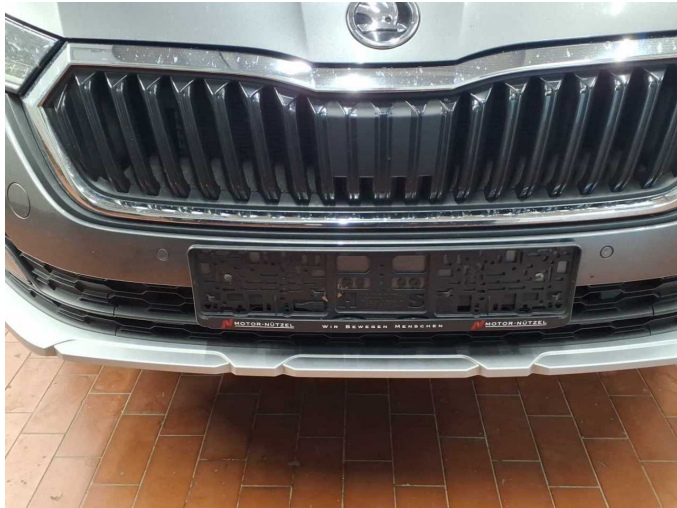
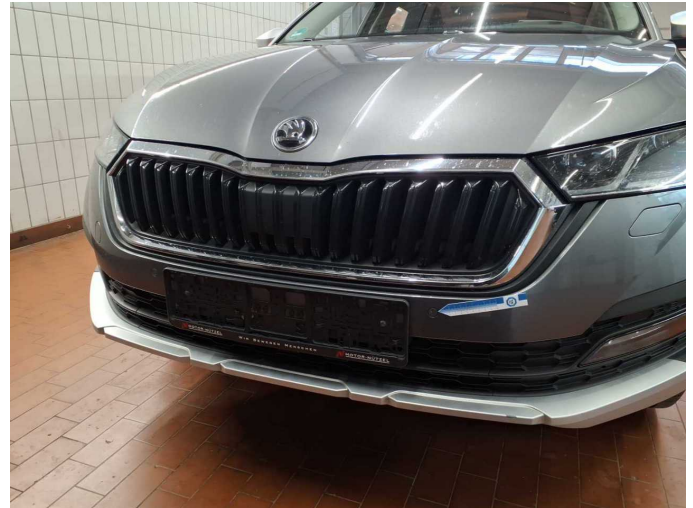
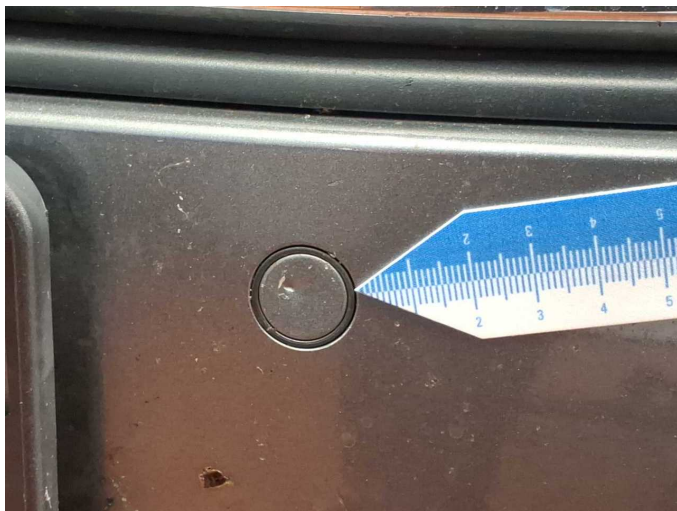
Damage 8: Front bumper: Parking sensors - centre - Electrical fault - Perform diagnosis

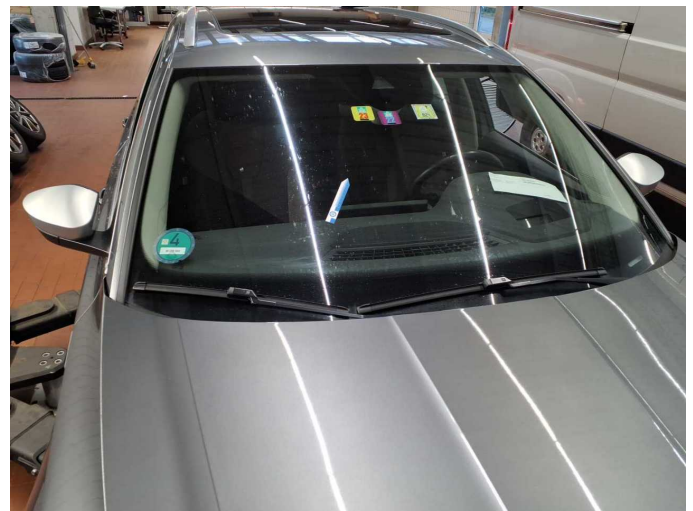
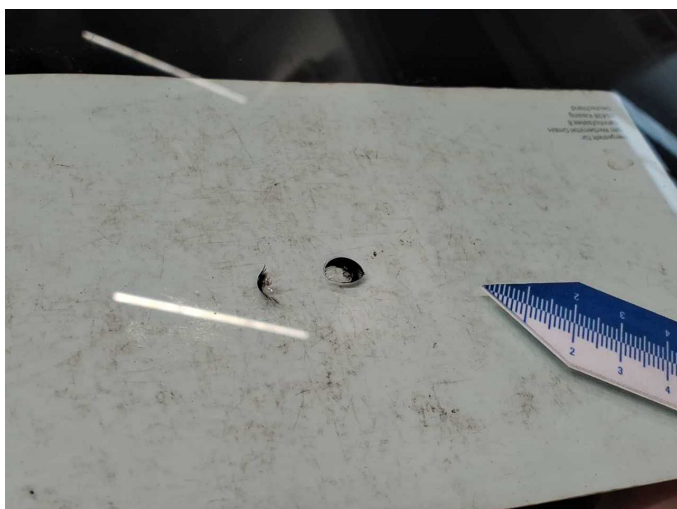
Damage 9: Vehicle glazing: Windscreen (2 x) - Stone chips - Replace

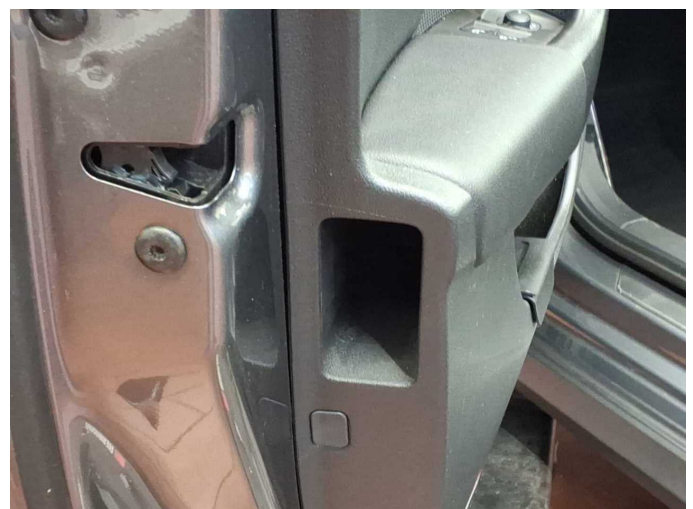
Missing part 1: Equipment: Umbrella - Missing - Replace

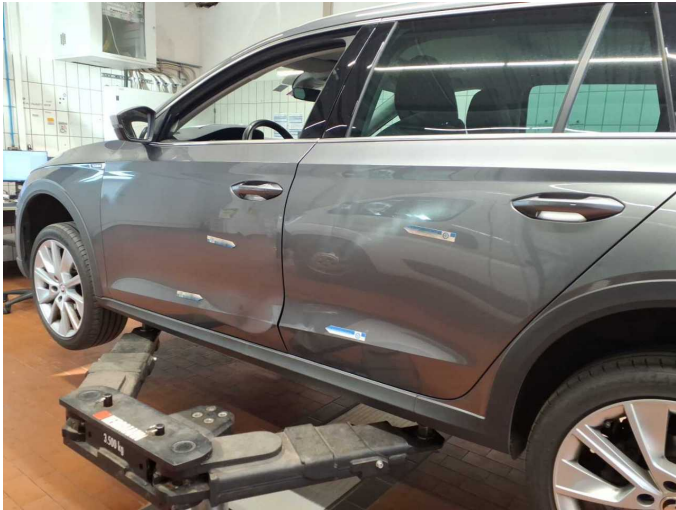
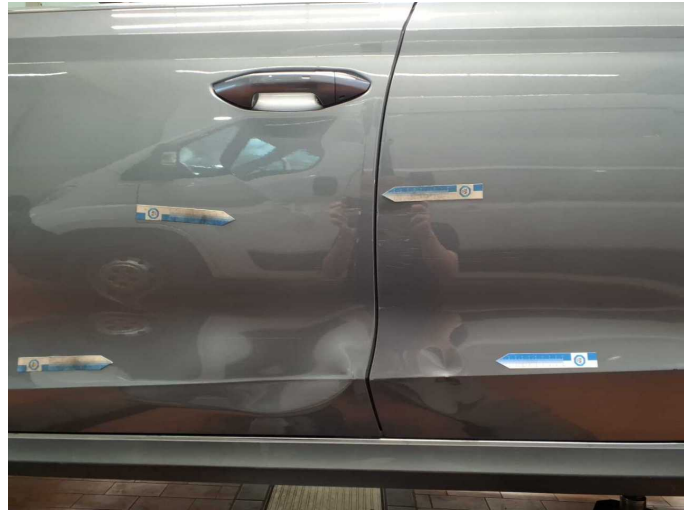
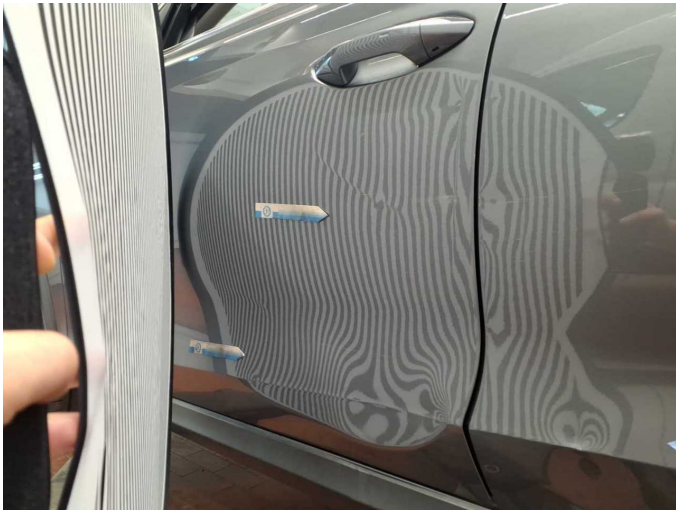
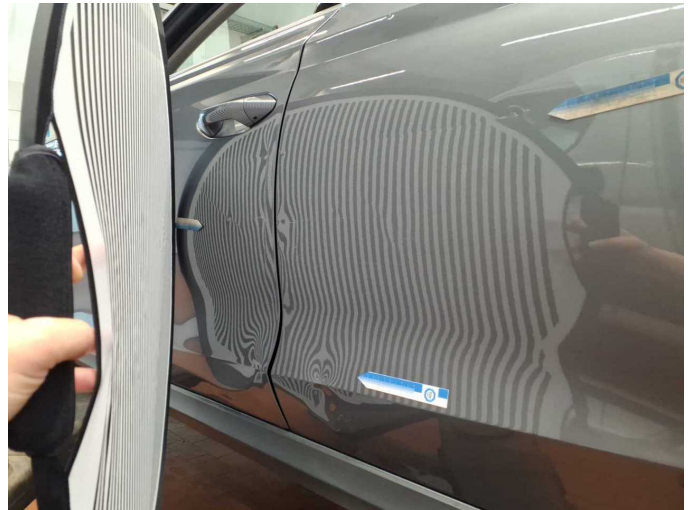
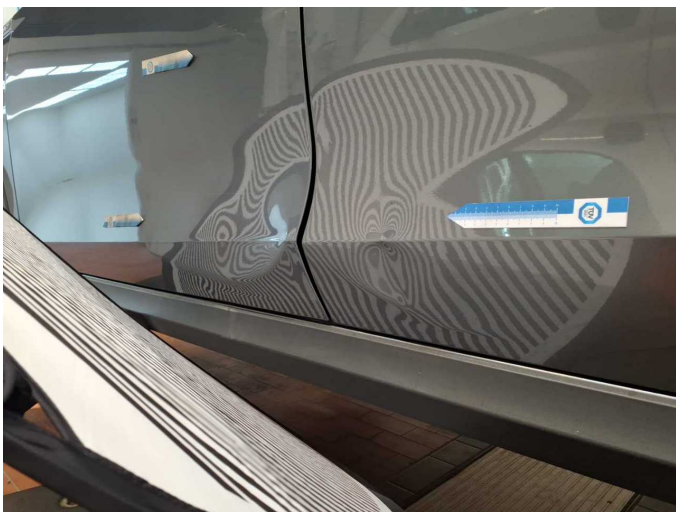
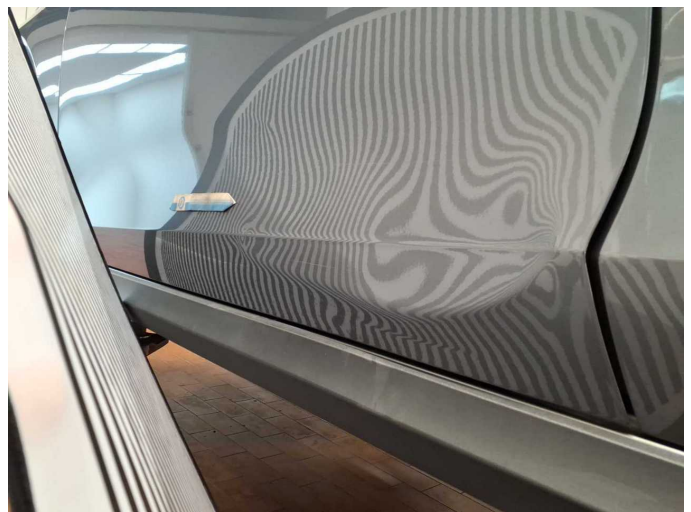
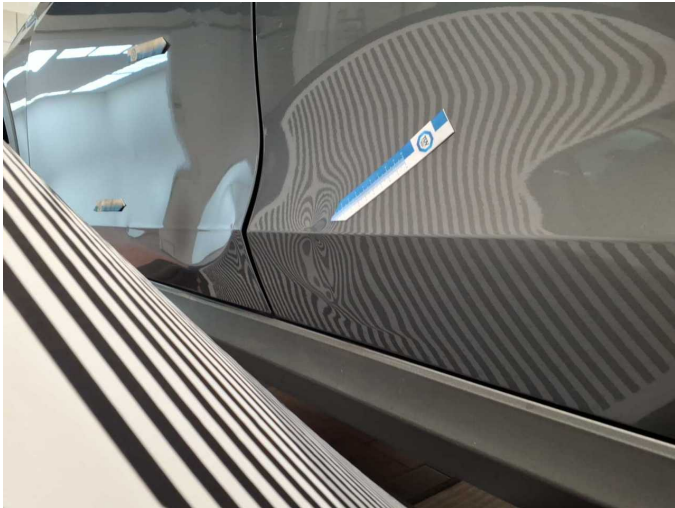
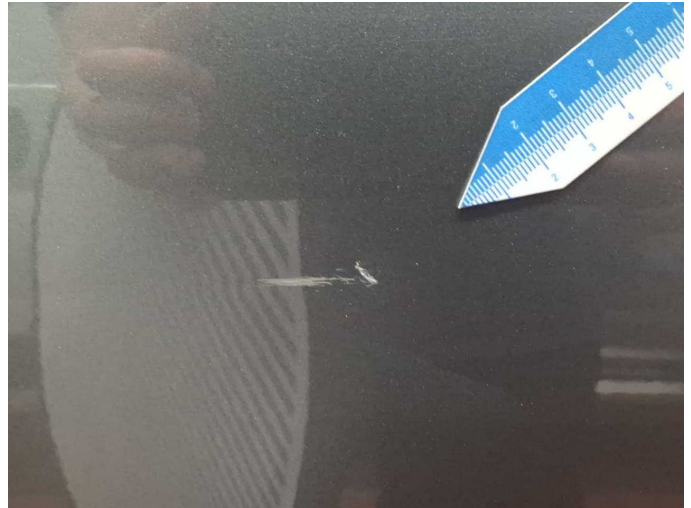
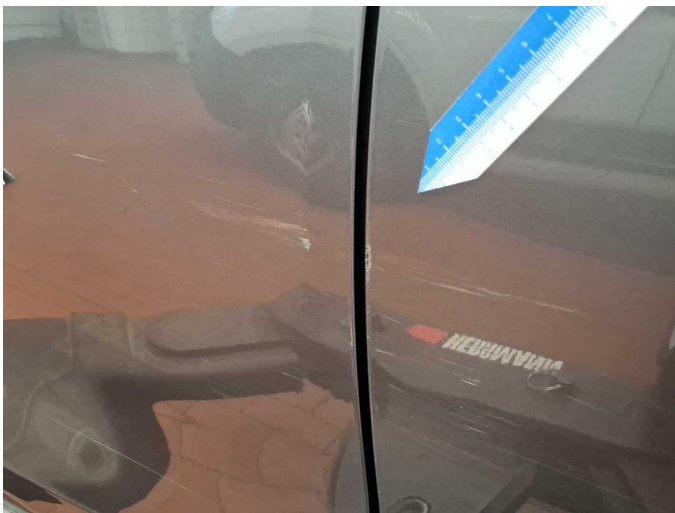
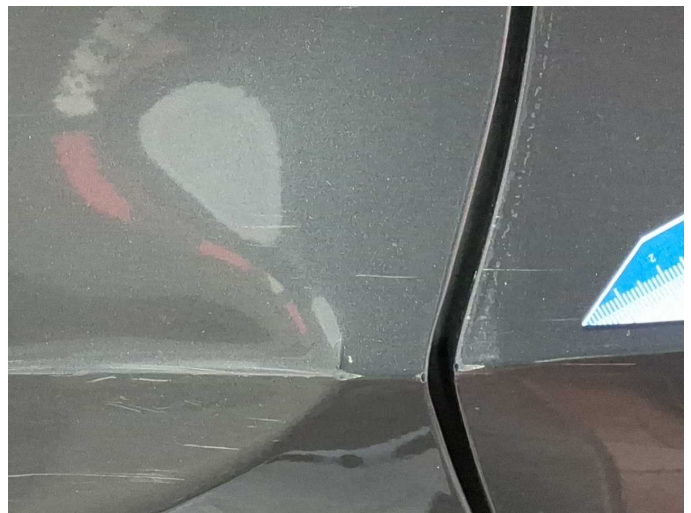
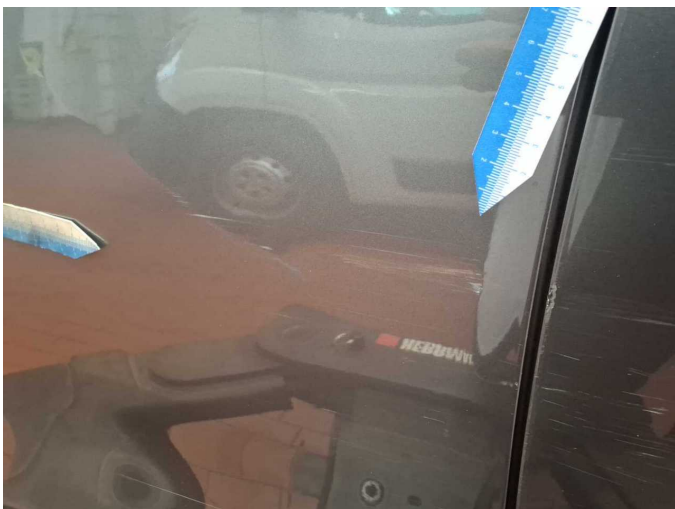
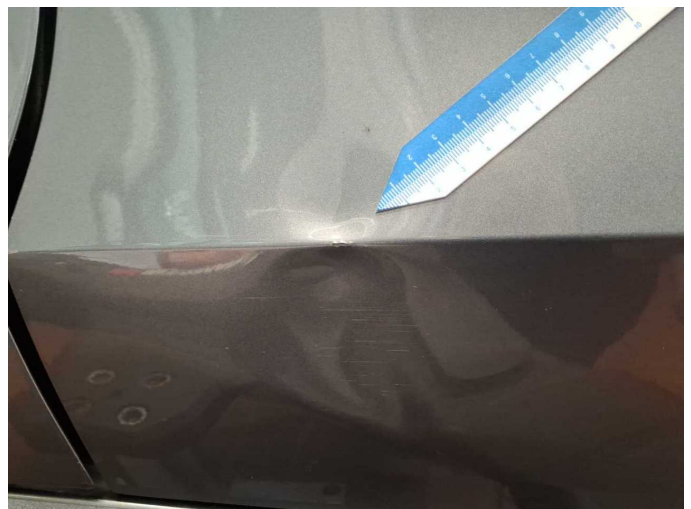
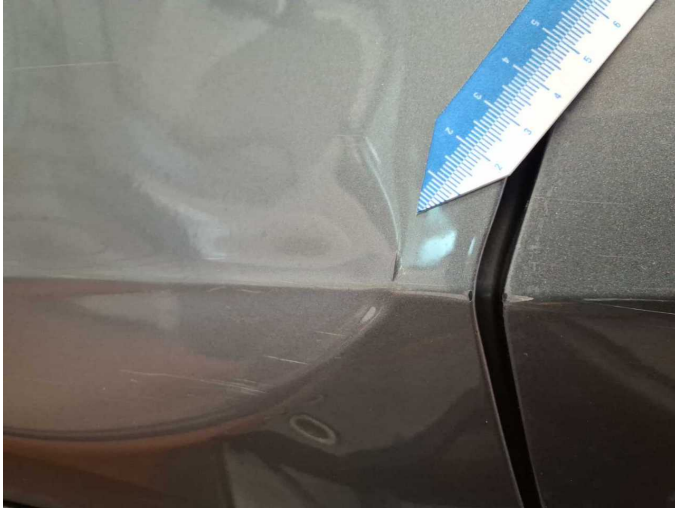
Accident 1: Side - left
