## Expertise

Protocol number: 46113523  
Order No. / Reference: 26434058  
Inspection date: 23 Jun 2026

Model: Kodiaq 2.0 TDI DSG Ambition

VIN: TMBJJ7NS4P8521769

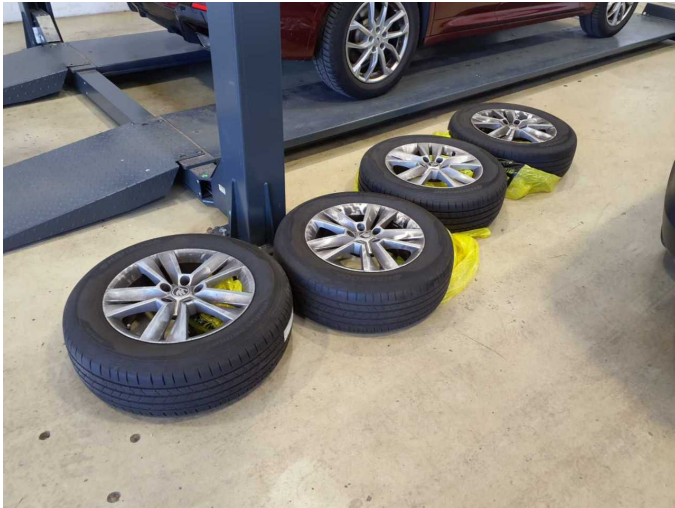
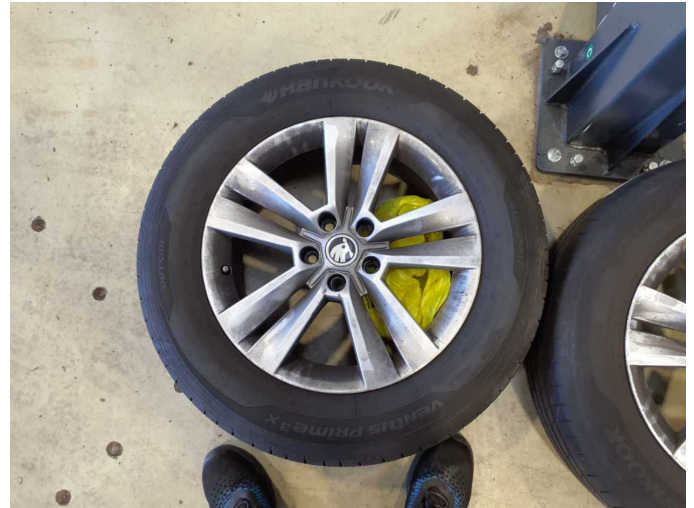
Figure 13: Additional tyres

| # | Tyre size | Type of tyre | Manufacturer | Tread depth |
|---|---|---|---|---|
| 1) | 215/65 R17 99V | Summer tyres on Light alloy | Hankook | 2mm / 2mm |
| 2) | 215/65 R17 99V | Summer tyres on Light alloy | Hankook | 4mm / 4mm |

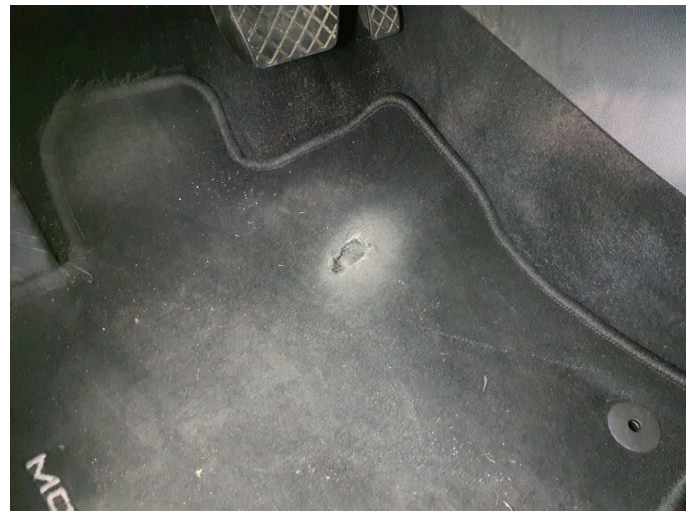
| No. | Component group | Description |
|---|---|---|
| 1 | Trim / covers | Floor mats - Broken / torn - Replace |

Damage 1: Trim / covers: Floor mats - Broken / torn - Replace

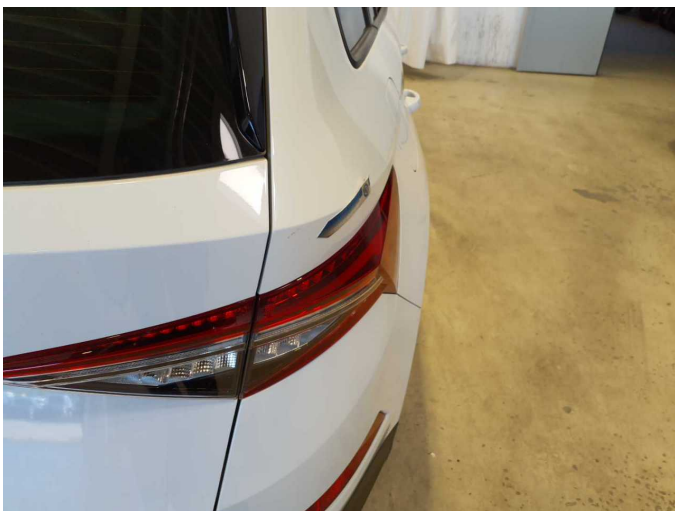
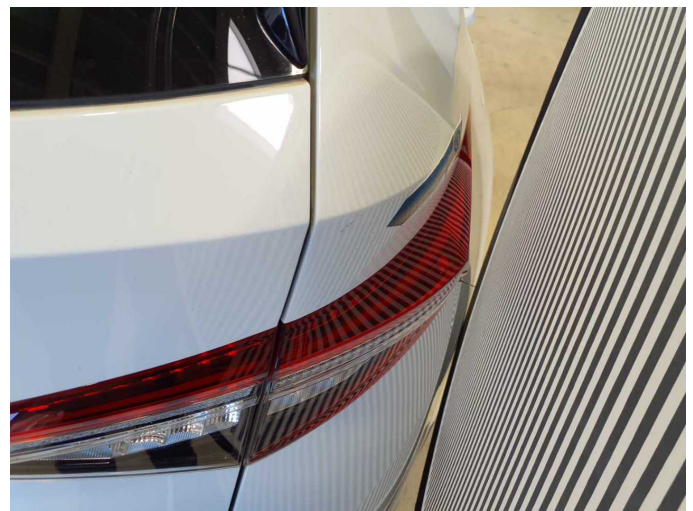
| No. | Component group | Description |
|---|---|---|
| 2 | Side panel - rear right side | Side panel - dent(s) - Smooth repair work |

Damage 2: Side panel - rear right side: Side panel - dent(s) - Smooth repair work

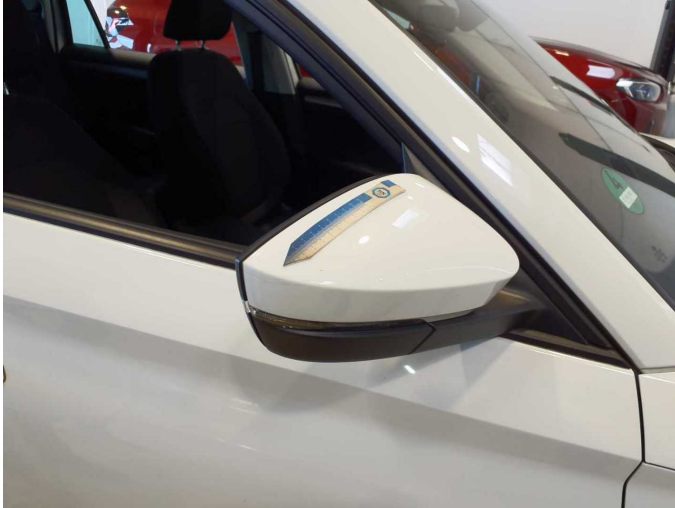
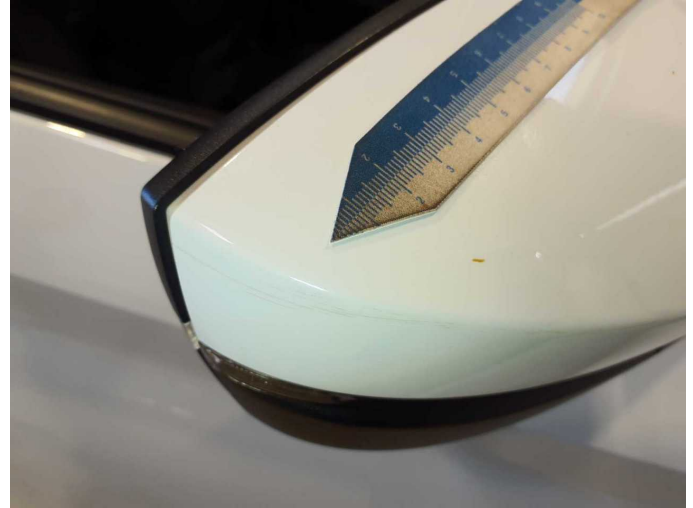
| No. | Component group | Description |
|---|---|---|
| 3 | Wing mirror - right side | Cap - Scratch(es) - Paint |

**Damage 3:** Wing mirror - right side: Cap - Scratch(es) - Paint

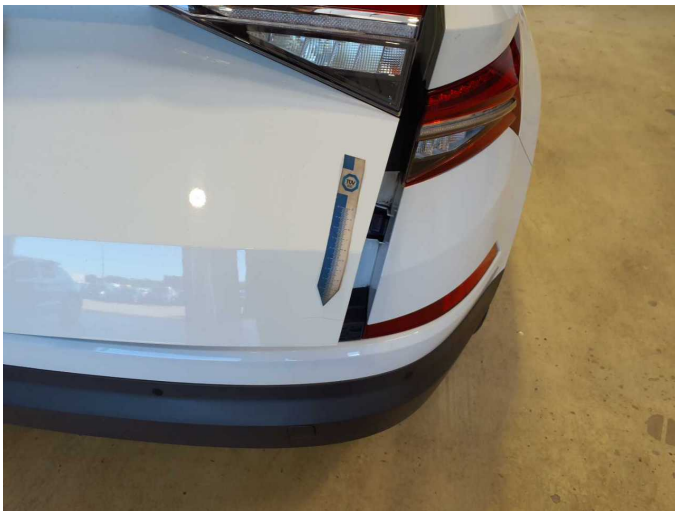
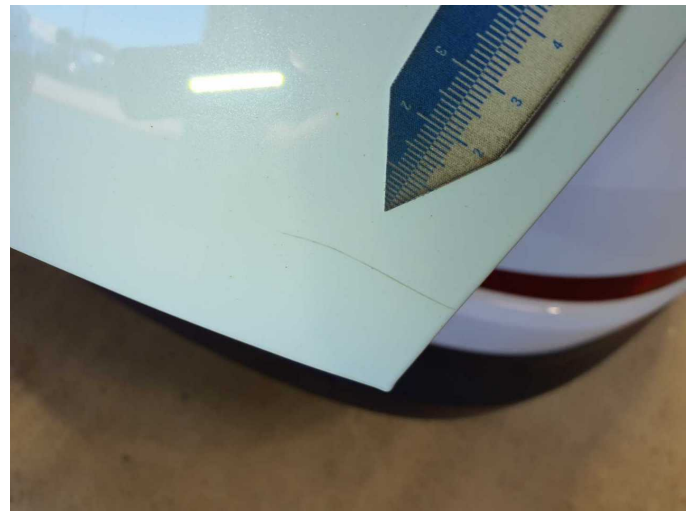
| No. | Component group | Description |
|---|---|---|
| 4 | Boot lid / rear door | Boot lid - Scratch(es) - Smart repair |

**Damage 4:** Boot lid / rear door: Boot lid - Scratch(es) - Smart repair

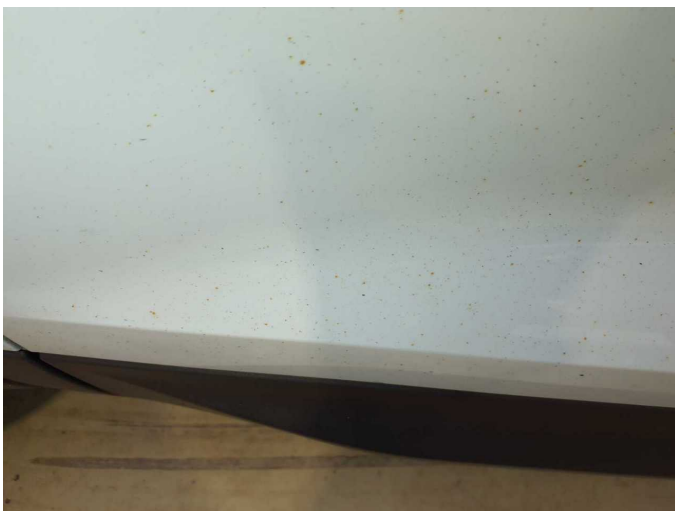
| No. | Component group | Description |
|---|---|---|
| 5 | Body | Body - Stone chips - Conditioning |

**Damage 5:** Body: Body - Stone chips - Conditioning

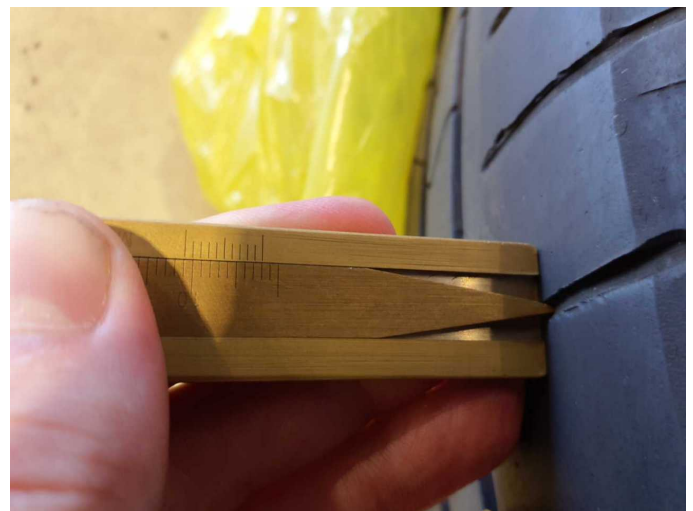
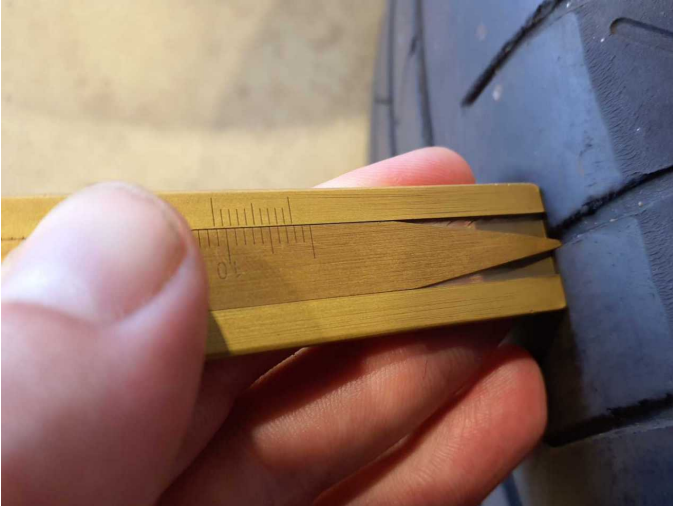
| No. | Component group | Description |
|---|---|---|
| 6 | 2nd wheel set | 2 tyres - Worn - Replace |

**Damage 6:** 2nd wheel set: 2 tyres - Worn - Replace

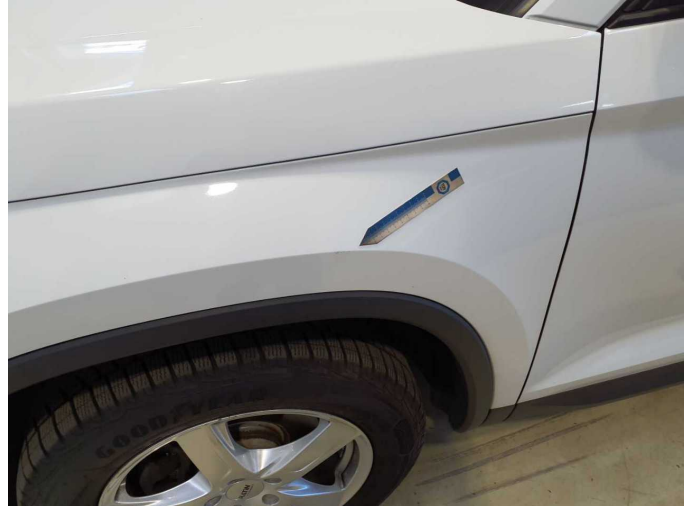
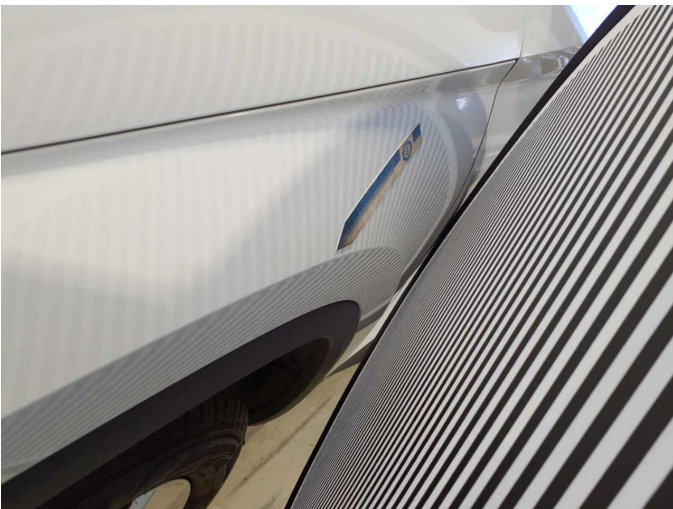
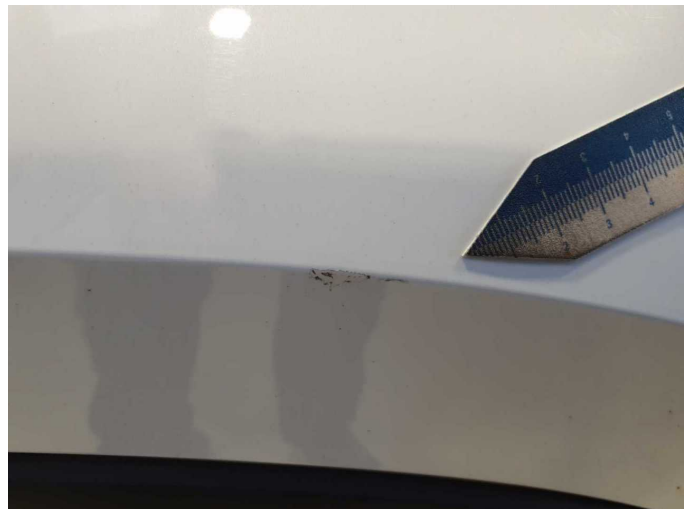
| No. | Component group | Description |
|---|---|---|
| 7 | Mudguard - left side | Mudguard - left side - Dent / paintcoat damage - Repair and paint |

**Damage 7:** Mudguard - left side: Mudguard - left side - Dent / paintcoat damage - Repair and paint

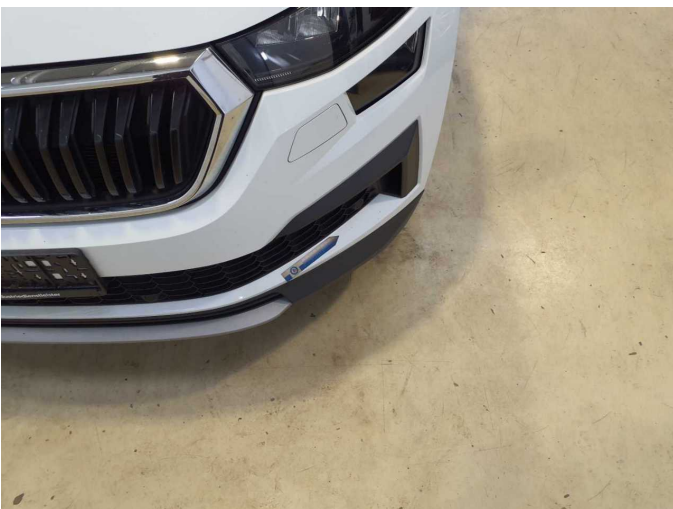
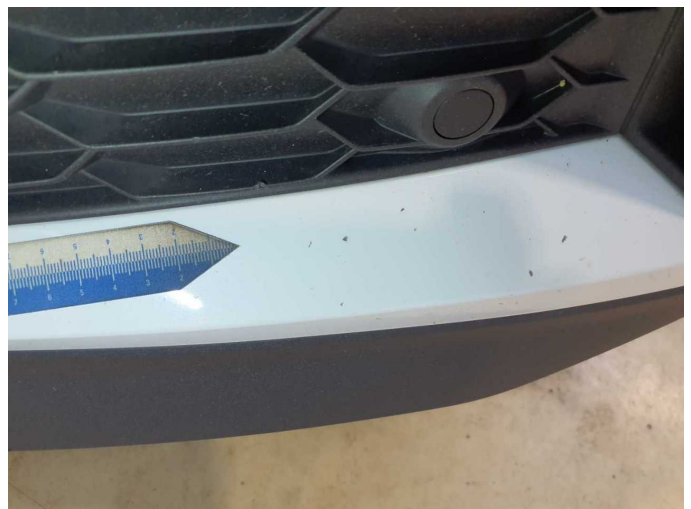
| No. | Component group | Description |
|---|---|---|
| 8 | Front bumper | Front bumper - Stone chips - Paint |

**Damage 8:** Front bumper: Front bumper - Stone chips - Paint

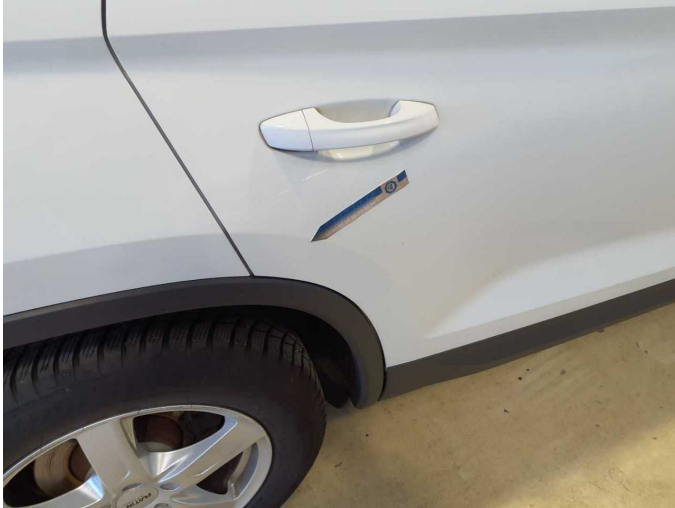
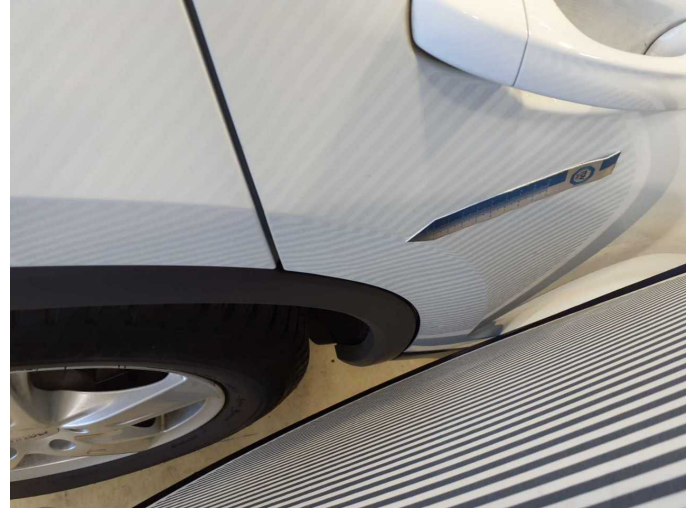
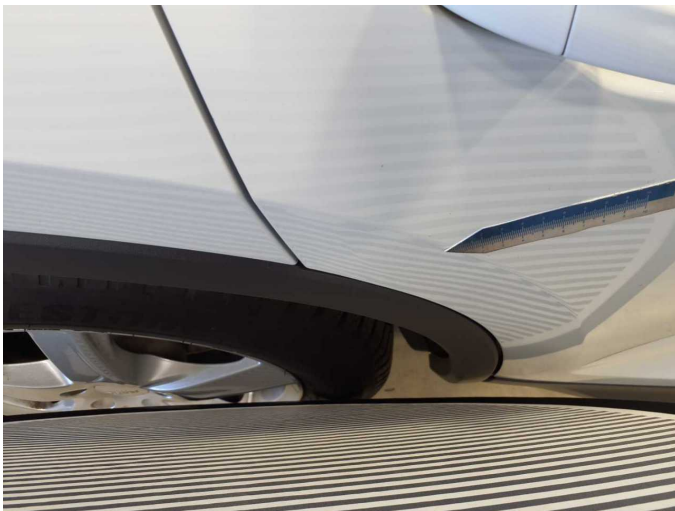
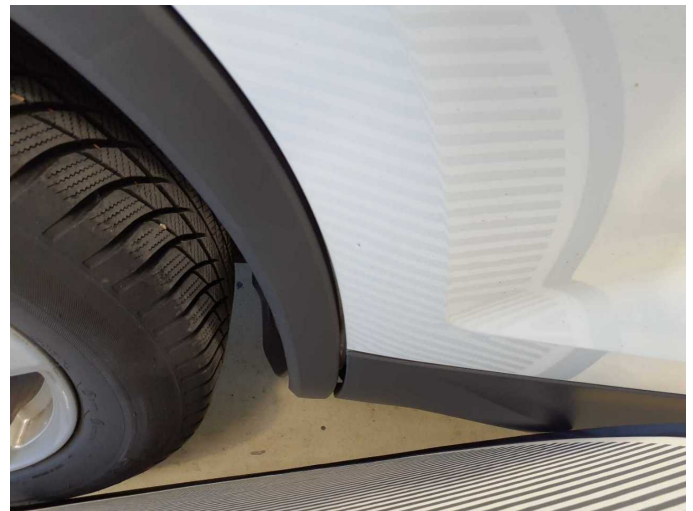
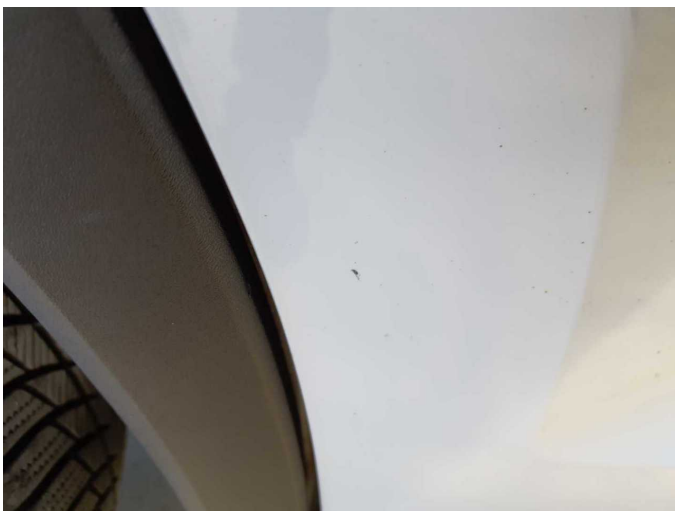
| No. | Component group | Description |
|---|---|---|
| 9 | Door - rear right side | Door - dent(s) - Repair and paint |

**Damage 9:** Door - rear right side: Door - dent(s) - Repair and paint

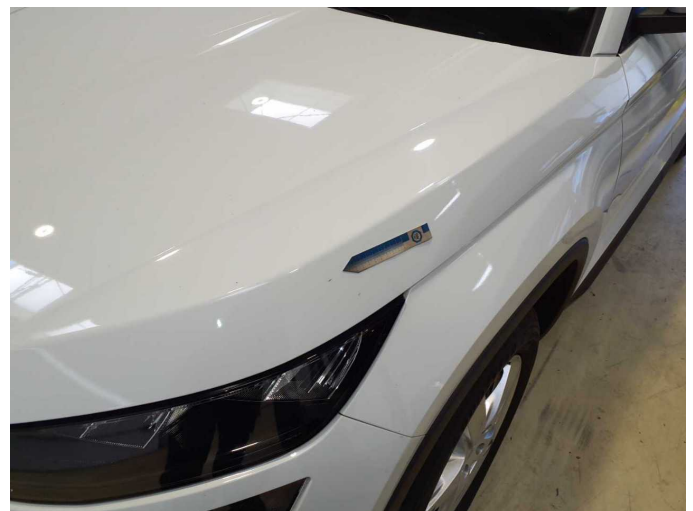
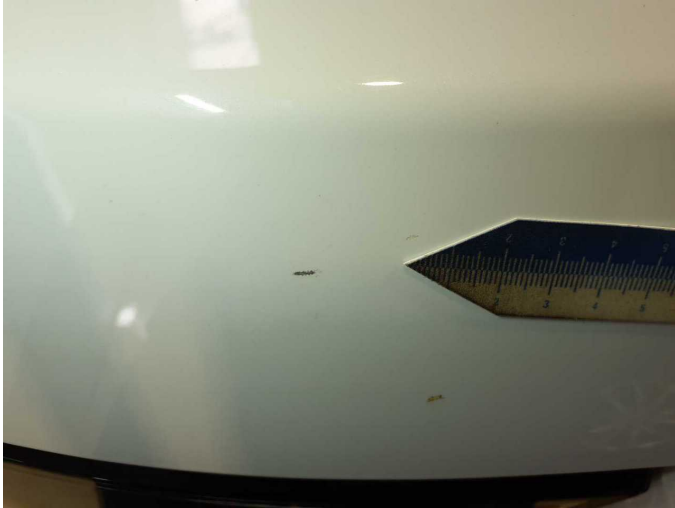
| No. | Component group | Description |
|---|---|---|
| 10 | Bonnet | Bonnet - Scratch(es) - Paint |

**Damage 10:** Bonnet: Bonnet - Scratch(es) - Paint

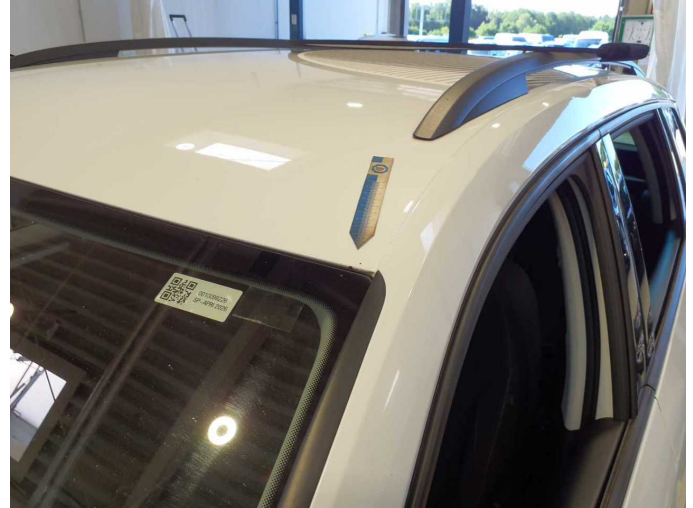
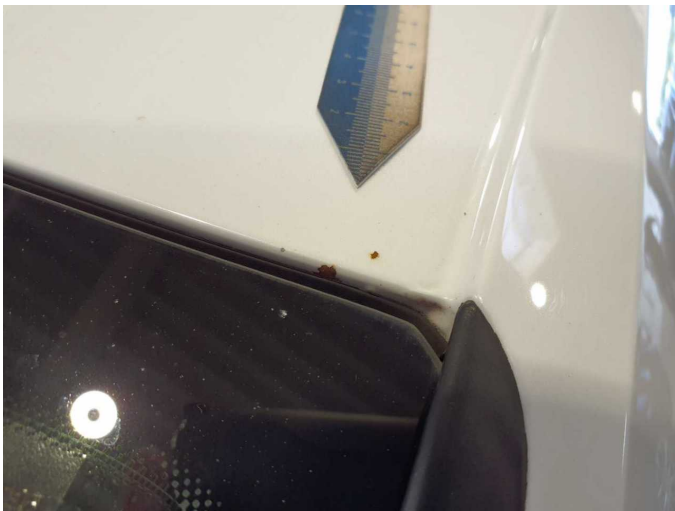
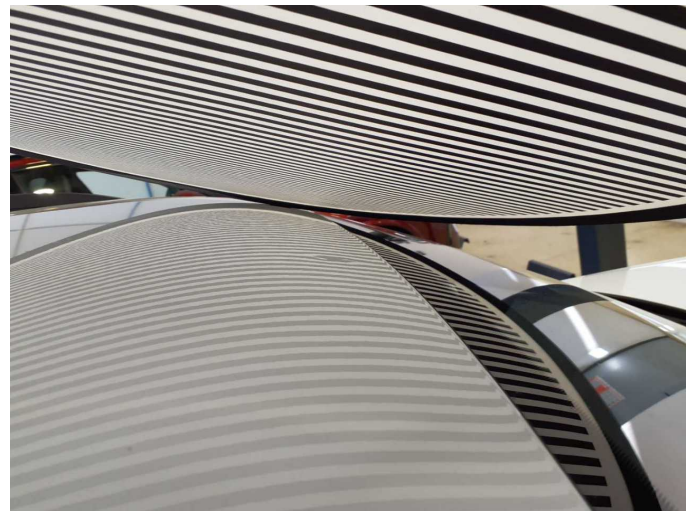
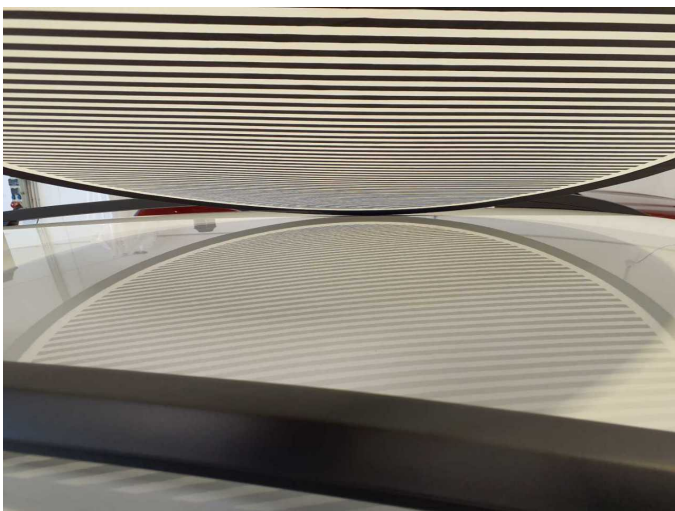
| No. | Component group | Description |
|---|---|---|
| 11 | Roof | Roof - Corrosion - Repair and paint |

**Damage 11:** Roof: Roof - Corrosion - Repair and paint

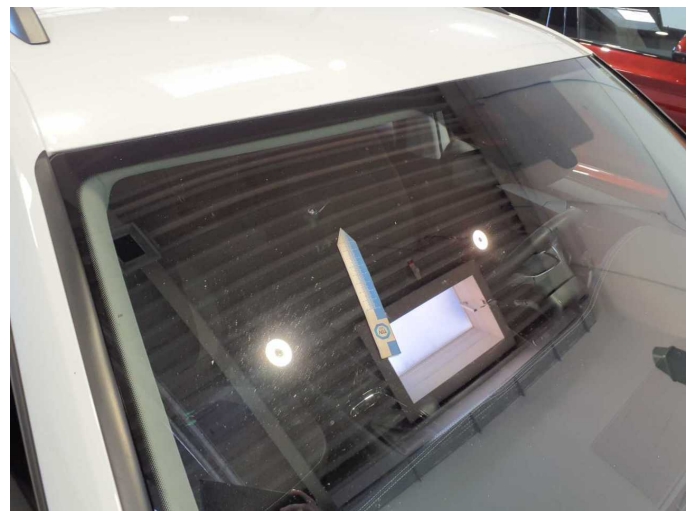
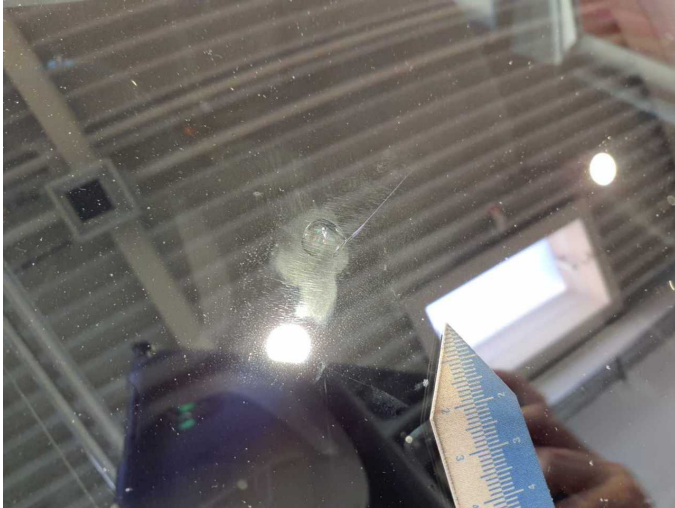
| No. | Component group | Description |
|---|---|---|
| 12 | Vehicle glazing | Windscreen - Broken / torn - Replace |

**Damage 12:** Vehicle glazing: Windscreen - Broken / torn - Replace

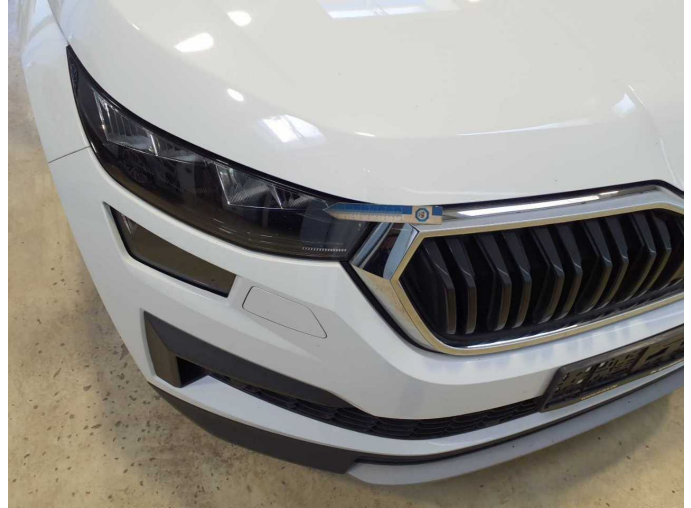
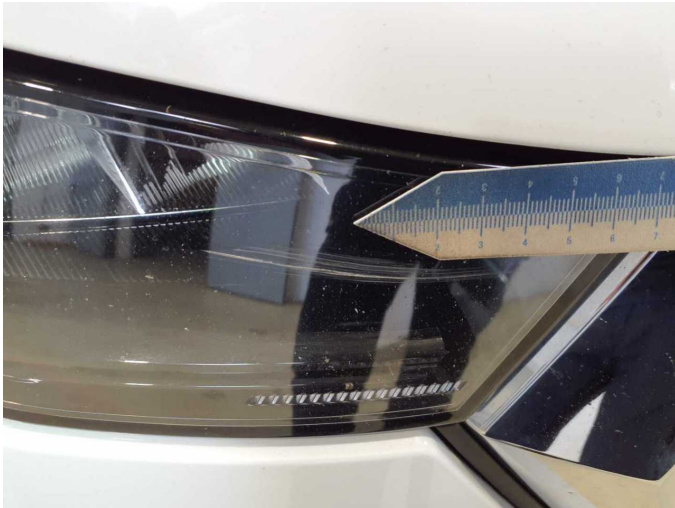
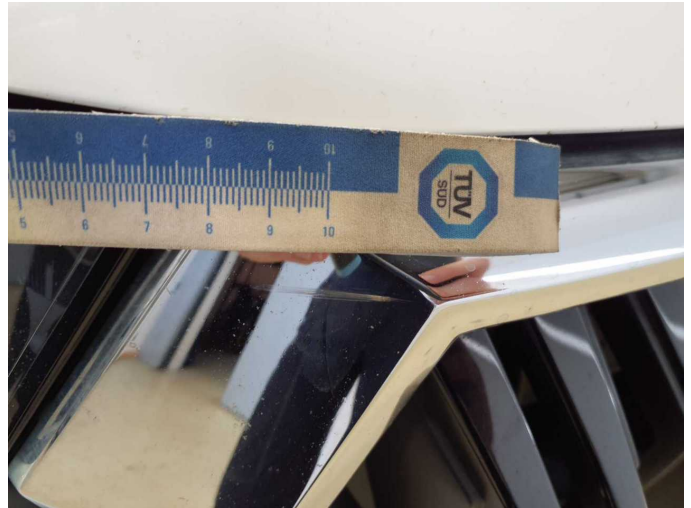
1 Front

**Accident 1:** Front
