## Expertise

Protocol number: 46130548  
Order No. / Reference: 26496406  
Inspection date: 22 Jun 2026

Manufacturer: Skoda

Model: Enyaq iV 80

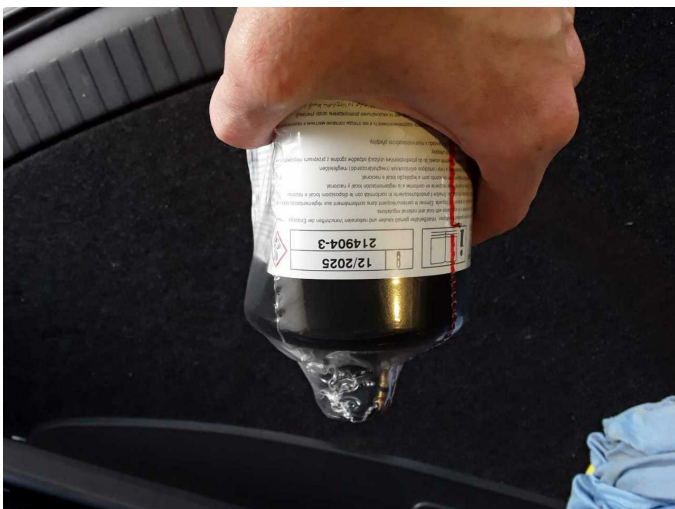
Damage 1: Equipment: Tirefit filler - Expired - Replace

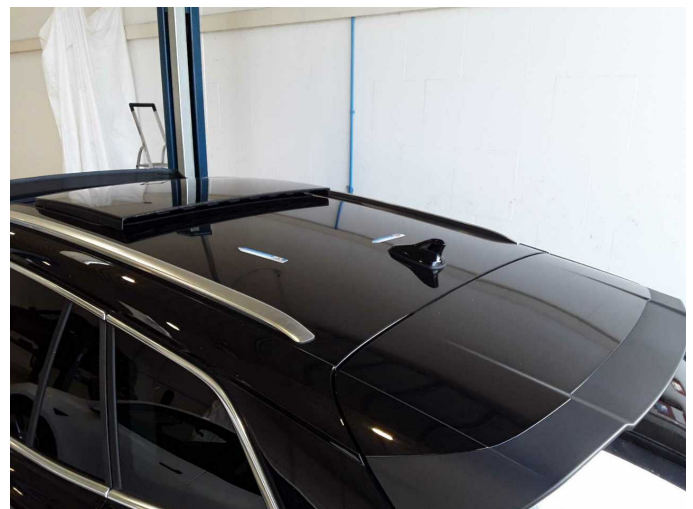
Damage 2: Roof: Roof - dent(s) - Smooth repair work

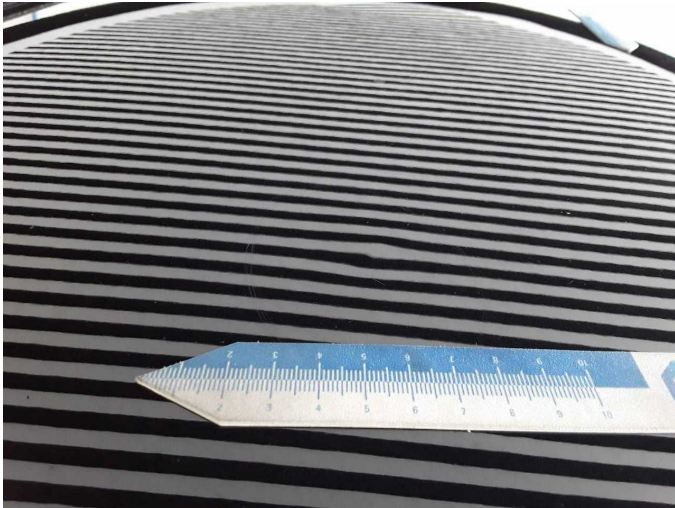
Damage 2: Roof: Roof - dent(s) - Smooth repair work

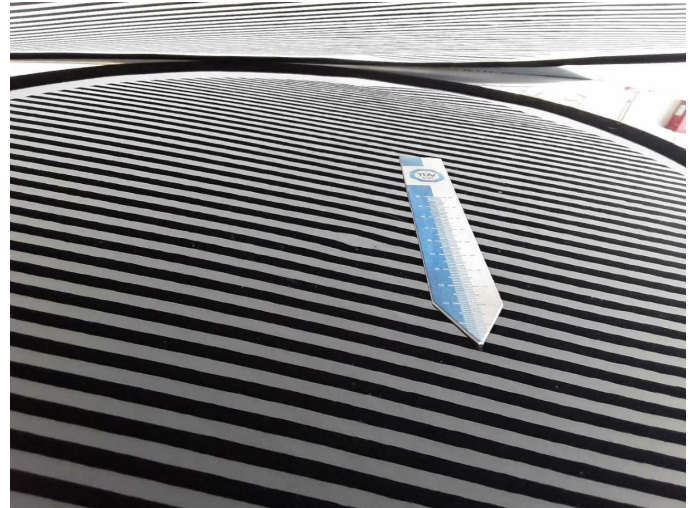
Damage 2: Roof: Roof - dent(s) - Smooth repair work

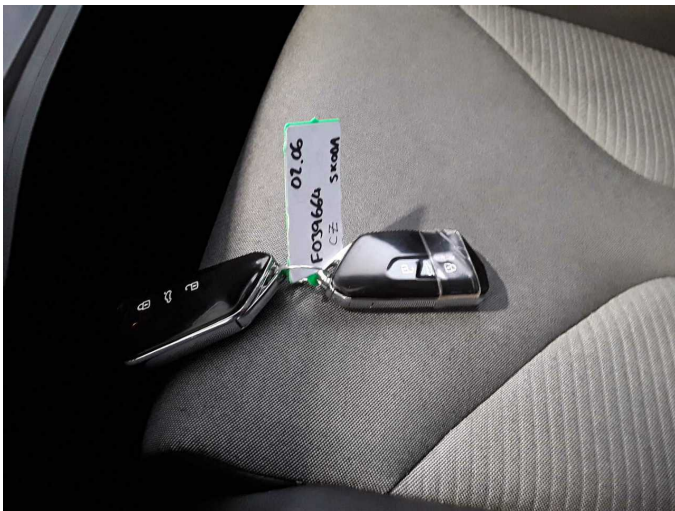
Damage 3: Equipment: Vehicle key (Abdeckung lose) - Damaged - Replace

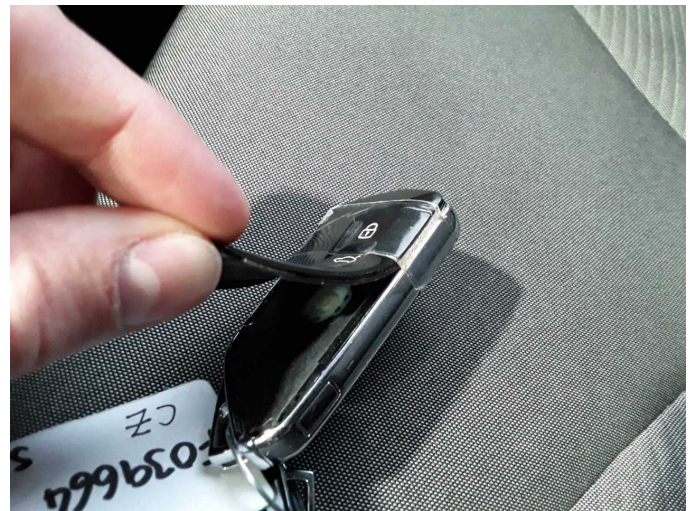
Damage 3: Equipment: Vehicle key (Abdeckung lose) - Damaged - Replace

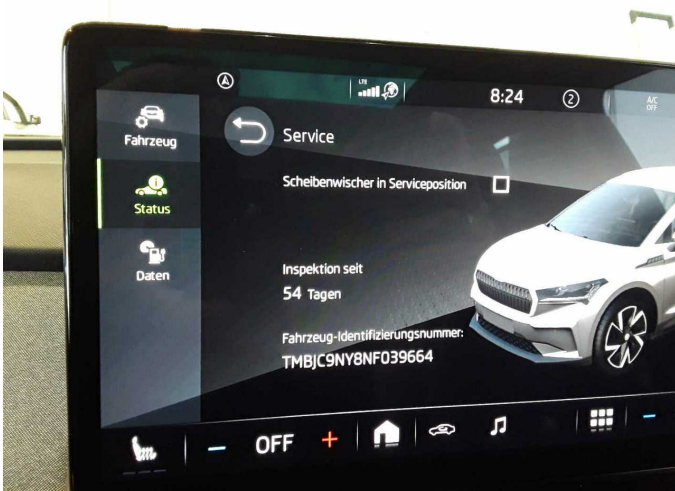
Damage 4: Misc.: Inspection / maintenance - Due - Perform
