Expertise

Protocol number: 46282597
Order No. / Reference: 26571386
Inspection date: 30 Jun 2026

Model: Kangoo Rapid (ENERGY) TCe 115 (Start & Stop) Extra

VIN: VF1FW54J260522689

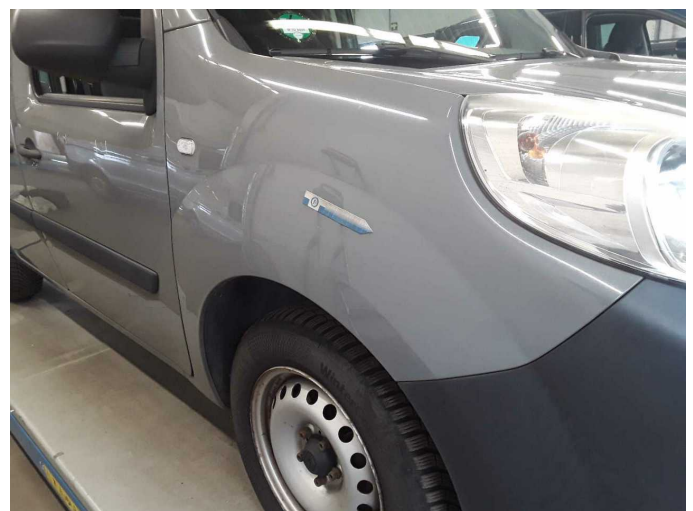
Damage 2: Mudguard - right side: Mudguard - right side - Scratch(es) - Smart repair

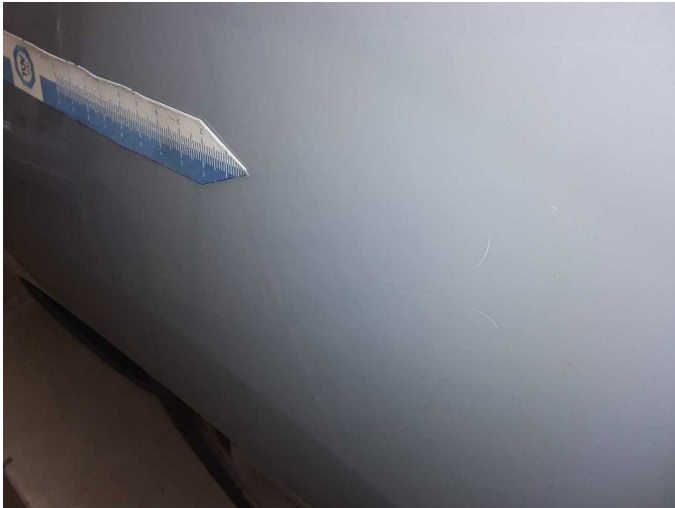
Damage 2: Mudguard - right side: Mudguard - right side - Scratch(es) - Smart repair

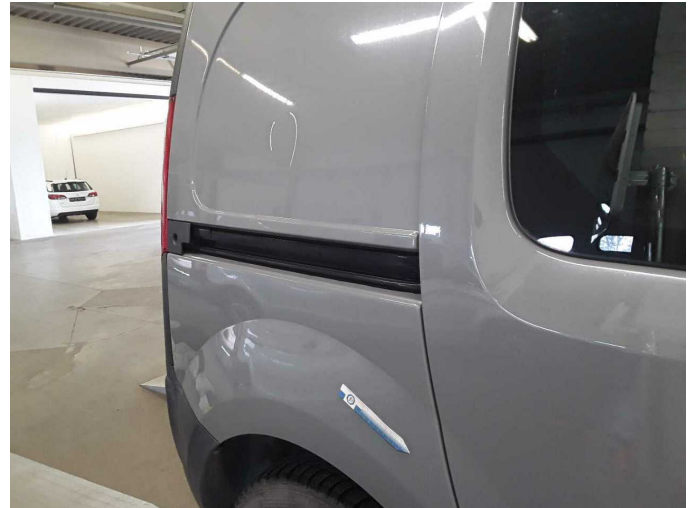
Damage 3: Side panel - rear right side: Side panel - Dent / paintcoat damage - Smart repair

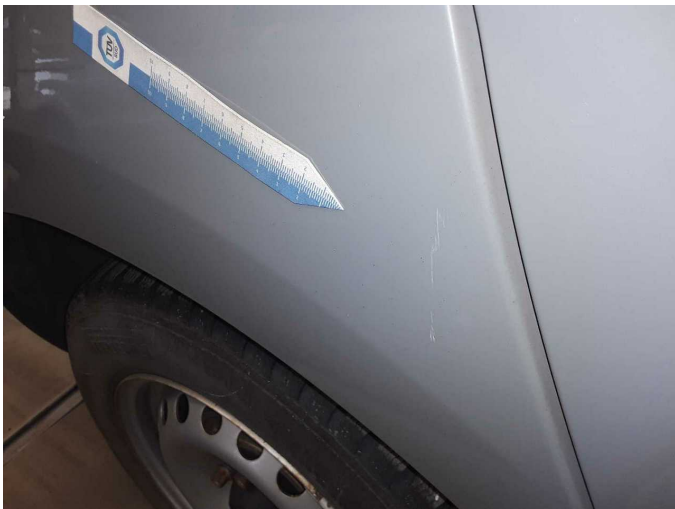
Damage 3: Side panel - rear right side: Side panel - Dent / paintcoat damage - Smart repair

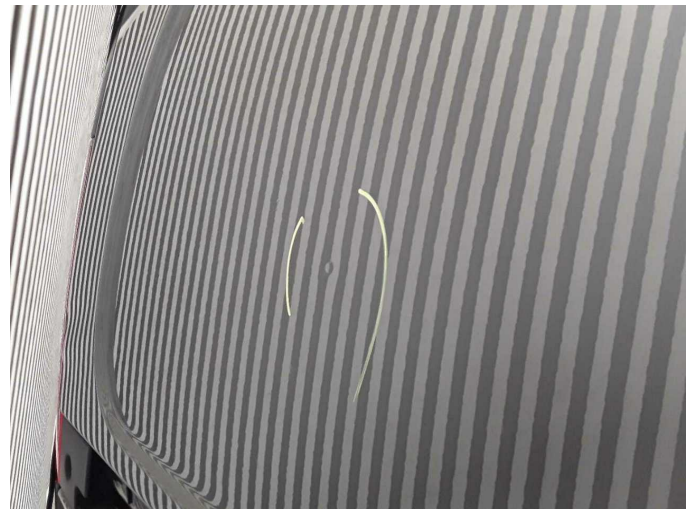
Damage 3: Side panel - rear right side: Side panel - Dent / paintcoat damage - Smart repair

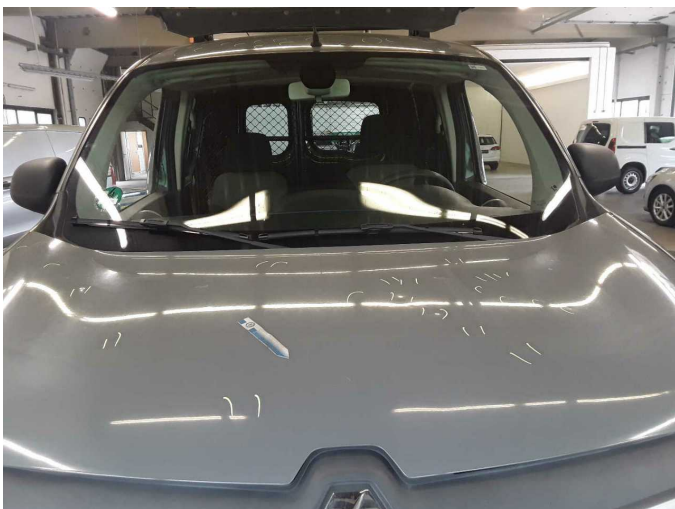
Damage 4: Bonnet: Bonnet - Scratched - Paint

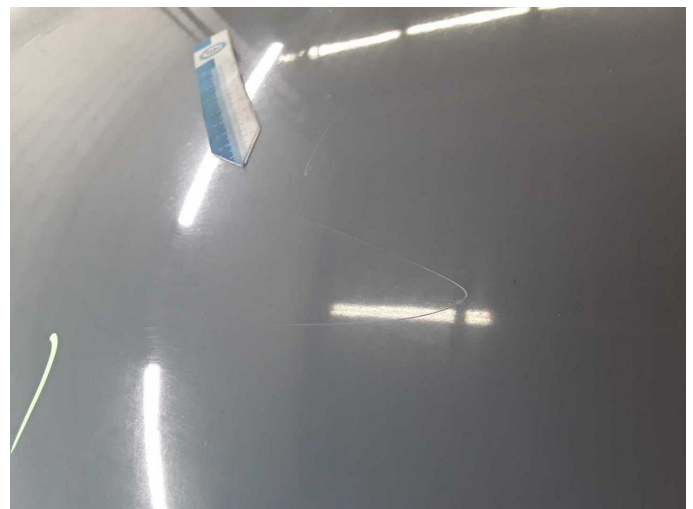
Damage 4: Bonnet: Bonnet - Scratched - Paint

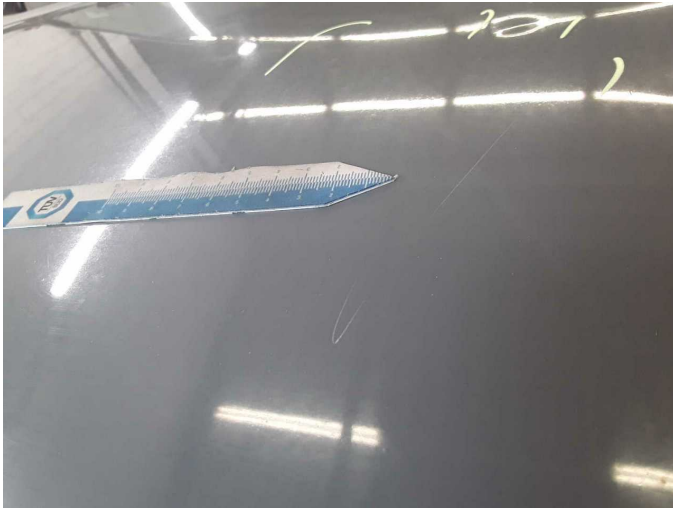
Damage 4: Bonnet: Bonnet - Scratched - Paint

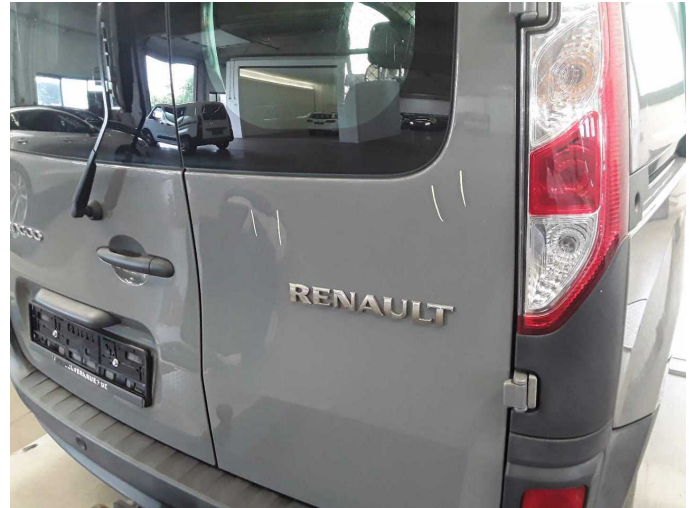
Damage 5: Boot lid / rear door: Rear door - right side - Scratch(es) - Paint

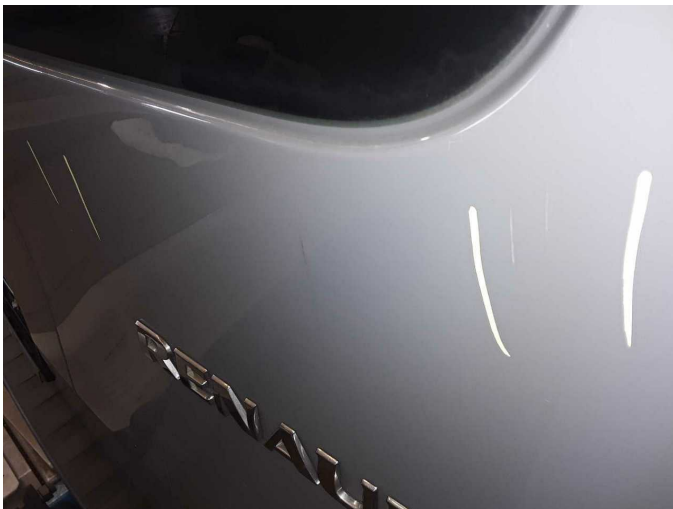
Damage 5: Boot lid / rear door: Rear door - right side - Scratch(es) - Paint

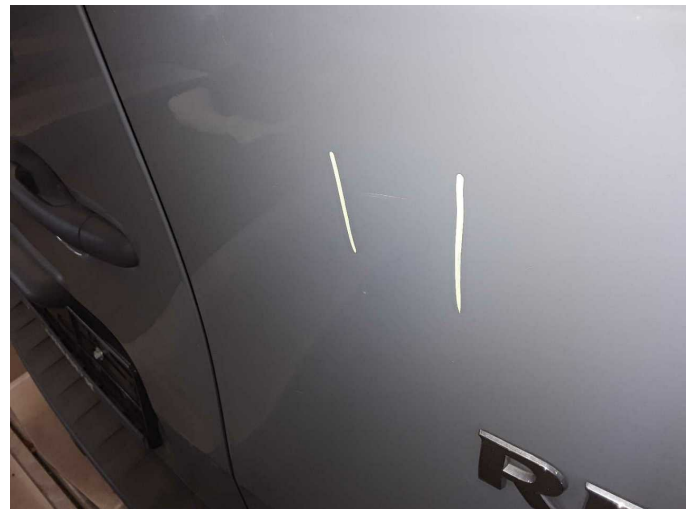
Damage 5: Boot lid / rear door: Rear door - right side - Scratch(es) - Paint

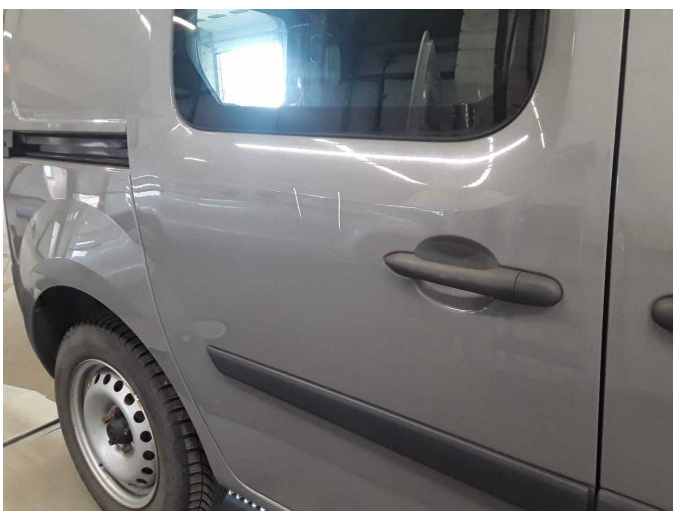
Damage 6: Sliding door, right: Sliding door - Dent / paintcoat damage - Repair and paint

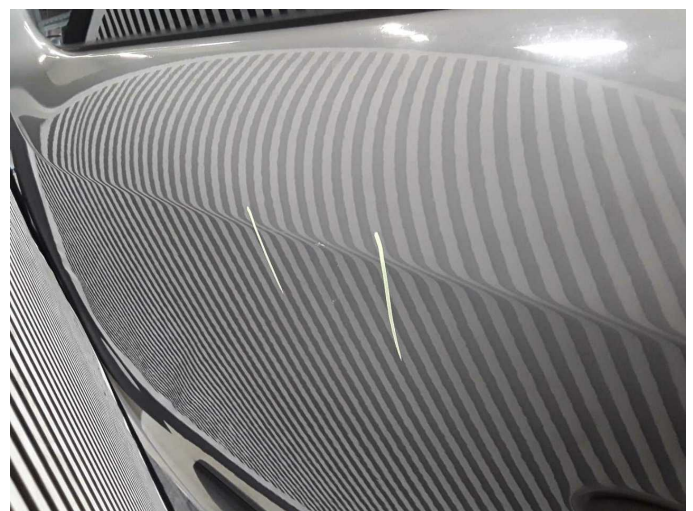
Damage 6: Sliding door, right: Sliding door - Dent / paintcoat damage - Repair and paint

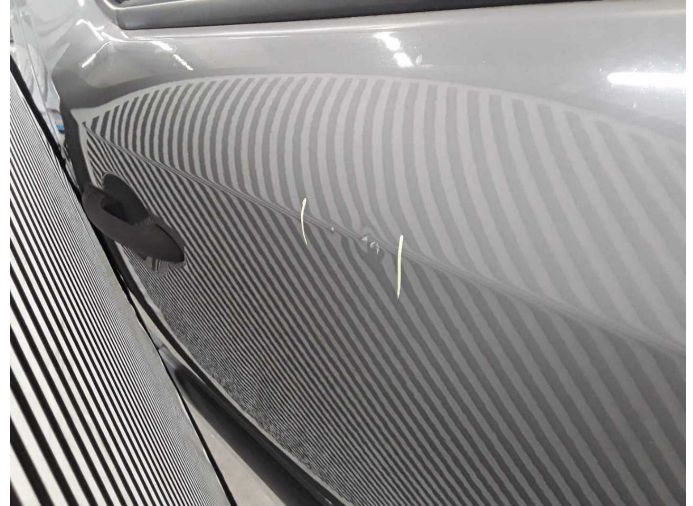
Damage 7: Door - front right side: Door - Dent / paintcoat damage - Repair and paint

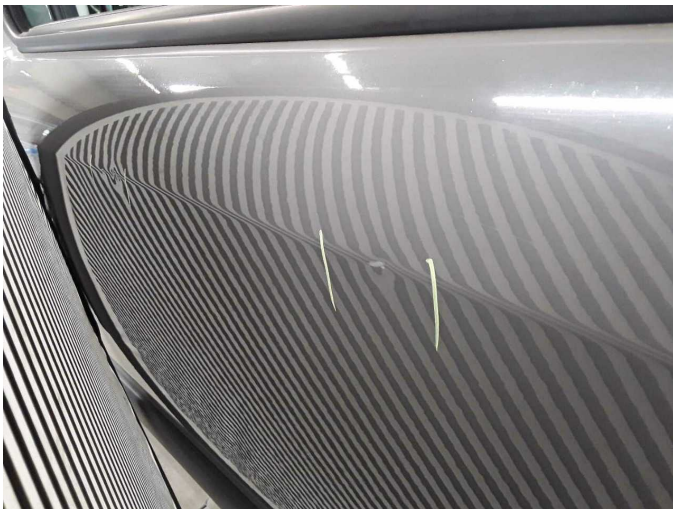
Damage 7: Door - front right side: Door - Dent / paintcoat damage - Repair and paint

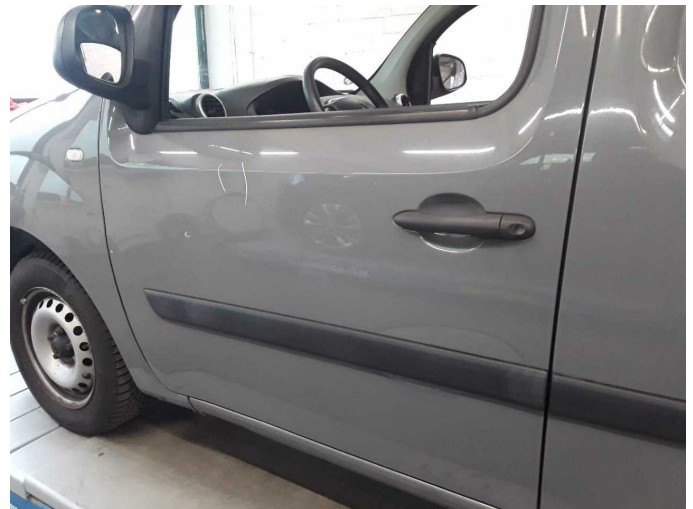
Damage 8: Door - front left side: Door - Dent / paintcoat damage - Repair and paint

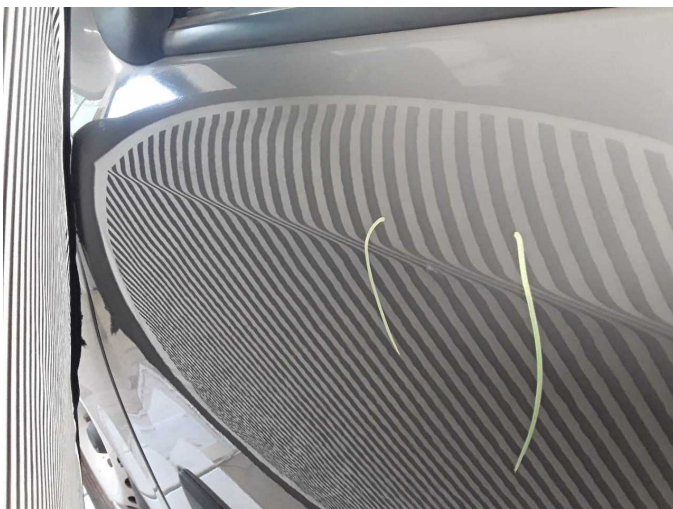
Damage 8: Door - front left side: Door - Dent / paintcoat damage - Repair and paint

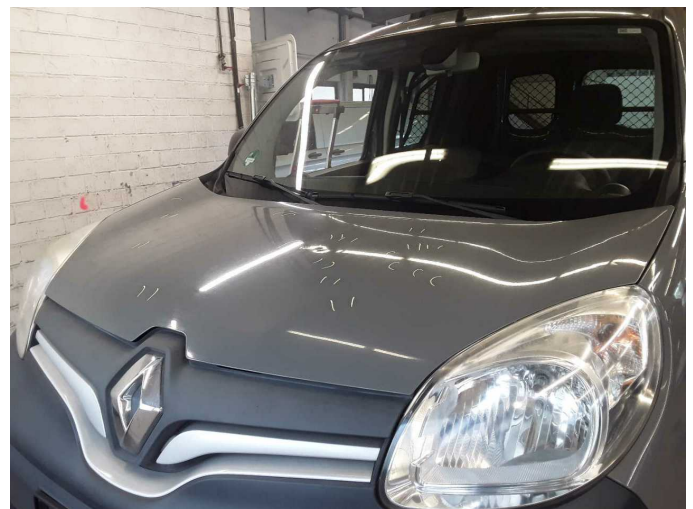
Damage 9: Body: Body - Damage by hail - repair according to calculation

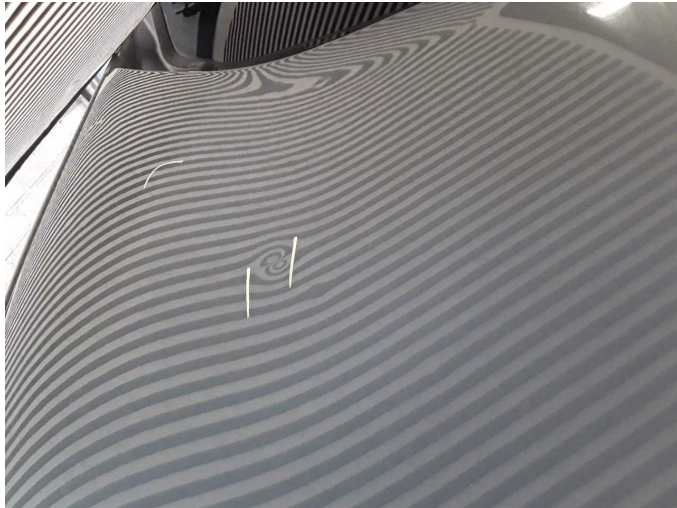
Damage 9: Body: Body - Damage by hail - repair according to calculation

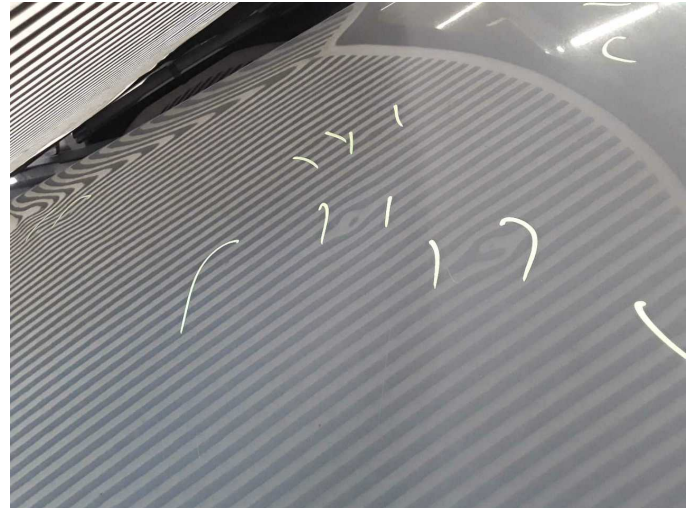
Damage 9: Body: Body - Damage by hail - repair according to calculation

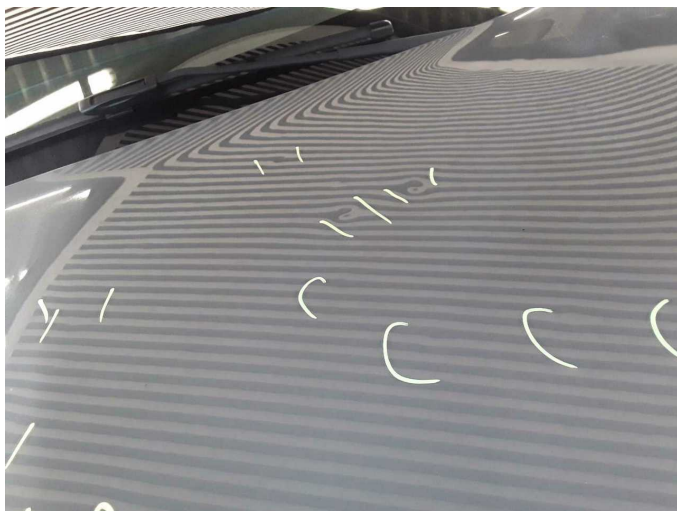
Damage 9: Body: Body - Damage by hail - repair according to calculation

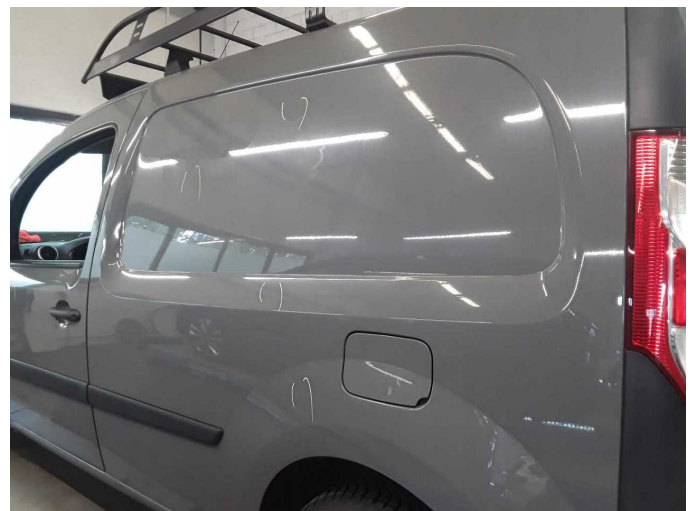
Damage 9: Body: Body - Damage by hail - repair according to calculation

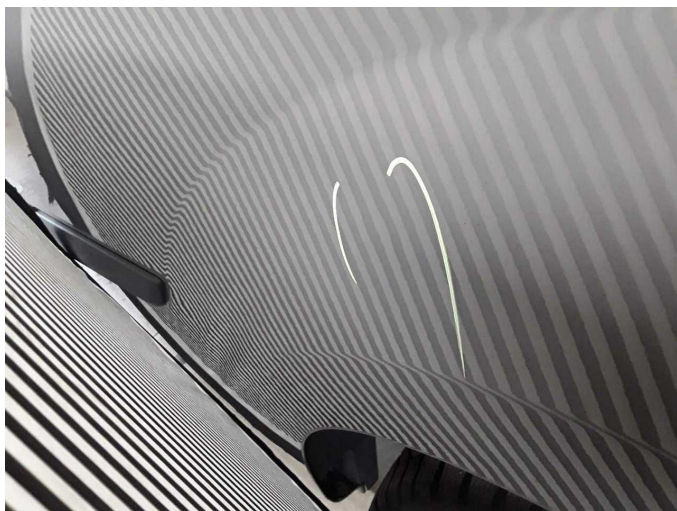
Damage 9: Body: Body - Damage by hail - repair according to calculation

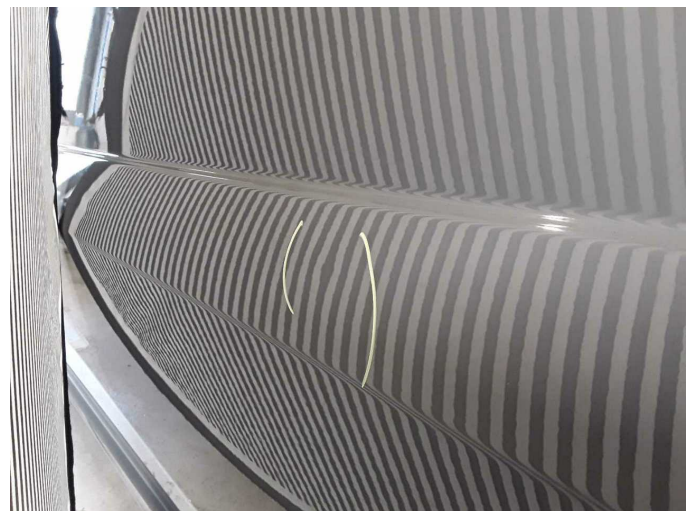
Damage 9: Body: Body - Damage by hail - repair according to calculation

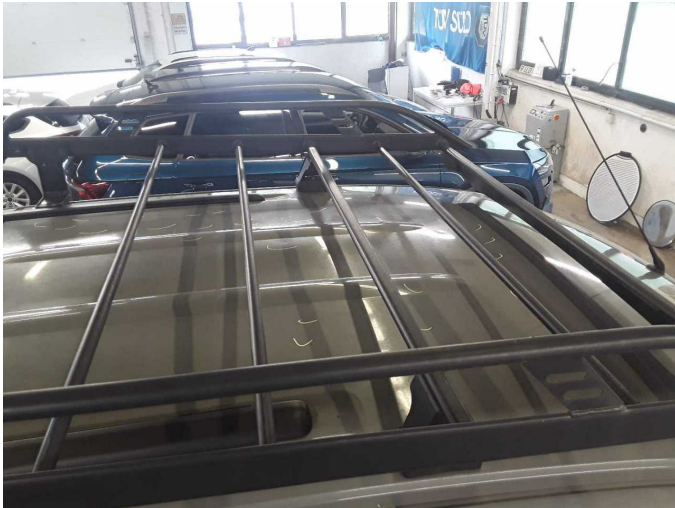
Damage 9: Body: Body - Damage by hail - repair according to calculation

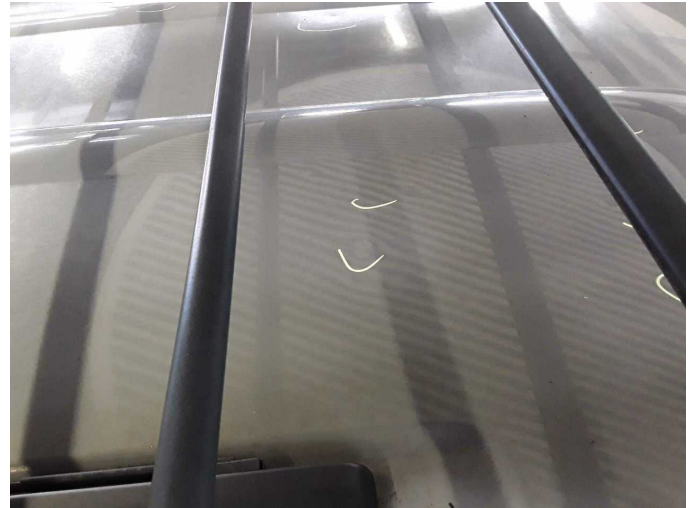
Damage 9: Body: Body - Damage by hail - repair according to calculation

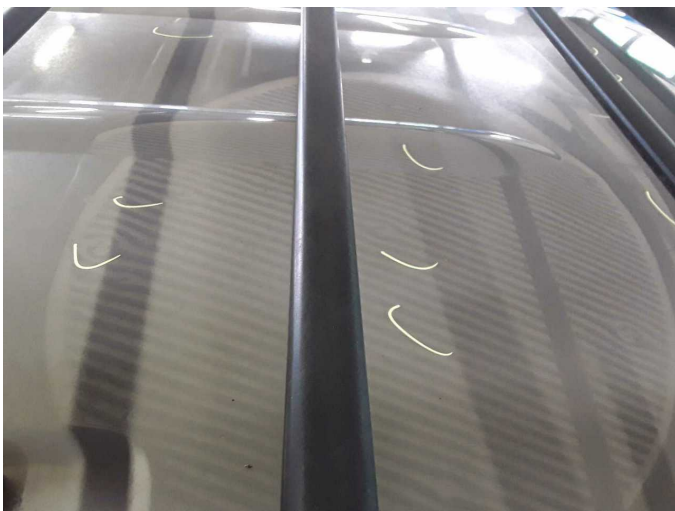
Damage 9: Body: Body - Damage by hail - repair according to calculation

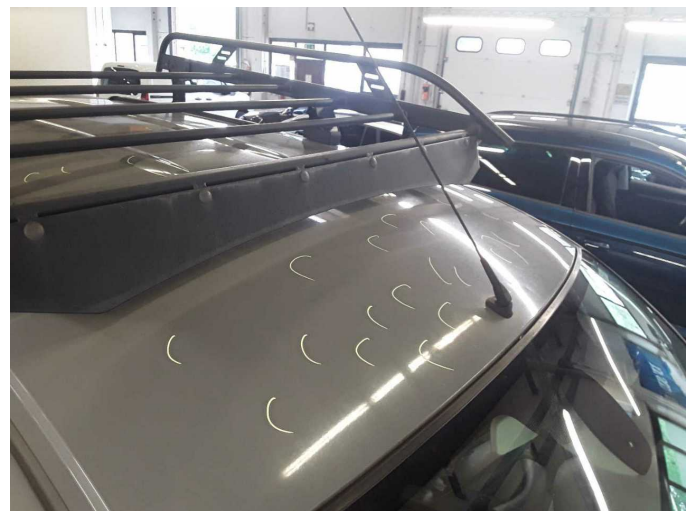
Damage 9: Body: Body - Damage by hail - repair according to calculation

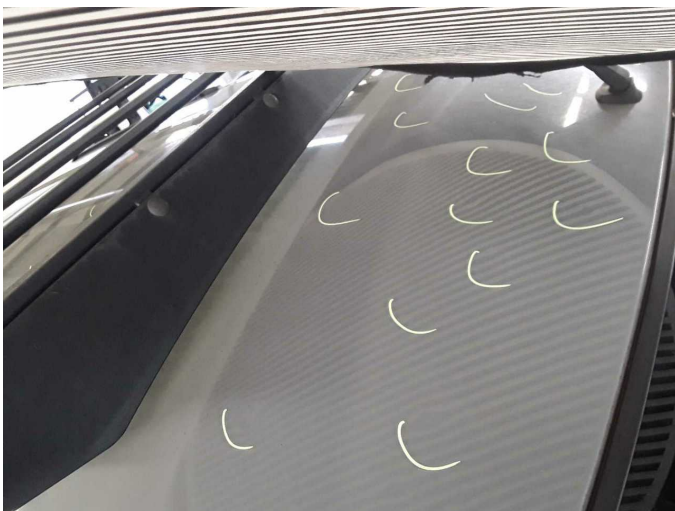
Damage 9: Body: Body - Damage by hail - repair according to calculation

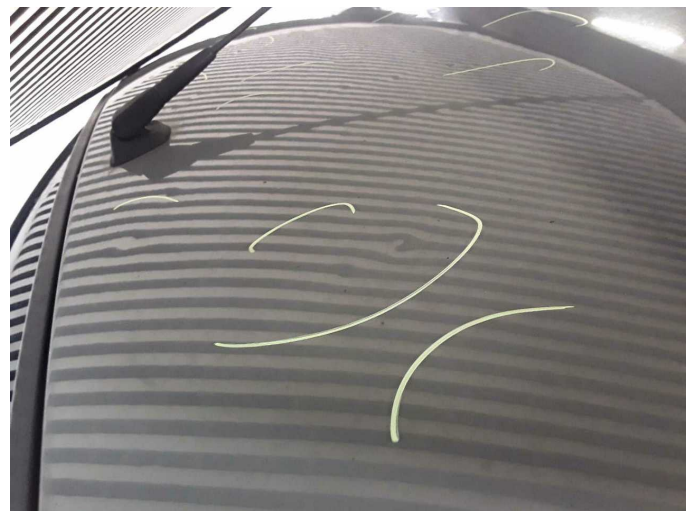
Damage 9: Body: Body - Damage by hail - repair according to calculation

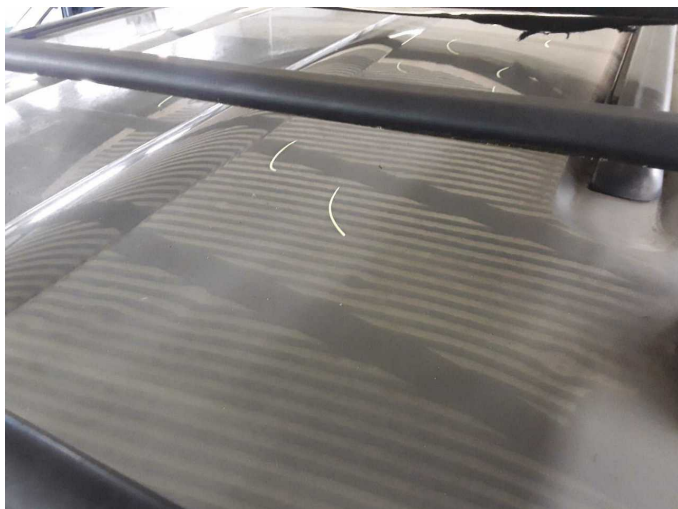
Damage 9: Body: Body - Damage by hail - repair according to calculation
