Expertise

Protocol number: 46202180
Order No. / Reference: 26544865
Inspection date: 26 Jun 2026

Manufacturer: Ford

Model: Transit Connect 250 L2 Trend

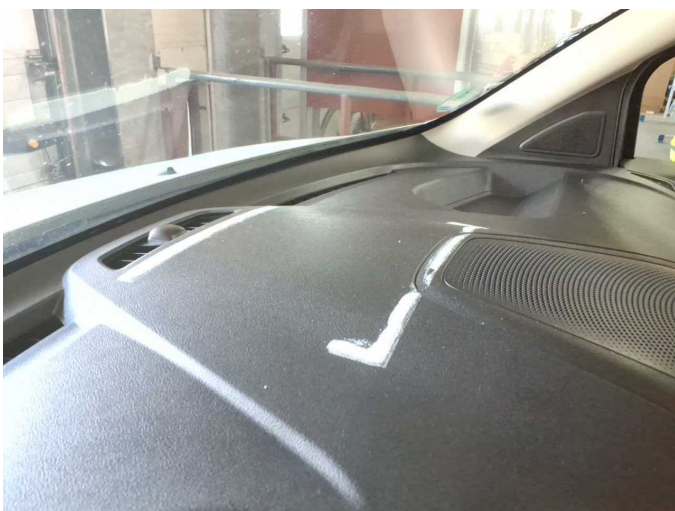
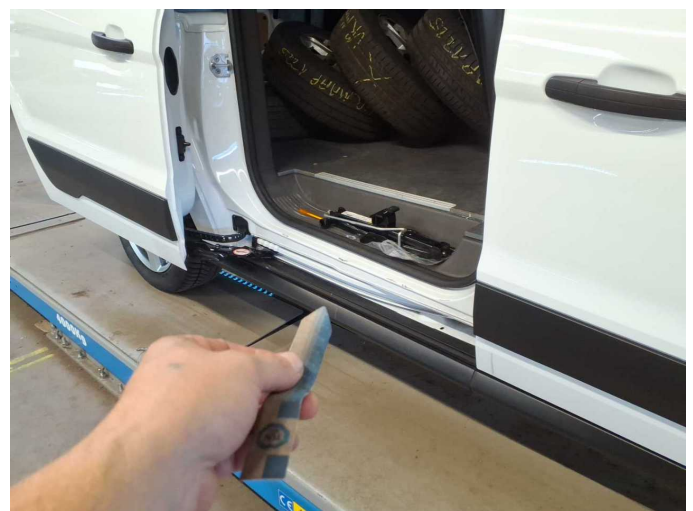
Damage 1: Instrument panel: Centre console - front - Glued / labelled - De-glue / neutralise

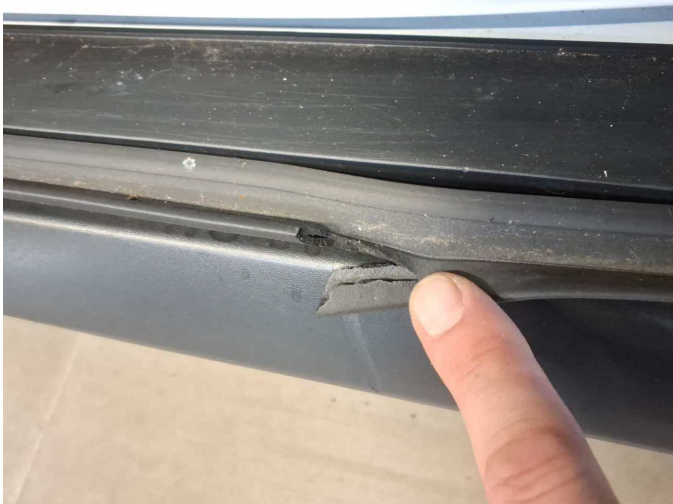
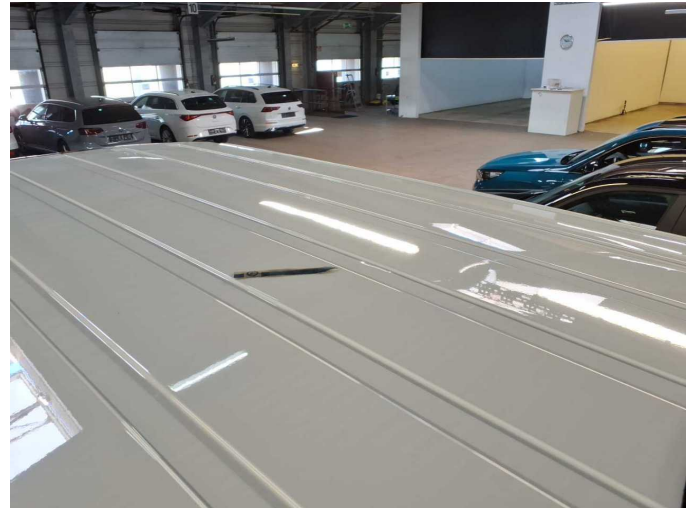
Damage 2: Sliding door, right: Door seal (Unten) - Broken / torn - Replace

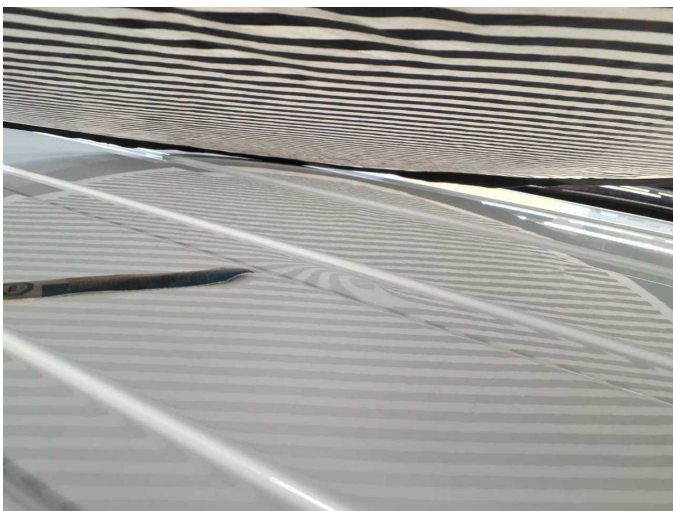
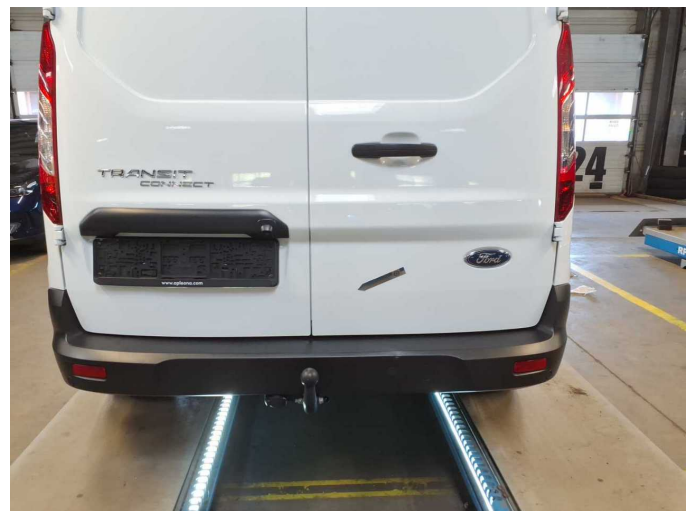
Damage 3: Roof: Roof - dent(s) - Smooth repair work

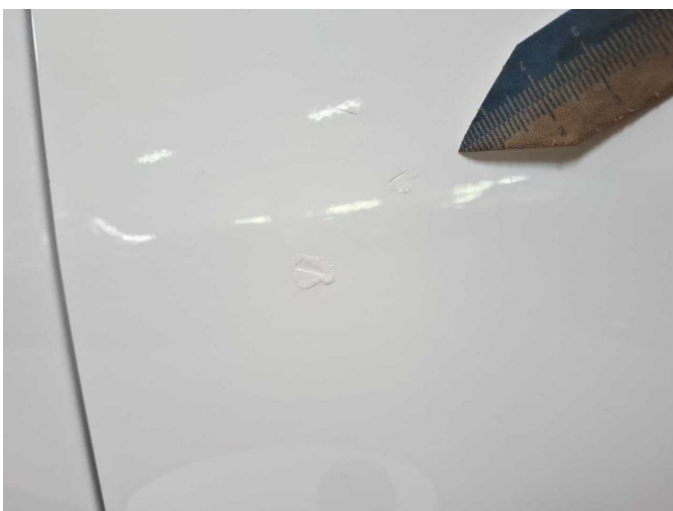
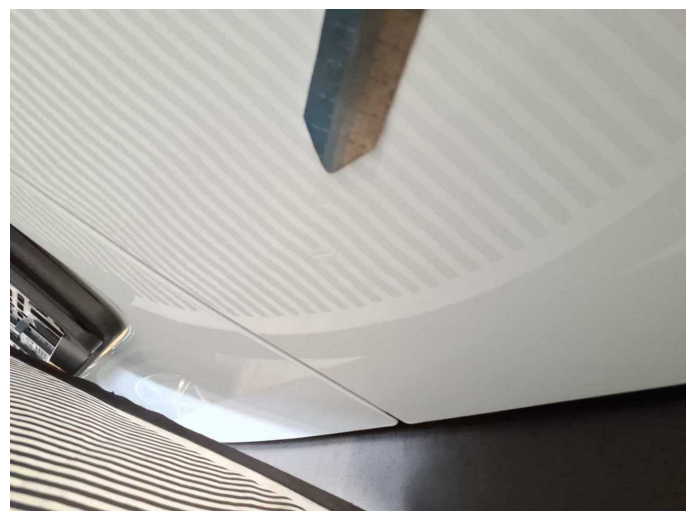
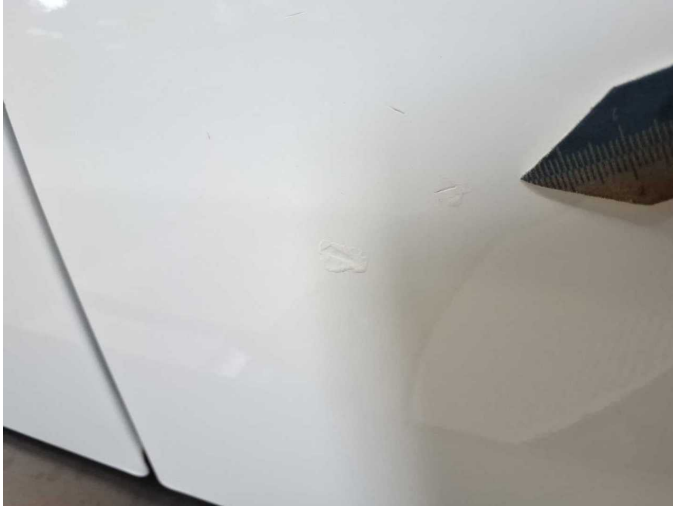
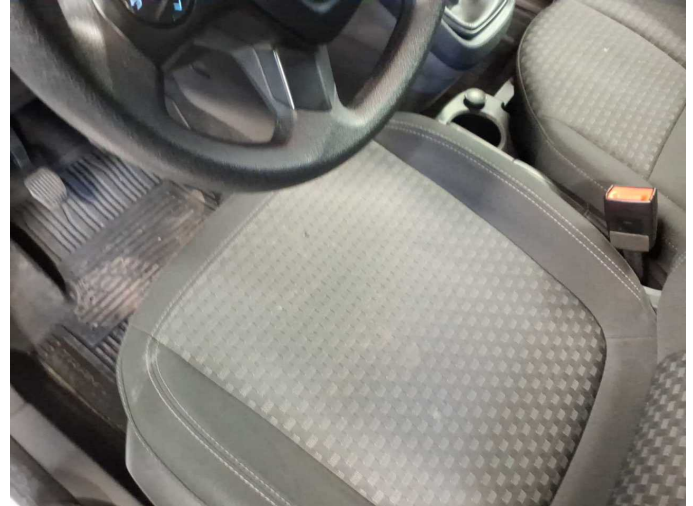
Damage 4: Boot lid / rear door: Rear door - right side - Paint defect - Smart repair

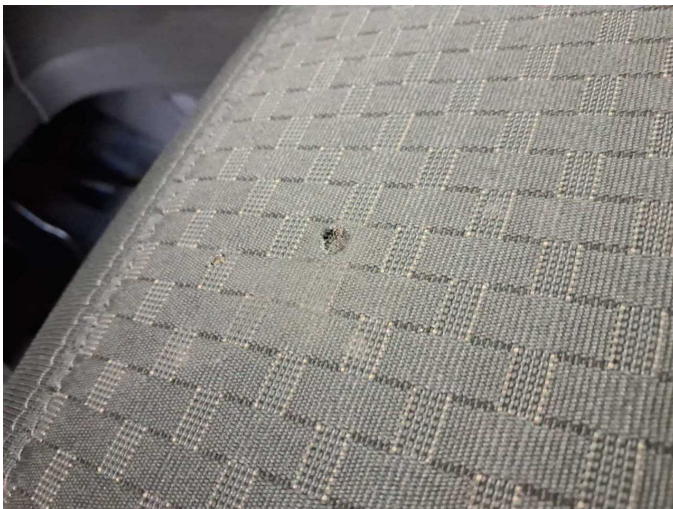
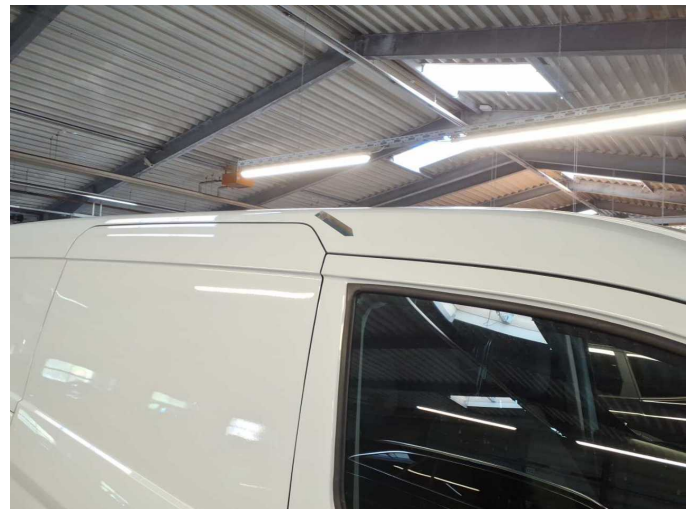
Damage 5: Seat - front: Seat cover - left side - Burn hole (cigarettes) - Smart repair

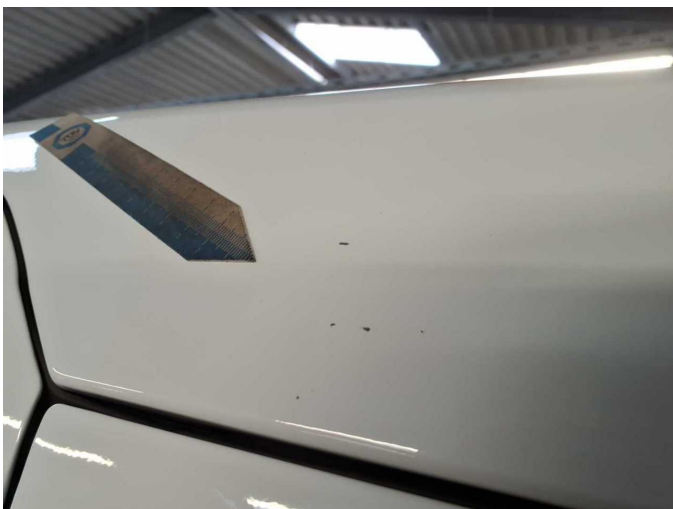
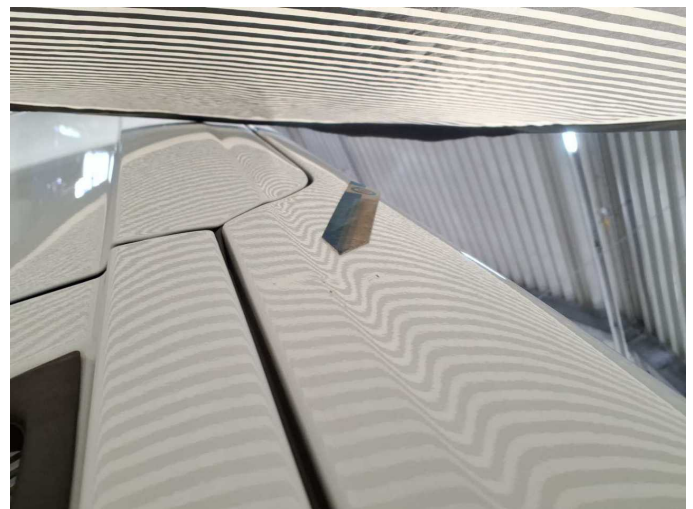
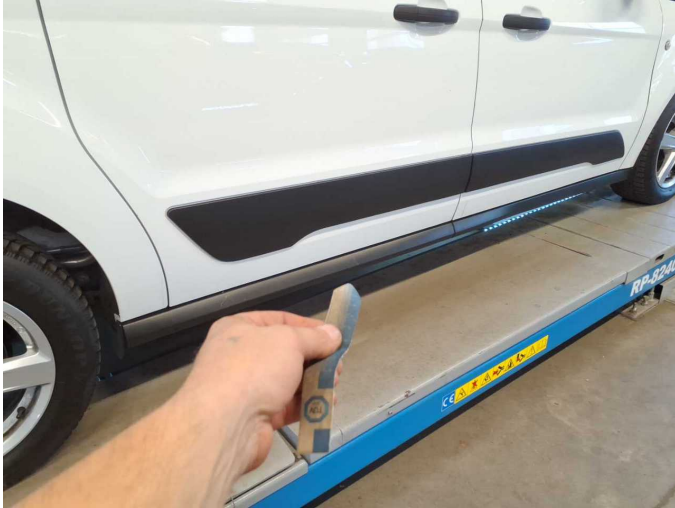
Damage 6: Roof: Roof rail - right side - Dent / paintcoat damage - Smart repair

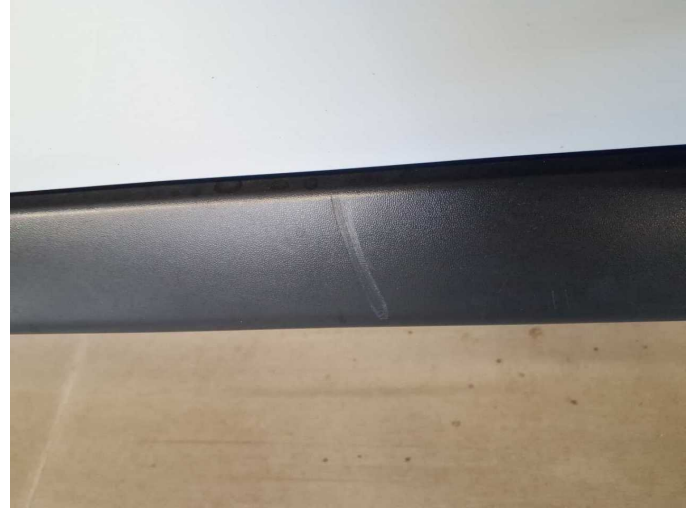
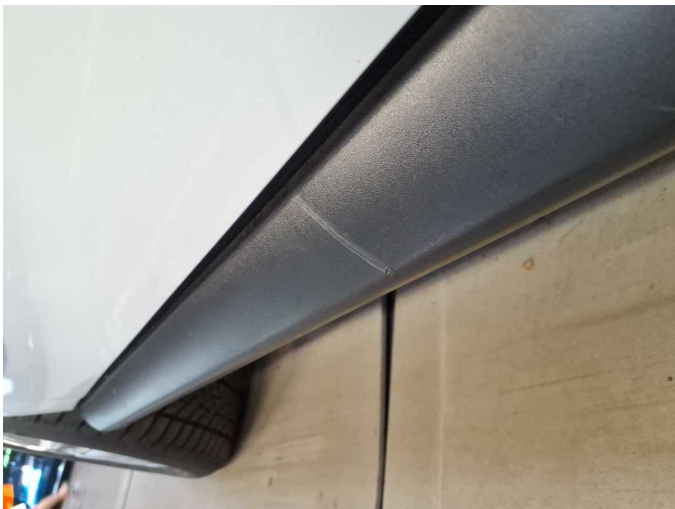
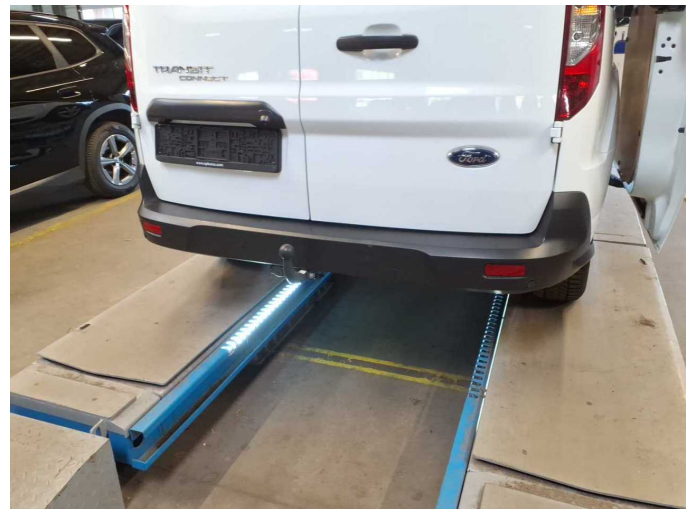
Damage 7: Sill - right side: Trim (Materialabtrag) - Scratched - Replace

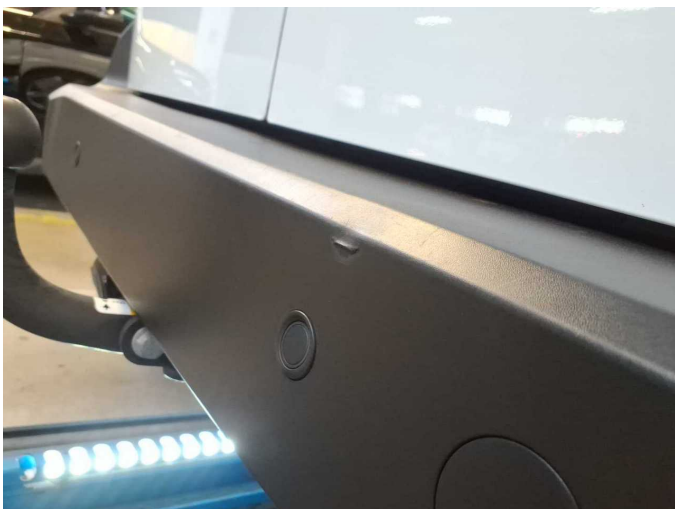
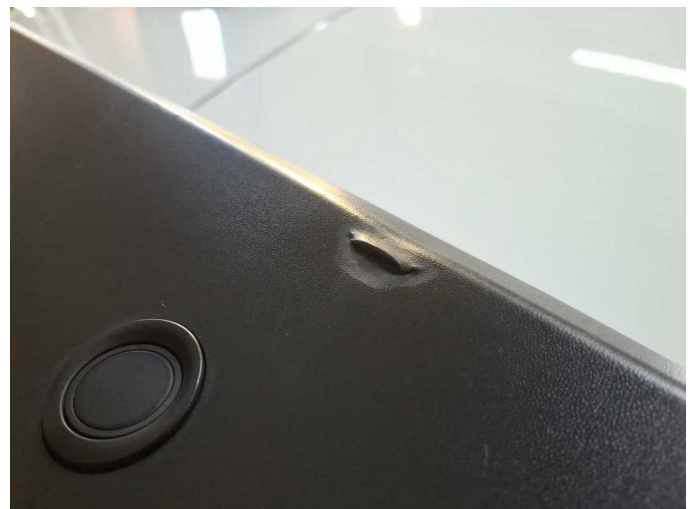
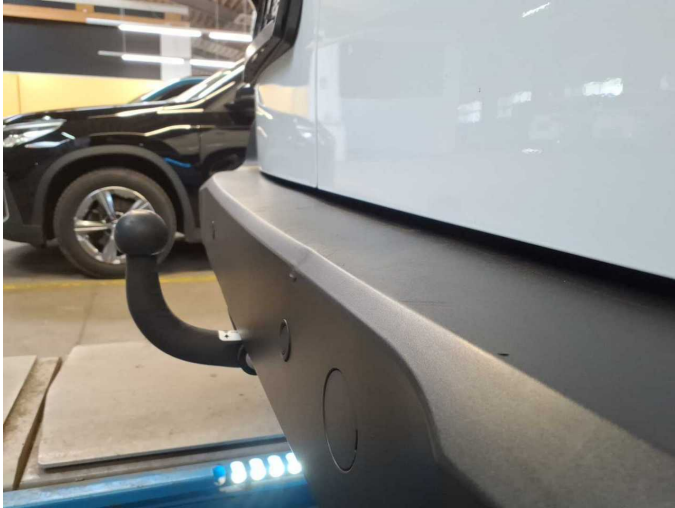
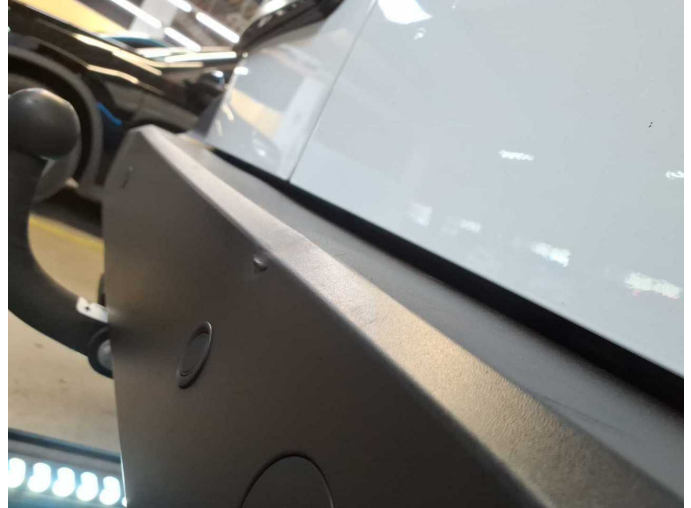
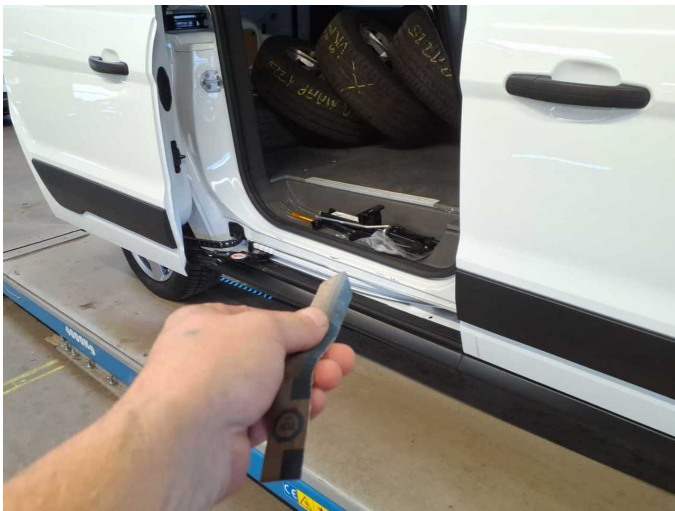
Damage 8: Rear bumper: Rear bumper (unpainted) - Broken / torn - Replace

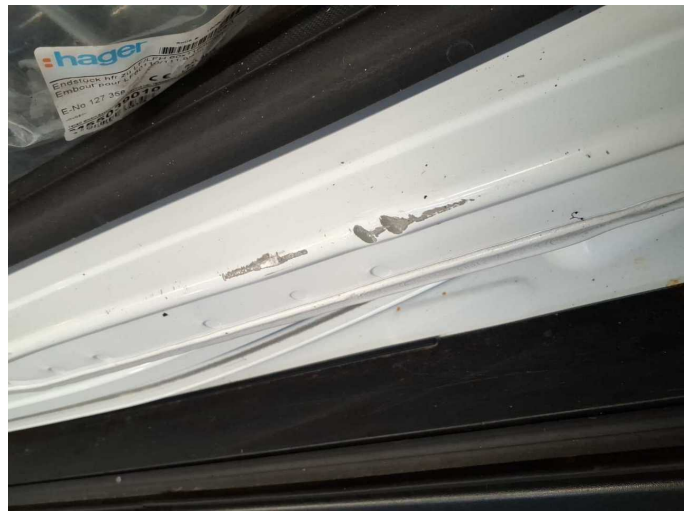
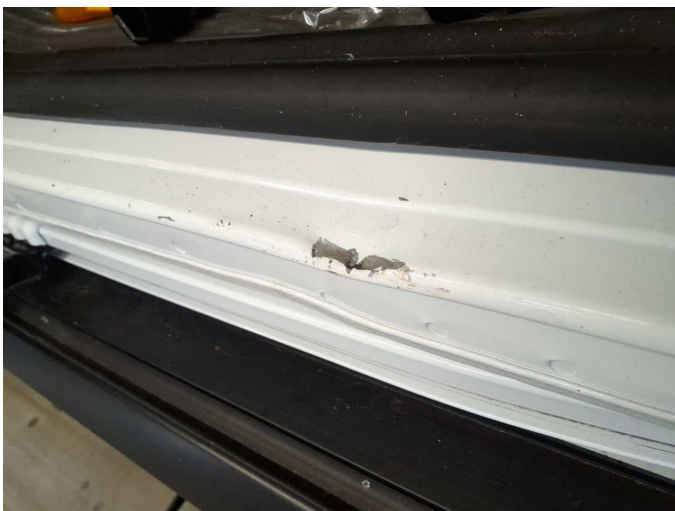
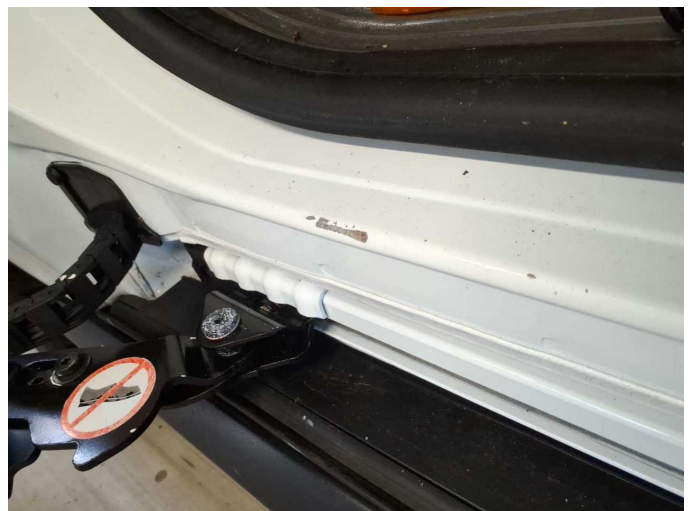
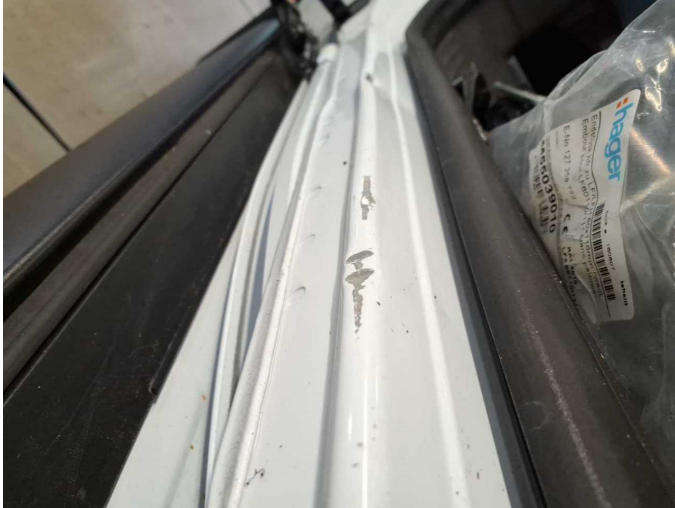
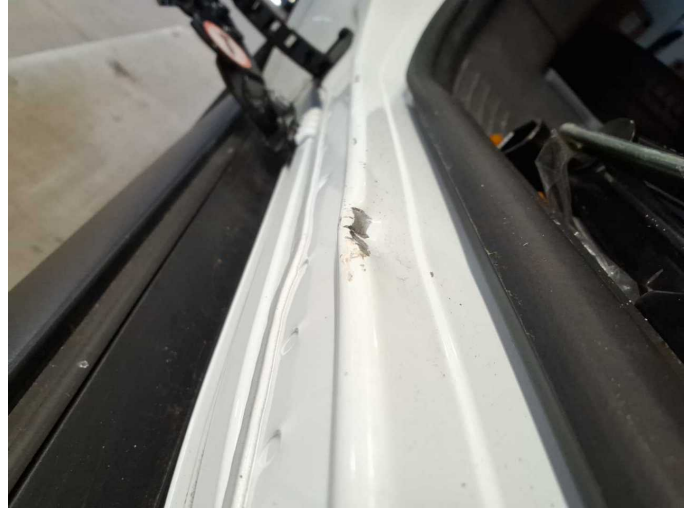
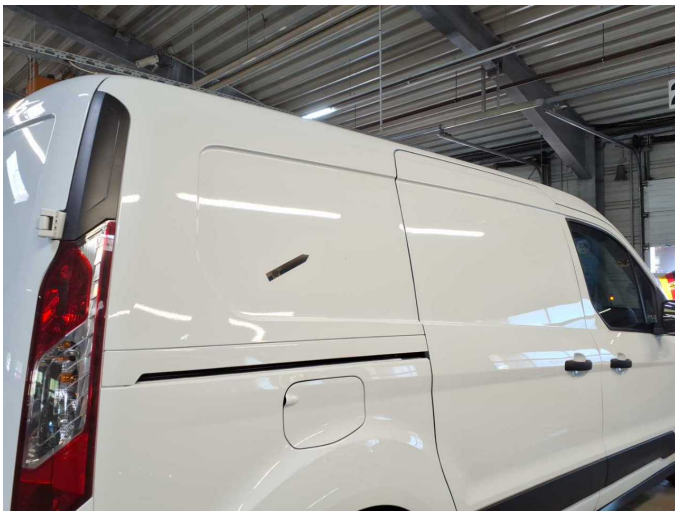
Damage 9: Sill - right side: Sill - Deformed - Repair and paint

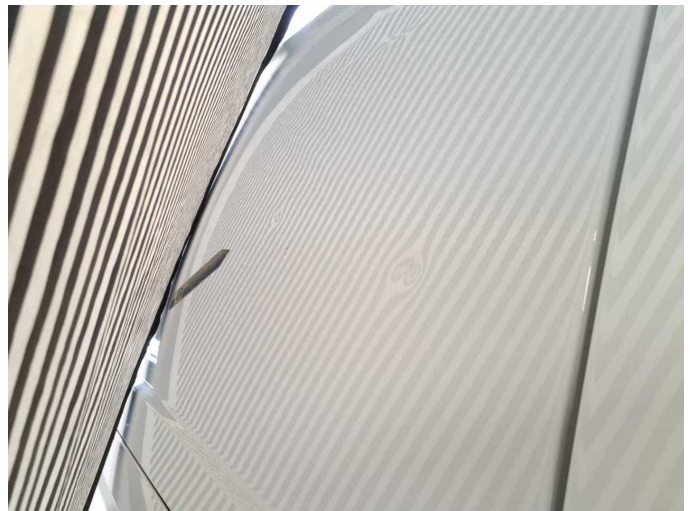
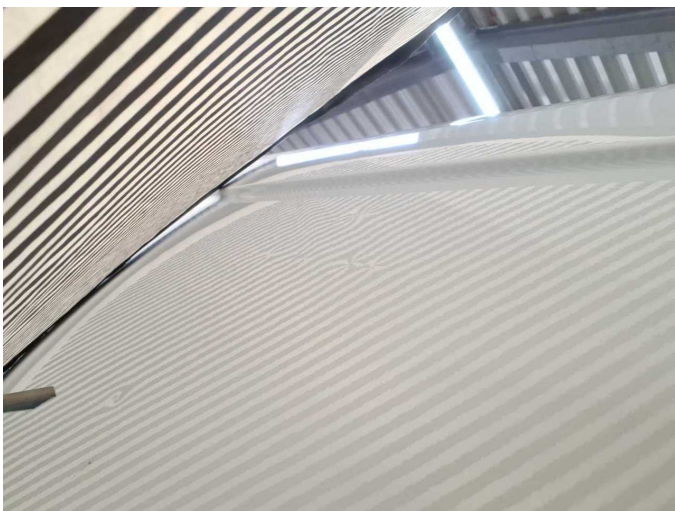
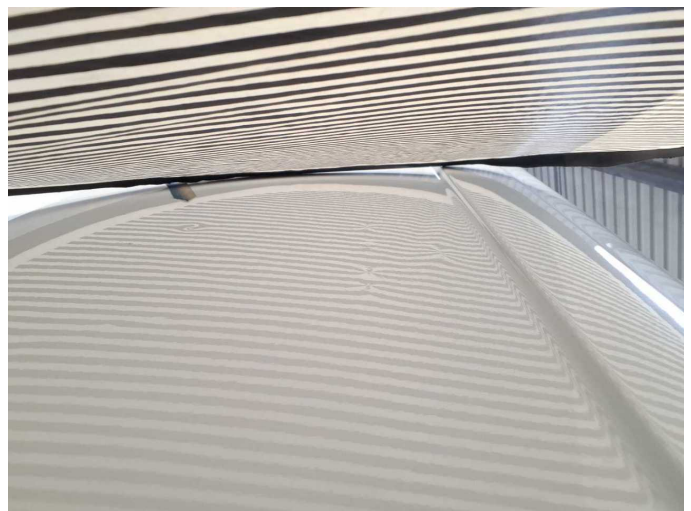
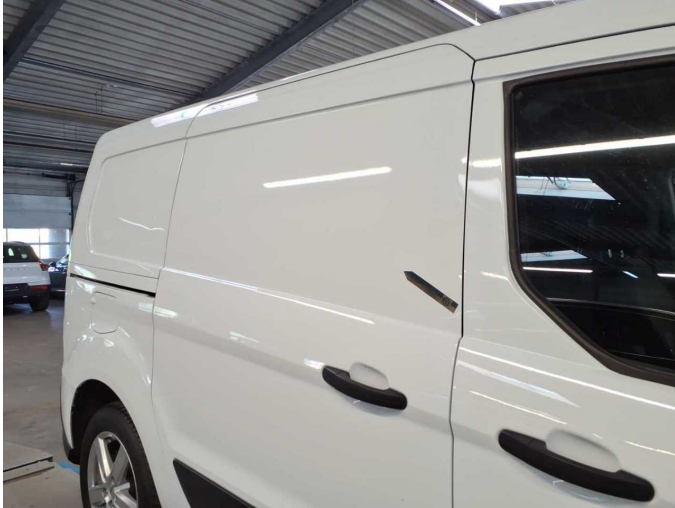
Damage 10: Side panel - rear right side: Side panel - Deformed - Repair and paint

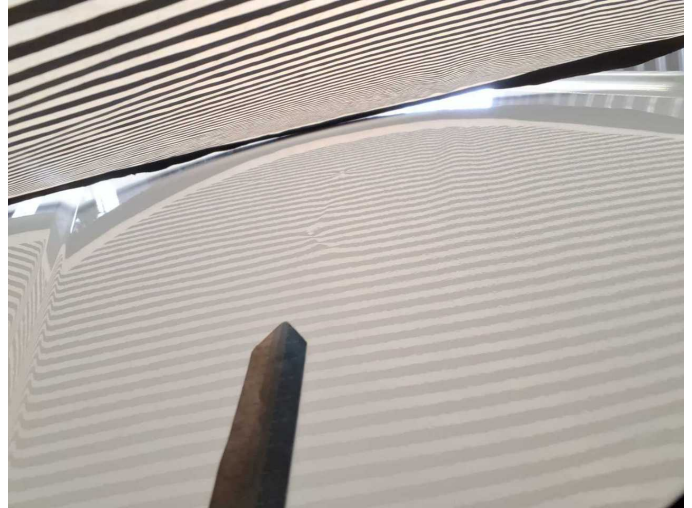
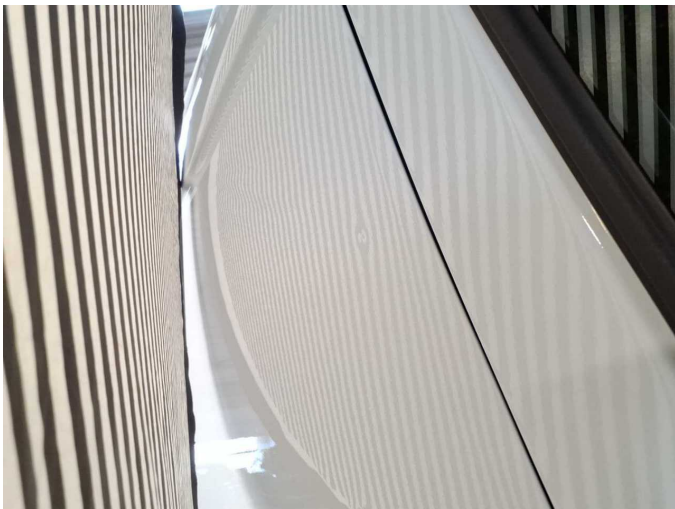
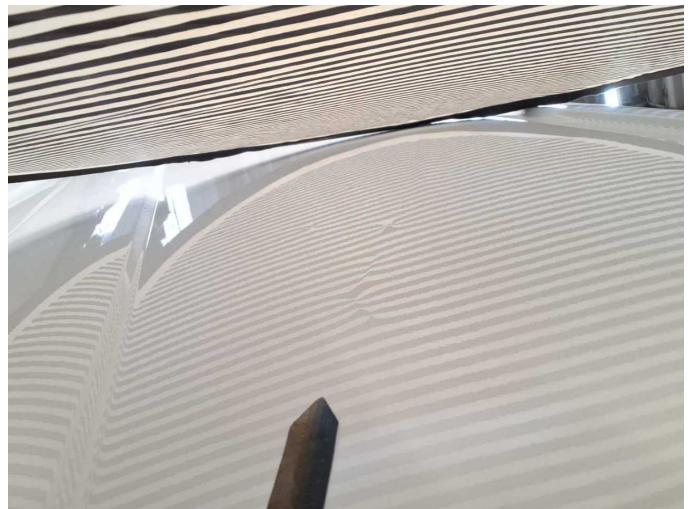
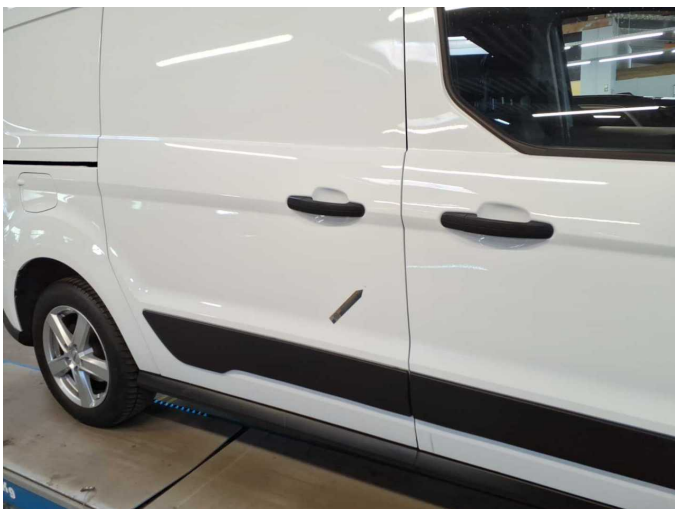
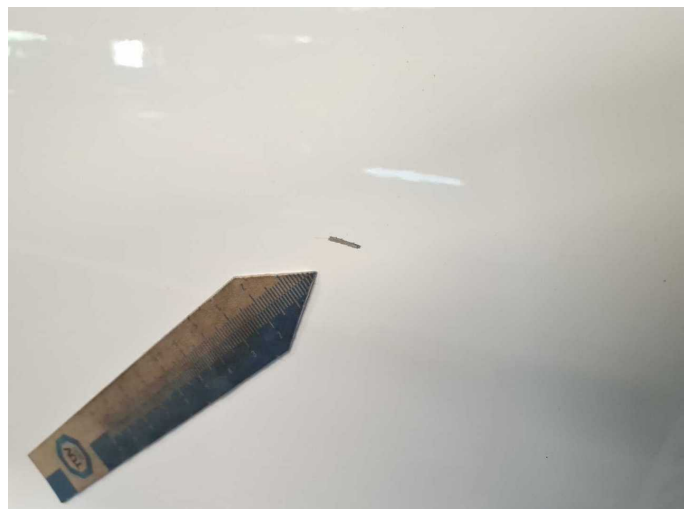
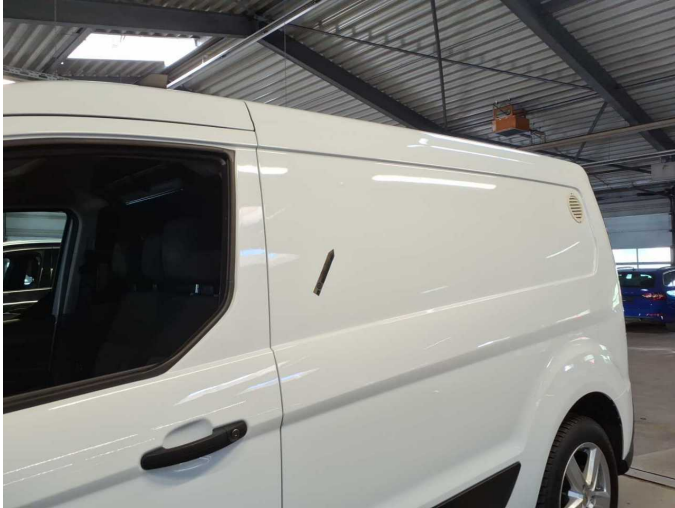
Damage 11: Sliding door, right: Sliding door - Deformed - Repair and paint

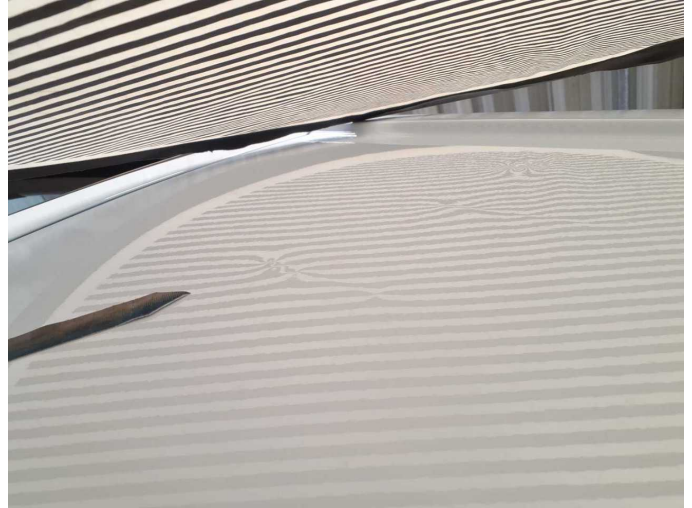
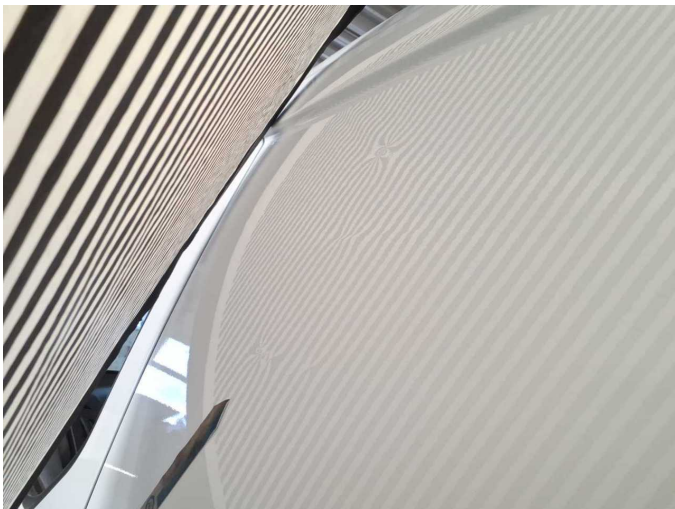
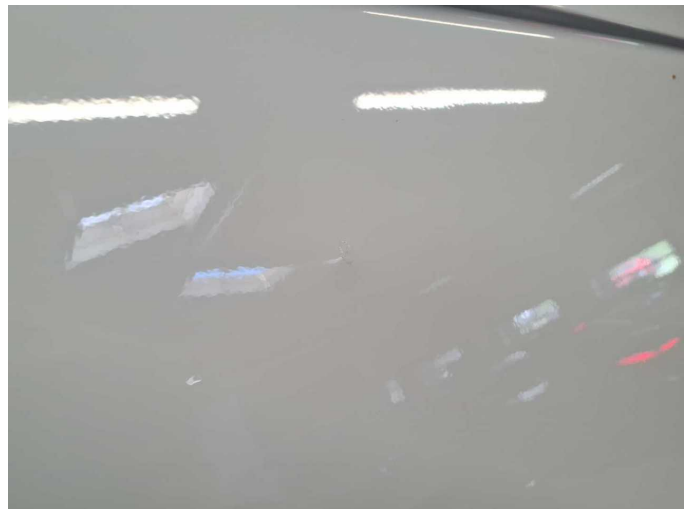
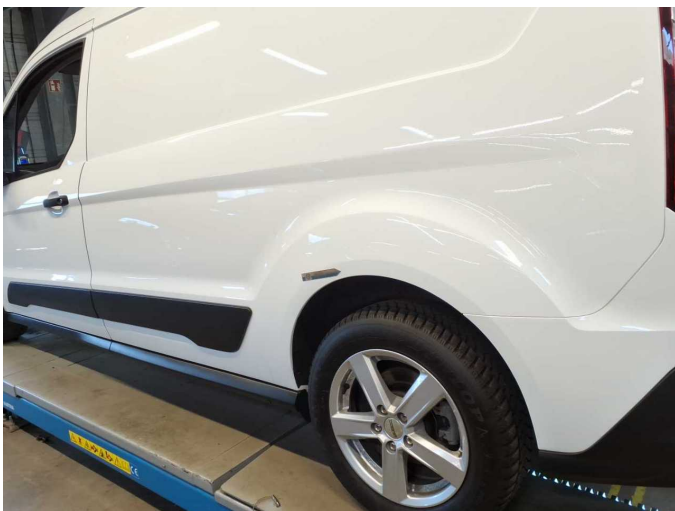
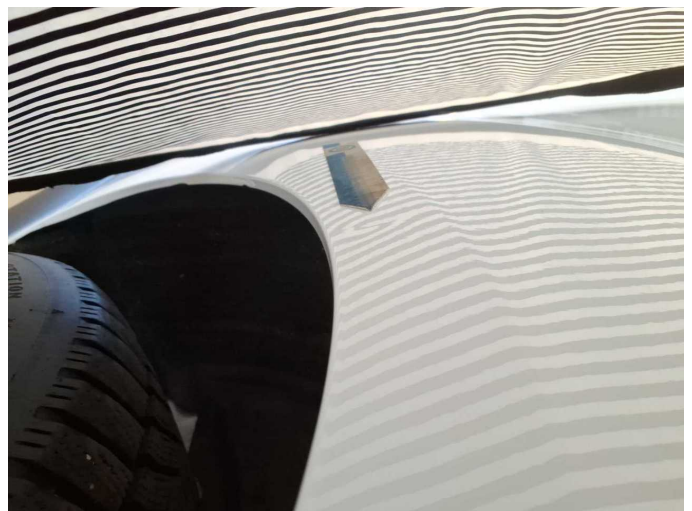
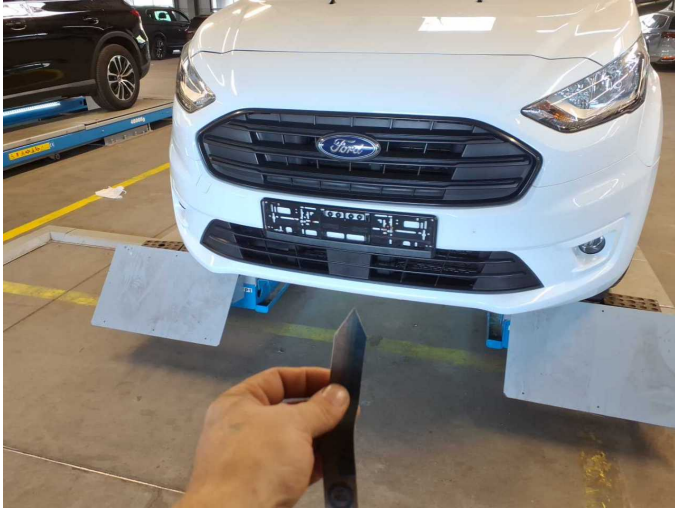
Damage 12: Side panel - rear left side: Side panel - Deformed - Repair and paint

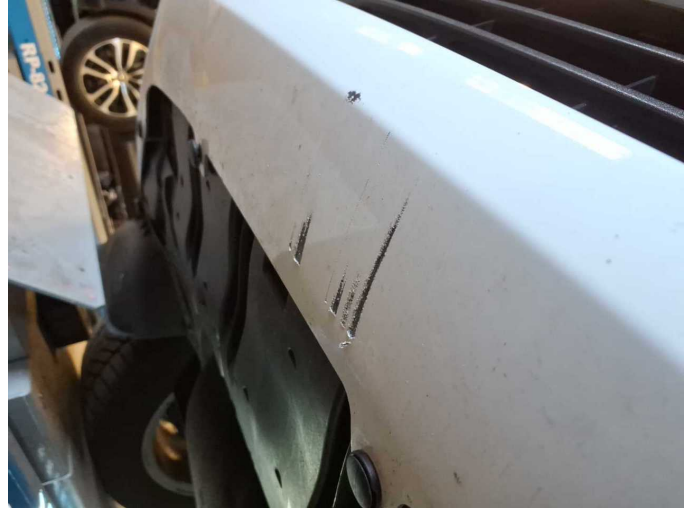
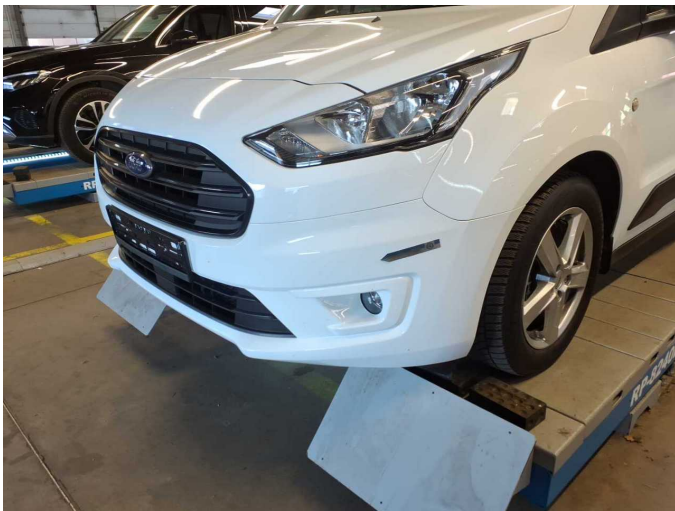
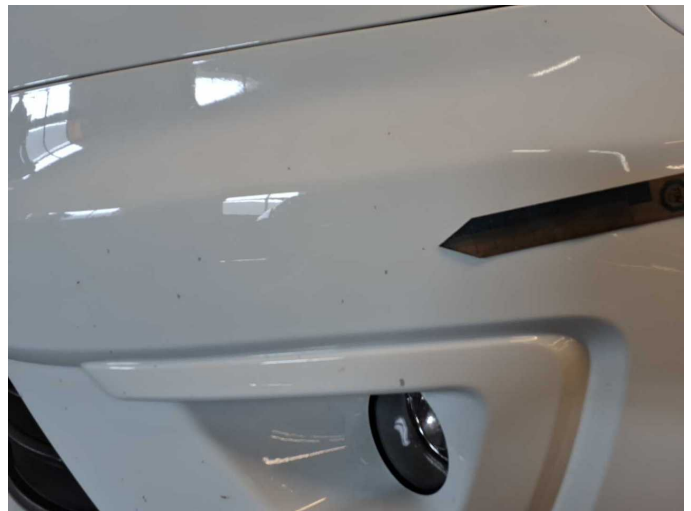
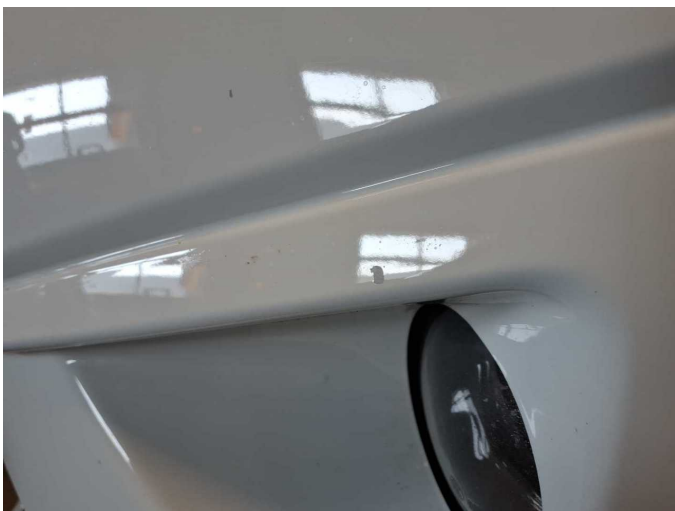
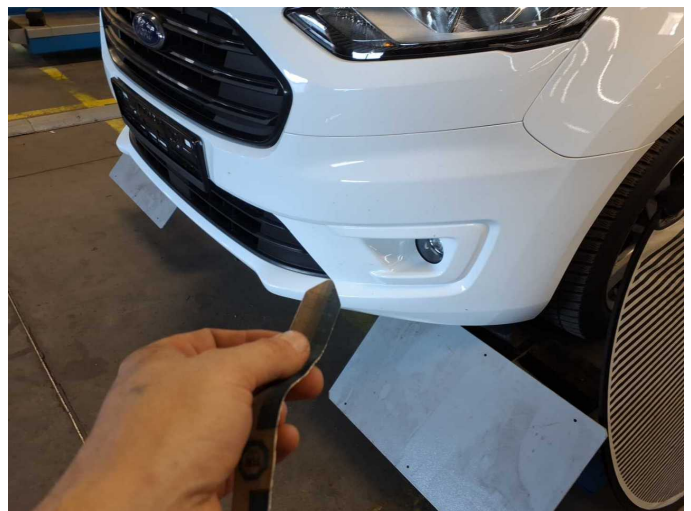
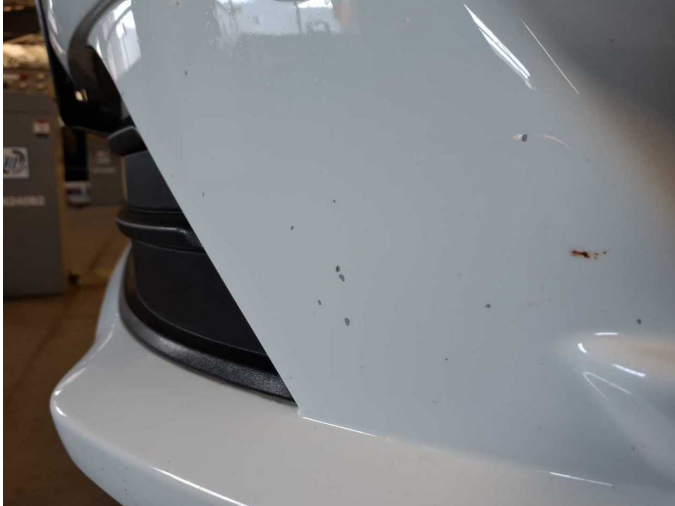
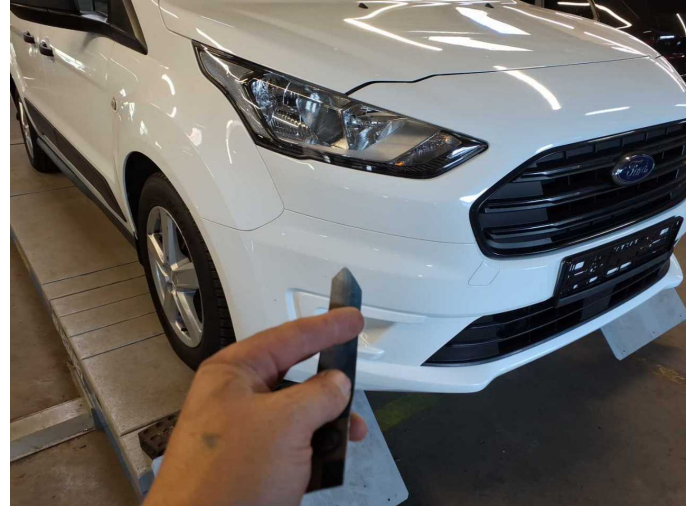
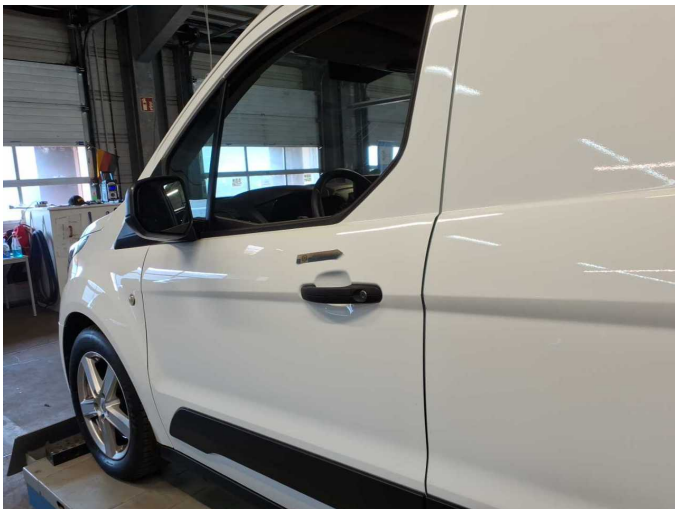
Damage 13: Front bumper: Front bumper (Kratzer) - Stone chips - Paint

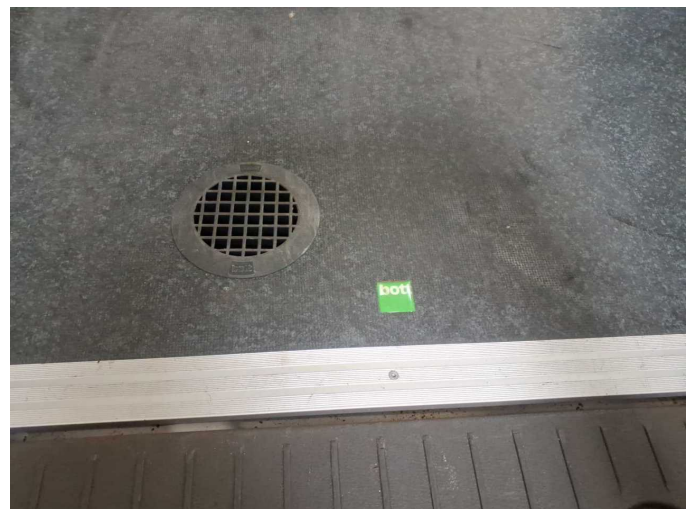
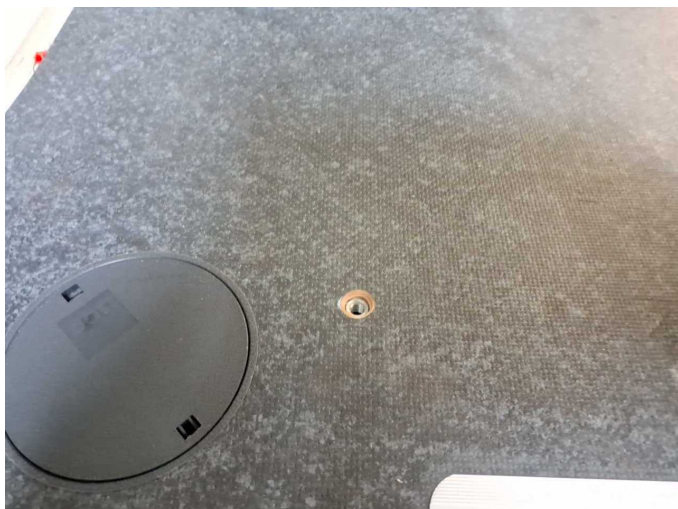
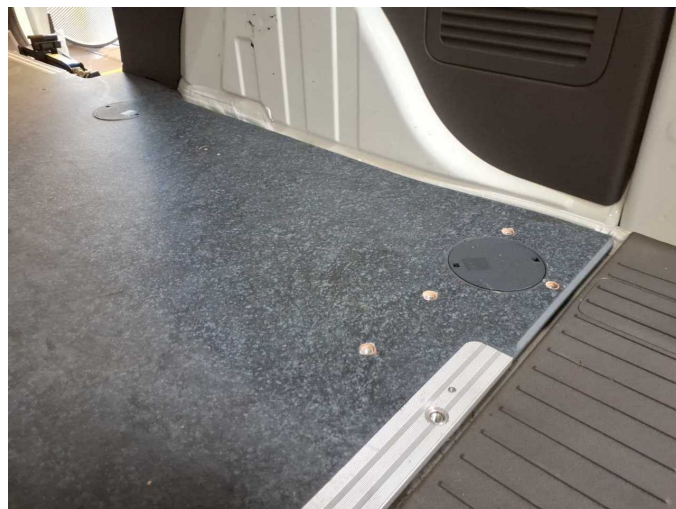
Wear and tear 4: Misc.: Misc. (Regale) - No deduction
