- Vehicle Inspection Report -

Number: 10422095
From: 14.04.2026

Vehicle category:	Passenger Car
Vehicle type:	EstateCar
Make:	Volkswagen
Model:	Passat
Manufacturers and type code:	0603 / BQS
Date of first registration:	05.03.2024
Mileage:	75,784 km
Proof of mileage:	ReadOff
Exterior colour:	Mangangrau Metallic
Roof colour:	Mangangrau Metallic
Propulsion:	Front
Fuel:	Diesel
Engine size (cc):	2,000 ccm
Performance:	110 kW (150 PS)
Length:	
Height:	
Width:	
Permitted total weight:	
Wheelbase:	
Number of powered axles:	2
Cylinders:	4
Euronorm:	Euro 6
Number of doors:	4
Number of seats:	5
Gearbox:	Automatic 7-speed
Upholstery type:	Lining fabrics
Interior colour:	Titanschwarz/Titanschwarz/Titanschwarz
Number of keys:	1

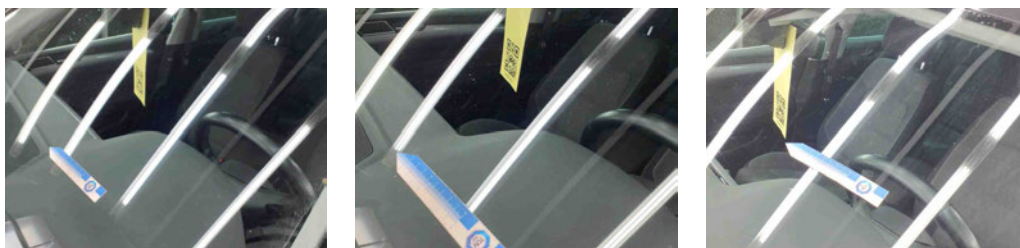
1 - Windscreen - Stone chip(s) - Replace		Repaircosts:	€ 831.00
		Net cost:	€ 831.00
Parts Price			€ 479.00
Body work	32 WU		€ 352.00
Comment	Eingeschränkte Sicht

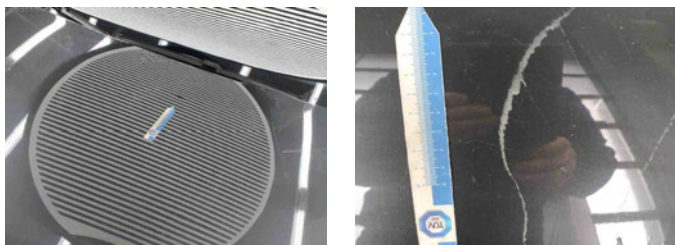
2 - Bonnet - Dent(s) and scratch(es) - Repair and paint (complete)		Repaircosts:	€ 507.50
		Net cost:	€ 355.25
Paint material			€ 147.50
Paint work	30 WU		€ 360.00

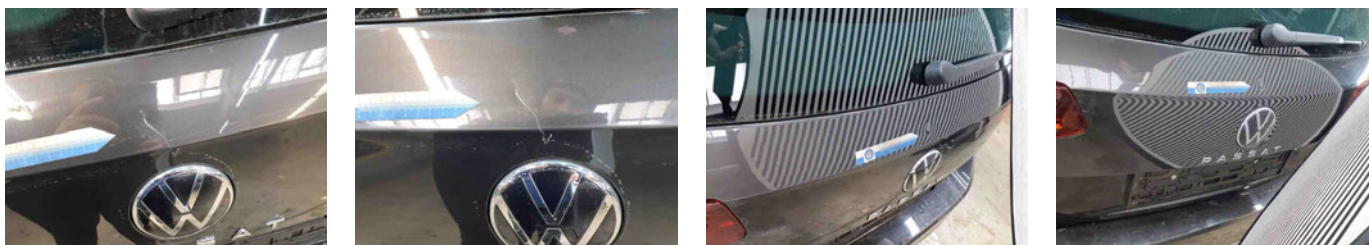
3 - Tailgate / Boot - Dent(s) and scratch(es) - Repair and paint (complete)		Repaircosts:	€ 456.25
		Net cost:	€ 319.38
Paint material			€ 96.25
Paint work	30 WU		€ 360.00

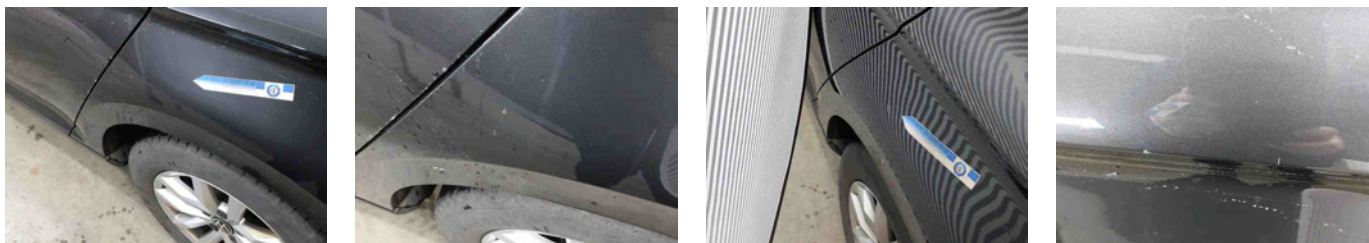
4 - Side wall RL - Dent(s) and scratch(es) - Repair and paint (partial)		Repaircosts:	€ 440.00
		Net cost:	€ 308.00
Paint material			€ 150.00
Body work	10 WU		€ 110.00
Paint work	15 WU		€ 180.00

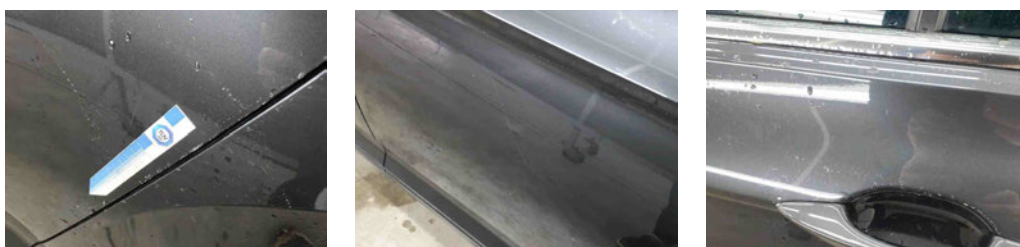
5 - Door RL - Scratch(es) - Repair and paint (complete)		Repaircosts:	€ 365.00
		Net cost:	€ 255.50
Paint material			€ 65.00
Paint work	25 WU		€ 300.00

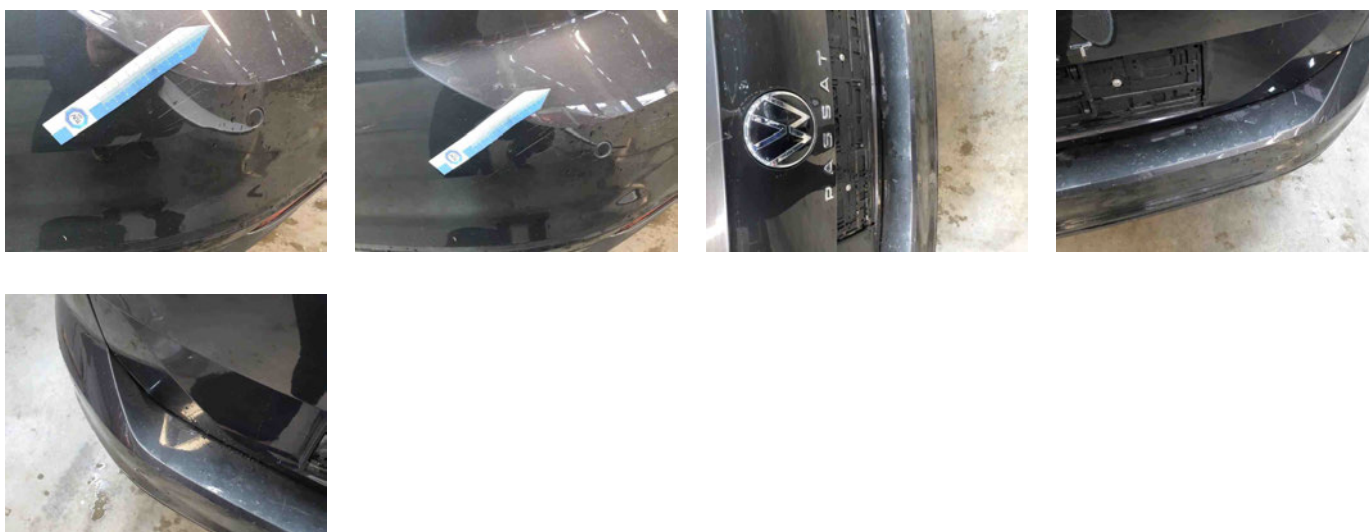
6 - Bumper R - Scratch(es) - Repair and paint (complete)		Repaircosts:	€ 360.50
		Net cost:	€ 252.35
Paint material			€ 72.50
Paint work	24 WU		€ 288.00
